**Report No. CDOT-DTD-R-2005-20
Final Report**

PERFORMANCE OF COLORADO'S FIRST RUBBLIZATION PROJECT ON I 76 NEAR STERLING

**Robert LaForce, P.E.
Yeh and Associates**

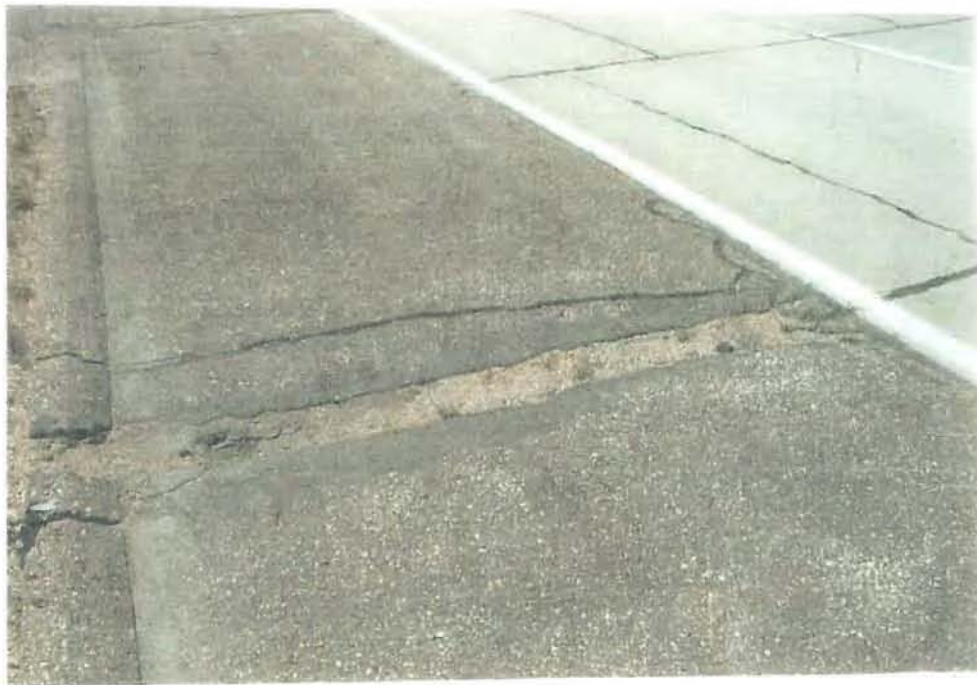
Figure 2. Pre-construction Roadway and Shoulder Condition

The existing asphalt shoulders had extensive cracking and major deterioration. A Bomag CMI 650 Reclaimer was used to break the shoulder material to approximately a minus 1-inch size. This process was used to eliminate any voids present under the old shoulders that might have been caused by erosion over the years. The material was then compacted and graded prior to placement of the asphalt overlay. Figure 2 shows the condition of the asphalt shoulders before they were broken up with the Bomag as well as typical longitudinal cracking on the concrete pavement prior to rubblization.
