**Report No. CDOT-2007-2**  
**Final Report**

# **SERVICE LIFE AND COST COMPARISONS FOR FOUR TYPES OF CDOT BRIDGE DECKS**

**September 2007**

**COLORADO DEPARTMENT OF TRANSPORTATION**  
**RESEARCH BRANCH**

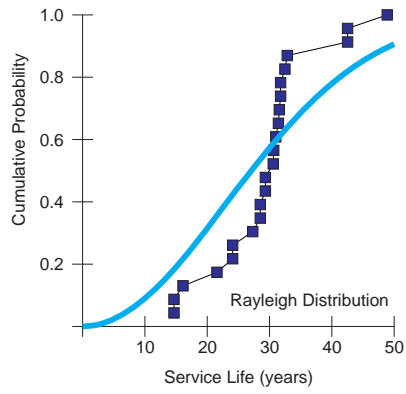
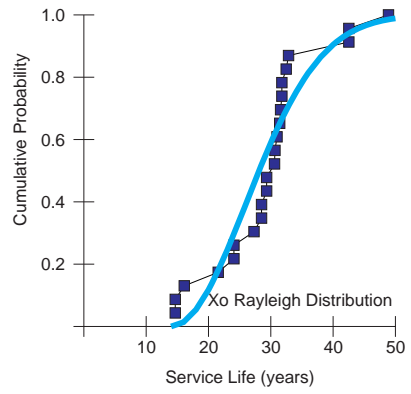
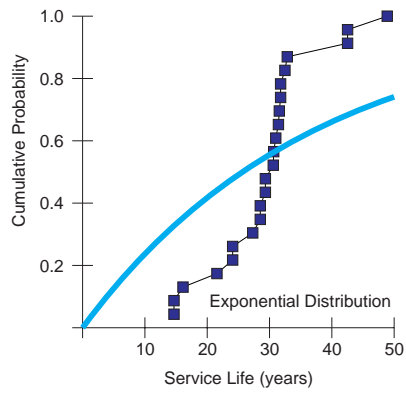
**Figure 8 - Element 23 Service Life Distributions**

Element 23 - Epoxy-Coated Steel, Penetrating Sealers

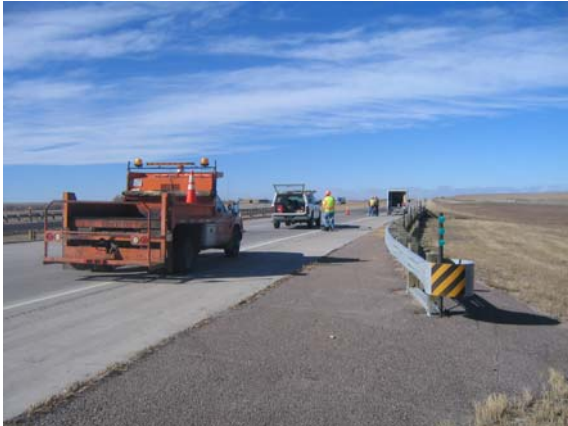
Two bridges were selected in the project for coring concrete samples: G-22-BJ and G-22-BL. See Figure 11 and 12.

**Figure 11 - Bridge G-22-BJ Westbound and CDOT Traffic Control Team**

The concrete samples were then tested for chloride profiles. Information on the concrete cores follows:

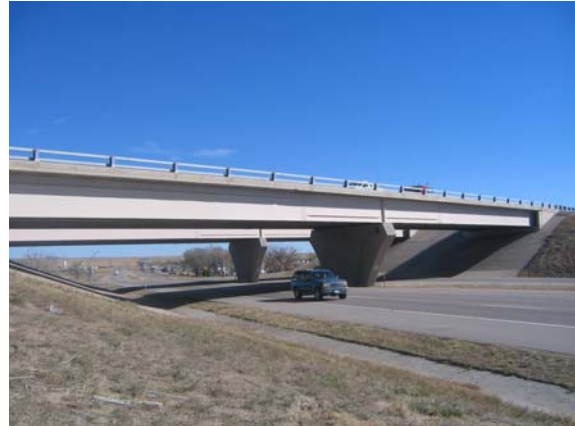
**Figure 12 - Bridge G-22-BL**

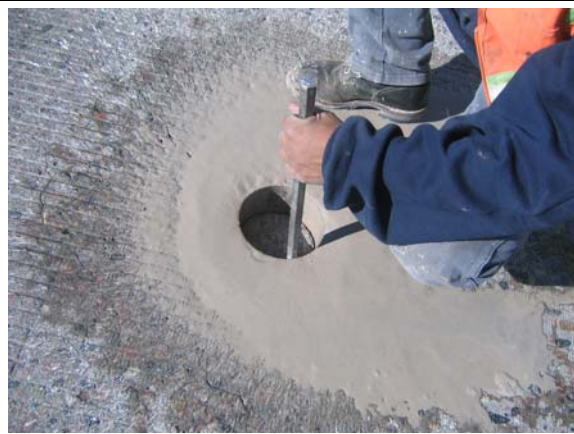
Figure 13 - Coring Concrete Samples on Bridge G-22-BJ. The Core Was Broken in the Traffic Lane

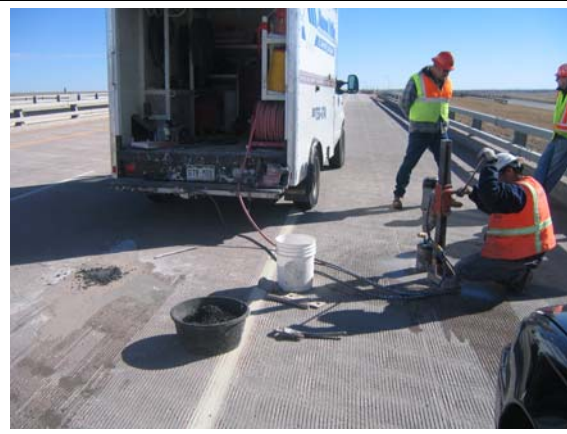
Figure 14 - Coring Concrete Samples on Bridge G-22-BL from the Shoulder
