Report No. CDOT-2009-8
Final Report

CONCRETE DECK PERFORMANCE RELATIVE TO AIR ENTRAINMENT

December 2009

COLORADO DEPARTMENT OF TRANSPORTATION
DTD APPLIED RESEARCH AND INNOVATION BRANCH

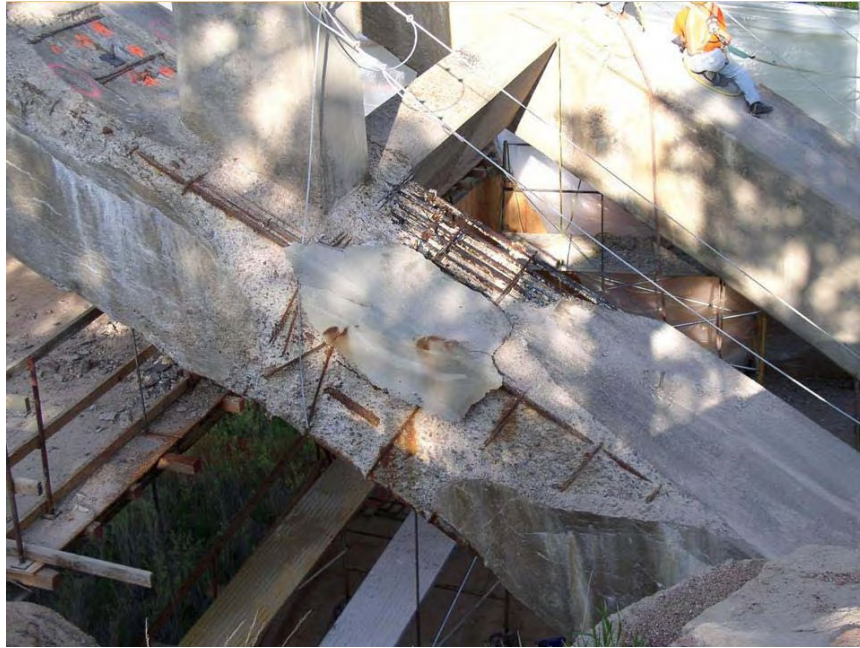
Figure 1. Freeze-thaw deterioration at Castlewood Canyon (Ardani, 2004)

Freeze-thaw (F-T) deterioration of hardened cement paste results from an improper amount and/or distribution of air voids in the paste. When concrete is critically saturated and exposed to below-freezing temperatures, the water in the capillary pores freezes and occupies roughly 9% greater volume. The expansion in turn exerts excessive pore pressure which, when greater than the tensile strength of the concrete, dilates and ruptures the capillary channels. Successive F-T cycles and accumulation of expansive forces disturb the aggregate-paste interface, and the distress manifests over time. The condition is further exacerbated when deicing chemicals used for snow and ice removal infiltrate the concrete and come in contact with the reinforcement through the process of osmosis. Accumulation of moisture in the vicinity of steel can lead to corrosion of the steel. Figure 1 shows a classic F-T problem at Castlewood Canyon's structure on SH 83. F-T action has inflicted significant damage to the arch, causing the concrete to delaminate and exposing the reinforcing steel to corrosion.

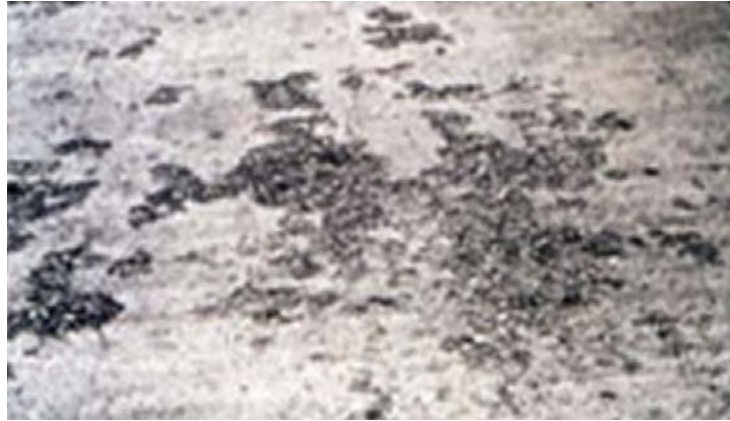
Figure 3. Concrete surface scaling (PCA, 2008)

Scaling normally is caused by excessive finishing of the concrete, causing the bleed water to be worked back into the upper surface of the concrete deck (see Figure 3). A higher water-cement

(w/c) ratio results in lower strength at the surface of the concrete. In addition, excessive finishing results in lower air content, which in turn reduces the resistance of concrete to F-T deterioration.

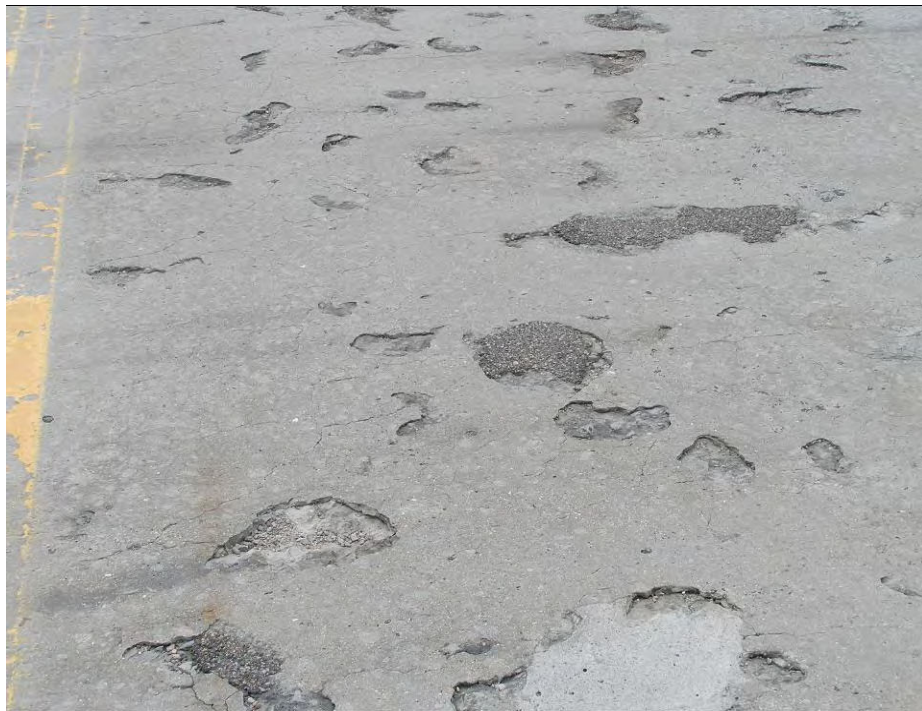
Figure 9. View of scaling on structure D-14-I

Structure D-14-I, built in 1973, is located on SH 7 over St. Vrain Creek, approximately 10 miles southeast of the town of Estes Park. SH 7 at this location is a mountainous, curvy two-lane route with an average daily traffic of 1900 vehicles. Of all the bridge decks investigated for this study, structure D-14-I is the one that exhibited possible signs of F-T with moderate to severe spalling and scaling of the surface (Figure 9). Some of the deeper spalls were patched with asphalt. However, as described in the data analysis section of this report, the petrographic analysis of the cores obtained from the deck of this bridge did not reveal any signs of F-T distress.

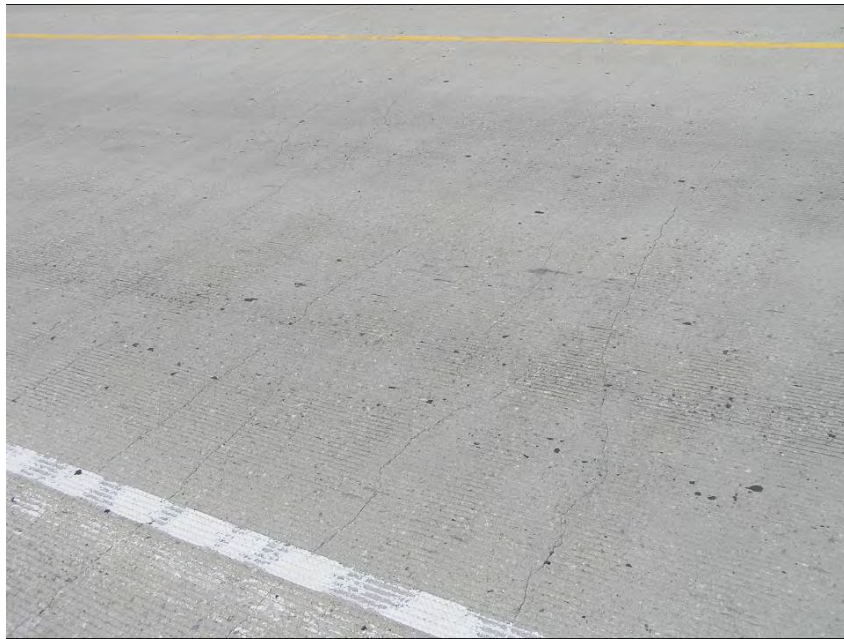
Figure 12. View of transverse cracking at structure F-15-BZ

Structure F-15-BZ over Clear Creek was built in 1999 and currently carries 428 vehicles per day. The structure is the on-ramp to I-70 eastbound, located just west of Idaho Springs (Figure 11). Distresses at this location included transverse cracking that covered the entire deck's surface in approximately 2 to 4-ft (0.6 to 1.2-m) intervals with no visible signs of F-T (Figure 12).

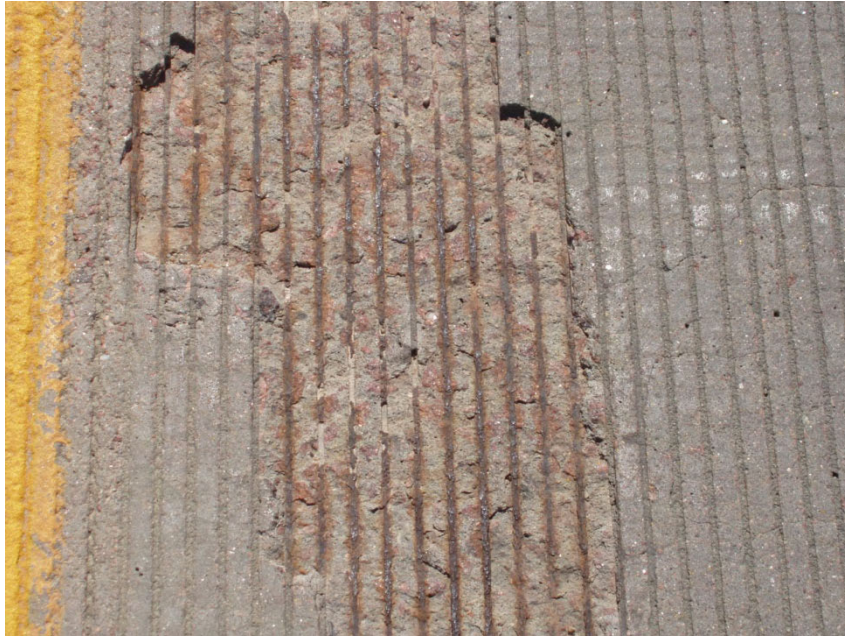
Figure 13. View of a scaling area on structure G-22-BY

Structure G-22-BY , built in 2000 over the Big Sandy Creek, is located at milepost 376.481, immediately south of the town of Limon. With an average daily traffic of 4600 vehicles per day, the deck exhibited shallow map cracking with isolated areas of scaling, as shown in Figure 13.

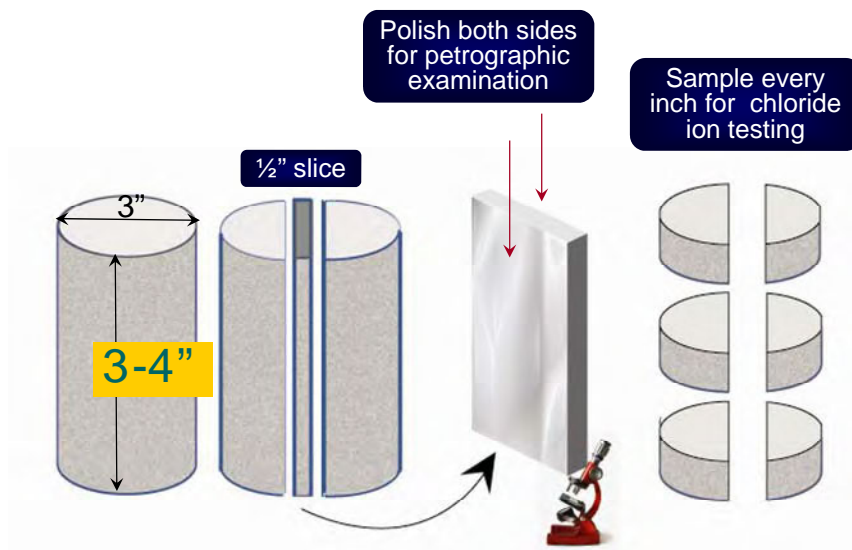
Figure 21. Samples obtained from each core for petrographic and chloride testing

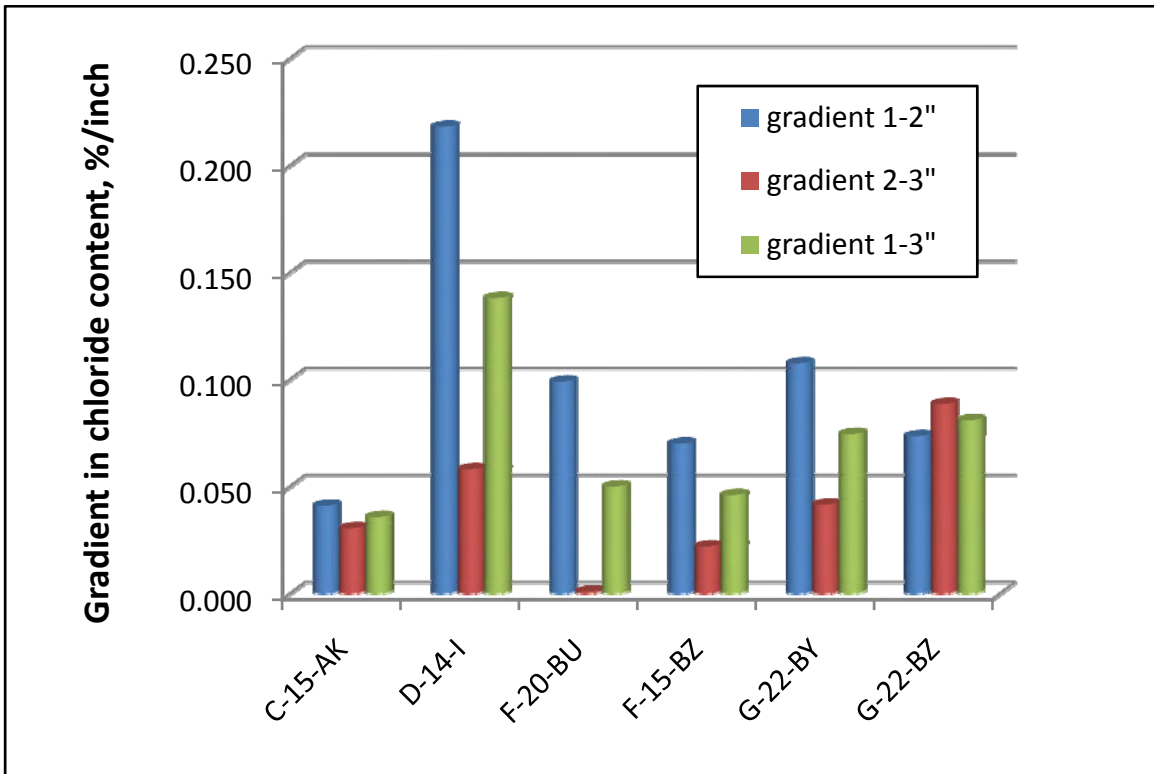
Figure 22. Chloride ion content gradient at three levels in the selected structures

Structure/ Specification		Cl ₂ , 0-1 in	Cl ₂ , 1-2 in	Cl ₂ , 2-3 in	Gradient 1-2 in	Gradient 2-3 in	Gradient 1-3 in
Point of Placement	C-15-AK	0.201	0.160	0.130	0.041	0.031	0.036
	D-14-I	0.285	0.067	0.009	0.218	0.058	0.138
	F-20-BU	0.105	0.006	0.005	0.099	0.001	0.050
Point of delivery	F-15-BZ	0.100	0.030	0.008	0.070	0.022	0.046
	G-22-BY	0.156	0.048	0.007	0.108	0.042	0.075
	G-22-BZ	0.217	0.144	0.055	0.074	0.089	0.081
Average Point of placement		0.197	0.077	0.048	0.119	0.030	0.075
Average Point of delivery		0.157	0.074	0.023	0.084	0.051	0.067

Structures C-15-AK and G-22-BZ show higher variability within the structure. However, the gradients are the same between the two cores from the structure. Also, as discussed previously, the chloride contents are within critical levels and do not signify a difference in durability of the mix or the performance of the structure. The plots shown on the same scale also illustrate the relative chloride ion contents across all structures and across specifications. The results suggest, again, that there is no significant difference in the chloride ion penetration in structures constructed under the two specifications.

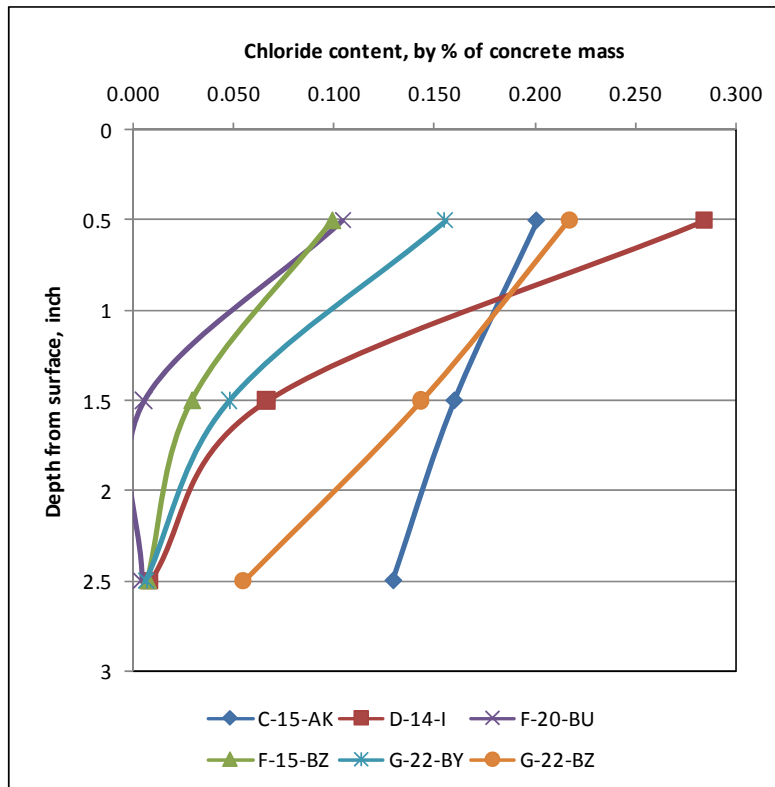
Figure 24. Average chloride ion concentration for all structures

are no clear trends in the distribution that could indicate any change in durability due to the change in specification. Structure D-14-1 shows a higher concentration near the surface, but perhaps it has a low permeability mix design that has maintained low chloride levels at lower depths, comparable to those in the relatively newer structures. Also, it is reasonable to say that the chloride analysis results are consistent with the findings of the air void analysis testing.

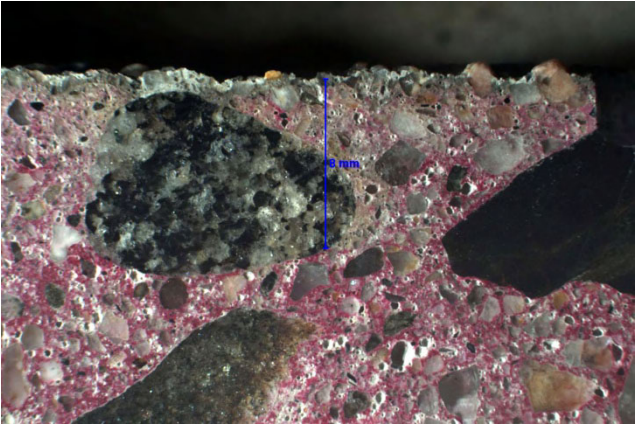
<p>a) SAMPLE: C-15-AK, N DESCRIPTION: Carbonation (unstained) ranges from negligible up to 0.32 in (8 mm) depth from the mortar eroded top surface. MAG: 5X</p>

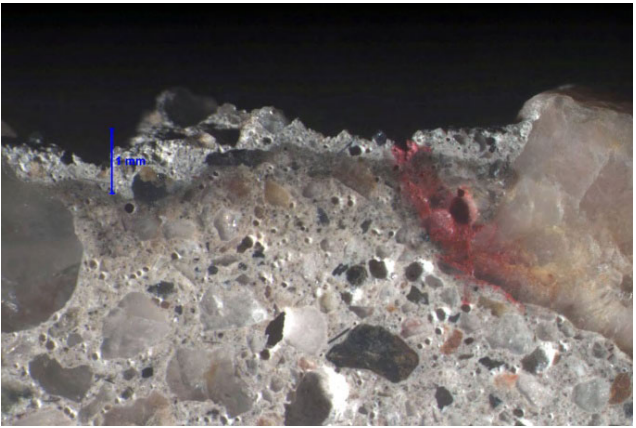
<p>b) SAMPLE: C-15-AK, N DESCRIPTION: The top up to 0.04 in (1 mm) on the concrete was characterized by a very soft, white paste. MAG: 15X</p>

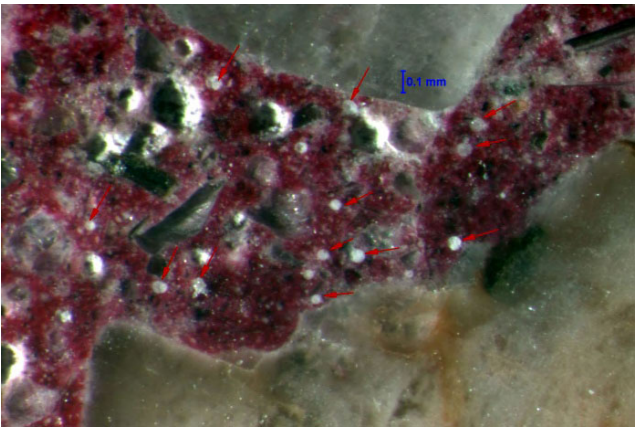
<p>c) SAMPLE: C-15-AK, N DESCRIPTION: White, ettringite-filled entrained air void spaces in phenolphthalein-stained paste at 0.71 in (18 mm) depth from the top surface of the core. MAG: 50X</p>

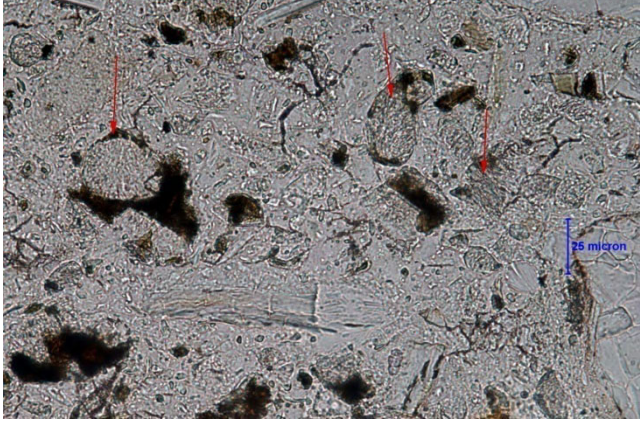
<p>a) SAMPLE: C-15-AK, N DESCRIPTION: Fully hydrated belites portland cement clinker relicts in thin section of concrete paste under plane polarized light. MAG: 400X</p>

consisted mostly of granite, gneiss, schist, quartzite, sandstone, and some shale. w/c ratio was estimated to be 0.45 to 0.5, and the alites and belites were fully hydrated. (Figures 27a, 27c)

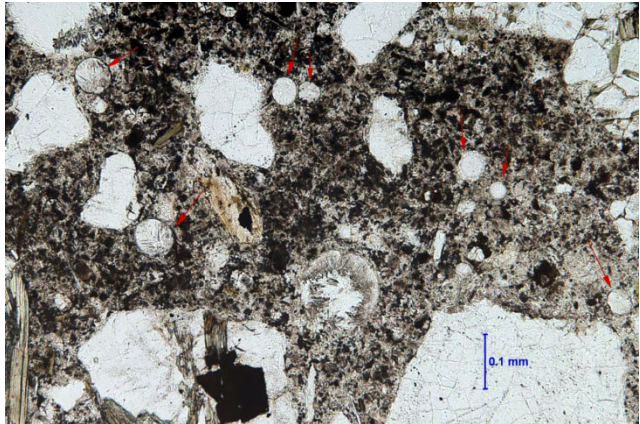
<p>b) SAMPLE: C-15-AK, C DESCRIPTION: Ettringite-filled entrained air void spaces (arrows) in thin section of concrete paste under plane polarized light MAG: 100X</p>

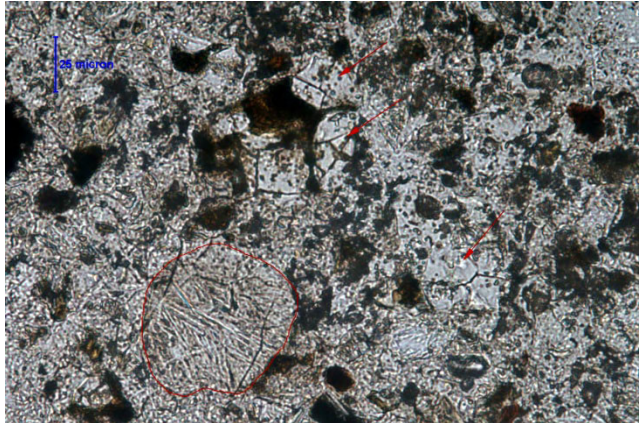
<p>c) SAMPLE: C-15-AK, C DESCRIPTION: Fully hydrated alites (arrows) and belites (circled) portland cement clinker relicts in thin section of concrete paste under plane polarized light. MAG: 400X</p>

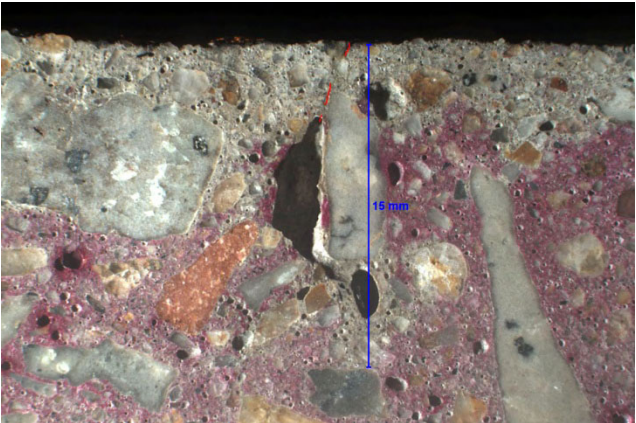
<p>a) SAMPLE: D-14-I (1) DESCRIPTION: Carbonation (unstained) proceeds up to 0.63 in (16 mm) depth from the mortar eroded top surface, along consolidation void space. Microcrack is mapped in red dash line. MAG: 5X</p>

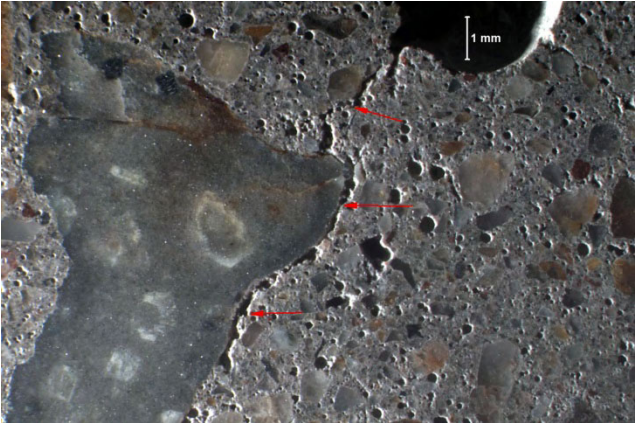
<p>b) SAMPLE: D-14-I (1) DESCRIPTION: Sinuous bleed water void space/channel proceeds along paste-coarse aggregate boundary at depth in the core. MAG: 10X</p>

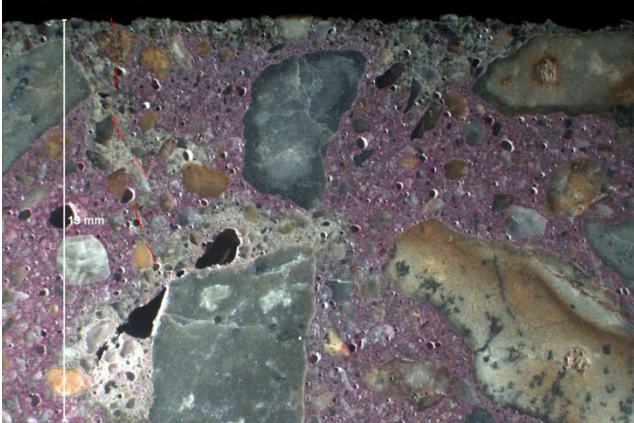
<p>a) SAMPLE: D-14-I (2) DESCRIPTION: Carbonation (unstained) proceeds up to 0.75 in (19 mm) depth from the mortar eroded top surface, along sub-vertical microcracking and consolidation void space. Microcrack is mapped in red dash line. MAG: 5X</p>

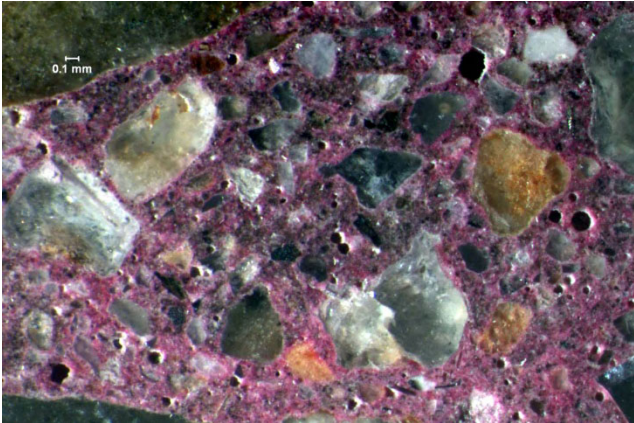
<p>b) SAMPLE: D-14-I (2) DESCRIPTION: Fine air void spaces relatively clean and free of secondary ettringite fillings. MAG: 30X</p>

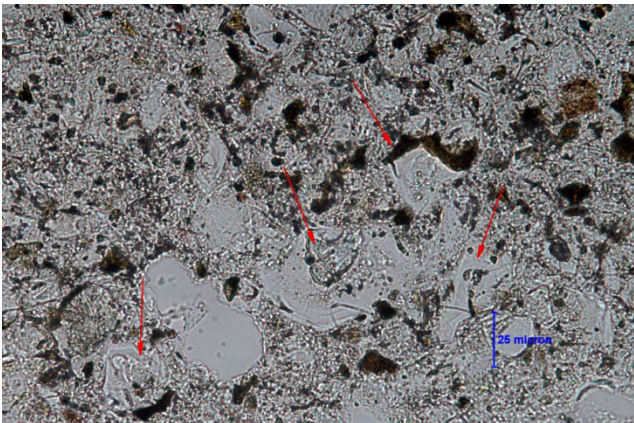
<p>a) SAMPLE: D-14-I (1) DESCRIPTION: Well to fully hydrated alites portland cement clinker particles in thin section of concrete paste under plane polarized light MAG: 400X</p>
---	---

Coarse aggregate was 1-in (25 mm) maximum sized crushed trap rock composed of felsites, and well graded and uniformly distributed. The w/c ratio was estimated to be between 0.43 and 0.48, and the alites and belites were well to fully hydrated (see Figure 30).

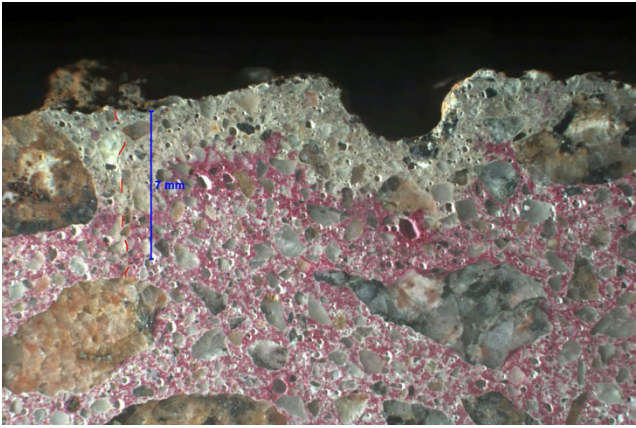
<p>a) SAMPLE: F-20-BU, E DESCRIPTION: Carbonation (unstained) ranges from negligible up to 0.28 in (7 mm) depth, intermittently, from the top surface of the core. MAG: 5X</p>

Magnified images of the two cores are presented in Figures 31 and 32. The cores from this structure had a rough mortar eroded surface with exposed fine aggregates. The cores also showed evidence of diamond sawn transverse tining, 0.16 in (4 mm) wide and 0.10 in (2.5 mm) deep. Drying shrinkage microcracks were observed up to comparable depths in both cores, 0.47 in (12 mm) in one core and 0.60 in (15 mm) in the other. Carbonation was not extensive in this structure, but where observed, it extended 0.28 to 0.35 in (7 to 9 mm) deep (see Figure 31). The concrete was considered to offer only limited F-T resistance.

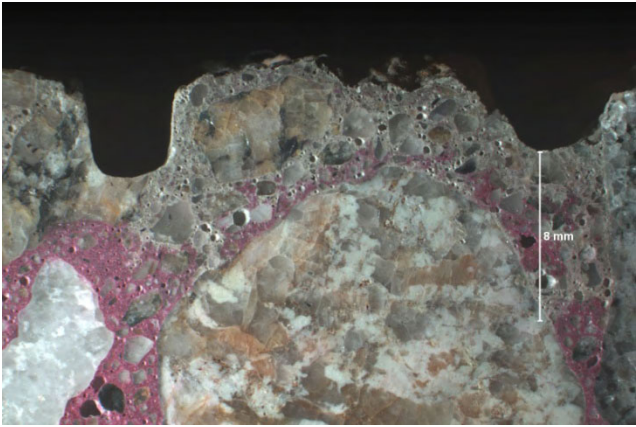
<p>b) SAMPLE: F-20-BU, C DESCRIPTION: Carbonation (unstained) ranges from negligible up to 0.28 in (7 mm) depth, intermittently, from the top surface of the core. MAG: 5X</p>

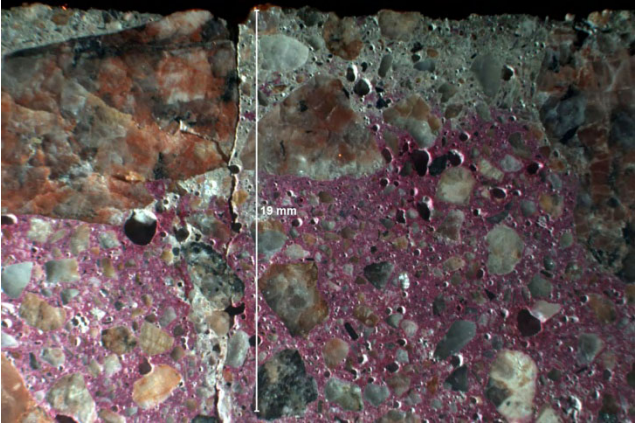
<p>a) SAMPLE: G-22-BY, N DESCRIPTION: Carbonation (unstained) proceeds up to 0.75 in (19 mm) depth, intermittently from the top surface of the core, along sub-vertical microcracking. MAG: 5X</p>

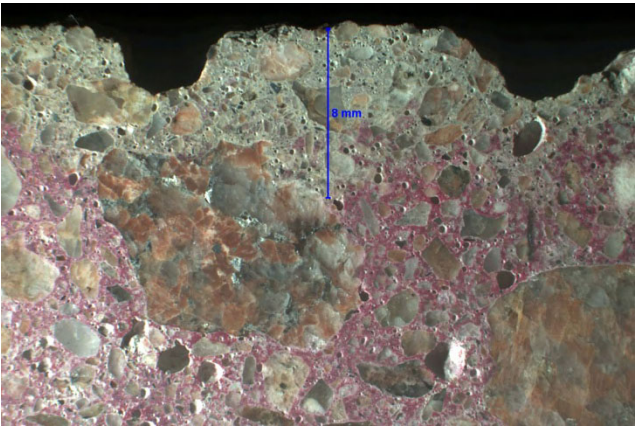
<p>b) SAMPLE: G-22-BY, S DESCRIPTION: Carbonation (unstained) proceeds up to 0.32 in (8 mm) depth from the top surface of the core MAG: 5X</p>

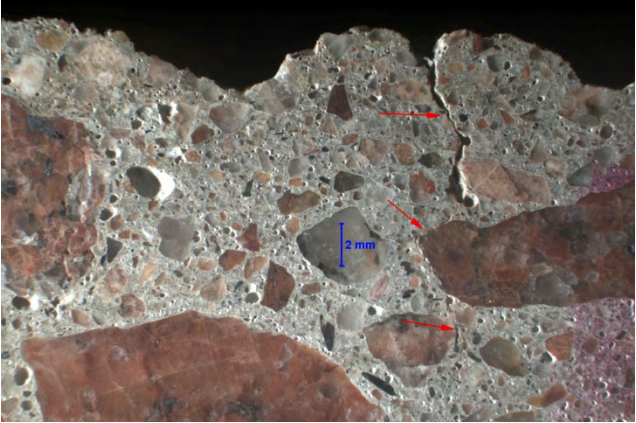
<p>c) SAMPLE: G-22-BY, S DESCRIPTION: Plastic shrinkage macrocrack proceeds intermittently from the top surface of the core. MAG: 5X</p>

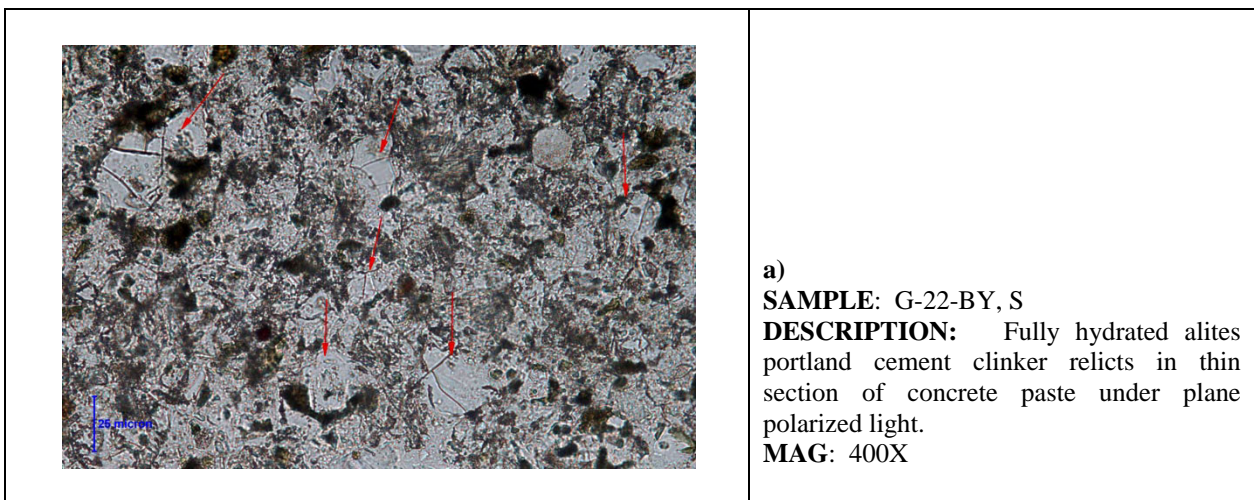
Figure 37. Examination under plane polarized light for structure G-22-BY

Coarse aggregate was ¾-in (19 mm) maximum sized crushed granite with well graded and uniform distribution. The w/c ratio was estimated to be between 0.39 and 0.44, and the alites and belites were mostly fully hydrated (see Figure 37).

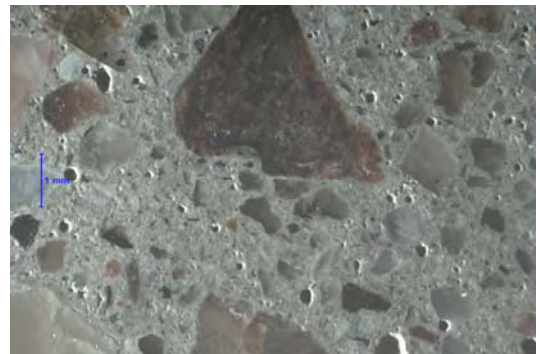
Magnification: 15x
Description: Hardened air void system.

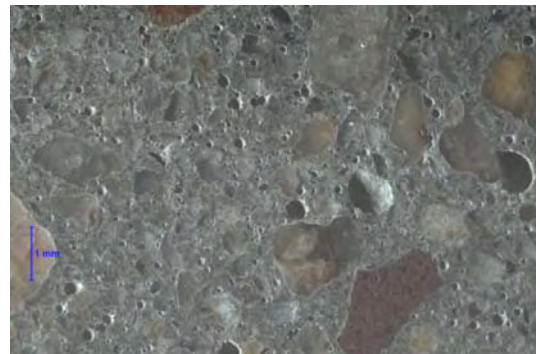
Magnification: 15x
Description: Hardened air void system.

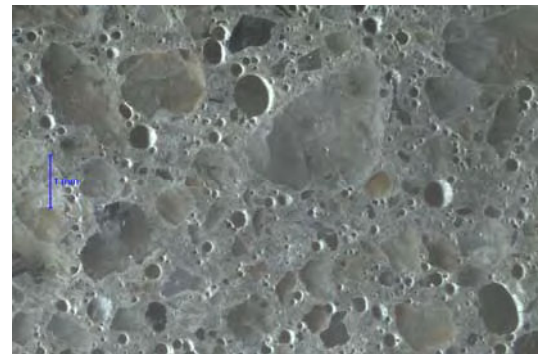
Magnification: 15x
Description: Hardened air void system.

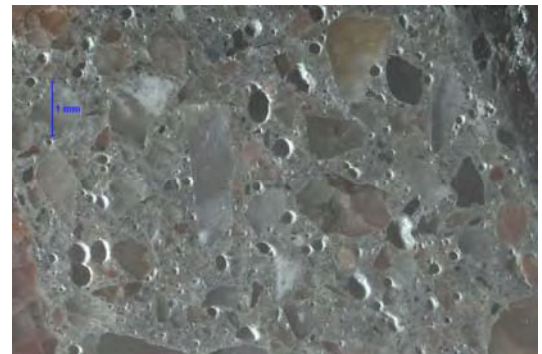
Magnification: 15x
Description: Hardened air void system.

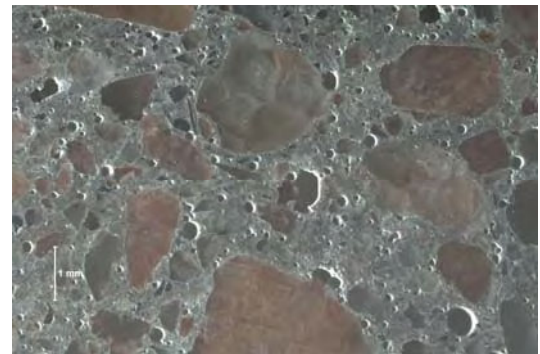
Magnification: 15x
Description: Hardened air void system.
