COLORADO
Department of Transportation

Evaluation of Tack Coat Bond Strength Tests

Report No. CDOT-2018-14
May 2018

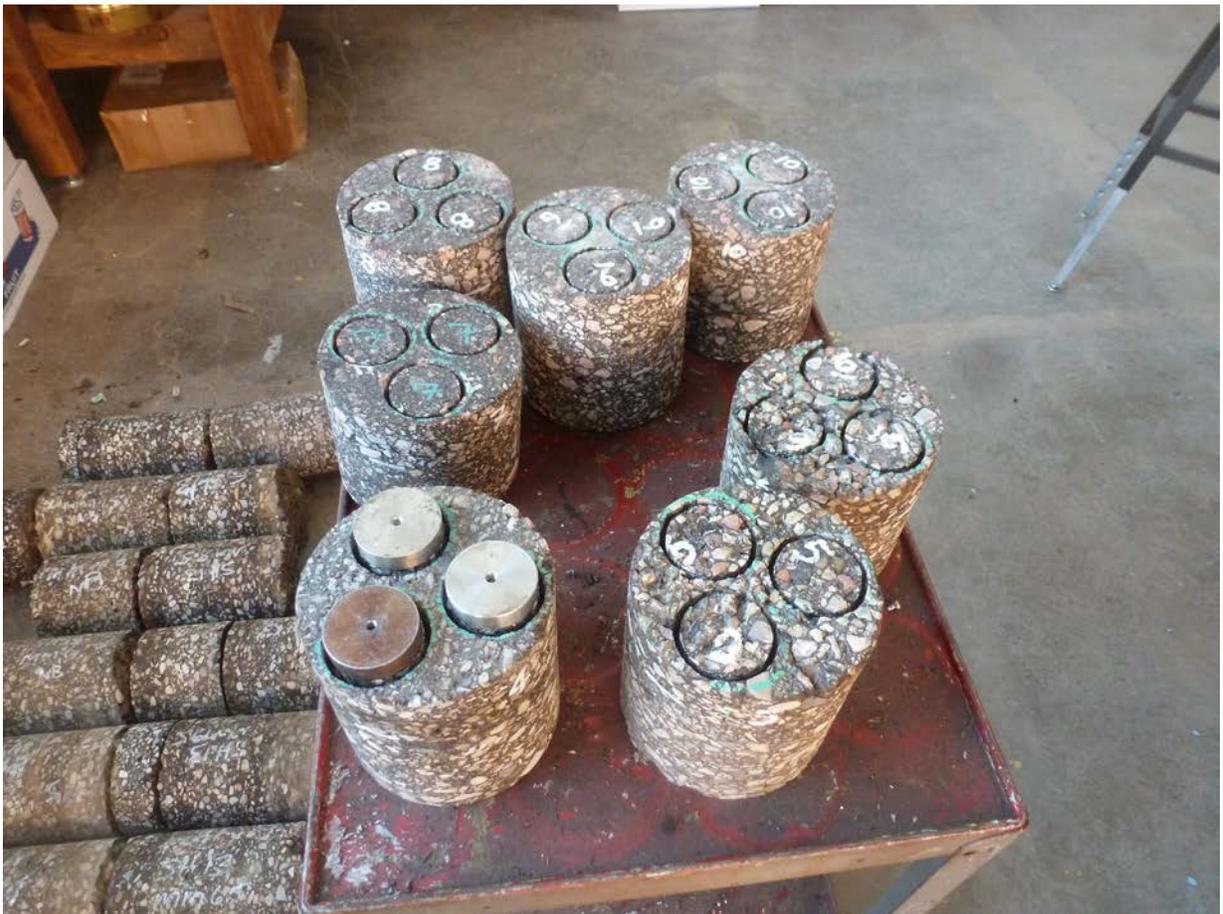
Figure 1. Direct Tension Cores

The cores were taken to the CSU laboratories in preparation for delamination testing. This preparation consisted of cutting three 2-inch diameter cores from within the six-inch cores as shown in Figure 1. Grips are cemented to the top of the core as shown in the lower left of Figure 1.

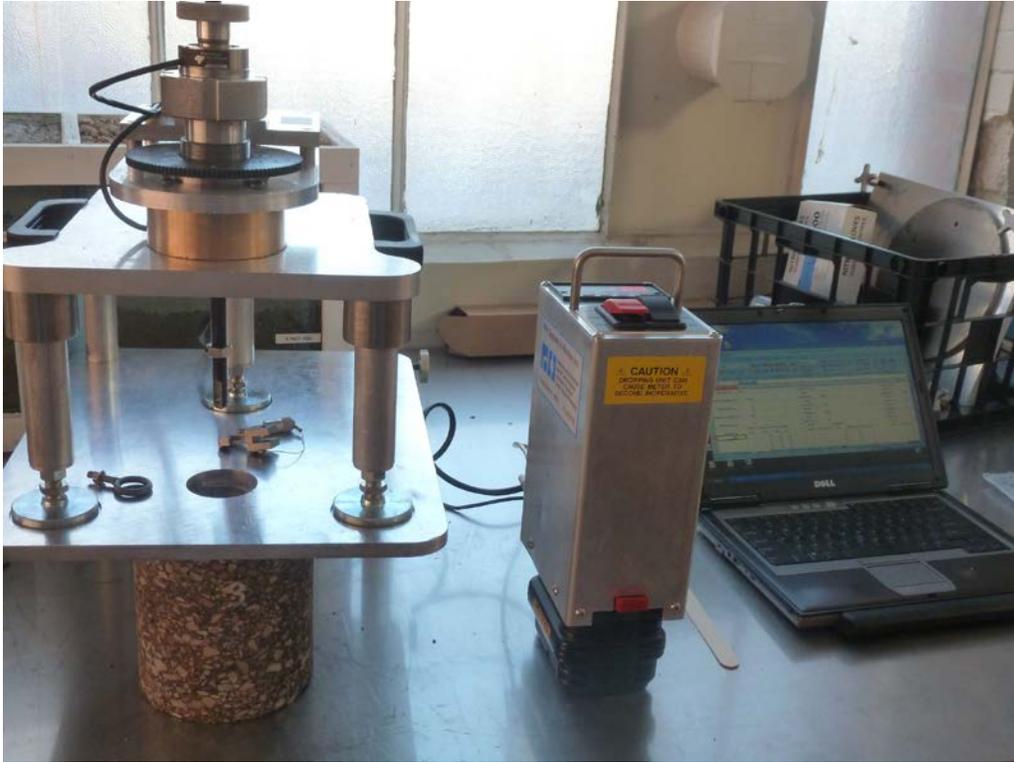
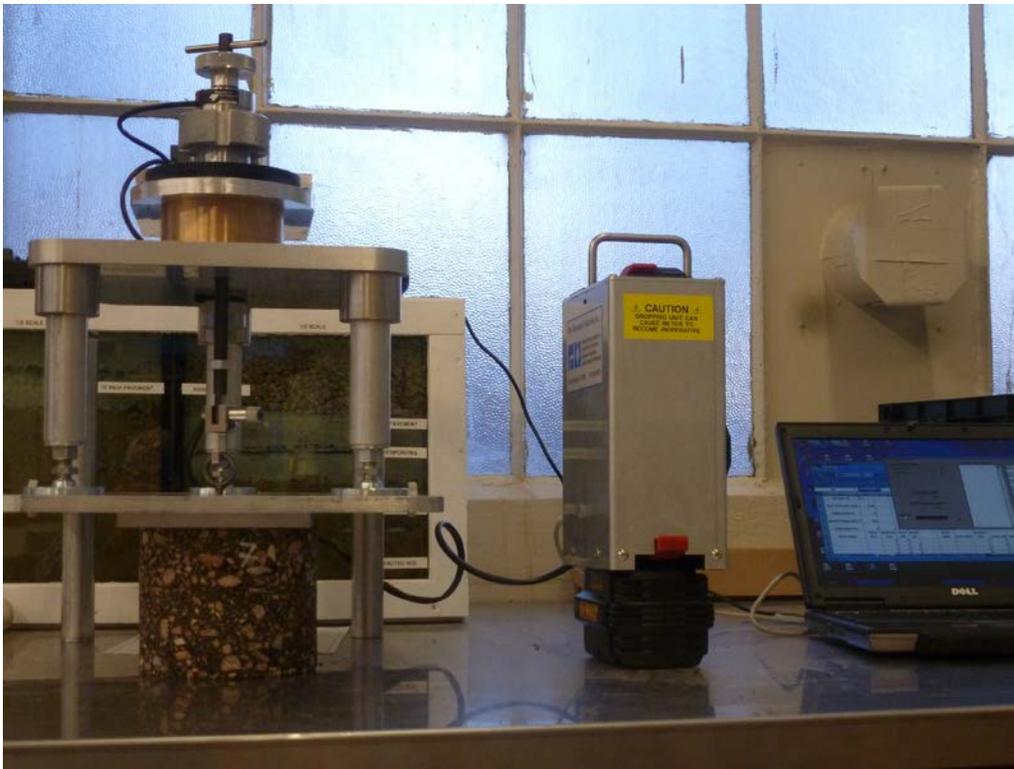
Figure 2. Direct Tension Apparatus

The six-inch core is positioned below the testing apparatus as shown in Figures 2 and 3. The grip is attached to the testing apparatus and the device begins to pull the grip away from the core. A successful test was when the core separated at the tack coat interface as shown in Figure 4. However, over 30 percent of the samples failed at the grip as seen in Figure 5.

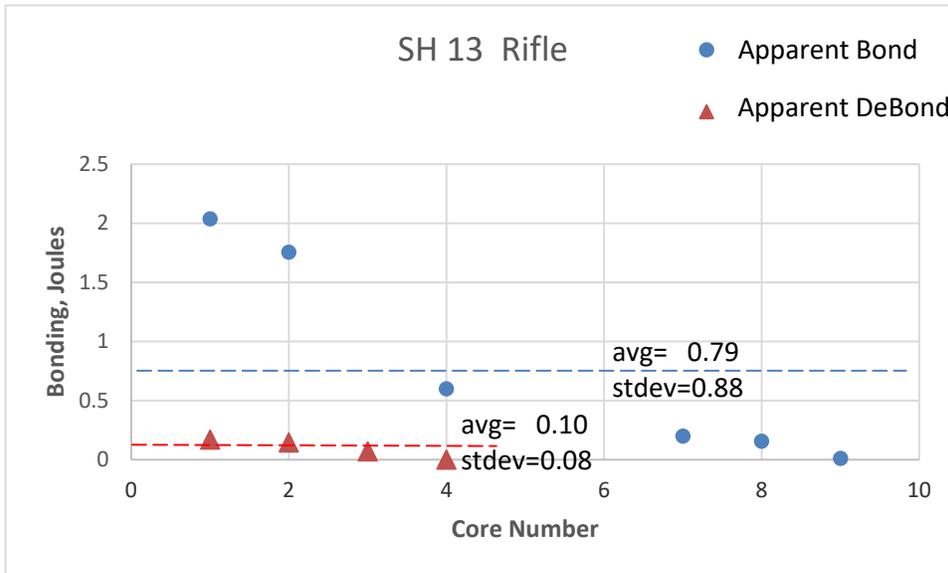
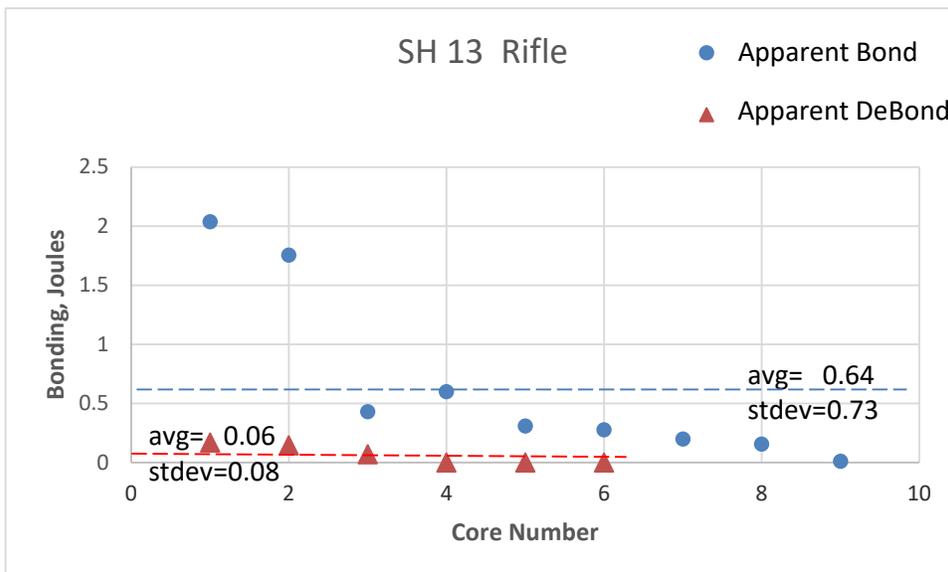
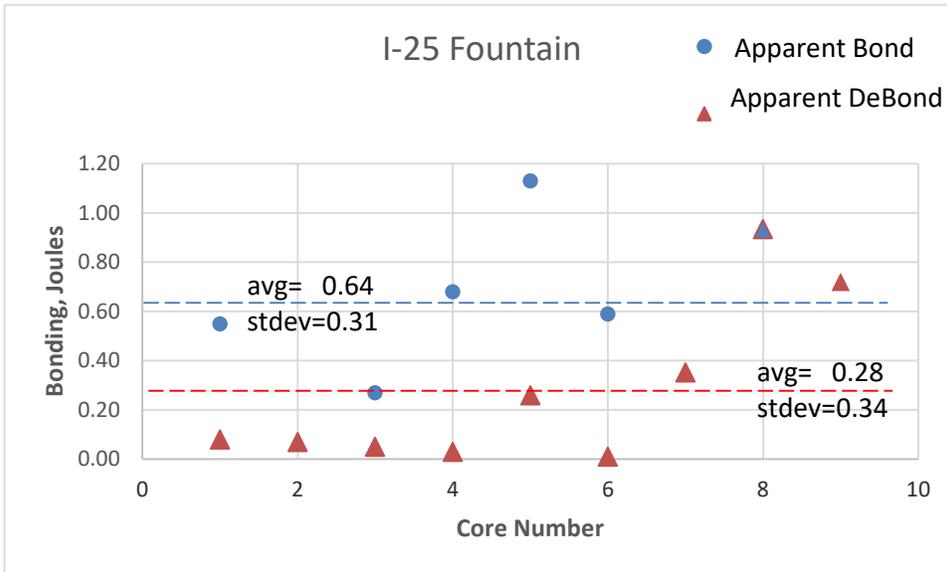
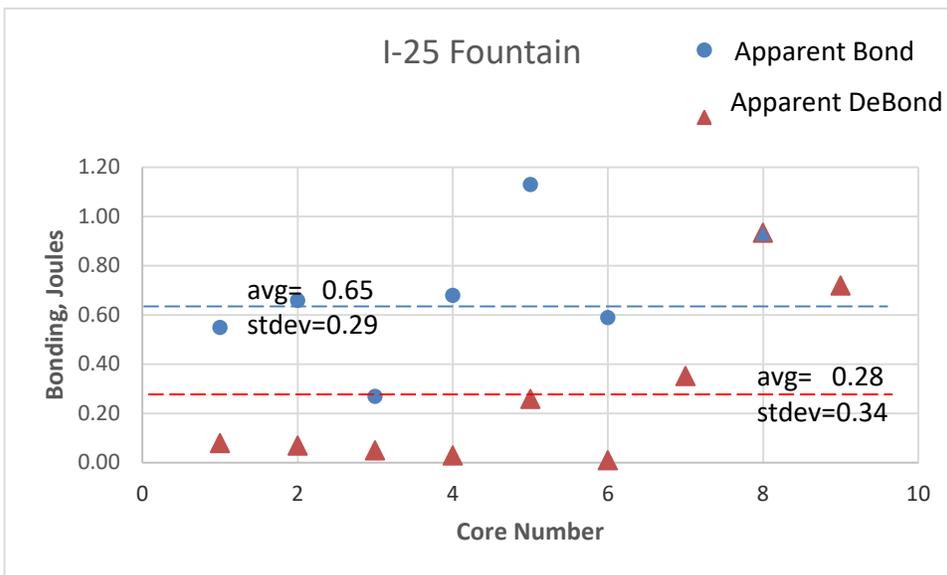
The work energy in Joules required to separate the overlay from the substrate is recorded and appears in Figures 6a and 6b for SH13 and 7a and 7b for I-25. Figure a is for cores that separated at the tack coat between the overlay and the substrate pavement. Figure b includes all cores, including those that failed at the grips. Tensile failure at the grips was always a very low value, hence the decrease in average work energy required to cause failure for both SH13 and I-25 cores.

Results shown above indicate that the cores from areas of the pavements where no delamination or lack of bonding is apparent appear to have higher bond strength than cores from areas of the pavement where debonding was evident. However, the variation in the test results is unacceptably high with standard deviations nearly equal to or greater than the average bond strength for three of the four groups of tests. This means the test cannot distinguish between well-bonded and poorly-bonded samples.

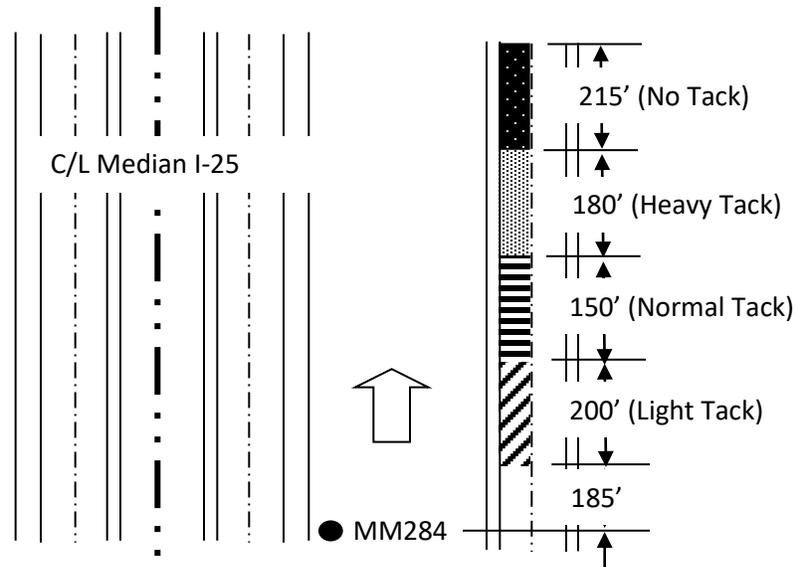
Figure 8. Bond Strength Test Sections on East Frontage Road of I-25

Site 3 was constructed on July 2, 2014 on the east frontage road of I-25 immediately north of mile marker 284. Four rates of tack coat were applied the surface of the existing asphalt pavement prior to placing the overlay as shown in Figure 8. CDOT Region 4 constructed the overlay by placing 1.5 inches of SX hot mix asphalt over the existing asphalt pavement. The tack coat applied was a CSS-1h emulsion with 65% residue by weight diluted 50:50 prior to spraying.

The ‘Normal’ tack coat rate was based on 250 gallons of tack coat emulsion placed in 2500 feet of roadway 15 feet wide. This equates to 0.06 gallons per square yard. The ‘light’ tack coat rate was achieved by doubling the speed of the tack coat distributor and the ‘heavy’ tack coat rate was achieved by slowing the speed by half. At these speeds the light rate and heavy rates, respectively would be 0.03 and 0.12 gallons per square yard.

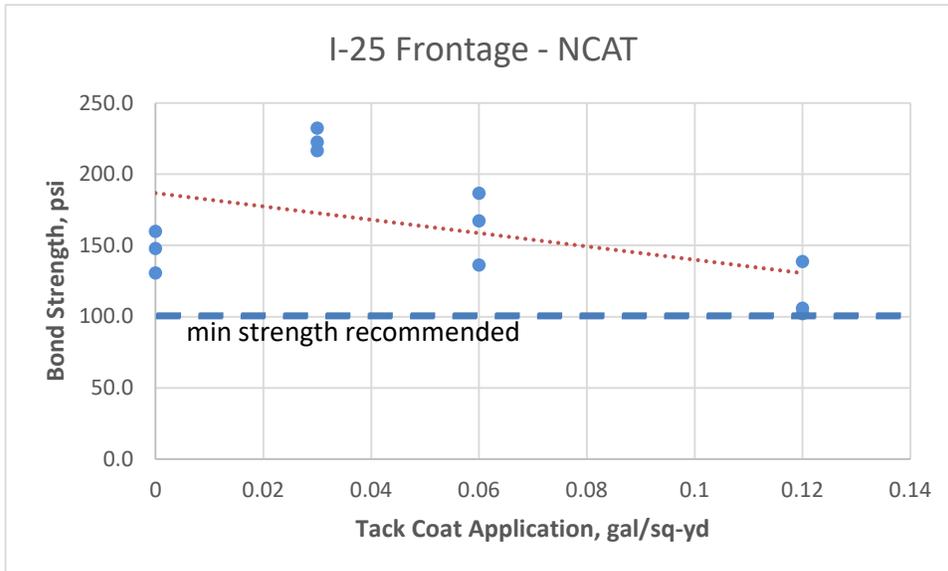
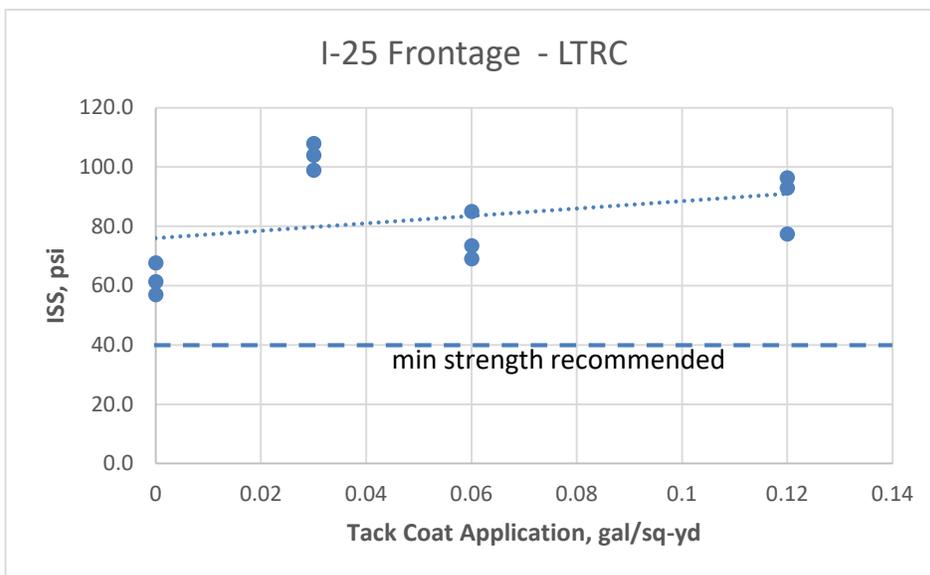
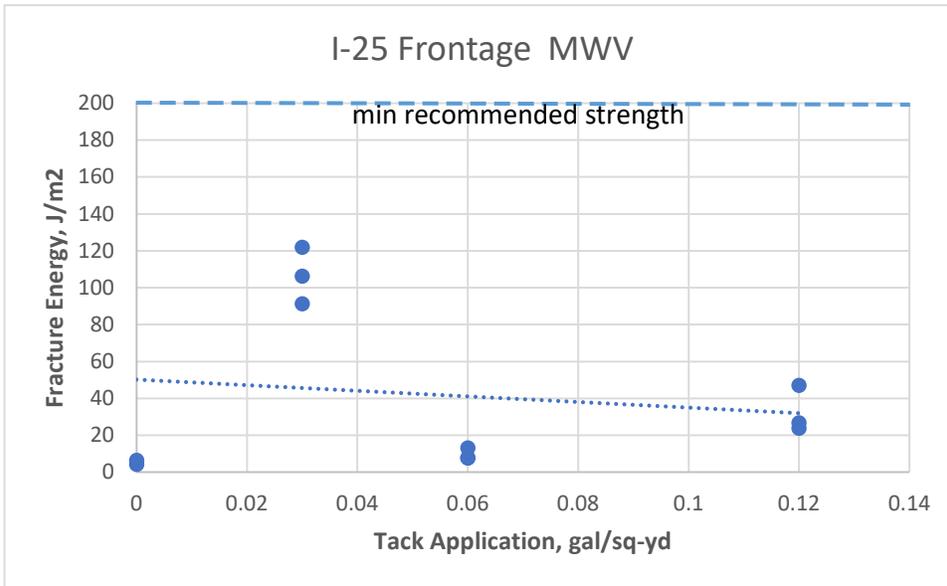
Results of all bond strength tests from Site 3 are shown in Figures 9, 10 and 11 below. The objective this research was to find a test that could discriminate between the various tack coat application rates. Therefore, although the dependent variable (y-axis) is unique to each test the tests can still be evaluated for how well each is able to determine the tack coat application rate. That is, if the tests cannot tell the difference between low tack coat rates and high rates, the value of the test must be questioned. Although cores were carefully wrapped and shipped in wooden crates, some cores were damaged and could not be tested. That is why, in some cases,

fewer than three data points are shown for some tack coat application rates. For example, in Figure 11 only two data points appear for the 0.06 gallon per square yard rate for the MWV tests.

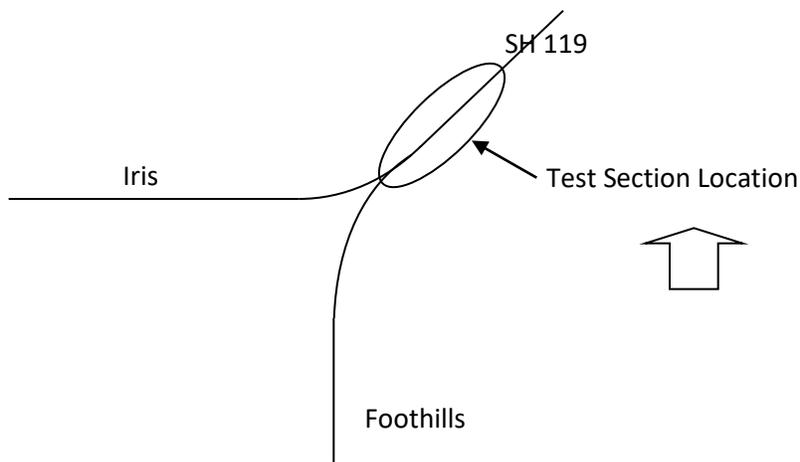
Figure 12. General Location of Test Sections on SH 119

The Site 4 project was constructed on July 15, 2014. CDOT Region 4 constructed the overlay by placing 1.5 inches of SX hot mix asphalt over the existing asphalt pavement. The tack coat applied was a CSS-1h emulsion with 65% residue by weight diluted 50:50 prior to spraying. It is located on SH119 in the northeast bound direction north of the intersection of Iris and Foothills Blvd near Boulder, CO. An area map is shown in Figure 12 and specific test segments are shown in Figure 13.

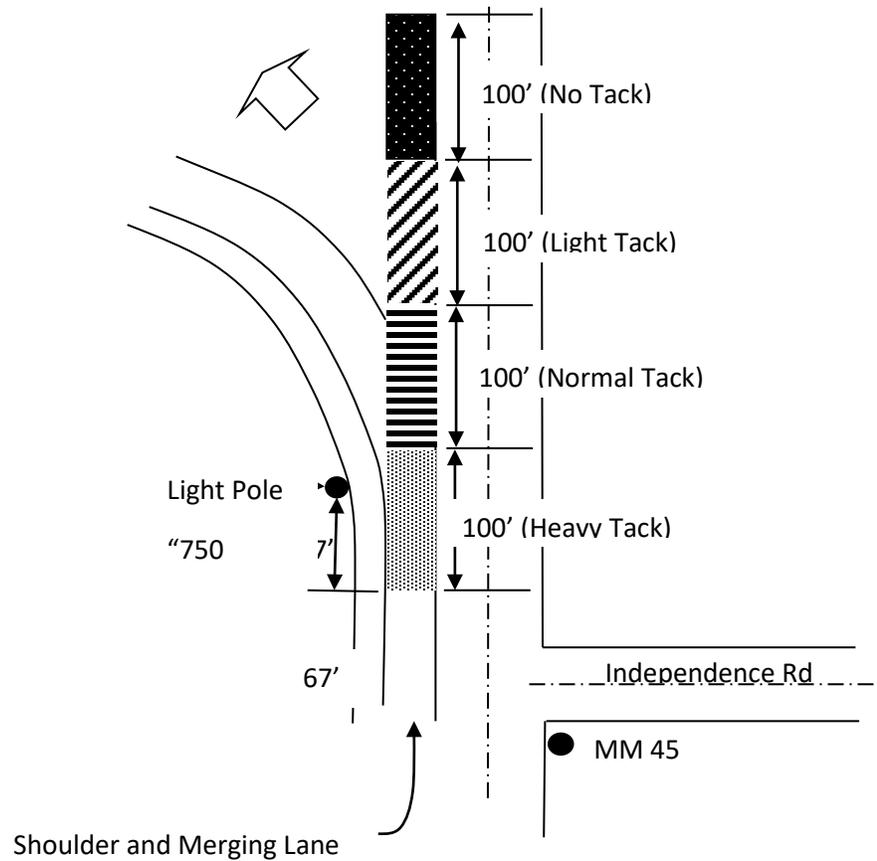
Figure 13. Specific Test Section Locations on SH 119

The ‘Normal’ tack coat rate was based on 250 gallons of tack coat emulsion placed in 3450 feet of roadway 13 feet wide. This equates to approximately 0.05 gallons per square yard. The ‘light’ tack coat rate was achieved by doubling the speed of the tack coat distributor and the ‘heavy’ tack coat rate was achieved by slowing the speed by half. At these speeds the light rate and heavy rates, respectively would be 0.025 and 0.10 gallons per square yard.

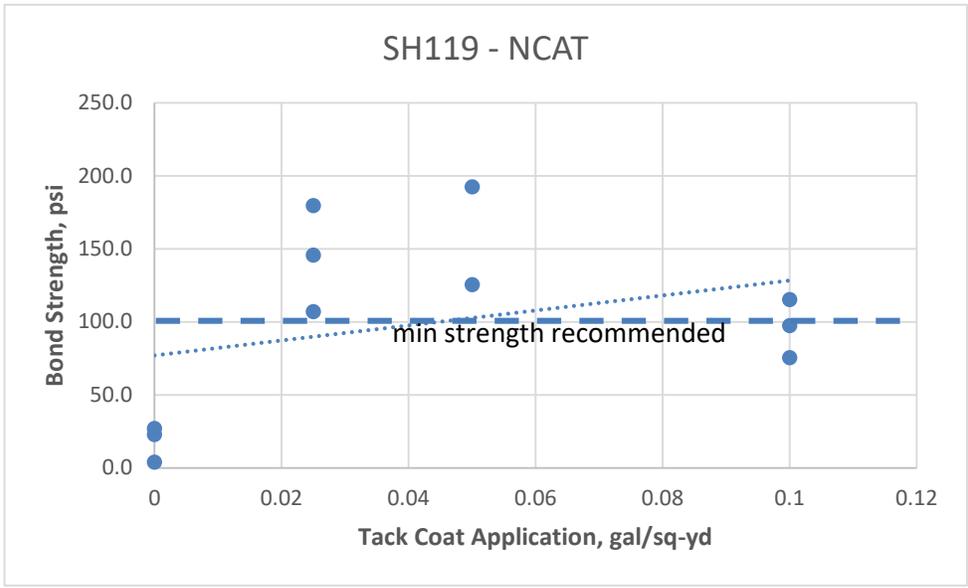
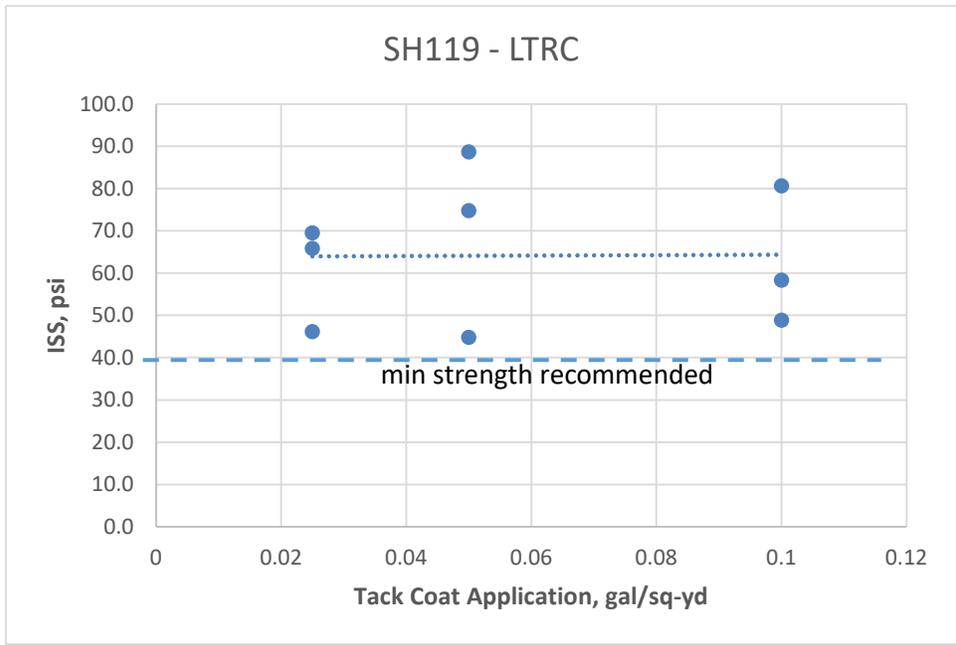
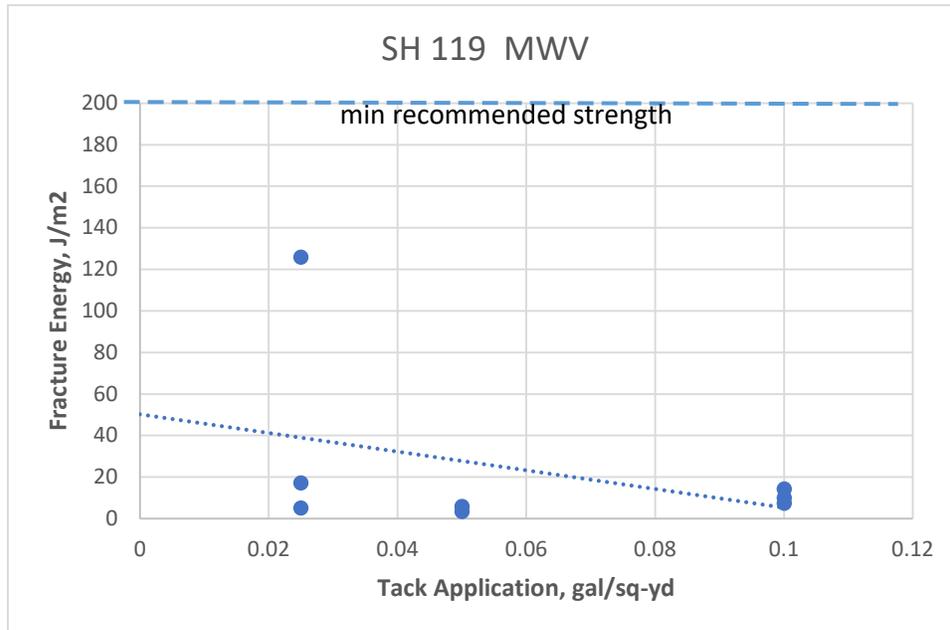
Results of all bond strength tests from Site 4 are shown in Figures 14, 15 and 16 below.

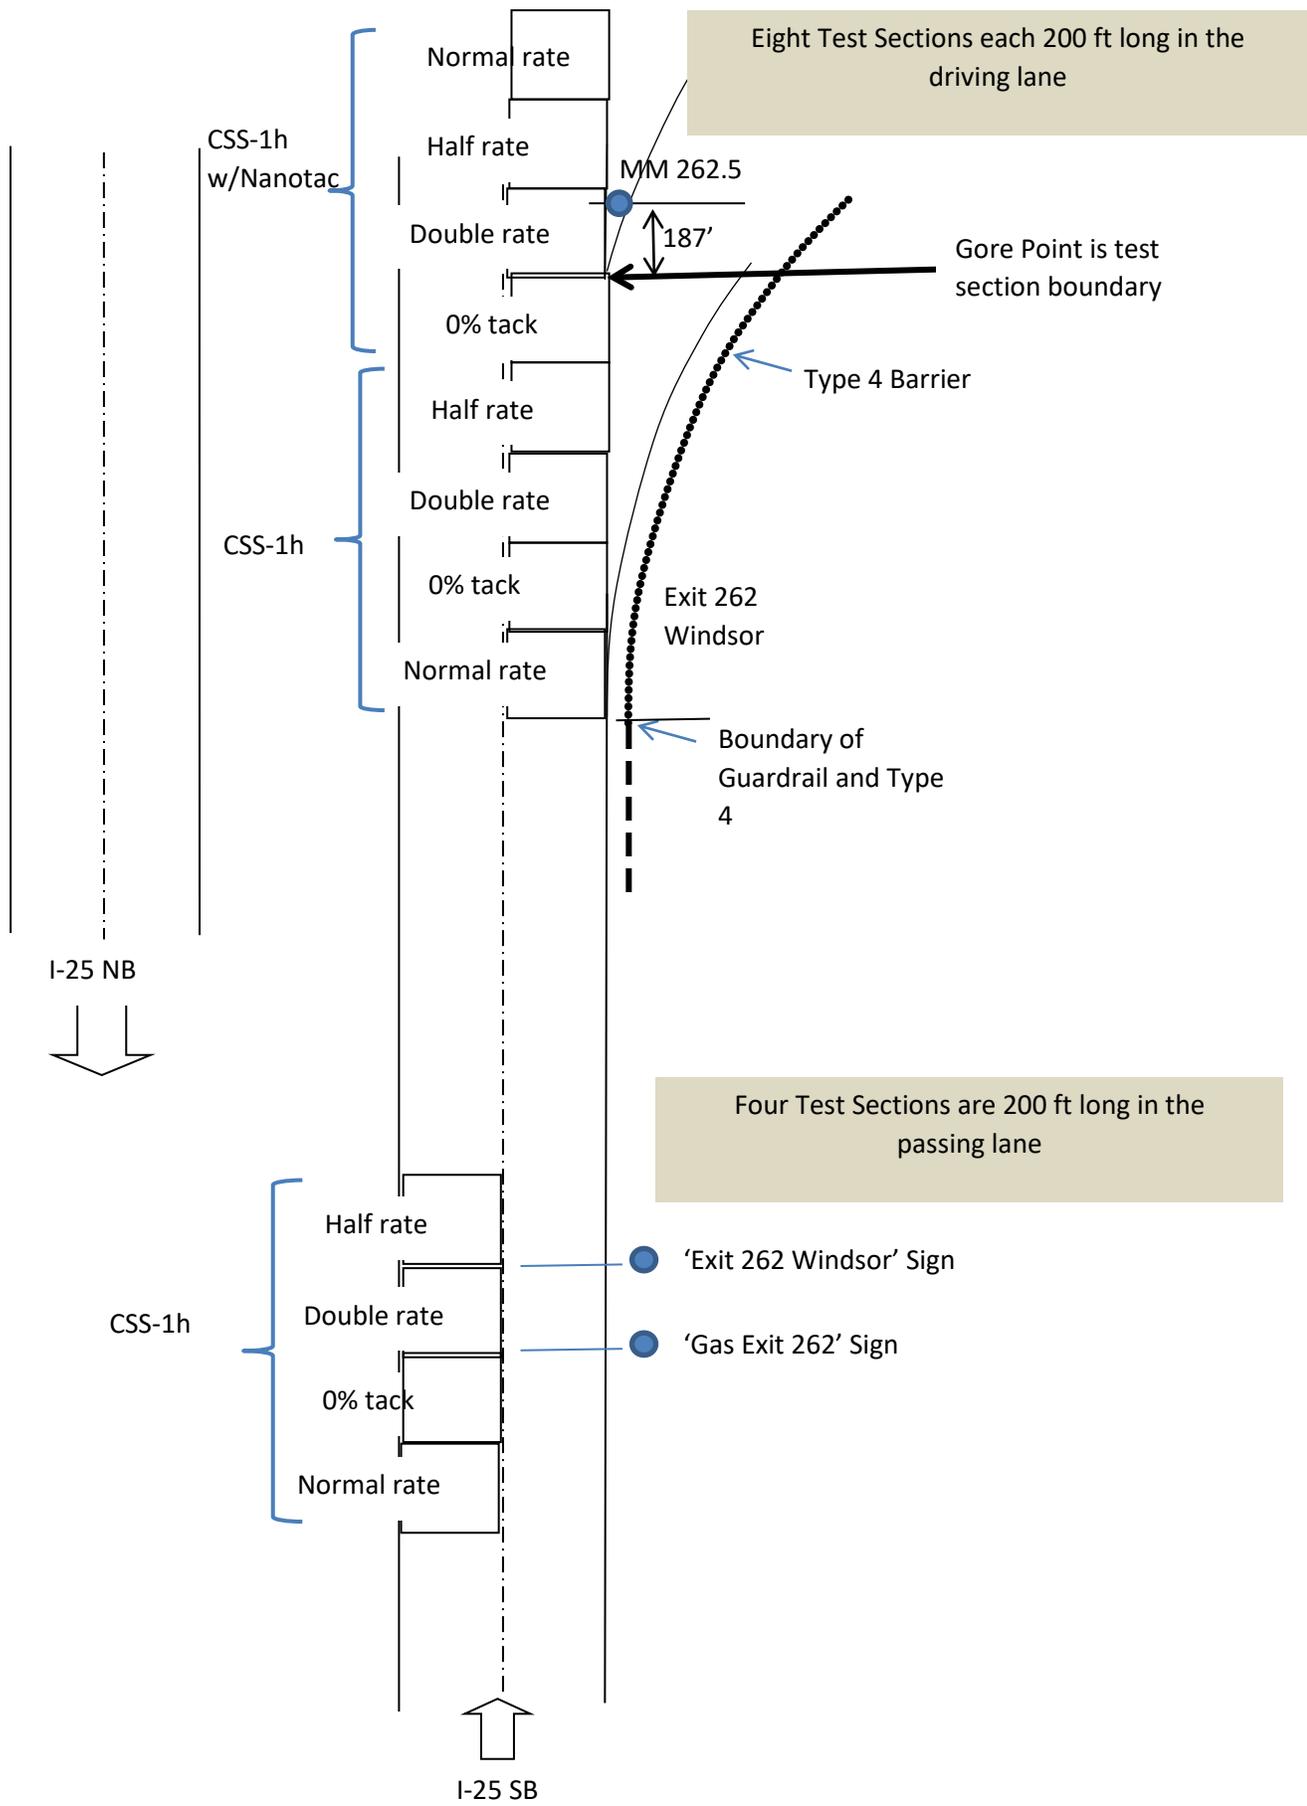
Four segments make up the test section in the passing lane and eight segments make up the test section in the driving lane. The four passing lane test segments are measuring tack coat bonding between dense graded hot mix and the SMA surface course. The eight driving lane test segments are measuring bonding between unmilled Portland cement concrete and the SMA surface course. In addition, four of the test segments in the driving lane were constructed with the proprietary tack coat additive ‘Nanotac’ to measure the difference in performance compared with conventional CSS-1h. The locations of these test segments are shown below:

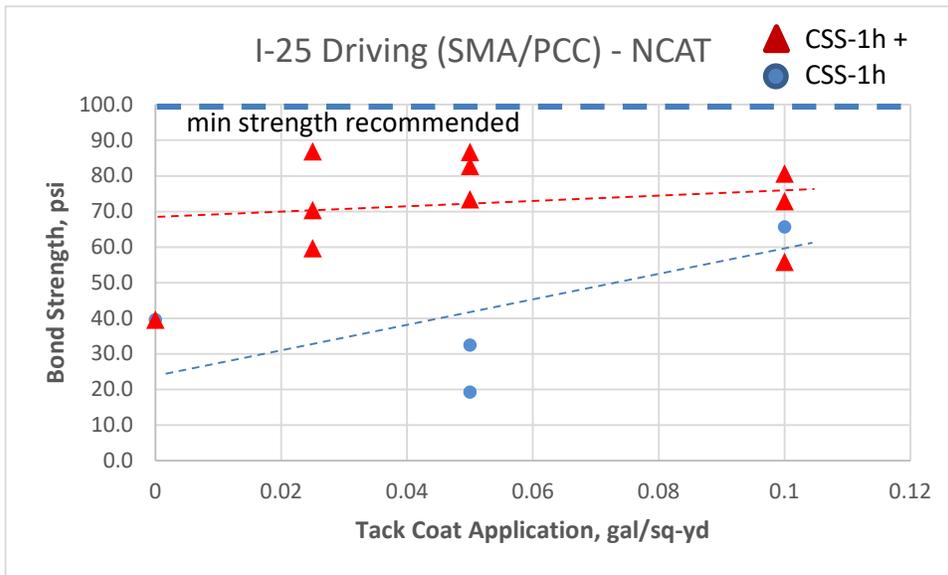
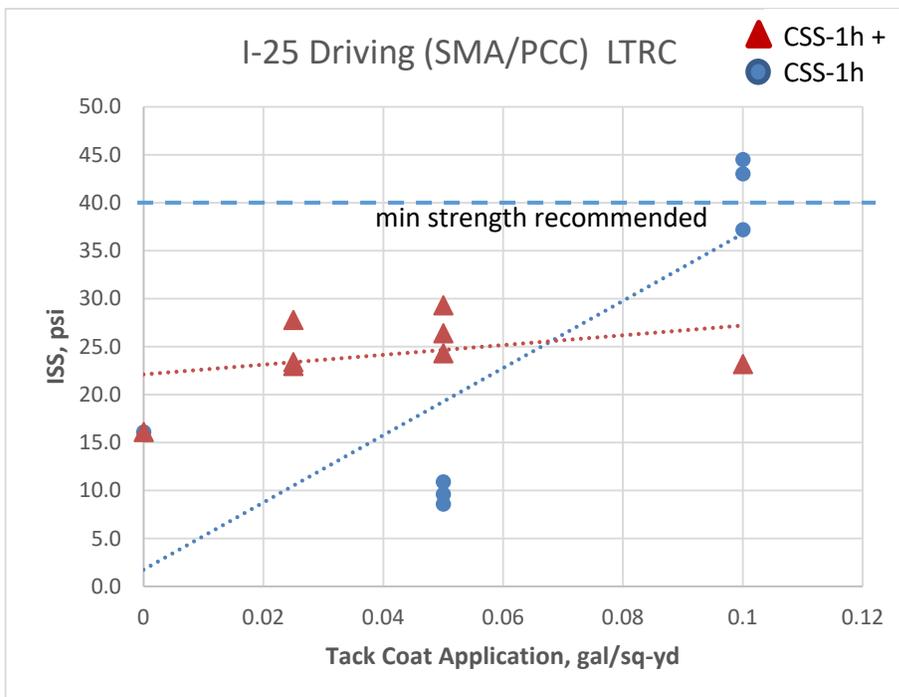
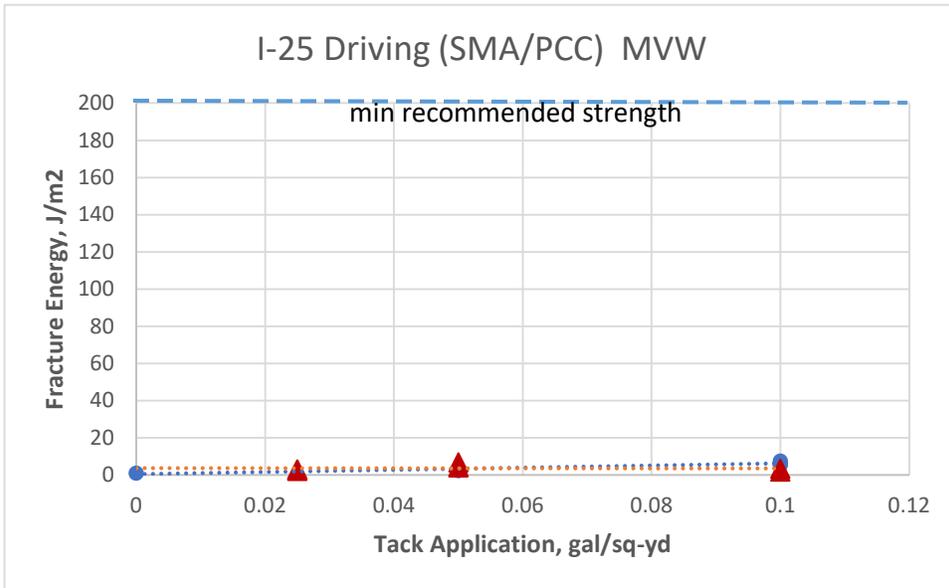
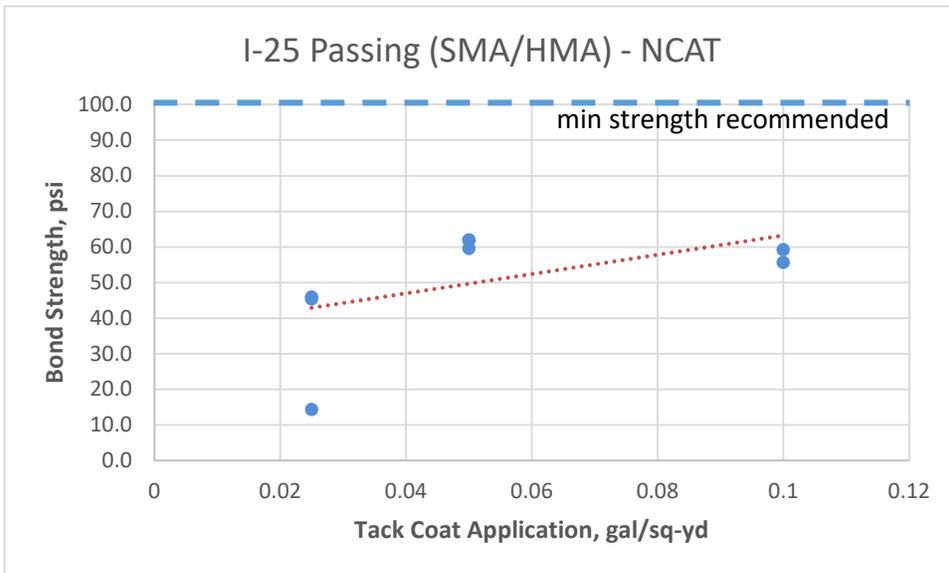
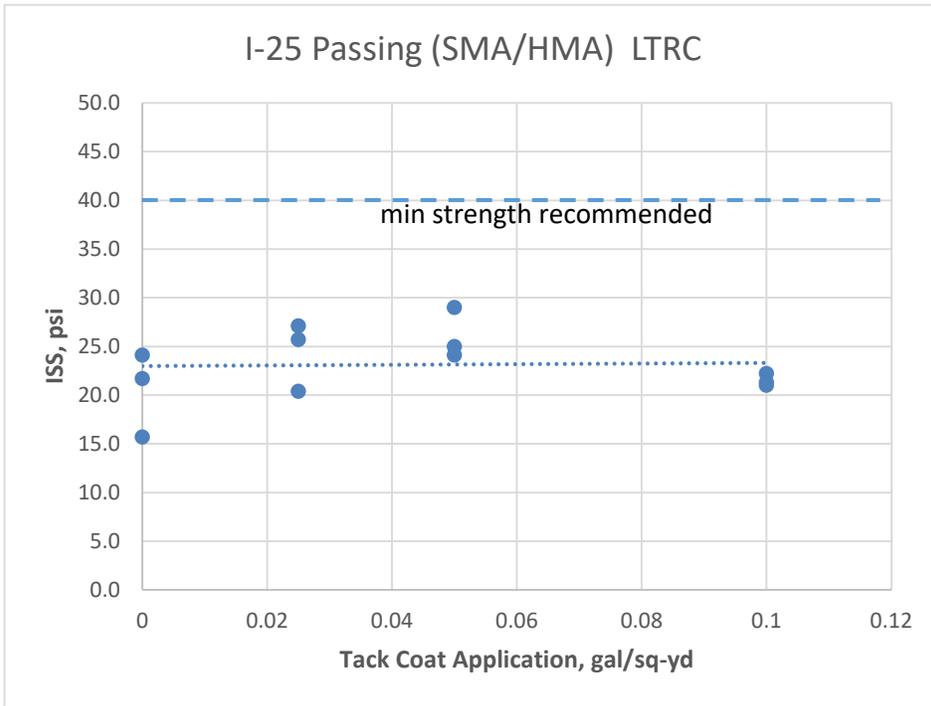
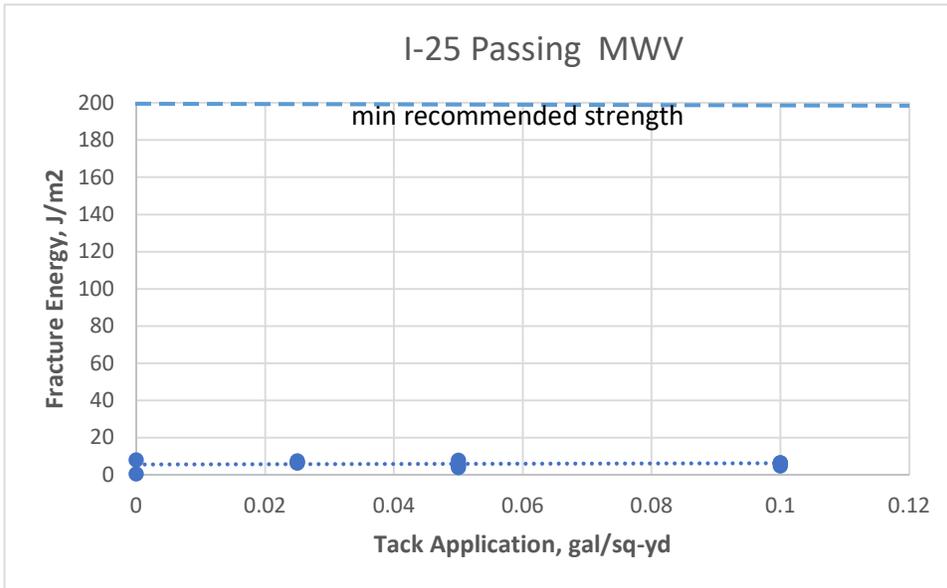
Results of all bond strength tests from Site 5 are shown in Figures 17 to 22 below. The segments where the Nanotac were applied are represented as “CSS-1h+”.

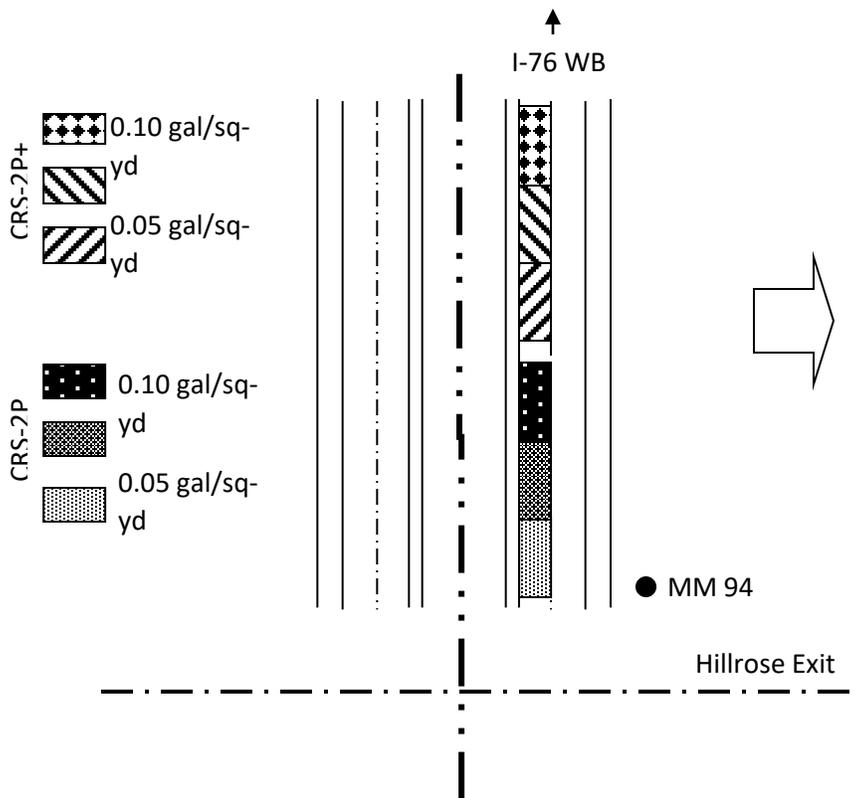
In addition to the CRS-2P sections, three test segments were, again, constructed with the proprietary tack coat additive ‘Nanotac’ to measure the difference in performance compared with conventional CRS-2P. The locations of these test segments are shown below:

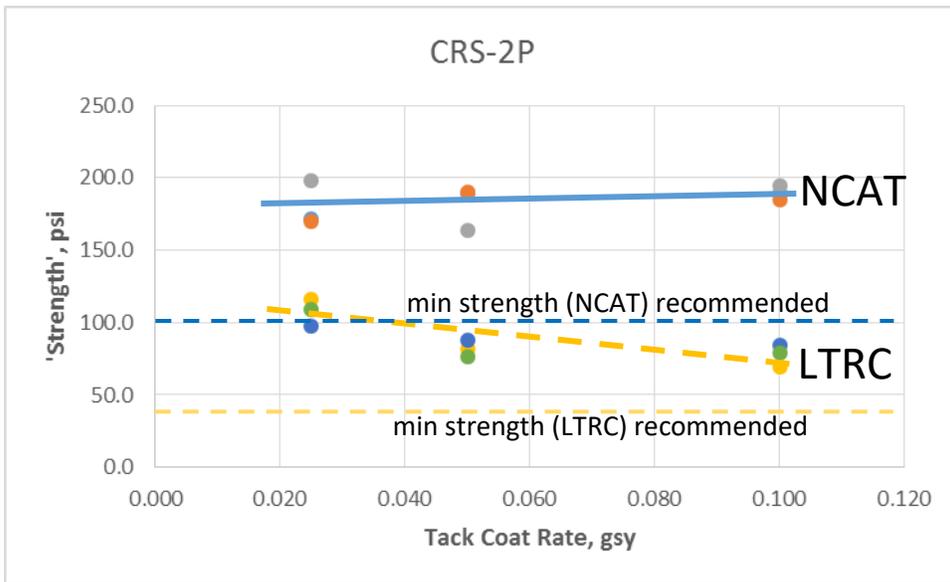
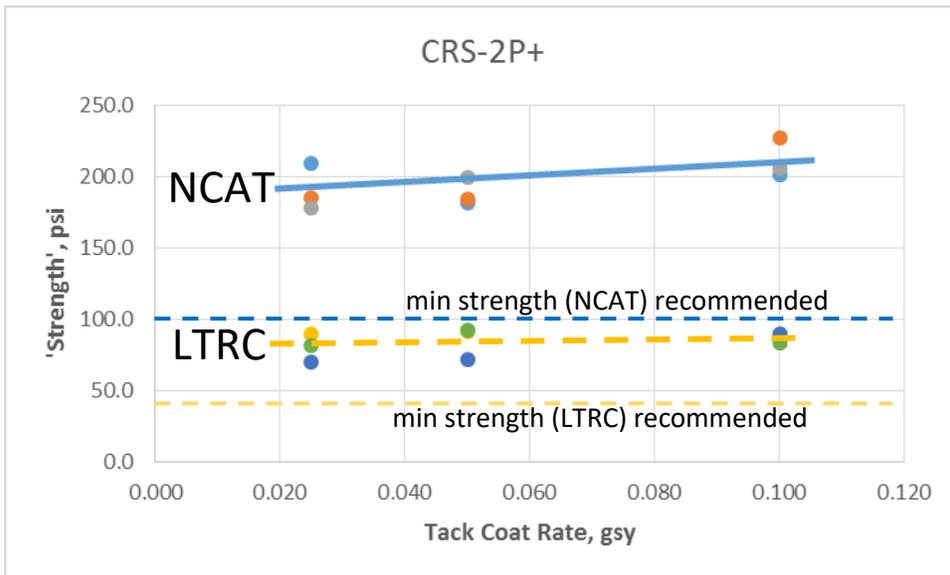
Bond strength tests from Site 6 are shown in Figures 23 and 24. Segments where Nanotac was added to the CRS-2P are represented as “CRS-2P+”. The MWV testing conducted at Site 5 was more variable than expected and, therefore, was not conducted at Site 6.

The apparently less variable data obtained from I-76 were analyzed using conventional ANOVA techniques in an attempt to determine statistical significance. This was done as a one-way analysis to determine significance of tack coat rate on bond strength. The results of this analysis are shown below.

Results of this analysis indicate that the NCAT bond test cannot discern the difference between any of the tack coat application rates as indicated by P-values well above $\alpha = 0.05$. Also, the LTRC bond test cannot discern differences in tack coat rate for the CRS-2P+. However, LTRC tests can detect a difference in bond strength for the CRS-2P. Further analysis of the LTRC data for the CRS-2P using a Newman-Keuls multiple range test indicates the 0.025 gal/sq-yd shot rate has a higher average bond strength at 107.67 psi compared with 82.00 psi and 77.33 psi at 0.05 and 0.10 gal/sq-yd, respectively.
