# **Non-Destructive Testing and Monitoring of Tunnels with Mobile LIDAR and Thermography (SHRP2 – Project R06G)**

**Report No. CDOT-2018-18**  
**March, 2018**

**STRATEGIC HIGHWAY RESEARCH PROGRAM (SHRP2)  
PROJECT R06G: High-Speed Non-destructive Testing Methods for Mapping  
Voids, Debonding, Delaminations, Moisture and Other Defects Behind or Within  
Tunnel Linings**

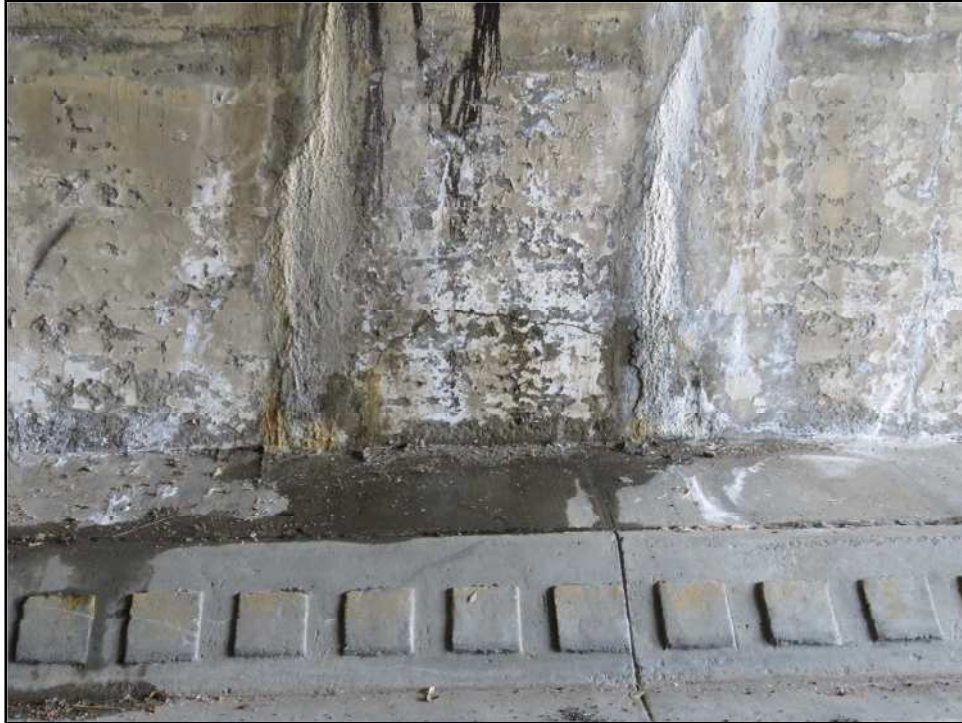
**Figure 5: RGB image of area with pocket of water behind liner**

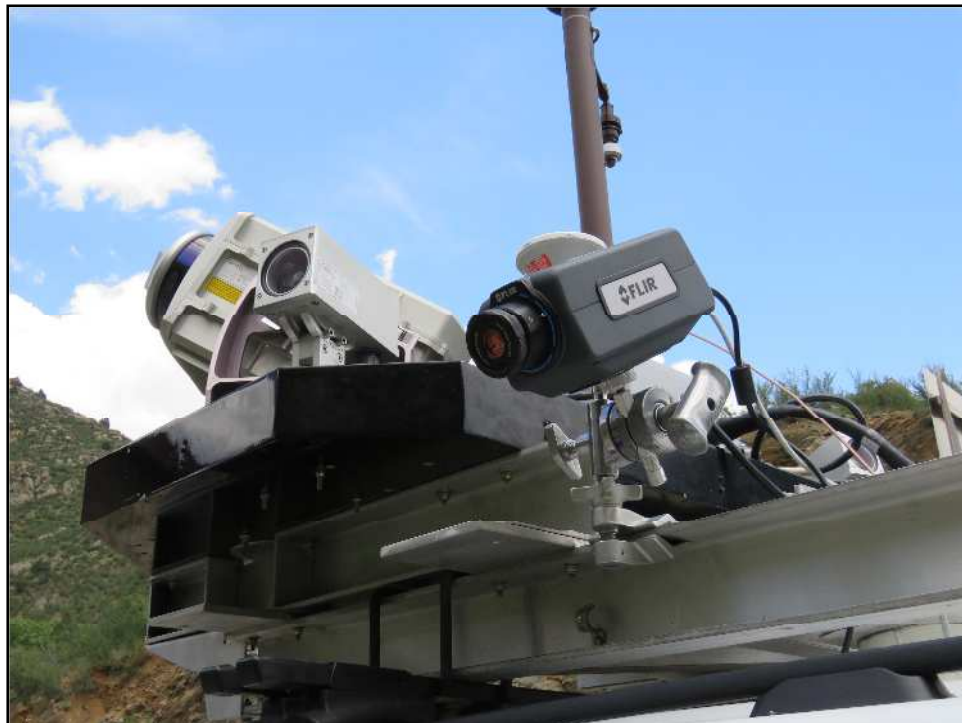
Following a few trials in Tunnel 4, a FLIR A6750sc series camera with a 13mm lens was selected. The camera provides a resolution of 640x512 and utilizes a FLIR-built cooler and InSb detector. With this camera and lens combination SAM was able to pick up sufficient detail of the tunnel liner to meet CDOT's desires, as well as feed into the geospatial deliverable creation.

**Figure 8: FLIR A6750 mounted to SAM mobile truck**

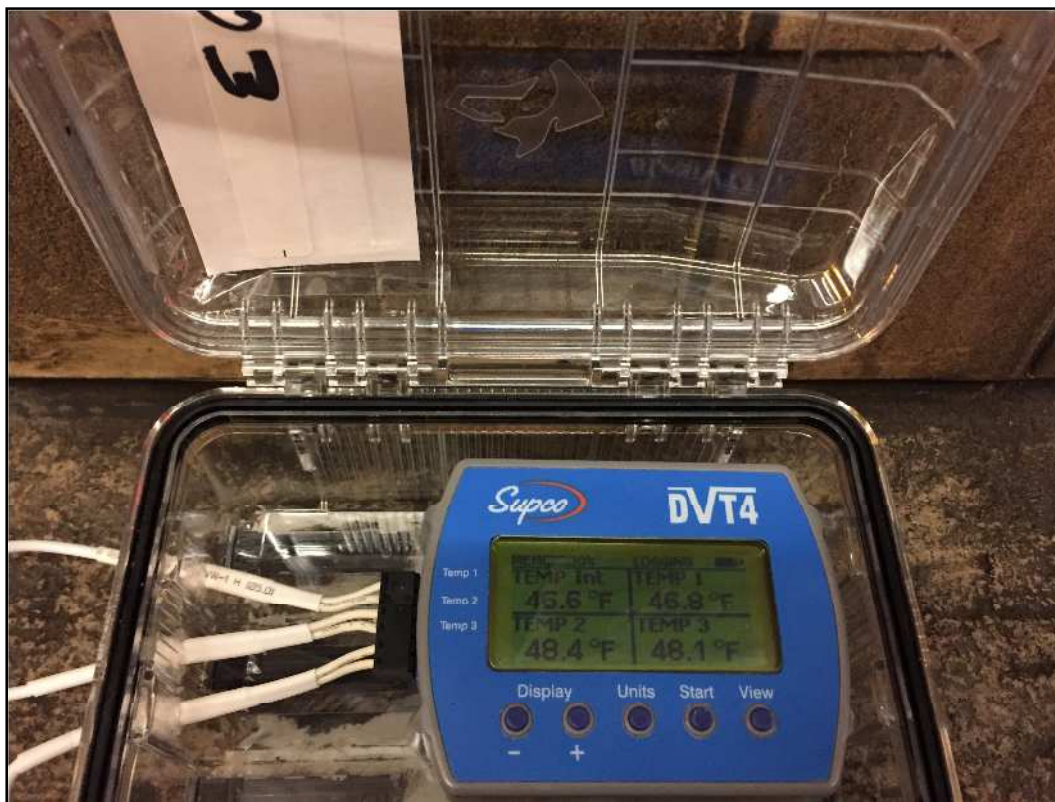
A thermocouple data logger is a device that monitors temperatures in a location over time. The data can be transmitted remotely, downloaded and reviewed later. A data logger typically has two wires attached to one end and is placed in or on an area of interest. The unattached ends of the wires have probes of dissimilar metals, one of which is heated.

**Figure 19: Thermocouple data logger installed in a custom waterproof box**

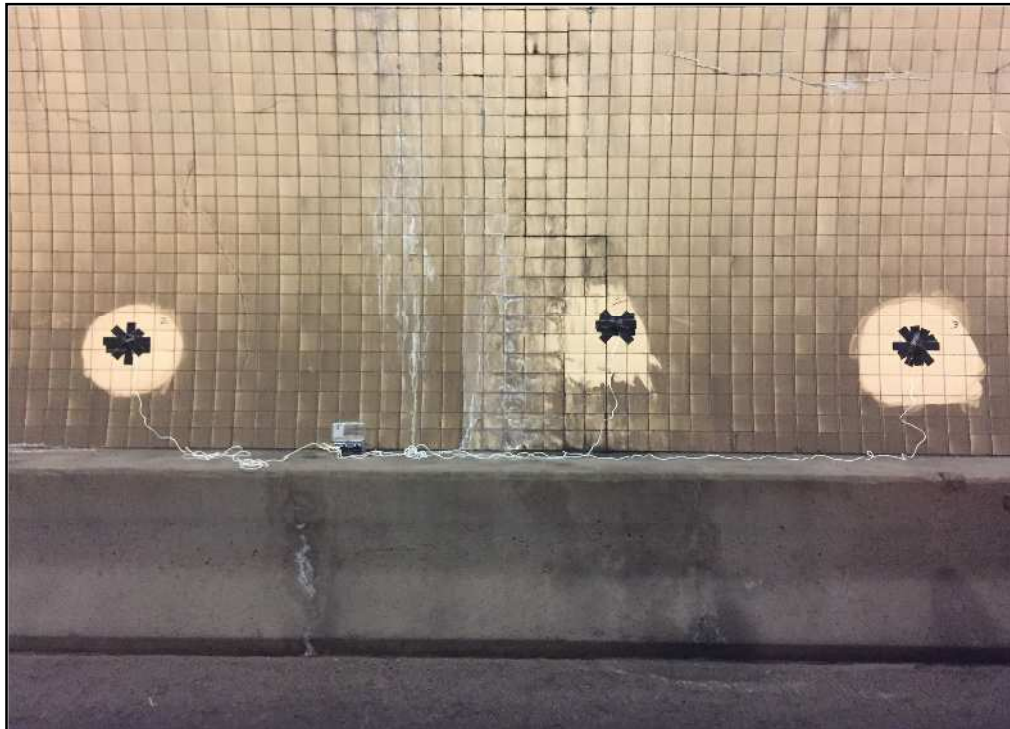
Since the DVT4 records four different temperatures, SAM intended to place four identical devices at intervals on the walls of each tunnel. One would be placed at each end of the tunnel, and the other two would be located somewhere in the middle at a problem area in order to monitor the delta of a good versus a bad spot. With the device itself recording ambient temperature, two sensors with nickel-plated copper probes were attached to a deficient area with thermally conductive silicone and the remaining sensor was attached in an identical manner to an area with no deficiencies.

**Figure 20: Example of logger installed at Hanging Lake Tunnel monitoring tile delamination with water and good tile surface on either side**

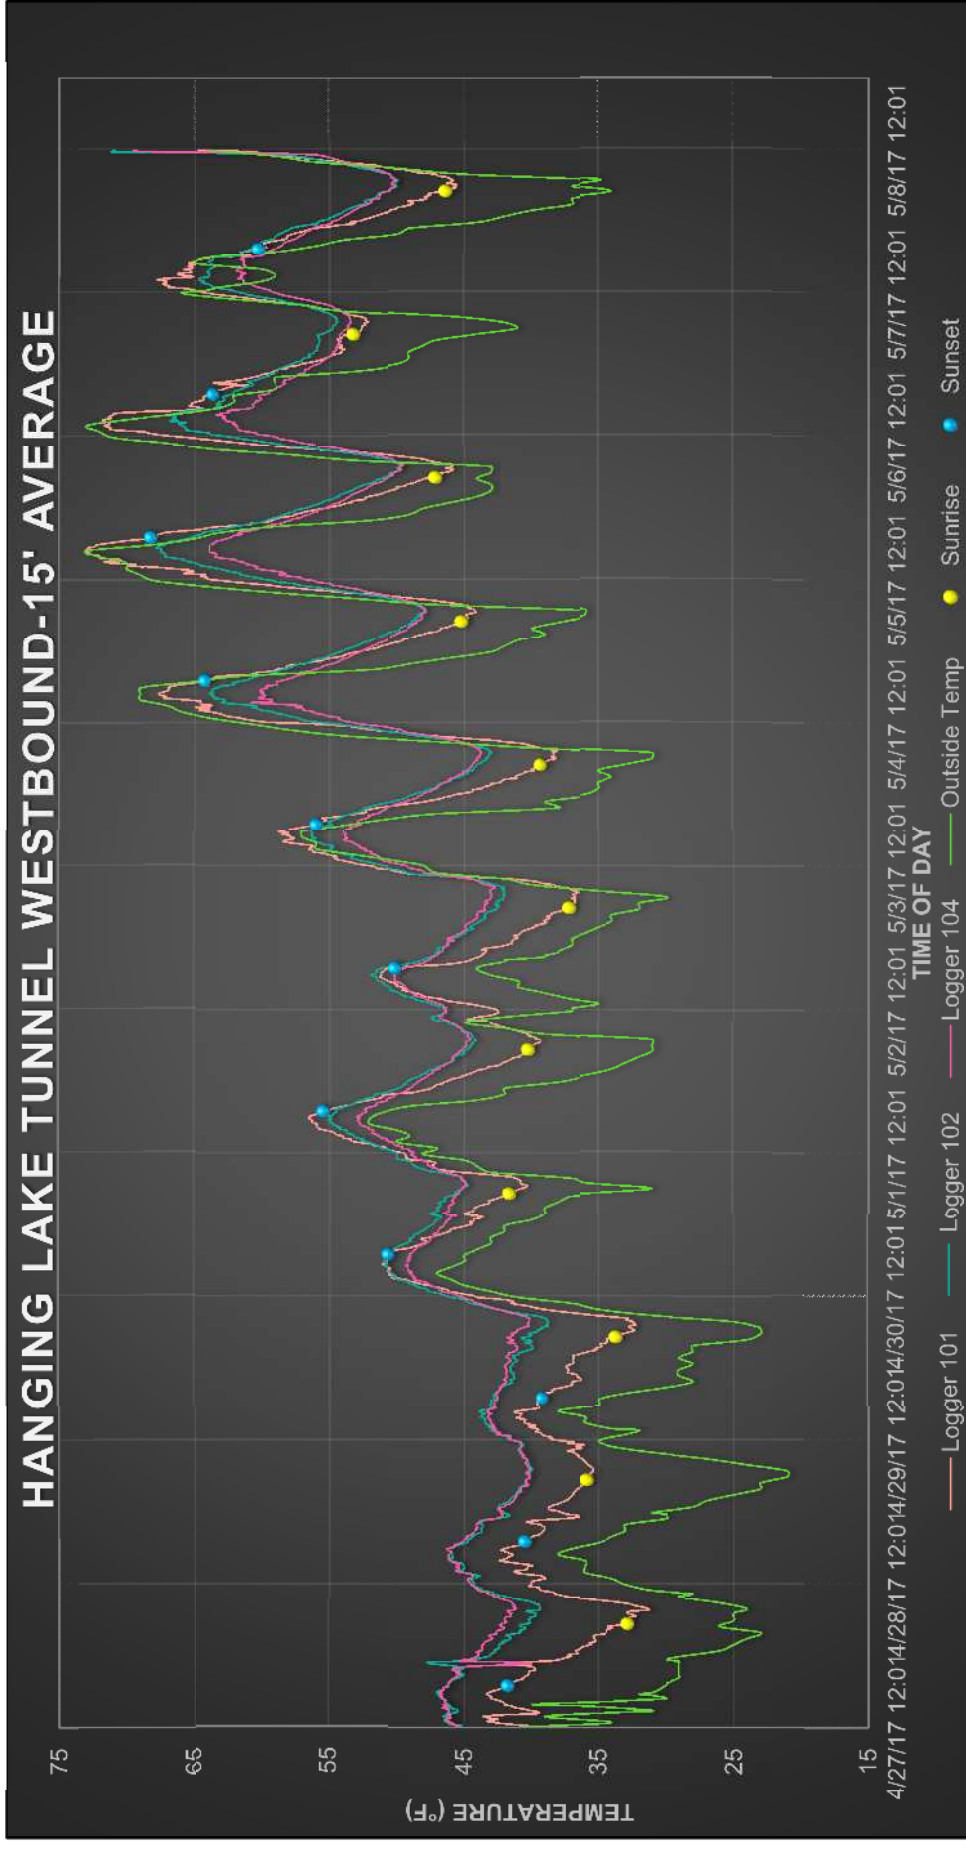
The graph on the following page (Figure 21) shows the ambient temperatures of each logger installed in HLT, the ambient temperature outside for comparison, and the sunrise and sunset times (greatly influencing the temperatures).

Figure 21: Ambient trends in HLT

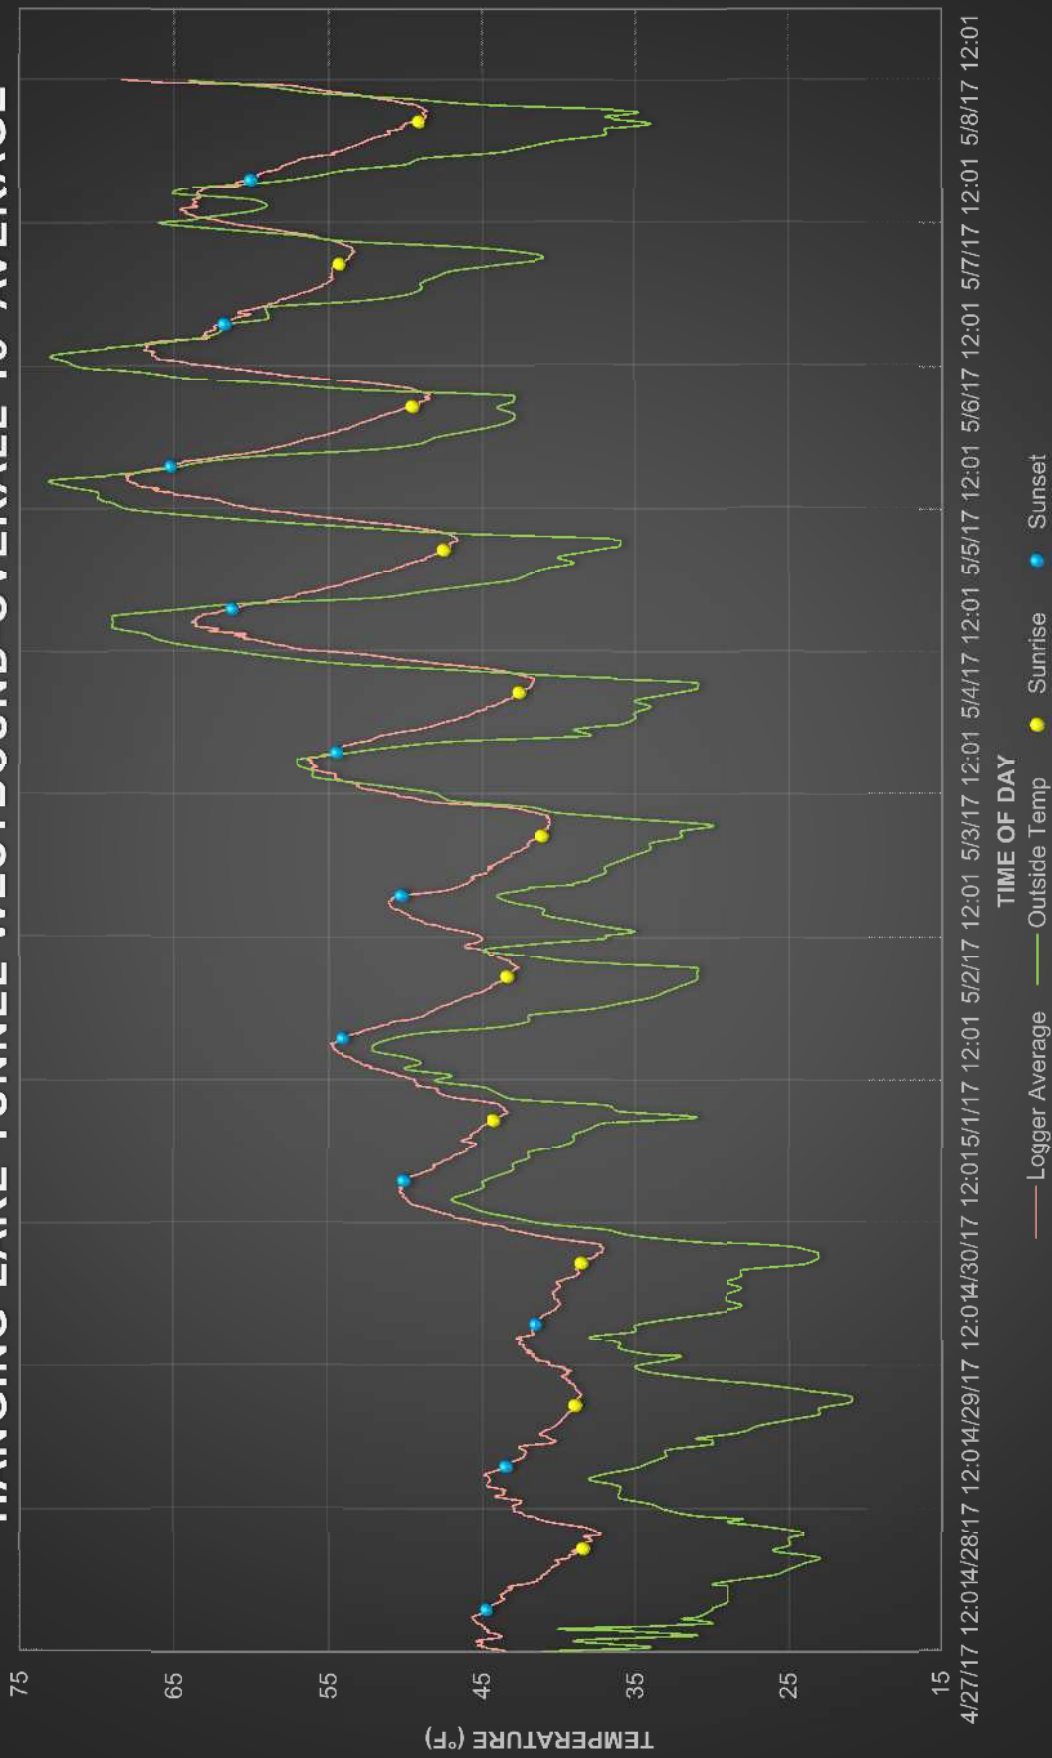
On the following pages, Figures 22-26 depict how the sun and outside temperature swings affect the defects in the tunnel lining. The first three days of logger data were tracked during a snow storm that resulted in a narrow change in temperature highs and lows, showing little to no detectable separation. Toward the end of the logger data, the separation of the daily high and low was significant and created a differential in the tunnel liner defect being monitored. It is also noteworthy that the largest and longest liner deltas happened shortly after sunset before narrowing back down. This data illustrates that with thermal sensors, the user can verify before mobilizing to the site that the collection will be successful.

Figure 22: Ambient averages from loggers inside HLT vs. outside temperatures

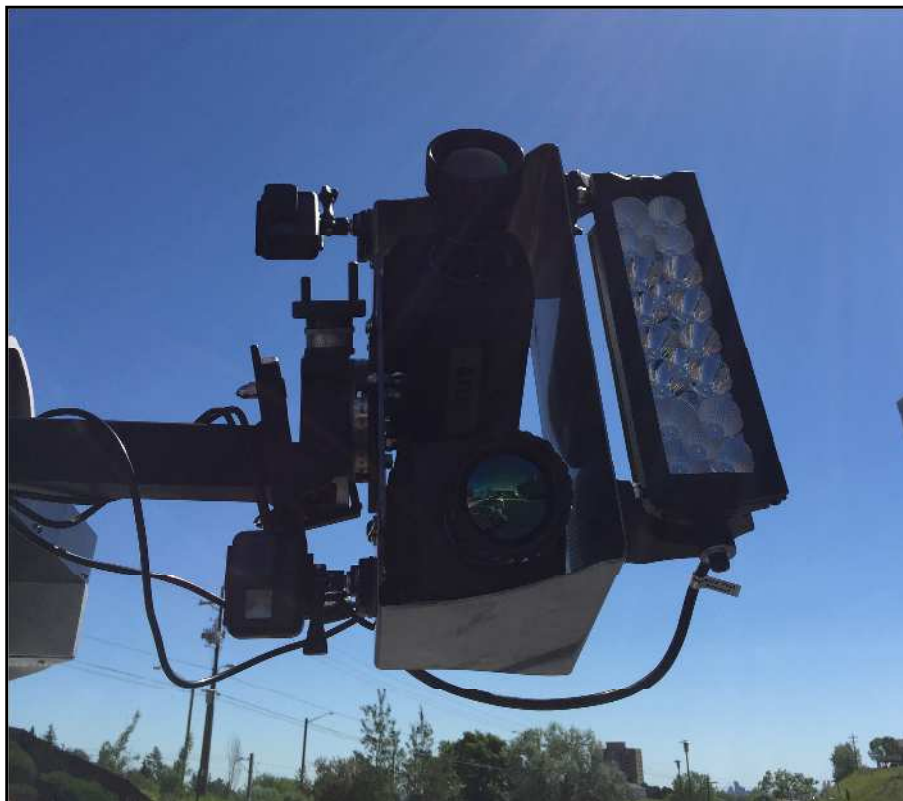
SAM commissioned a third party to custom machine and fabricate a new camera mount similar to those used in film-making. The new mount had the ability to accurately and repeatedly replicate precise camera angles. The camera mount location was moved from the passenger side to the back of the driver's side, keeping it close to the IMU for spatial precision and allowing a 360° view allowing collection in one-way traffic tunnels. Two HD thermal cameras were then attached, offering a coverage area that changed with distance. This meant that, depending on a tunnel's size and shape, thermal imagery could be collected in fewer passes.

Figure 30: Custom camera mount with light bar, thermal and RGB cameras

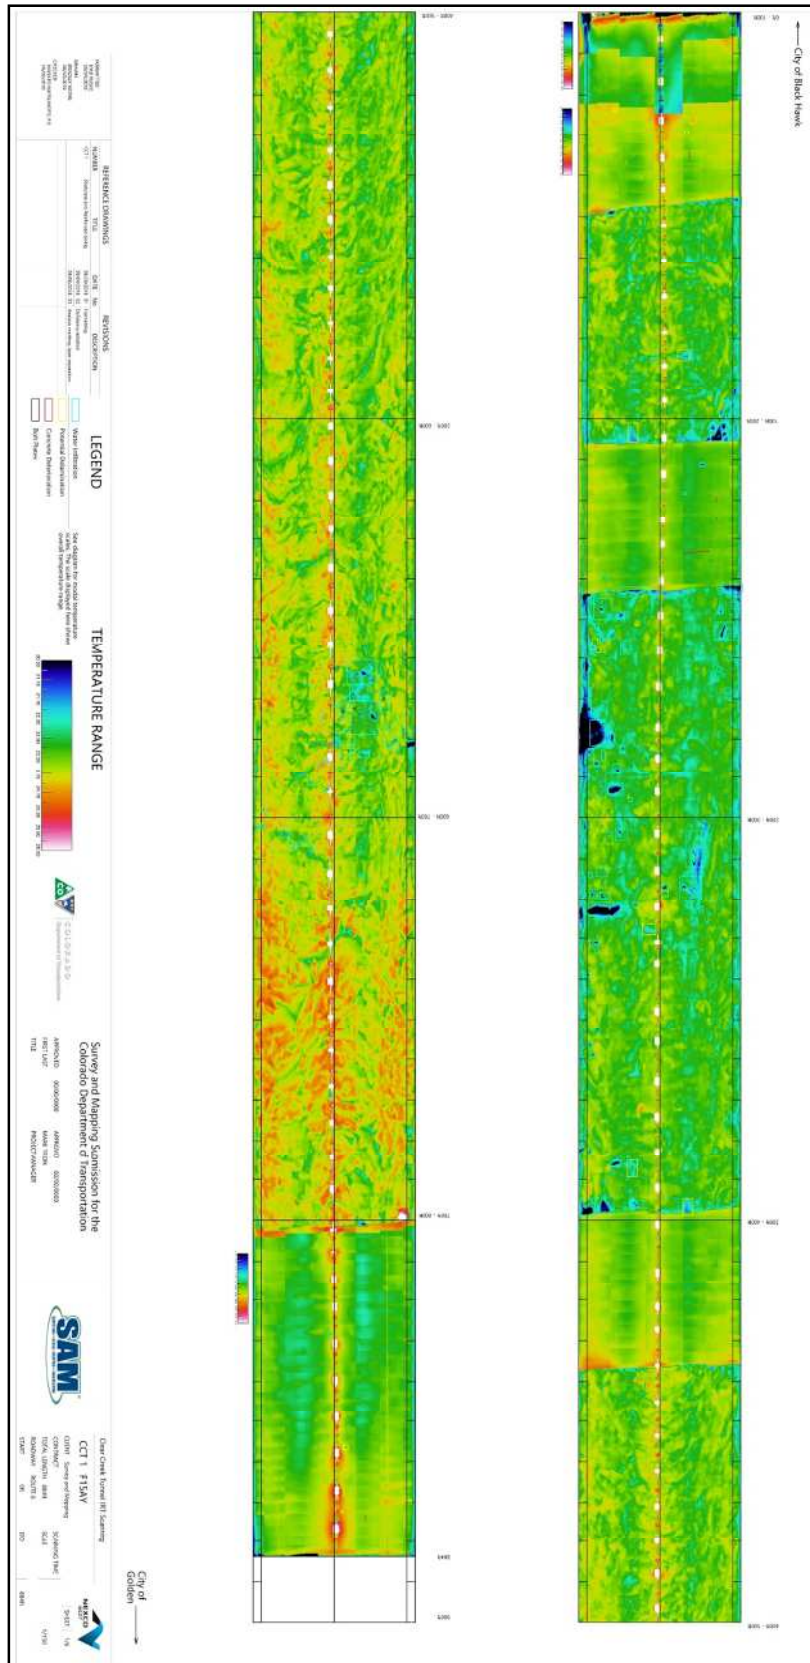
Figure 64: Tunnel 1 Infrared

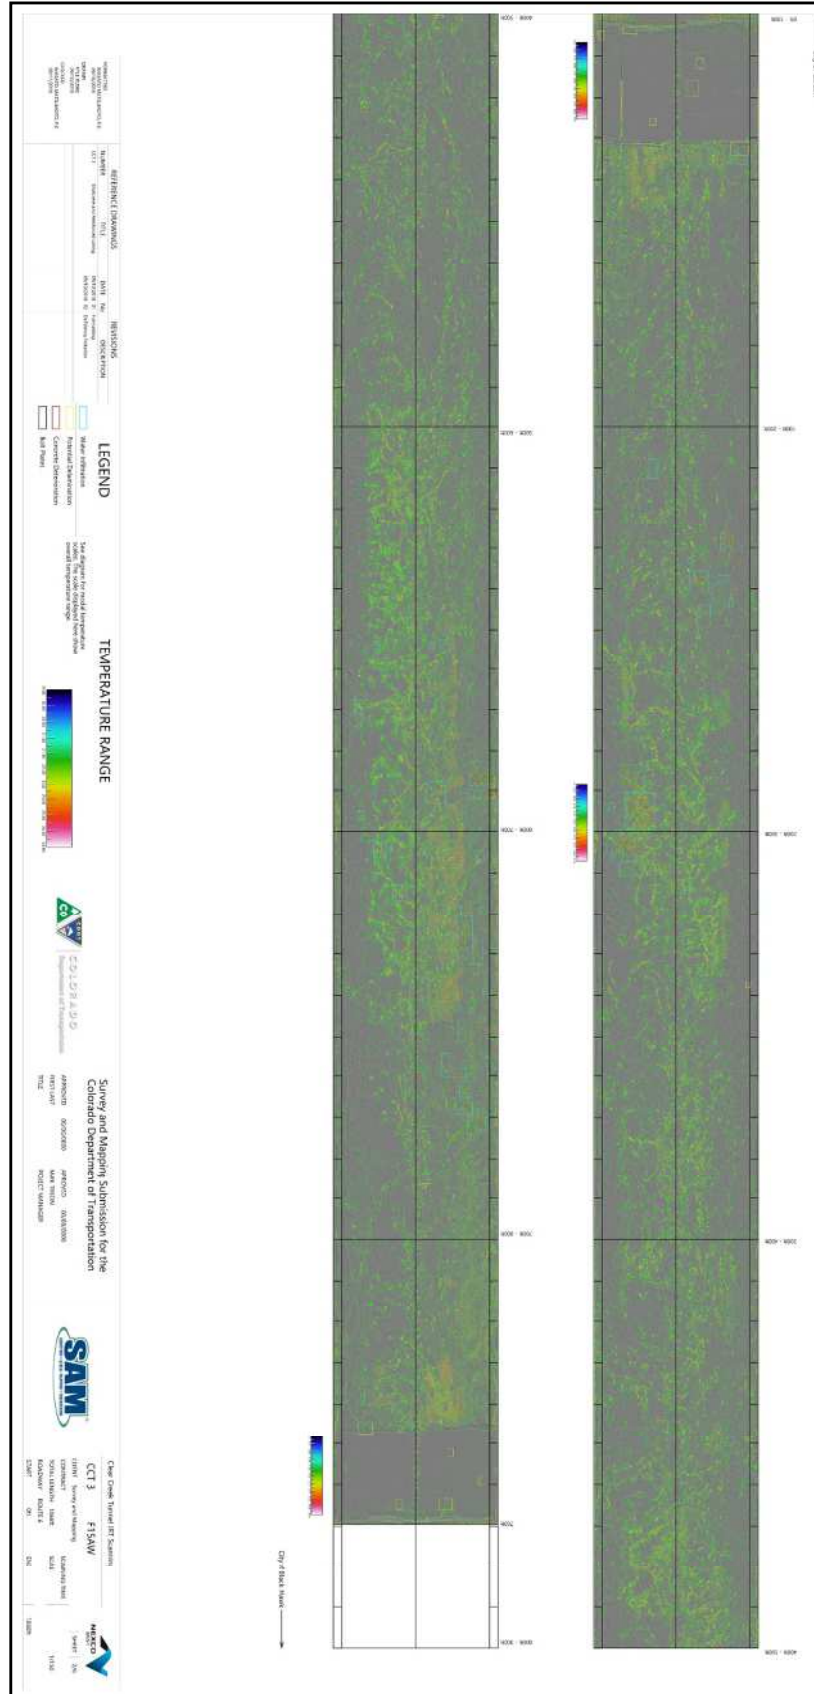
Figure 70: Tunnel 3 Auto Detection

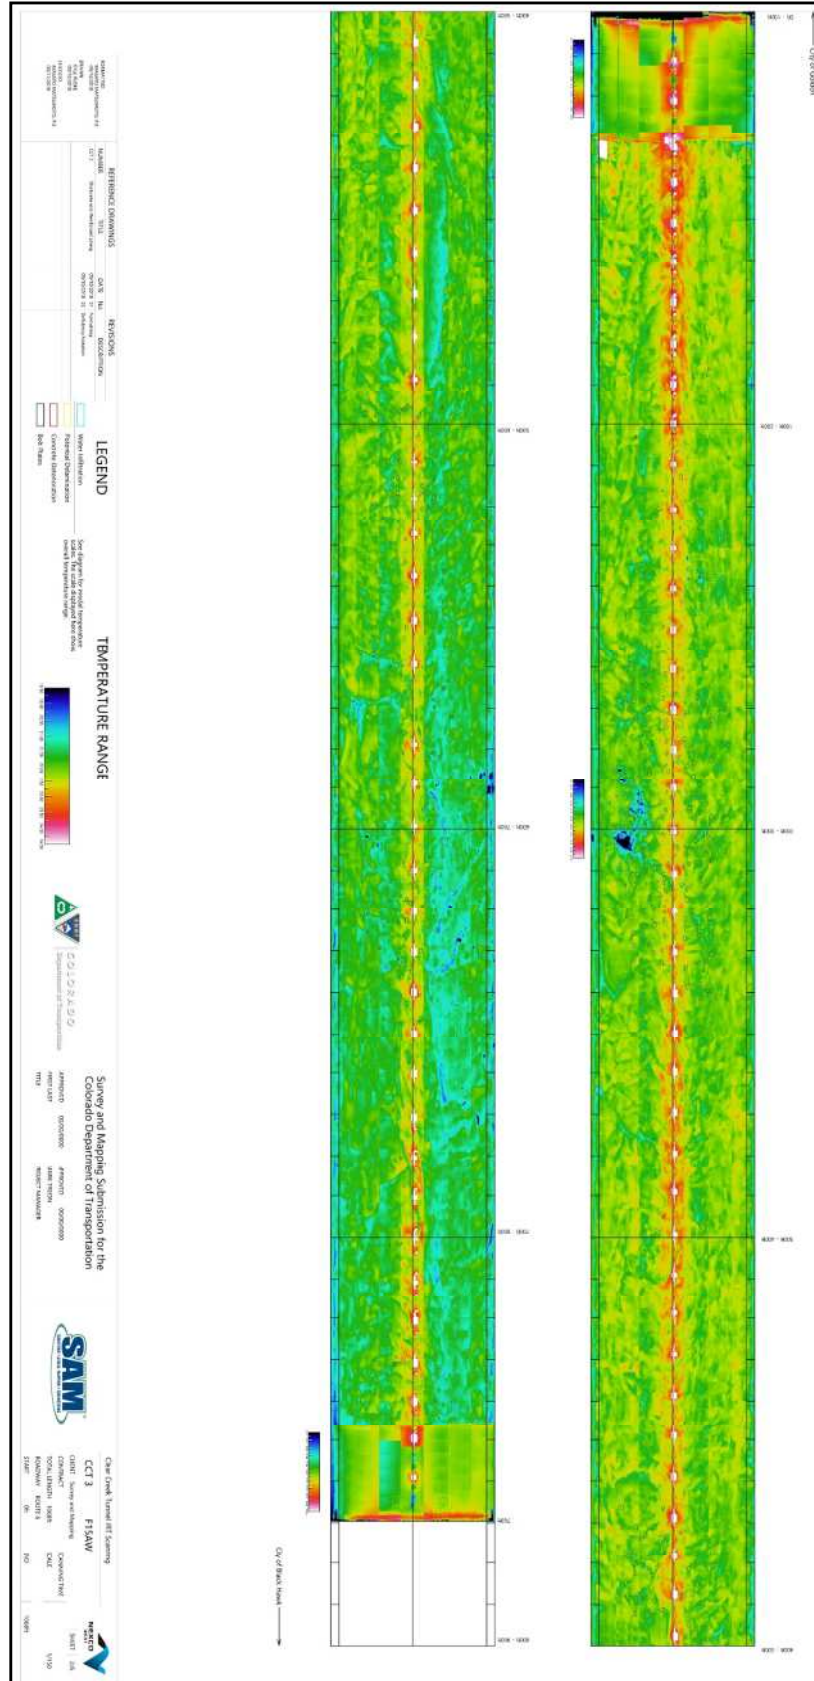
Figure 73: Tunnel 3 Infrared, Bolt Plates
