STATE HIGHWAY 9 WILDLIFE CROSSINGS MONITORING – YEAR 4 PROGRESS REPORT

Study Number 115.01

March 2020

Report to the Colorado Department of Transportation
Applied Research and Innovation Branch

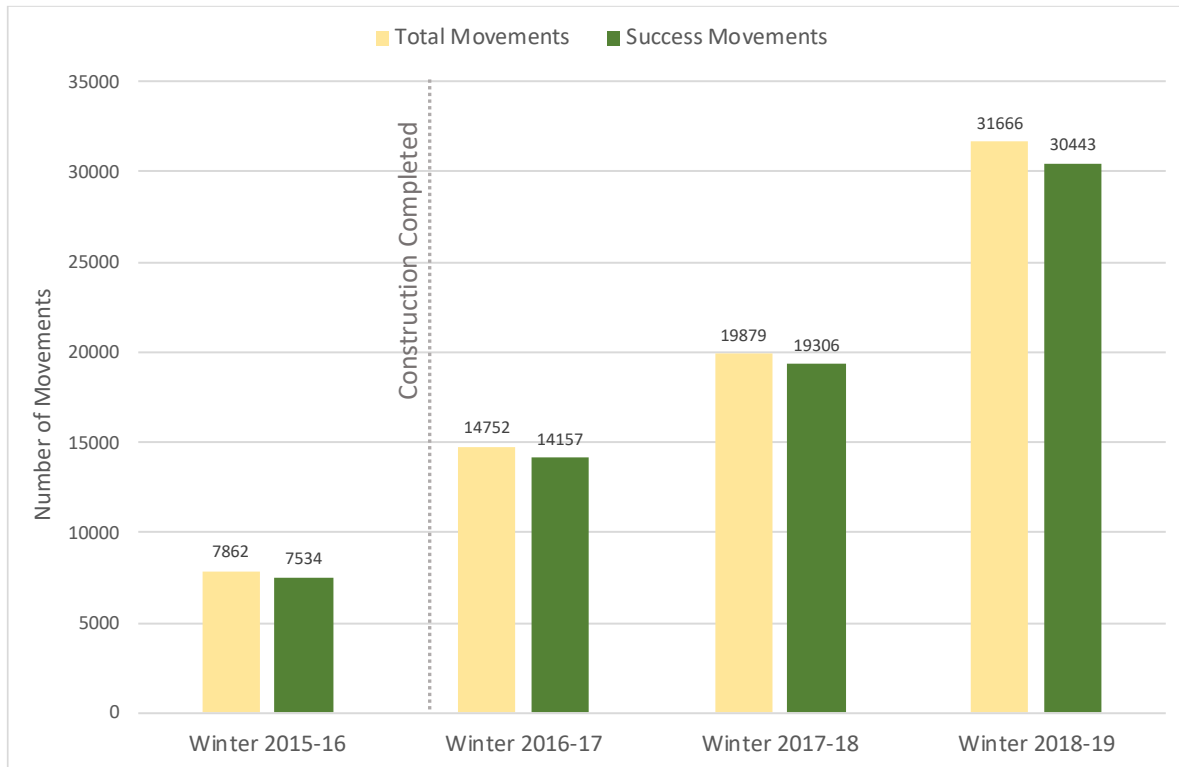
Figure E-1. Total number of mule deer movements and successful movements at crossing structures during each winter of the research. In Winter 2015-16, only the northern portion of the project area was constructed and monitored.

Mule deer success movements through or over the crossing structures increased each year, totaling 83,256 mule deer success movements since the start of this research (Fig. E-1). Combined with an overall mule deer success rate of 96%, these results indicate that the mitigation has been highly effective in accommodating mule deer movements and may have increased connectivity for mule deer across SH 9 to a higher level than prior to the construction of the wildlife crossing structures. In Year 4, ‘winter’ was redefined to include November through April (instead of December – April), thereby altering the presentation of each year’s results from what was reported in previous progress reports. Accordingly, in Winter 2018-19, the total number of mule deer success movements increased by 58% relative to the Winter 2017-18, and by 36% in Winter 2017-18 relative to Winter 2016-17, the first winter post-construction.

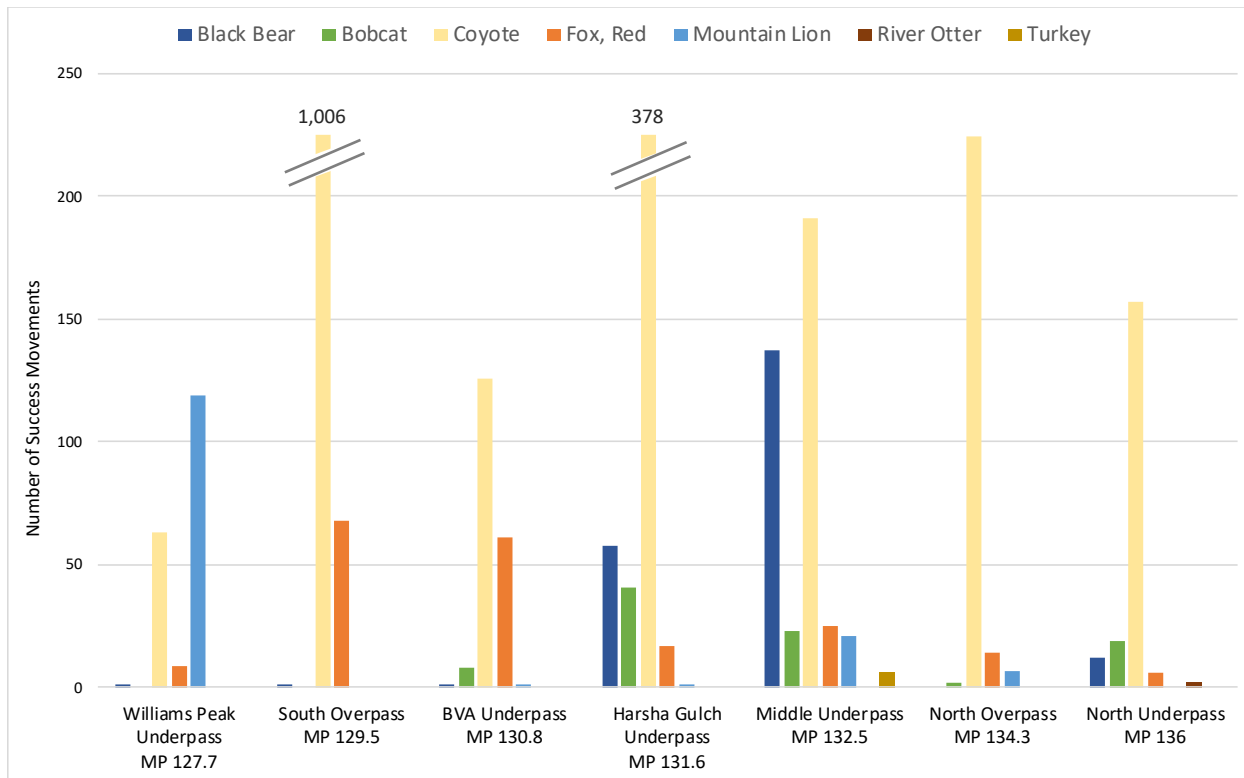
Figure 19. Success movements by non-ungulate species each wildlife crossing structure from the onset of the study in December 2015 through April 2019.

The success movements of six species of mammals plus wild turkey were plotted at each wildlife crossing structure (Fig. 19). The majority of coyote passages in Year 4 occurred at the South Overpass ($n=552$) and Harsha Gulch Underpass ($n=303$), while mountain lion activity was highest at the Williams Peak Underpass ($n=78$). Black bear continued to be documented primarily crossing through Harsha Gulch Underpass ($n=33$) and the Middle Underpass ($n=29$) and were captured for the first time crossing over an overpass structure, the South Overpass. Other species documented passing through or over wildlife crossing structures include badger, bird, hare, raccoon, skunk, domestic animals (cats, dogs and cows) and, as previously noted, river otter and turkey.

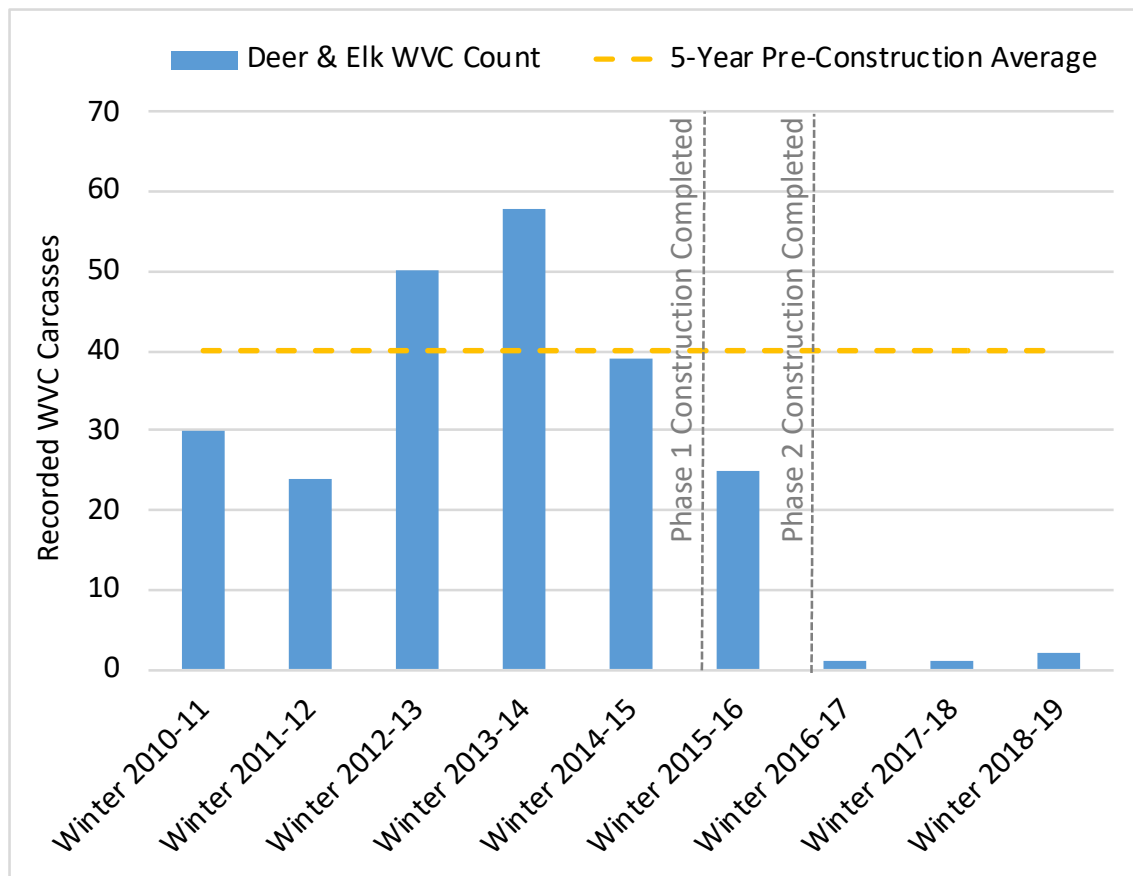
Figure 24. Wintertime mule deer and elk carcass counts recorded by CDOT Maintenance within the project area (MP 216.6 – 137.0) compared to the five-year pre-construction average of 40.2 carcasses each winter.

Post-construction WVC carcass reports remained low in Winter 2018-19 within the mitigation project area. Two mule deer carcasses were reported inside the project area in Winter 2018-19, which is up slightly from one each in Winter 2017-18 and Winter 2016-17, but well below the five-year pre-construction average of 40.2 carcasses per winter, representing a 95% decrease in WVCs (Fig. 24). Only one WVC carcass has been reported during the summer months since construction was completed.

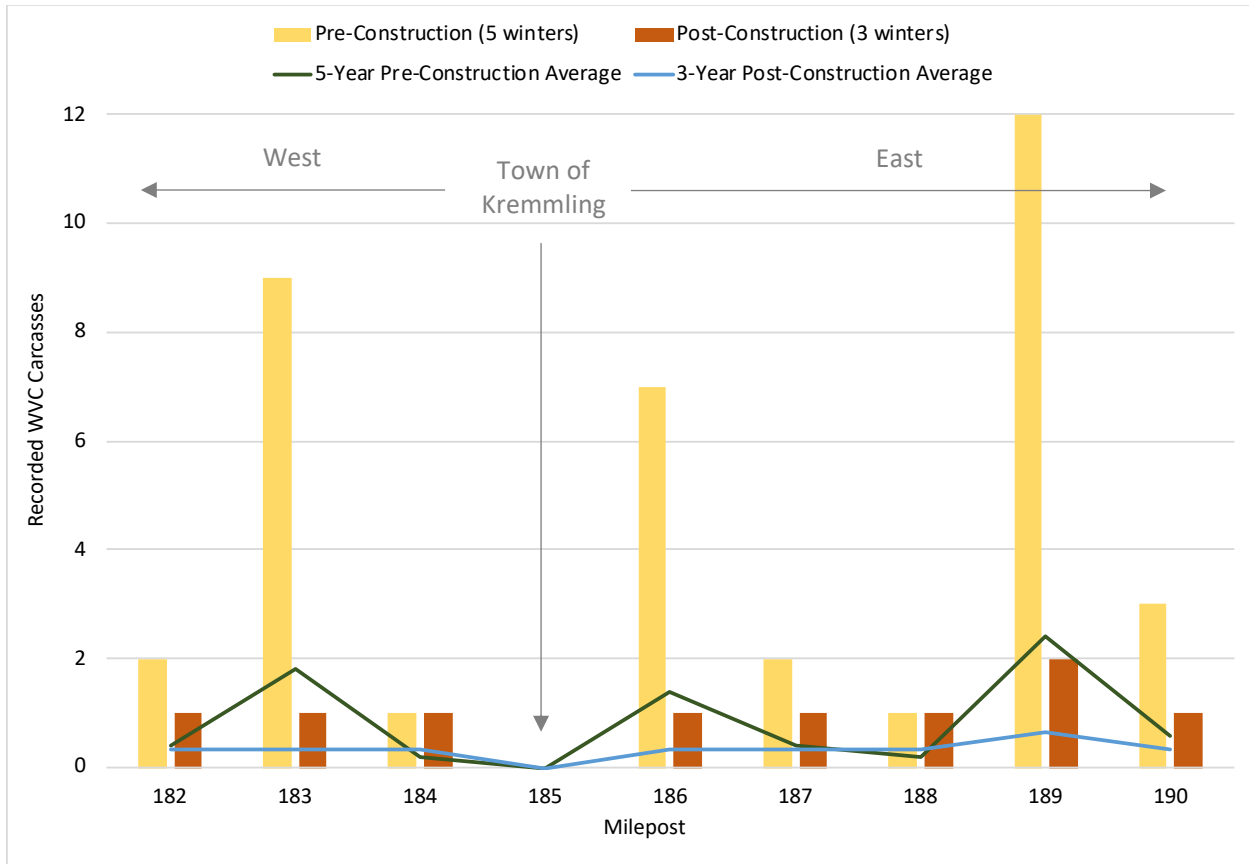
Figure 27. Ungulate carcass counts recorded by CDOT Maintenance on US 40 east and west of Kremmling (MP 185) for five winters prior to mitigation construction and three winters post-construction. The 5-year pre-construction winter average was calculated for each one-mile segment.

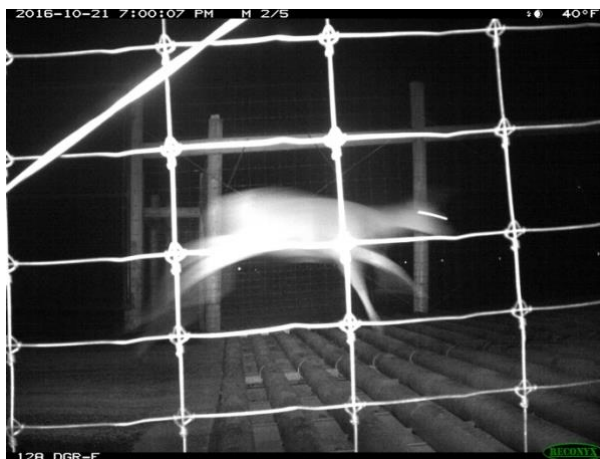
Figure 32. Mule deer breach at the Triangle Road Deer Guard (round bar).
