# I-25 South Gap Queue Warning System Evaluation

1. Report No. CDOT-2020-17		2. Government Accession No.		3. Recipient's Catalog No.	
4. Title and Subtitle I-25 GAP QUEUE WARNING SYSTEM EVALUATION				5. Report Date May 2020

16. Abstract During a construction project, traffic traveling through the construction zone experiences frequent instances where construction vehicles, incidents, and recurring congestion interrupt traffic flow that result in long queues and delays as well as increased crash rates. In an effort to help mitigate these instances, CDOT has deployed numerous smart work zone systems throughout the I-25 Gap construction zone including Queue Warning Systems (QWS) This report discusses the deployment of a QWS in the I-25 Gap work zone. Lessons learned regarding the QWS set up are discussed and field speed data has been analyzed to verify the system was operating as intended and to quantify the effectiveness of it.  The results are intended to give CDOT confidence QWS are effective in mitigating sudden stops due to unanticipated queuing. Two measures of effectiveness (MOEs) were observed and evaluated for a one month period with I-25 Gap QWS activated (December 2019) a

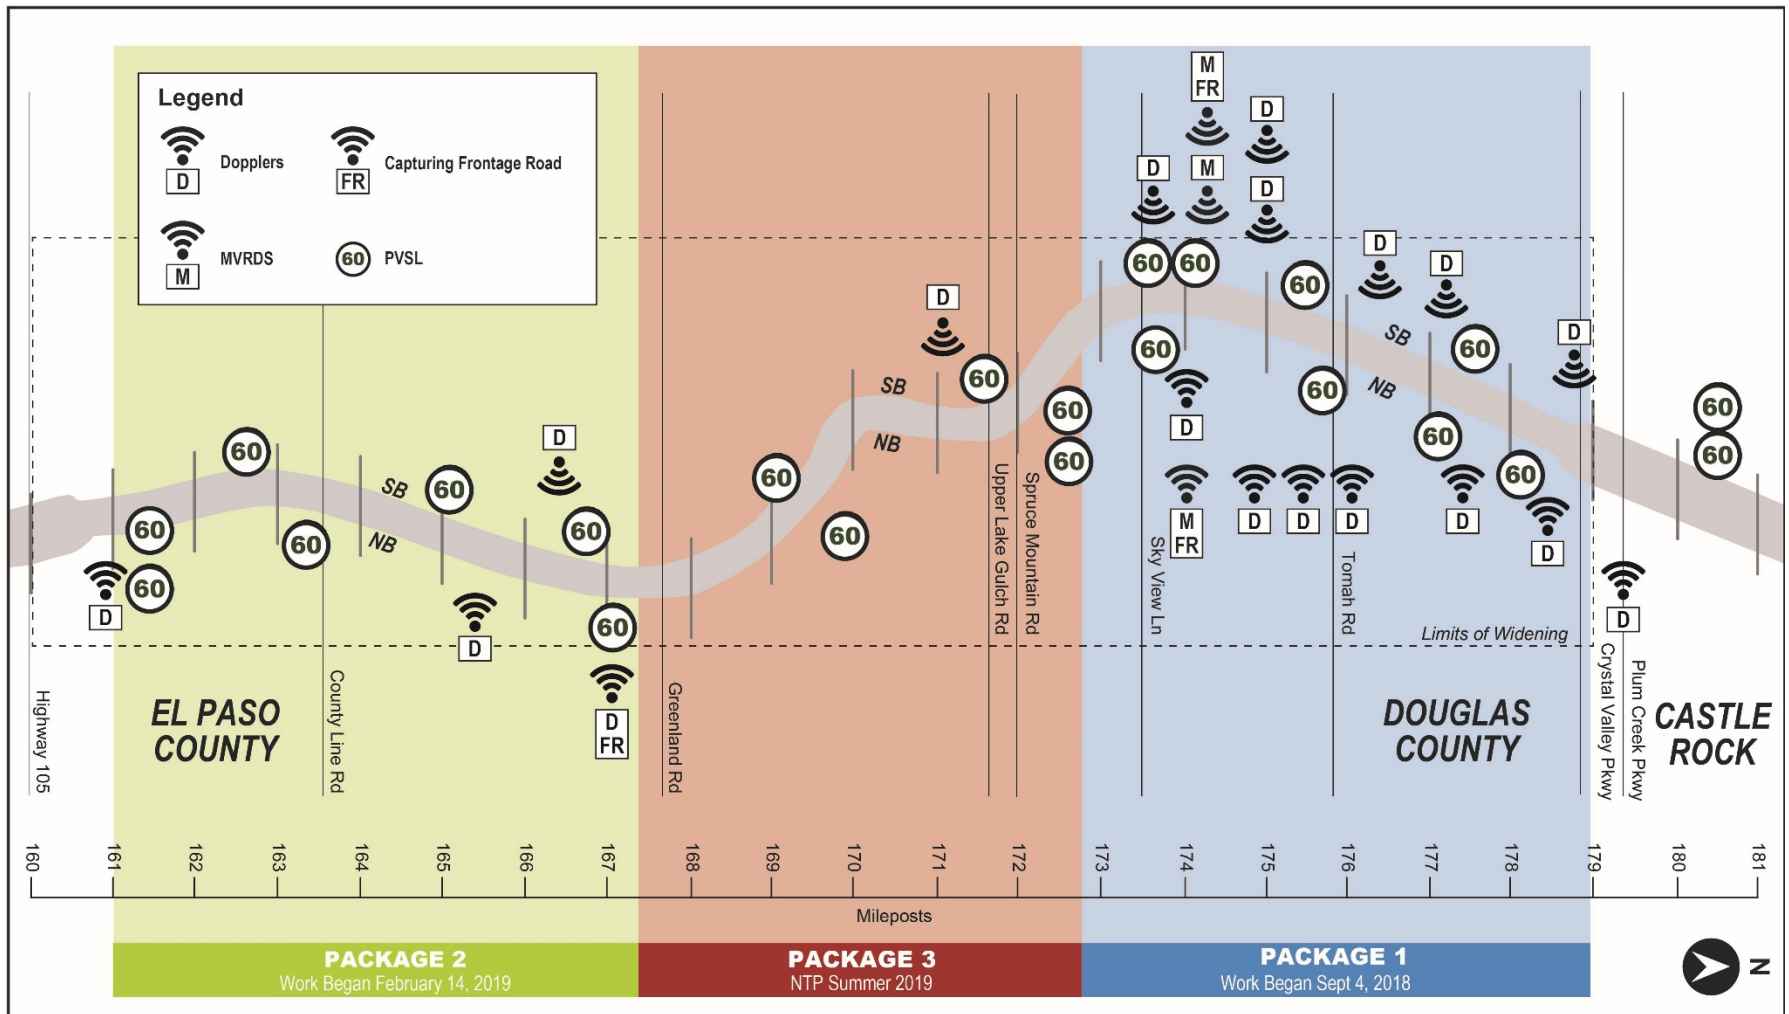
Figure 2. I-25 Gap Smart Work Zone Devices

These devices provided continuous data collection and public information throughout the project extents. **Figure 2** provides an overview of the ITS devices used throughout the I-25 Gap construction project.

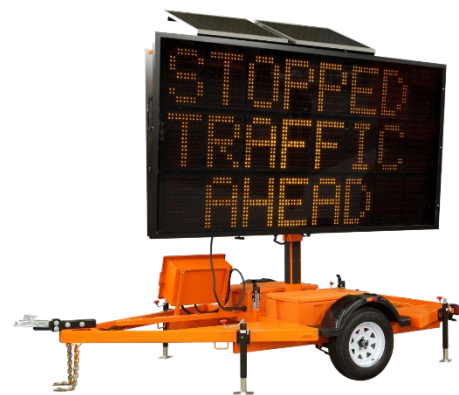
**Figure 3. PCMS Image  
(Courtesy of Street Smart)**

A QWS is a fully automated, stand-alone system that detects the presence of real-time traffic congestion within the work zone and informs approaching motorists that traffic is either slowed or stopped ahead. **Figure 3** is an example of the Portable Changeable Message Sign (PCMS) used to inform drivers about upcoming roadway conditions. QWS benefit locations where queue lengths are anticipated to vary greatly and are used to prevent abrupt stopping and/or deceleration within the traffic flow with the goal to reduce queueing-related collisions. In addition, QWS has the potential to smooth traffic speeds so that traffic flow operates more efficiently, which can result in reduced congestion and reduced abrupt speed drops.

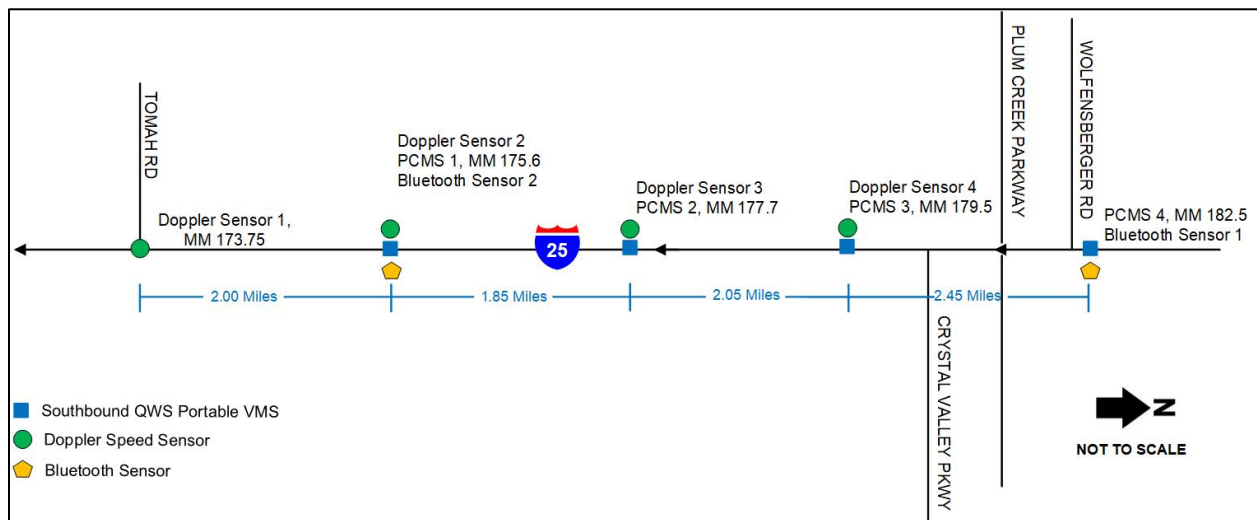
**Figure 4. Southbound I-25 Gap QWS Setup**

The southbound I-25 Gap QWS setup is illustrated in **Figure 4**. As shown, the system was composed of 4 Doppler speed sensors and 4 portable message boards. The QWS spanned approximately 8 miles of the construction zone (each pair of devices was spaced approximately 2 miles apart) from Wolfensberger Road to Tomah Road. In addition, the QWS utilized Bluetooth travel time sensors that were deployed within the work zone. The naming convention used in this report is identical to what was programmed into the JamLogic software. JamLogic is a proprietary software used to control traffic operations by connecting the data collection and public information devices in the field to inform the traveling public about nearby roadway speed conditions.

Note that PCMS 4 served as an “End of Queue” warning message board since it was located well in advance of the construction zone. This sign also displayed travel time estimates to Tomah Road and the Larkspur interchange. As **Figure 4** indicates, Sensor 2, Sensor 3, and Sensor 4 were mounted on PCMS 1, PCMS 2, and PCMS 3 respectively in the field (see Figure 3). Sensor 1, located at the Tomah Road interchange, served as a standalone sensor that provided the necessary speed information to the upstream message boards.

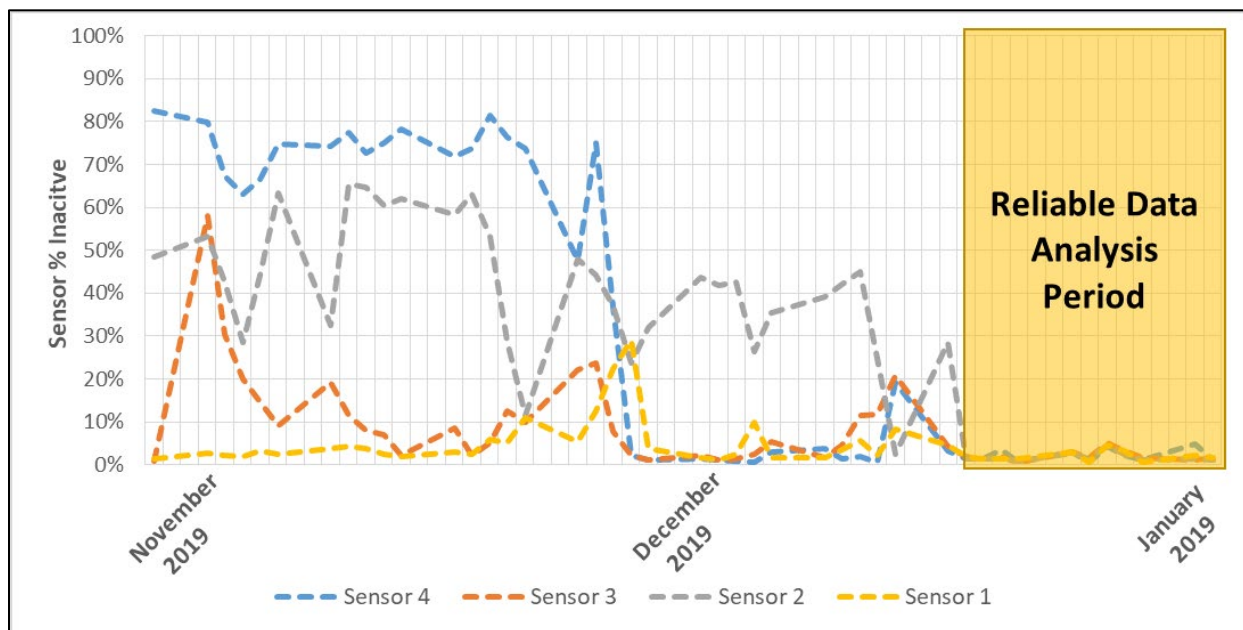
**Figure 5. QWS Data Gap Reliability Profile**

QWS device reliability was observed to be an issue and required regular communications with the vendor to address, especially during the early part of the monitoring. After several months of working with the Street Smart vendor, data reliability improved significantly. Monitoring of the QWS reliability primarily focused on the speed sensors to observe if there were extended time periods where no speed data was being collected. As shown in Figure 5, early on in the study period data from the speed sensors showed significant periods of unreliability. For example during the month of November, Sensor 2 and Sensor 1 experienced periods where there was no speed detected for more than 60 percent of a typical 24 hour period. This remained true up until mid-December 2020 when the speed device reliability increased to 90%. **Appendix B** provides sample data tables developed during this data validation process.

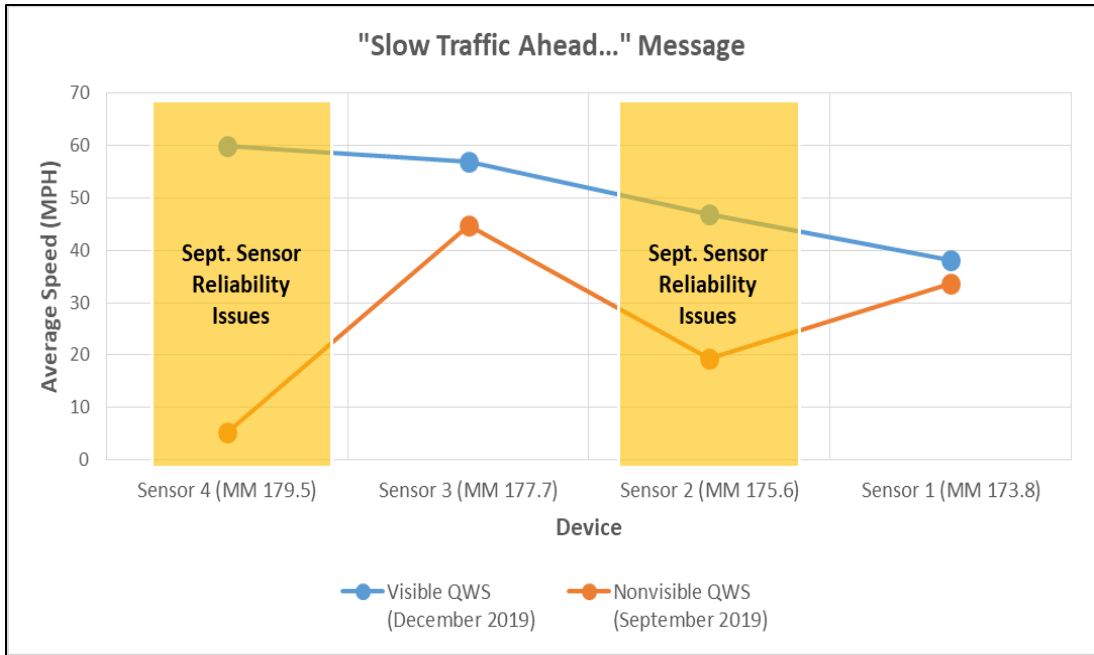
**Figure 13. Average Speed Profile during "Slow Traffic Ahead..." Message**

The objective of the average speed comparison is to observe how the southbound QWS messages impacts travel speeds in the area approaching the measured queue. The average speeds were measured only during message activations for a one month period with the messages visible and one month with the messages not visible to travelers. **Figure 13** through **15** illustrate the comparison between the two analysis periods. Note that the data for average speeds during the signing not visible time period at Sensors 4 and 2 is incomplete and therefore should not be considered in the analysis (although it is shown on the figures for context). These figures show that the average speed during “Slow Traffic Ahead...” and “Stopped Traffic Ahead...” messages was higher when the messages are visible to travelers compared to periods when travelers had no information about upcoming congestion. This is especially true for sensor 3 which is further from the downstream queue.

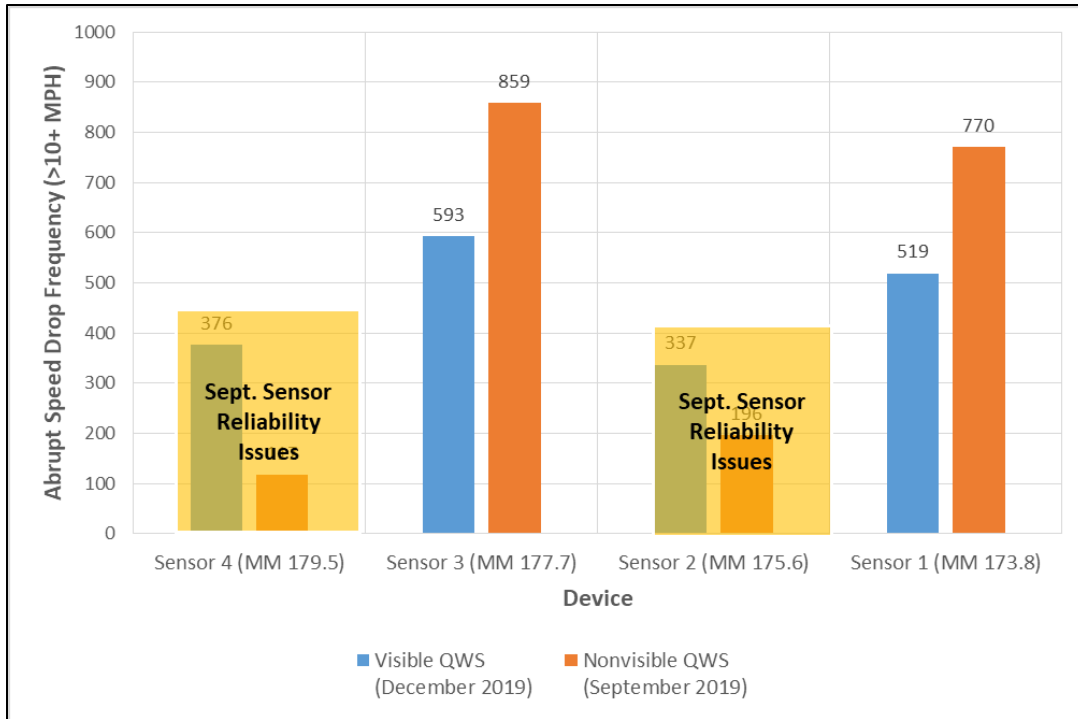
**Figure 16. Abrupt Speed Drop Frequency (> 10+ MPH)**

The objective of the abrupt speed reduction comparison is to measure how the southbound QWS messages impact abrupt speed reductions in the area approaching the measured queues. This measure was analyzed by counting the number of 10+ and 15+ mph speed reductions recorded during message activations within a one month period with the messages visible and one month with the messages not visible to travelers. **Figures 16** and **17** illustrate the comparison between the two analysis periods. Note that the data for average speeds during the signing not visible time period at Sensors 4 and 2 was incomplete and therefore should not be considered in the analysis (although it is shown on the figures for context). As these figures show, for sensors 3 and 1, there were significantly less abrupt speed reductions counted when the messages are visible to the travelers.
