Influence of the Mount Evans Highway (SH 5) on Alpine Wetland Hydrologic Processes, Permafrost, and Vegetation, Colorado Rocky Mountains

Technical Report Documentation Page

1. Report No. CDOT-2021-03		2. Government Accession No.		3. Recipient's Catalog No.	
4. Title and Subtitle Influence of the Mount Evans Highway (SH 5) on Alpine Wetland Hydrologic Processes, Permafrost, and Vegetation, Colorado Rocky Mountains				5. Report Date July 2021

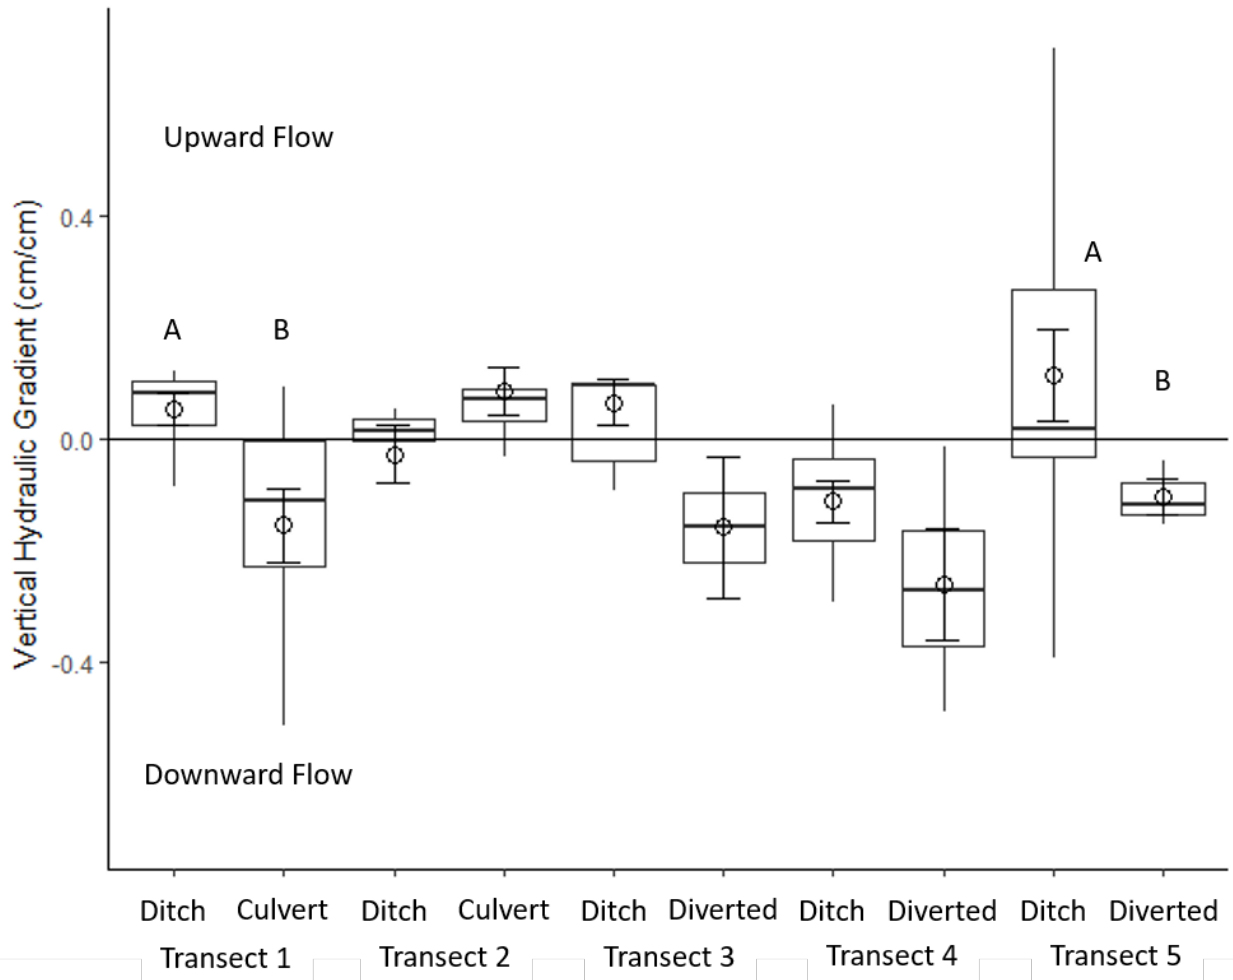
Figure 5. Vertical hydraulic gradients above and below roadways. Transects 1-4 span SH5. Transect 5 spans the abandoned access road. Positive values reflect upward groundwater flow, while negative values reflect downward infiltration. Letters indicate significant differences within transects.

Vertical hydraulic gradients measured in ditches and below roadways confirmed that groundwater is captured by roadside ditches, although there was considerable spatial variability (Figure 5). Upward seepage of groundwater into ditches along SH5 at transect 1 and along the abandoned access road at transect 5. Groundwater levels downslope of these areas were driven primarily by downward infiltration of surface water. While the highly variable vertical gradients at transects 3 and 4 produced similar mean values on either side of the roadway ($p = 0.059$ and $p = 0.093$ respectively), gradients were exclusively negative downslope of the road, indicating that the water table was supported solely by infiltrating surface water.

Comparisons of vertical hydraulic gradients across SH5 were not possible along transects 5 and 6 due to frequent high water levels in the ditch that would have submerged the piezometers, making them unmeasurable. However, downslope piezometers on these transects had positive mean values (5B1: 0.082 ± 0.134 , 6B1: 0.035 ± 0.062), indicating that groundwater flow paths do cross beneath SH5 here. This is significant because these locations both receive roadway inflows, from the culvert outfall at transect 5 and ditch overflow at transect 6.

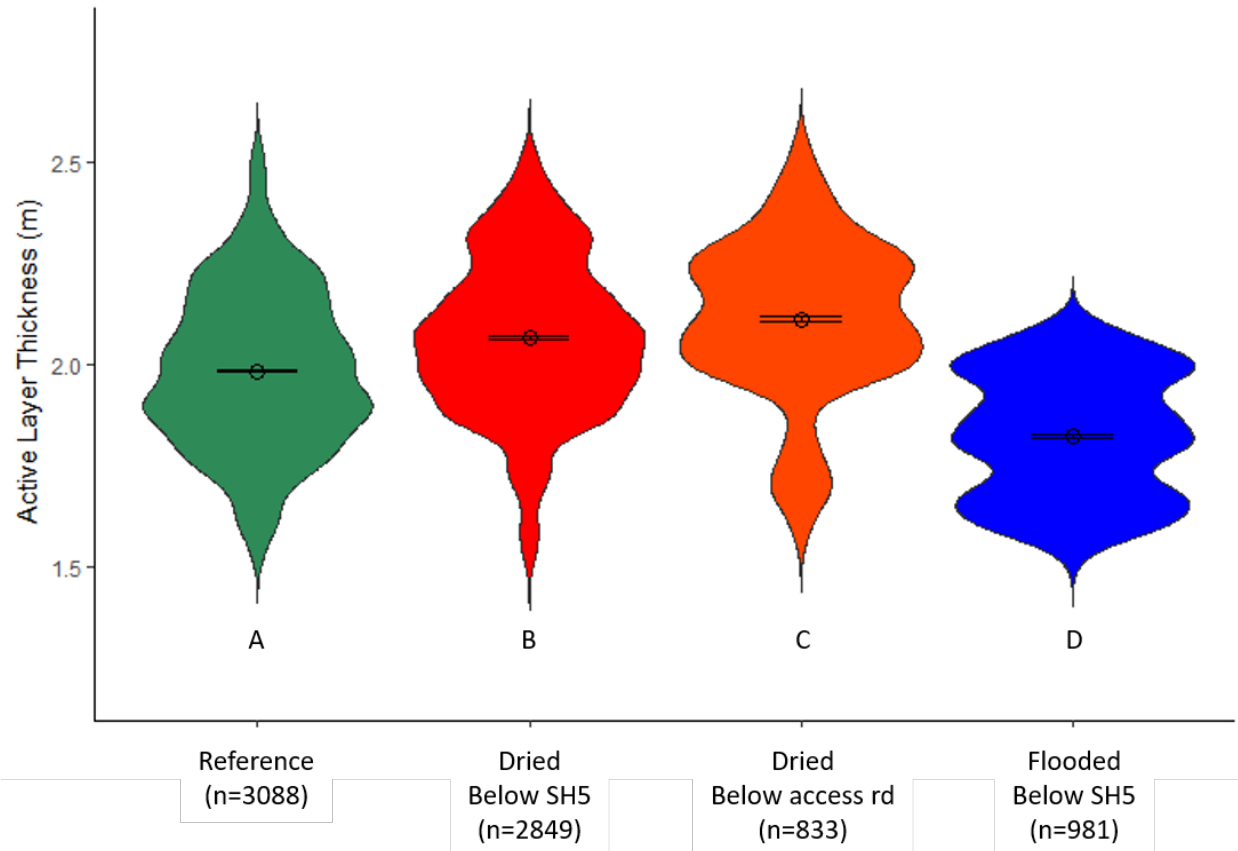
Figure 8. Mean active layer thickness outside of the road corridor. Letters indicate significant differences.

The 250 MHz GPR surveys demonstrated that active layer thickness away from the SH5 corridor has also been affected by hydrologic alteration (Figures 7 and 8). Late-summer mean permafrost depth within reference areas west of SH5 was 1.98 ± 0.01 m, while permafrost was deeper east of SH5 (2.07 ± 0.01 m; $p < 0.0001$), and the deepest permafrost table occurred downslope of the abandoned access road (2.11 ± 0.01 m; $p < 0.0001$). The mean differences were somewhat attenuated by the large range of permafrost depths within these areas (1.4-2.7 m), and the modal depths showed greater disparities. In contrast, active layer thickness was significantly

smaller in areas receiving roadway inflows (1.82 ± 0.01 m; $p < 0.0001$). While permafrost depth was highly variable within each area, these results indicate that diversion of sheetflow and shallow groundwater by roadways increases permafrost declines during the growing season, while the addition of roadway runoff was associated with reduced seasonal thaw depth. Surprisingly, changes to active layer thickness downslope of the small abandoned access road were comparable to those downslope of the much larger SH5. Declines in the permafrost table, which likely creates a perched water table, could exacerbate late-summer water table declines outside of the road corridor.

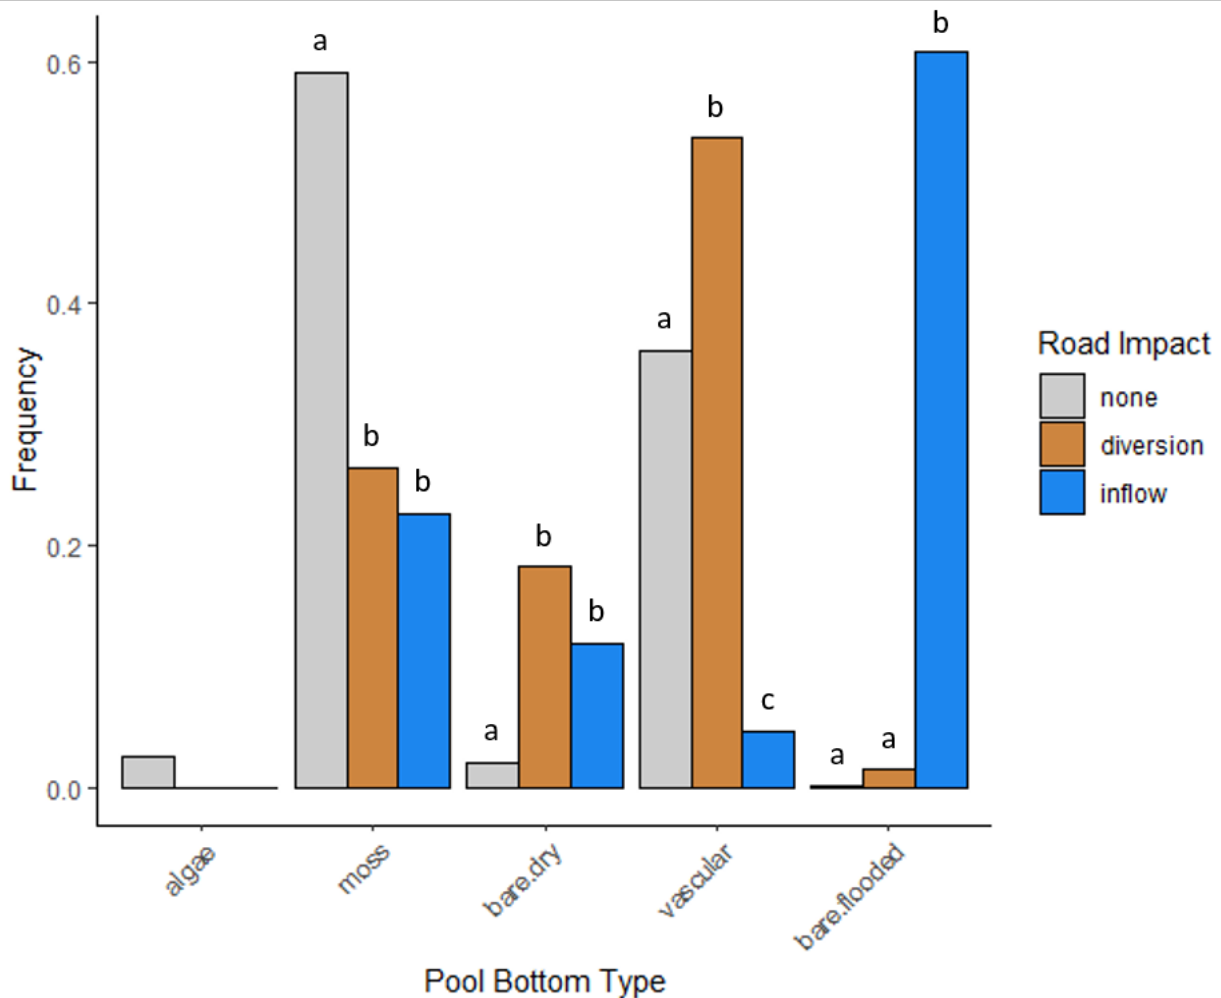
Figure 12. Frequency of alpine pool bottom community types within reference areas and areas affected by roadway diversions and inflows. Lower case letters indicate differences in the frequency of pool bottom type among roadway impacts ($\alpha=0.05$).

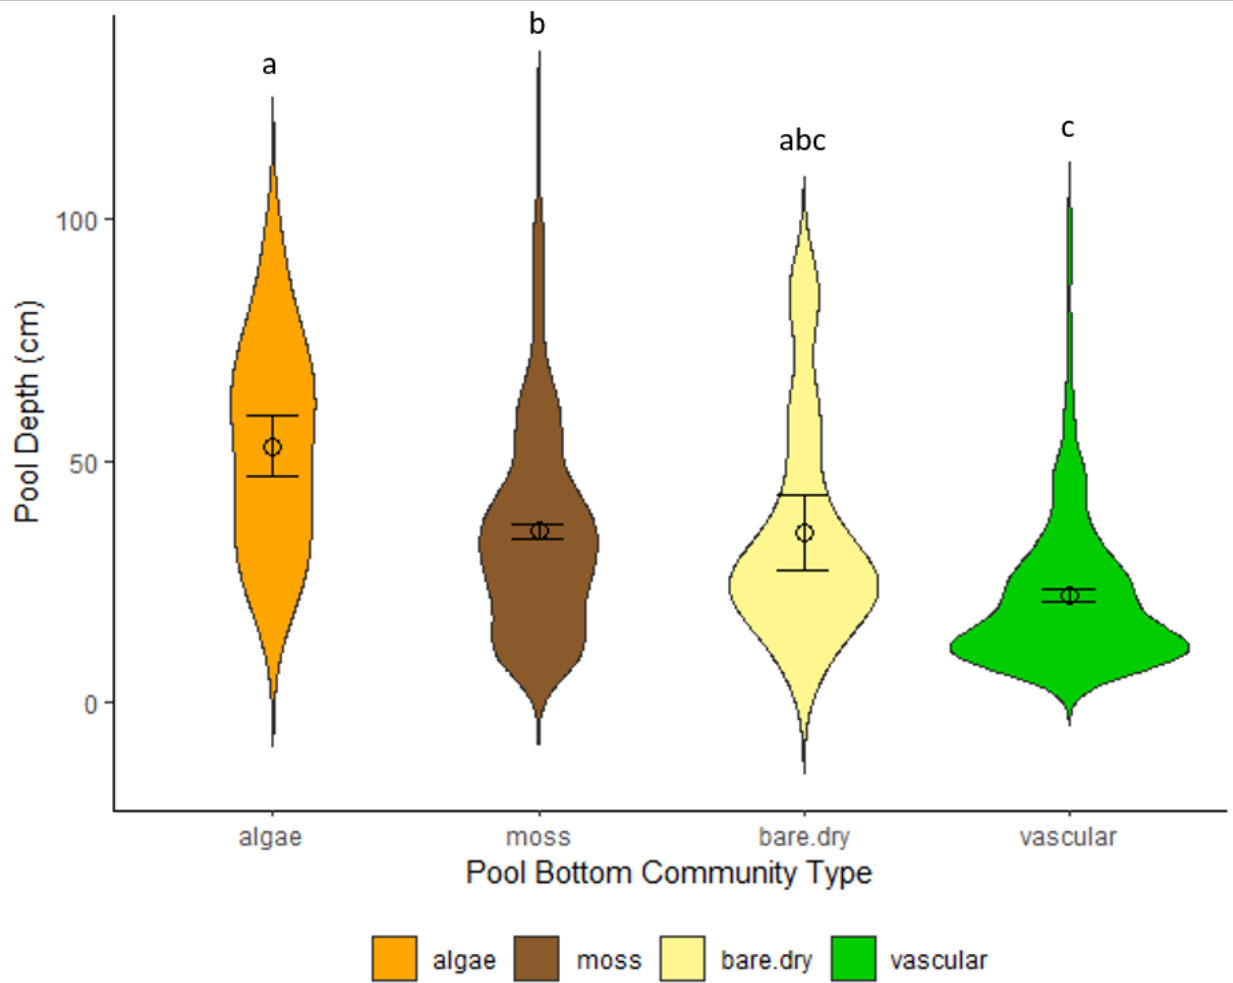
Figure 13. Violin plot of alpine pool depth for each pool bottom community type in reference areas. Circles with error bars indicate mean \pm 1 SE for community types. Letters indicate significantly different mean depths within community types ($\alpha=0.05$).

In reference areas unaffected by the roadway, pool bottom community types occurred at different depths below the turf surface (Figure 13). The mean depth of algal mat communities (52.9 ± 6.3 cm, $n = 11$) was greater than that of moss communities (35.4 ± 1.3 cm, $n = 255$), while vascular communities were generally in the shallowest pools (22.2 ± 1.3 cm, $n = 156$). The depth of unvegetated pool bottoms (35.1 ± 7.7 cm, $n = 9$) was more variable, and was not distinguishable from other community types ($p > 0.15$).

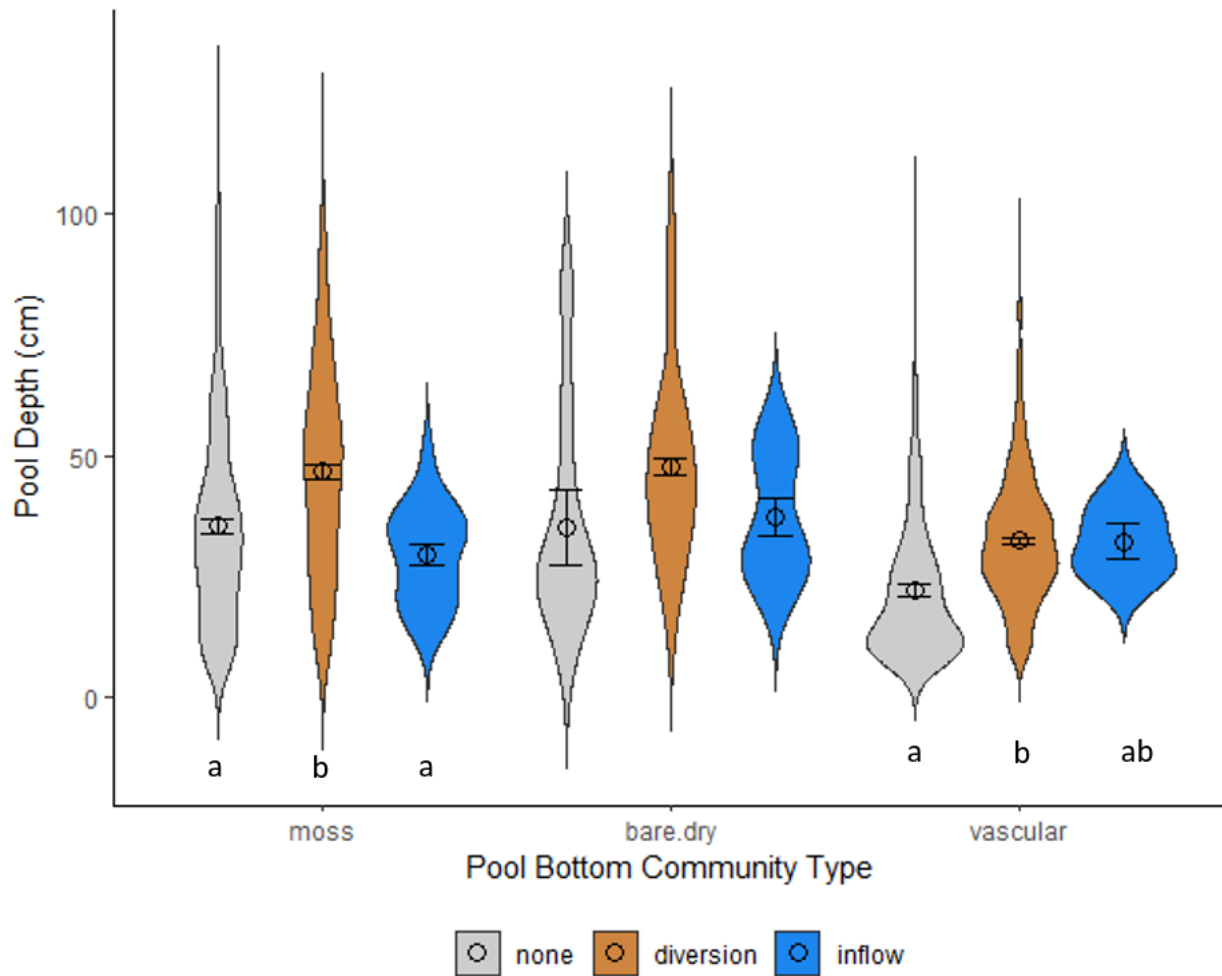
Figure 14. Violin plot of alpine pool depth for common pool bottom community types in reference areas and areas affected by roadway diversions and inflows. Circles with error bars indicate mean \pm 1 SE for community types. Letters indicate significantly different mean depths within community types ($\alpha=0.05$).

Sheetflow and shallow groundwater diversions along the roadway have increased the depths at which common pool bottom community types occur (Figure 14). Relative to reference areas, the remaining moss communities in dewatered pools were 11.3 ± 1.9 cm deeper ($n = 241$,

$p < 0.0001$), and vascular communities were 10.3 ± 1.3 cm deeper ($n = 490$, $p < 0.0001$). However, the depths of pools containing unvegetated bottoms with intact turf margins and unvegetated pools with recently killed *C. scopulorum* margins were highly variable and not clearly different among hydrological impacts ($p = 0.066$ and $p = 0.24$ respectively). The mean depths of community types in areas receiving inflow from culverts and roadside ditches were not distinguishable from those in reference areas.

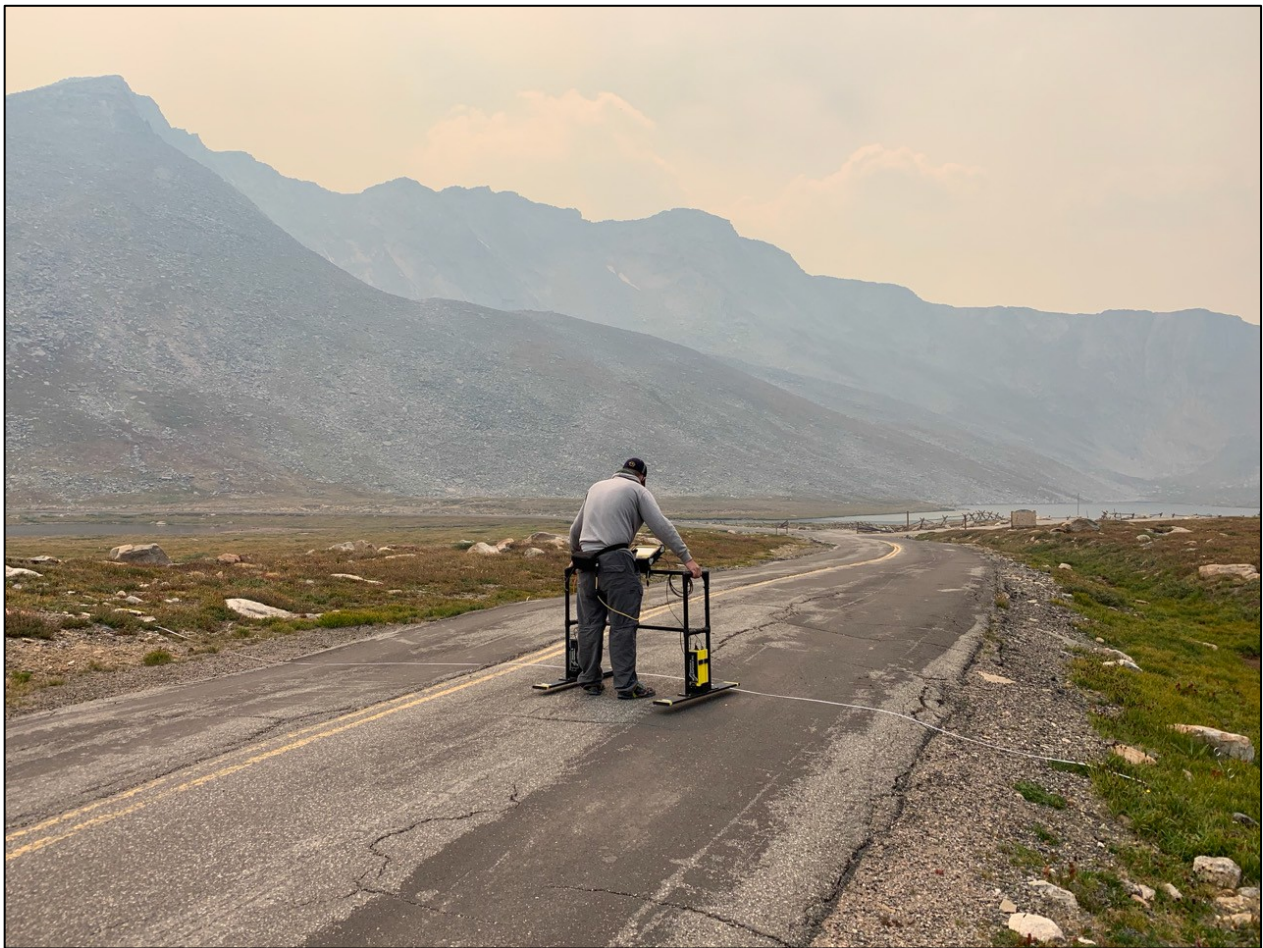
R. Bonnell conducting 100 MHz common offset ground-penetrating radar surveys near Summit Lake, Mt. Evans.

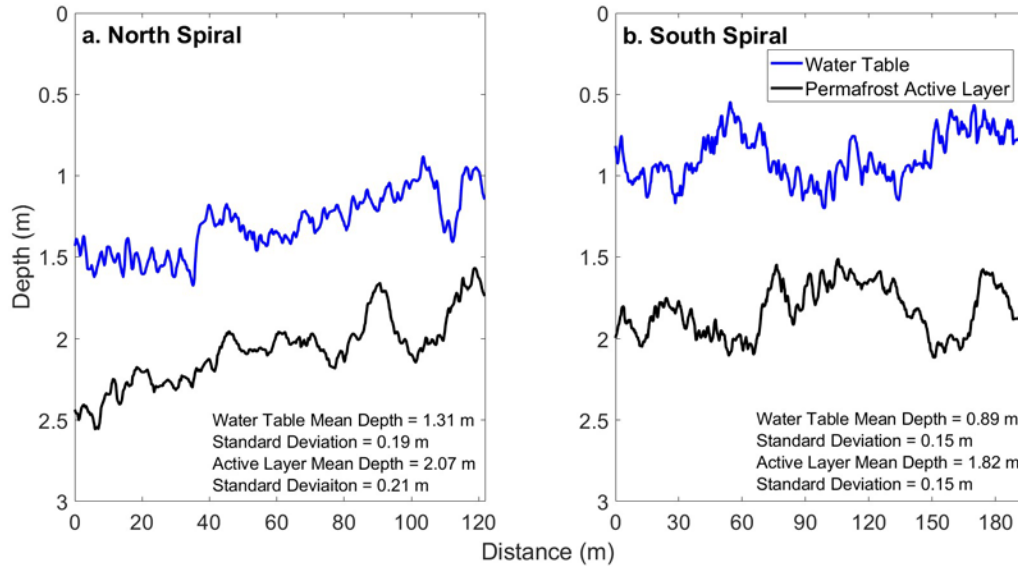
Figure 2: Water table and depth to permafrost surface in the spiral to the north of the road (a.) and the spiral to the south of the road (b.). Depths derived from 250 MHz GPR survey.

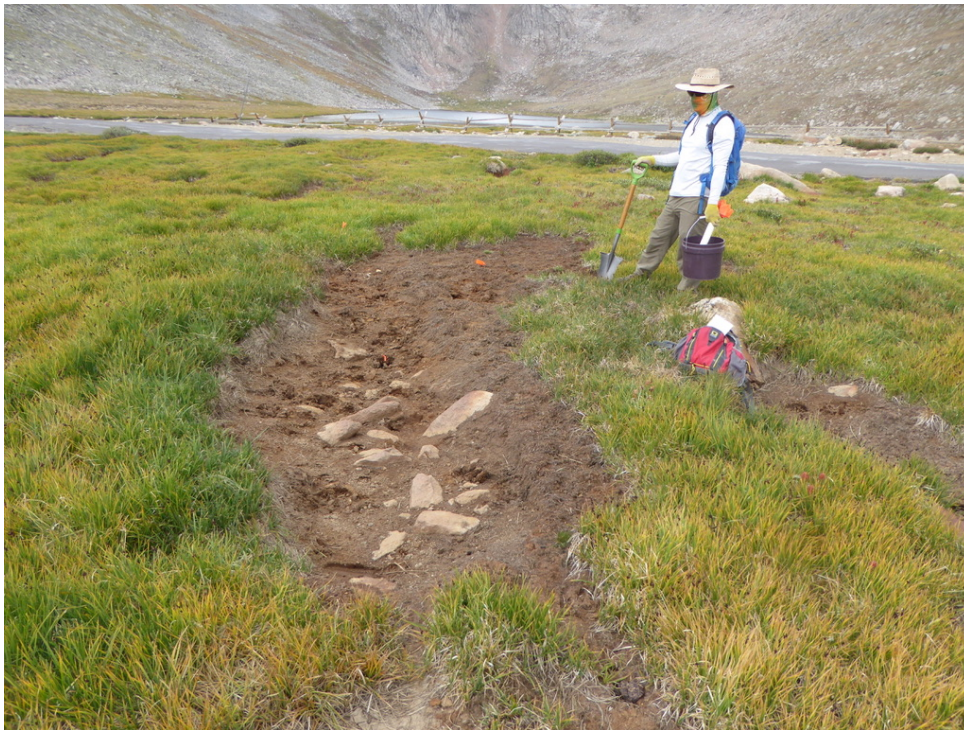
Figure 1. Bare pool created by persistent flooding.

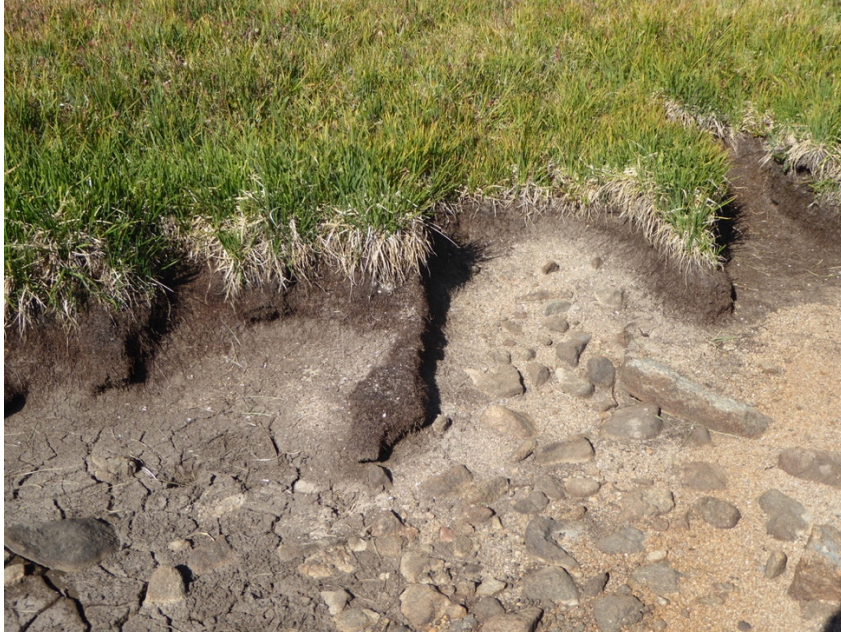
Figure 3. Pool margin erosion illustrated by bare organic rich soils that lack vegetation. Pools appear to be expanding due to erosion.

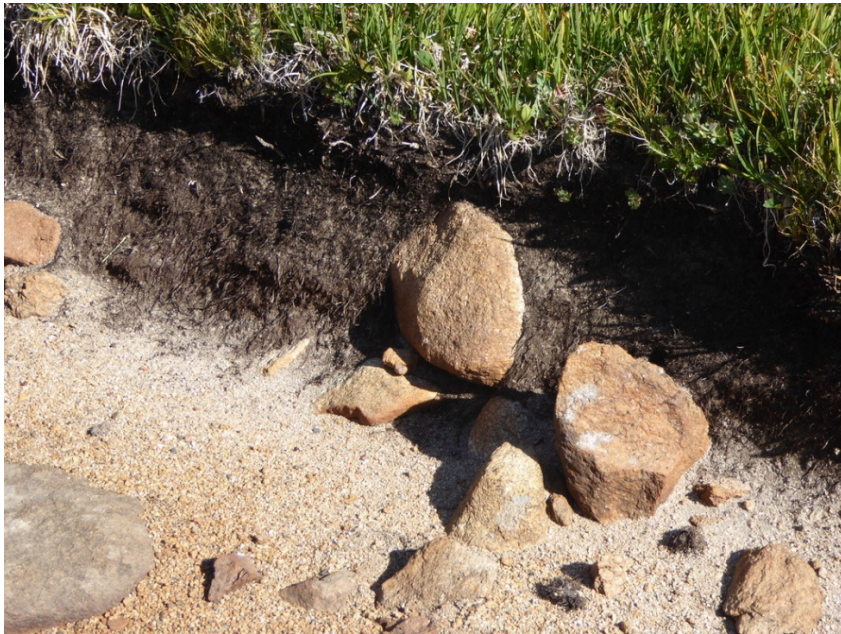
Figure 4. Close up of eroding soil showing roots of the turf and newly exposed rocks that have no lichens on them.

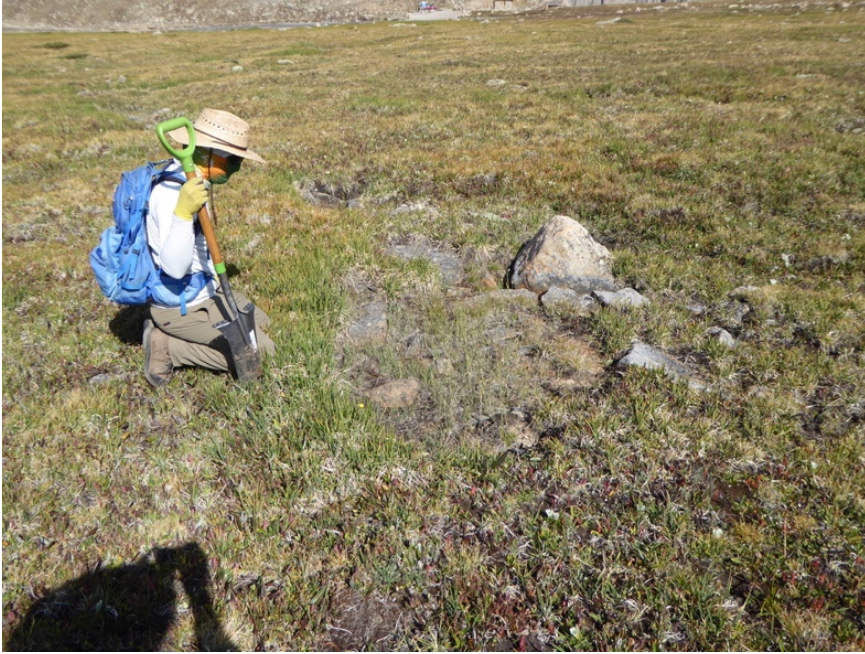
Figure 5. Dry pool colonized by *Alopecurus magellanicus*.

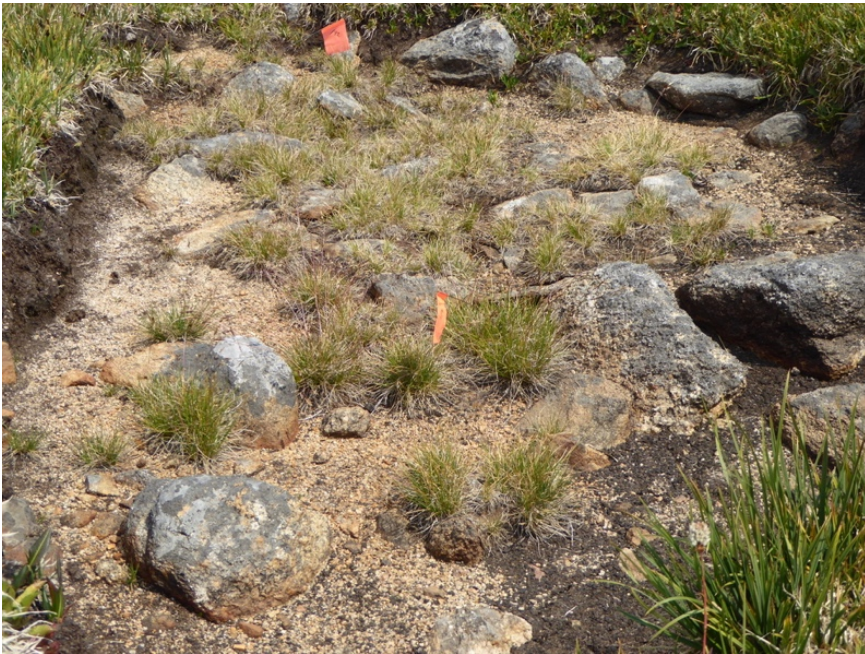
Figure 6. Dry pool colonized by *Deschampsia brevifolia*.

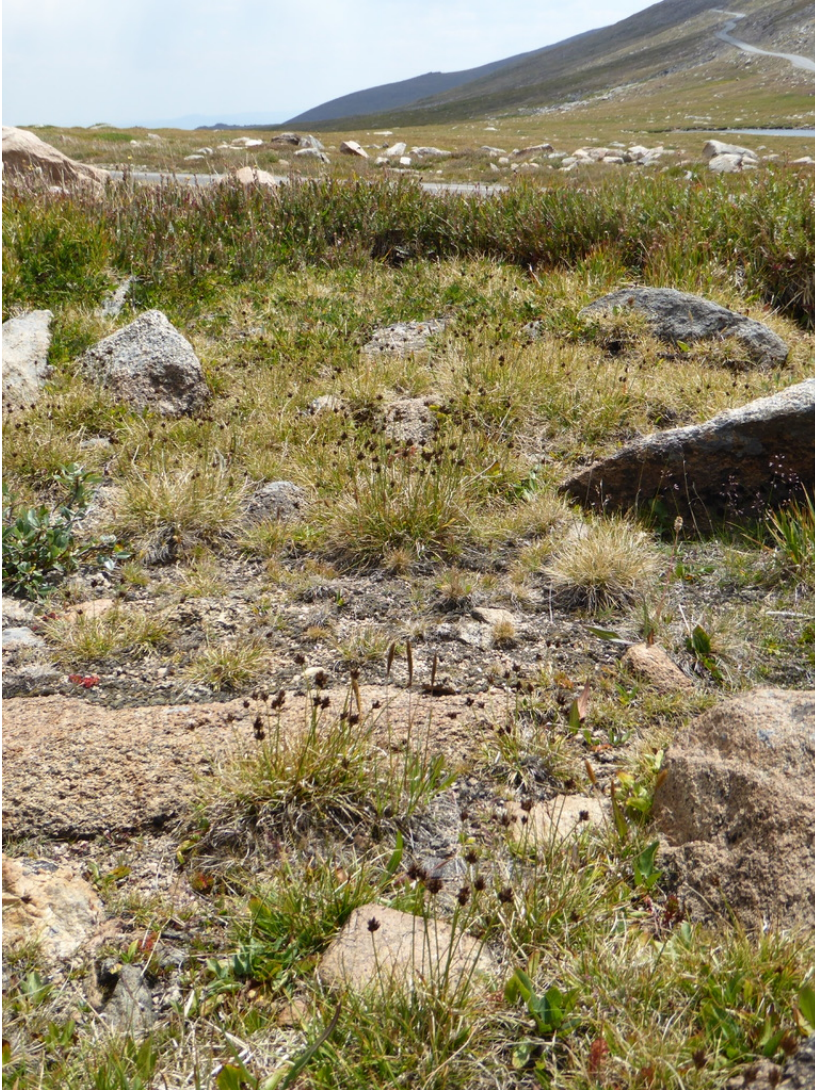
Figure 7. Dry pool dominated by *Carex ebenea*.

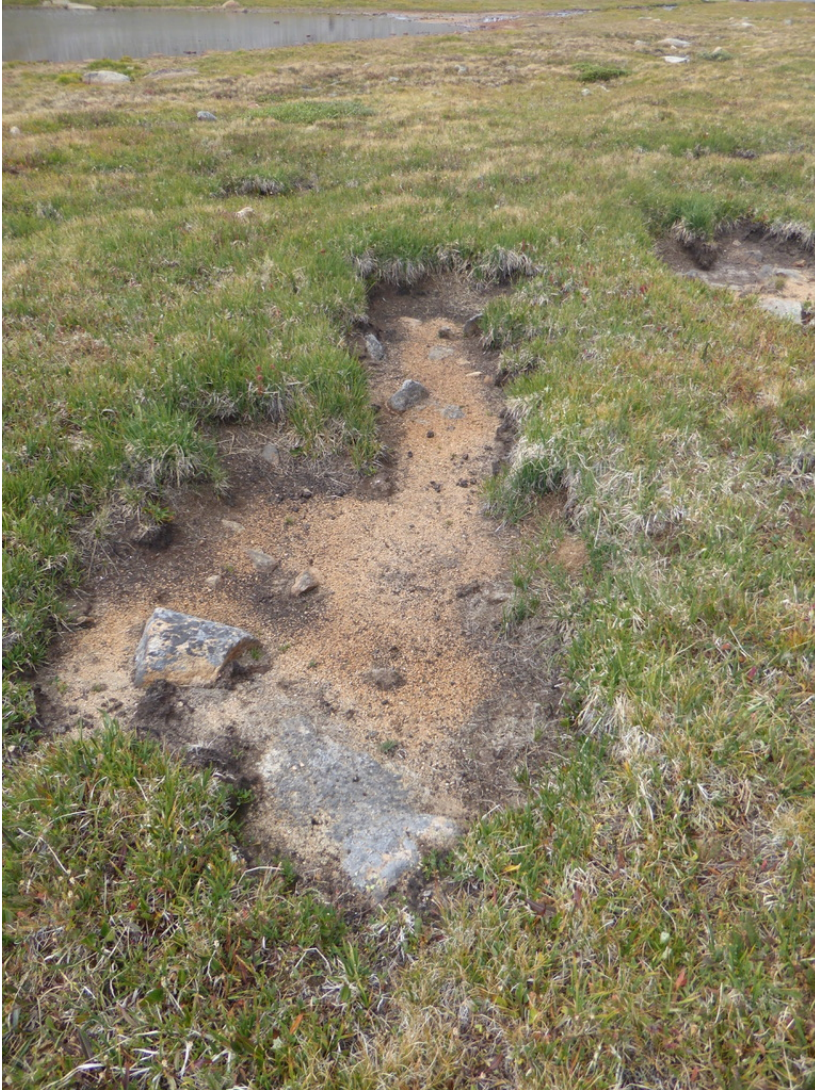
Figure 8. Bare dry pool.
