Striping Materials Performance Curves – Life Cycle Analysis

1. Report No. CDOT-2021-04		2. Government Accession No.		3. Recipient's Catalog No.	
4. Title and Subtitle Striping Materials Performance Curves – Life Cycle Analysis				5. Report Date May 2021

Final Report

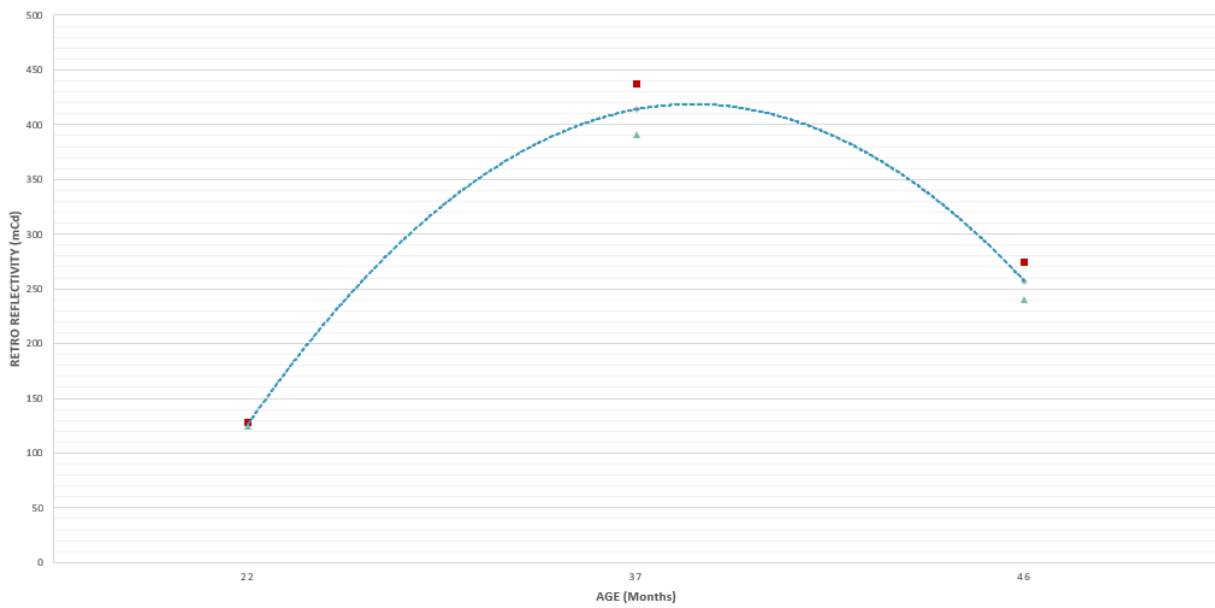
Figure 15. Performance curve for road 270A when the following criteria is selected; High → Bituminous → Epoxy → Urban → White.

If we further inspect the age chart in Figure 12, and narrow the selection down to road level, we can see the following: (a) Road 006G decay in retroreflectivity occurs at about month 16 and the curve remains practically unchanged to month 39 (see Figure 13), (b) the curve formed for road 470A has not enough information (enough data) to conclude anything, and therefore it should be removed from the analysis (see Figure 14), (c) Road 270A shown in Figure 15, shows an inverted curve suggesting that the age data provided is not accurate, and (d) road 070A performance curve is depicted in Figure 16, where a minimum occur around month 29 and if last data at week 45 is neglected, it appears that the performance curve remains constant. This suggest that month age (45 months) is not correct. If we look at the same sets of conditions used in Figure 16 but this time using the DSS section 2 or Time Chart, we can see that the age reported for June of 2019 cannot be 45 months but should be 0 or 1 month old (Figure 17.)

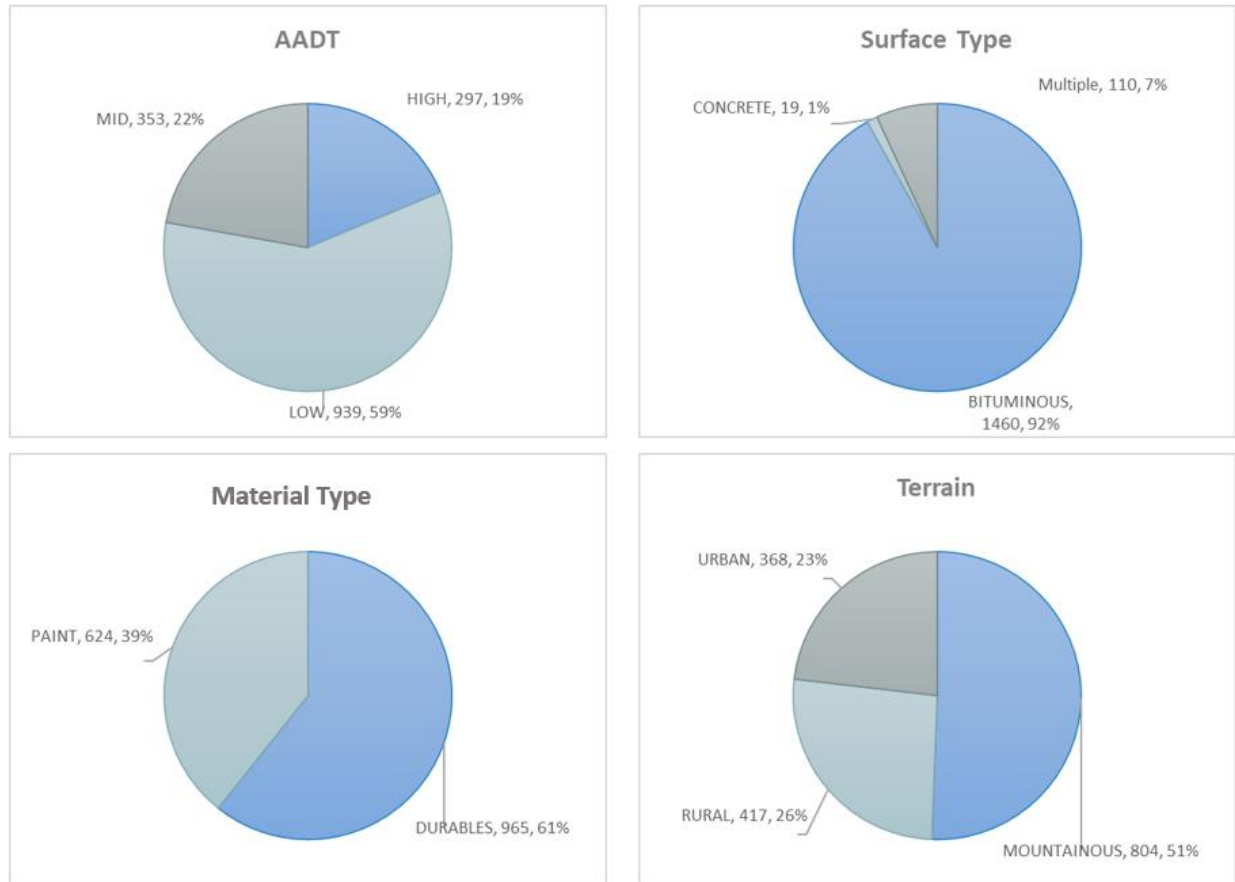
Figure 23. Road features surveyed in Region 3 for AADT, Surface Type, Material Type and Terrain. In each inserted figure, the callout indicates feature, total mileage measured, and relative percentage.

A total of 1589 miles were surveyed in 12 roads and 17 sections. The characteristics of the roads surveyed are shown in Figure 23. In this region, only 1% of the roads surveyed are concrete, and the results obtained on concrete surfaces might not be statistically significant.

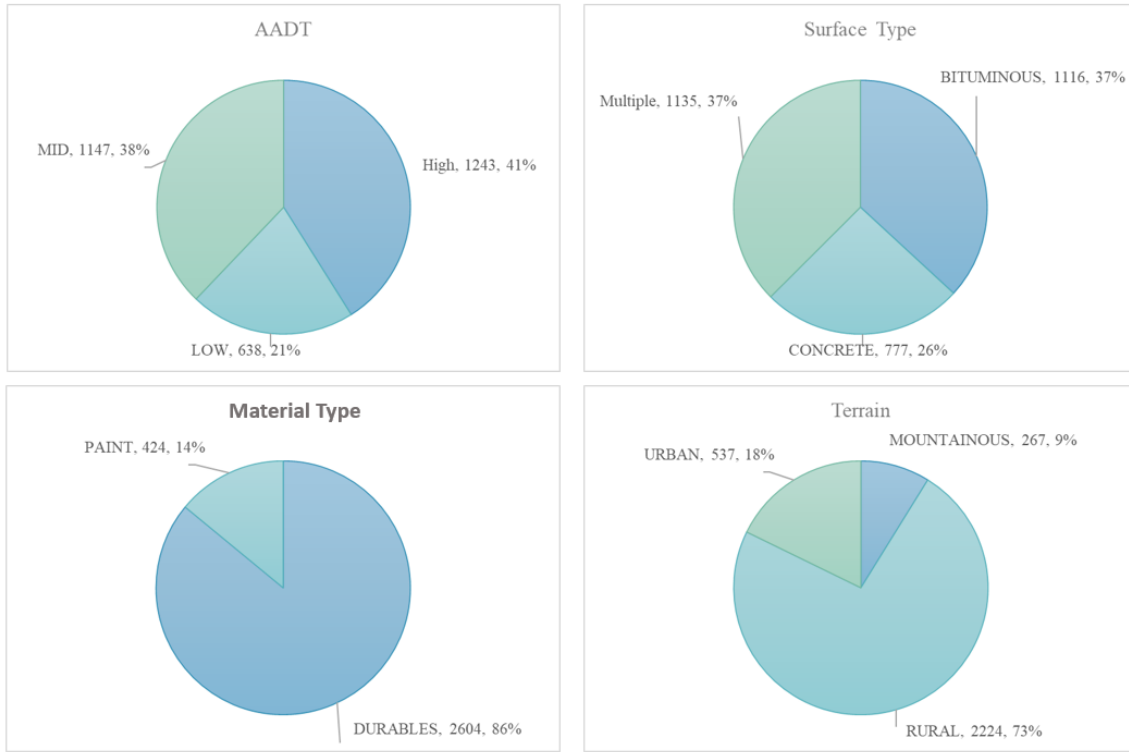
Figure 26. Road features surveyed in Region 4 for AADT, Surface Type, Material Type and Terrain.

In Region 4, 3028 miles were surveyed on 13 roads, and 16 sections. Figure 26 shows the distribution of these miles in terms of AADT, Surface Type, Materials Type, and Terrain. Figure 27 shows the performance curve obtained when the following criteria is selected: High AADT → Multiple → Durables (Both epoxy and Tape) → RURAL → WHITE. The graph in Figure 27 suggests a decay trend of the retroreflectivity data but the dispersion is too large to assume that this is correct. Further refinement of the data from DURABLES to EPOXY (Figure 28) and

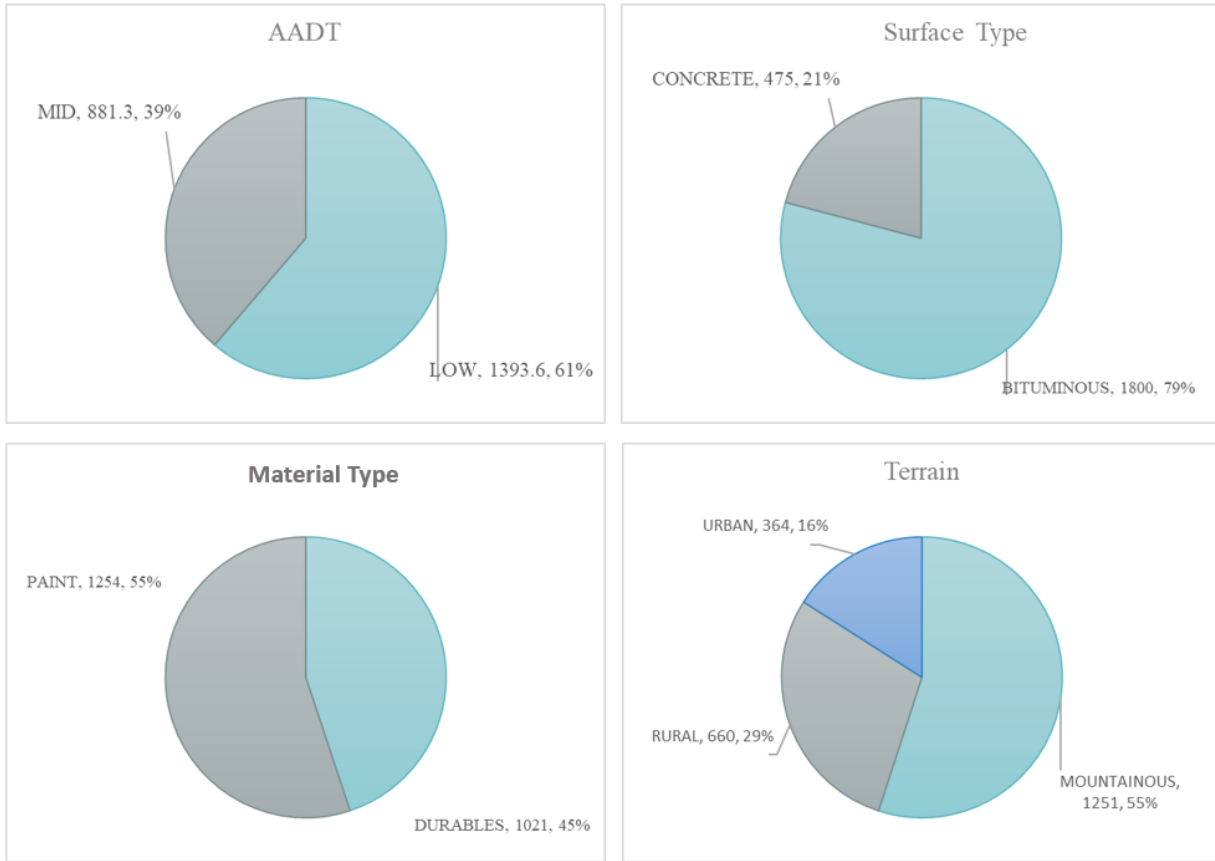
Figure 30. Road features surveyed in Region 5 for AADT, Surface Type, Material Type and Terrain.

In this region, a total of 2,275 miles were measured on 6 roads, and 14 sections. Figure 30 shows the distribution of characteristics in this region.
