**COLORADO**  
Department of Transportation

# US Highway 6 Wildlife-Highway Mitigation Assessment

Report No. CDOT-2020-14  
November 2020

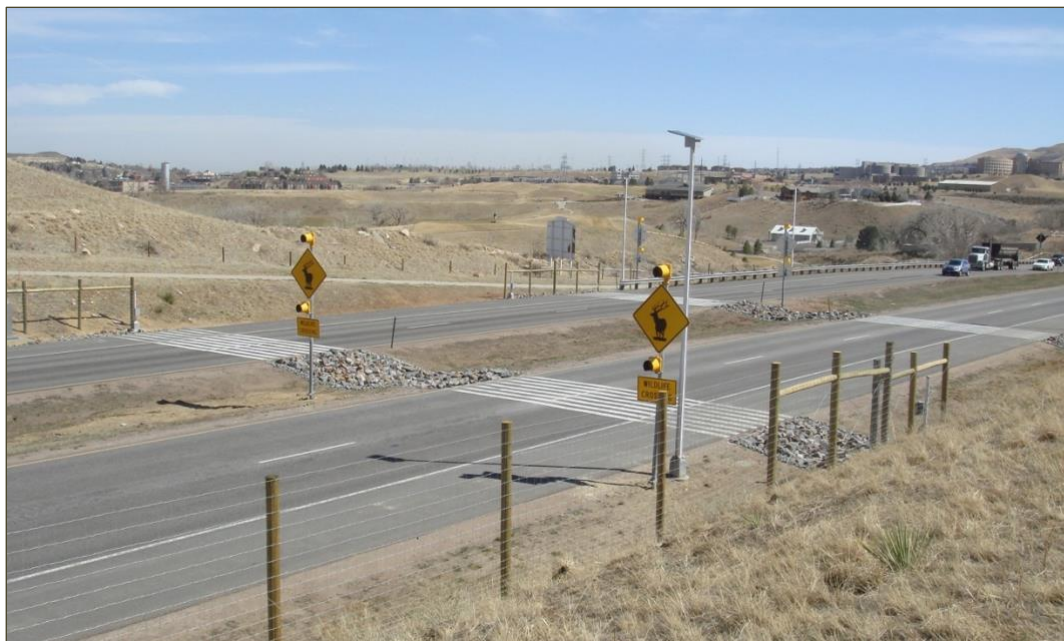
**Figure 3. At-grade crosswalk system on US 6. Photo credit: CDOT**

- Roadside reflectors and audible warning devices at each fence end to deter wildlife from entering into the fenced right-of-way.

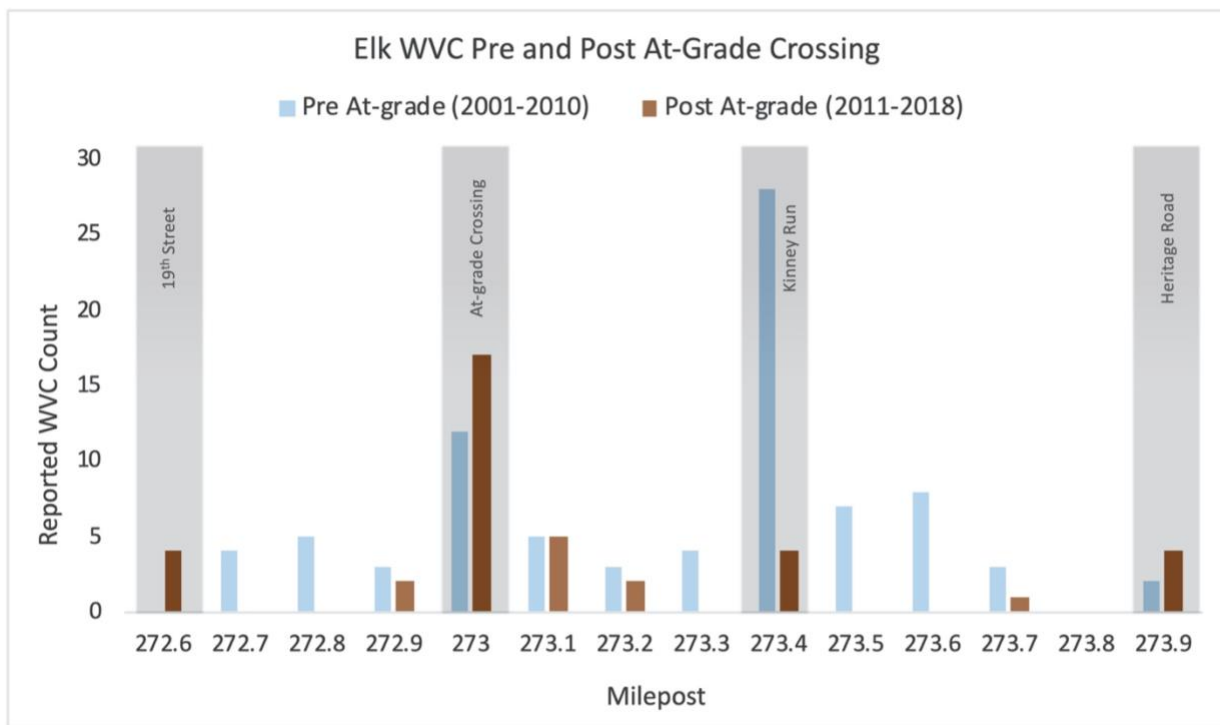
**Figure 4. Elk-vehicle collisions by milepost 10 years prior to the installation of the at-grade crosswalk system (2001 – 2010) and 8 years following the installation of the at-grade crosswalk system (2011-2018).**

Between 19<sup>th</sup> Street and Heritage Road, both deer and elk WVC were reported throughout the segment prior to the installation of the at-grade crosswalk. For both species, the majority of WVC occurred at Kinney Run (MP 273.4) during this timeframe. Kinney Run is a natural drainage corridor that provided direct access between undeveloped areas on either side of US 6. Following the construction of the at-grade crosswalk system, however, spatial patterns in crossing activity shifted. The new wildlife exclusion fencing prevented animals from crossing at Kinney Run and, as animals learned to navigate the at-grade crosswalk and associated fencing, wildlife movements across US 6 shifted primarily to the area around the designated crosswalk and to the fence ends at 19<sup>th</sup> Street and Heritage Road, as is reflected in the WVC accident data (Figs. 4 & 5).

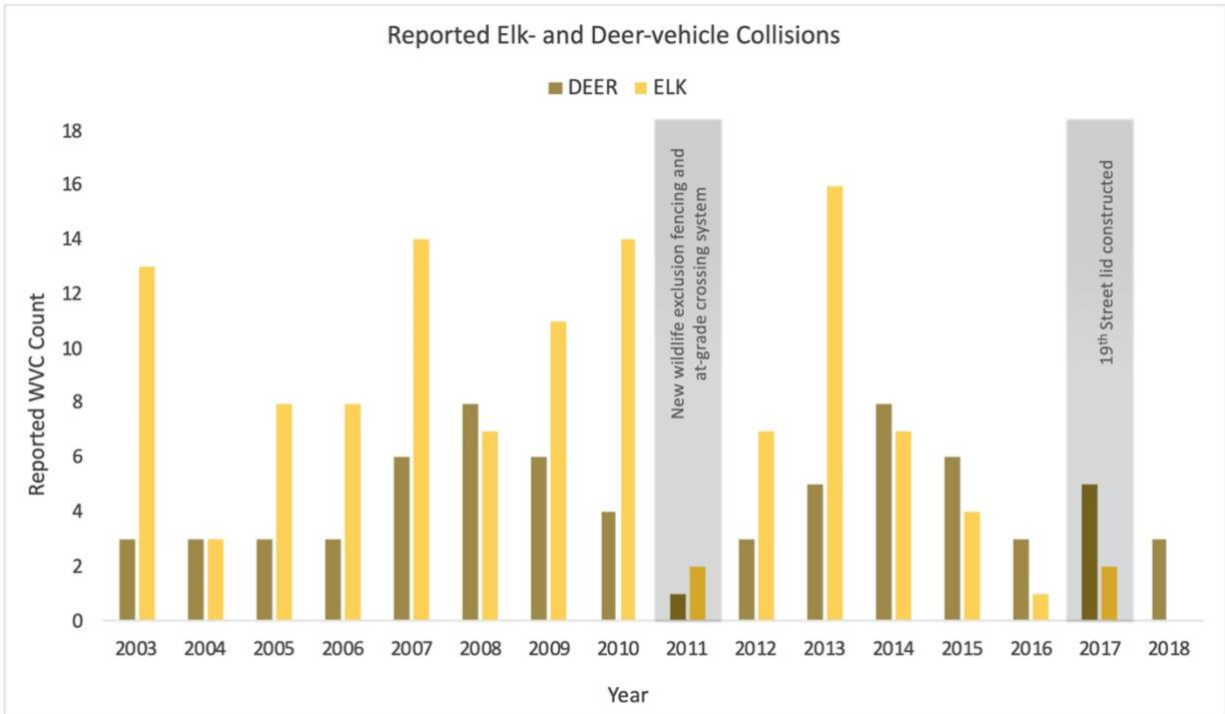
Further shifts in wildlife movement patterns appear to be occurring since the completion of the 19<sup>th</sup> Street interchange in mid-2017 (Fig. 6). The removal of the signal has resulted in more constant traffic flows on US 6 (i.e., fewer gaps during which animals may cross) and higher speeds. These changes in traffic patterns appear to be increasing the barrier effect of traffic on wildlife movement at the at-grade crosswalk. While only preliminary data are available, from June 2017 through 2018, WVC decreased to an average of 5.7 WVC per year. An increase in the barrier effect is corroborated by camera monitoring at the at-grade crosswalk, which has documented a longer crossing time for the elk herd at the at-grade crosswalk and an increase in repel behavior before an animal attempts crossing at the crosswalk (see below section on Wildlife Monitoring). In Winters 2017-18 and 2018-19, the herd was observed by Golf Course personnel to be spending longer stretches of two weeks or more on the golf course before returning west. In Winter 2019-20, however, camera monitoring detected a sharp increase in the number of crossing events with fewer elk per crossing event. Correspondingly, WVC also appear to have increased in 2019, with 12 deer and elk-vehicle collisions recorded by the City of Golden.

**Figure 6. Wildlife-vehicle collisions by year (MP 272.6-273.9). Fossil Trace Golf Course was constructed on the site of a former clay mine in 2002, attracting elk across US 6. In late 2010/early 2011 the at-grade crosswalk and wildlife exclusion fence were installed. Construction of the 19th Street interchange was completed in mid-2017.**

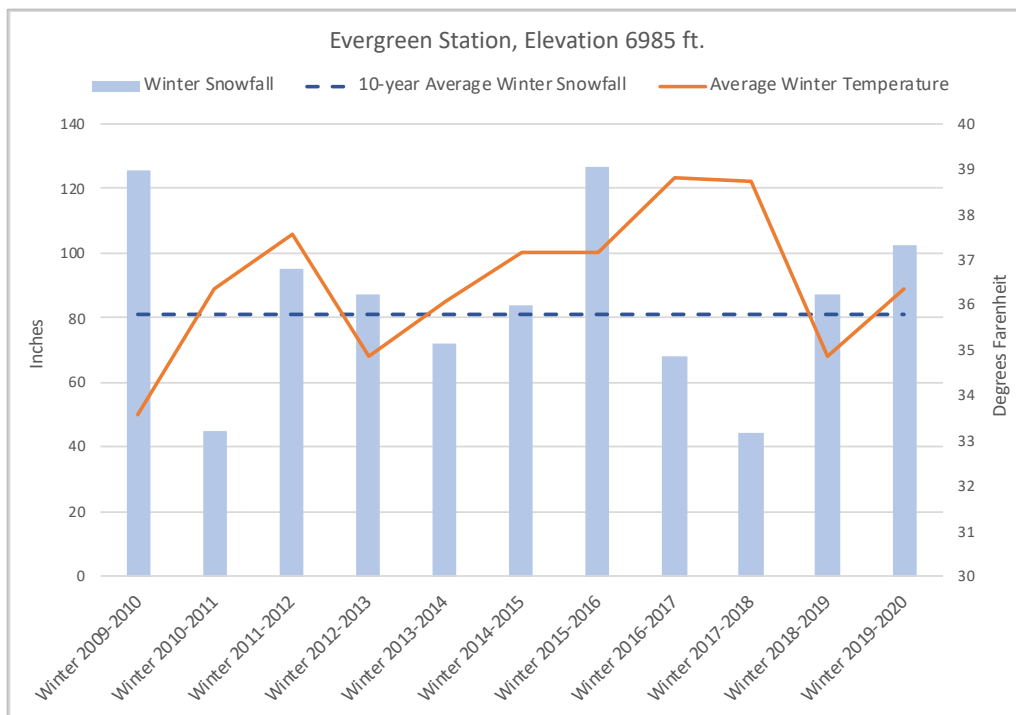
**Figure 7. Winter snowfall and average winter (October-May) temperatures from 2009-2020. The Evergreen weather station was used as data for the Golden weather station on Lookout Mountain were incomplete. Annual patterns in snowfall and temperature are similar at both weather stations, although the Evergreen weather station records greater annual snowfall than the Golden Station.**

Winter severity – including snowfall, snow depth and temperature – in the foothills above Golden are expected to have some impact on elk and deer movement across US 6 and, subsequently, on WVC (Fig. 7). However, given that there are multiple interacting variables influencing wildlife movements, it is difficult to distinguish any direct correlations between winter conditions and WVC rates (Fig 8).

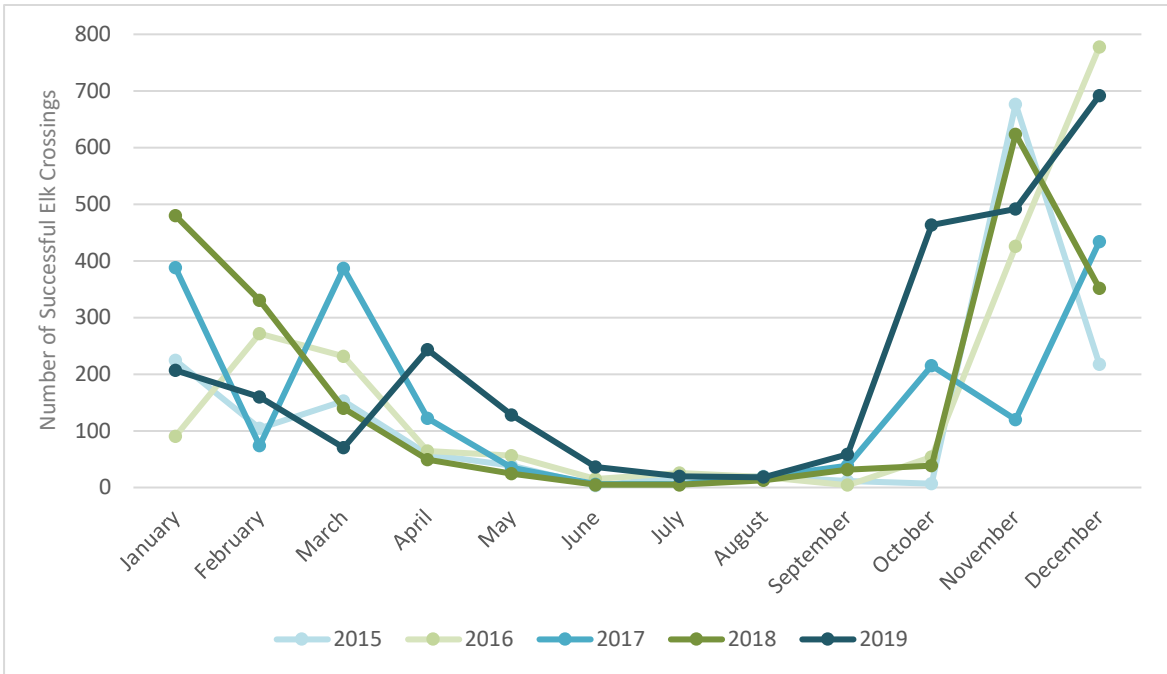
**Figure 9. Number of individual elk successfully using the at-grade crosswalk, 2015-2019. Note y-axis scale is 0-800.**

From October 2014 through December 2019, 11,330 individual successful westbound elk movements were documented at the at-grade crosswalk (Fig. 9) in 780 successful crossing events (Fig. 10). This equates to a crossing success rate of approximately 77% for individual elk movements. A crossing event is composed of an individual or a group of elk using the at-grade crosswalk at the same time. A single crossing event may last a few seconds or up to a few hours, depending on the size of the group and whether all individuals were able to cross together, or some were initially deterred from crossing due to approaching traffic. In addition to successful crossings, some wildlife approaches to the at-grade crossing resulted in failed movements where the animal repelled from the at-grade crossing, typically due to traffic. An additional 3,385 individual failed elk movements were documented during this timeframe in 389 failed crossing events (Fig. 11). This equates to a crossing failure rate of 23% for individual elk movements.

Successful elk crossings, successful elk crossing events, and failed elk crossing events were highest in the late fall across all years, generally October-December with a peak, in most cases, in November. The total number of successful movements decreased in April and May and remained low through the summer months (June to September). These movements were made primarily by individuals, pairs or small sub-herds. Conversely, during the fall, winter and early spring months, most movements were made by animals traveling in herds averaging between 10-30 animals with the maximum herd sizes ranging from 73-130 animals.

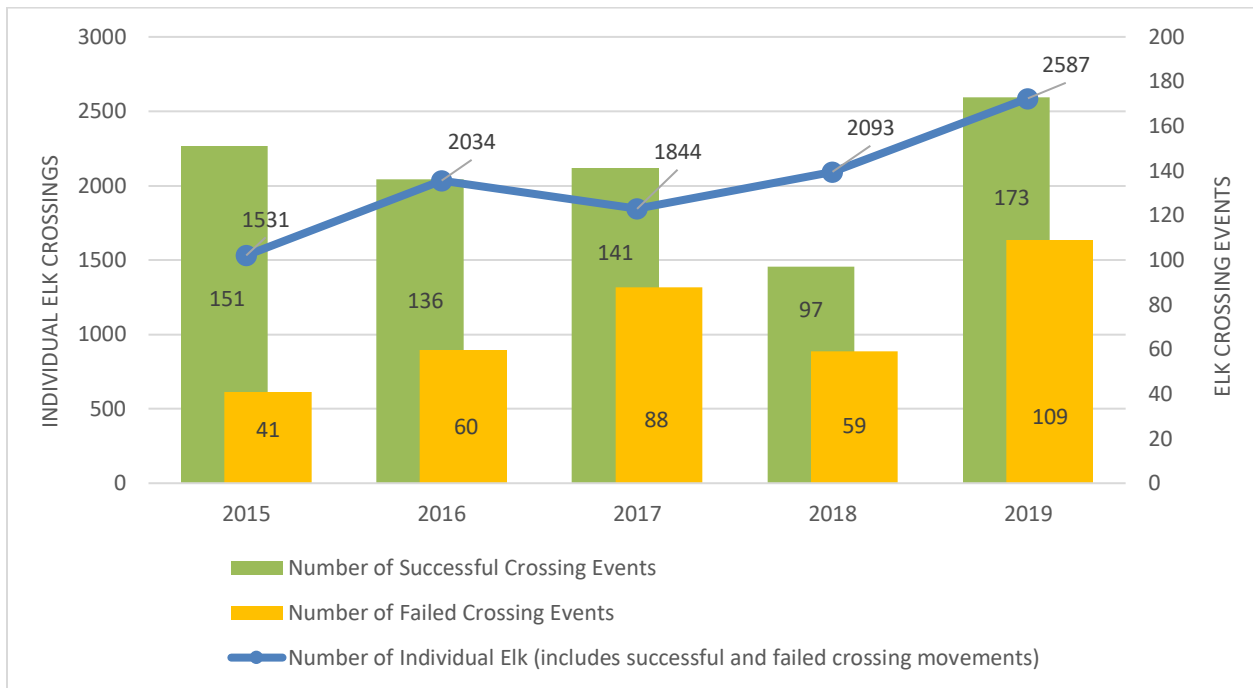
**Figure 12. Annual comparison of successful crossing events, failed crossing events, and the total number of individual elk, including both successful and failed crossing movements, 2015-2019.**

Overall, while the number of individual successful elk crossings has increased from 2015-2019, the number of successful and failed elk crossing events has varied from year to year (Fig. 12). Both successful crossing events and failed crossing events decreased in 2018, corresponding with the timeframe following the completion of the 19<sup>th</sup> Street interchange and subsequent changes in traffic patterns. Yet, despite this decrease in the total number of crossing events, in 2018, the number of individual elk movements – including both successful crossings and failed

attempts – continued to increase, indicating an increase in the number of elk per crossing event. In 2019, successful crossing events, failed crossing events, and the total number of elk movements were all at their highest in the five-year monitoring timeframe. The number of elk per crossing event decreased again to a level consistent with the years prior to the interchange construction (2015-2017). The crossing success rate of elk that approached the crosswalk was highest in 2015 (79%) and decreased in 2016 (70%) and 2017 (62%), where it remained consistent through 2018 and 2019.

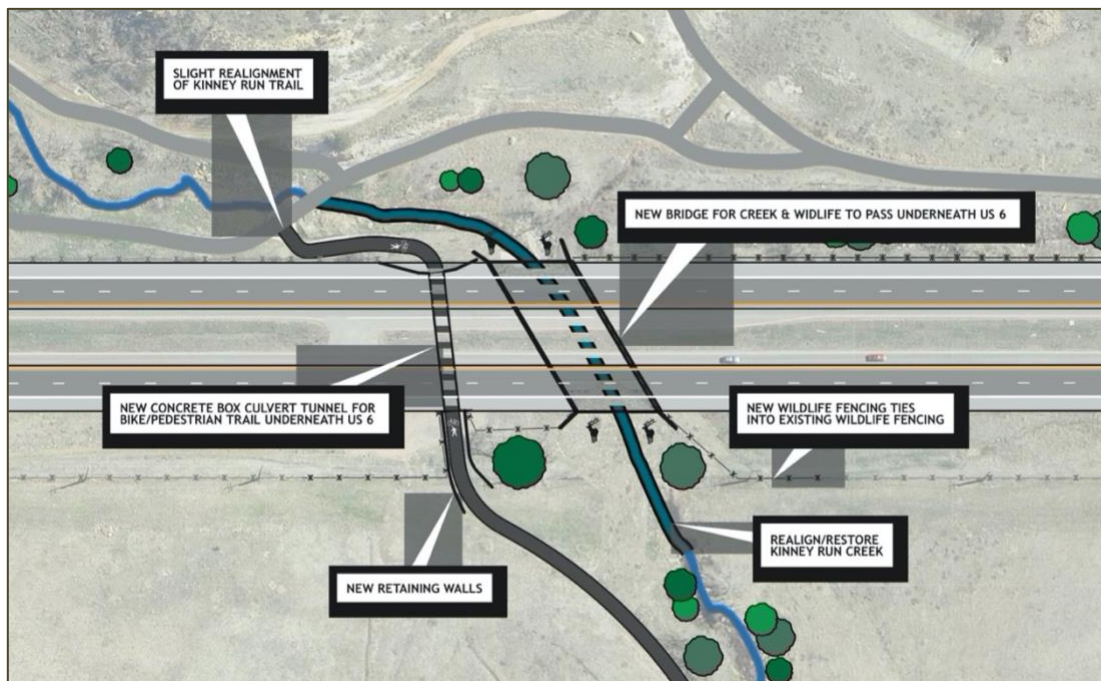
**Figure 13. Alignment of the separated wildlife underpass, Kinney Run Creek, and the box culvert for the bike/pedestrian trail (milepost 273.4). Drawing courtesy of HDR.**

Based on the project team’s evaluations and public input on each of these alternatives, CDOT has proceeded with the design for the preferred crossing structure alternative to replace the existing double box culvert at Kinney Run (Fig. 13). The design team completed its preliminary design phase (Field Inspection Review [FIR], equivalent to 30% design) in November 2019, and completed final design (Final Office Review [FOR], equivalent to 85-90% design) in Fall 2020 (see Appendix C for the wildlife crossing plans). While construction funding has not been identified, the project partners remain committed to enhancing safety for motorists and wildlife across US 6.

reduce WVC and other wildlife conflict, resulting in the recommendation to remove the at-grade crosswalk and constructing a wildlife underpass to replace the existing double box culvert at Kinney Run (MP 273.4). The construction of a bridge underpass over Kinney Run Creek with a separate recreation trail culvert will benefit wildlife, stream health, recreationists, and driver safety.

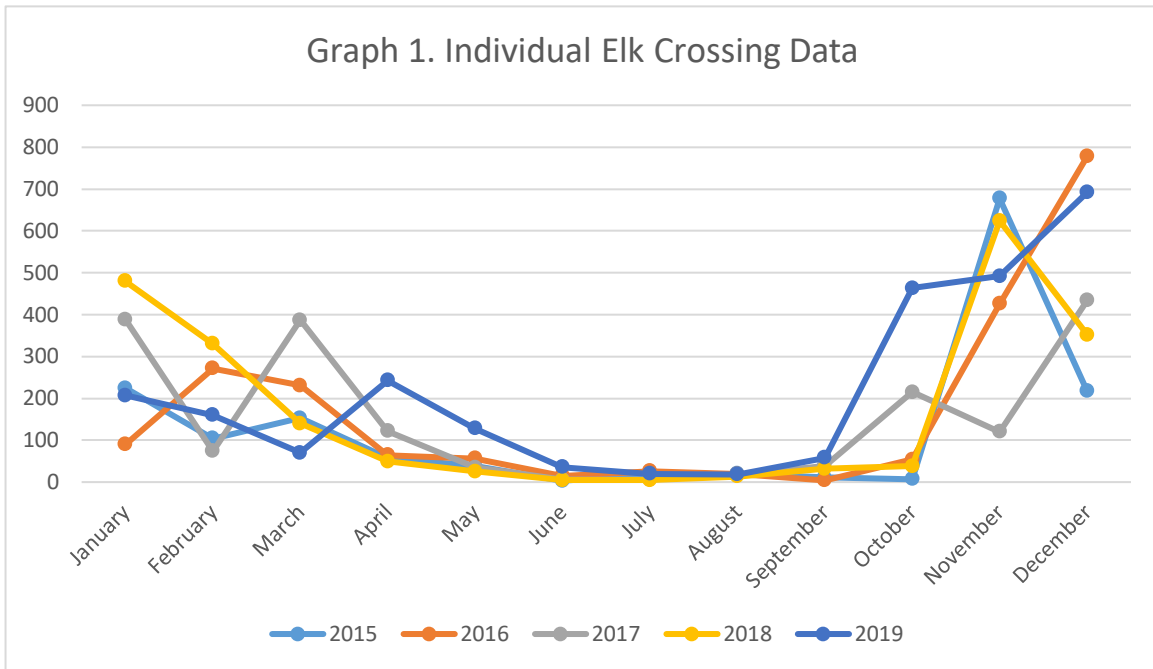
Graphs 1 through 3, below, display elk crossing data from 2015 through the end of 2019 by month. Elk activity is by far the greatest during fall and early winter with little activity during summer months.

**Note:** This number represents individual elk noted using the crossing. Data calculated using a 38% overlap (percent overlap accounts for the camera view overlap between cameras 3 and 4; this helps prevent double-counting animals caught on camera).

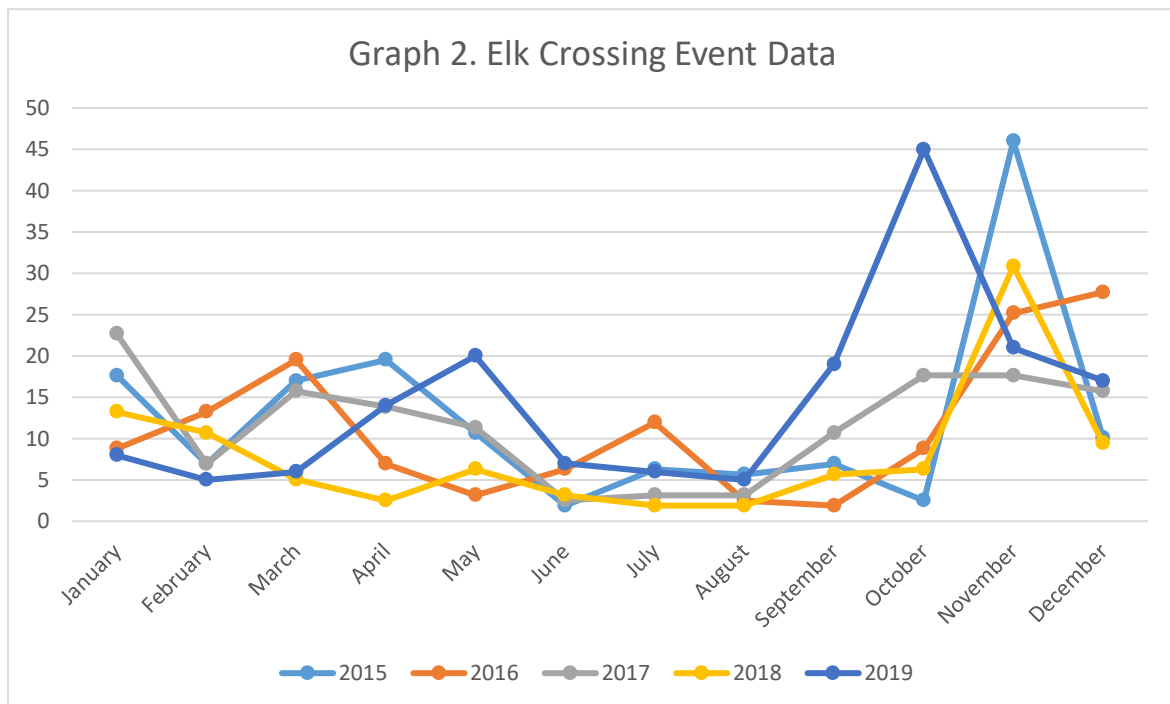
**Note:** A crossing event is where elk (single elk or herd of elk) use the crossing at any given time. For example, one crossing event would be considered when one or more elk attempt to use the crossing at the same time. A single crossing event may last a few seconds or up to a few hours, depending on whether or not the elk are deterred from crossing due to traffic.

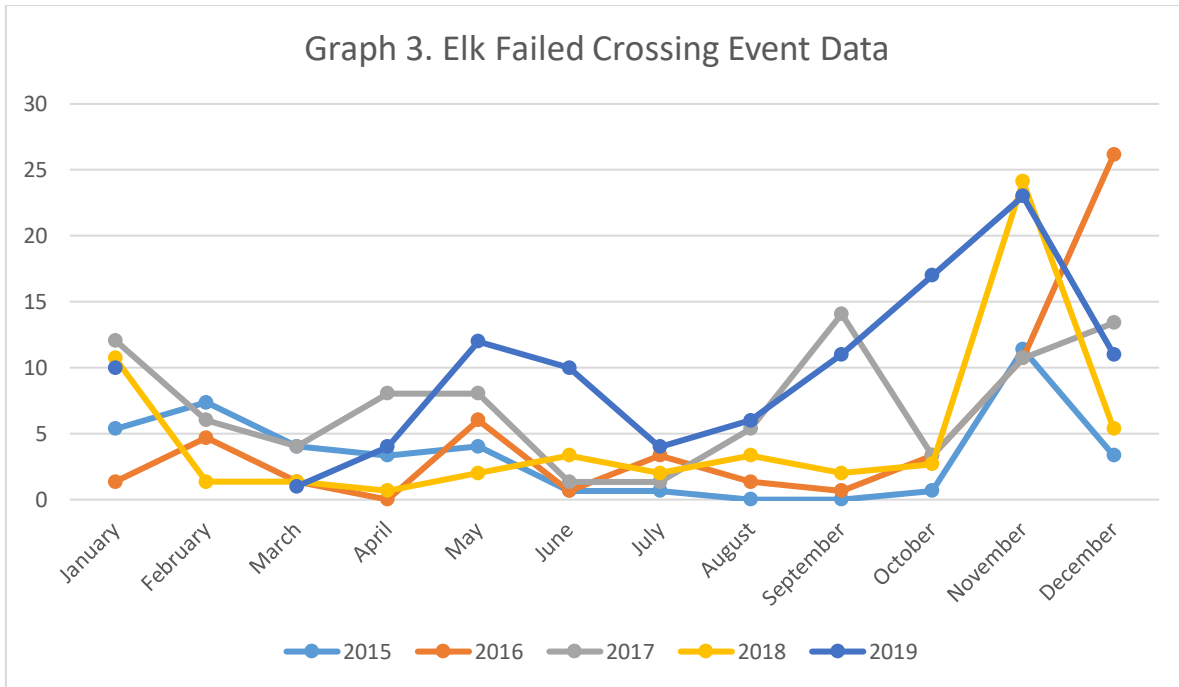
Note: This number represents a crossing event where elk attempted to cross but failed (elk were likely deterred from crossing due to heavy traffic).

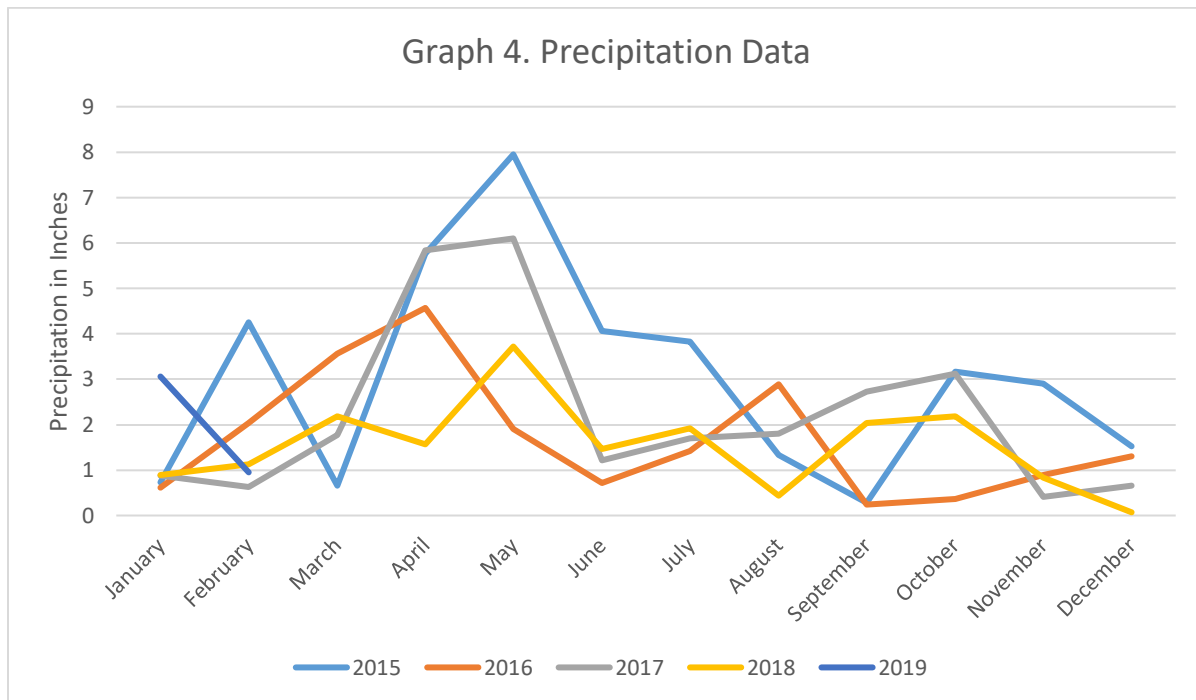
Note: This number represents the total amount of precipitation, in inches, received each month. (Source: The National Centers for Environmental Information website, <https://www.ncdc.noaa.gov>) GOLDEN 2.1 SW, CO US

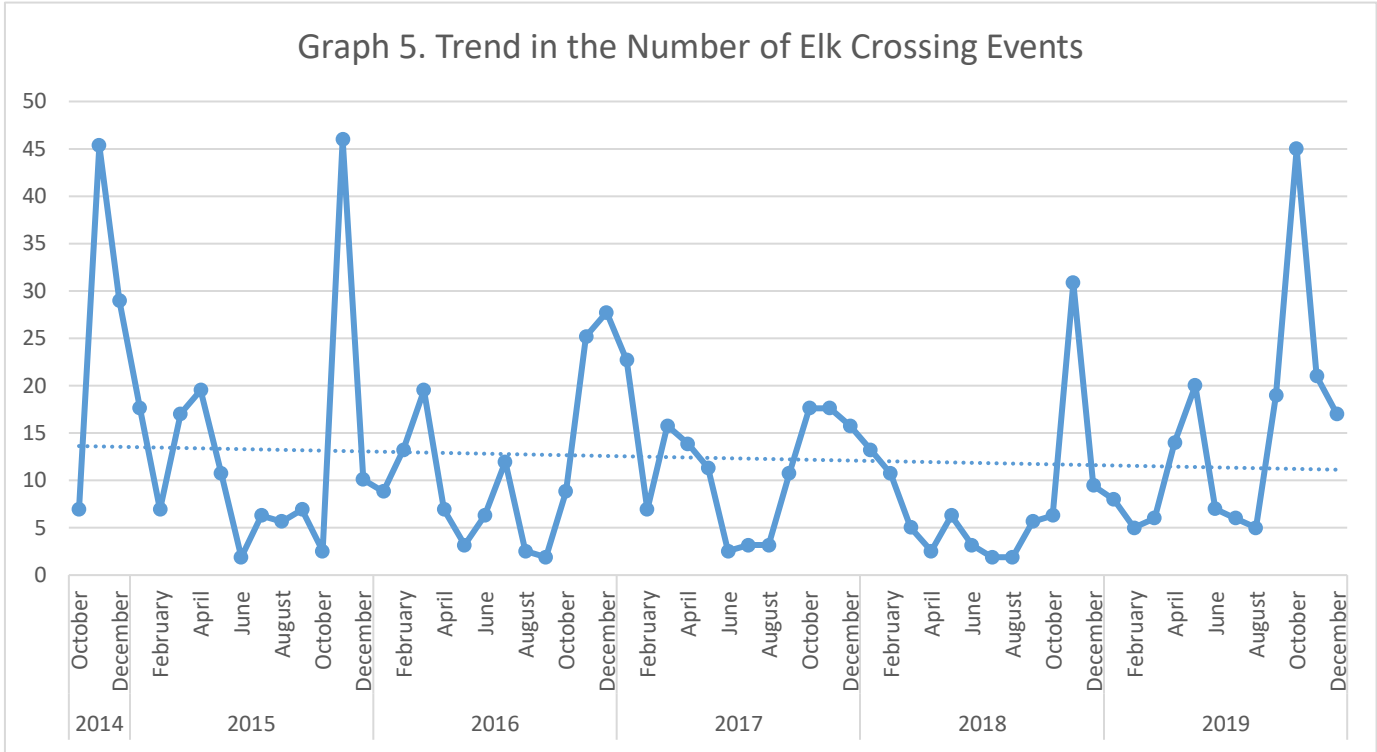
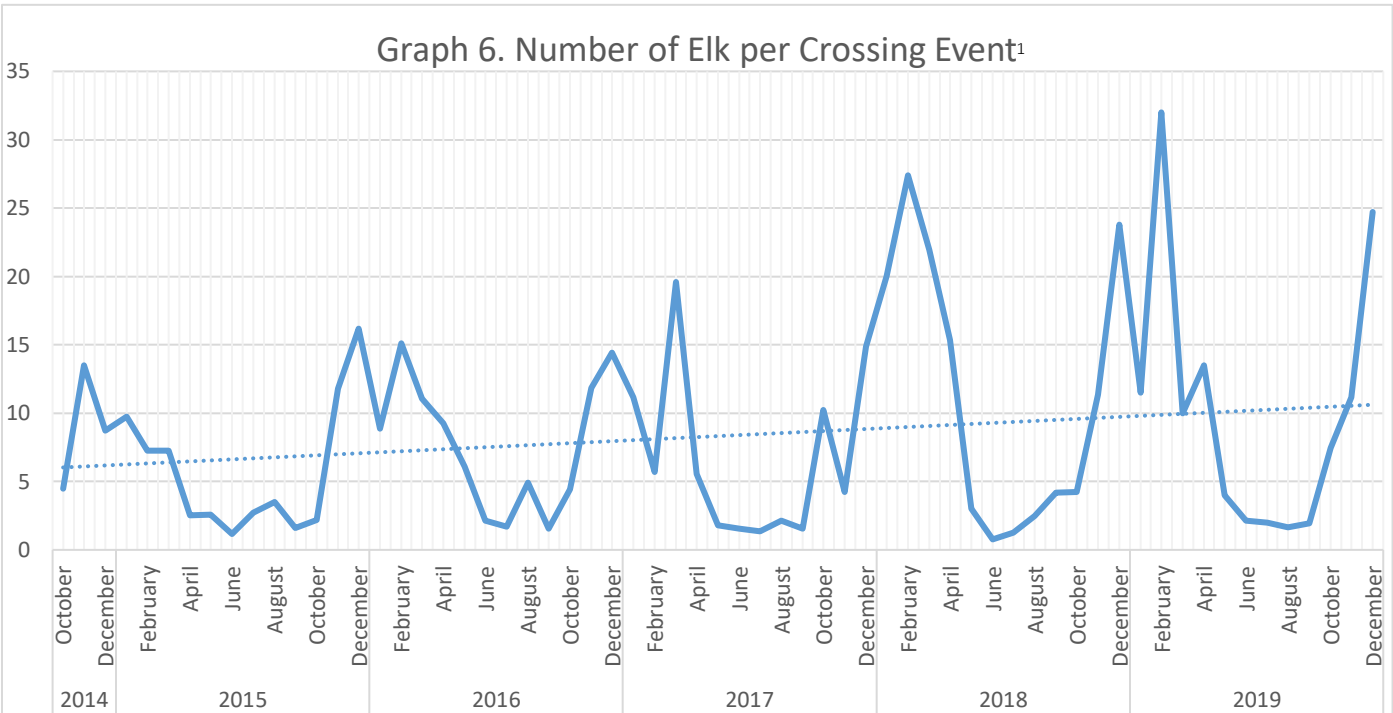
The number of elk crossing events shows a weak downward trend observed from 2014 through 2019 (Graph 5) whereas the number of elk per crossing appears to have trended upwards since 2015 (Graph 6).

<sup>1</sup>Includes successful and fail crossing events.

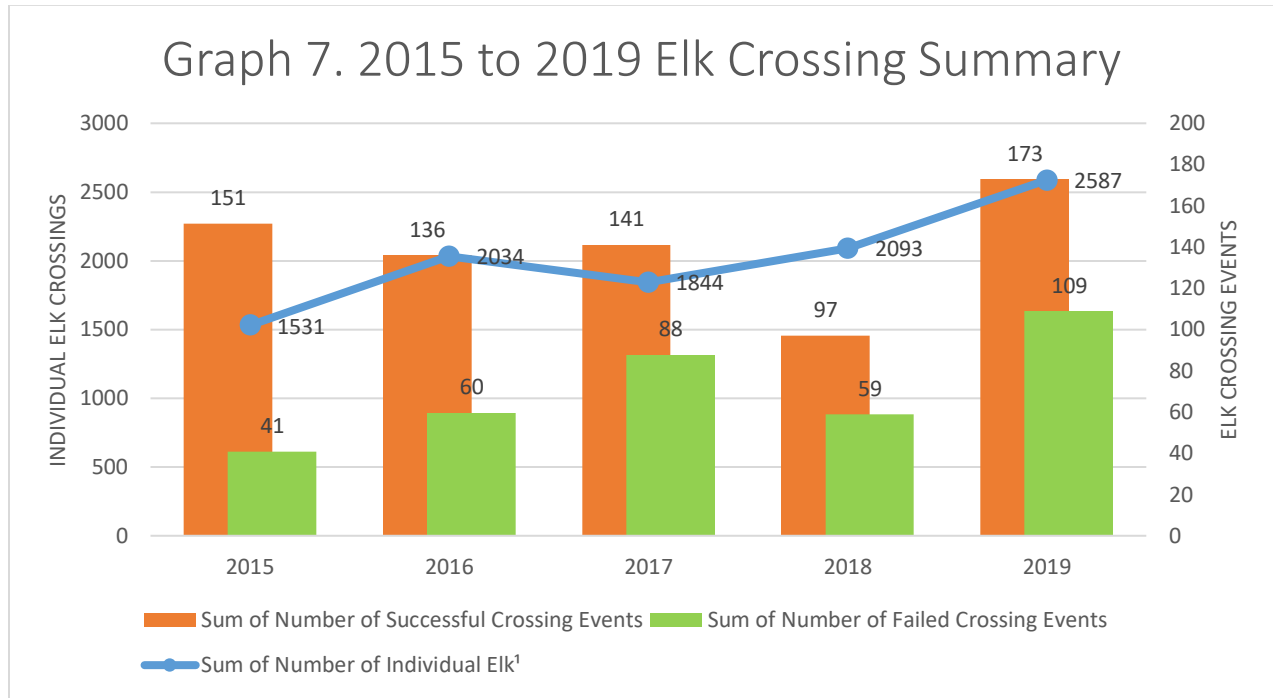
There is an increasing trend in the number of individual elk crossings since 2015 (Graph 7); however, the number of crossing events during that same time do not show a similar trend. There was a large drop in the number of crossing events (both successful and failed) in 2018 while individual elk crossings did not experience a similar drop. In fact, the number of individual elk crossings increased from 2017 to 2018.

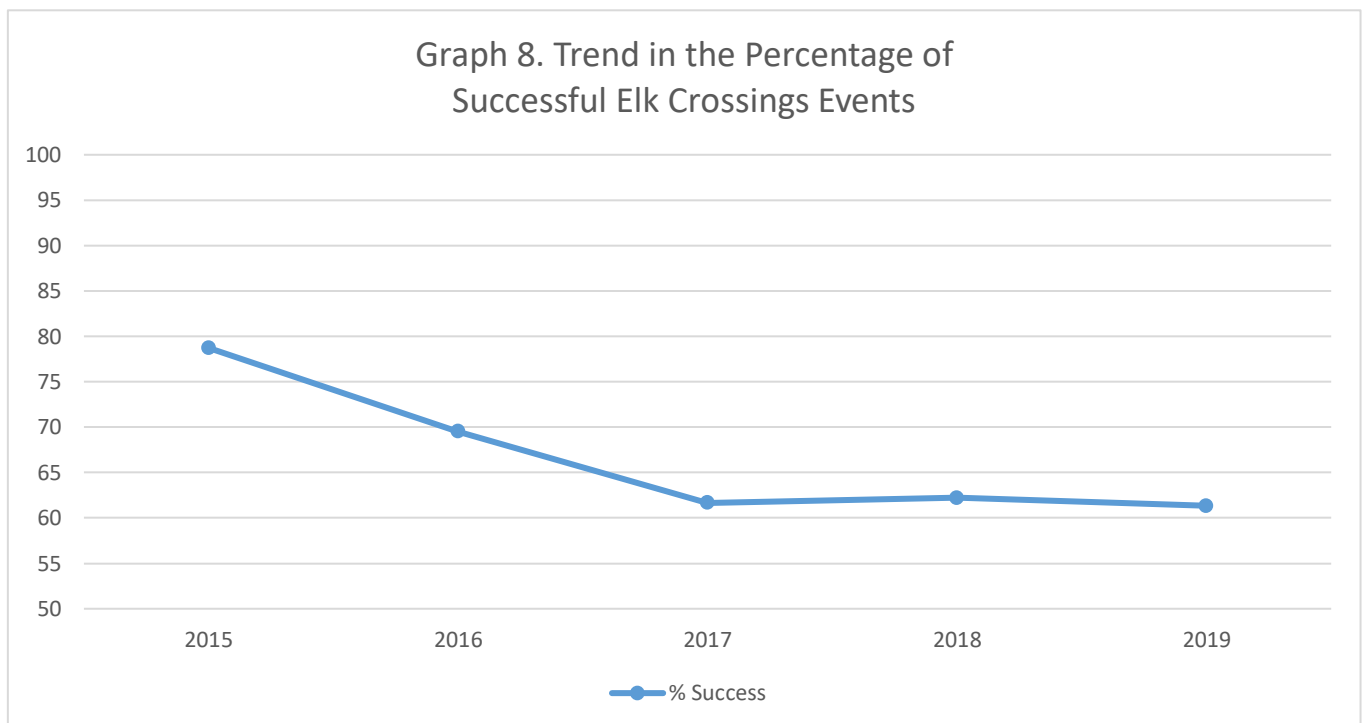
Graph 8 shows the percent of successful crossings by individual elk since 2018 which declined from 2015 to 2017 and then appeared to level in 2018 and 2019.

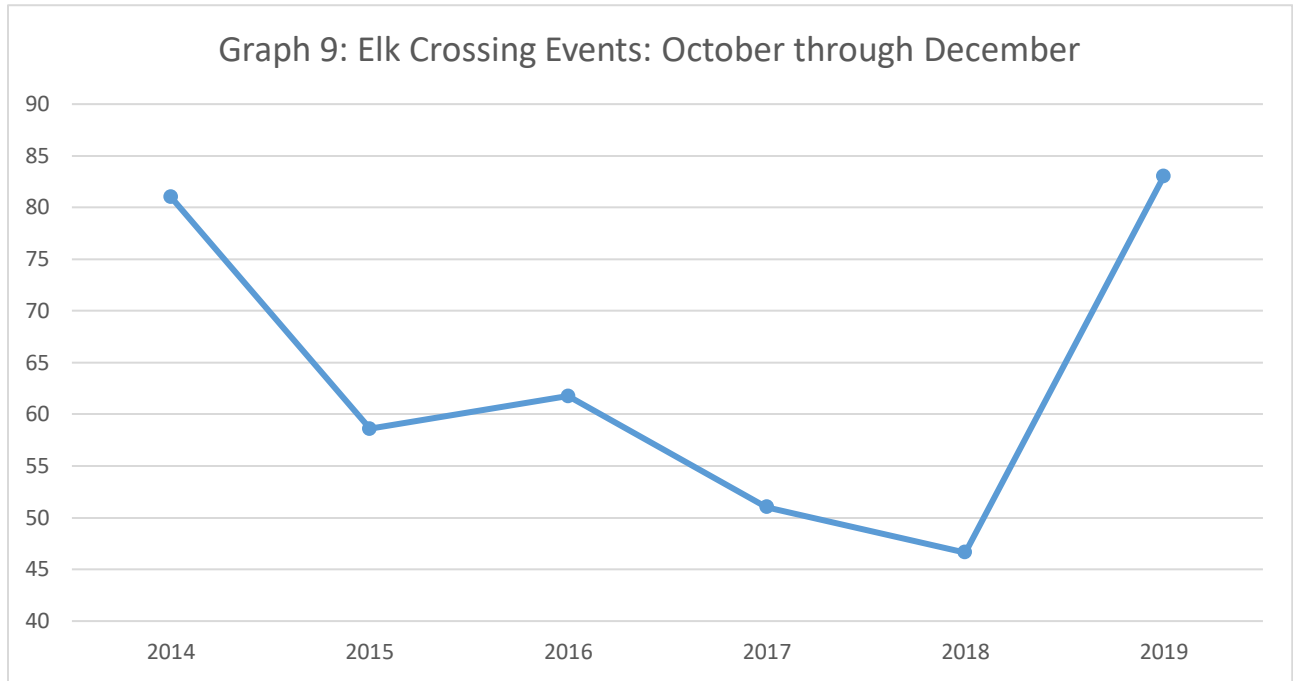
Graph 9 shows elk crossing events during the peak movement period of October through December (2014 to 2019). The frequency of crossings during peak months (October through December) declined from 2014 to 2018 and then sharply increased in 2019.

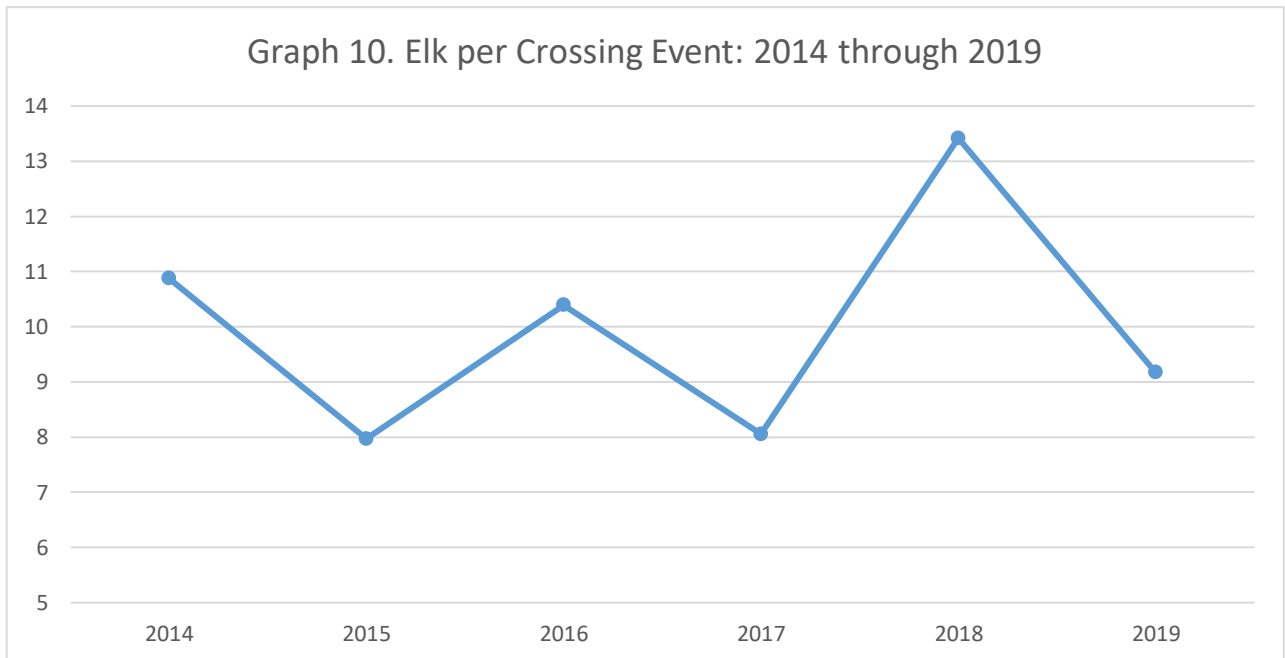
Graph 10 shows a spike in elk per crossing event in 2018, followed by a sharp decrease in 2019.

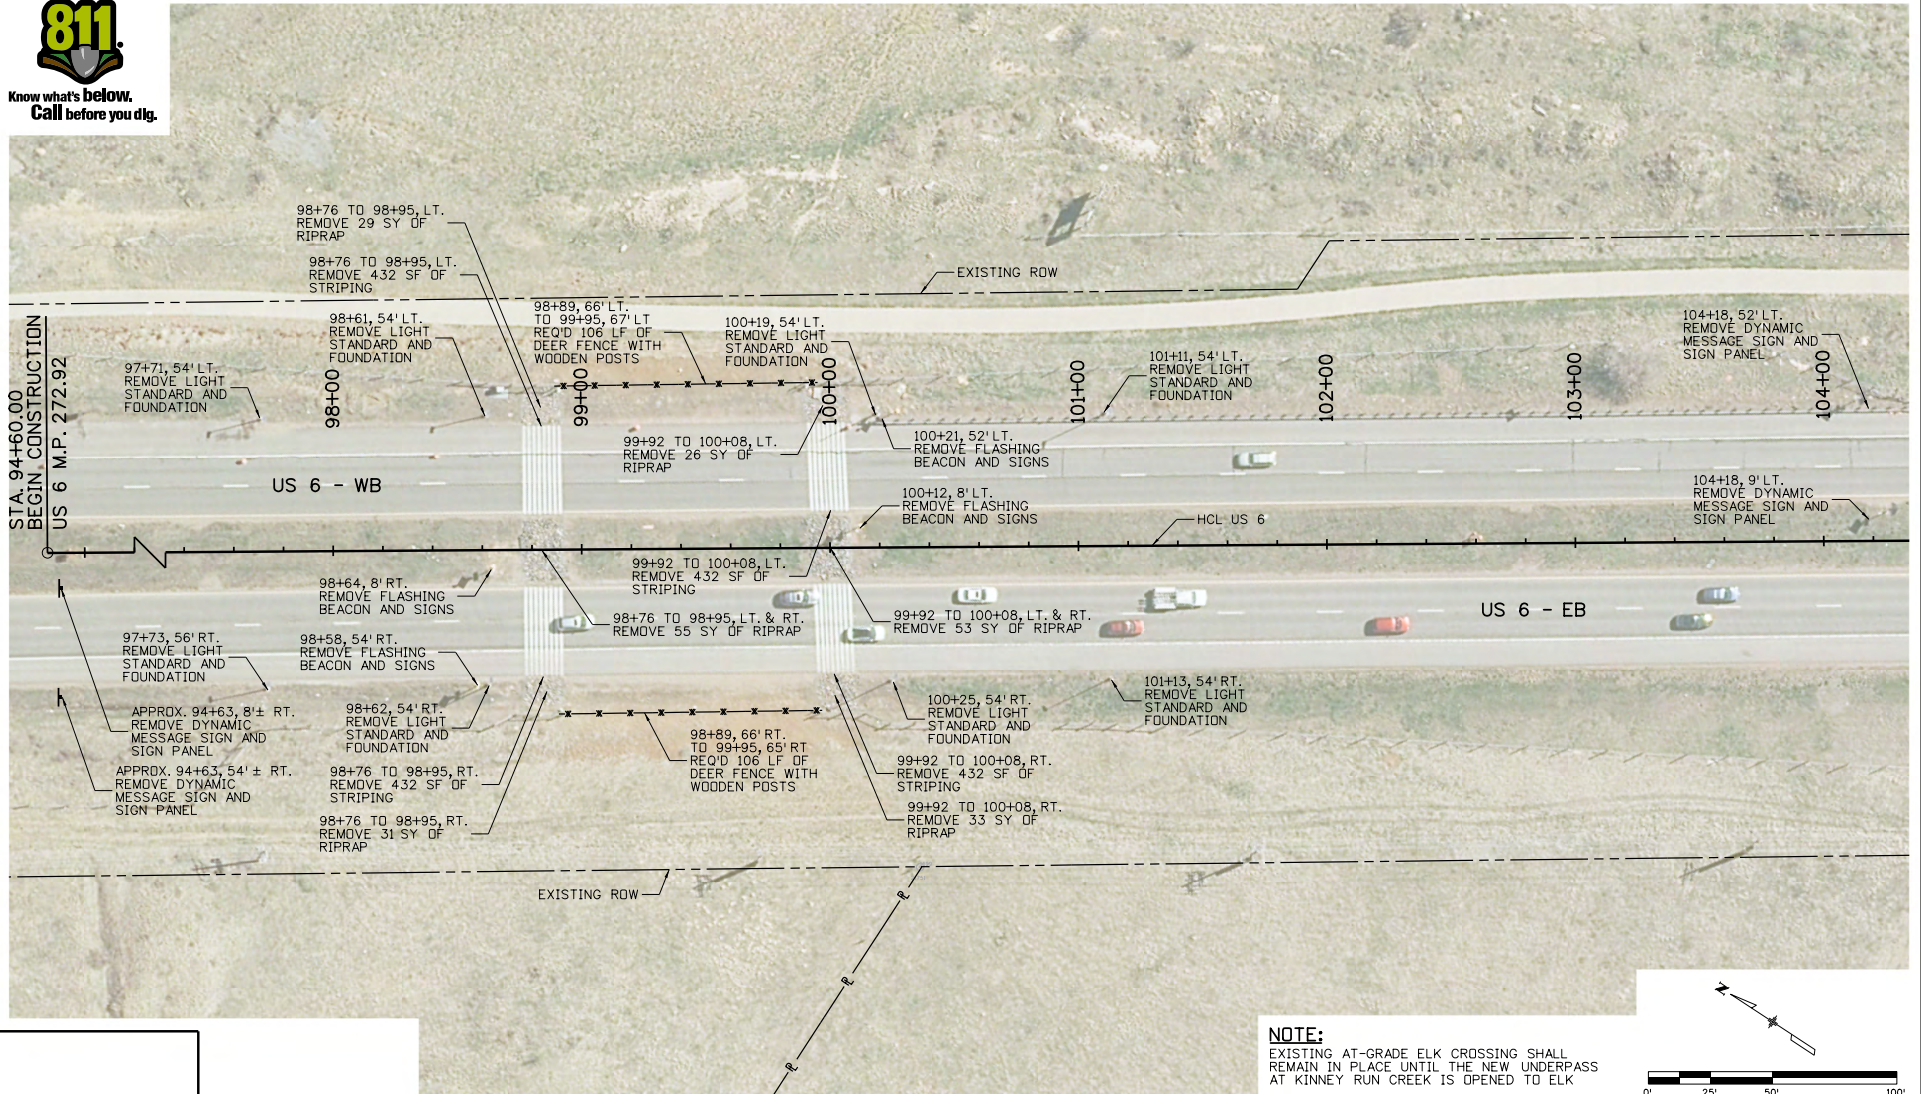
STA. 94+60.00  
BEGIN CONSTRUCTION  
US 6 M.P. 272.92

**NOTE:**  
EXISTING AT-GRADE ELK CROSSING SHALL REMAIN IN PLACE UNTIL THE NEW UNDERPASS AT KINNEY RUN CREEK IS OPENED TO ELK

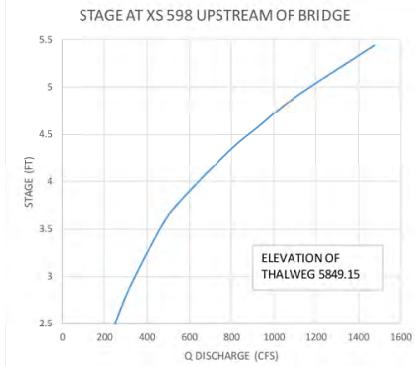
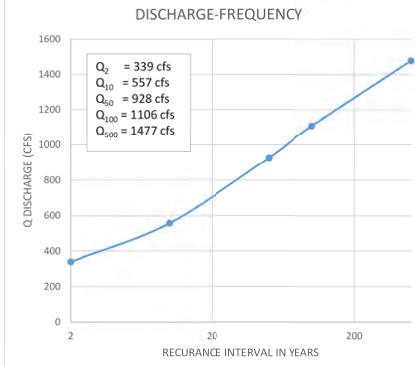
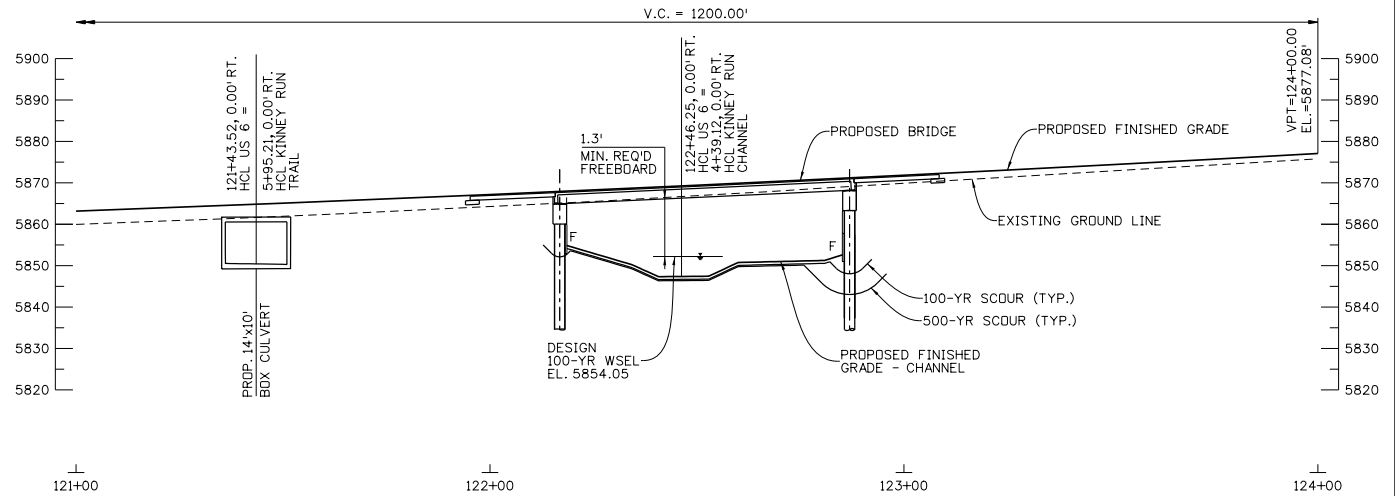
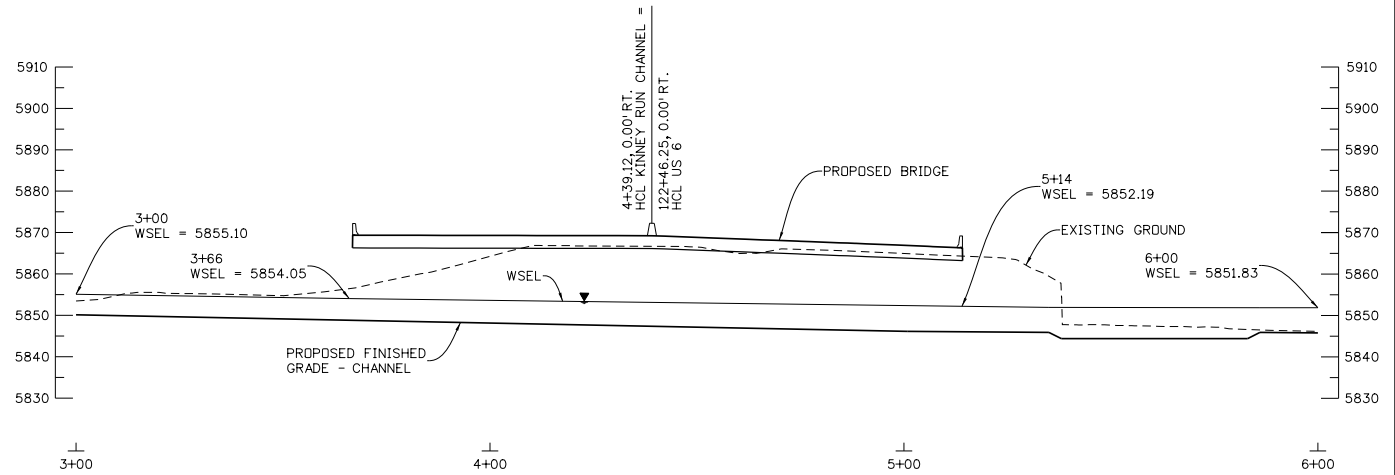
COMPARISON OF HYDRAULICS				
	VELOCITY (AVG) (FPS)	REQUIRED FREEBOARD (FT)	ACTUAL FREEBOARD (FT)	MAX. BACKWATER SURFACE ELEV. (FT)
EXISTING	2.7	0.9	0.1	5859.26
PROPOSED	7.4	1.3	9.9	5855.01

**CHANNEL DESCRIPTION**  
 EXISTING CHANNEL STREAM BED CONSISTS OF COHESIVE SOILS AND BOULDERS  
 STREAM FORM - MEANDERING  
 DEBRIS - LOW TO MODERATE DEBRIS STREAM  
 MANNINGS "N" FOR DESIGN: CHANNEL 0.045-0.065, BANKS 0.04  
 DRAINAGE AREA = 1.23 SQUARE MILES
