US 6 Bridges Design Build Project

Hazardous Materials Technical Report

Prepared for:
Colorado Department of Transportation
Federal Highway Administration

August 2012
Revised December 2012

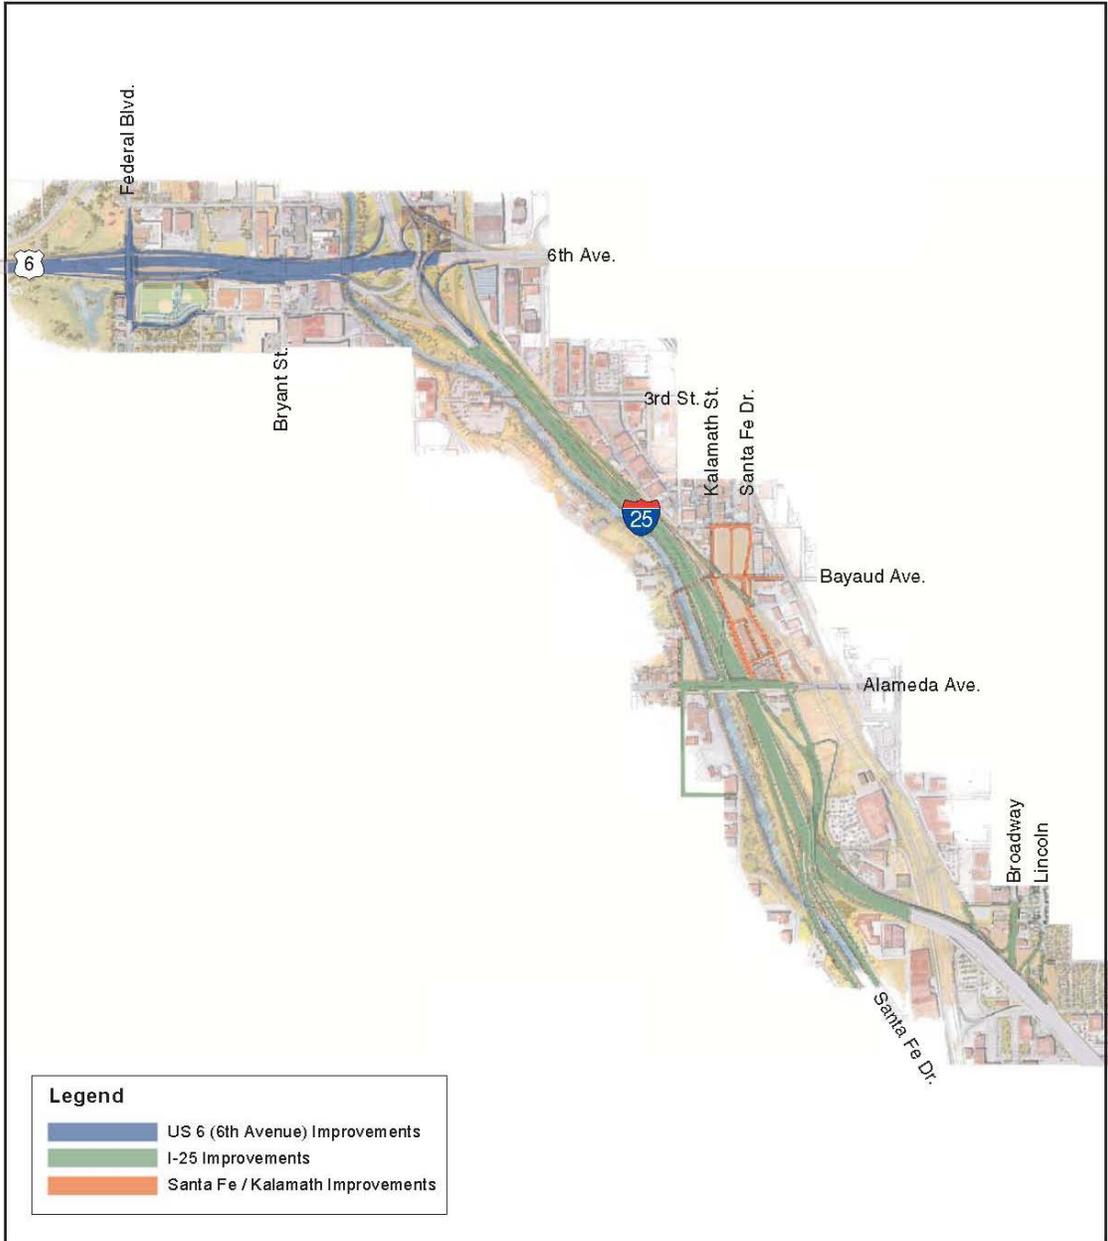
Figure 1: I-25 Valley Highway Project Preferred Alternative

The Preferred Alternative of the Valley Highway Project is shown in Figure 1.

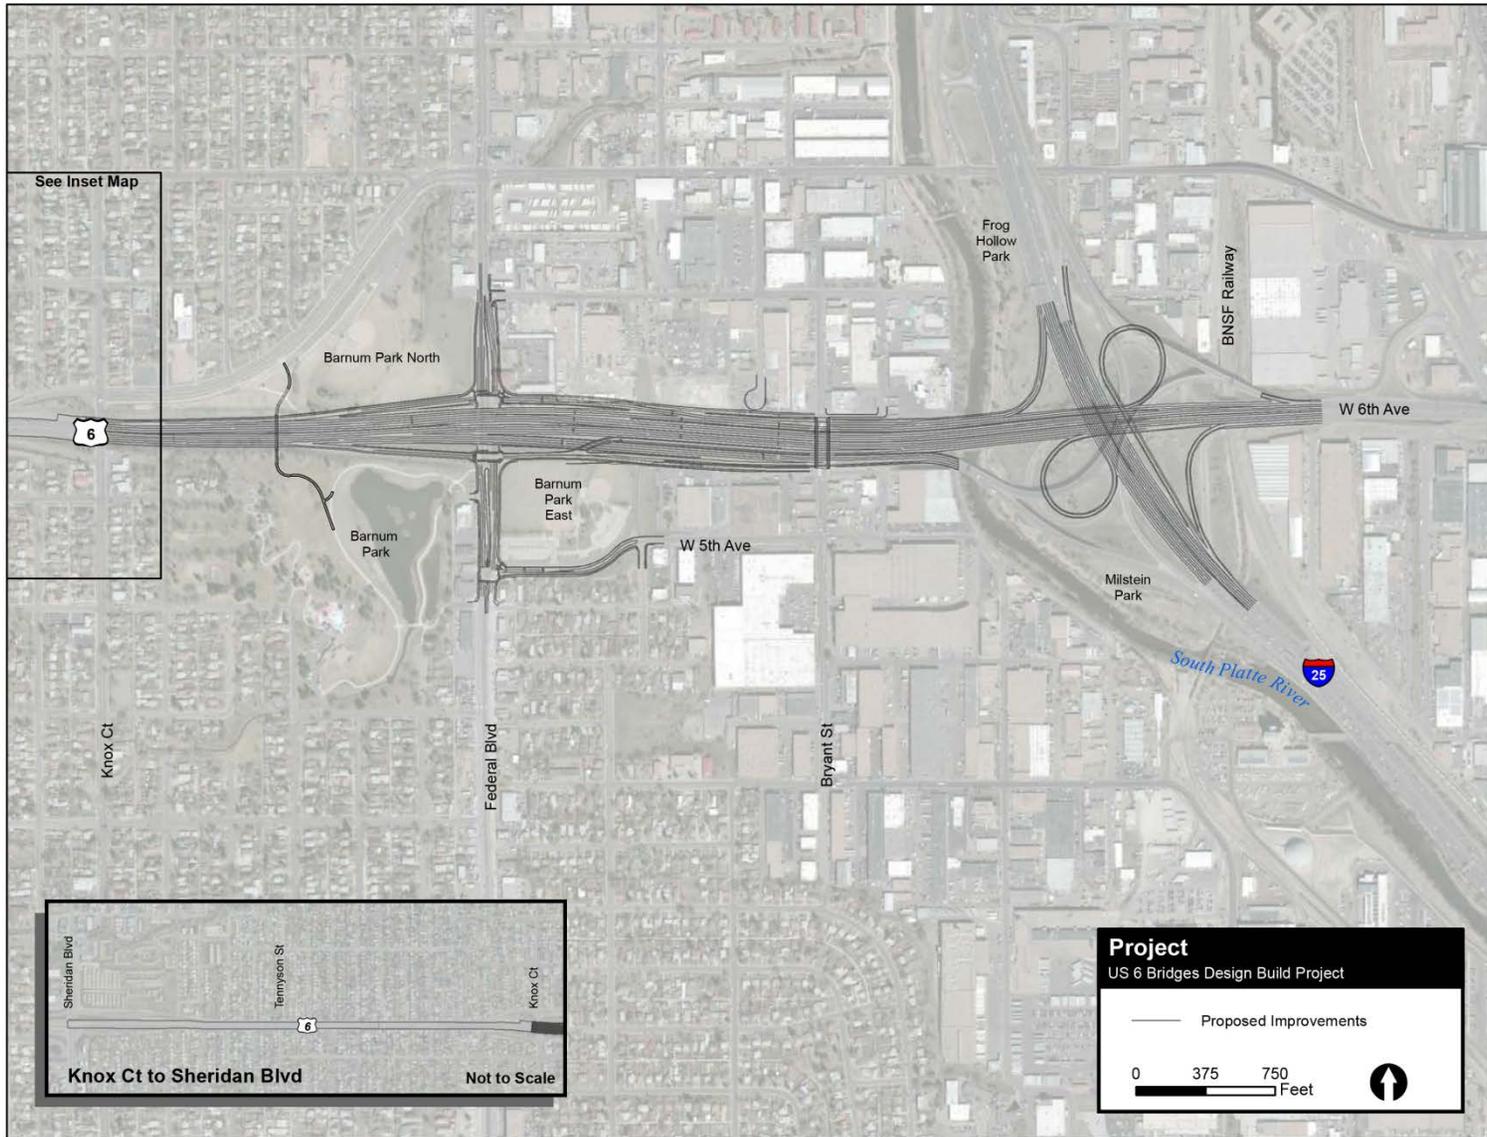
Figure 2: Project

The Project includes the reconstruction of US 6, reconfiguration of interchanges from Federal Boulevard to I-25, and replacement of the US 6 bridges from Federal Boulevard to the bridge over the BNSF Railway. More specifically, the Project includes the following elements:

Figure 2 shows the Project.

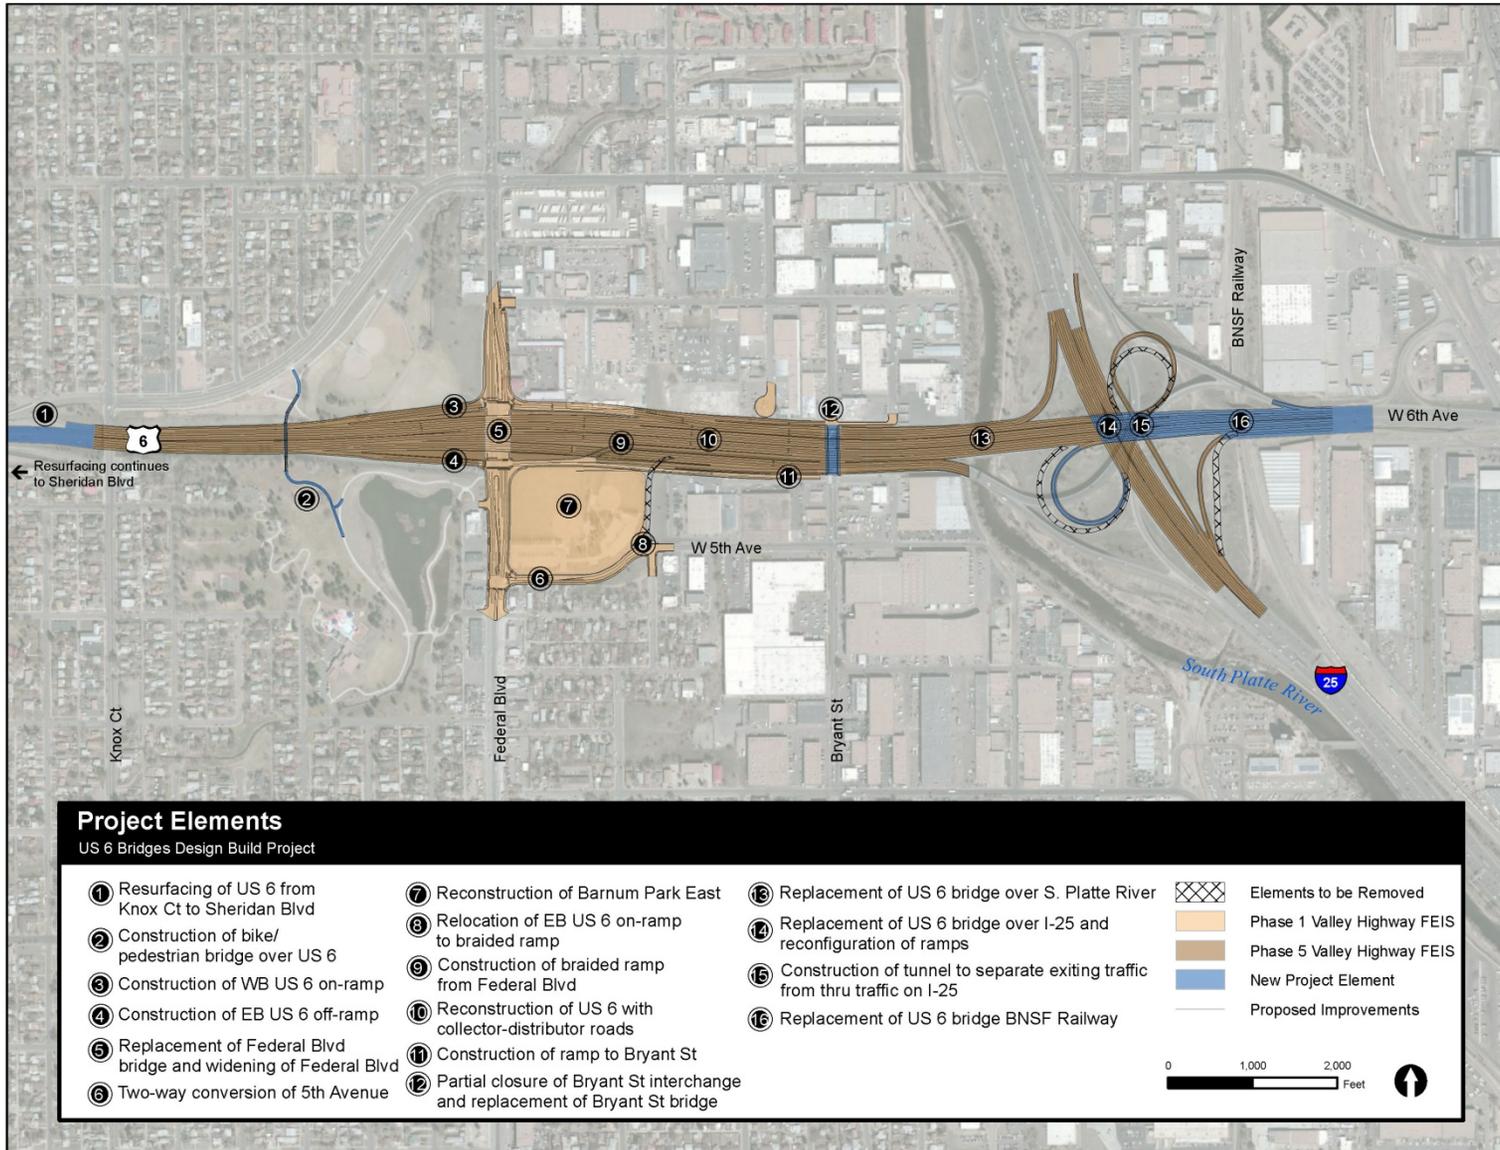
Figure 4: Project Elements

At this time, the Project includes six additional elements that were not included in the FEIS or 2007 ROD:

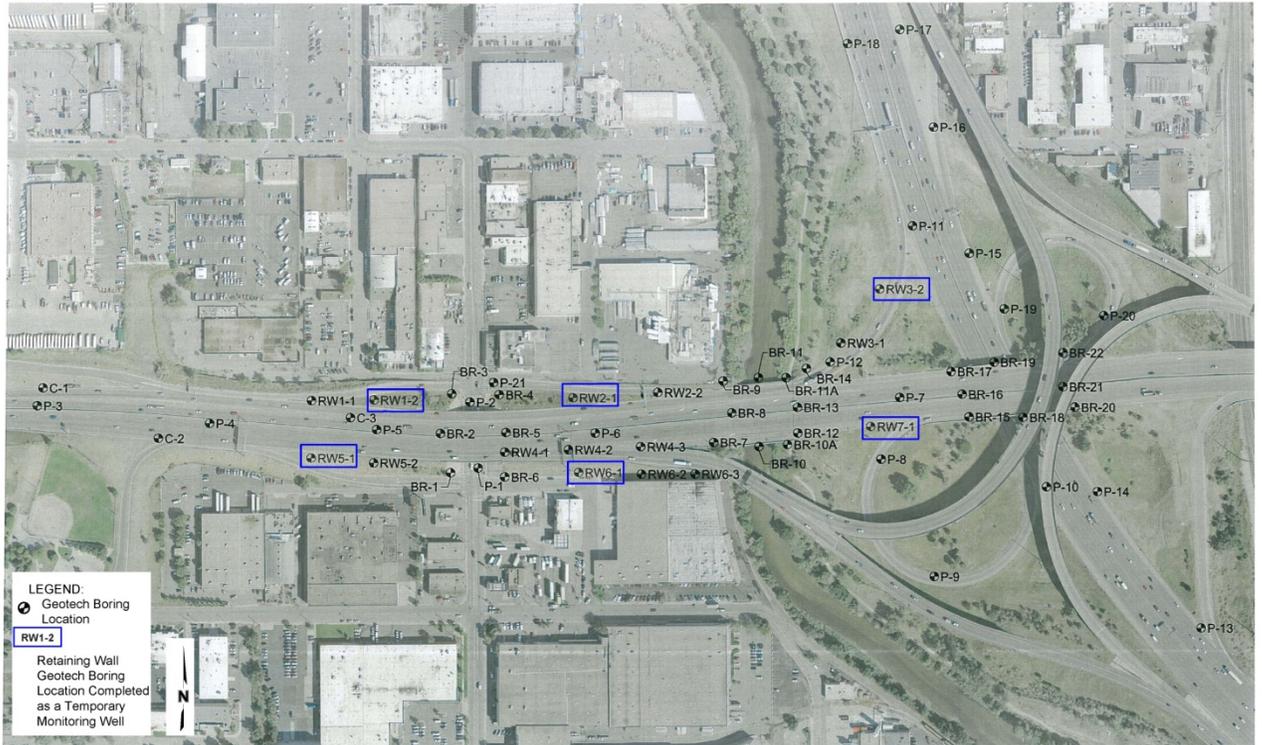
Figure 5: Subsurface Monitoring Wells December 2011/January 2012

A limited subsurface investigation and the installation of temporary groundwater monitoring wells were conducted in December 2011 in conjunction with geotechnical borings advanced by Rocksol. Subsurface soils from a total of six of the geotechnical borings drilled for retaining walls were collected for laboratory analysis. The retaining wall borings were selected since they were advanced to depths where groundwater was expected to be encountered based on a review of the State Engineer’s office records for existing water wells in the area. The six retaining wall borings were completed as temporary monitoring wells (RW 1-2, RW2-1, RW 3-2, RW 5-1, RW 6-1, and RW 7-1) and are shown in Figure 5. These wells were installed along the US 6 right-of-way from the interchange with I-25 to approximately the Bryant Street bridge on December 7, December 9, December 12, and December 20, 2011.

Fluid level measurements and field parameters were measured in all six of these wells prior to sampling. Grab groundwater samples were collected from all six monitoring wells on January 4, 2012. The results indicated that the subsurface soil and groundwater encountered in these borings were not significantly impacted. Metals concentrations may be related to anthropogenic sources or they may be due to elevated natural background, or a combination.

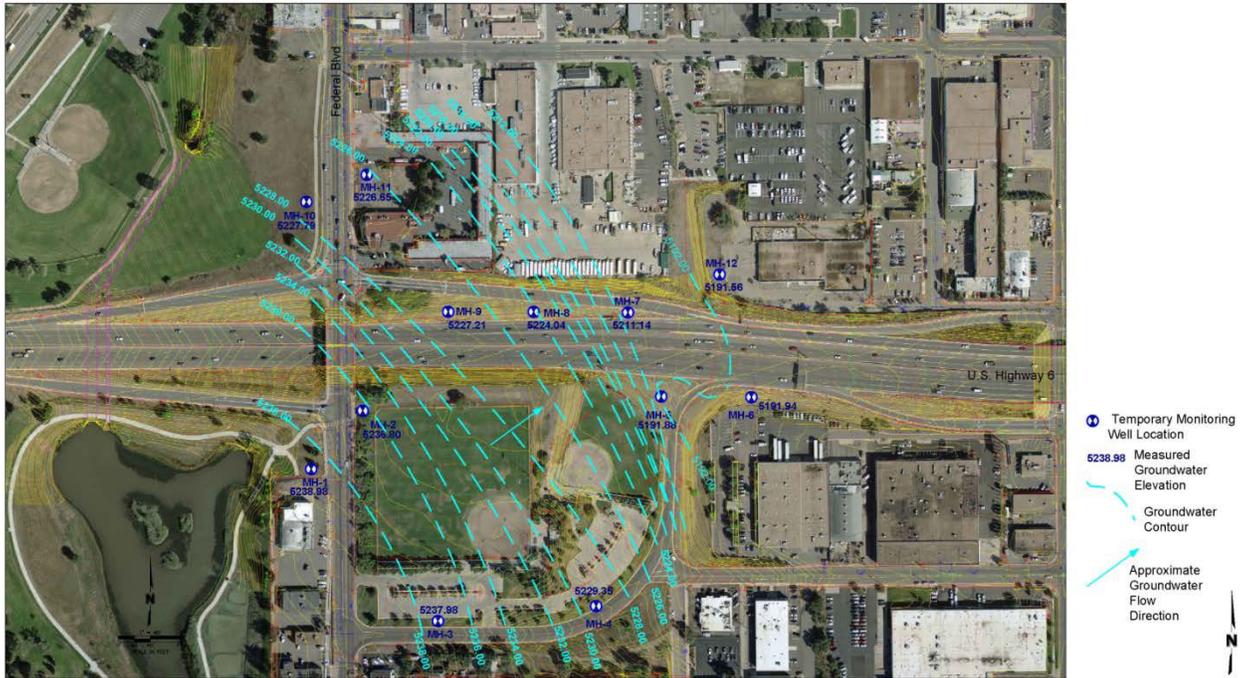
Figure 6: Subsurface Monitoring Wells June/July 2012

Olsson Associates conducted a limited subsurface investigation in July 2012 in the US 6 and Federal Boulevard right-of-way. This was done to identify areas adjacent to, or within the Project footprint that may have contaminated soils and/or groundwater, potentially impacting the construction of the Project. During the limited subsurface investigation, twelve (12) temporary monitoring holes were drilled along the Project footprint west of Bryant Street with soil and groundwater samples collected at each of the test hole locations. The location of the test holes are shown below as well as in Figure 1 of the Limited Subsurface Investigation Report, which is provided in **Appendix D** to this report.

The collected soil and groundwater samples were submitted to a laboratory for analysis and were tested for petroleum hydrocarbon constituents benzene, toluene, ethylbenzene, and total xylenes (BTEX) by Method SW8260, total concentrations of the eight Resource Conservation and Recovery Act (RCRA) Metals by SW 6020/SW 7471A, and percent moisture by SW 3550. A summary of the findings of the limited subsurface investigation is provided in Section 3.2.1.1 of this report.

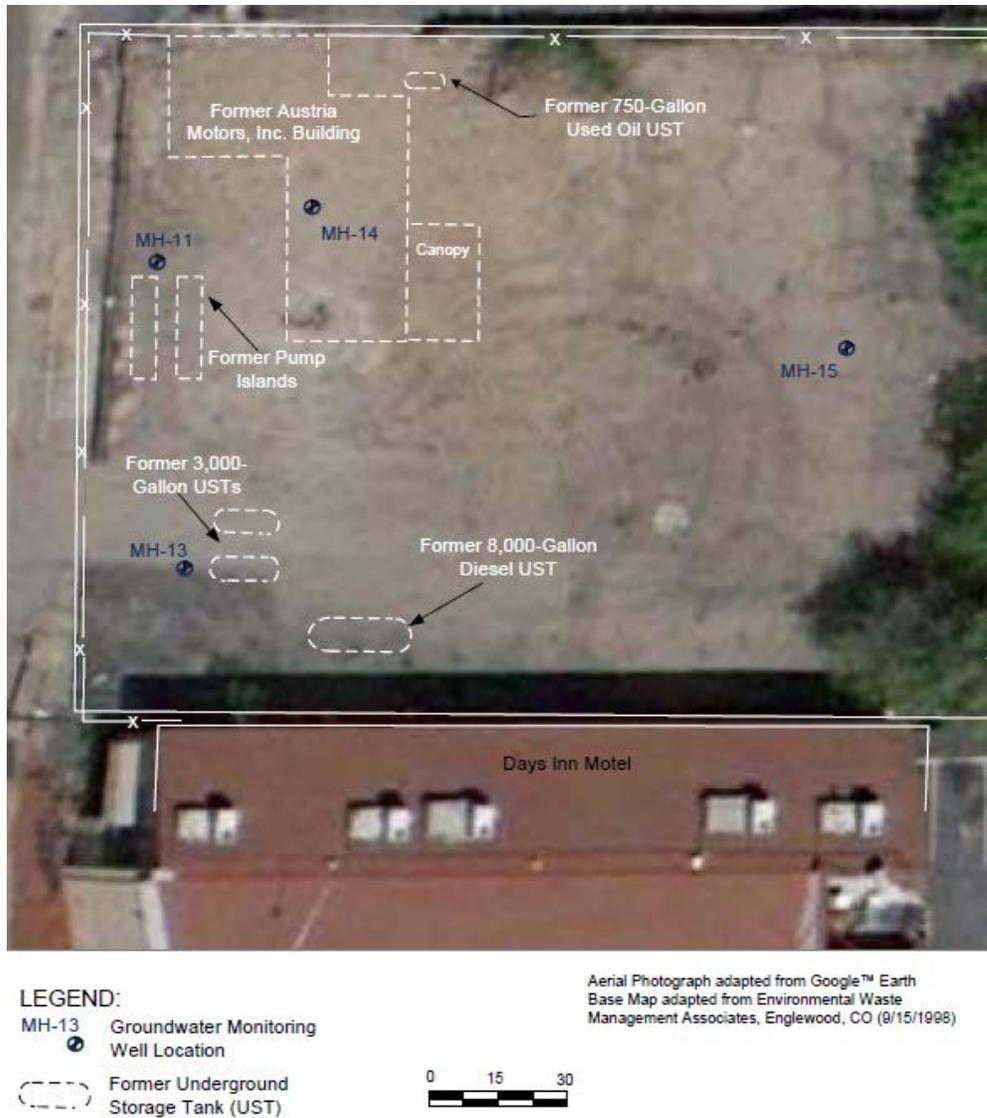
Figure 7: Monitoring Well locations at 642 Federal Boulevard

Due to concerns raised by the findings at well MH-11, an additional limited subsurface investigation was conducted on October 16, 2012 at the vacant property formerly occupied by the Austria Motors, Inc. dealership and automotive repair, located at 642 Federal Boulevard. This site was a former leaking underground storage tank (LUST) site that received closure following site investigation and remediation. A release was reported to the Colorado Department of Labor and Employment, Division of Oil and Public Safety (OPS) in October 1997 and assigned event #6193. The OPS issued a no further action (NFA) letter on July 7, 1999 following completion of the site remediation.

This limited subsurface investigation was conducted on October 16, 2012 and included the installation of three soil borings completed as temporary monitoring wells identified as MH-13, MH-14, and MH-15 as shown on Figure 7. These wells were drilled in locations suggested by CDOT to assess the nature and extent of impacted soil and groundwater discovered in temporary monitoring well MH-11 which was installed on the northwest side of the property in August 2012. The soil samples submitted for laboratory analysis were collected from the interval that exhibited staining, hydrocarbon odor, the highest headspace PID readings, the interval at or above the water table, and from the total depth of the well boring. Olsson personnel logged the borings to record the lithologies encountered, the depth to groundwater, and observed staining or odors that suggested petroleum hydrocarbon or chemical impacts. Copies of the lithologic logs for each boring are presented in Appendix F. A summary of the findings of this limited subsurface investigation is provided in Section 3.2.1.1 of this report

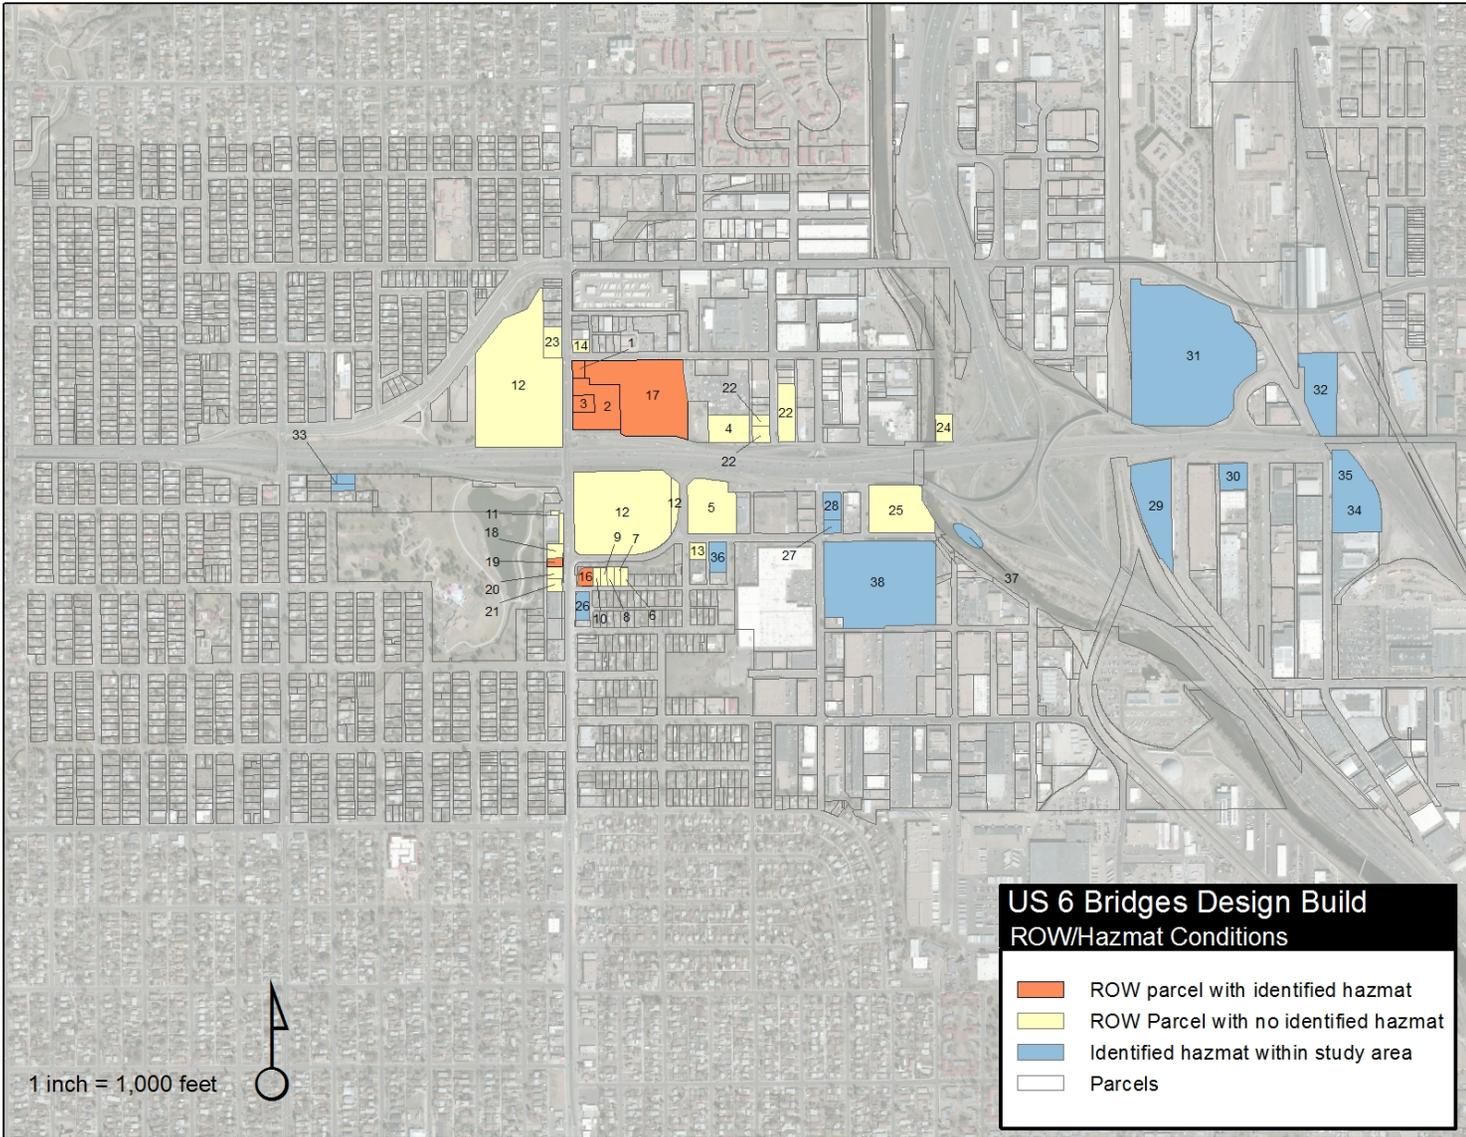
Figure 8: ROW / Hazmat Conditions

The acquisition of right-of-way will be required from four LUST sites (former and active) within the Project Footprint. These sites (Legend Numbers 1, 3, 16, and 17) are shown in **Figure 8 ROW / Hazmat Conditions** and listed in **Table 4**. One site, Legend Number 2, is not a LUST site; however, it is discussed in the following paragraphs since it may have been impacted by an adjacent LUST site (Legend Number 3).
