US 6 Bridges Design Build Project

Hazardous Materials Technical Report

Prepared for:
Colorado Department of Transportation
Federal Highway Administration

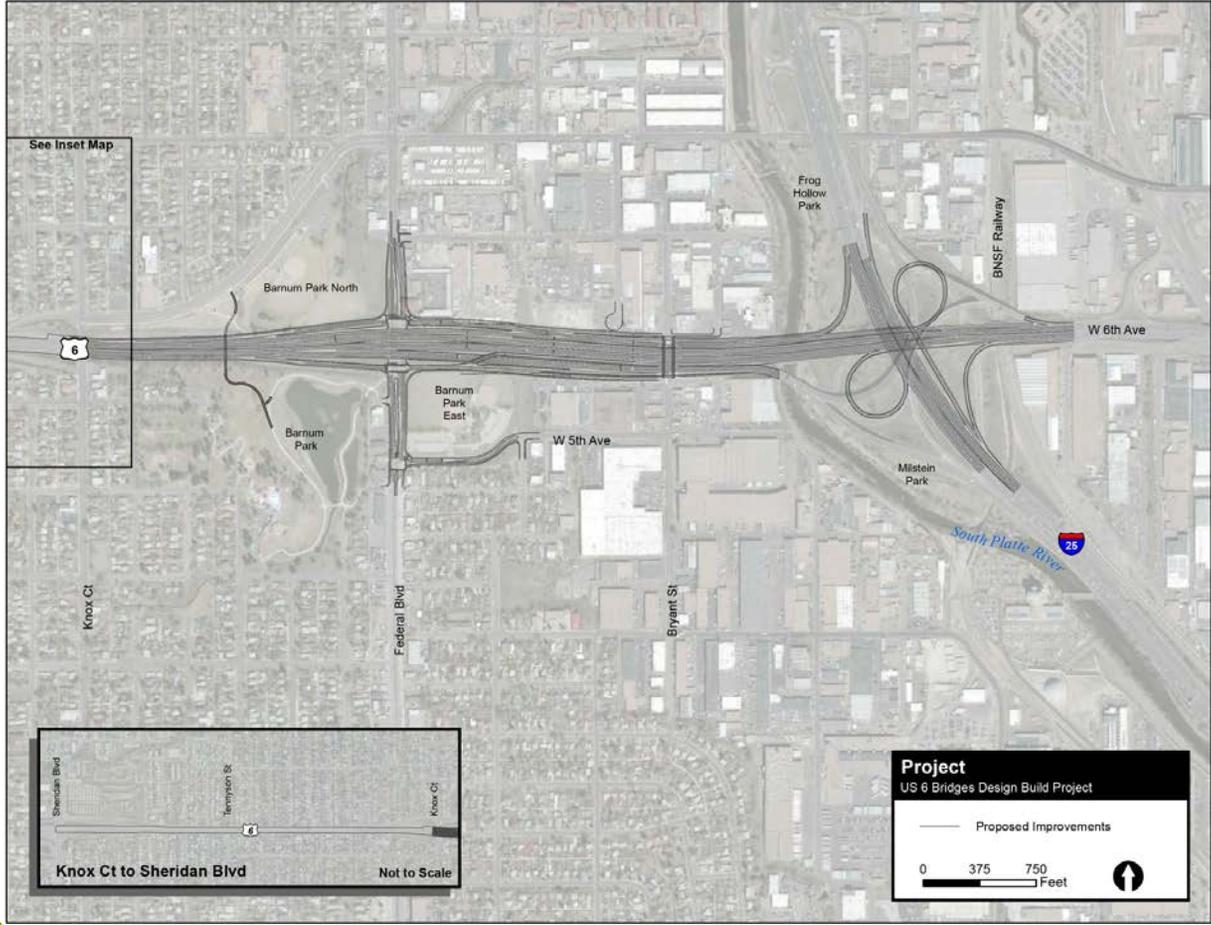
Figure 2: Project

Figure 2 shows the Project.

The Project includes the reconstruction of US 6, reconfiguration of interchanges from Federal Boulevard to I-25, and replacement of the US 6 bridges from Federal Boulevard to the bridge over the BNSF Railway. More specifically, the Project includes the following elements:

- The replacement of five bridges along US 6: Federal Boulevard, Bryant Street, South Platte River, I-25, and BNSF Railway. Three of these bridges are in poor condition and the other two are functionally obsolete. The project would also add a tunnel immediately east of I-25 under US 6 to separate traffic on northbound I-25 from traffic exiting the interstate to travel east and west on US 6.

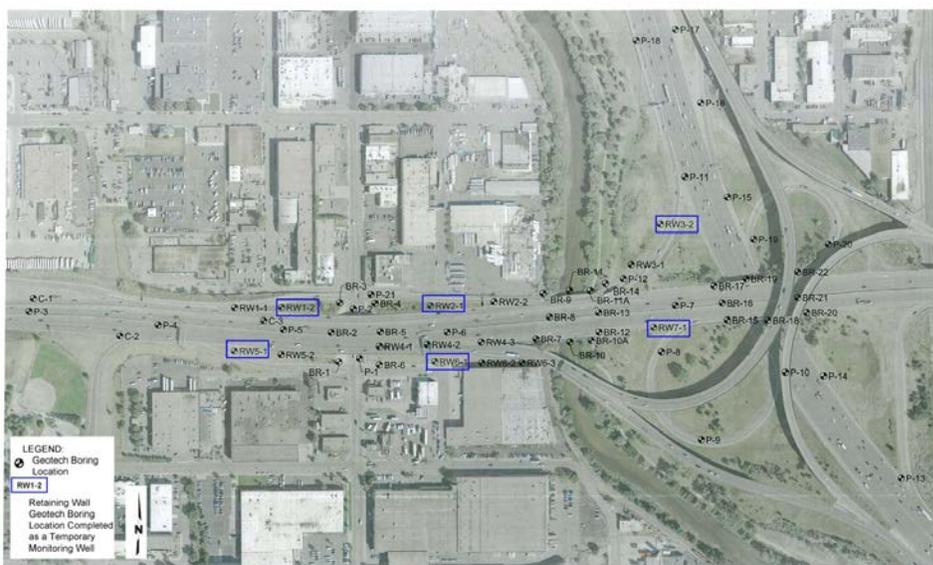
Figure 5: Subsurface Monitoring Wells December 2011/January 2012

These wells were installed along the US 6 right-of-way from the interchange with I-25 to approximately the Bryant Street bridge on December 7, December 9, December 12, and December 20, 2011.

Fluid level measurements and field parameters were measured in all six of these wells prior to sampling. Grab groundwater samples were collected from all six monitoring wells on January 4, 2012. The results indicated that the subsurface soil and groundwater encountered in these borings were not significantly impacted. Metals concentrations may be related to anthropogenic sources or they may be due to elevated natural background, or a combination.

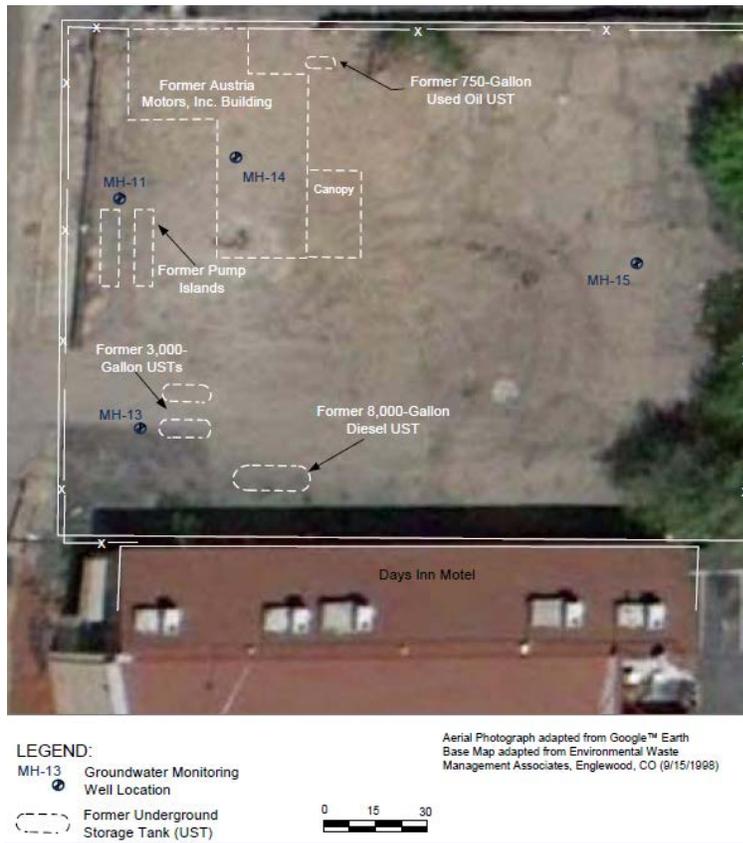
Figure 7: Monitoring Well locations at 642 Federal Boulevard

Olsson Associates conducted a limited subsurface investigation in July 2012 in the US 6 and Federal Boulevard right-of-way. This was done to identify areas adjacent to, or within the Project footprint that may have contaminated soils and/or groundwater, potentially impacting the construction of the Project. During the limited subsurface investigation, twelve (12) temporary monitoring holes were drilled along the Project footprint west of Bryant Street with soil and groundwater samples collected at each of the test hole locations. The location of the test holes are shown below as well as in Figure 1 of the Limited Subsurface Investigation Report, which is provided in [Appendix D to D](#) to this report.

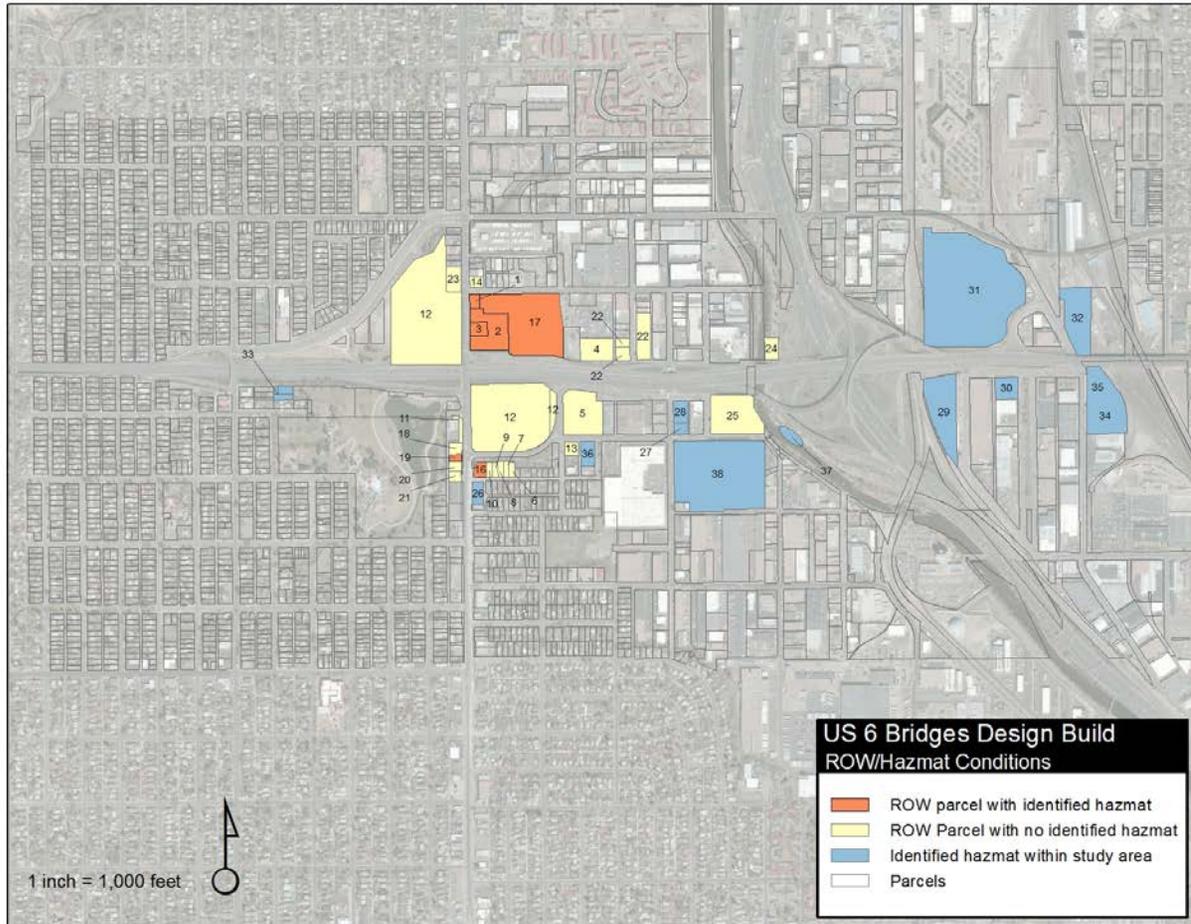
Figure 78: ROW / Hazmat Conditions

The acquisition of right-of-way will be required from four LUST sites (former and active) within the Project Footprint. These sites (Legend Numbers 1, 3, 16, and 17) are shown in [Figure 58 ROW / Hazmat Conditions](#) and listed in [Table 4](#). One site, Legend Number 2, is not a LUST site; however, it is discussed in the following paragraphs since it may have been impacted by an adjacent LUST site (Legend Number 3).
