# US 6 Bridges Design Build Project

## Biological Resources Report

Prepared for:  
Colorado Department of Transportation  
Federal Highway Administration

October 2012

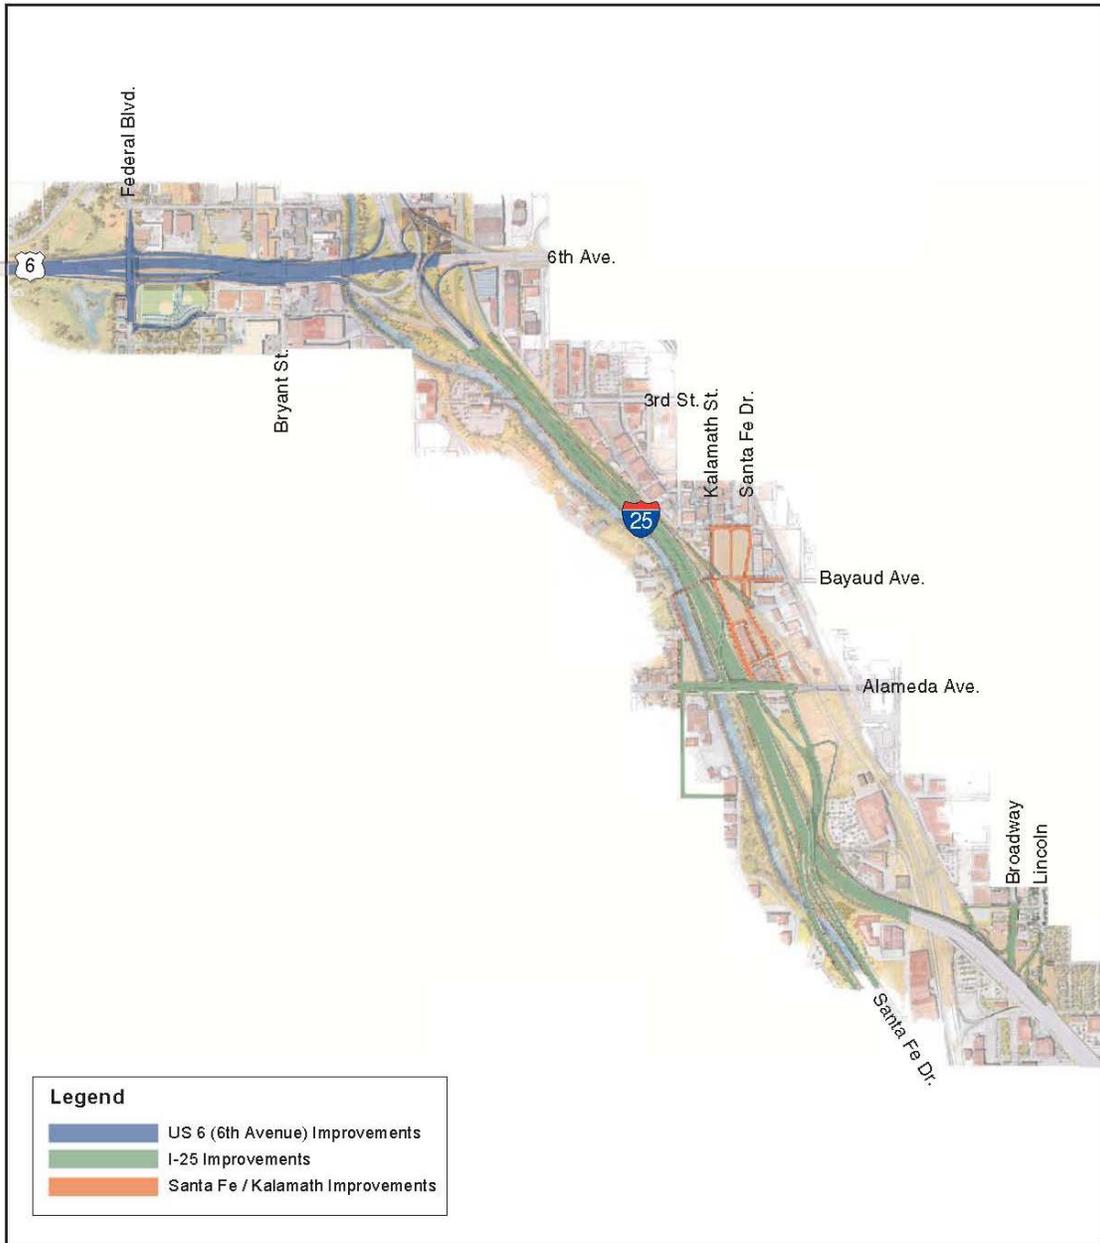
**Figure 1: I-25 Valley Highway Project Preferred Alternative**

The Preferred Alternative of the Valley Highway Project is shown in Figure 1.

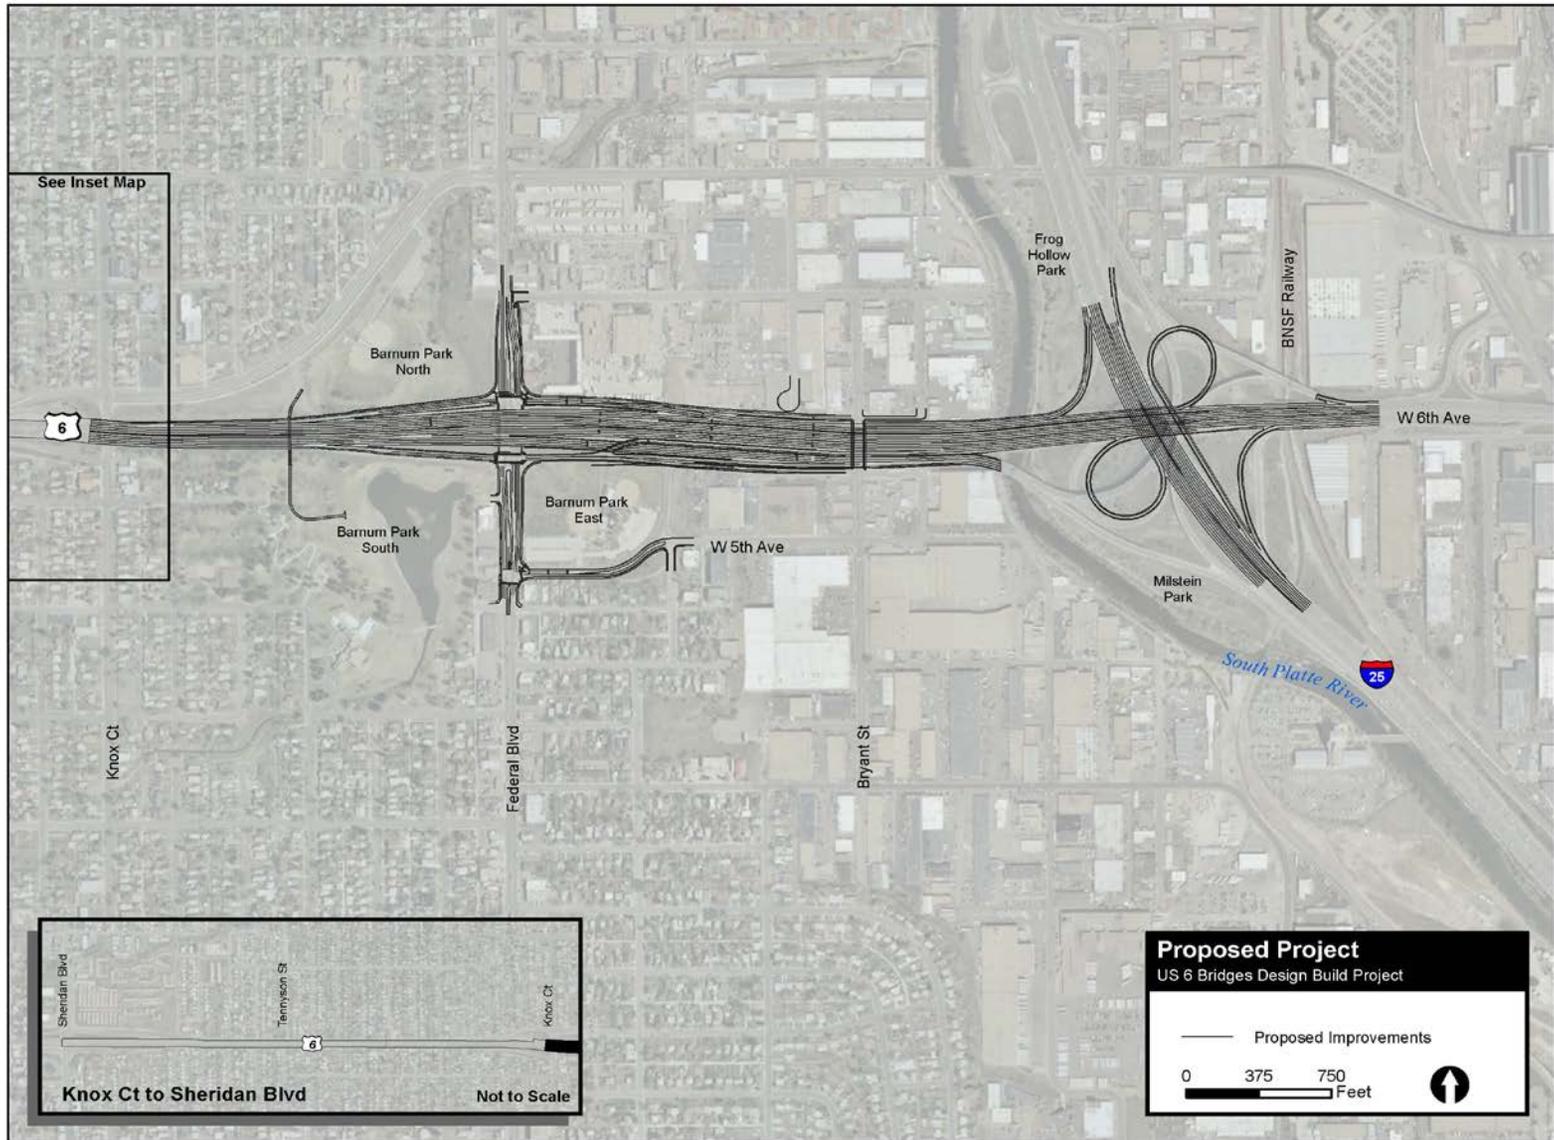
Figure 2: Proposed Project

Figure 2 shows the Proposed Project.

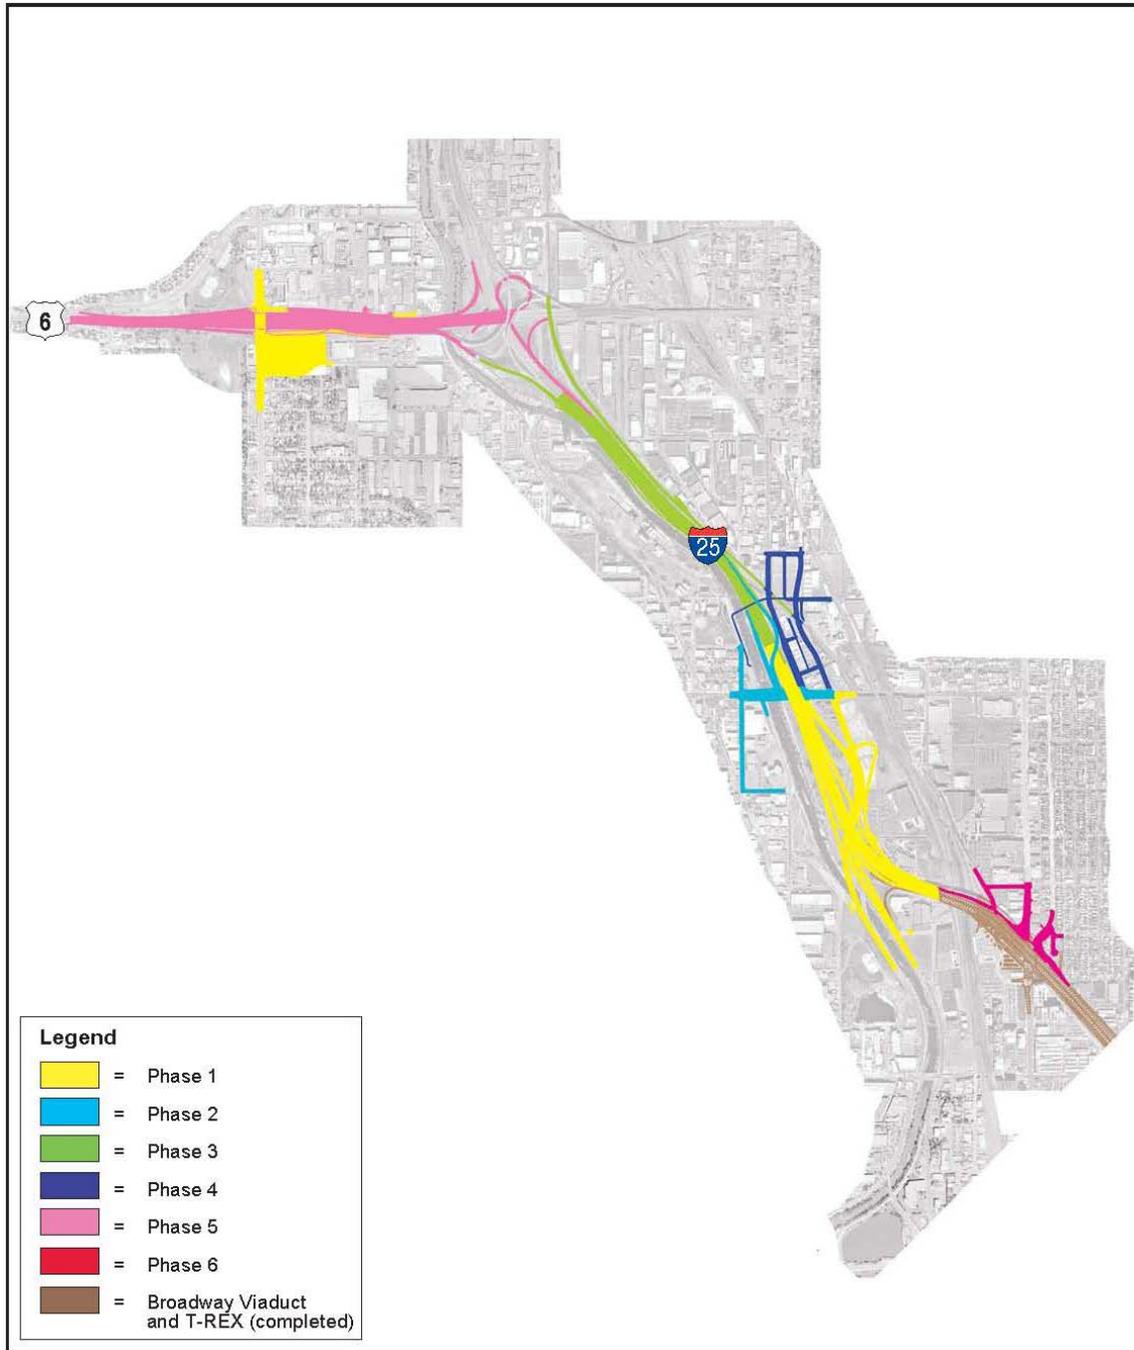
**Figure 3: Valley Highway EIS Phased Implementation of the Preferred Alternative**

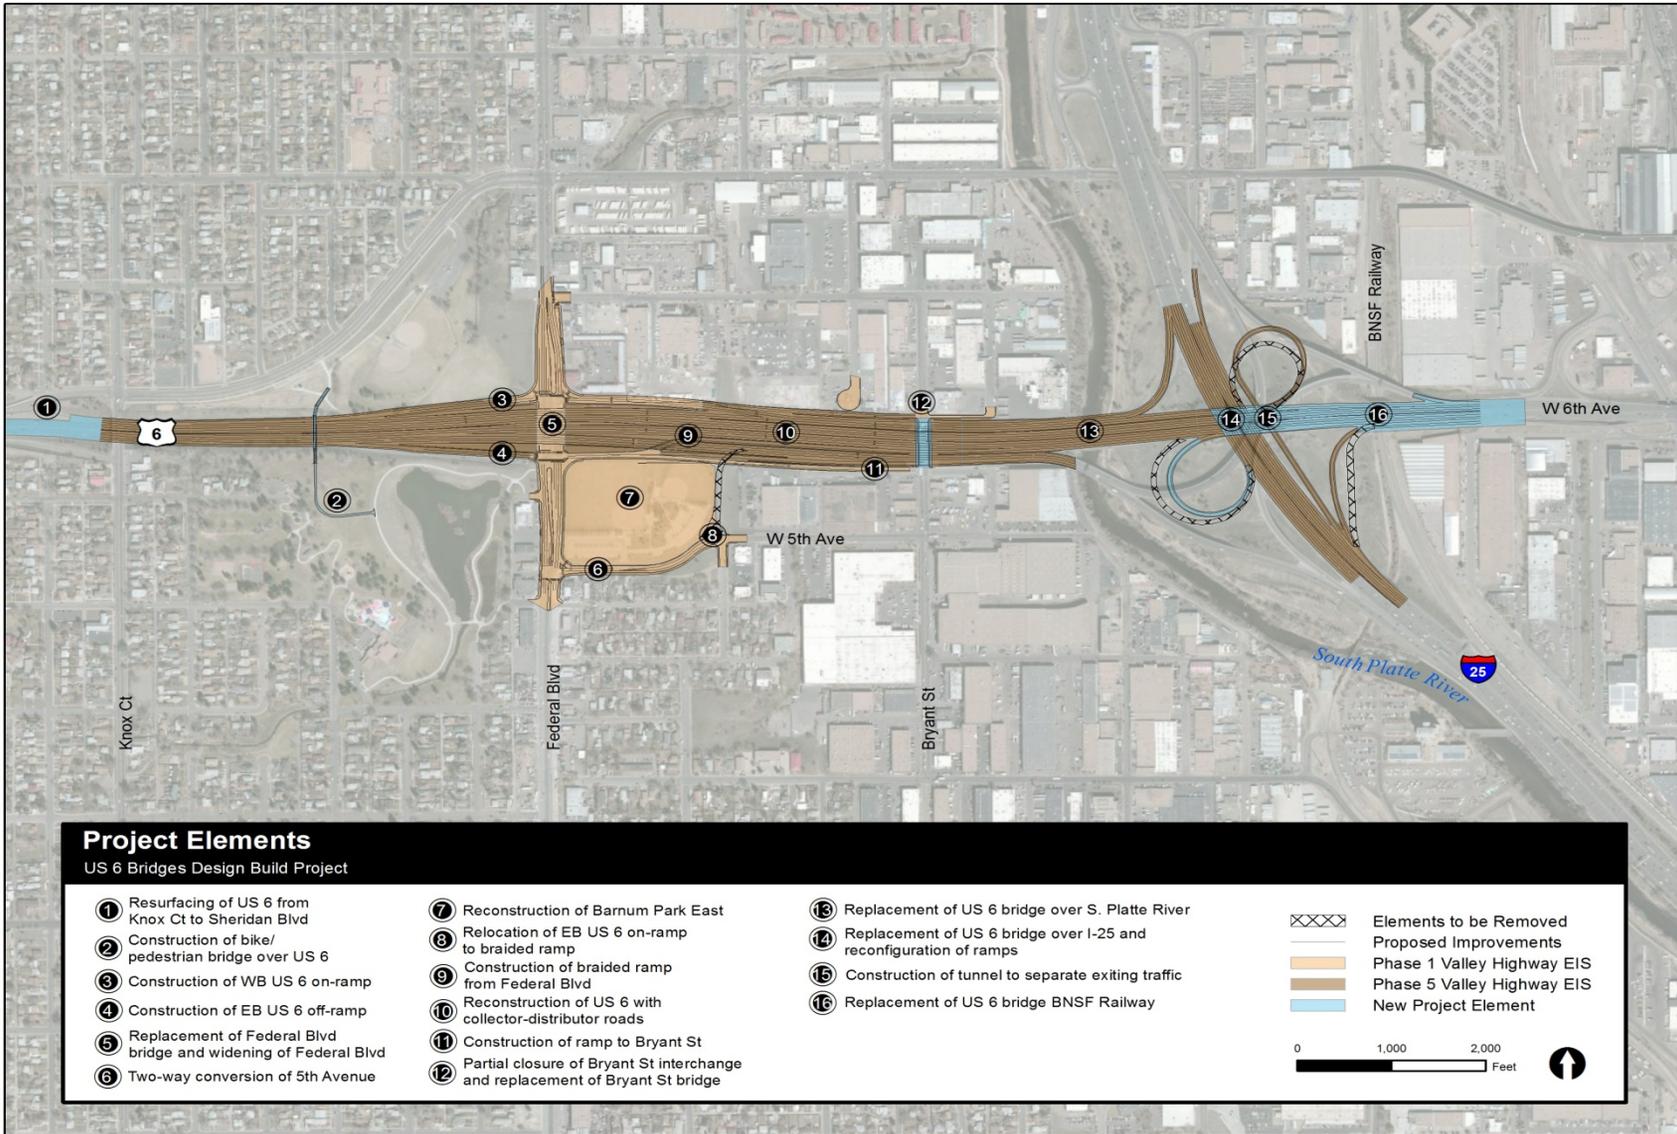
Figure 4: Proposed Project Elements

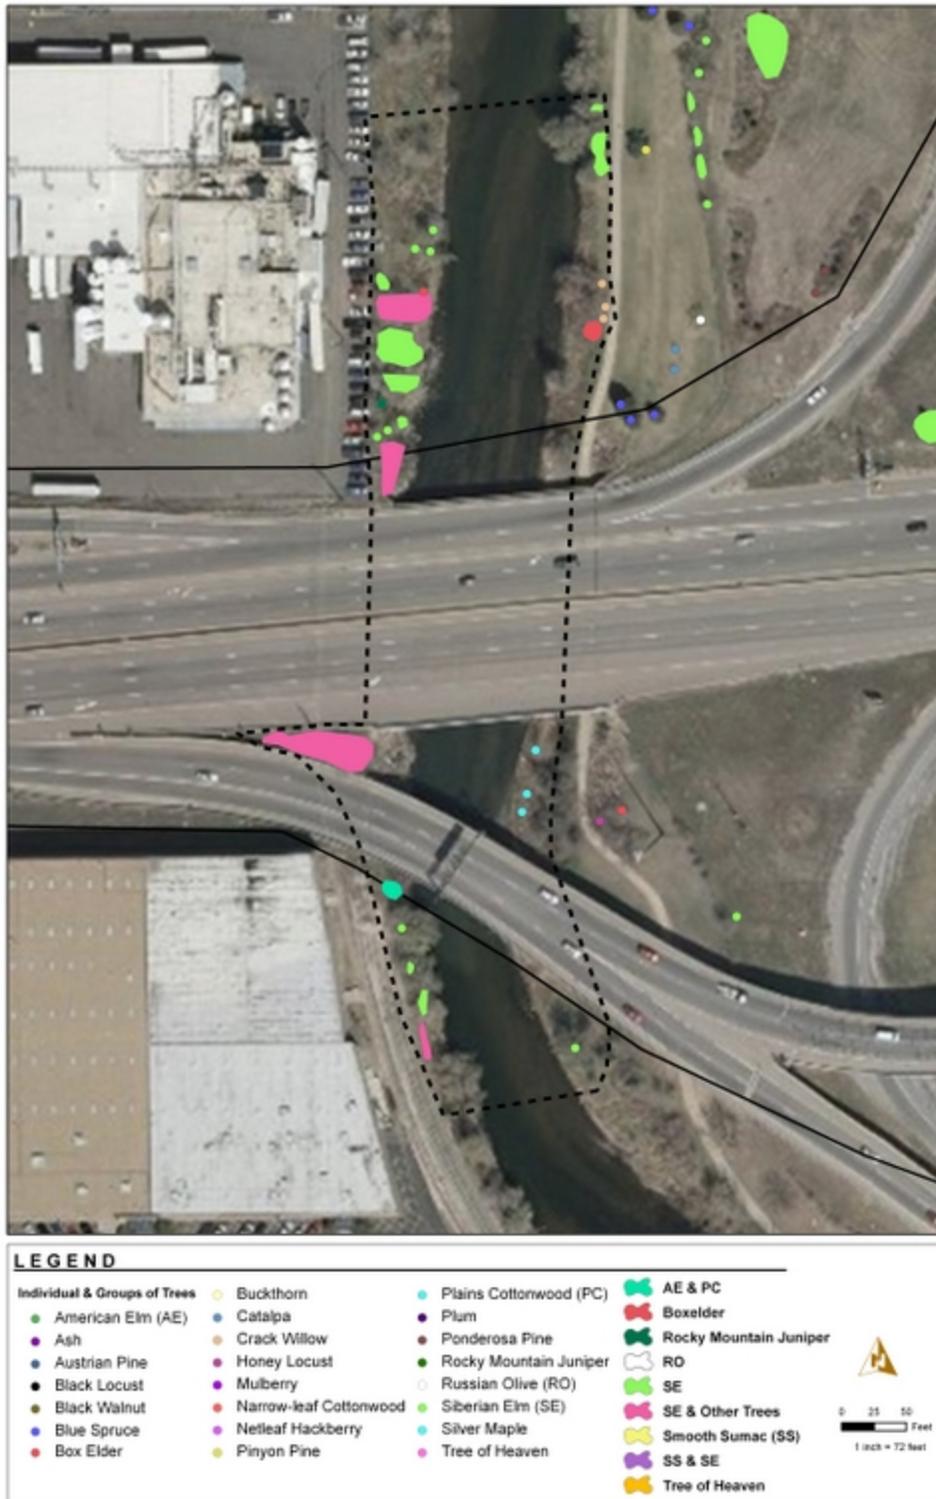
Figure 6: Senate Bill 40 Trees

The SB 40 tree species identified during the field visits are shown in Figure 6 and in **Appendix 2**. This is based on the proximity to the South Platte River and the size of the tree (SB 40 trees are at least 2 inches diameter-breast-height [dbh]).

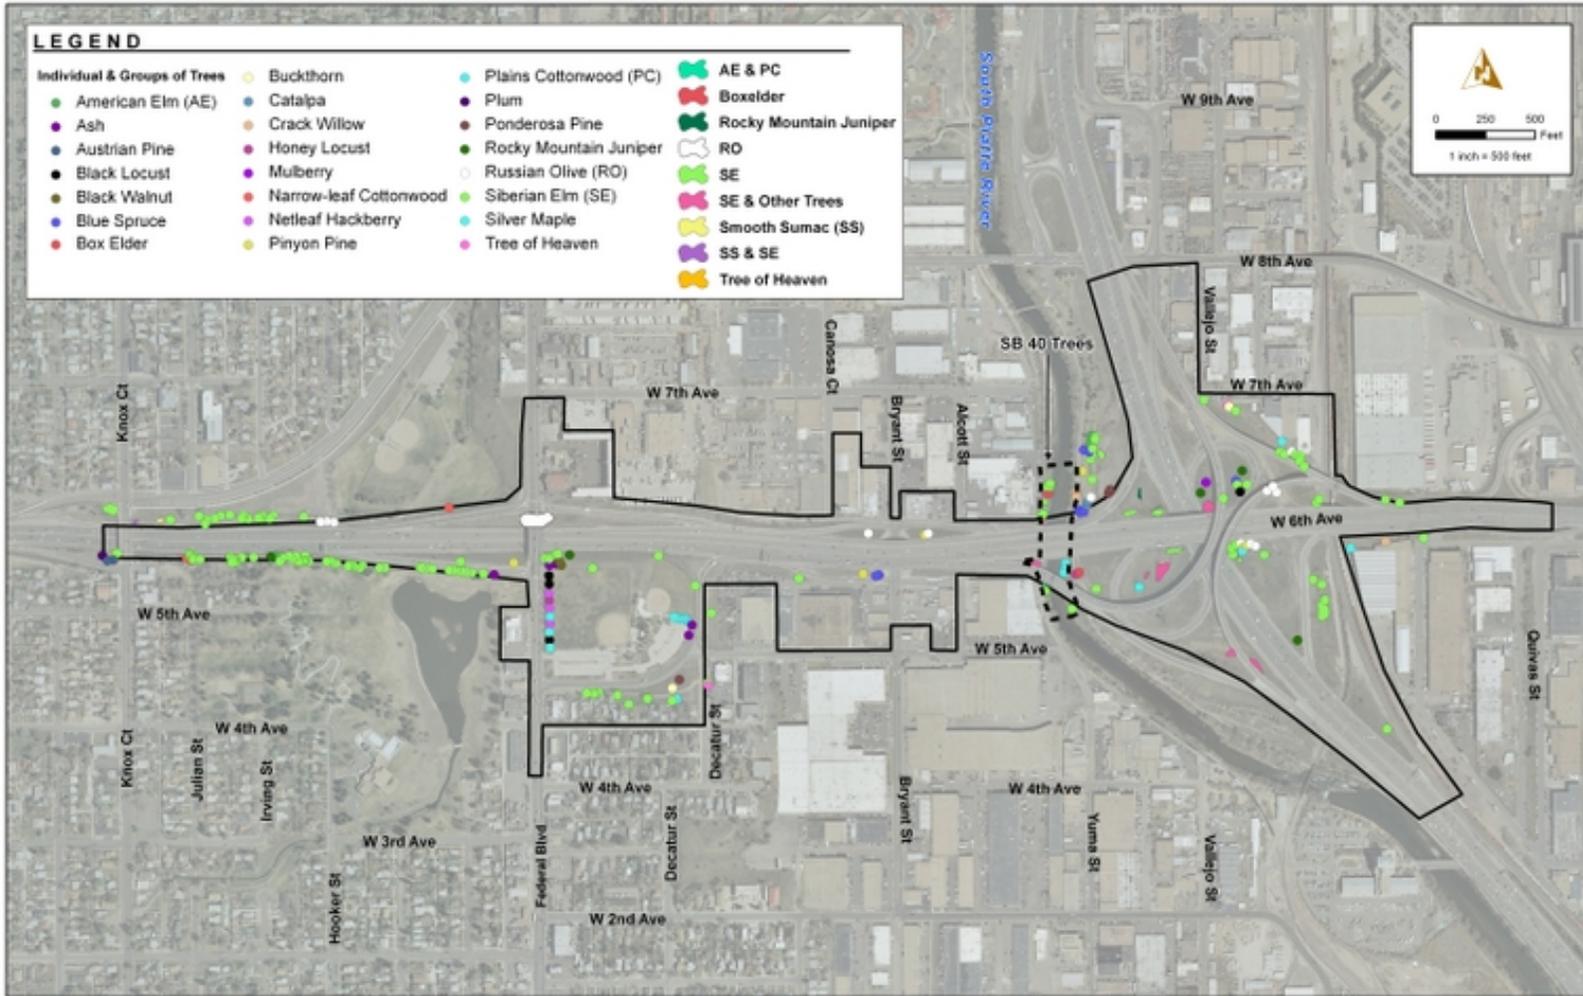
Figure 7: Upland Tree Resources

CDOT Region 6 mitigates for the removal of both native and non-native trees greater than four inches DBH. Trees greater or equal to this threshold were inventoried and data was collected with sub-meter accuracy Trimble GeoHX GPS units within the Project Area. A total of 750 trees were identified within the Project Area. As seen in the site photos, these trees include groups of American elm (*Ulmus americana*), Siberian elm, plains cottonwood (*Populus deltoides*), box elder (*Acer negundo*), and Ailanthus tree of heaven (*Ailanthus altissima*) trees. There are numerous trees located within the roadway ROW that will be affected by this project. Based on current design and grading plans, the Proposed Project will remove 169 upland trees. These trees, shown in Figure 7, will be replaced with native species at a 1:1 ratio in accordance to CDOT Region 6 policy.

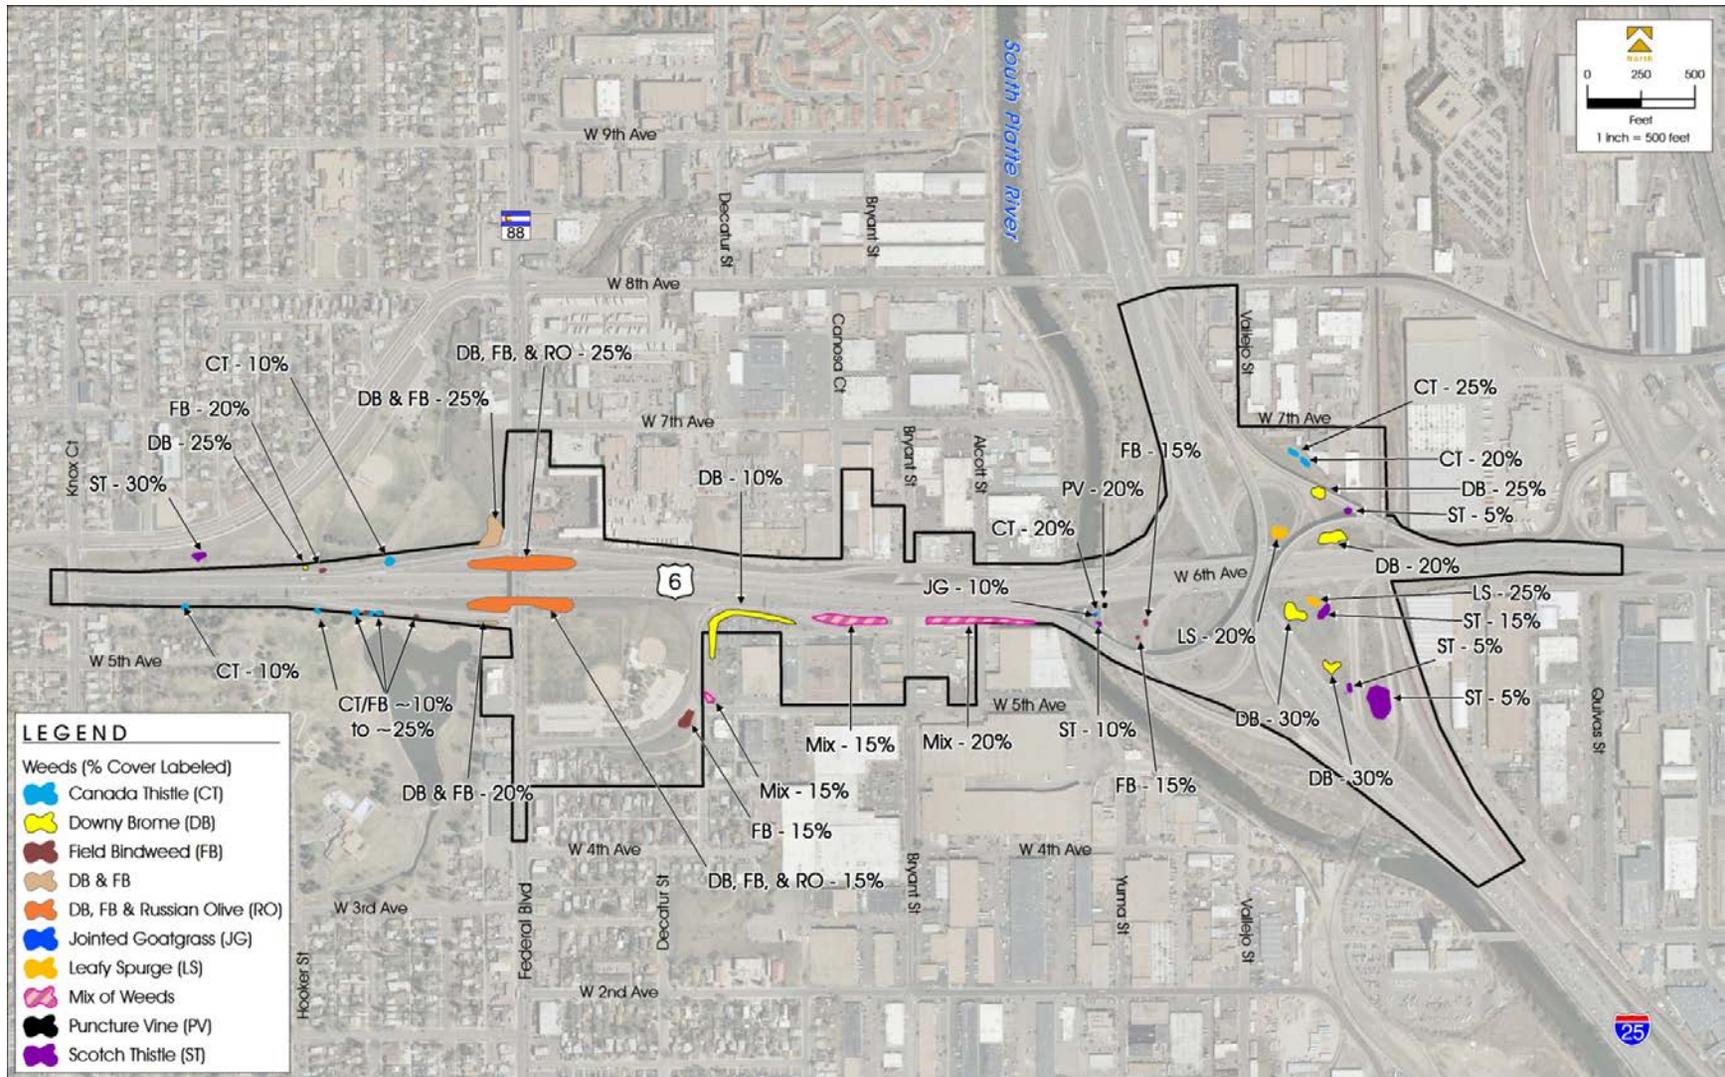
Figure 8: Noxious Weeds in the Project Area

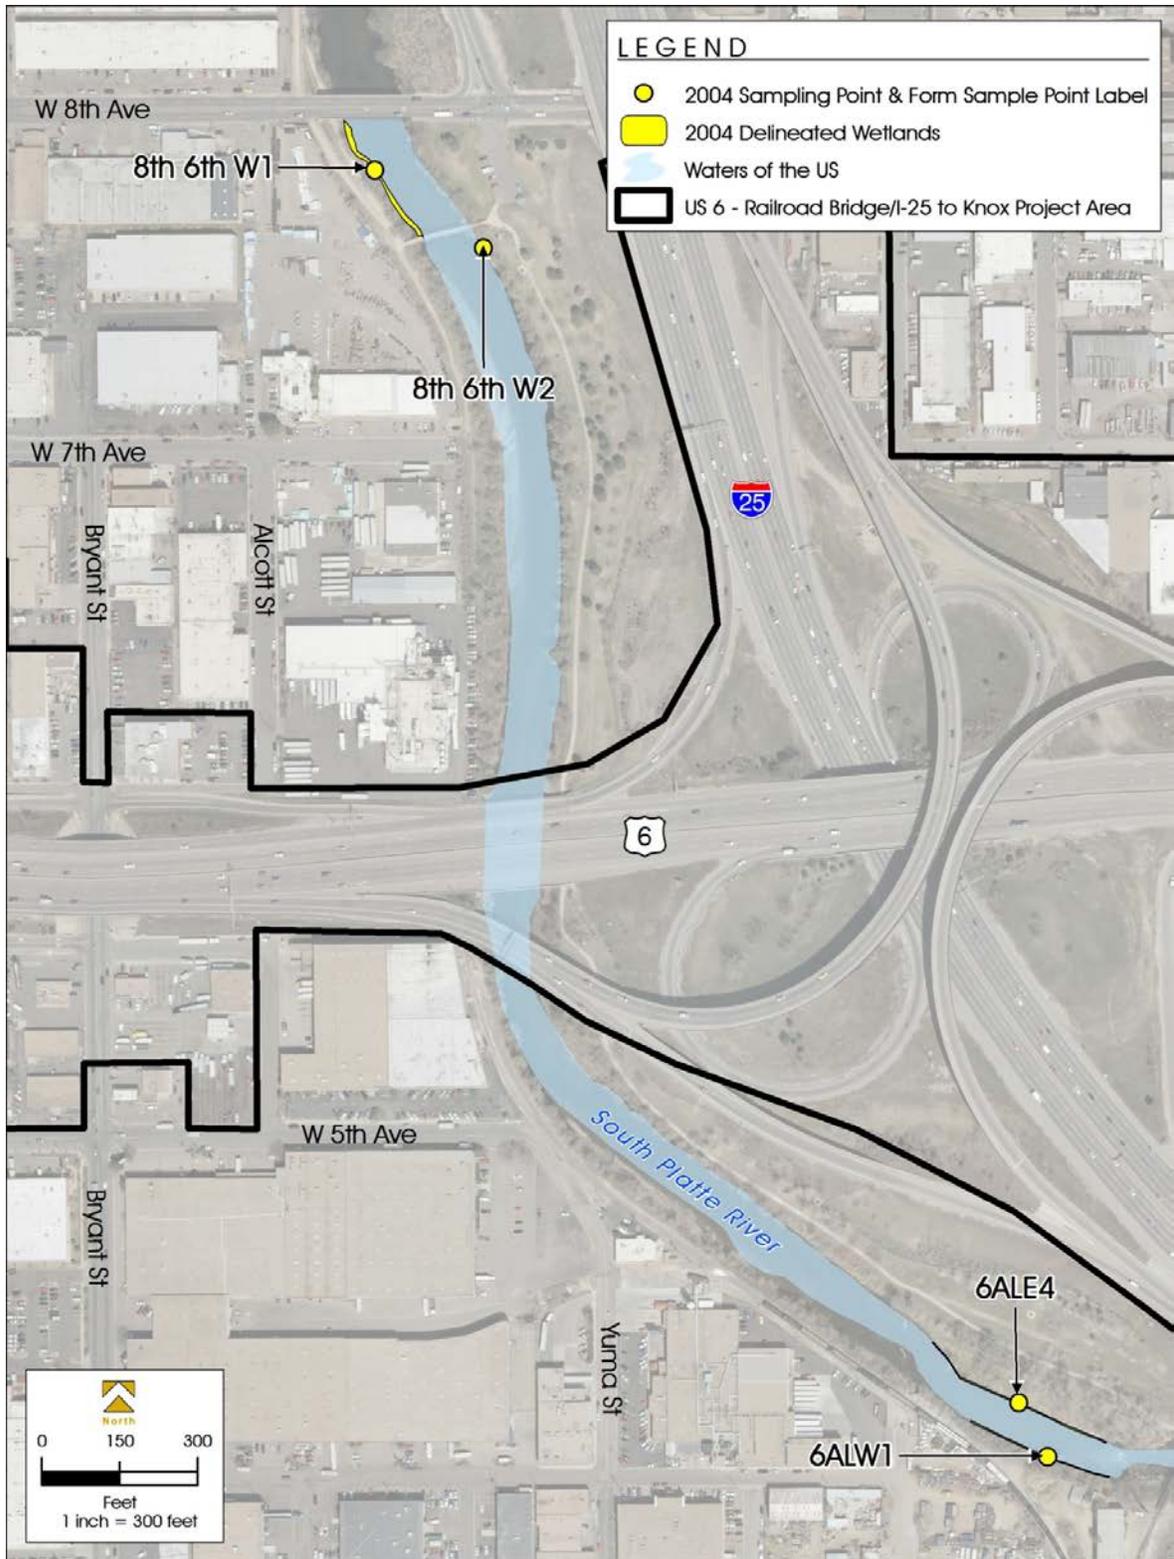
Figure 9: 2004 Delineated Wetlands near the Project Area

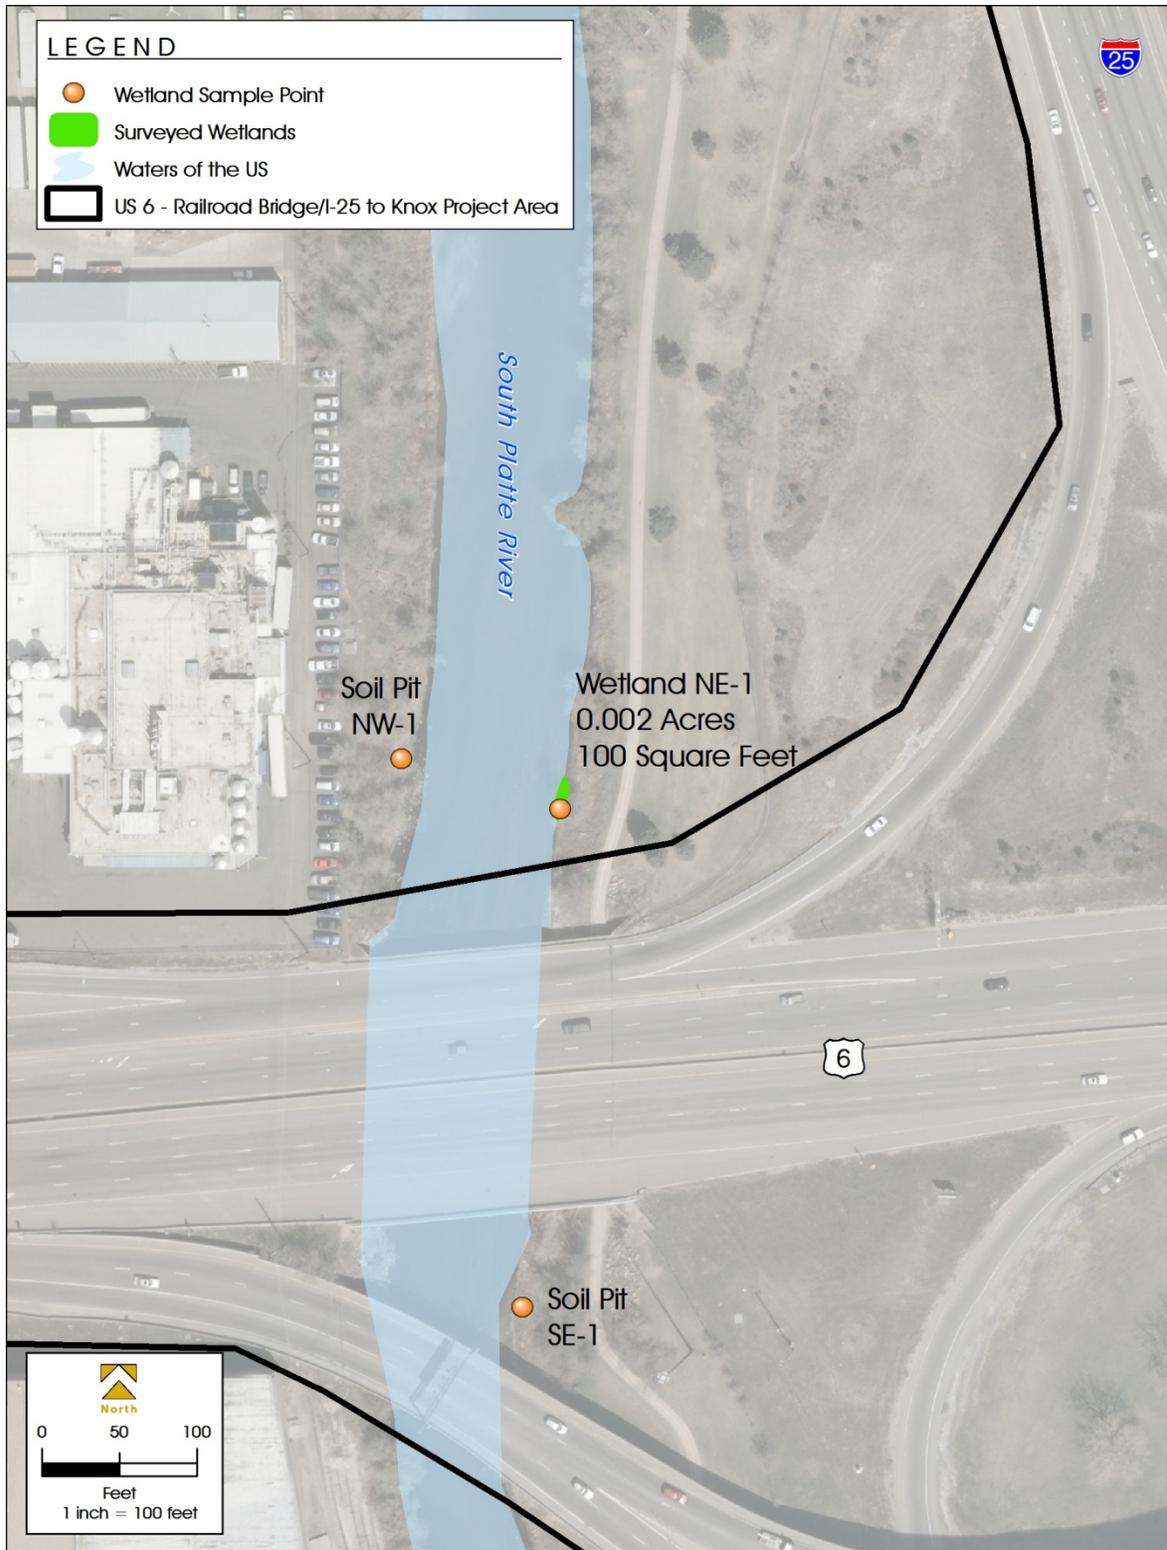
Figure 10: 2011 Delineated Wetlands near the Project Area

The wetland characteristics and boundaries described in the 2004 delineation report are generally consistent with the current conditions. No adjustments to the previous 2004 wetland boundaries along the banks of the South Platte River were made in 2011. A new wetland was identified in the Project Area in 2011.

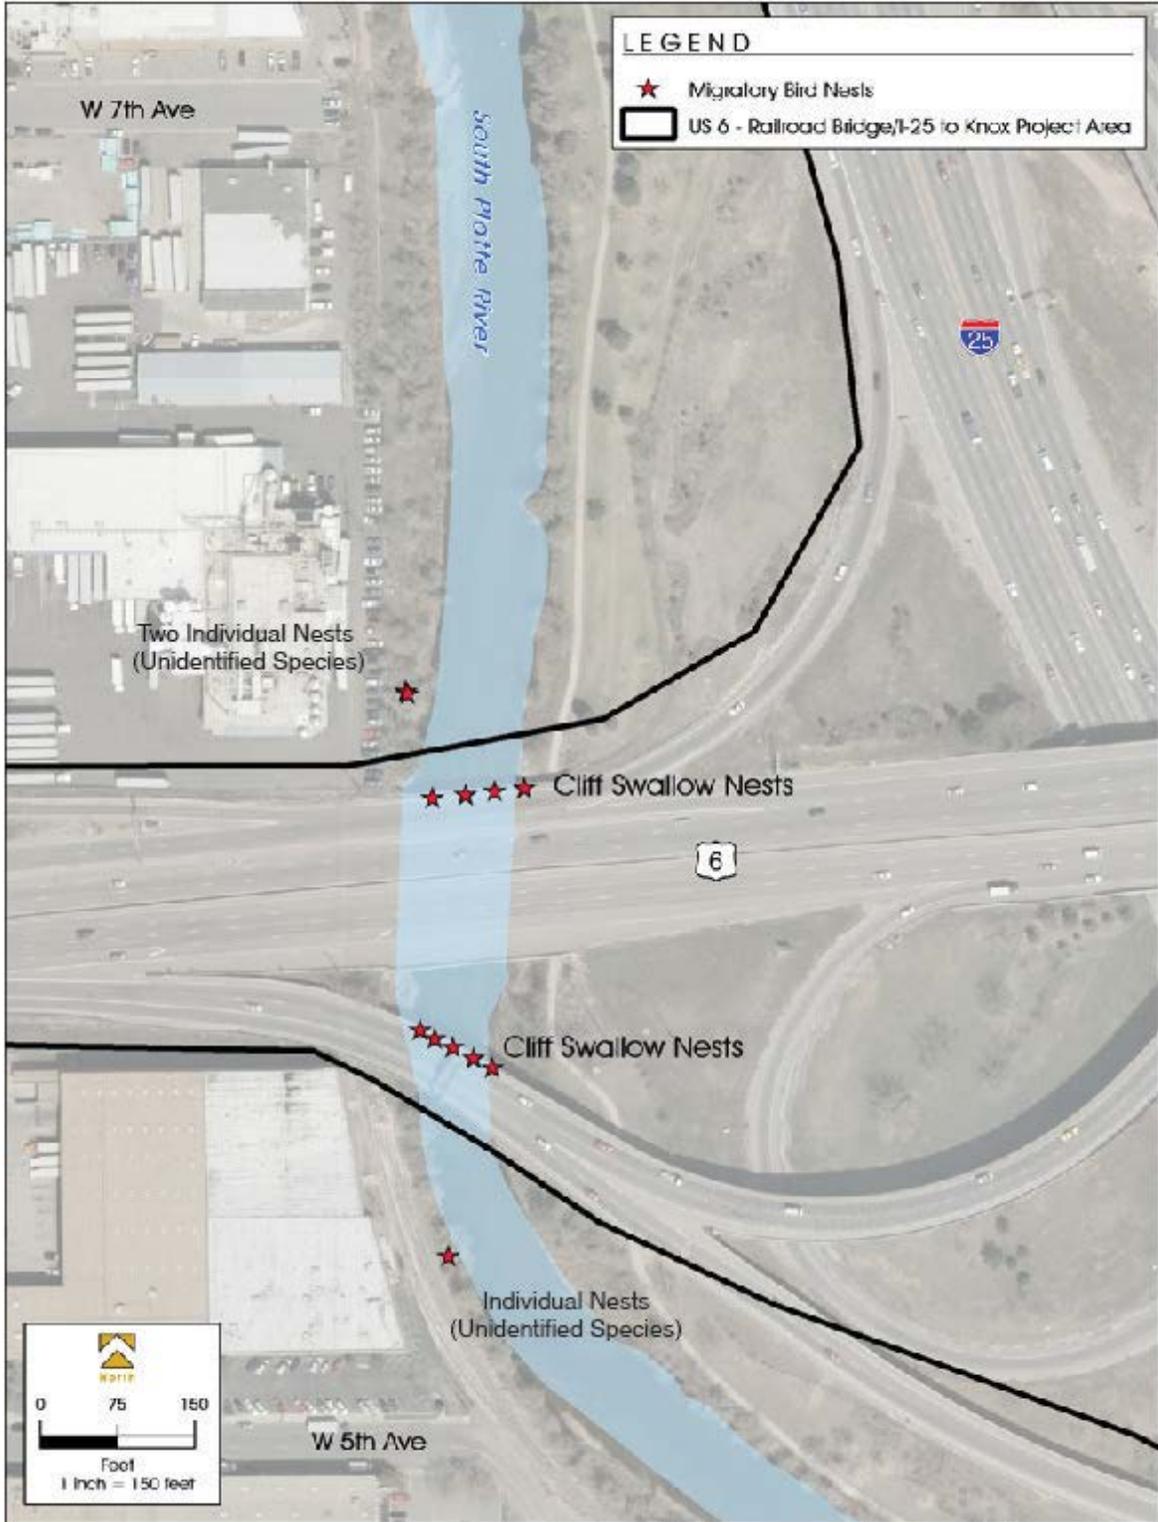
Figure 11: Bird Nests in the Project Area

During the site visits in 2011 and 2012, FHU conducted a breeding bird survey to identify the species and locations of breeding birds. During this survey, trees and structures were searched to identify any bird nests. Three individual inactive nests of unknown species and a colony of inactive Cliff Swallow nests were identified during the field visits in October 2011 and early May 2012 (Figure 11). The three unknown nests are north and south of the US 6 bridge over the South Platte River on the west bank of the river, while the colony of Cliff Swallow nests are found on the main US 6 bridge as well as the US 6 exit ramp to I-25. All were inactive at the time of the survey. Therefore, impacts to migratory birds could occur if bridge construction occurs within the nesting season for birds (April 1 to August 31).

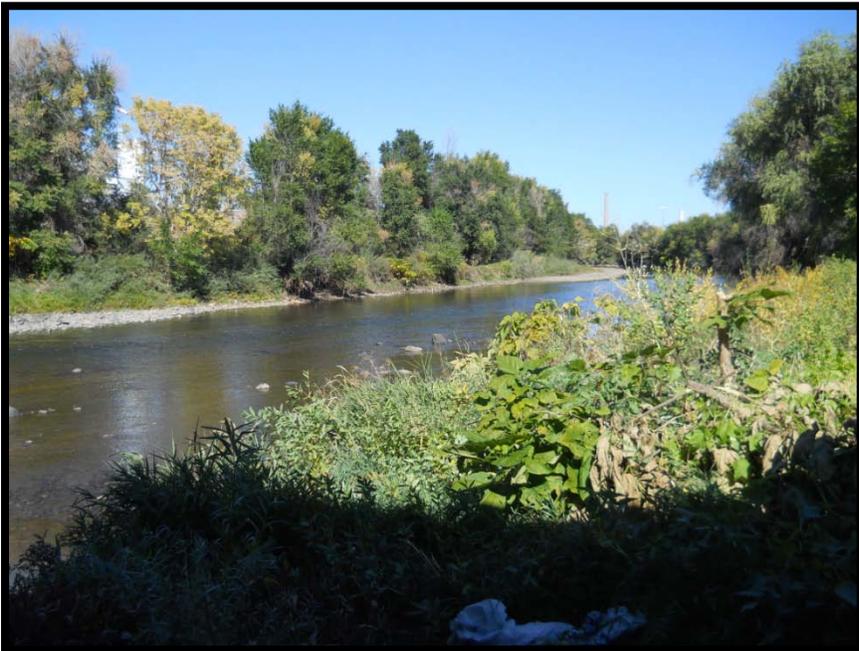
**Photo 6 — Looking north from the east side of the South Platte River, the US 6 Bridge is just to the south (Data Point NE-1 in Appendix 4)**

northeast side of the US 6 bridge over the South Platte River. The wetland area is a fringe wetland (about 4 feet wide or less) (**Appendix 1, Photo 6**) that is found on a lower bank of the river where sediment has deposited in the last seven years. Refer to the *US 6 Bridges Design Build Project Wetland Delineation Report* (FHU 2012) for additional information on characteristics of wetlands in the Project Area, wetland determination forms, and the 2004 delineation (attached as **Appendix** in that report). No other wetlands were identified.

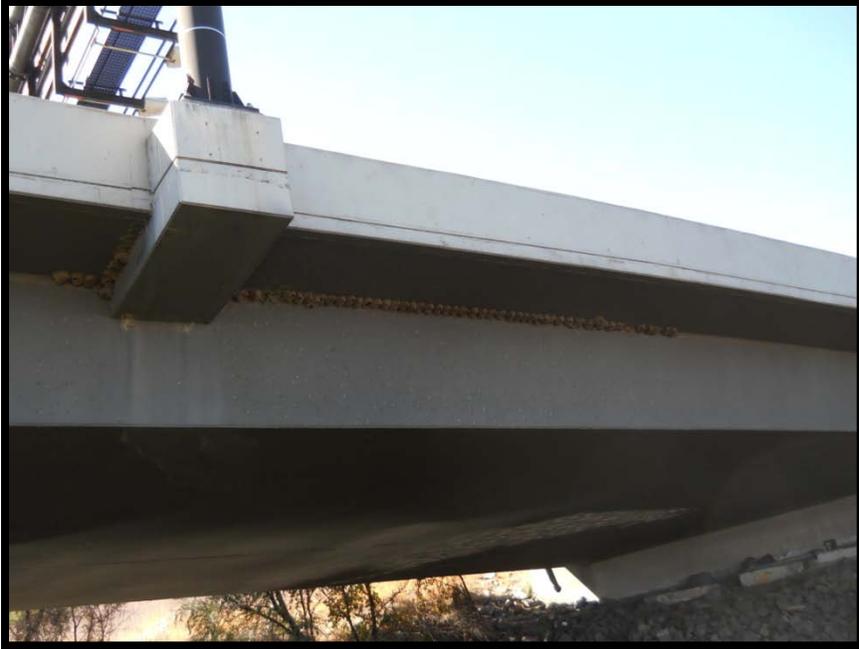
**Photo 9 — Looking at the US 6 Bridge over the South Platte River, cliff swallow nests are visible on the bridge**

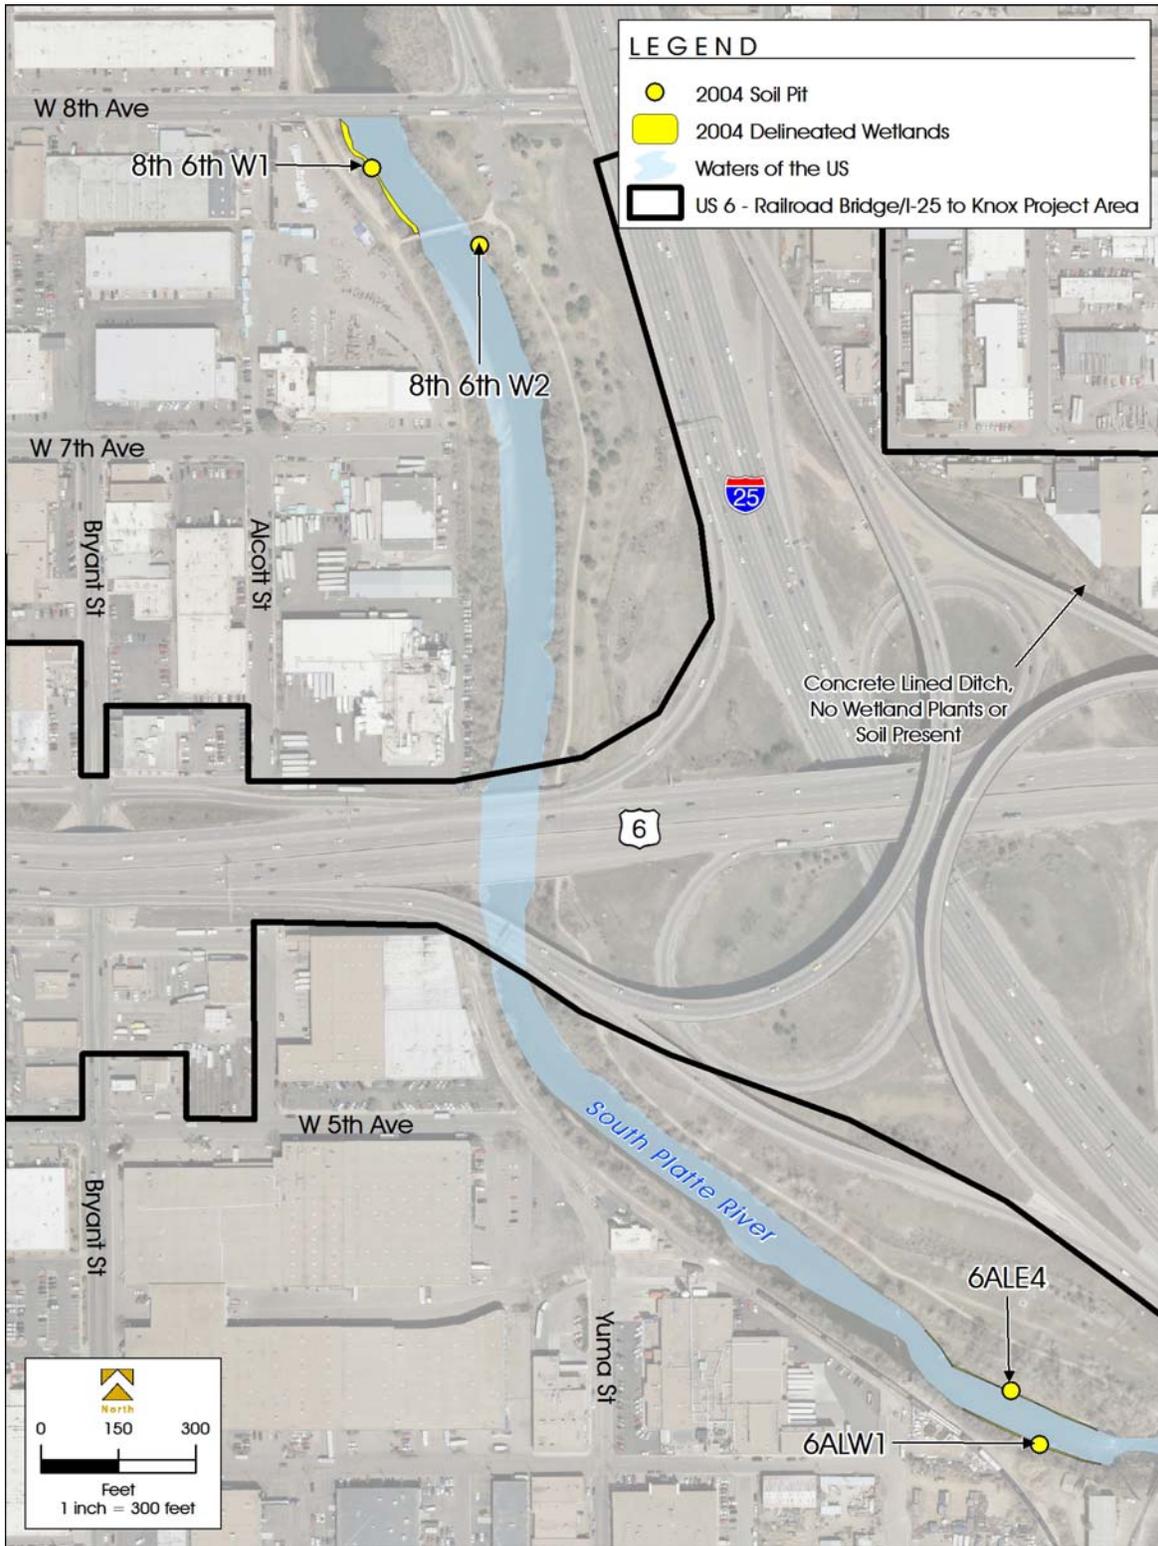
Figure 2 2004 Delineated Wetlands near the Project Area

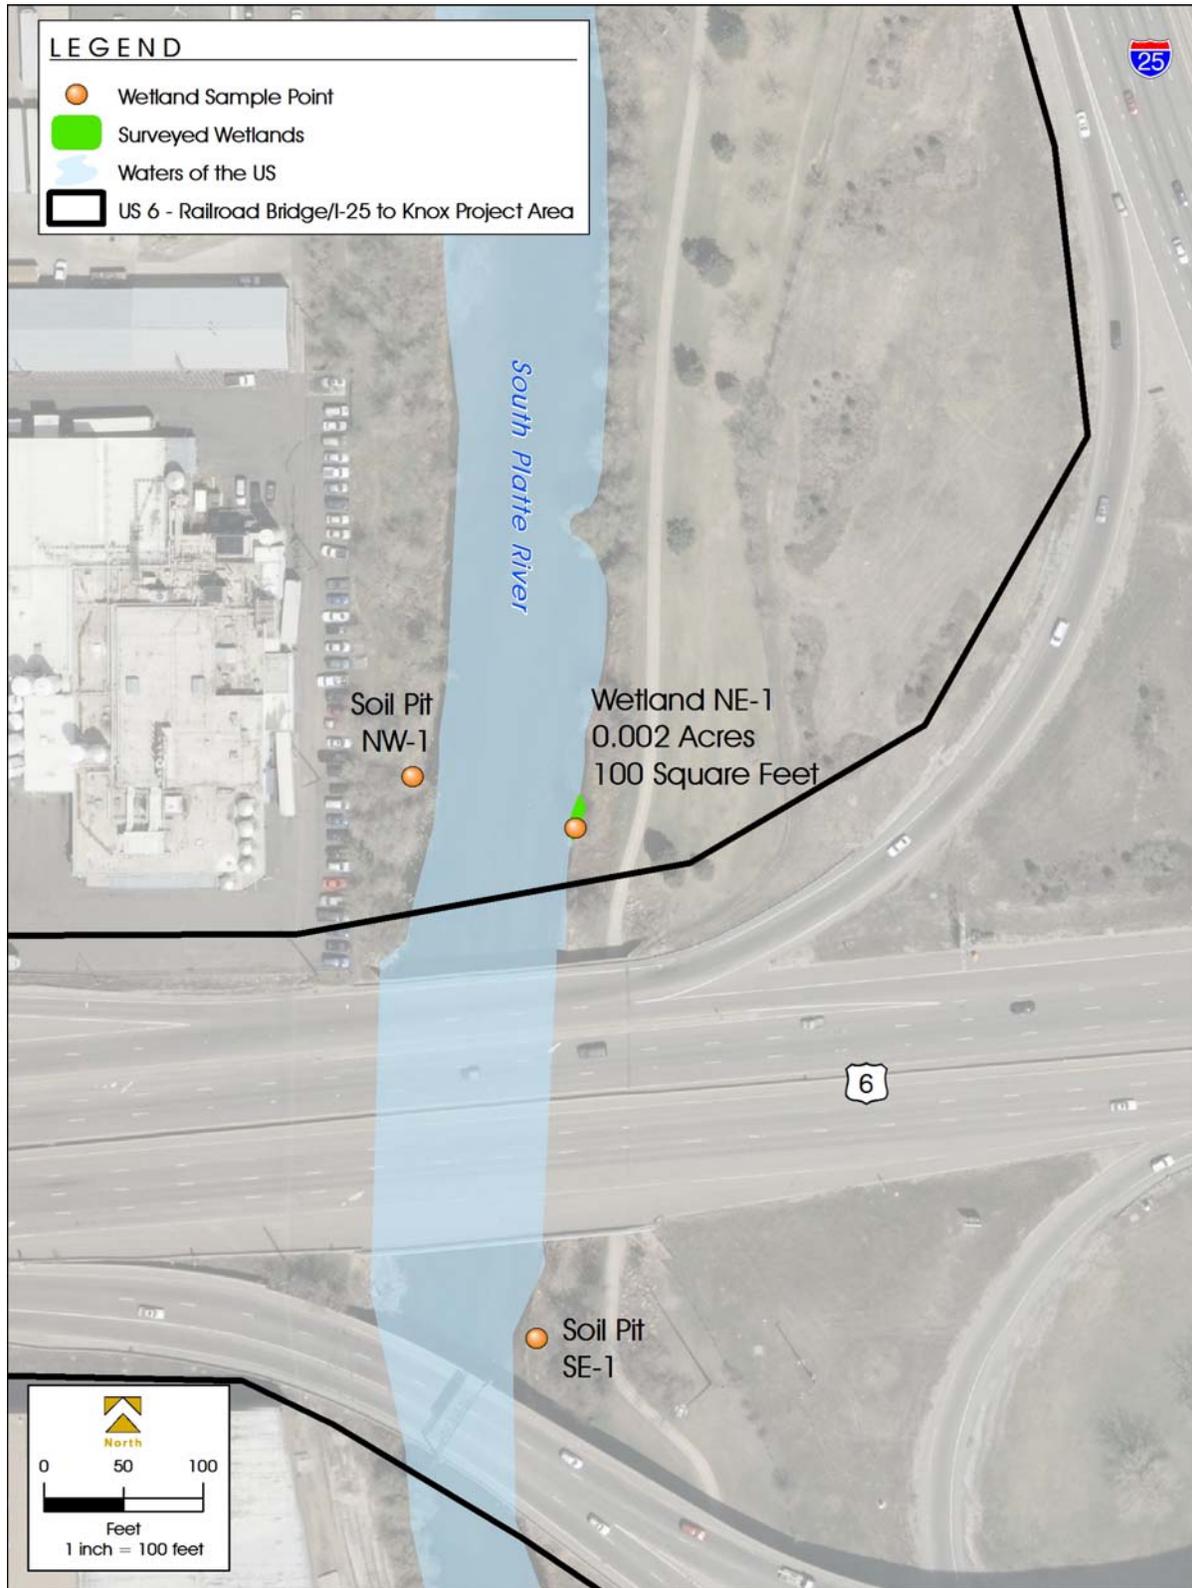
Figure 3 Newly Identified Wetland in the Project Area

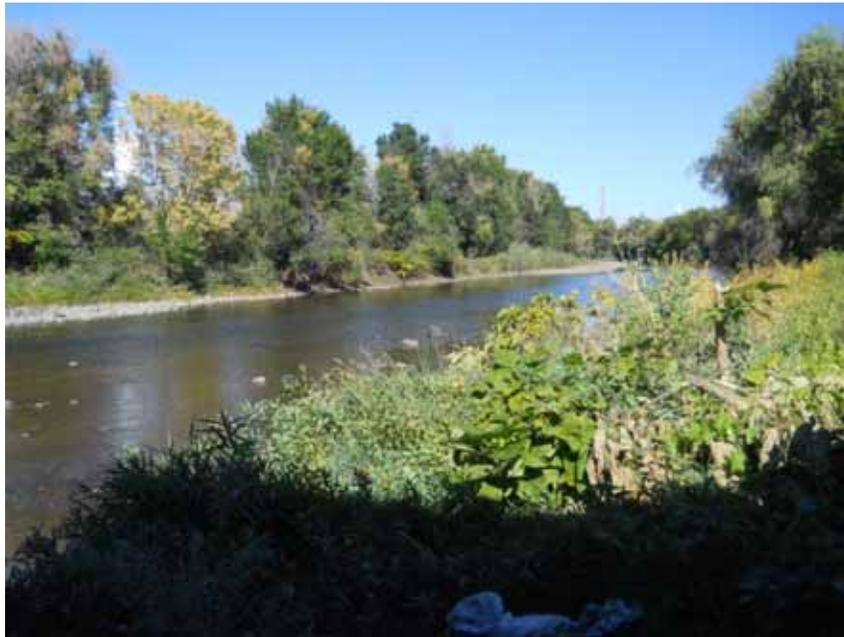
Photo 5 — Looking north from the east side of the South Platte River, the US 6 bridge is just to the south; the NE-1 Wetland is located on a small sandbar in front of the vegetation in this picture
