# US 6 Bridges Design Build Project

## Biological Resources Report

Prepared for:  
Colorado Department of Transportation  
Federal Highway Administration

October 2012

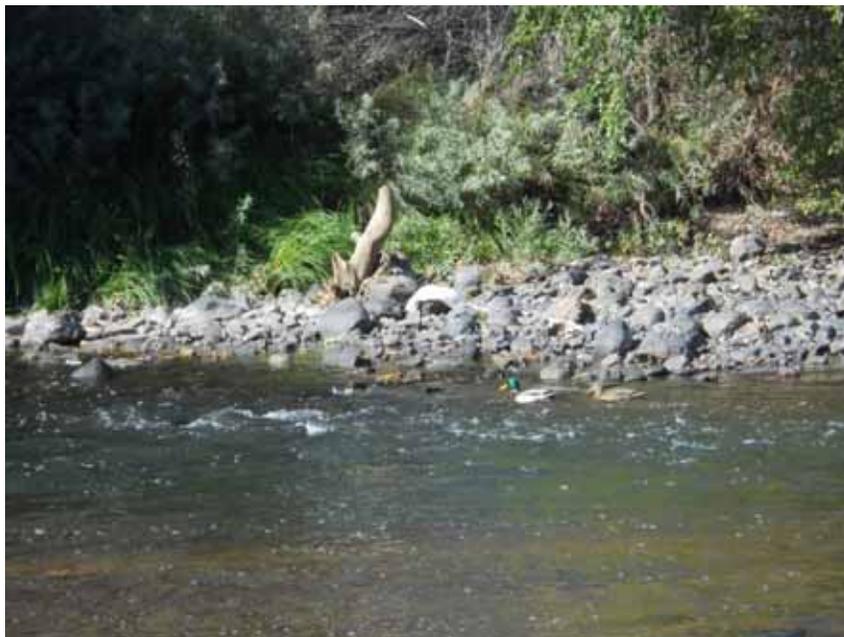
Photo 10 — A view of the rip-rap and thin layer of vegetation along the banks of the South Platte River

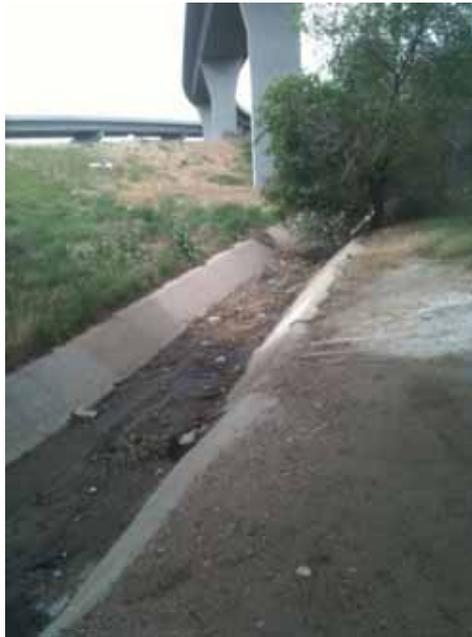
Photo 11 — The concrete lined ditch north and east of US 6 and I-25. No wetland plants or hydric soils are present; it is just filled with trash and mud.
