US 6/Wadsworth

Environmental
Assessment

Summary of Existing Conditions

US 6 and Wadsworth Boulevard Area

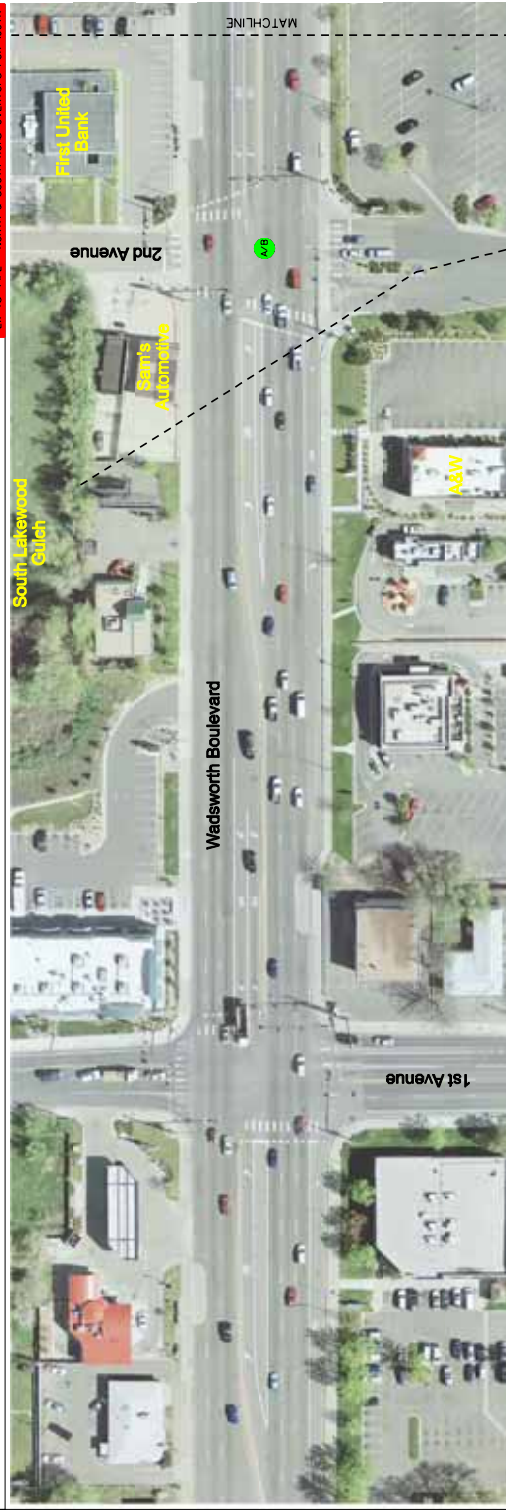
STRUCTURE CLASSIFICATION
 (ND): NEITHER FUNCTIONALLY STRUCTURALLY DEFICIENT
 (SD): STRUCTURALLY DEFICIENT
 (SD) AND/OR (FC): STRUCTURALLY DEFICIENT AND/OR FUNCTIONALLY OBSOLETE CLEARANCE AVAILABLE
 (FC): FUNCTIONALLY OBSOLETE CLEARANCE AVAILABLE

HORIZONTAL ALIGNMENT	
VERTICAL ALIGNMENT	
VERTICAL SIGHT STOPPING DISTANCE	
ACCESS CONTROL/ MEDIAN TREATMENT	
SPACING OF INTERSECTING STREETS	
EXIT AND ENTRANCE DESIGN	
RAMP DESIGN	
WEAVE DISTANCE	
LEVEL OF SERVICE (AM/PM)	
ACCIDENT RATES	
CONNECTIVITY	
CLASSIFICATION	
MAJOR

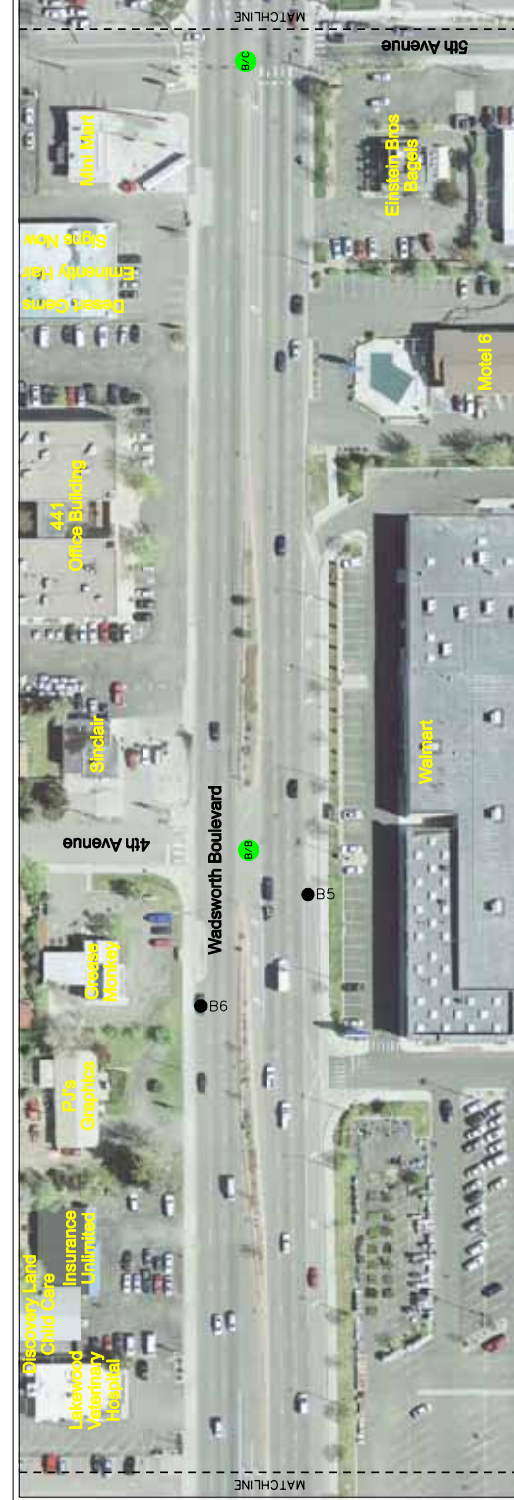
(ND): NEITHER FUNCTIONALLY OR STRUCTURALLY DEFICIENT
(F): FAIR CONDITION NEARING END OF DESIGN LIFE
(SD) AND/OR (FO): STRUCTURALLY DEFICIENT AND/OR FUNCTIONALLY OBSOLETE CLEARANCE
(A): AVAILABILITY REPORTS NOT AVAILABLE

HORIZONTAL ALIGNMENT	
VERTICAL ALIGNMENT	
VERTICAL SIGHT STOPPING DISTANCE	
ACCESS CONTROL/MEDIAN TREATMENT	
SPACING OF INTERSECTING STREETS	
EXIT AND ENTRANCE DESIGN	
RAMP DESIGN	
WEAVE DISTANCE	
LEVEL OF SERVICE (AM/PM)	
ACCIDENT RATES	
CONNECTIVITY	
CLASSIFICATION	
MAJOR

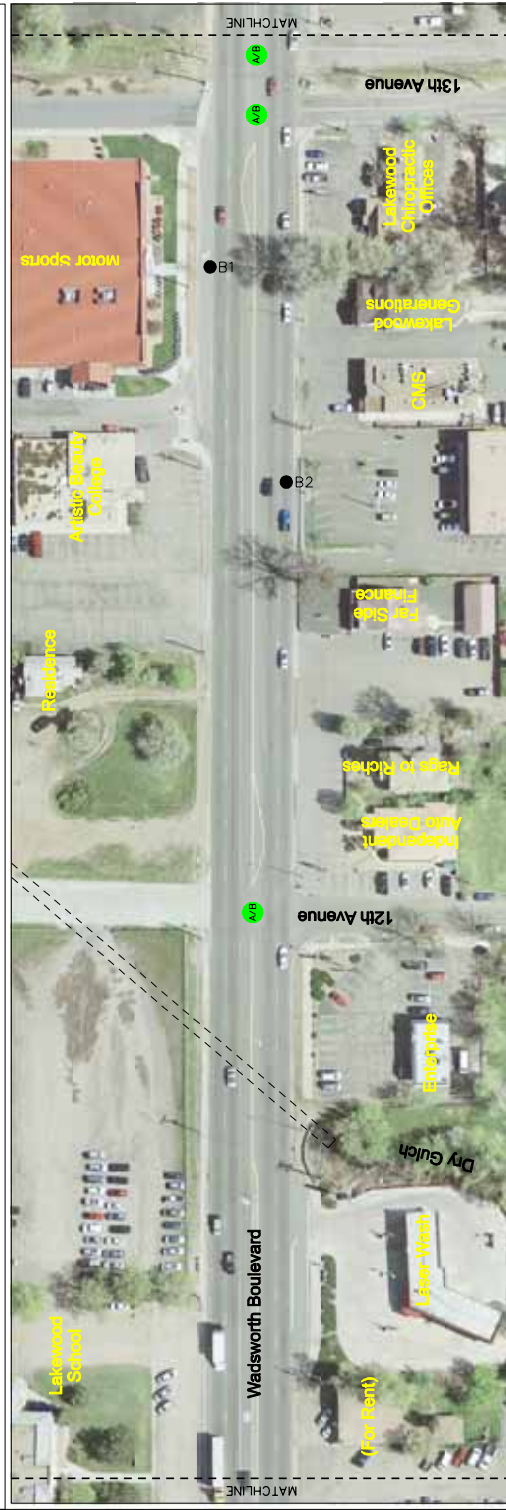
NB-A/A	NB-B	NB-E/F	NB-E/F
MISSING S/W	MISSING S/W	DRIVEWAY ISLAND OBSTRUCTS PED/BIKES	NARROW, ATTACHED S/W

OPERATIONAL FEATURES	WEAVE DISTANCE
PERFORMANCE MEASURES	LEVEL OF SERVICE (AM/PM)
PEDESTRIAN	ACCIDENT RATES
STRUCTURAL CLASSIFICATION	CONNECTIVITY
DRAINAGE	MAJOR
