Hazardous Materials MESA Addendum

PROJECT: US 6 and Wadsworth Boulevard Interchange Environmental

Assessment

SUBJECT: MESA Supplement

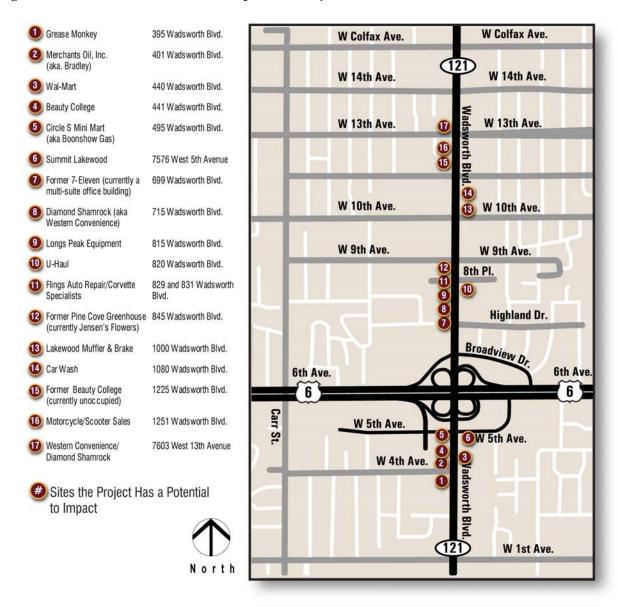
Figure 1-Sites with the Potential to Impact the Project

Pinyon completed a survey of the Site addresses on April 8, 2009, by driving to the listed properties and noting the current Site use. Some possible historical uses were also noted. All observations were from public right of ways or publically accessible parking lots. The following table (Table 1) lists the property, the current use, any potential recognized environmental conditions (RECs) based on current or known historical uses, and a recommendation for additional work, if necessary. Table 1 lists all of the full acquisitions and the partial acquisitions with RECs. The properties with RECs are mapped in Figure 1 and shown in detail on the project atlas included at the end of this document.
