Scoping Summary Report

APPENDIX E

Agency Scoping Meeting Presentation and Display Boards

US 6 and Wadsworth Boulevard Environmental Assessment Agency Scoping Meeting

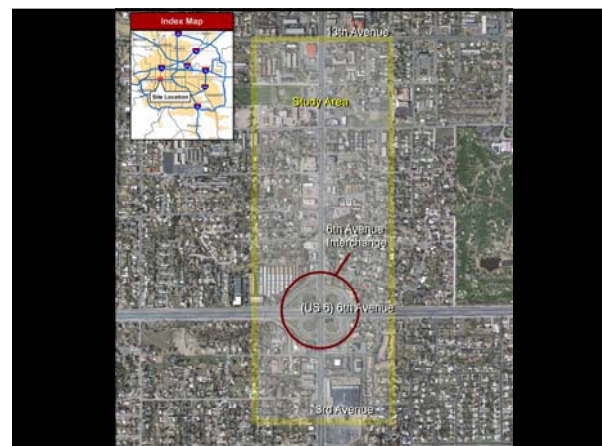
Study Corridor

- Approximately 1-mile-long corridor within Lakewood, Colorado
- 500-foot corridor on either side of Wadsworth Boulevard centerline between 3rd and 13th avenues
- 500-foot corridor along each side of US 6 between approximately Broadview Drive to the east and Allison Street to the west
- Logical termini not yet finalized

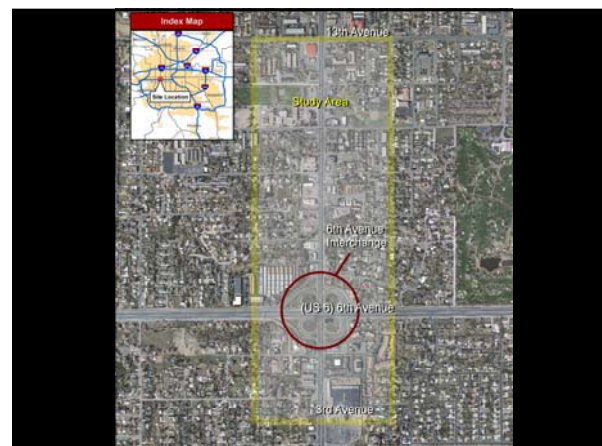
Study Corridor

- Approximately 1-mile-long corridor within Lakewood, Colorado
- 500-foot corridor on either side of Wadsworth Boulevard centerline between 3rd and 13th avenues
- 500-foot corridor along each side of US 6 between approximately Broadview Drive to the east and Allison Street to the west
- Logical termini not yet finalized

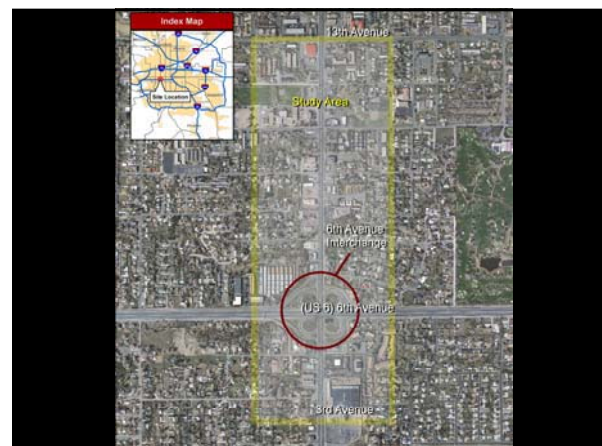
Study Corridor

- Approximately 1-mile-long corridor within Lakewood, Colorado
- 500-foot corridor on either side of Wadsworth Boulevard centerline between 3rd and 13th avenues
- 500-foot corridor along each side of US 6 between approximately Broadview Drive to the east and Allison Street to the west
- Logical termini not yet finalized

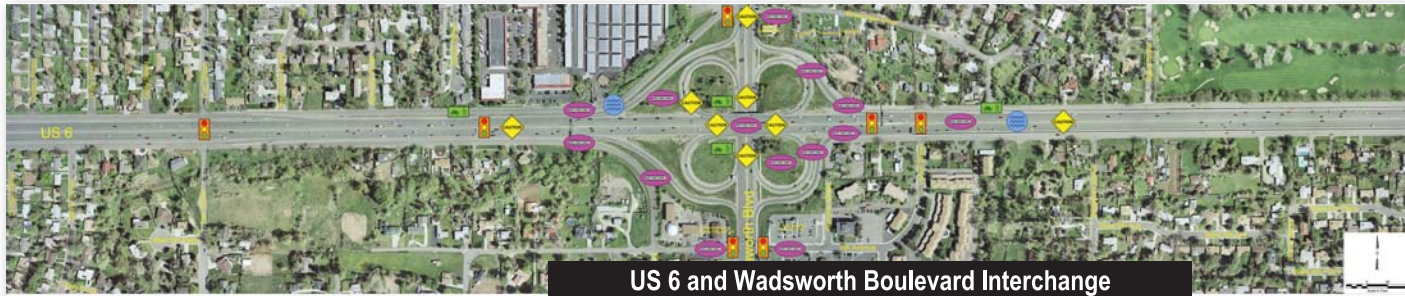
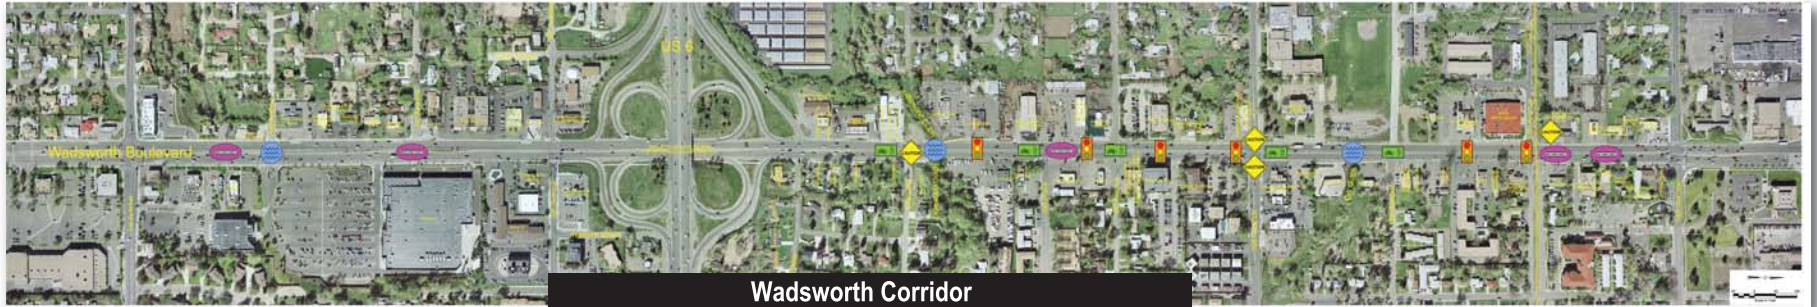
Project Issues

Roadway and Bridge Issues
 This symbol indicates an area of roadway or structural deficiencies, including such issues as inadequate vertical or horizontal curves, insufficient acceleration or deceleration lanes, intersections that are too closely spaced, and conflicts between travel lanes and shoulders or medians.

Safety Issues
 This symbol represents areas with frequent or severe crashes. Roadway deficiencies contribute to these conditions.
-

Bicycle/Pedestrian Issues
 This symbol is located in areas where pedestrian and bicycle facilities are limited or non-existent. Barriers to pedestrian and bicycle travel also are shown with this symbol.
