Project Summary:

May 28, 2010
Day 894 of 1278

Recent Construction Highlights

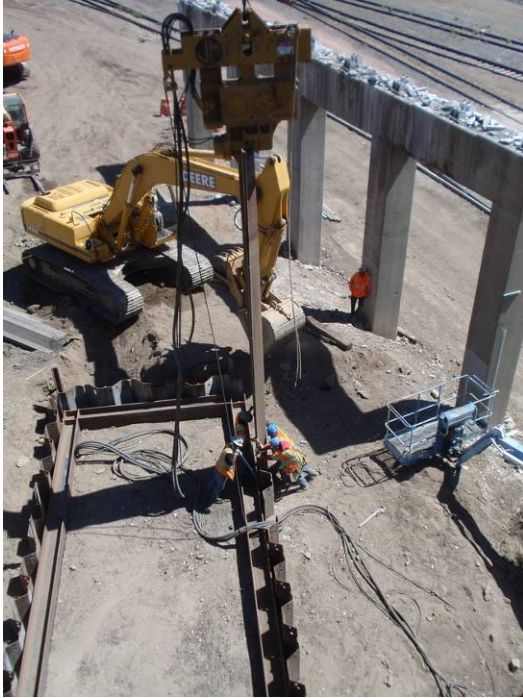
Figure 1 – EB Pier 5 Footing Excavation – May 5, 2010:
A Flatiron crew drives sheet pile around the perimeter of the EB Pier 5 footing excavation area. The removal of girders from Spans 1 and 2 of the existing bridge was required prior to beginning foundation construction at EB Pier 5 and EB Abutment 6. An existing bridge pier is adjacent to the work area.

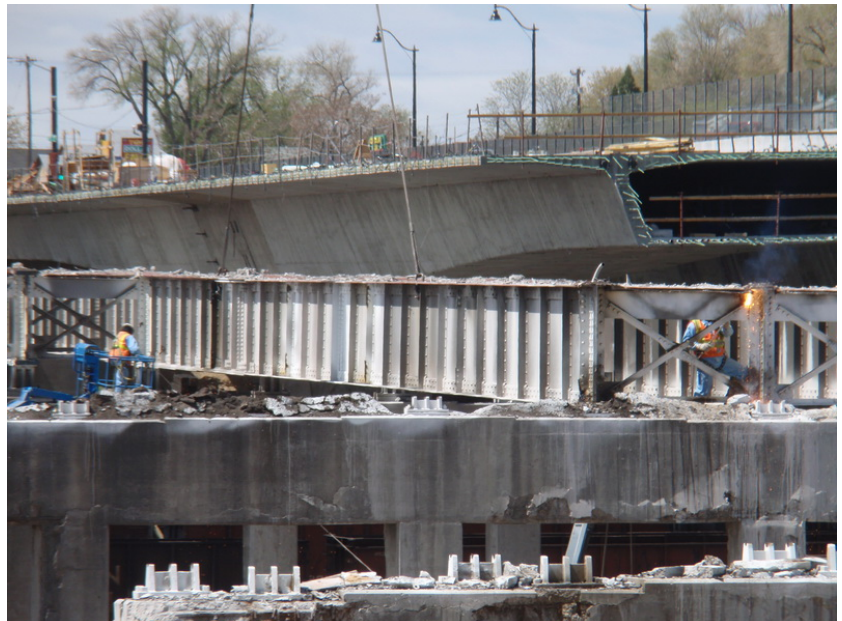
Figure 2 – Existing Bridge Demolition – May 7, 2010:
A worker makes the final cut through a cross frame needed to remove a girder in Span 3 of the existing bridge. The girder is rigged to a 300-ton crane positioned on an access road in the rail yard. The main-span tip of Cantilever 3 EB can be seen on the right.

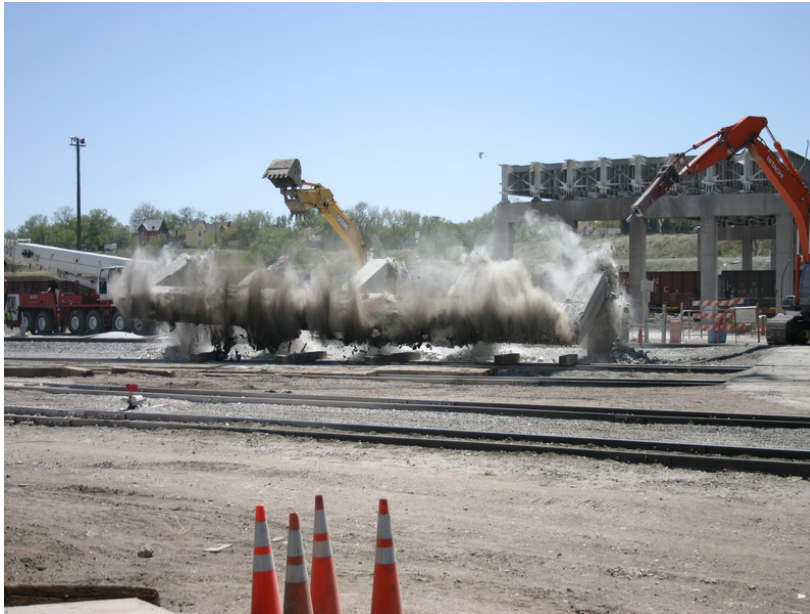
Figure 3 – Existing Bridge Demolition – May 10, 2010:

After removing about 75% of cross section at the mid-height of each column with a demolition hammer, two excavators push over the upper half of this existing bridge pier. The 300-ton crane used for girder removal is in the background on the left.

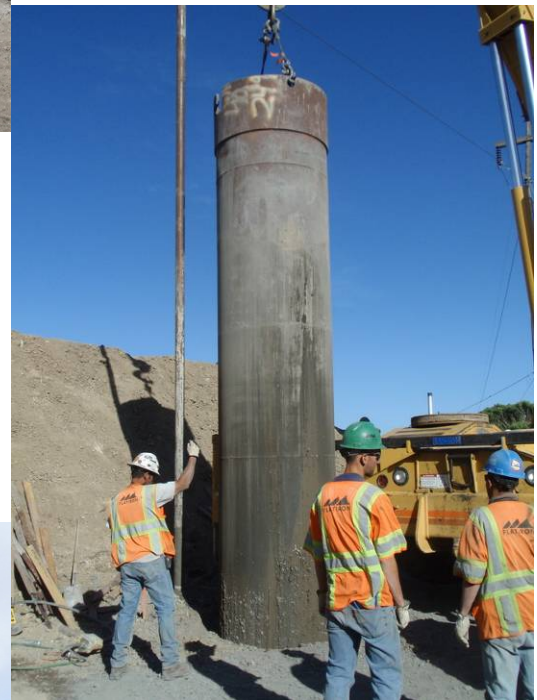
Figure 4 – EB Abutment 6 Drilled Shaft Construction – May 10, 2010:

A Flatiron foreman signals the crane operator to continue pulling the temporary casing from a drilled shaft at EB Abutment 6 during the shaft concrete pour. The three drilled shafts at EB Abutment 6 are 48” diameter and approximately 62’ in length.

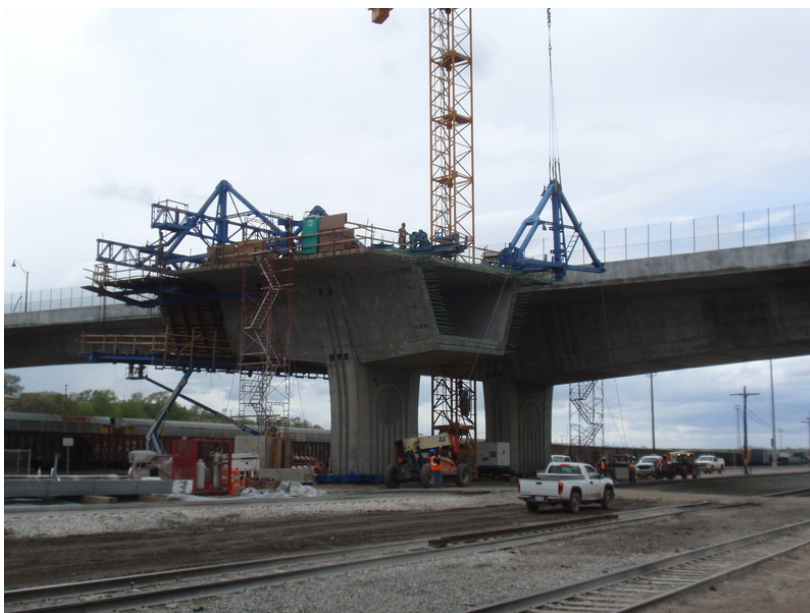
Figure 5 – Cantilever 4 EB Segmental Construction – May 12, 2010:

The tower crane lifts the right horse of the side-span form traveler onto EB Pier Table 4. Segment E4-1W in the main-span has been cast and the main-span form traveler launched forward to make room on the pier table for the side-span traveler.

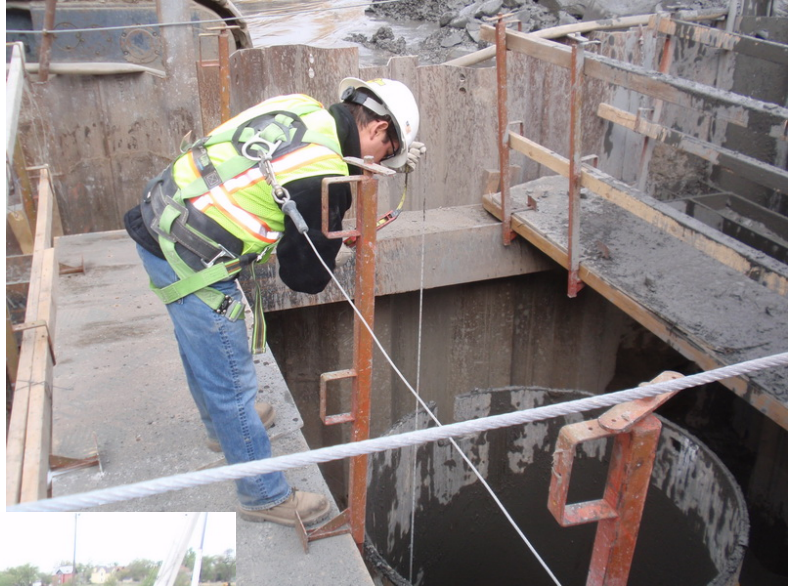
Figure 6 – EB Pier 5 Drilled Shaft Construction – May 13, 2010:

A geotechnical engineer drops a tape down the right drilled shaft at EB Pier 5 to determine if the drillers have reached the required shaft tip elevation.

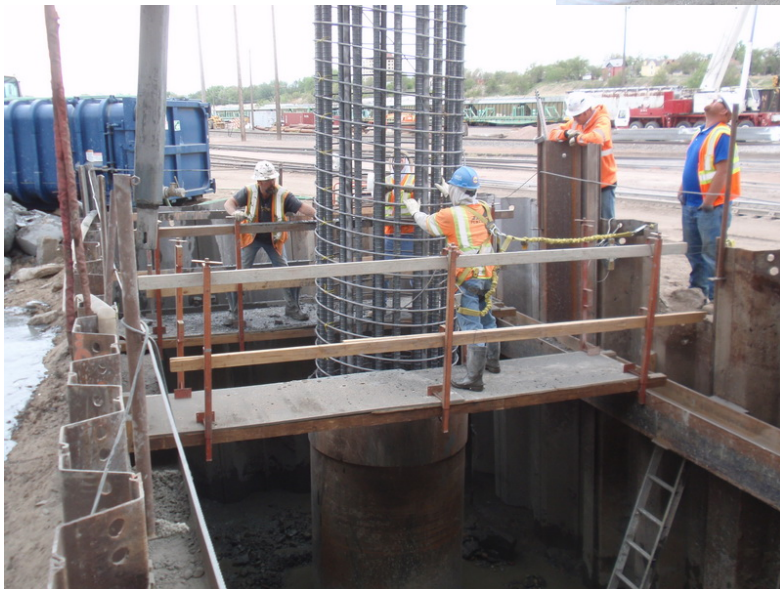
Figure 7 – EB Pier 5 Drilled Shaft Construction – May 13, 2010:

Immediately following completion of drilling and acceptance of the condition of the hole by the geotechnical engineer, crews lower the reinforcing cage into the hole for the right shaft at EB Pier 5. The temporary casing can be seen extending above the seal slab at the bottom of the excavation.

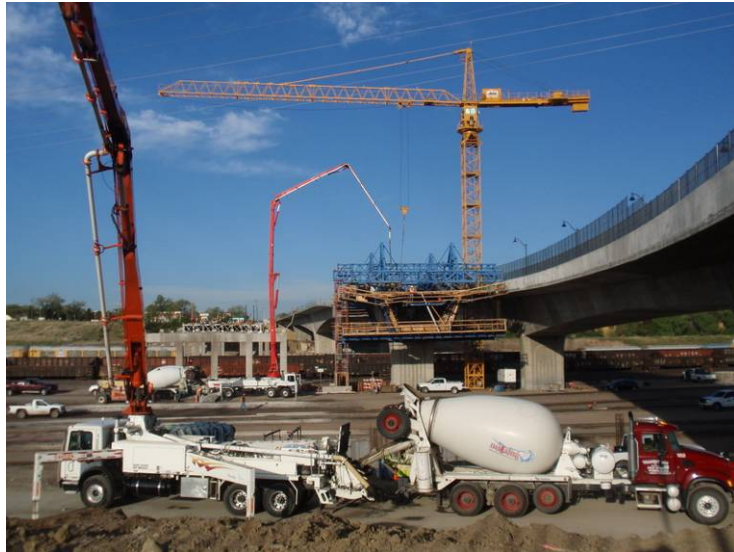
Figure 9 – EB Bridge Construction – May 21, 2010:

A view of the project from EB Abutment 6 looking west shows concrete placement for Segment E4-1E and the EB Abutment 6 beam seat occurring simultaneously. Girders from the existing bridge have been removed from all spans except Spans 6 and 7 on the West end of the project.
