**4TH STREET BRIDGE CONSTRUCTION
WETLAND FINDINGS
FINAL REPORT**

August 2006

**Colorado Department of Transportation-Region 2
905 Erie Avenue
Pueblo, CO 81002**

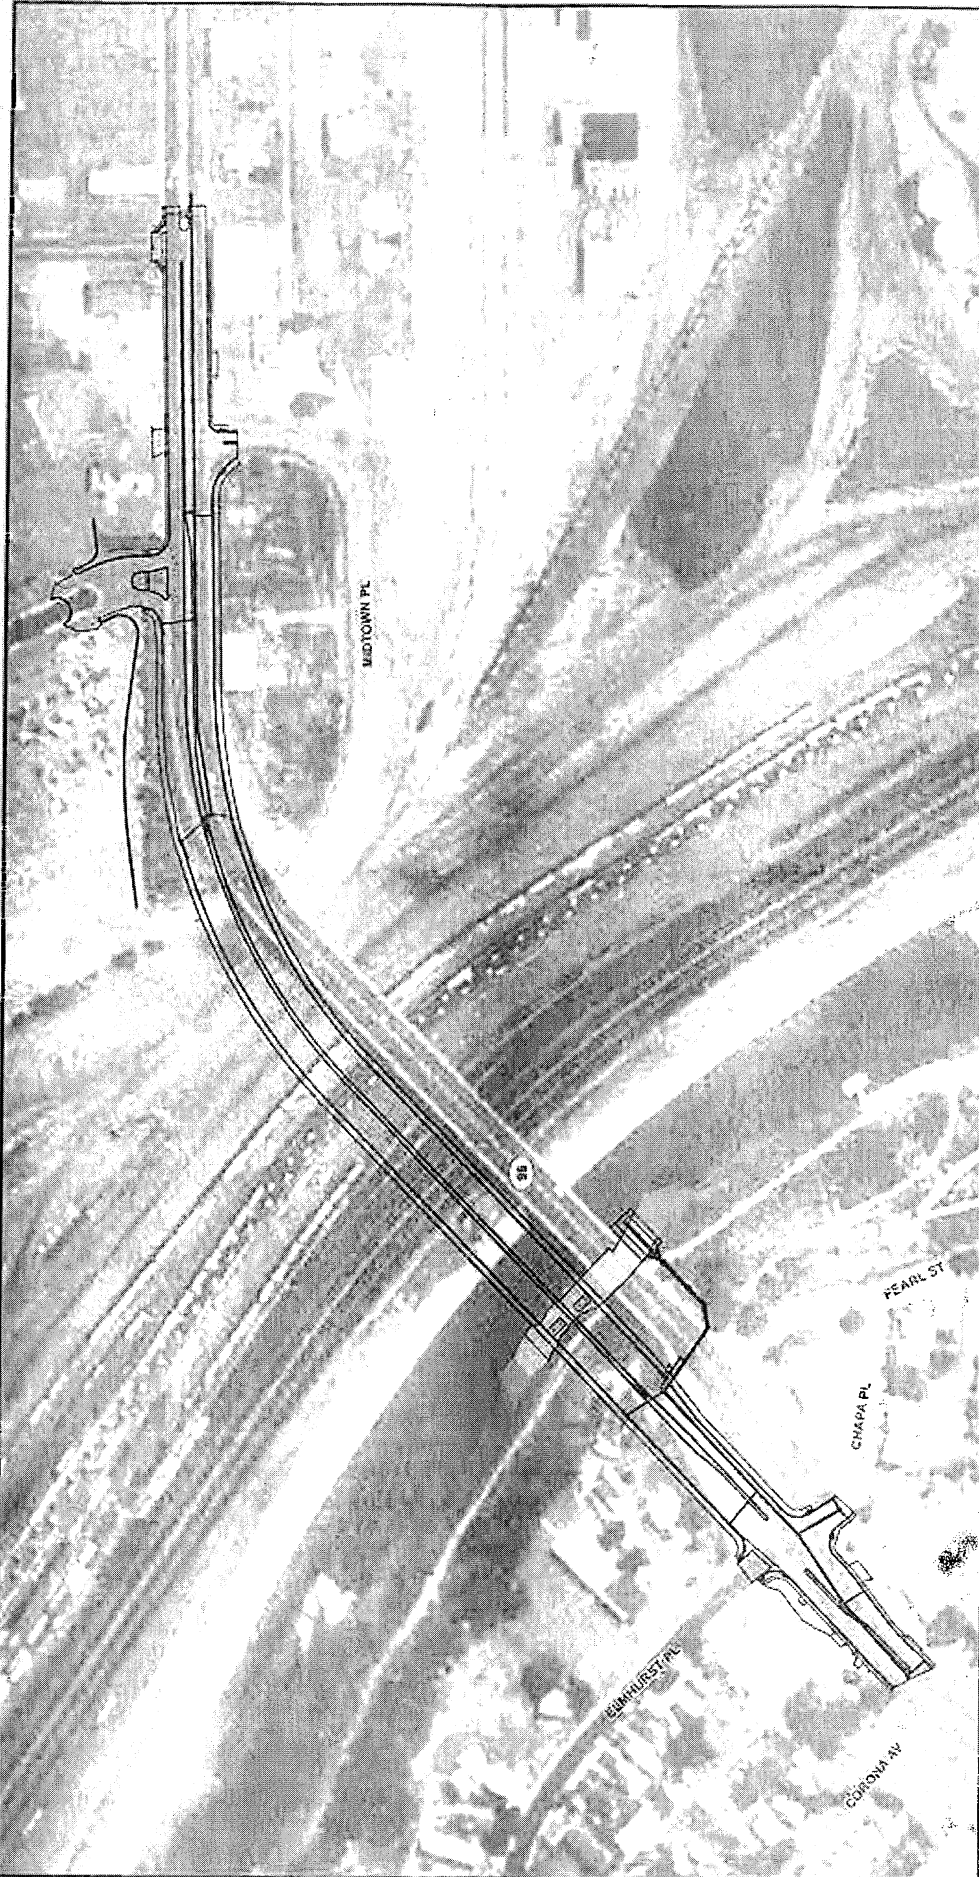
4691 17th Blvd, Ste 710
 Denver, CO 80202
 Phone: (303) 221-1774 Fax: (303) 221-7276
Figure 2
4th Street Bridge
 City of Pueblo, Pueblo County
 Wetland Map
 Prepared for:
 Job no.: 246683.04 Scale: 1:12000
 Prepared by: PESS/JJK Date: March 1, 2008
 File: wetlands.mxd

Wetland Impacts
 No Impacts
 Permanent Impact
 Temporary Impact
Alignment
 Alignment

Category	Acres
No Impacts	0.225
Permanent Impact	0.053
Temporary Impact	0.312
Totals	0.590

A wetland delineation was conducted by PBS&J field ecologists on December 29, 2005. One wetland (Wetland A) was identified within the project area during the delineation and field assessment (see Figure 2). Representative photographs of the wetland can be found in Appendix A, and USACE Routine Wetland Delineation Data Forms are located in Appendix B.

Wetland A is an emergent wetland, mapped in the field with a GPS handheld unit as 0.54 acre, on the south bank of the Arkansas River within the river's flood plain. As the Arkansas River swells from increased precipitation, the area along the banks becomes inundated. This repeated inundation has created hydric soils. Inundated conditions and hydric soils have provided an environment conducive for the establishment of hydric vegetation. Over time these elements have formed a palustrine emergent wetland that is temporarily flooded throughout the year.

The total amount of wetlands that would be adversely impacted during construction of the new 4th Street bridge at the Arkansas River is approximately 0.315 acre. Of this amount, approximately 0.312 acre would be temporary impacts, which would occur to the areas to be utilized as access and work areas for construction of the new structure, destruction of the existing structure, and construction of a drainage channel. Approximately 0.003 acre would be permanently impacted. Permanent impacts are attributed to areas in which two new bridge piers will be placed.

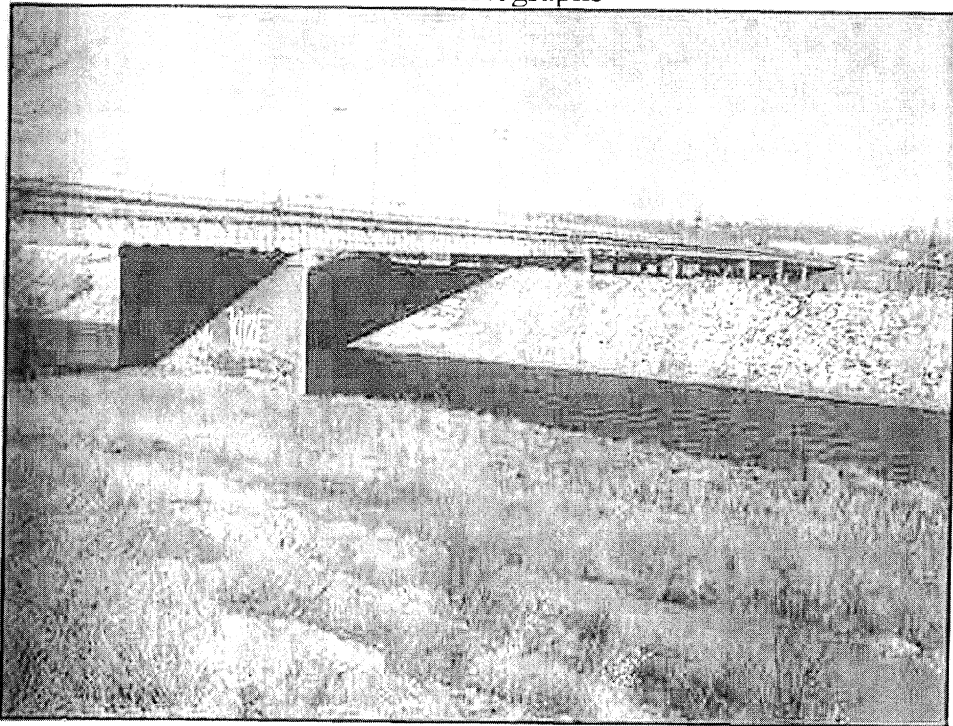
Photograph 1: Overview of project area facing northeast

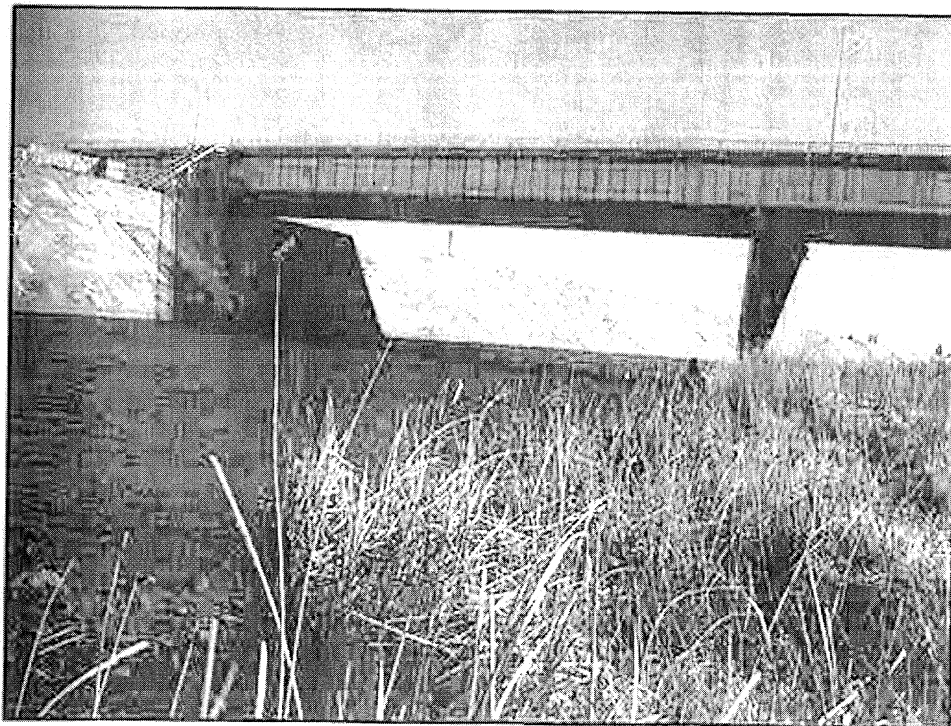
Photograph 2: Overview of proposed construction site facing east.

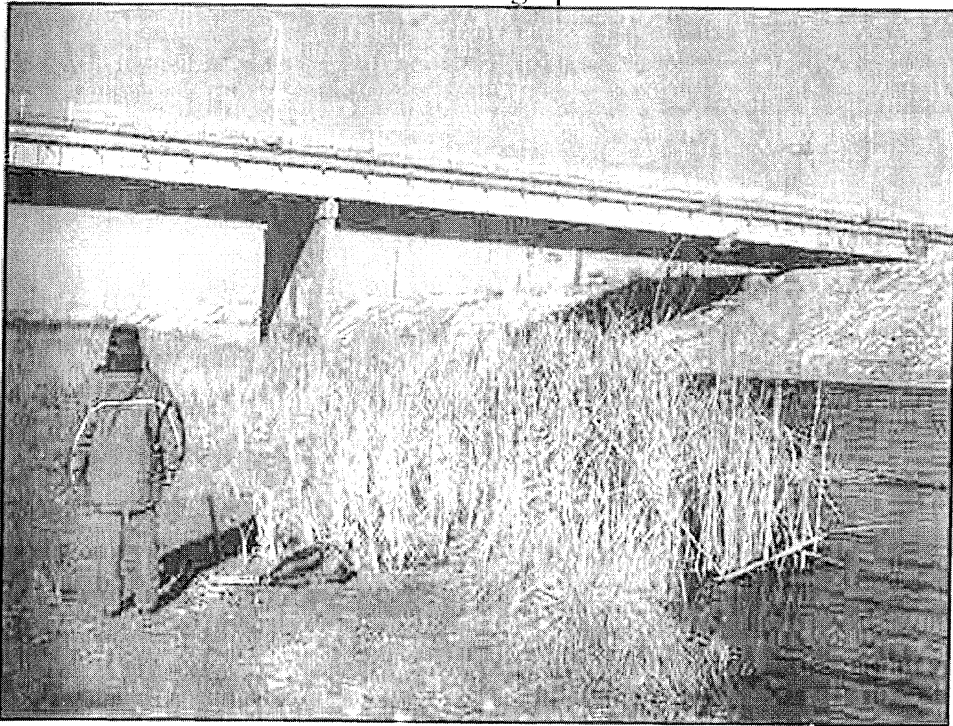
Photograph 3: View of emergent vegetation in Wetland A (DP-1) facing west.

Project/Site: 4 th Street Bridge Applicant/Owner: Colorado Department of Transportation, Region 3 Investigator(s): Francesca Licionne & Nicolle Esquivel (PBS&J)	Date: 12/29/05 County: Pueblo State: Colorado
Do Normal Circumstances exist on the site? <input checked="" type="checkbox"/> YES <input type="checkbox"/> NO Is the site significantly disturbed (Atypical Situation)? <input type="checkbox"/> YES <input checked="" type="checkbox"/> NO Is the area a potential Problem Area? <input type="checkbox"/> YES <input checked="" type="checkbox"/> NO (If needed, explain on reverse.)	Community ID: PEM Wetland Transect ID: Plot ID: DP-1

Dominant Plant Species	Stratum	Indicator	Dominant Plant Species	Stratum	Indicator
<i>Typha latifolia</i>	Herb	OBL			
<i>Phalaris arundinacea</i>	Herb	FACW+			
<i>Phragmites australis</i>	Herb	FACW			
<i>Lolium arundinaceum</i>	Herb	FACU			
Percentage of Dominant Species that are OBL, FACW, or FAC (excluding FAC-): 3/4=75% Remarks: This data point contains a dominance of hydrophytic vegetation; therefore, the hydrophytic vegetation criterion is met.

Field Observations: Depth of Surface Water: <u>None</u> Depth to Free Water in Pit: <u>None</u> Depth to Saturated Soil: <u>At Surface</u>	Remarks: One primary and one secondary indicator of wetland hydrology were observed at this data point; therefore, the wetland hydrology criterion is met.

<input checked="" type="checkbox"/> Gleyed or Low-Chroma Colors		<input type="checkbox"/> Listed on National Hydric Soils List			
		<input type="checkbox"/> Other (Explain in Remarks)			
Remarks: The soil at this data point is highly disturbed with gravel throughout the matrix. The soil matrix at this data point exhibits a low chroma indicative of hydric conditions; therefore, the hydric soil criterion is met.

Hydrophytic Vegetation Present? <input checked="" type="checkbox"/> YES <input type="checkbox"/> NO	Is the Sampling Point within a Wetland? <input checked="" type="checkbox"/> YES <input type="checkbox"/> NO
Wetland Hydrology Present? <input checked="" type="checkbox"/> YES <input type="checkbox"/> NO	Indicate size of wetland: 0.54 acre
Hydric Soils Present? <input checked="" type="checkbox"/> YES <input type="checkbox"/> NO	
Remarks: All three wetland criteria were observed at this data point. The area is identified as Wetland A.

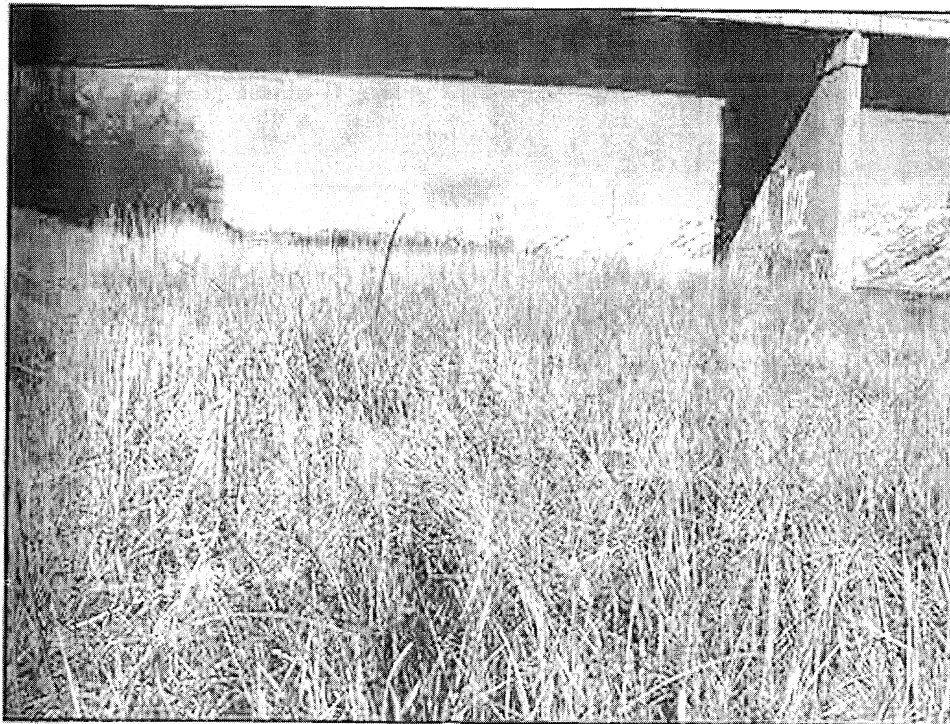
Photograph 4: Overview of Wetland A facing west.

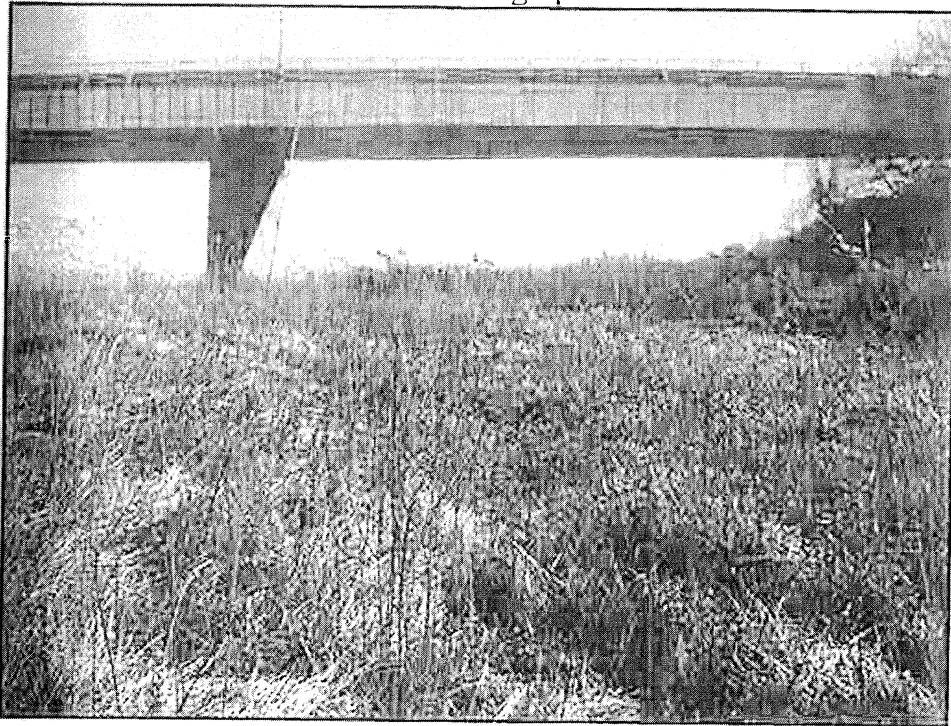
Photograph 6: Overview of Wetland A (DP-4) facing east.

Remarks: The soil matrix at this data point exhibits a low chroma indicative of hydric conditions; therefore, the hydric soil criterion is met.

Hydrophytic Vegetation Present? <input checked="" type="checkbox"/> YES <input type="checkbox"/> NO	Is the Sampling Point within a Wetland? <input checked="" type="checkbox"/> YES <input type="checkbox"/> NO Indicate size of wetland: 0.54 acre
Wetland Hydrology Present? <input checked="" type="checkbox"/> YES <input type="checkbox"/> NO	
Hydric Soils Present? <input checked="" type="checkbox"/> YES <input type="checkbox"/> NO	
Remarks: All three wetland criteria were observed at this data point. The area is identified as Wetland A.

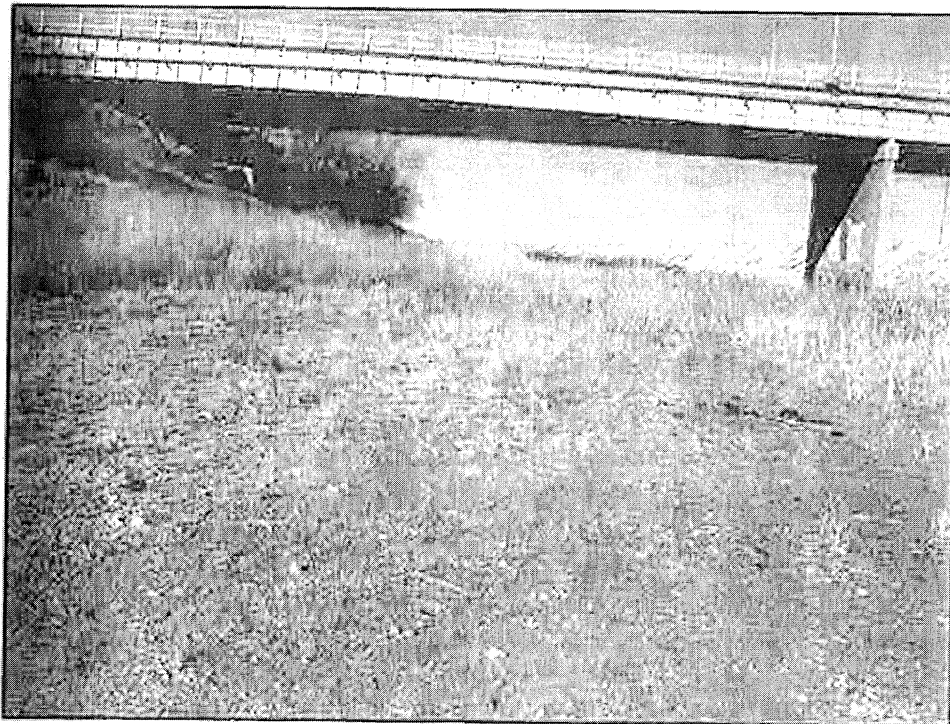
Photograph 7: View of un-vegetated area in Wetland A (DP-2) facing west.

Remarks: The soil at this data point is highly disturbed with rock and gravel throughout the matrix. The soil matrix at this data point exhibits a low chroma indicative of hydric conditions; therefore, the hydric soil criterion is met.

Hydrophytic Vegetation Present? <input checked="" type="checkbox"/> YES <input type="checkbox"/> NO	Is the Sampling Point within a Wetland? <input checked="" type="checkbox"/> YES <input type="checkbox"/> NO Indicate size of wetland: 0.54 acre
Wetland Hydrology Present? <input checked="" type="checkbox"/> YES <input type="checkbox"/> NO	
Hydric Soils Present? <input checked="" type="checkbox"/> YES <input type="checkbox"/> NO	
Remarks: All three wetland criteria were observed at this data point. The area is identified as Wetland A.
