APPENDIX A

Agency Correspondence

*For the C-470 Corridor
Revised Environmental Assessment*

July 2015

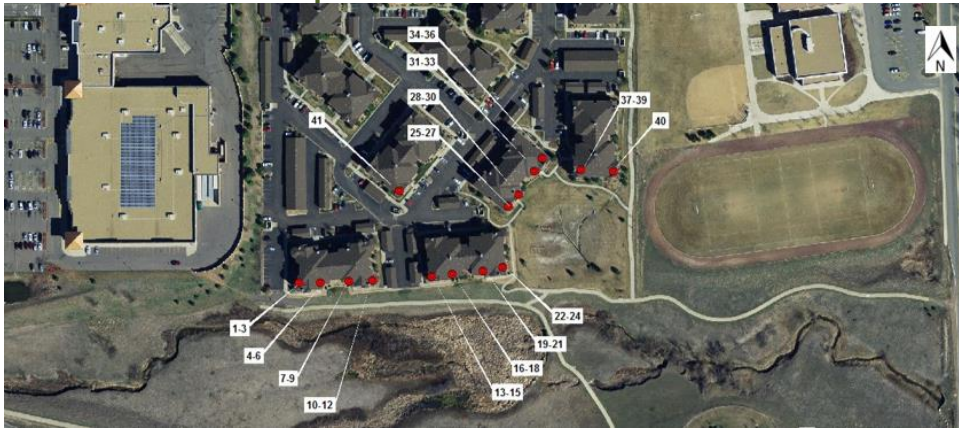
Redstone Ranch Receptor Locations

Note: Impacted receptors are shaded green

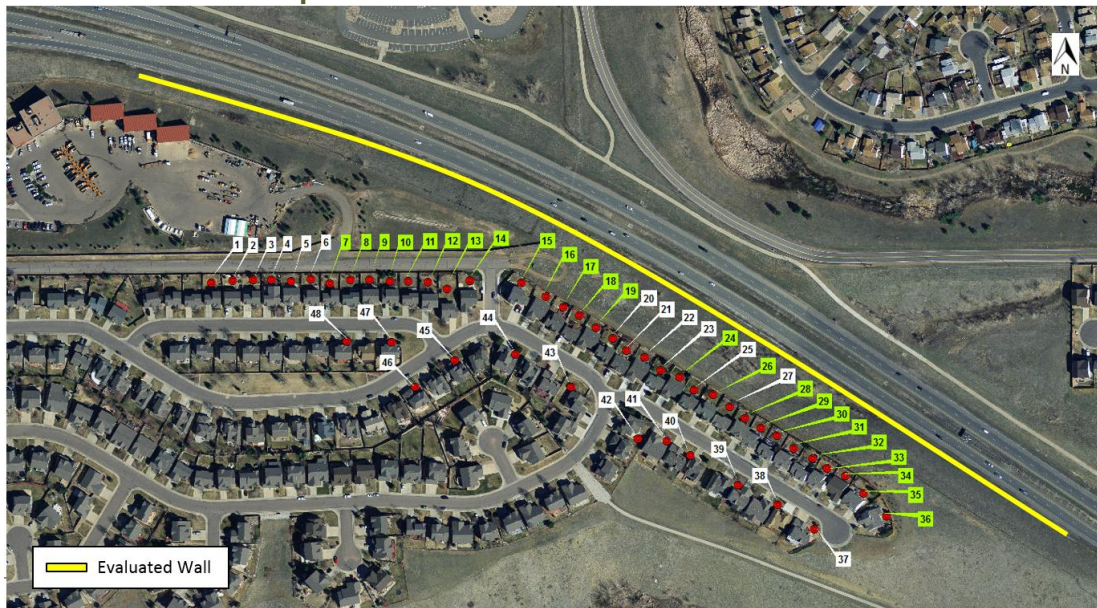
Chatfield Bluffs Receptor Location

Note: Impacted receptors are shaded green

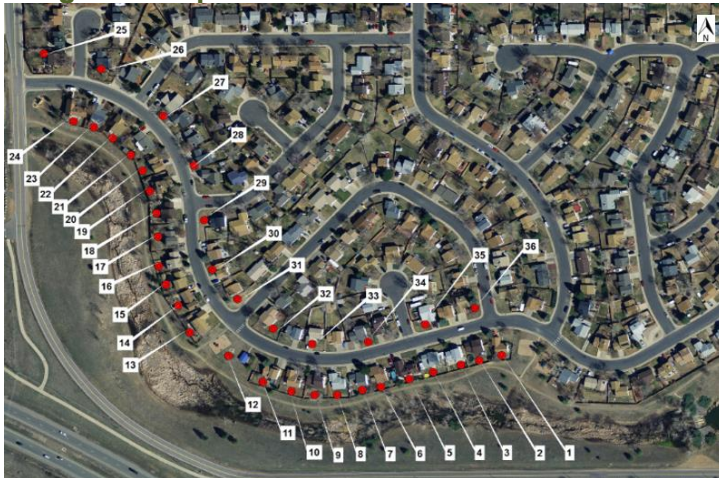
Wingate Receptor Locations

Note: Impacted receptors are shaded green

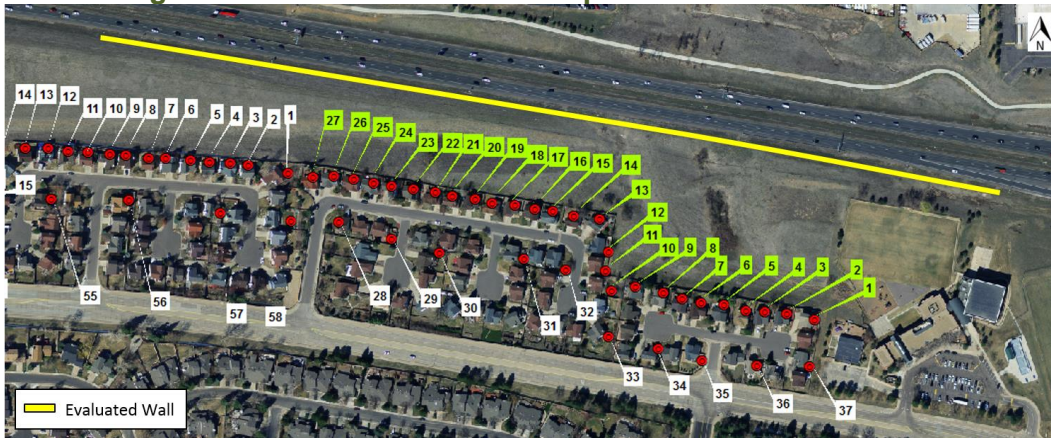
Eastern Highlands Ranch Dad Clark Receptor Locations

Note: Impacted receptors are shaded green

Twenty-seven receptors equal or exceed CDOT impact criteria for residential and thus per CDOT policy are considered impacted. The optimal wall, providing the greatest noise reduction for impacted receptors per square foot of wall, is 1,900 feet long and averaging 18.5 feet tall. The Benefit Cost Index for this wall location within CDOT ROW is calculated as:

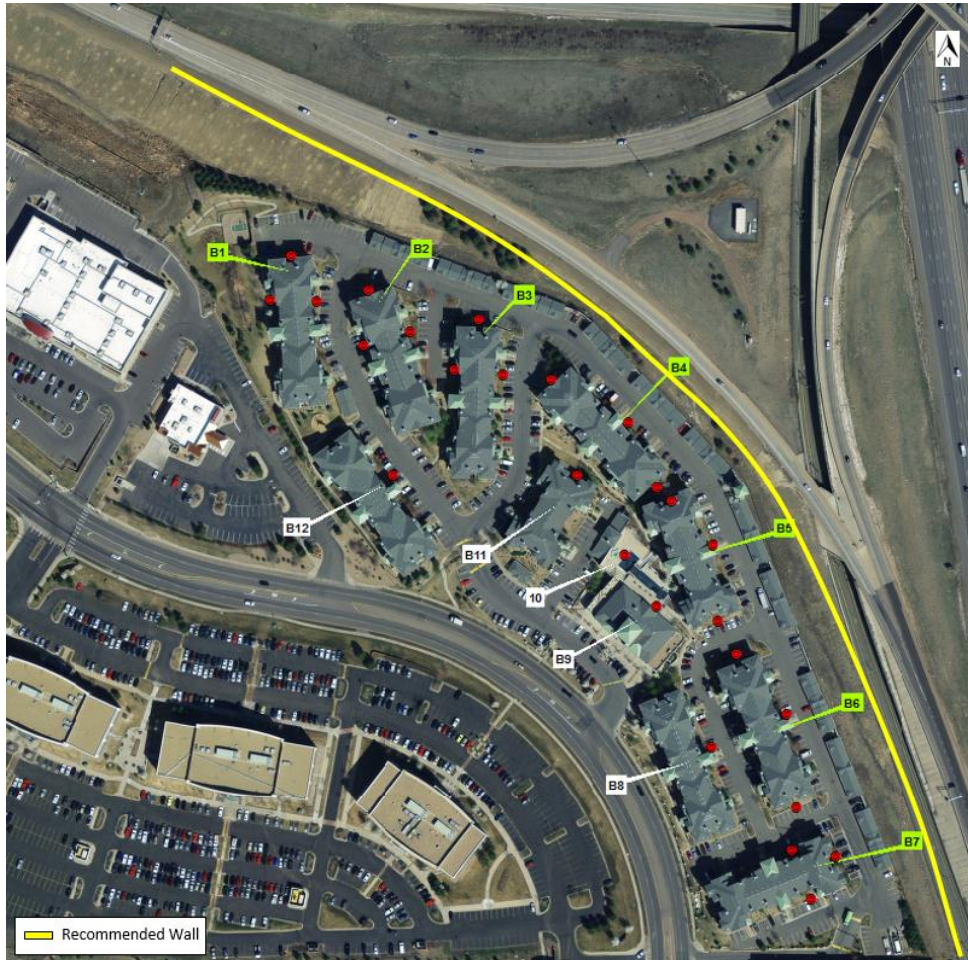
Crest Receptor Locations (each site has multiple levels)

Note: Impacted receptors are shaded green

Seventy-six receptors equal or exceed CDOT impact criteria for residential, primarily on the upper floors, and thus per CDOT policy are considered impacted. The optimal wall, providing the greatest noise reduction for impacted receptors per square foot of wall, was roughly 2,300 feet long and 18.2 feet tall. The Benefit Cost Index for this wall location within CDOT ROW is calculated as:
