US 6 over the BNSF Railway Bridge Replacement

*Replacement Structure Alternative Analysis
Existing Structure F-16-EJ
New Structure F-16-YJ*

Prepared for CDOT Region 6
Project Number: FBR 0062-026 (18202)
December 28, 2011

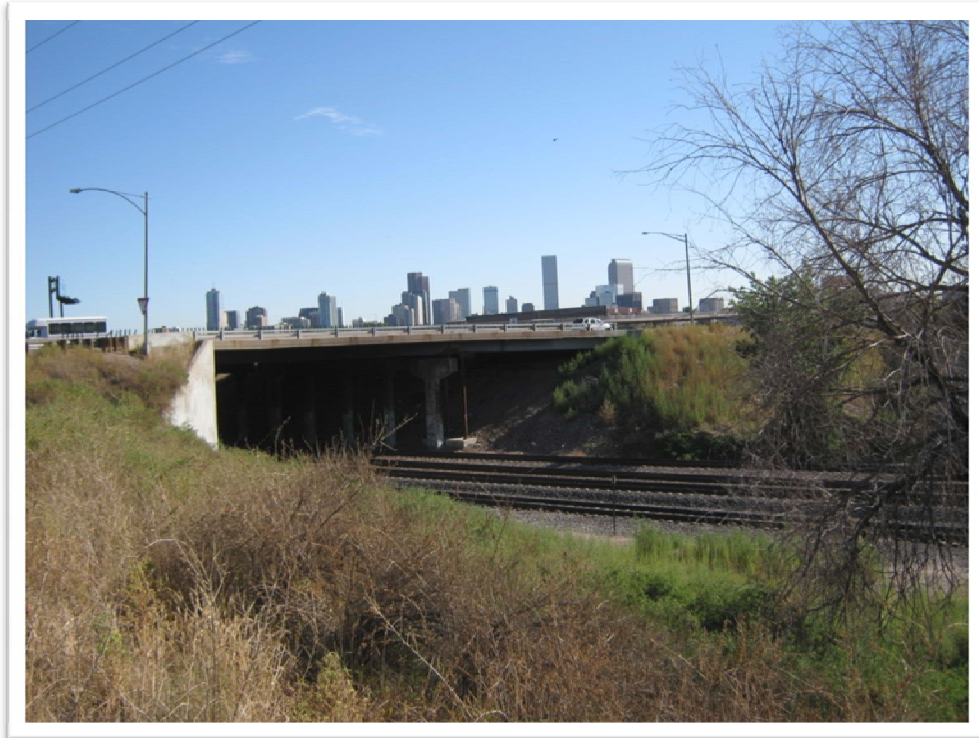
Photograph 1 – Elevation of existing bridge looking north

The existing structure F-16-EJ was originally constructed in 1956 as a set of twin structures carrying eastbound and westbound traffic over railroad lines. Subsequent widening, with additions to the interior and exterior of both bridges, created a single structure in 1967. The existing bridge is a two-span, W36 rolled steel girder with a non-composite concrete deck slab that is 130 feet long. The bridge currently carries four lanes of eastbound and four lanes of westbound traffic on US 6. See Appendix A for photographs of the existing bridge.

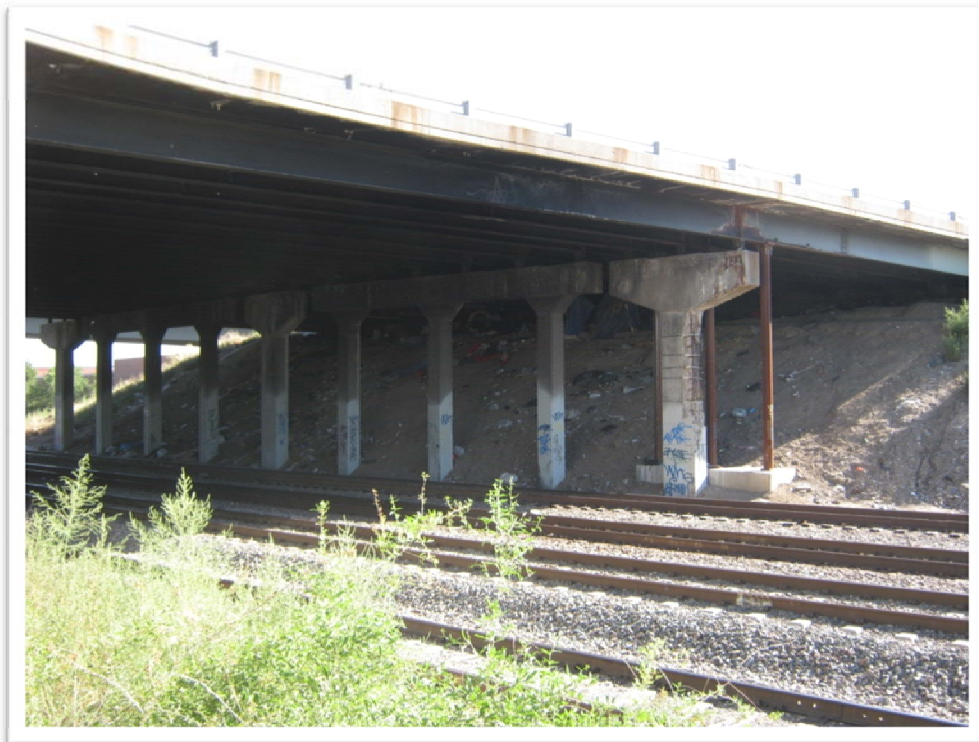
Photograph 2 – Elevation of existing pier looking east

In 2009, the bridge received a sufficiency rating of 47.8 and was categorized as Structurally Deficient. The most recent Structural Inventory and Appraisal is provided in Appendix B. A temporary repair conducted in 2008 provided additional support at the southern column of the pier which is badly deteriorated.

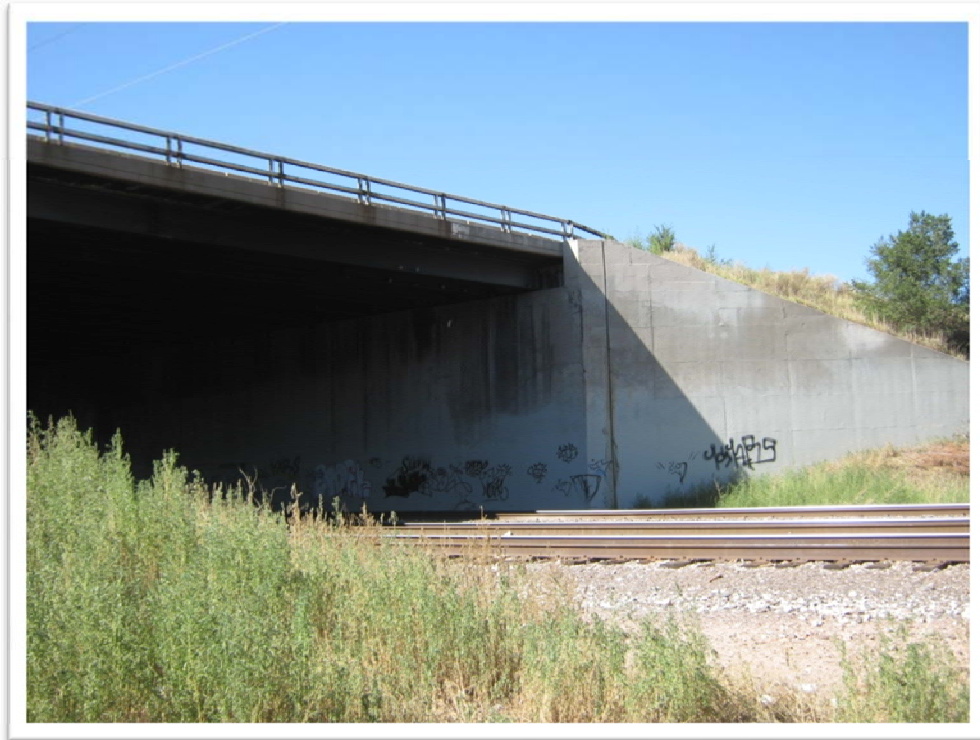
Photograph 3 – Existing abutment looking west

The west span of the bridge crosses two main line and two siding tracks of the BNSF Railway Company (BNSF). The west abutment is a tall, cantilever wall-type abutment on a spread footing while the east abutment is short, seat-type abutment founded on a combination of steel pipe and H-piles. The pier consists of several reinforced concrete columns founded in individual spread footings with a combination of hammerhead and continuous cap beams. Both the existing west abutment and the pier are located within the BNSF's right-of-way and fail to meet the minimum clearance requirements of the railroad. The current minimum horizontal clearance is approximately 9'-6" at both the west abutment and the pier. Additionally, with a current minimum vertical clearance of 22'-2", the existing bridge also fails to meet the minimum vertical clearance requirement for railroad grade separation facilities of 23'-4".

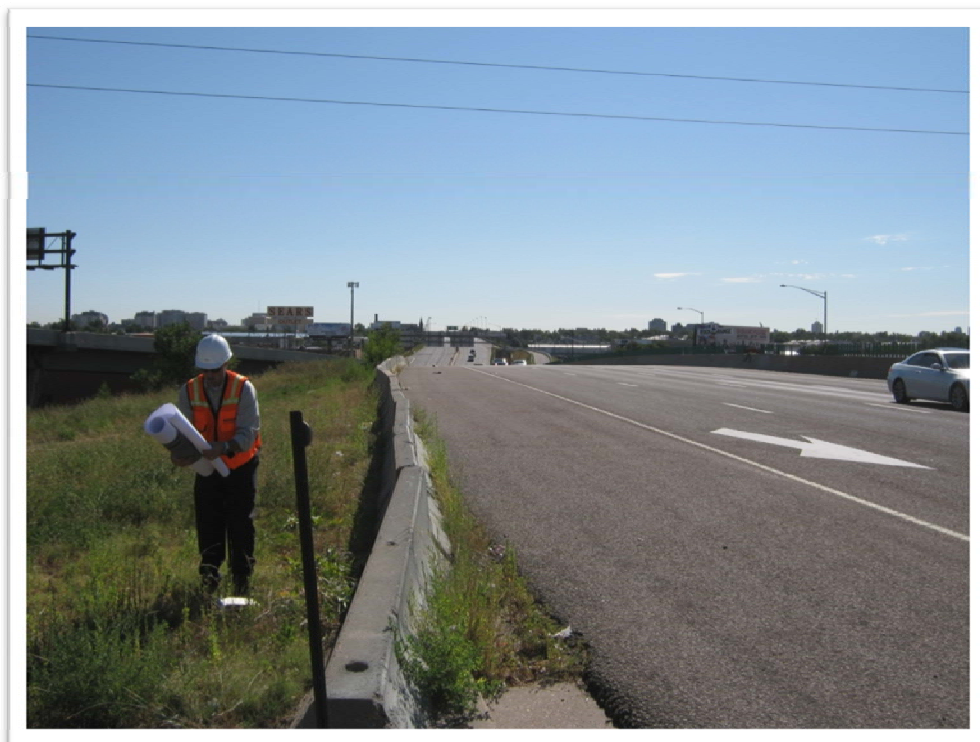
Photograph 4 – West approach looking east

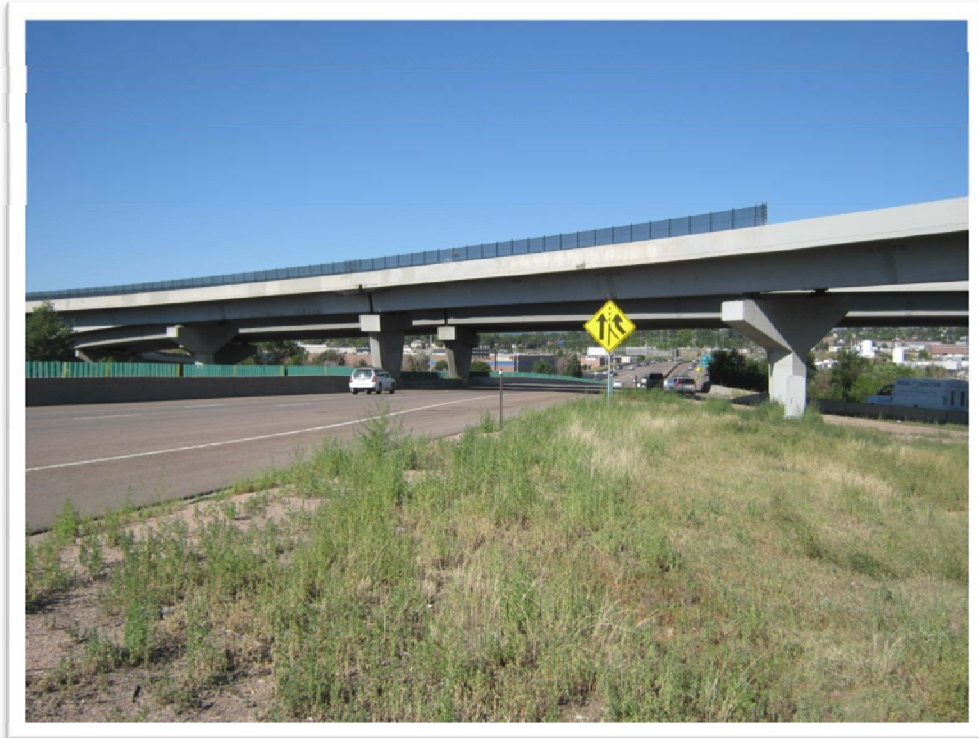
Photograph 6 – Existing US-6 under Structure F-16-OL looking west

- Located approximately 190 feet east of the existing east abutment, a gore for the westbound US 6 to eastbound I-25 ramp (Structure F-16-OL) restricts modification of the roadway profile.
- Approximately 450 feet west of the existing west abutment, a minimum under clearance of 16'-6" to Structure F-16-OL must be maintained.
- Any profile which provides adequate vertical clearance over the railroad and meets the existing constrained conditions to the east and west of the structure along US 6 will have design speeds reduce to approximately 45 mph.
