US 6 Bridges Design Build Project

Hazardous Materials Technical Report

Prepared for:
Colorado Department of Transportation
Federal Highway Administration

August 2012
Revised January 2013

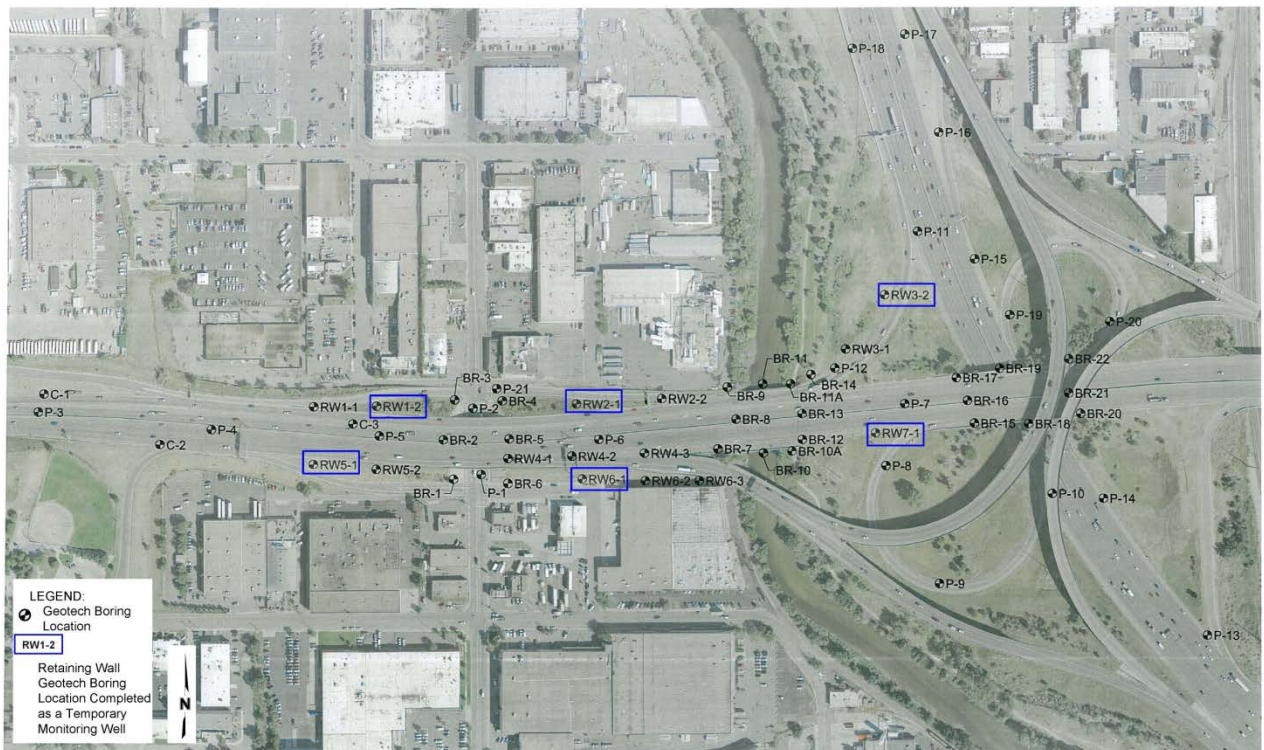
Figure 5: Subsurface Monitoring Wells December 2011/January 2012

Fluid level measurements and field parameters were measured in all six of these wells prior to sampling. Grab groundwater samples were collected from all six monitoring wells on January 4, 2012. A summary of the findings of this limited subsurface investigation is provided in Section 3.2.1.1 of this report.

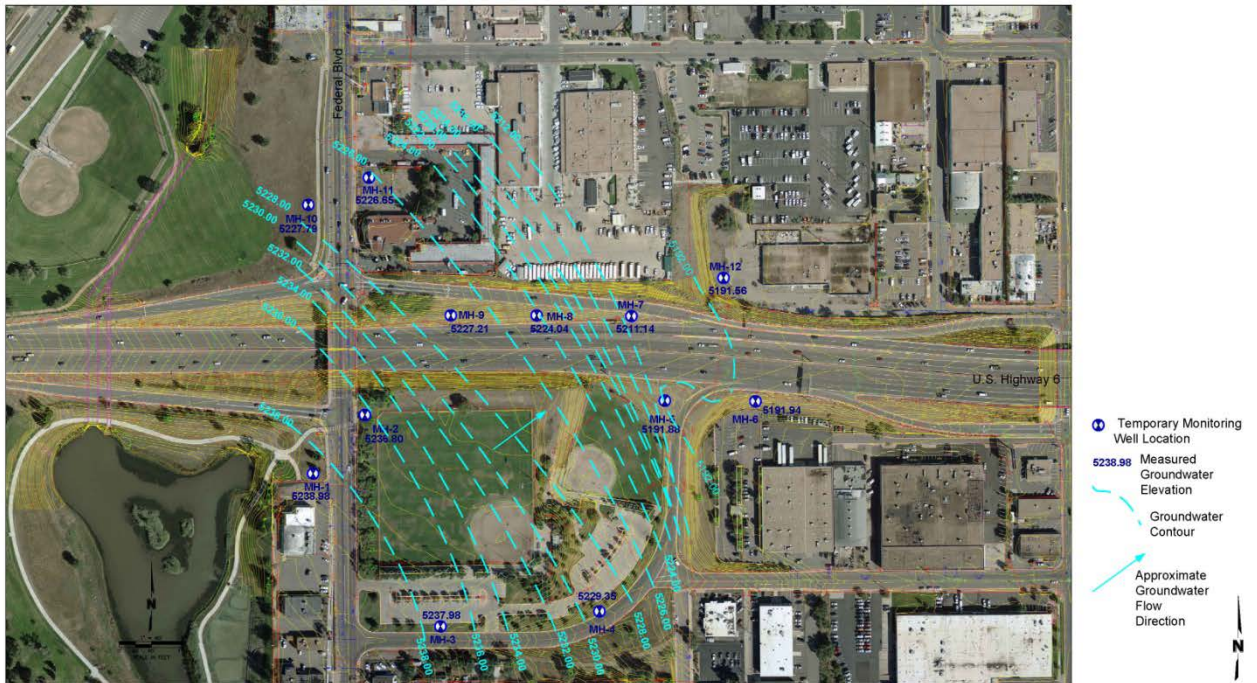
Figure 6: Subsurface Monitoring Wells June/July 2012

The collected soil and groundwater samples were submitted to a laboratory for analysis and were tested for petroleum hydrocarbon constituents benzene, toluene, ethylbenzene, and total xylenes (BTEX) by Method SW8260, total concentrations of the eight Resource Conservation and Recovery Act (RCRA) Metals by SW 6020/SW 7471A, and percent moisture by SW 3550. A summary of the findings of the limited subsurface investigation is provided in Section 3.2.1.1 of this report.

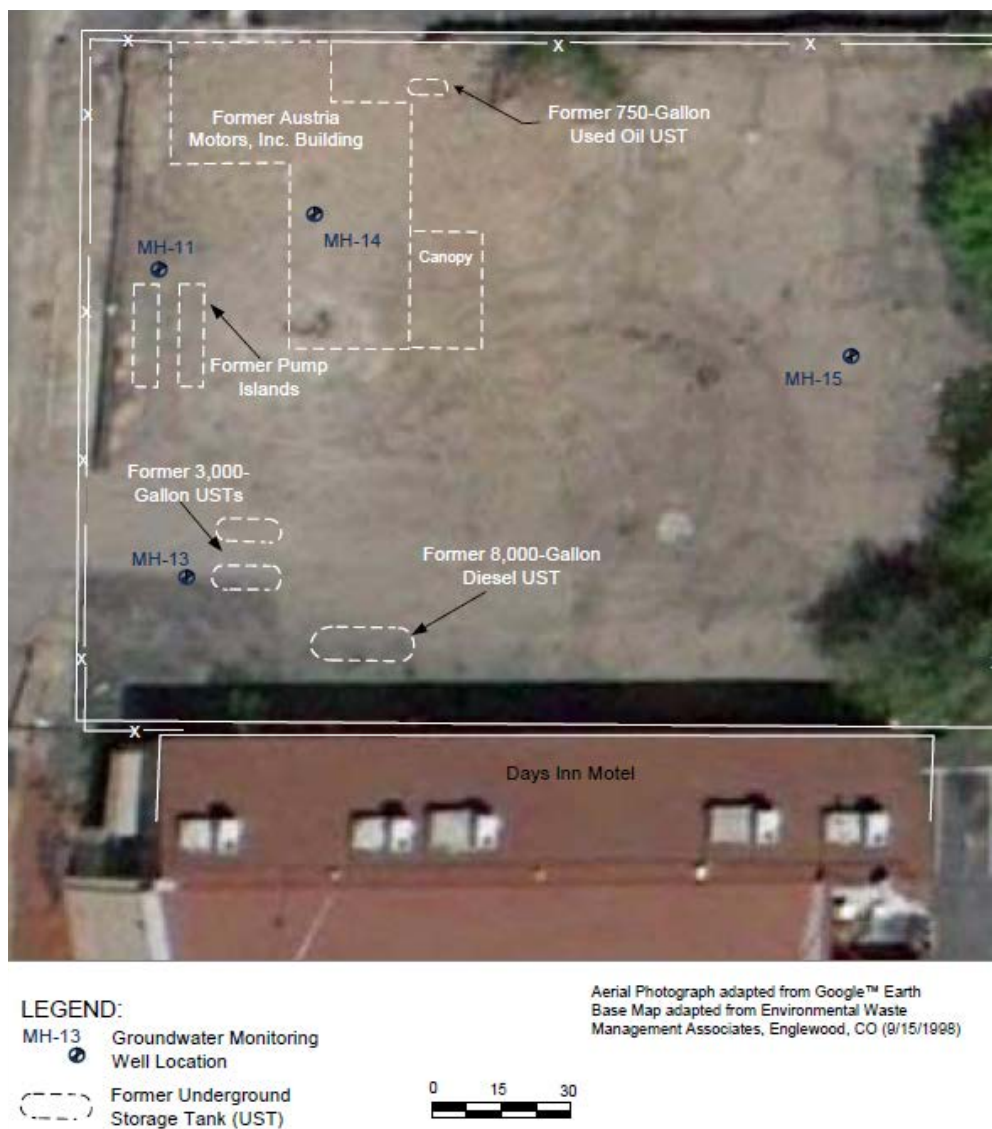
Figure 7: Monitoring Well locations at 642 Federal Boulevard

Due to concerns raised by the findings at well MH-11, an additional limited subsurface investigation was conducted on October 16, 2012 at the vacant property formerly occupied by the Austria Motors, Inc. dealership and automotive repair, located at 642 Federal Boulevard. This site was a former leaking underground storage tank (LUST) site that received closure following site investigation and remediation. A release was reported to the Colorado Department of Labor and Employment, Division of Oil and Public Safety (OPS) in October 1997 and assigned event #6193. The OPS issued a no further action (NFA) letter on July 7, 1999 following completion of the site remediation.

This limited subsurface investigation was conducted on October 16, 2012 and included the installation of three soil borings completed as temporary monitoring wells identified as MH-13, MH-14, and MH-15 as shown on Figure 7. These wells were drilled in locations suggested by CDOT to assess the nature and extent of impacted soil and groundwater discovered in temporary monitoring well MH-11 which was installed on the northwest side of the property in August 2012. The soil samples submitted for laboratory analysis were collected from the interval that exhibited staining, hydrocarbon odor, the

highest headspace PID readings, the interval at or above the water table, and from the total depth of the well boring. Olsson personnel logged the borings to record the lithologies encountered, the depth to groundwater, and observed staining or odors that suggested petroleum hydrocarbon or chemical impacts. Copies of the lithologic logs for each boring are presented in Appendix F. A summary of the findings of this limited subsurface investigation is provided in Section 3.2.1.1 of this report.

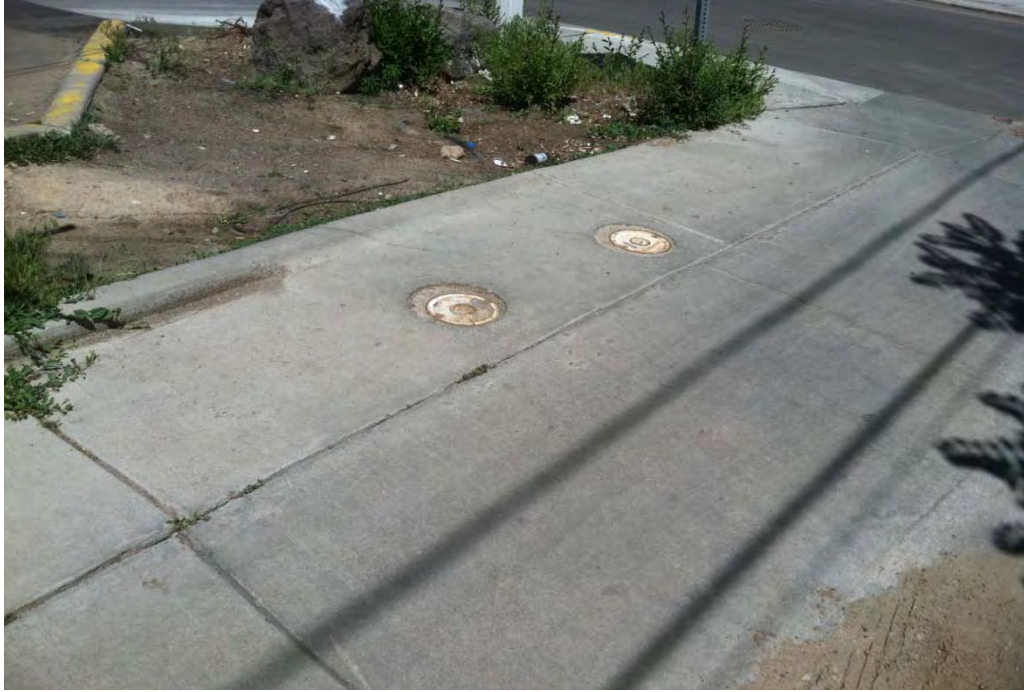
Photo 1 (438 Federal Boulevard) – View of monitoring wells located in alley behind Conoco gas station

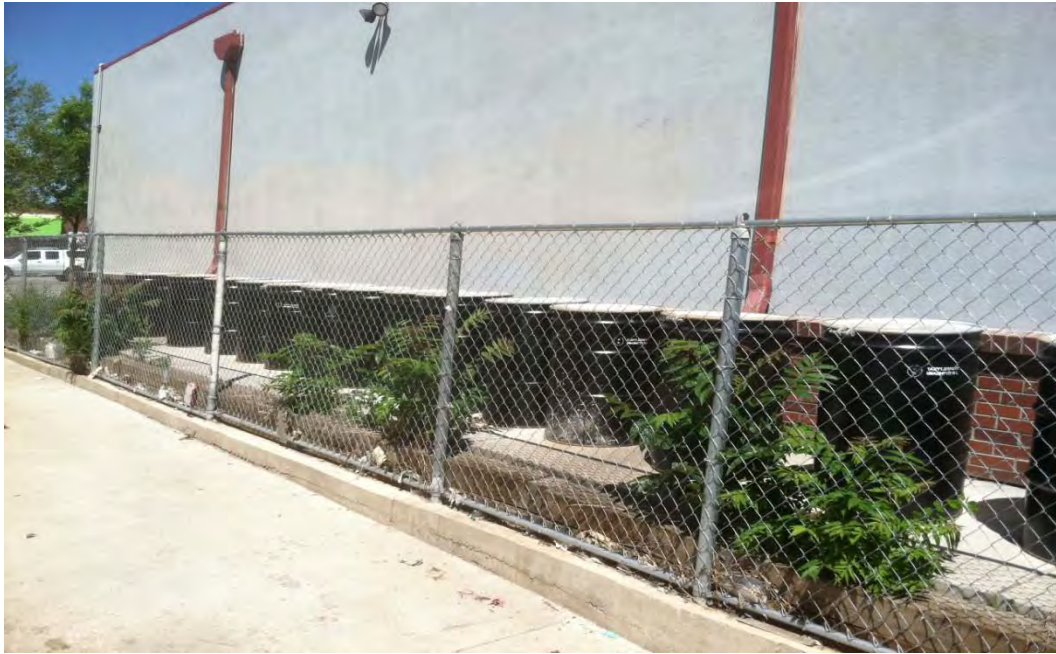
Photo 2 (438 Federal Boulevard) – View of 55-gallon drums located behind Conoco gas station building

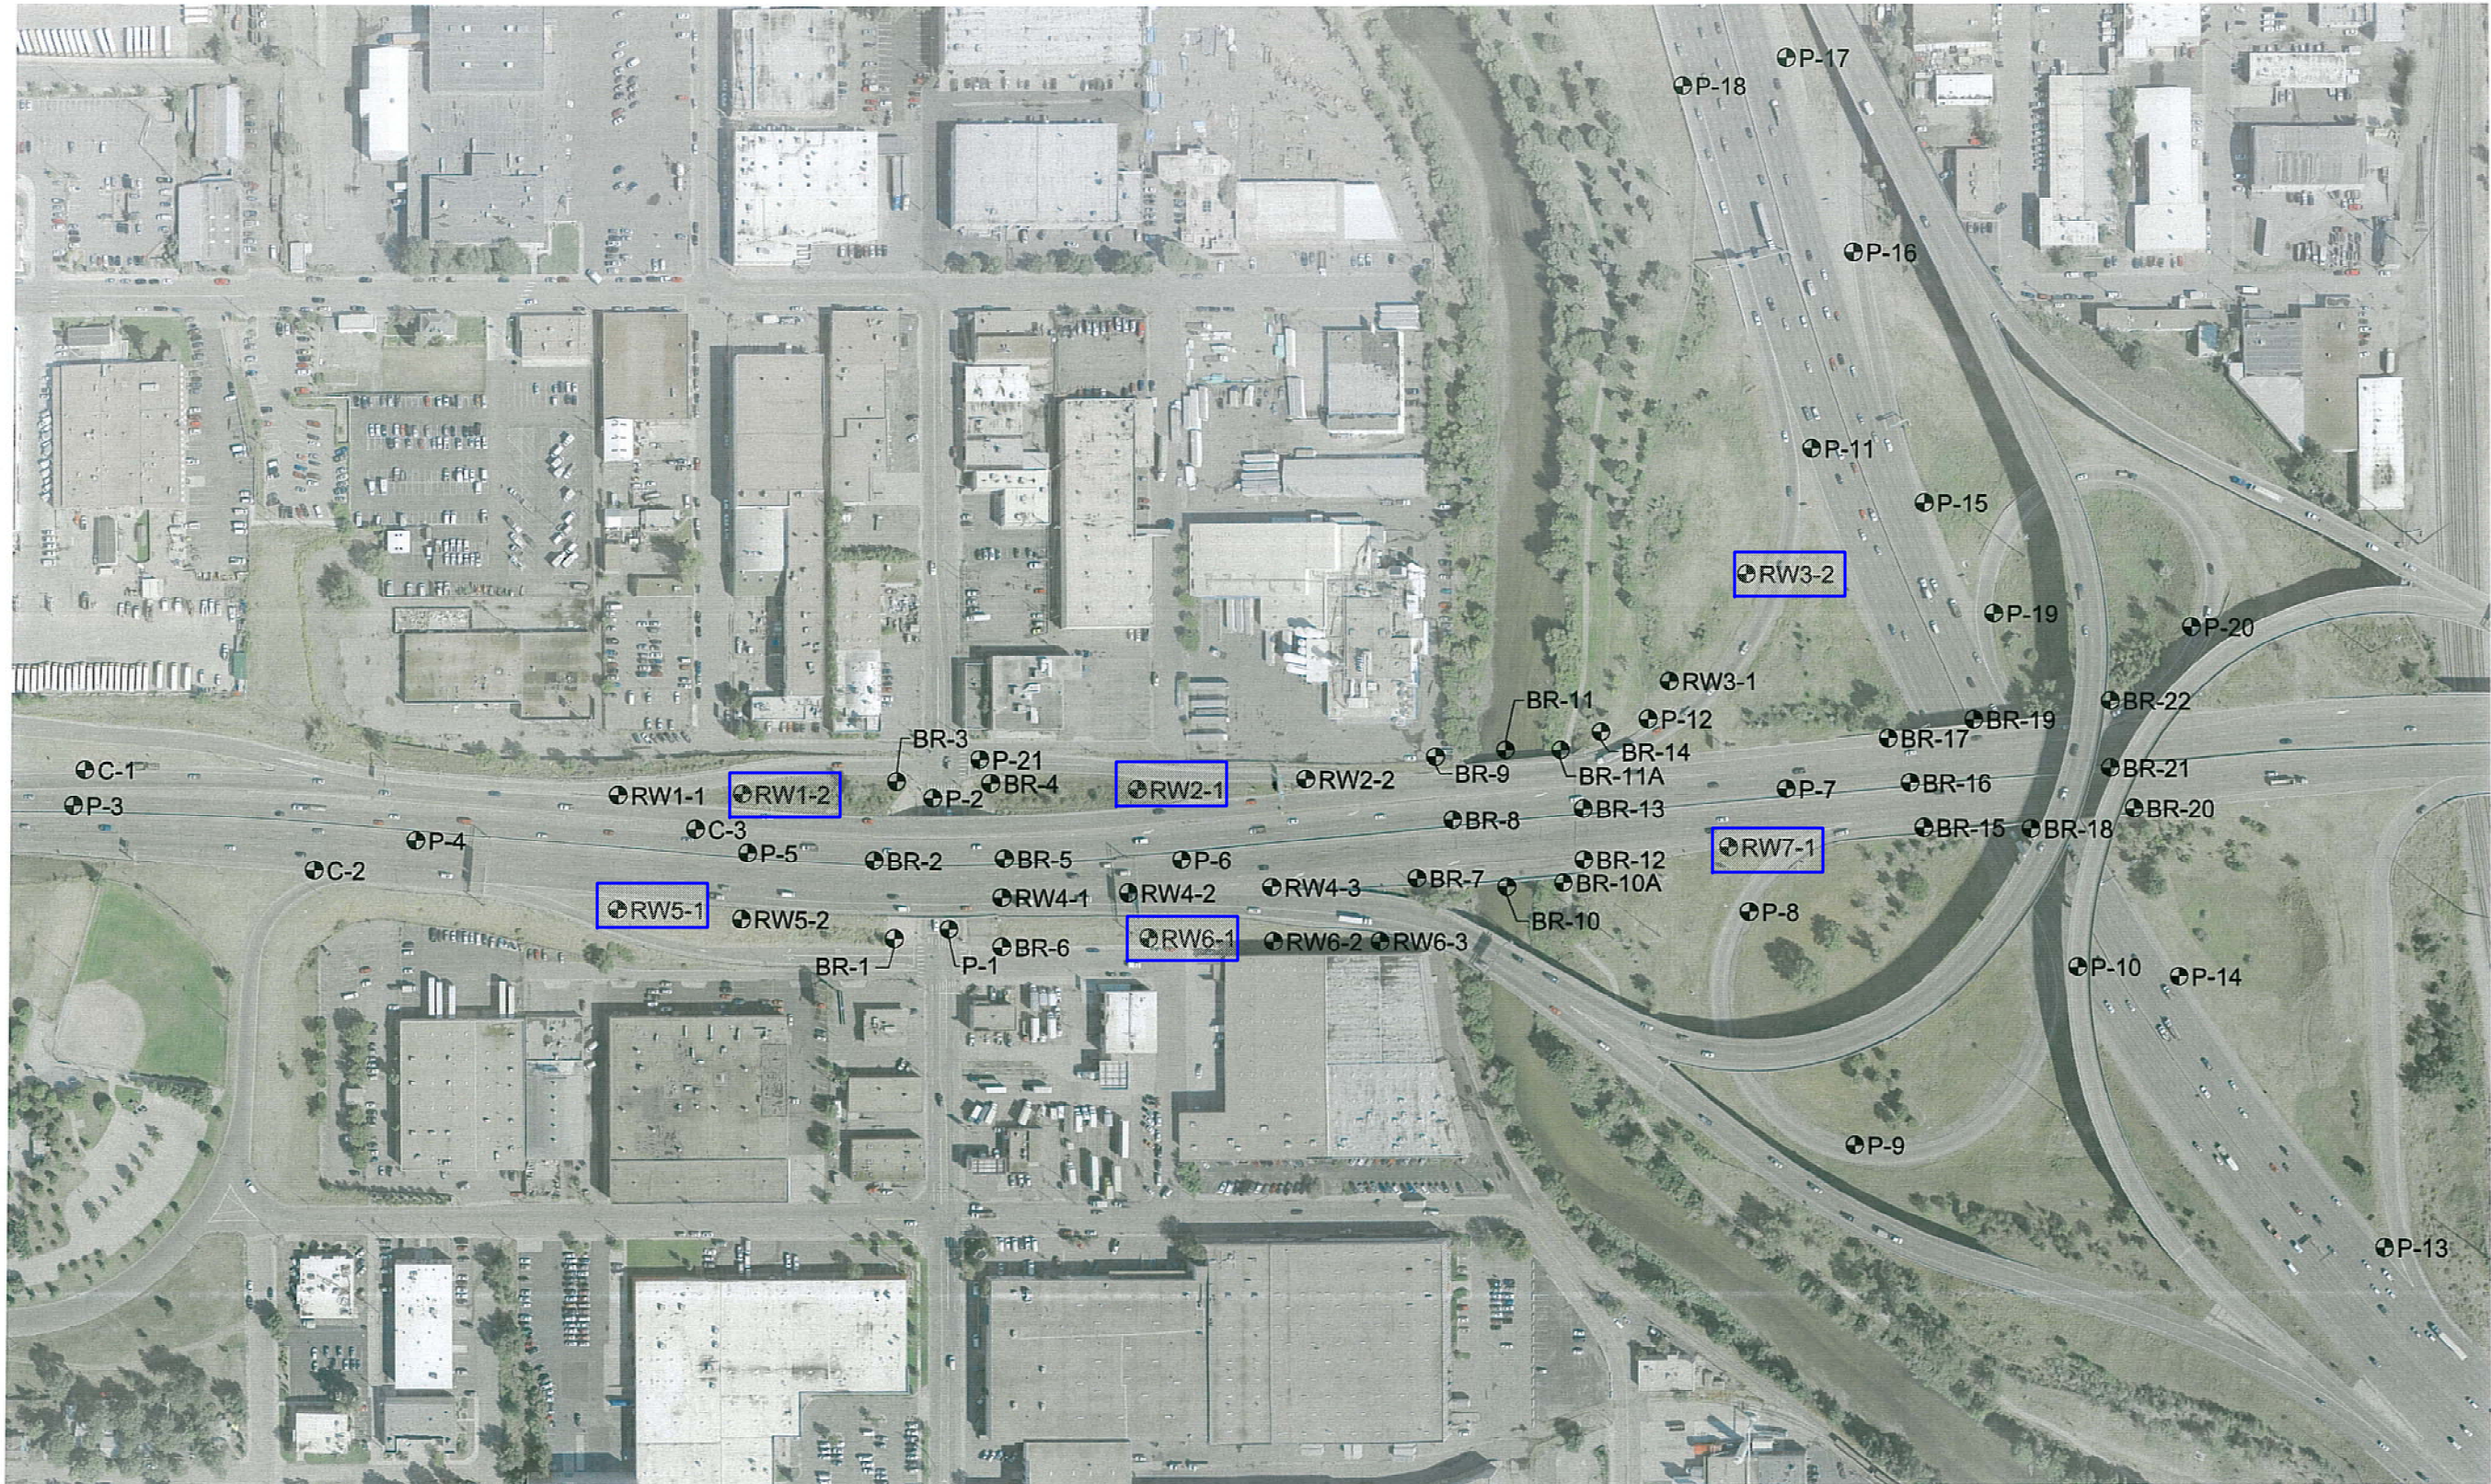
FIGURE

TEMPORARY GROUNDWATER MONITORING WELL LOCATIONS

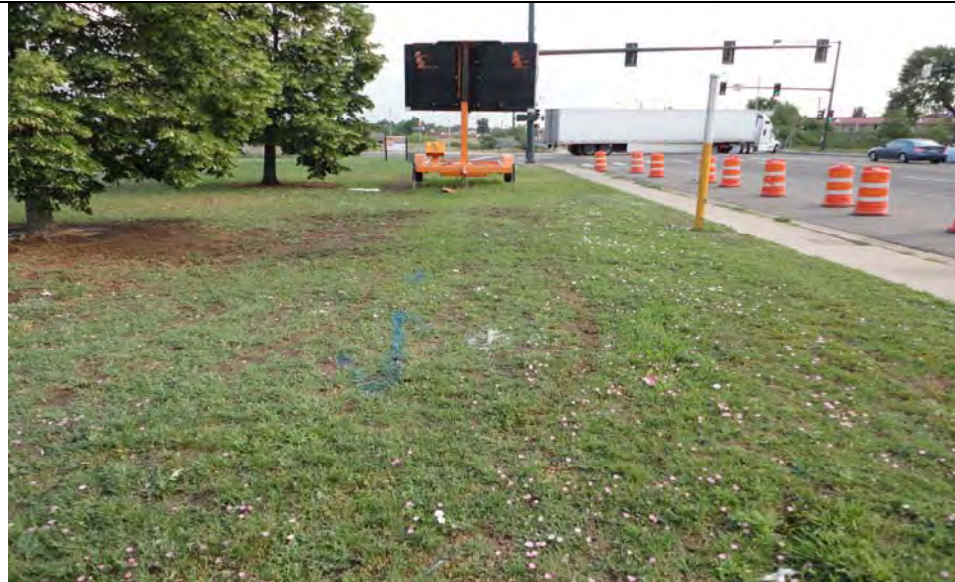
Subject: Monitoring Hole MH-1 was located in Barnum Park Southwest Corner of U.S. Highway 6 and Federal Boulevard. The proposed location (white spray paint/whisker) was near an irrigation line (blue spray paint line), so it was moved approximately another foot east.

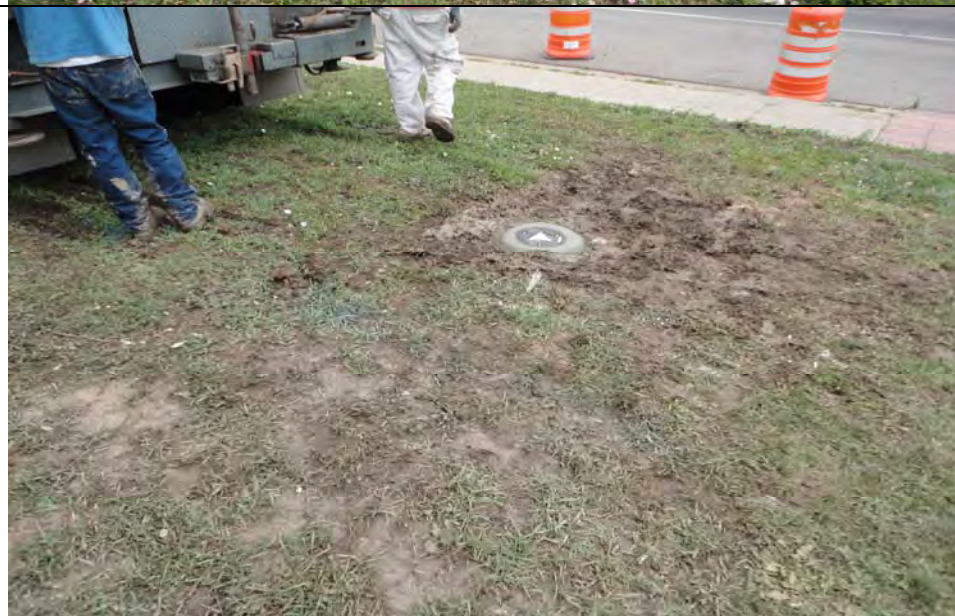
Subject: Photograph shows monitoring hole MH-1 completion. MH-1 was completed using a flush-mounted well cover grouted in place and was low enough to not interfere with mowing.

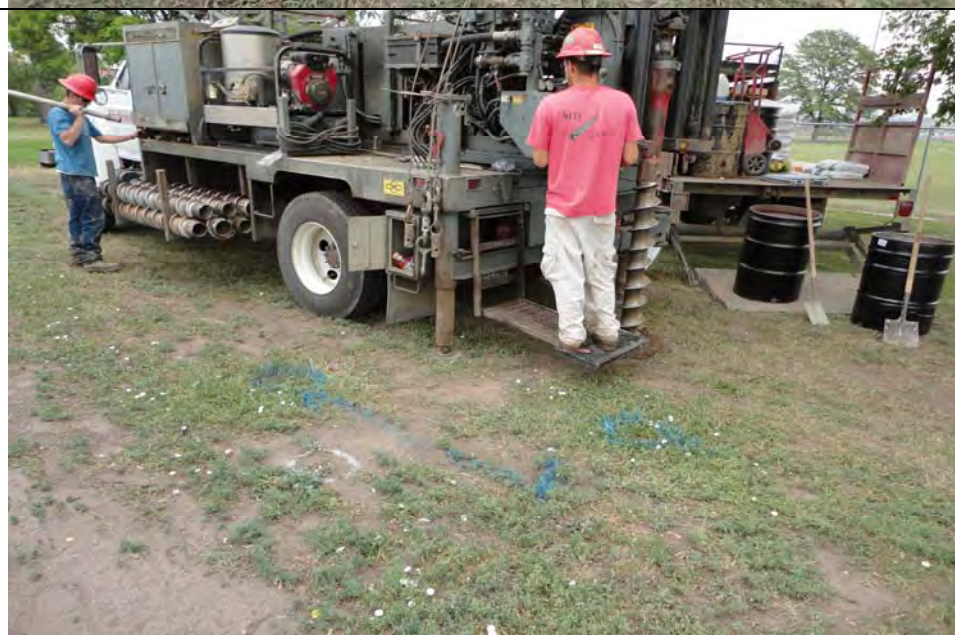
Subject: Monitoring Hole MH-2 was located in Barnum Park East on the southeast corner of U.S. Highway 6 and Federal Boulevard. Irrigation water lines (blue spray paint) were located close to the proposed MH-2 location, so it was moved approximately 8 feet to the east.

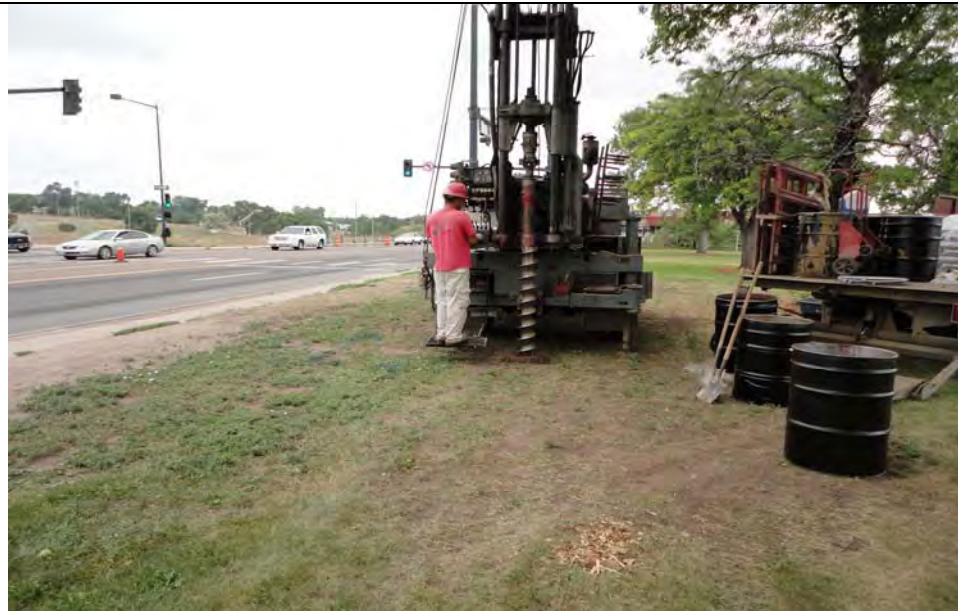
Subject: Photograph shows the location of MH-2 in Barum Park East on the west side of the baseball fields.

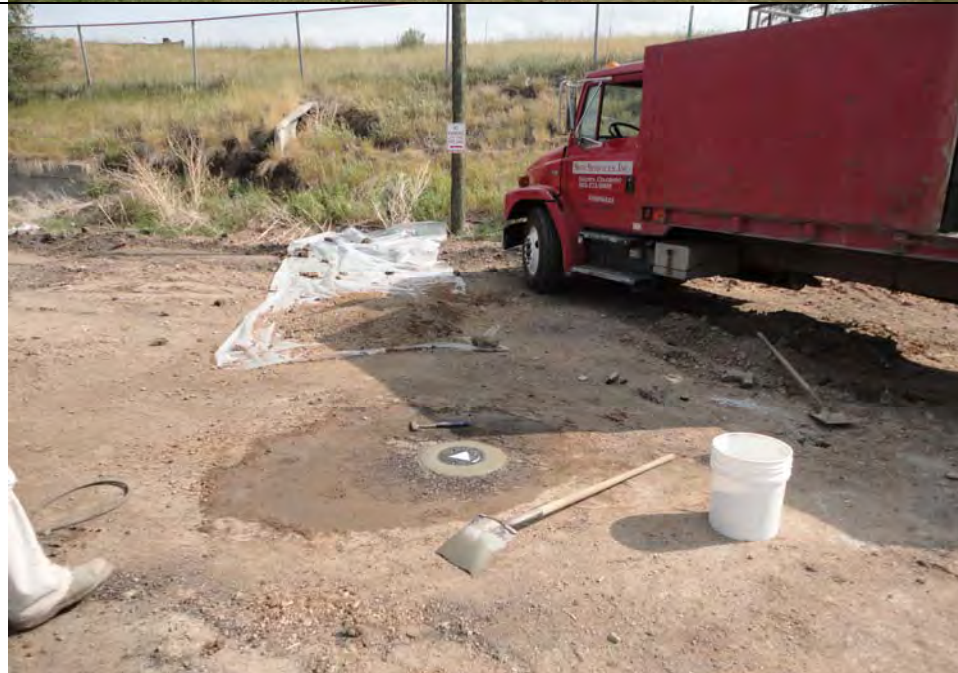
Subject: Monitoring Hole MH-12 was located on CDOT property on the north side of U.S. Highway 6 and to the east of the Denver Public Schools school bus facility. Drill cuttings were placed on plastic and were covered adjacent to the MH-12 location. All of the wells were completed with flush-mounted well covers.

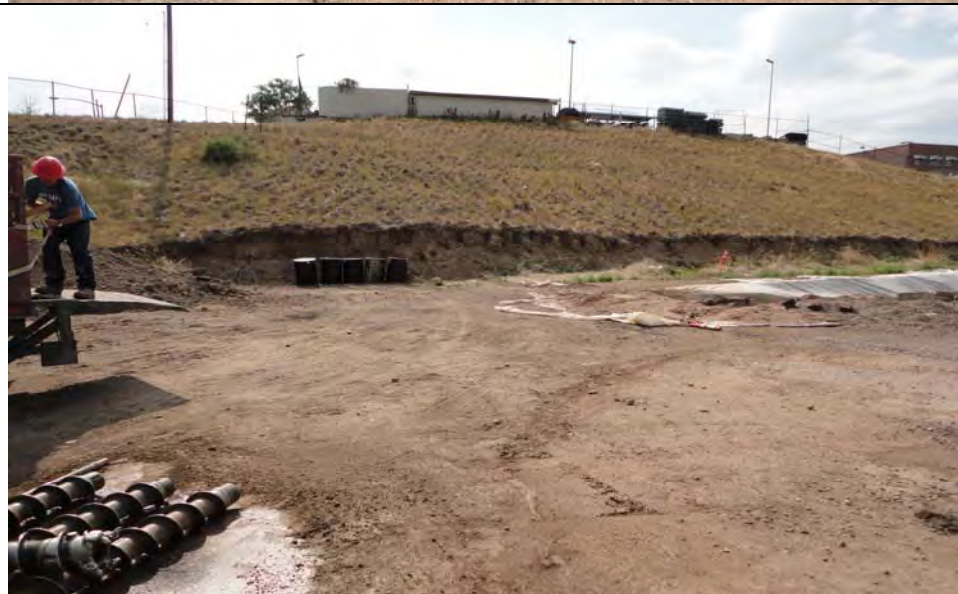
Subject: Photograph shows the location of soil drums staged near MH-12 on CDOT property and concrete wash out area. The soil cuttings were removed from the temporary wells (MH-1 through MH-4) drilled in Barnum Park. The Denver Public Schools property is shown at the top of the hill.

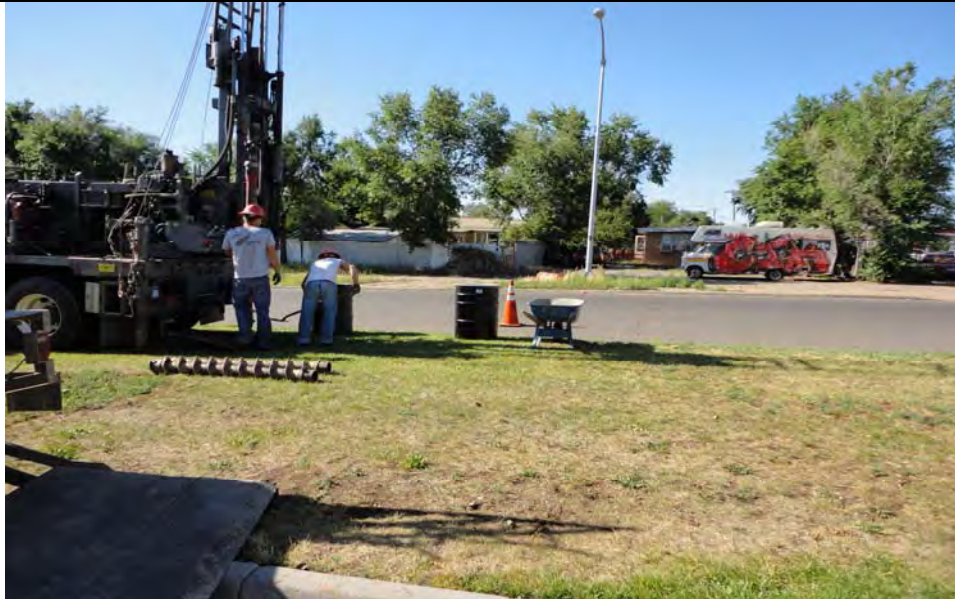
Subject: Monitoring Hole, MH-3, was located on the south side of Barnum Park East near West 5th Avenue and the on-ramp to east bound U.S. Highway 6. Traffic control was set up for the shoulder work.

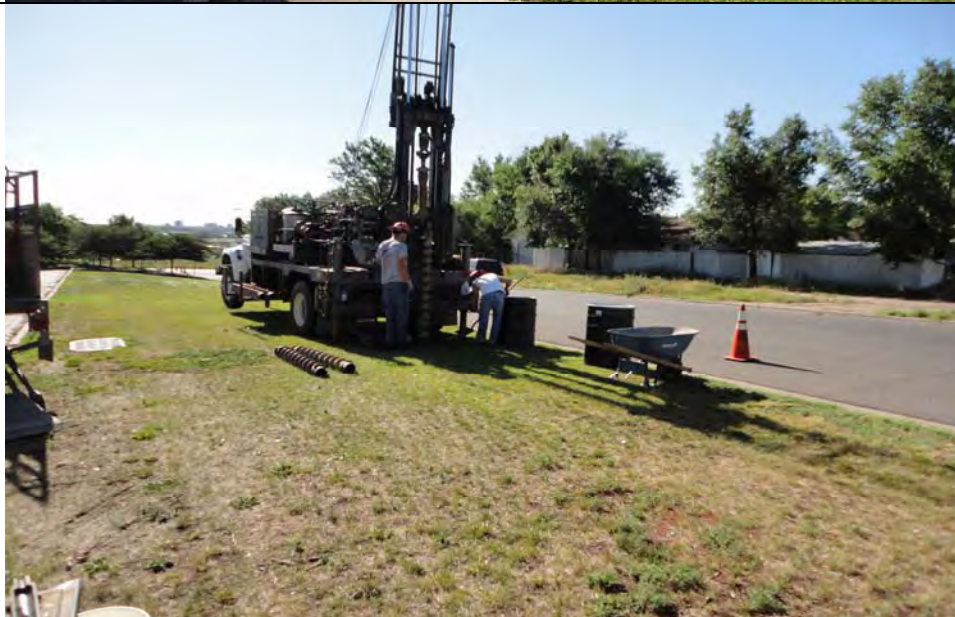
Subject: Photograph shows the drilling of MH-3 along west 5th Avenue, East Barnum Park, Denver, CO.

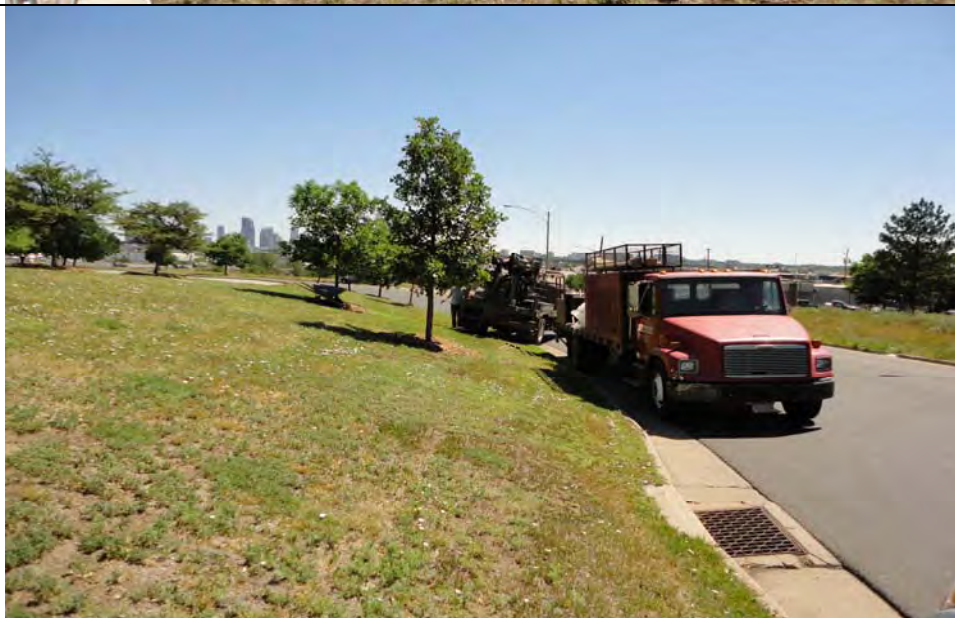
Subject: Photograph shows monitoring hole, MH-4, location on the southeast side of the Barnum Park baseball fields and West 5th Avenue and the on-ramp to east bound U.S. Highway 6.

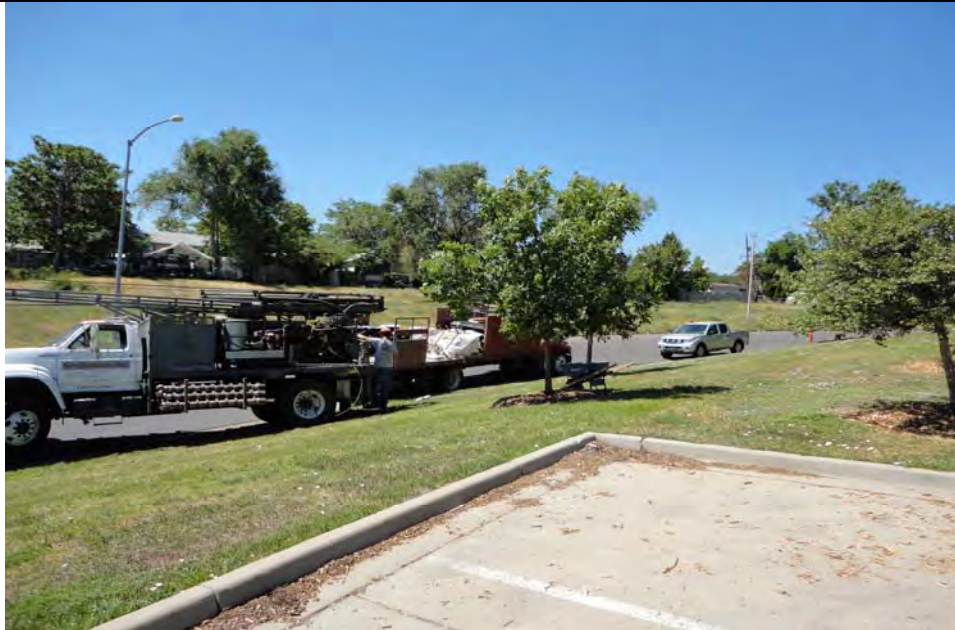
Subject: Photograph shows the MH-4 location near the curb along West 5th Avenue.

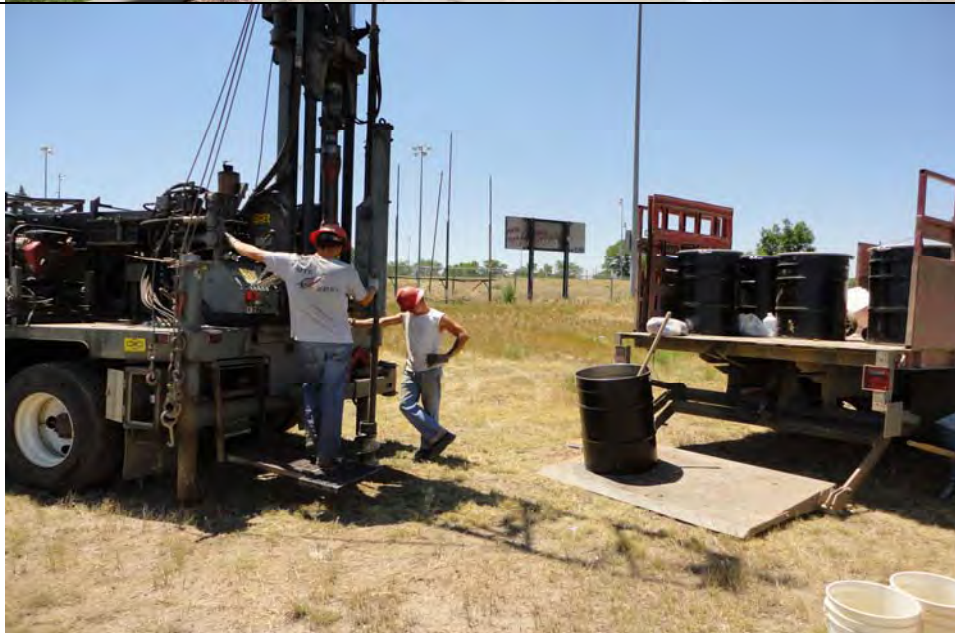
Subject: Photograph shows the location of monitoring hole, MH-5, located near the on-ramp to east bound U.S. Highway 6 and northeast of the Barnum Park East baseball fields (background).

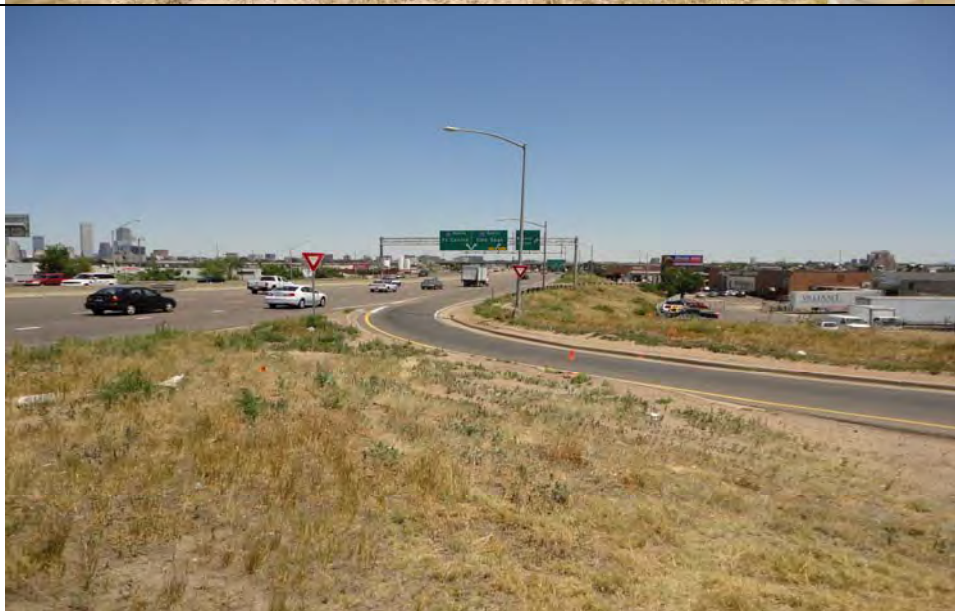
Subject: Photograph taken from the location of monitoring hole MH-5 toward the MH-6 location.

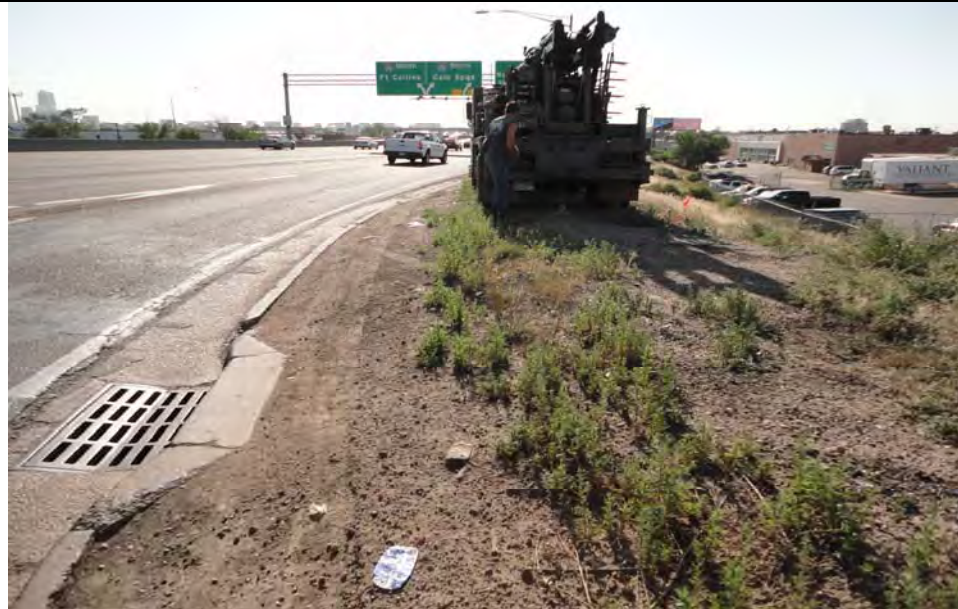
Subject: Photograph shows the location of monitoring hole, MH-6, on the south side of east bound U.S. Highway 6 and east of the on-ramp. The topography slopes to the east and southeast.

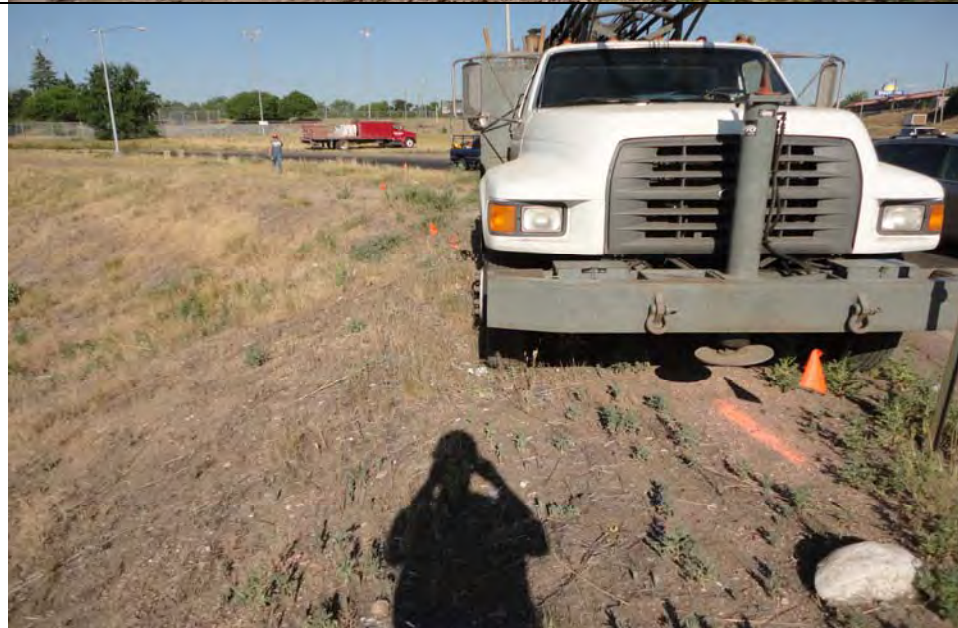
Subject: Photograph shows the MH-6 location and the hill slope to the south. The U.S. Highway 6 onramp is shown in the background. There were fiber optic lines belonging to CDOT marked in the area of MH-6.

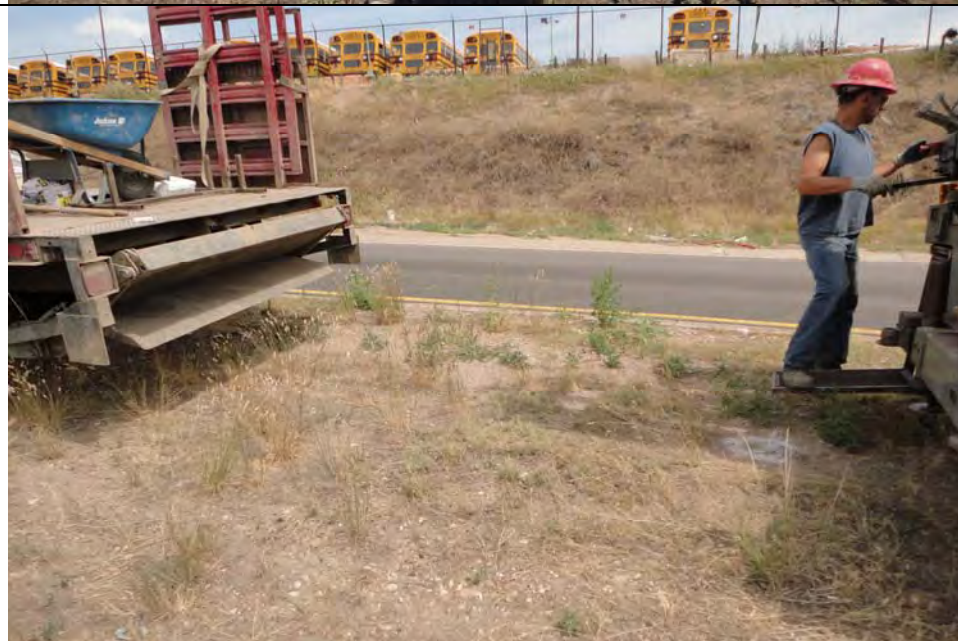
Subject: Photograph shows the location of monitoring hole, MH-7, located on the eastern tip of the median separating the off-ramp and west bound U.S. Highway 6. The MH-7 location was downhill from the Denver Public Schools bus facility.

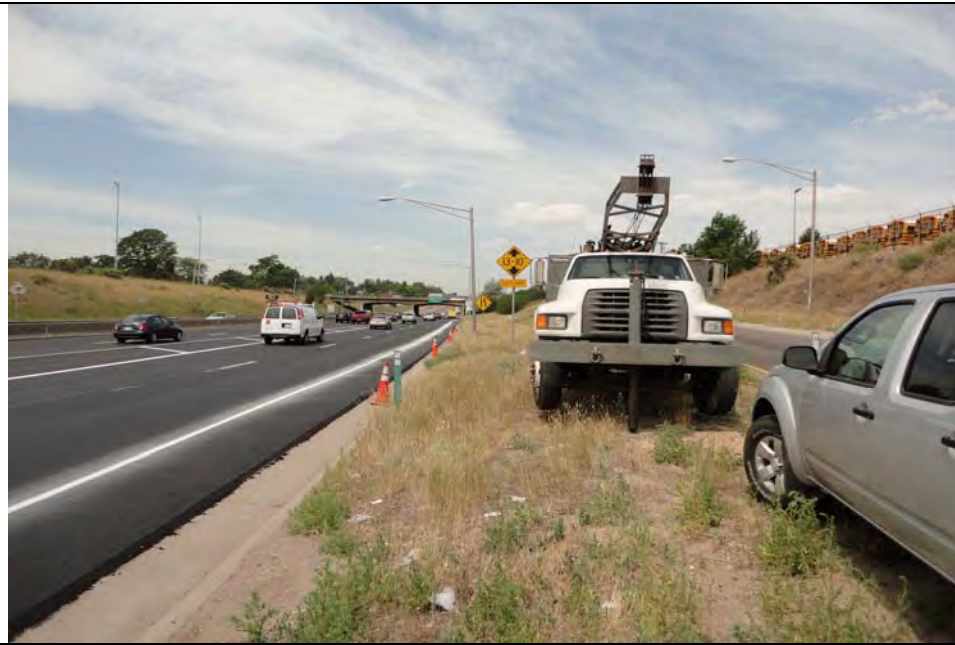
Subject: Photograph shows the location of MH-7 on the median between U.S. Highway 6 west bound (left) and the off-ramp to north bound Federal Boulevard (right) and the Denver Public Schools bus facility.

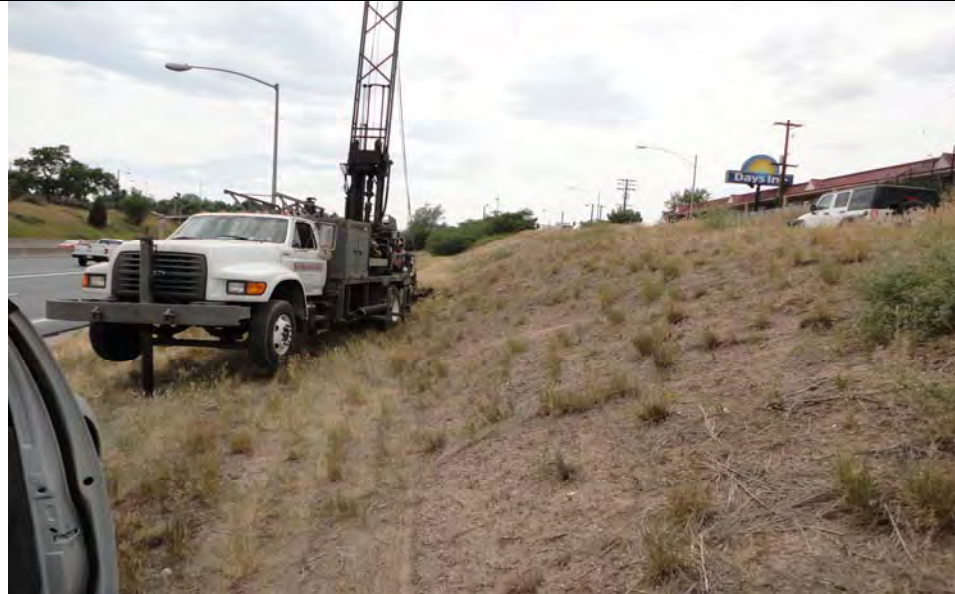
Subject: Photograph shows the location of MH-8 located at the bottom of the hill slope on the north side of west bound U.S. Highway 6, to the east of Federal Boulevard and the Days Inn motel property, and south of the off-ramp to north bound Federal Boulevard, and the Denver Public Schools school bus facility.

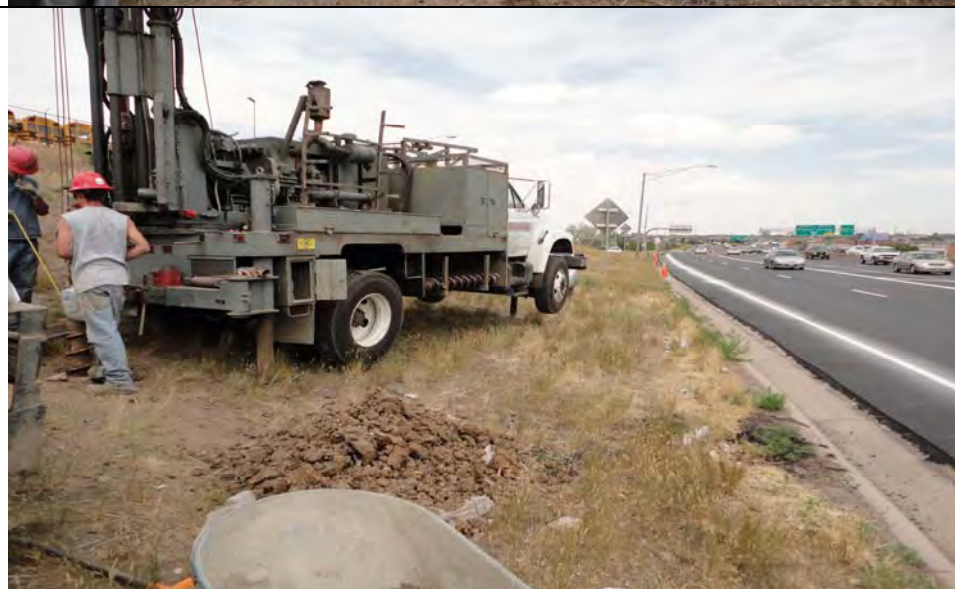
Subject: Photograph shows the MH-8 location on the north side of U.S. Highway 6. Drill cuttings were stored on plastic.

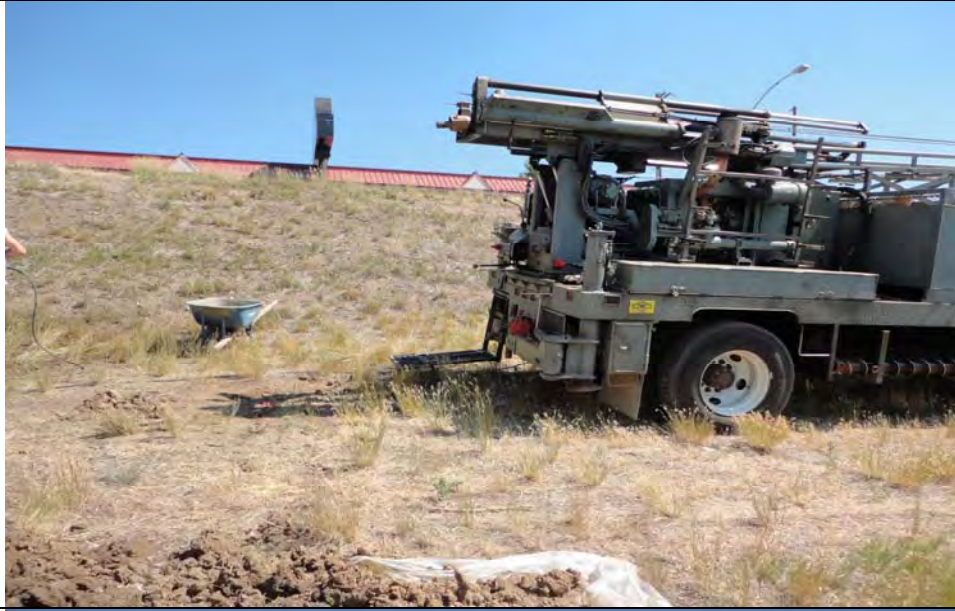
Subject: Monitoring hole, MH-9, was located downhill from the Days Inn Motel sign on the north side of U.S. Highway 6 west bound, and south of the off-ramp to north bound Federal Boulevard.

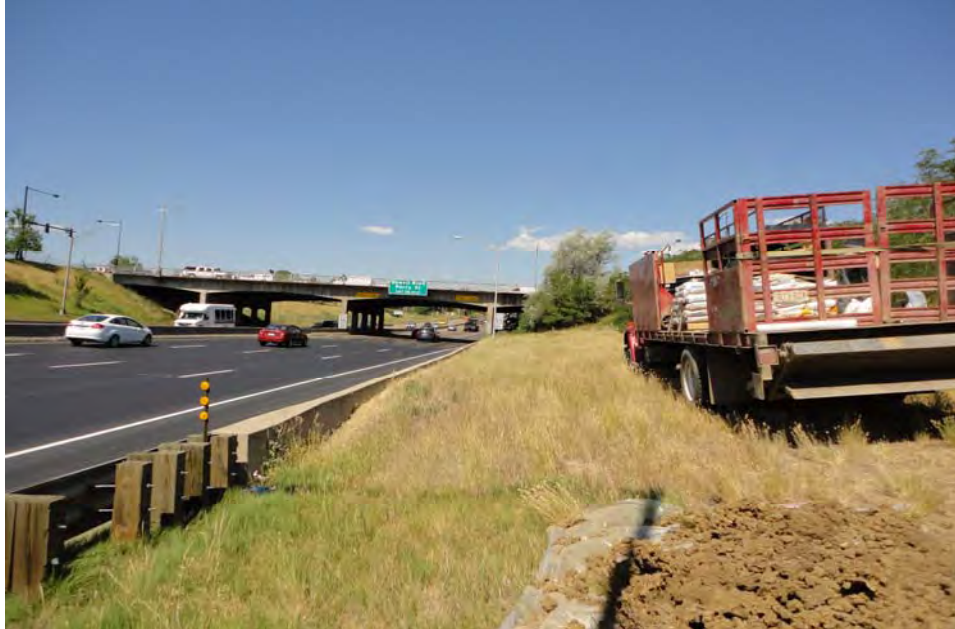
Subject: Photograph shows the location of MH-9 along the north side of west bound U.S. Highway 6. The soil drill cuttings were stored on plastic.

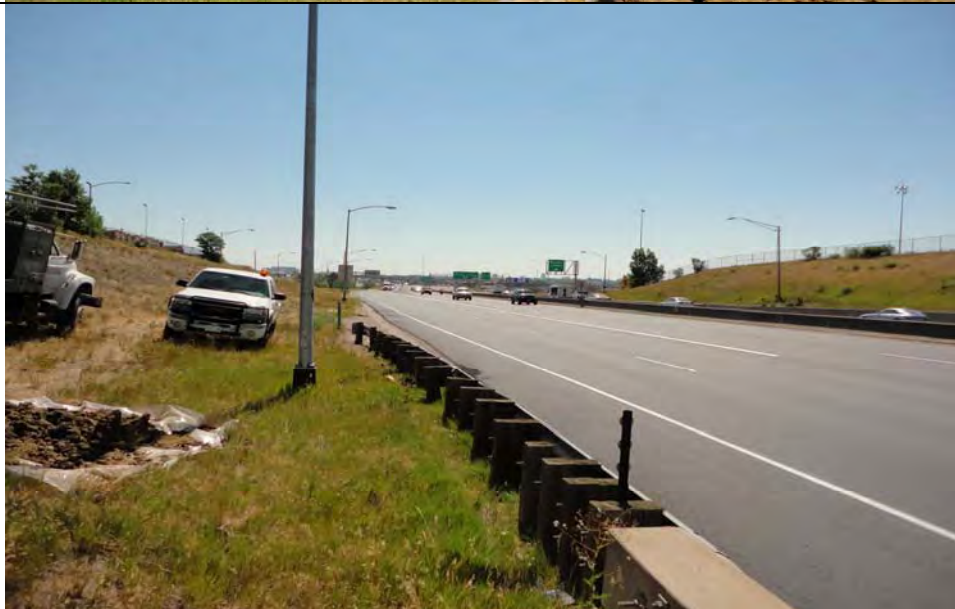
Subject: Photograph was taken from the MH-9 location looking along U.S. Highway 6 west and east bound lanes.

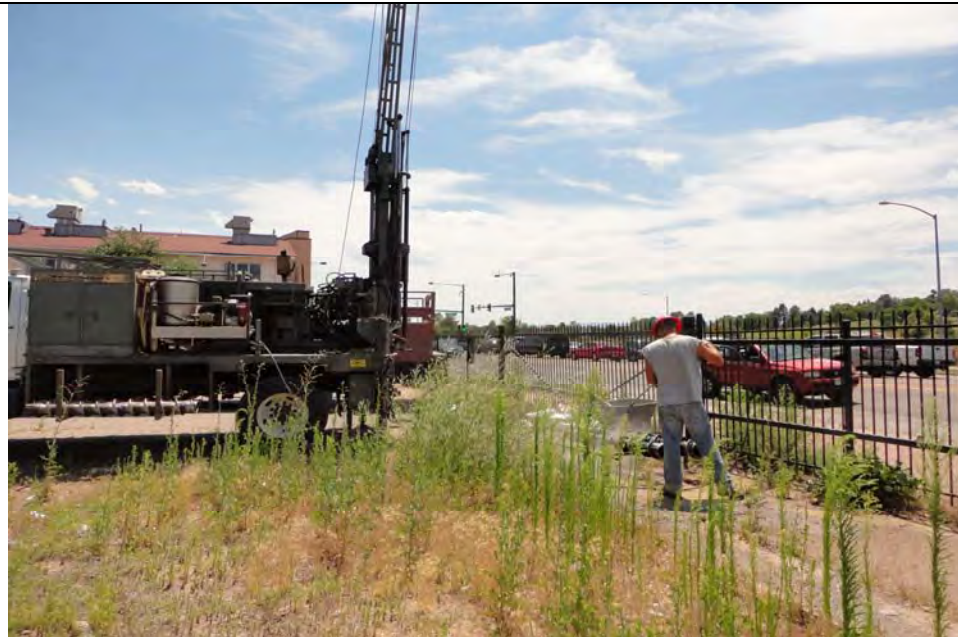
Subject: The location of monitoring hole MH-11 was inside the fence on the northwest corner of the CDOT that is bound to the west by Federal Boulevard, to the south east, and northeast by the Days Inn motel property, and to the north by a parking lot.
