US 6 Bridges Design Build Project

Hazardous Materials Technical Report

Prepared for:
Colorado Department of Transportation
Federal Highway Administration

August 2012
Revised January 2013

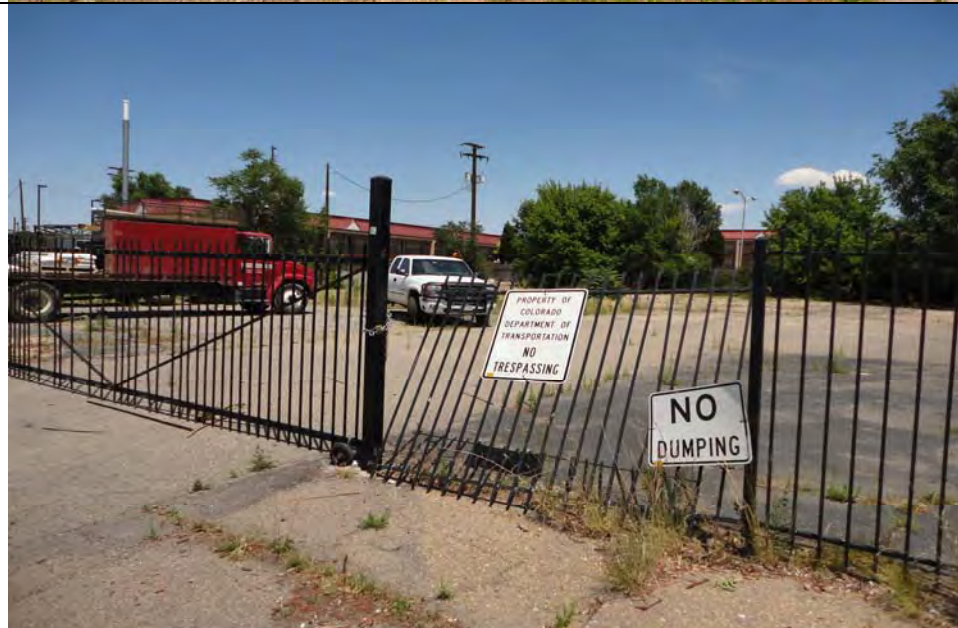
Subject: The CDOT property where MH-11 was located was partially paved with asphalt, and partially unpaved.

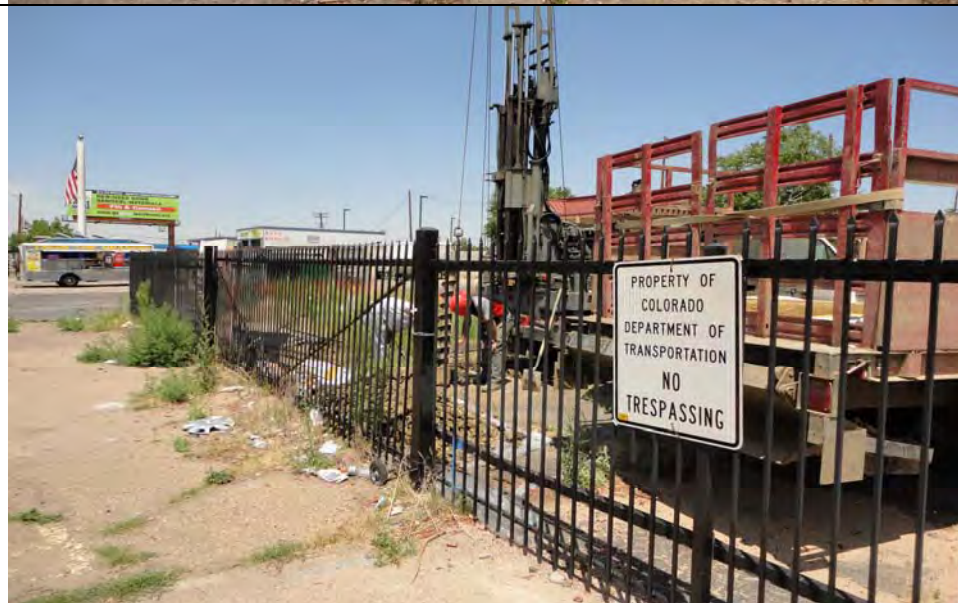
Subject: Photograph shows the location of MH-11 on the northwest corner of the CDOT property. Drill soil cuttings were stored on plastic.

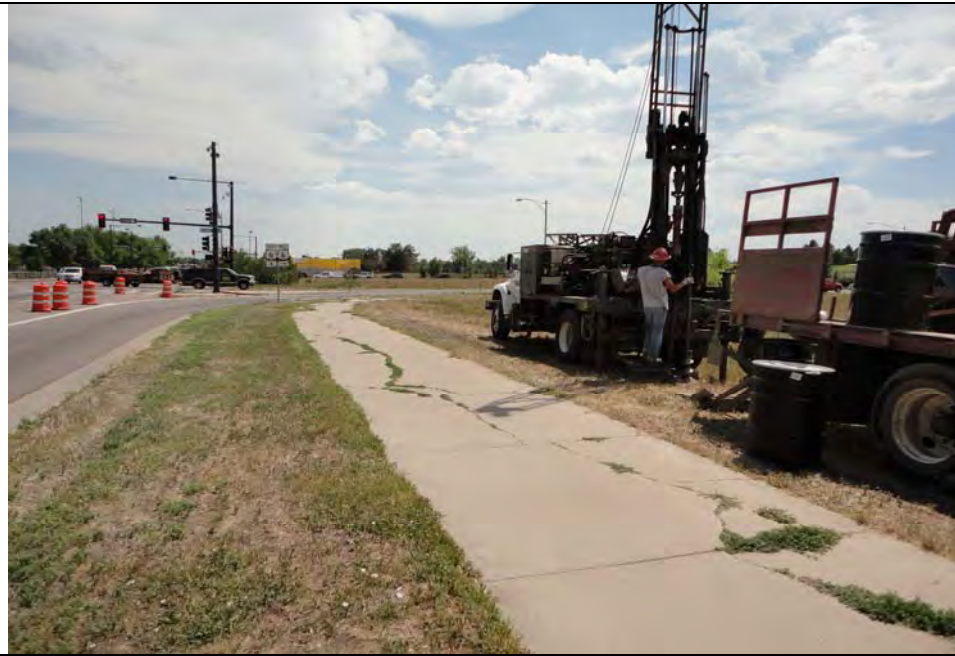
Subject: Photograph shows the location of monitoring hole, MH-10, located on the northwest corner of Federal Boulevard and U.S. Highway 6.

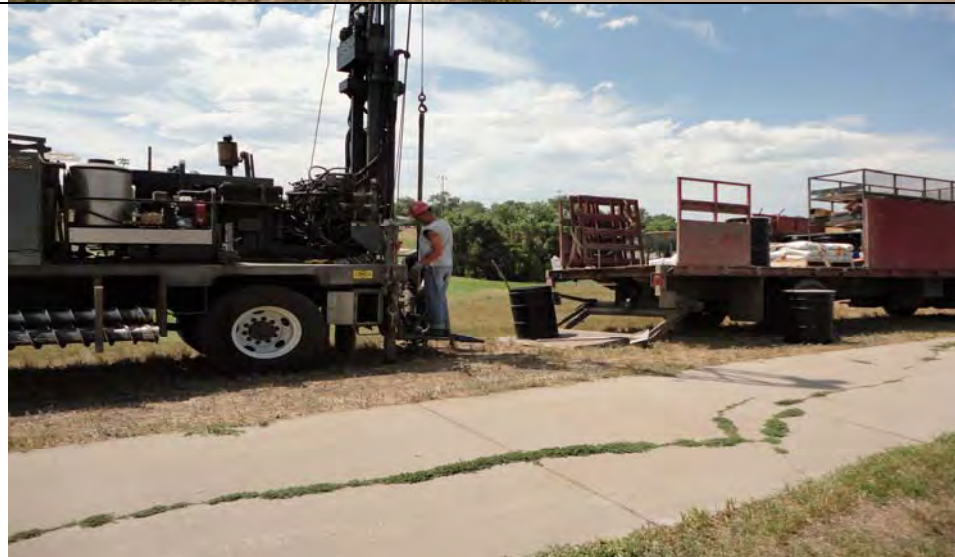
Subject: Monitoring hole, MH-10, was located near baseball fields on the northwest corner of Federal Boulevard and U.S. Highway 6. The temporary well was installed as a flush-mounted well on the west side of the sidewalk.

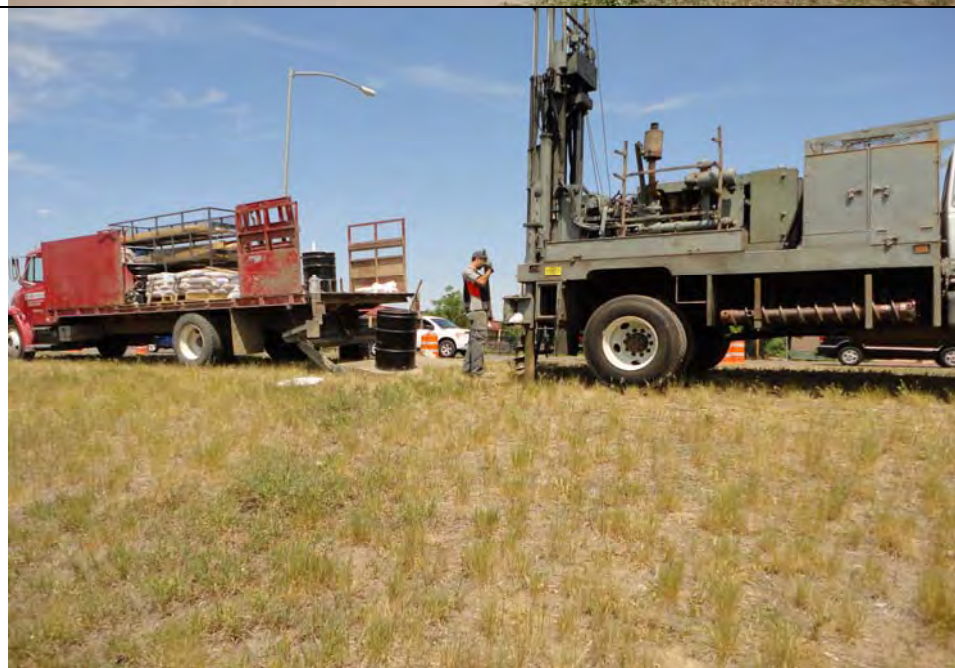
Subject: Photograph shows the hill slope adjacent to MH-10. The drill cuttings were drummed since the well was located in Barnum Park.

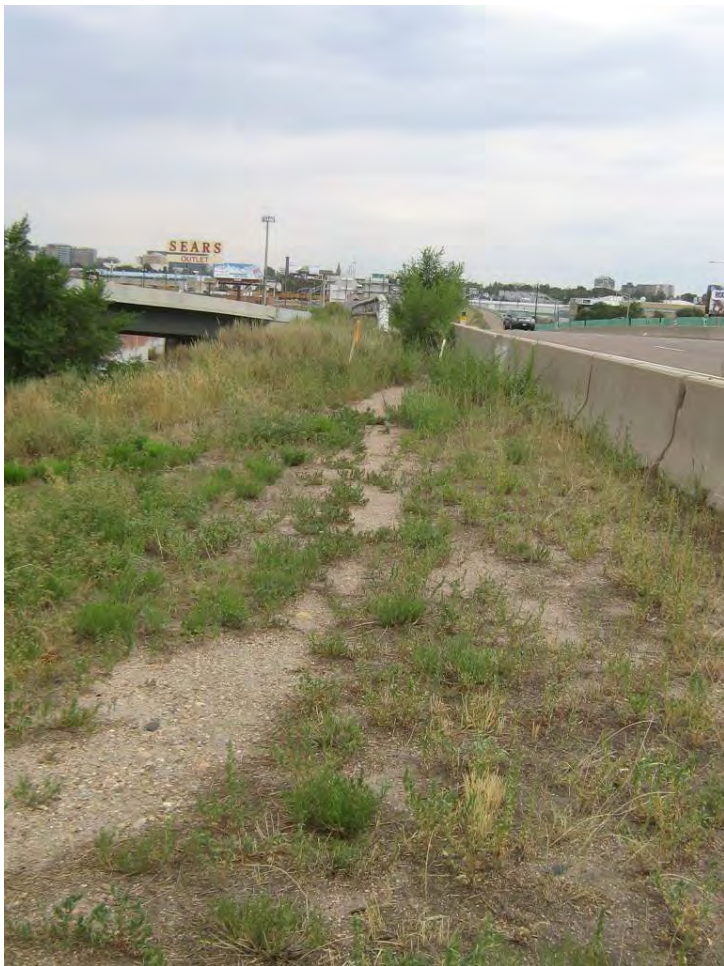
1. North Side of Bridge, Looking East

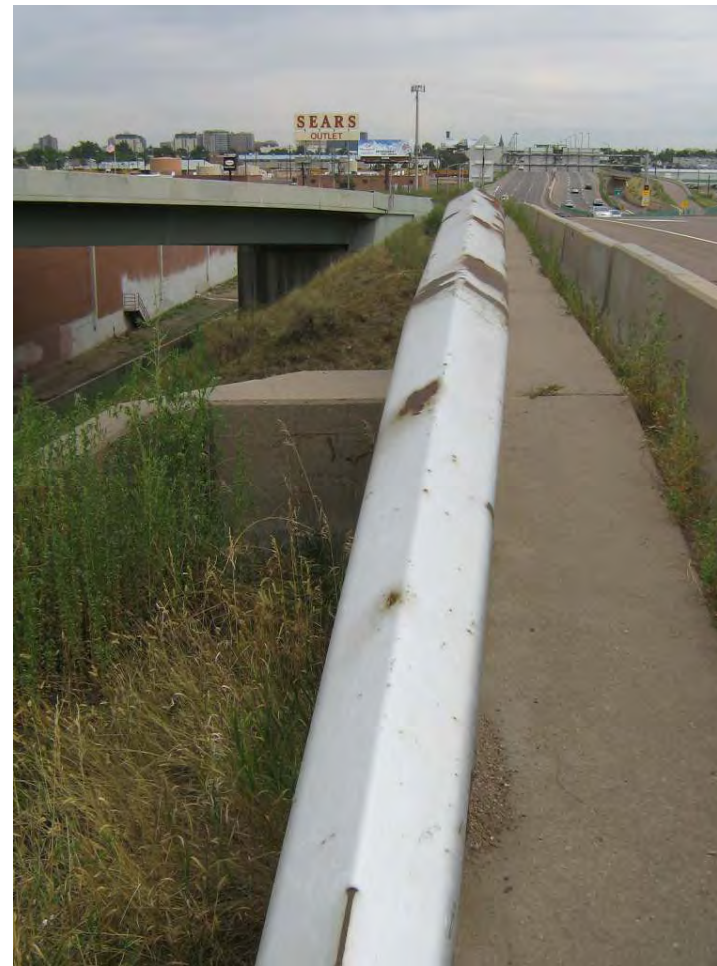
2. Pedestrian Walkway on the North Side of Bridge

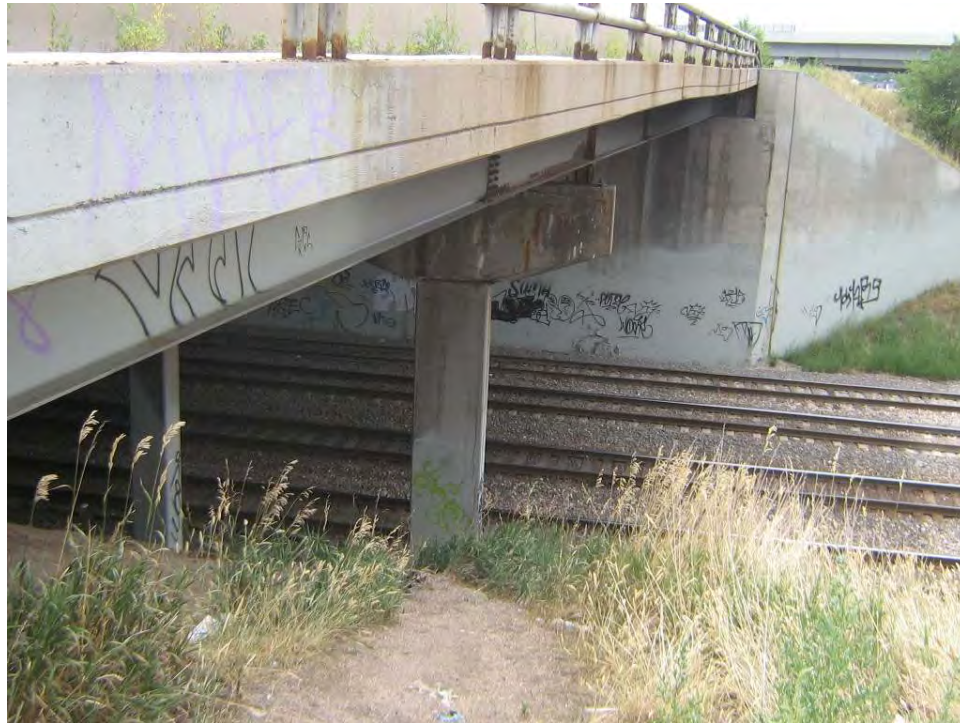
4. Transient Belongings Under Bridge

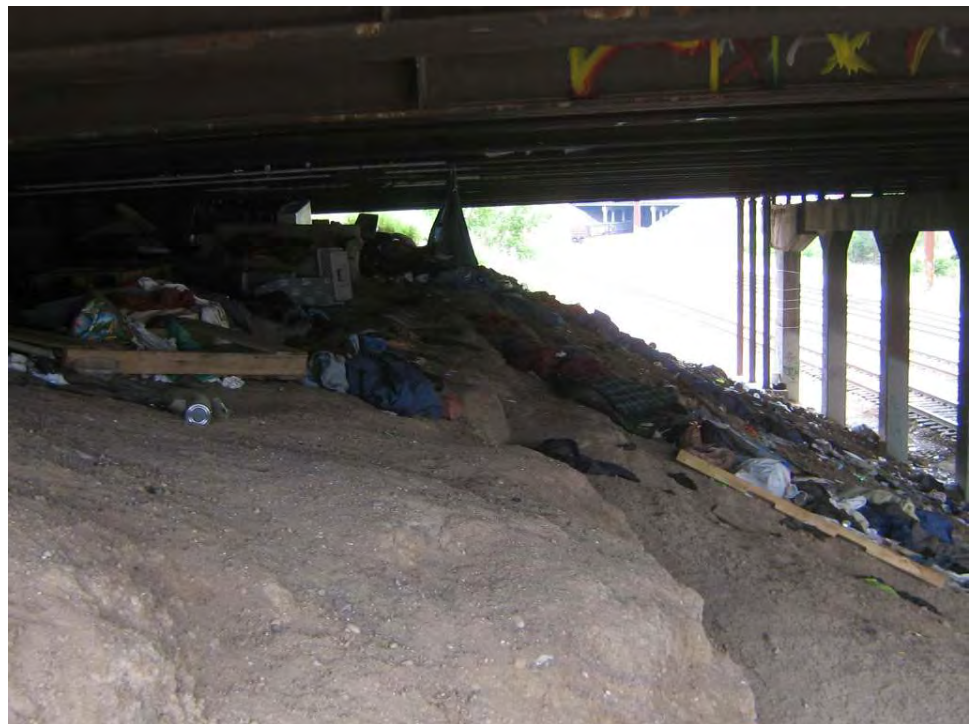
5. Underside of Bridge on the South Side

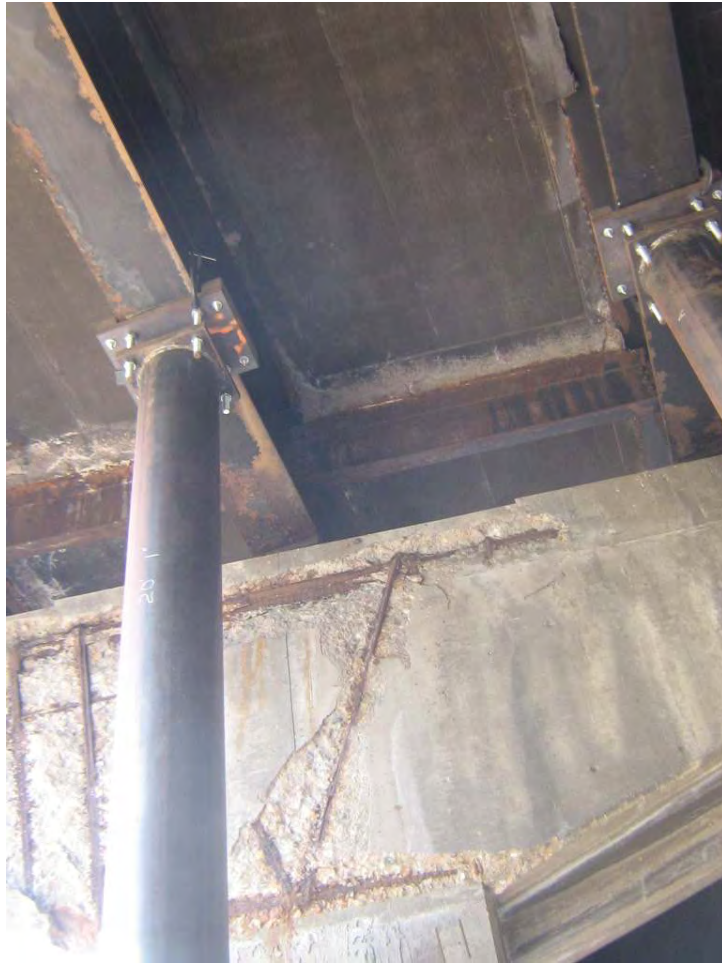
Pinyon Environmental collected four lead and one suspect asbestos containing material sample from the four paint colors observed on the BNSF bridge and from the caulking observed on the south bridge piers,

respectively. Three paint samples collected from the BNSF bridge (F-16-EJ) were found to contain lead. The brown paint contained lead at 7.246% and the gray paint contained lead at 2.693%. These levels exceed the US Environmental Protection Agency (EPA) minimum lead by weight content, 0.5% lead by weight (EPA 1992); and are therefore considered to be lead-based. The silver paint sample contained 0.07% lead, which is below the EPA standard for lead-based paint. No lead was found in the red paint sample collected from the bridge. Asbestos was not found in the caulking collected from the south bridge piers; however, based on the number of samples, this screening should not be considered comprehensive.

6. Caulking on Bridge Pier at the South End
