CDOT STRUCTURE F-19-E REPLACEMENT

Preliminary Hydraulic Design Report

March 2020

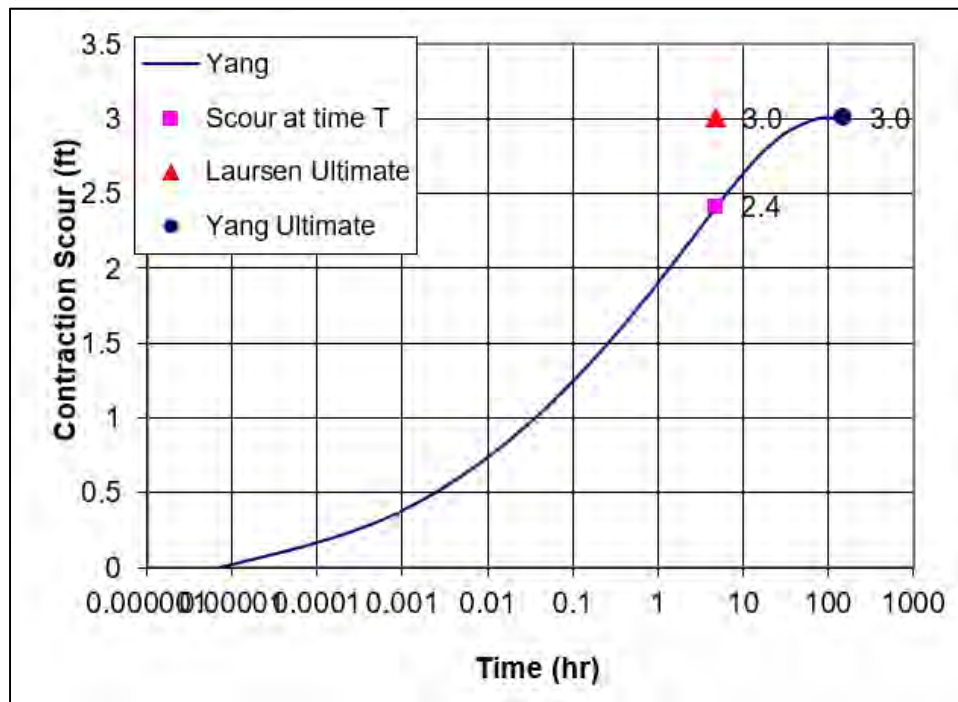
Figure 7. 100-Year Time Dependent Contraction Scour

Because the channel has cohesive properties, scour is expected to occur at a much slower rate than it would in a sand-channel bed. To take this into account clear-water contraction scour calculations have been adjusted using Yang’s total load sediment transport equation for sand with the limiting value of erosion being the clear-water scour. Hydrographs for both the 100-year and 500-year storm events were used to determine storm duration. Since the 10-year storm flows were sufficient enough to result in velocities that transport bed material this flow-rate is the ideal value at which to take the storm duration measurement; however, to be conservative a slightly larger duration was taken at 50 cfs, see **Figure 5** and **Figure 6**. Time dependent scour for the 100-year event is presented in **Figure 7**.

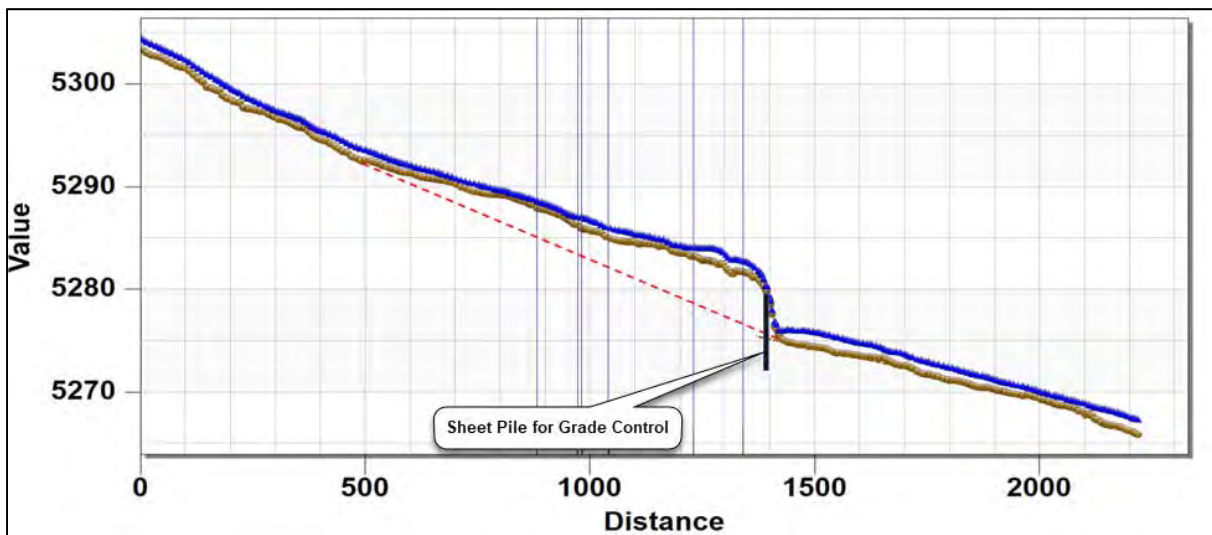
Figure 8. Channel Bed Profile

The terrain data captures a significant drop in the channel located approximately 35 feet downstream of the proposed bridge, as can be seen in **Figure 8**. This drop has an approximate 13.4% grade and is likely caused by agricultural practices. While there is not presently an active headcut at this location, there is potential for one to initiate during high flows. The channel slope downstream of the drop is approximately 1.11% and the channel slope upstream of the drop is 1.60%.

To determine the long-term degradation that threatens the stream, the slope downstream of the potential headcut would, ideally, be projected upstream until it intersects the thalweg upstream of the potential headcut. However, this situation does not present itself based on ground data upstream of the proposed bridge. **Figure 8** presents a potential scenario for propagation of the potential headcut upstream, which would result in a 1.9% channel slope. The vertical channel degradation that could potentially be experienced at the proposed bridge location is shown in **Table 7**. A potential location for a grade control structure is shown in **Figure 8**.

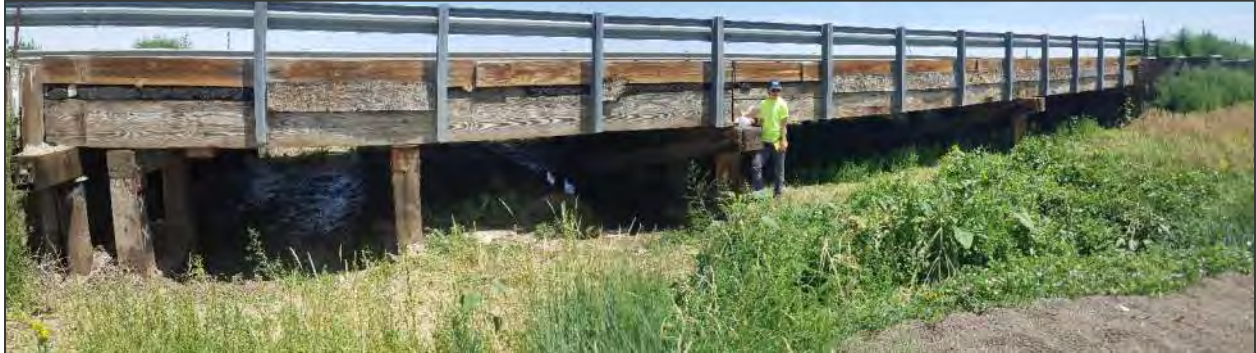
Figure 3. View looking downstream at US36 Bridge F-19-E near Strasburg, CO.

Bridge F-19-E, which is about 80 feet wide, consists of vertical timber retaining wall abutments with timber wingwalls. The bridge sits on 3 pile bents which contains 7 wood piles that are 12 inches in diameter. Wood cross braces are present on the pile bent. There are 2 short crutch bents with two 12-inch square wood piles with a 12-inch square wood header each at the southwest corner of the bridge and appear to be associated with repairs conducted in 2008. Currently, both crutch bents do not contact the low chord of the bridge and appear to have only provided support to that corner of the bridge during repairs. In addition, 2 trenches appear to have been excavated under the west span and may have been used to allow movement of equipment under the bridge during the repairs. The pavement above the crutch bents appears

to have been repaired as well, although the reason for the repair is unknown. The pile bents are skewed about 10° relative to the upstream and downstream channel. **Figure 3** shows the configuration of the bridge.

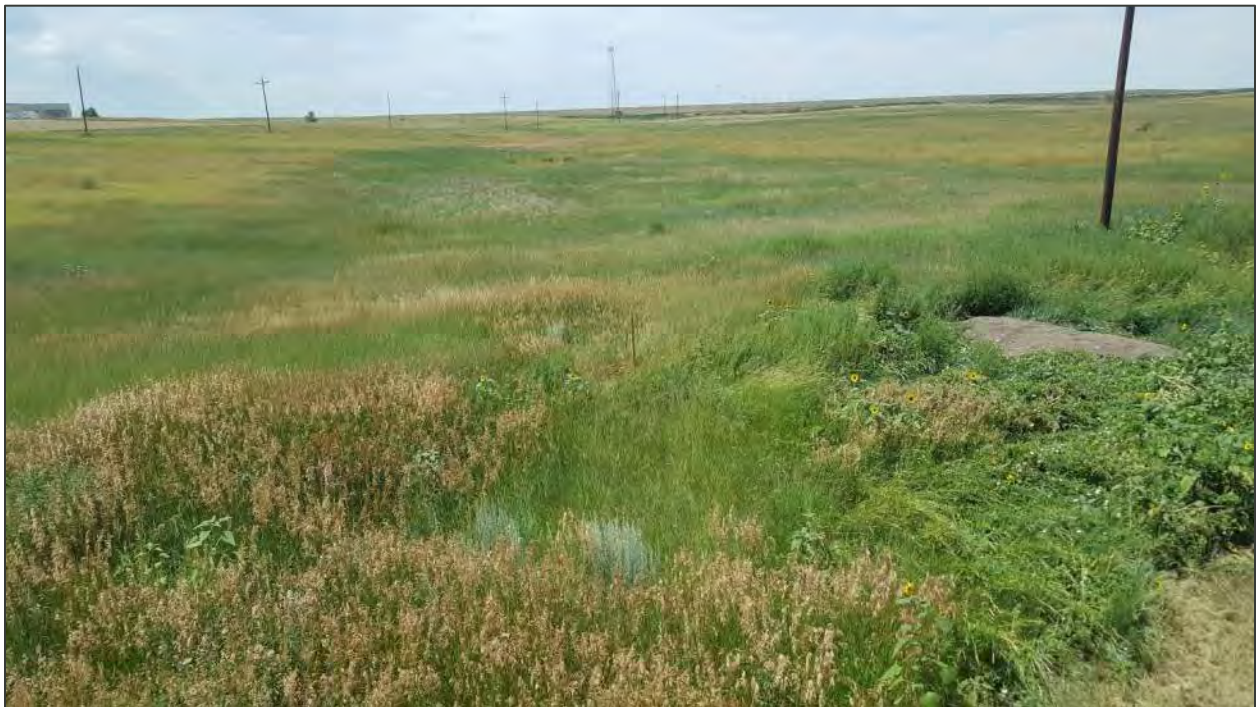
Figure 4. View looking at the drainage upstream from Bridge F-19-E.

The channel upstream and downstream of the bridge contains a dense growth of grasses and weeds. **Figure 4** shows the upstream swale channel. Just upstream of the bridge is a mound of dirt and ground up asphalt in the swale channel that may have been left behind during the repairs. There is also a long berm along the downstream side of the bridge with about a 6-7 foot drop from the berm to the downstream swale channel (**Figure 5**), which could be problematic for the bridge if the berm were to be breached during high flows.

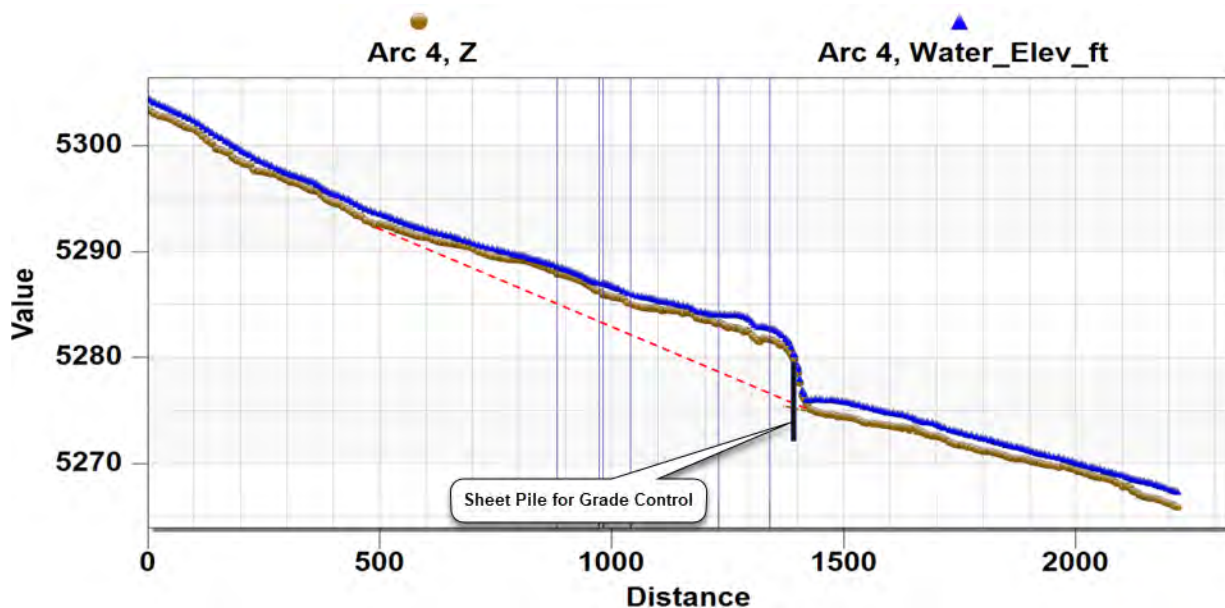
Figure 7. Channel Bed Profile

The survey provided by CDOT captures a significant drop in the channel located approximately 35 feet downstream of the proposed bridge, see **Figure 7** below. This drop has an approximate 13.4% grade and is caused by agricultural practices; while there is not presently an active headcut at this location, there is potential for one to start during high flows. The channel slope downstream of the drop is approximately 1.11% and the channel slope upstream of the cut is 1.60%.

To determine the long-term degradation that threatens the stream the slope downstream of the headcut would, ideally, be projected upstream until it intersects the thalweg upstream of the headcut; however, this scenario does not present itself due to the limit of ground data upstream of the proposed bridge. **Figure 7** above shows a potential scenario for propagation of the headcut upstream, which would result in a 1.9% slope. The vertical channel degradation that could potentially be experienced at the proposed bridge location is shown below in **Table 2**. A potential location for a grade control structure is shown above in **Figure 7**.
