I-70 GLENWOOD CANYON  
VARIABLE SPEED LIMITS

ABBREVIATED VISUAL IMPACT ASSESSMENT

FINAL

June 27, 2017

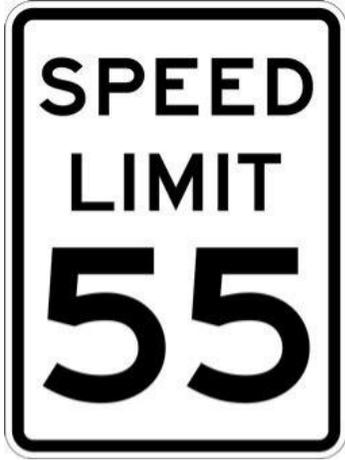
Existing Speed Limit Sign

Figure 1 Existing Speed Limit Signs and Proposed VSL Sign

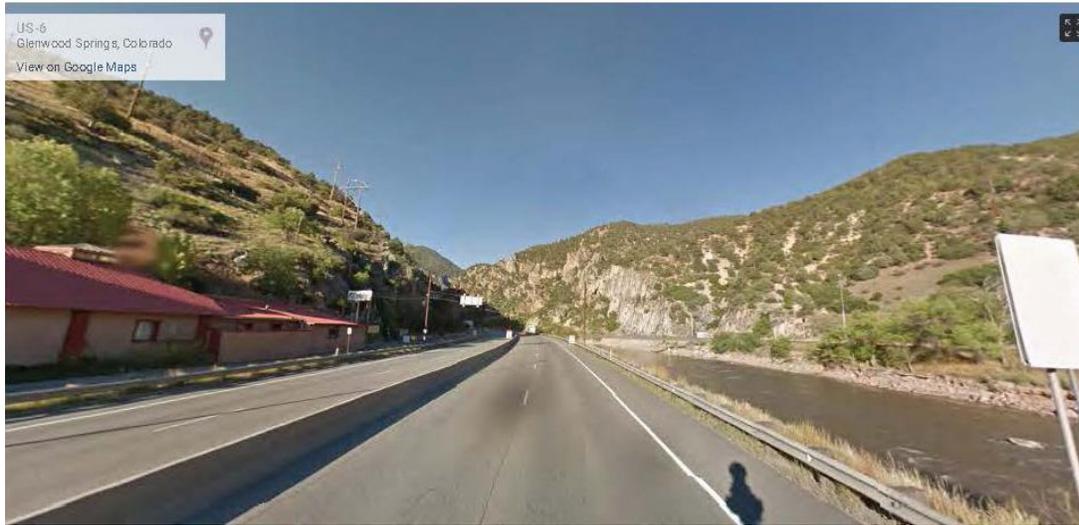
#### Site 1 – 116.89 EB

View looking east toward Glenwood Canyon with the Colorado River visible to eastbound motorists. Commercial buildings associated with the Yampah Hot Springs and vapor caves located at the eastern end of Glenwood Springs are located on the left.

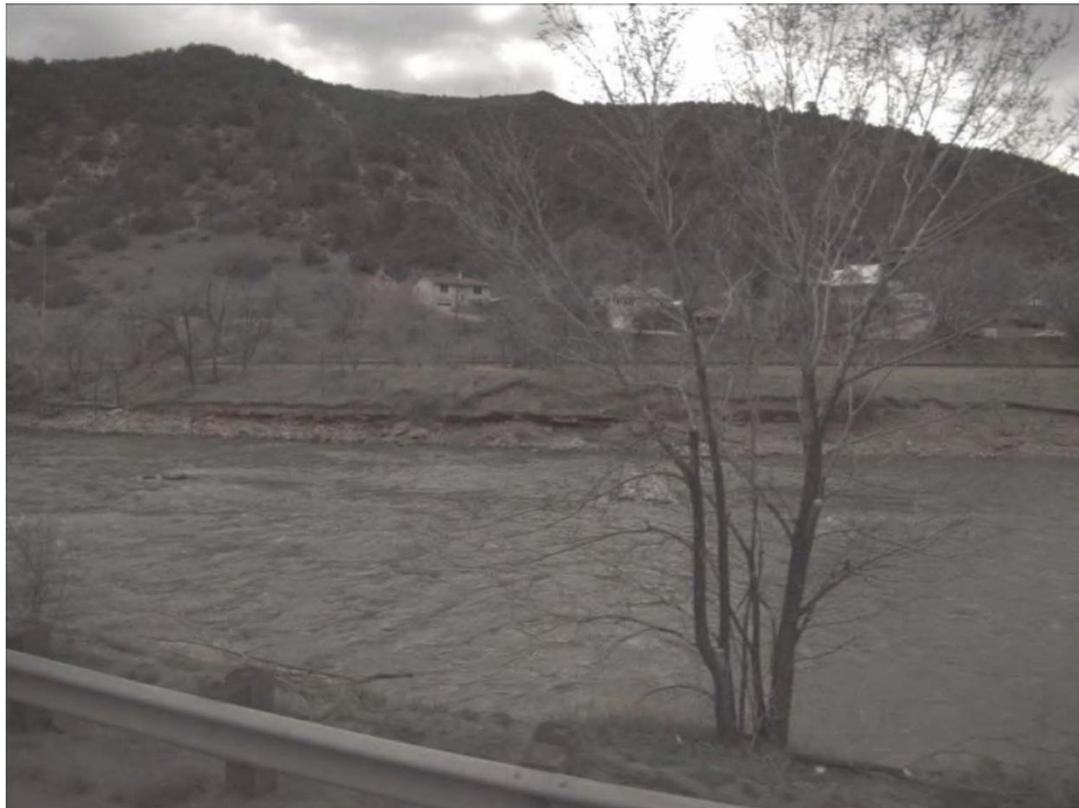
#### Site 1 – 116.89 EB

View of the Colorado River looking at the approximate location where the VSL sign would be placed.

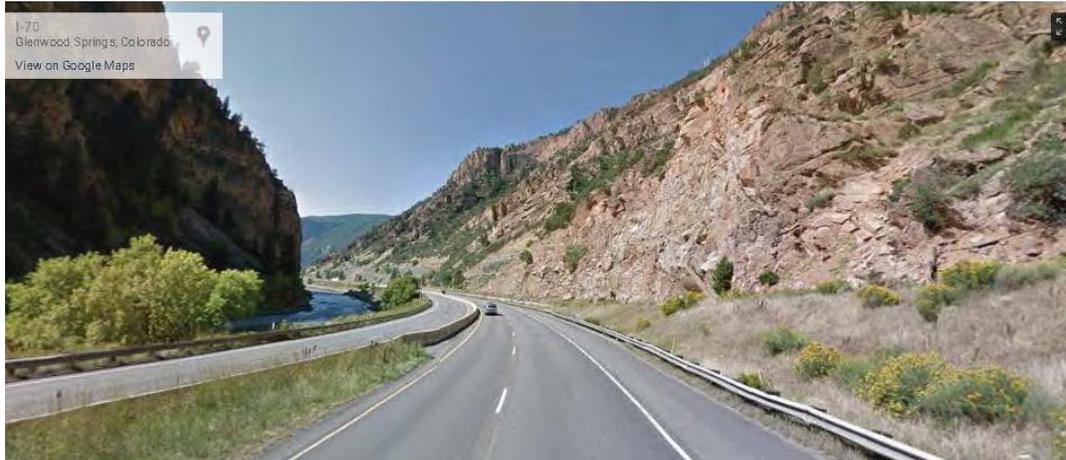
Site 2 – 117.68 WB

View looking west at the Colorado River and canyon slopes visible to westbound motorists. A utility access roadway that also serves as a segment of the Glenwood Canyon Hiking Biking Trail is visible on the right. The Glenwood Canyon Hiking Biking Trail bridge over I-70 and an I-70 tunnel is located behind this vantage point.

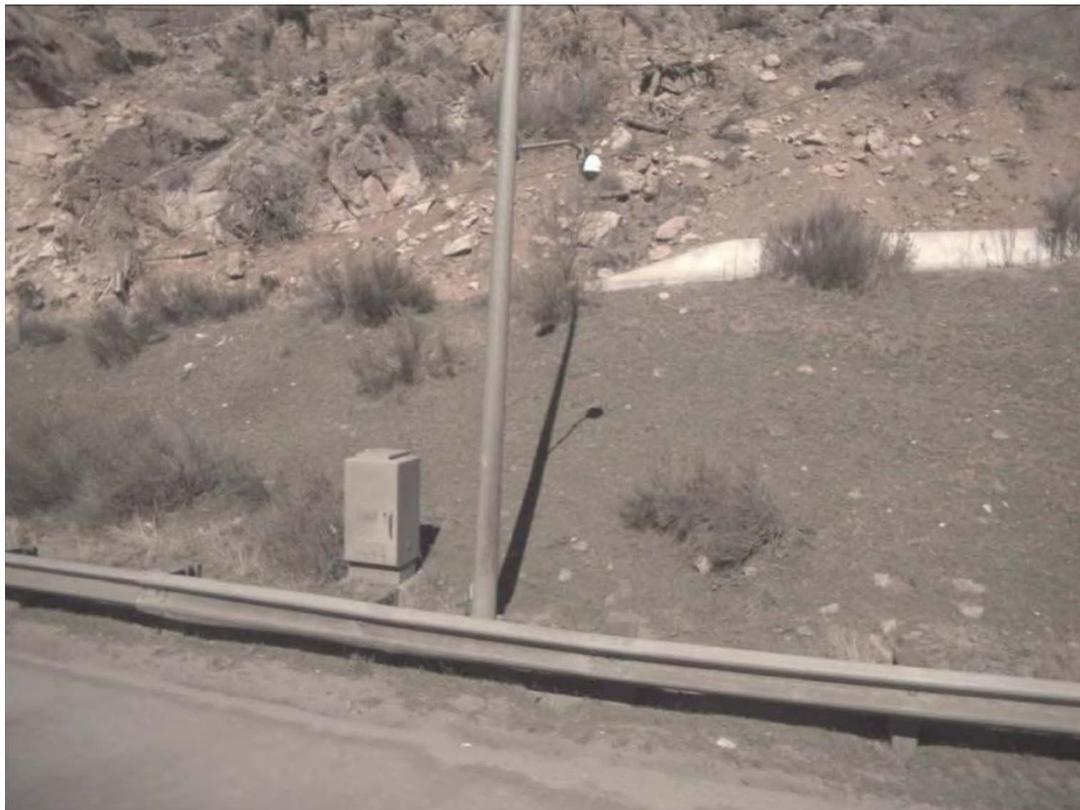
Site 2 – 117.68 WB

View of a light pole and utility cabinet located where the VSL sign would be placed. The retaining wall for the utility road and trail is visible beyond the pole on the right.

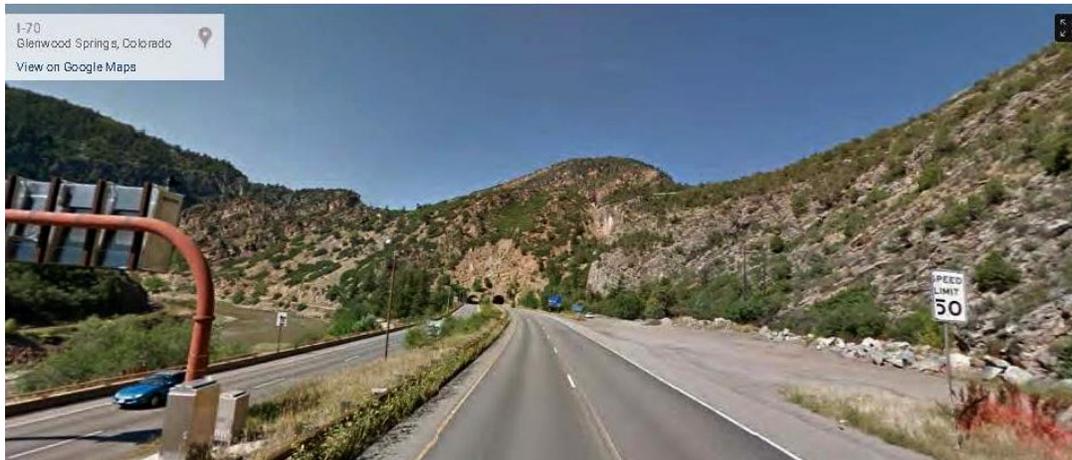
### Site 3 – 118.12 WB

View looking west at the Colorado River and canyon slopes visible to westbound motorists. A pull off area with a gravel surface is located on the right. An existing speed limit sign is visible on the right. An overhead gantry is visible on the left.

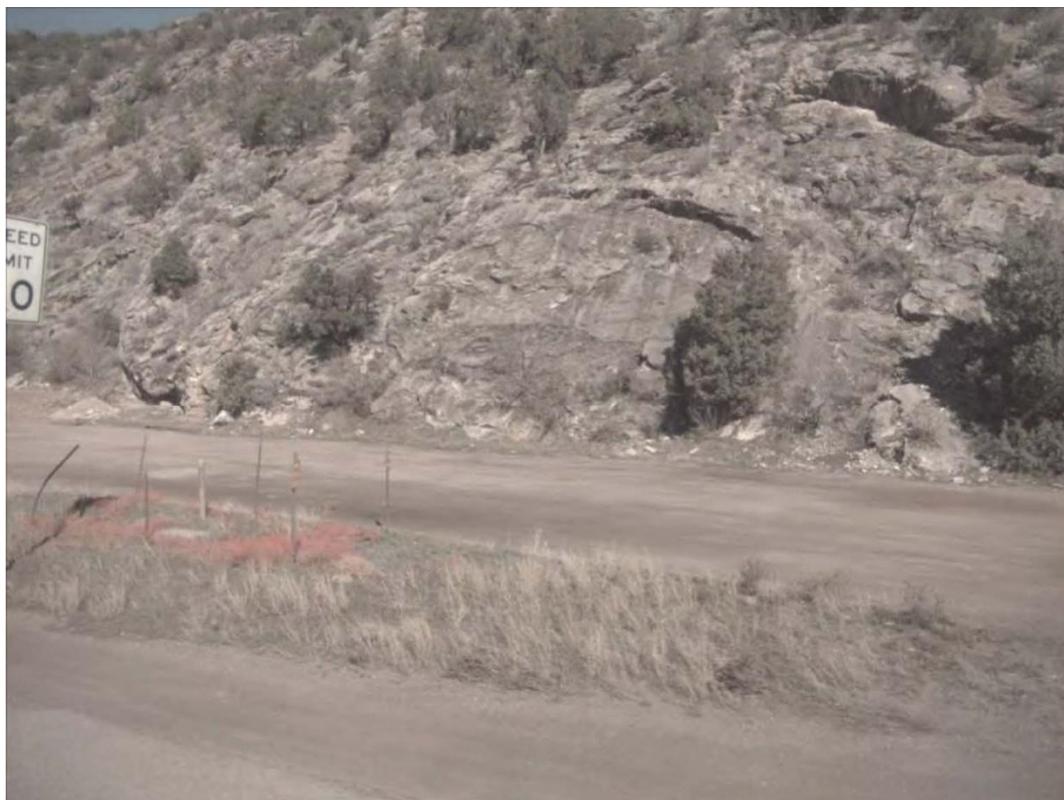
### Site 3 – 118.12 WB

View of the approximate location where the VSL sign would be placed. The existing speed limit sign is partially visible on the left.

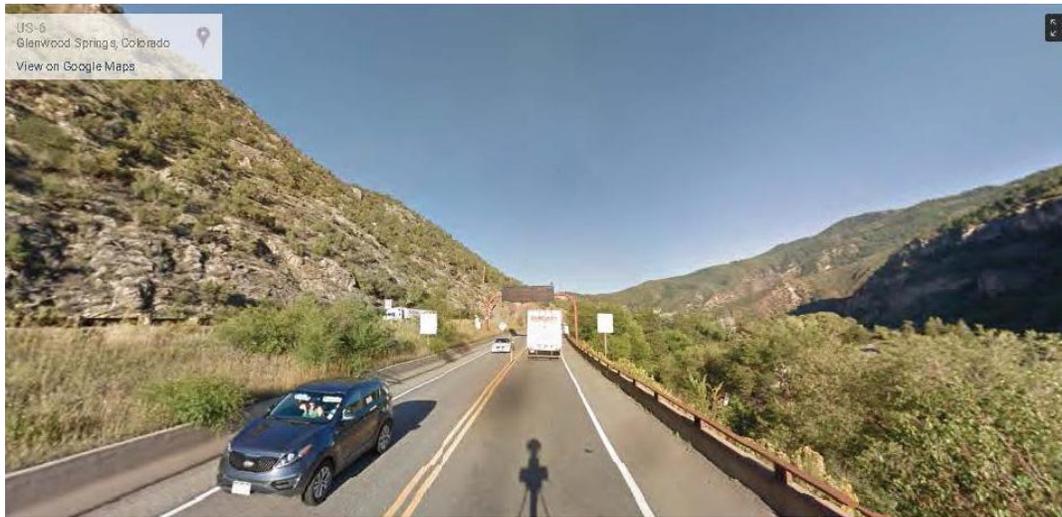
Site 4 – 118.19 EB

View looking east at the vegetated slope between I-70 and the Colorado River and steep canyon slopes visible to eastbound motorists.

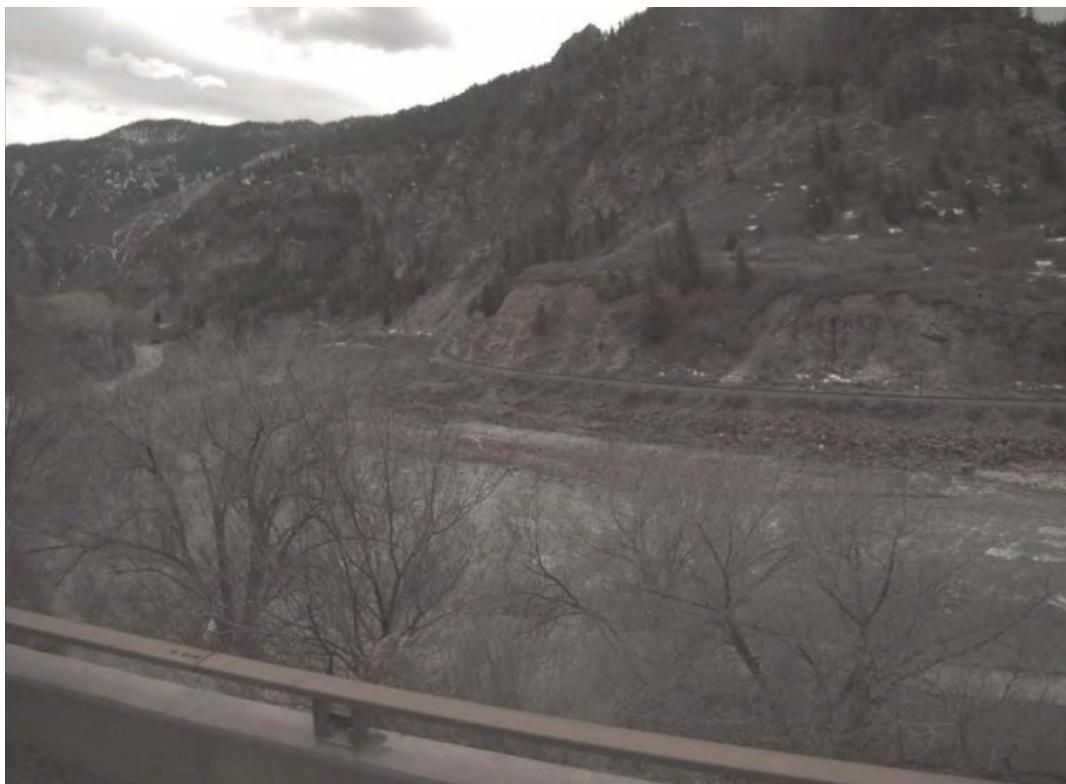
Site 4 – 118.19 EB

View of the approximate location where the VSL sign would be placed along the guardrail. The lack of leaves on the trees and resulting increases in visibility and views during the late fall, winter and early spring seasons is clear in this image. The railroad alignment on the over side of the Colorado River is visible in distance.

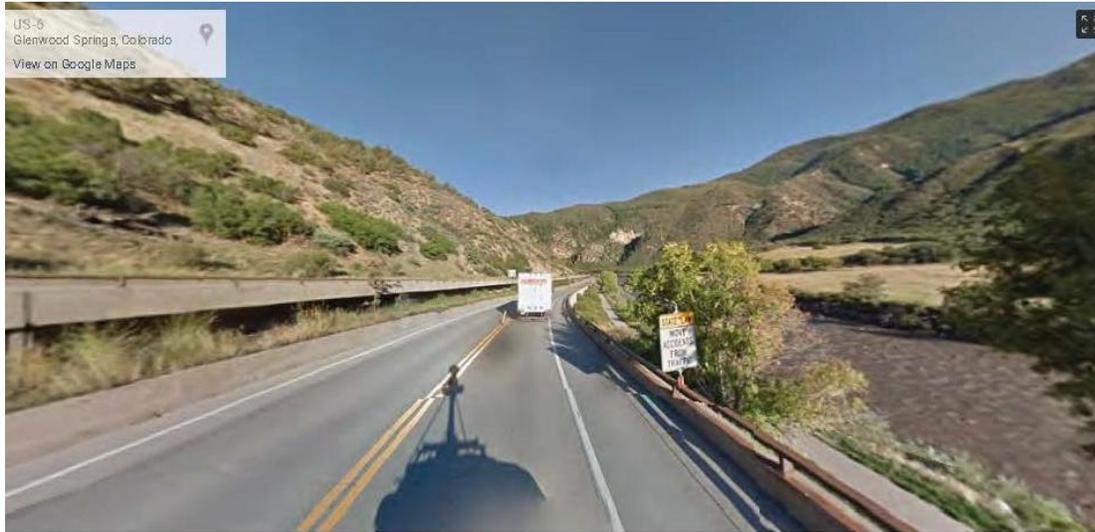
### Site 5 – 118.98 EB

View looking east at the split vertical alignment of I-70 with broad views of Glenwood Canyon and the Colorado River.

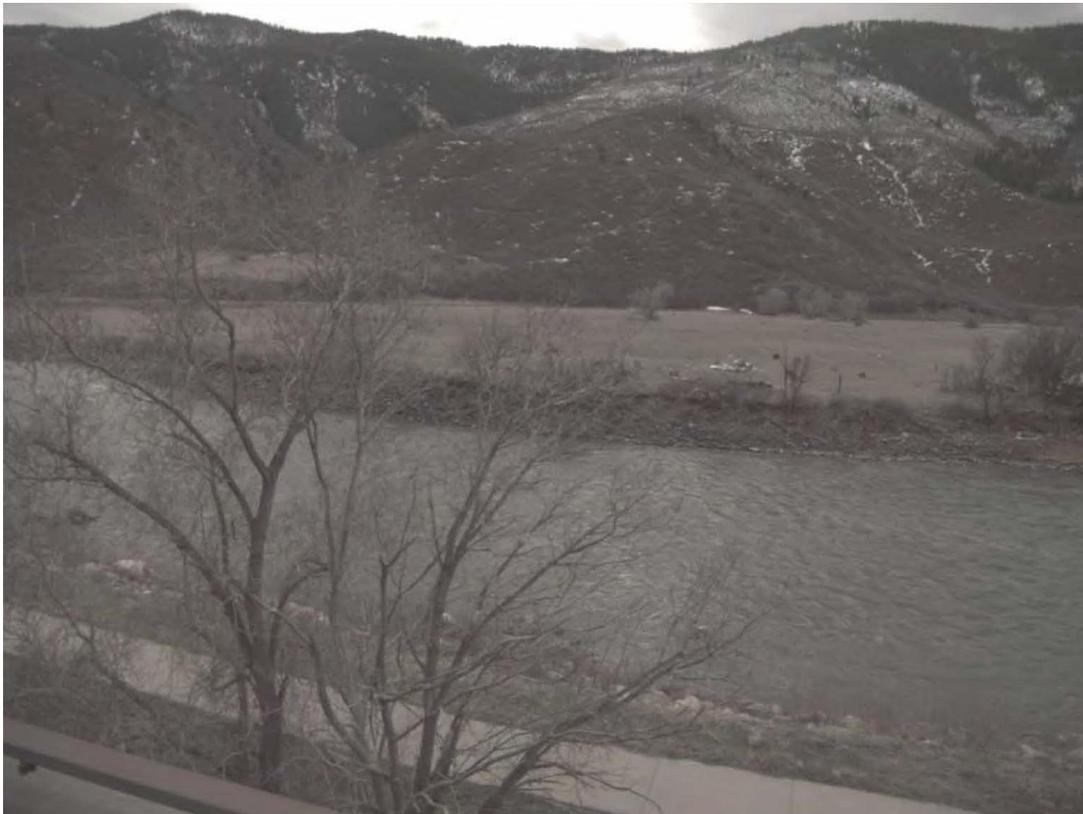
### Site 5 – 118.98 EB

View of the approximate location where the VSL sign would be placed along the guardrail. The adjacent walking and cycling path is visible between I-70 and the Colorado River.

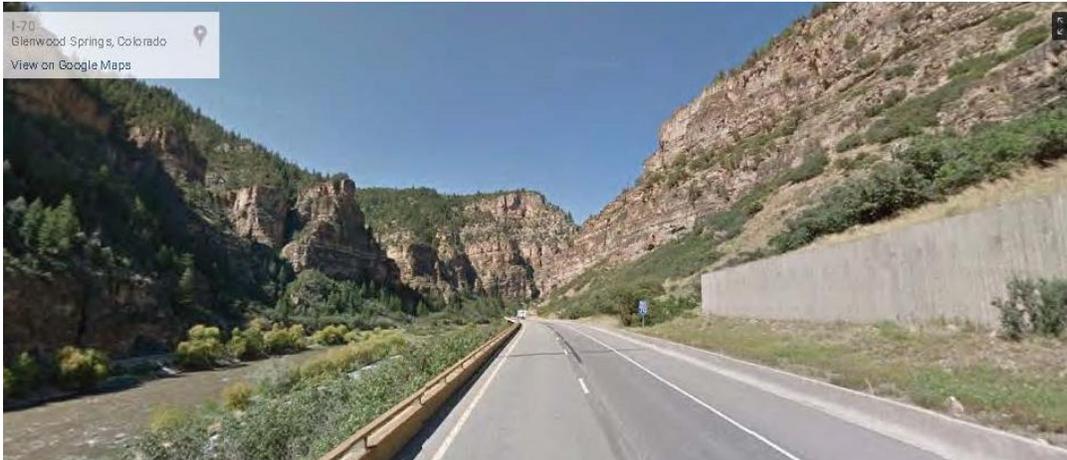
Site 6 –120.68 WB

View looking west at the primary features of Glenwood Canyon including steep rocky slopes, cliffs, natural vegetation and the Colorado River. The eastbound lanes are barely visible from this vantage point.

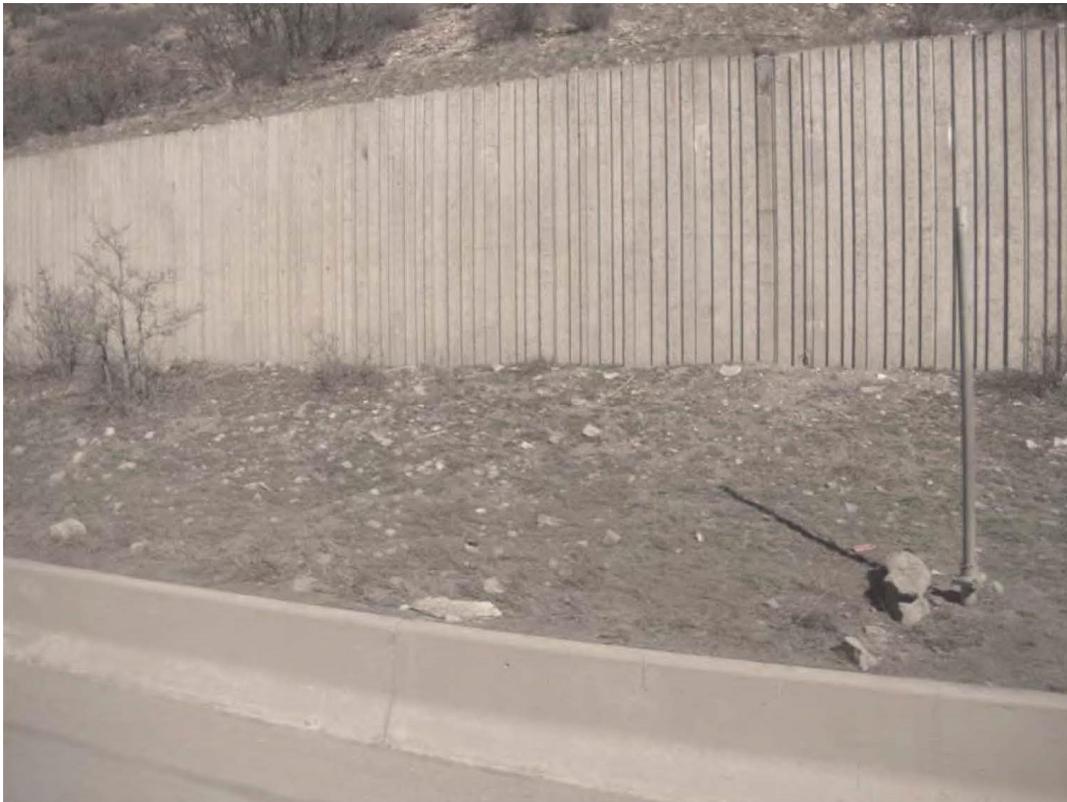
Site 6 –120.68 WB

View of the approximate location where the VSL sign would be placed along the retaining wall. The sign on the right is a yellow diamond deer crossing (warning) sign

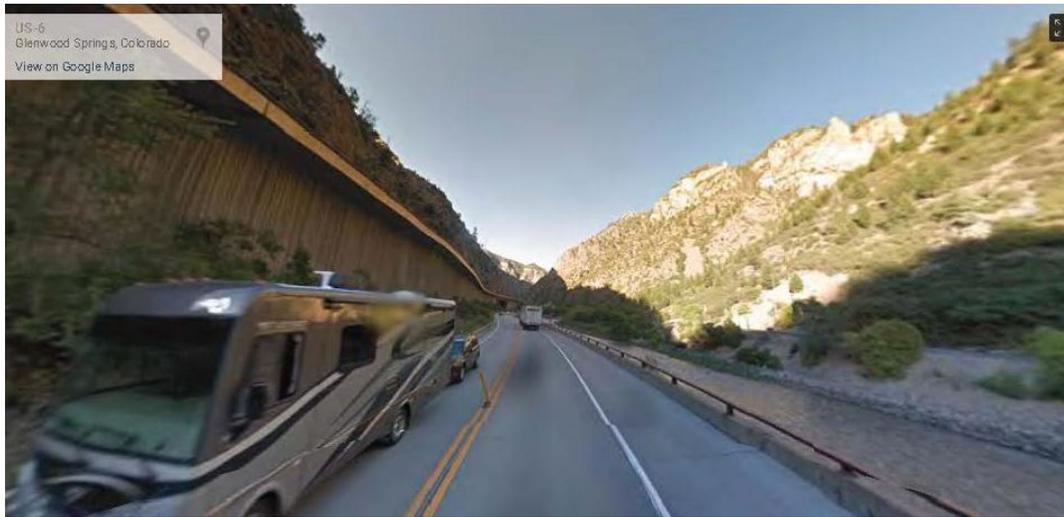
Site 7 – 121.73 EB

View looking east at canyon slopes and the Colorado River to the right and the split level construction of I-70 (retaining wall) to the left. The trail is located directly below the guardrail on the right.

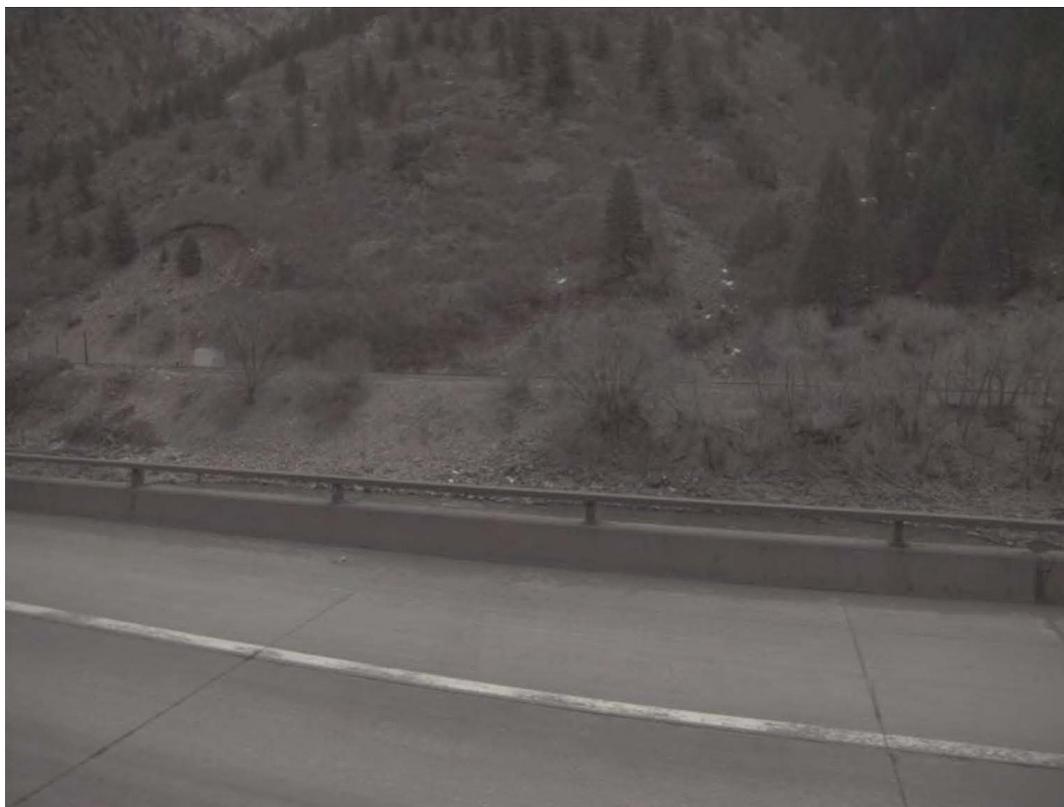
Site 7 – 121.73 EB

View of the approximate location where the VSL sign would be placed along the guardrail. The trail is located directly below the proposed sign. The railroad tracks are visible in the distance.

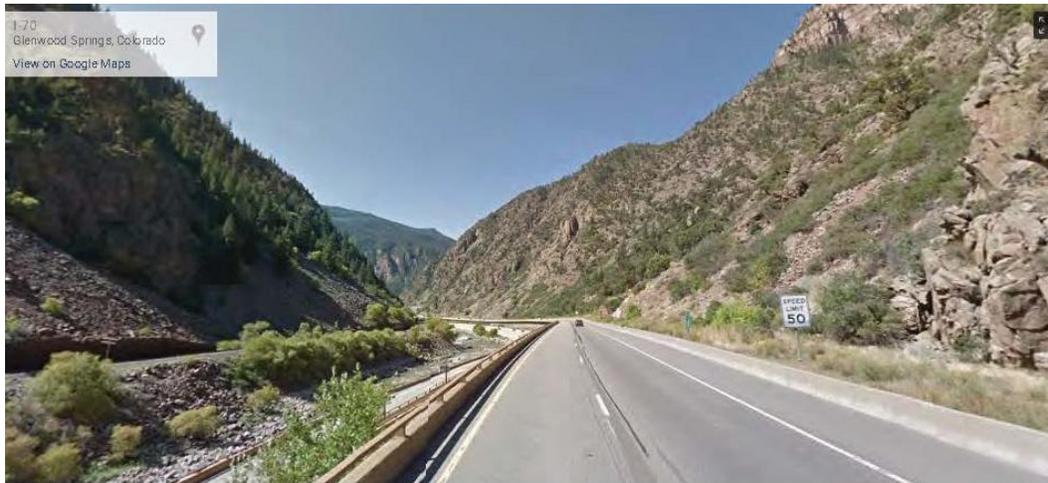
Site 8 - 122.45 WB

View looking west at the forested slopes on the left and rocky outcrops on the right. The westbound lanes and trail are located directly below the guardrail between the eastbound lanes and the Colorado River. The existing speed limit sign is visible on the right.

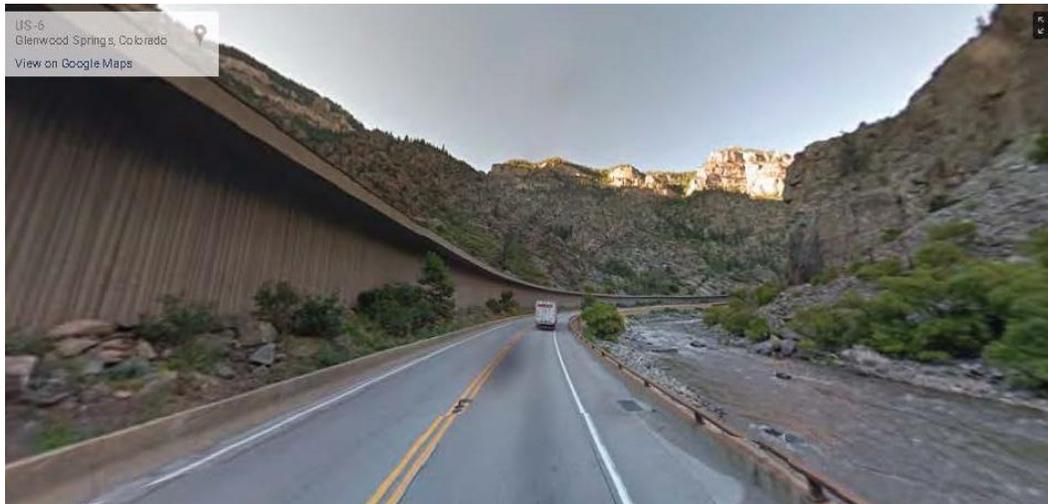
Site 9 - 123.20 EB

View looking east at distinct I-70 construction design elements on the left, the Colorado River on the right, and canyon cliffs and slopes visible in the distance.

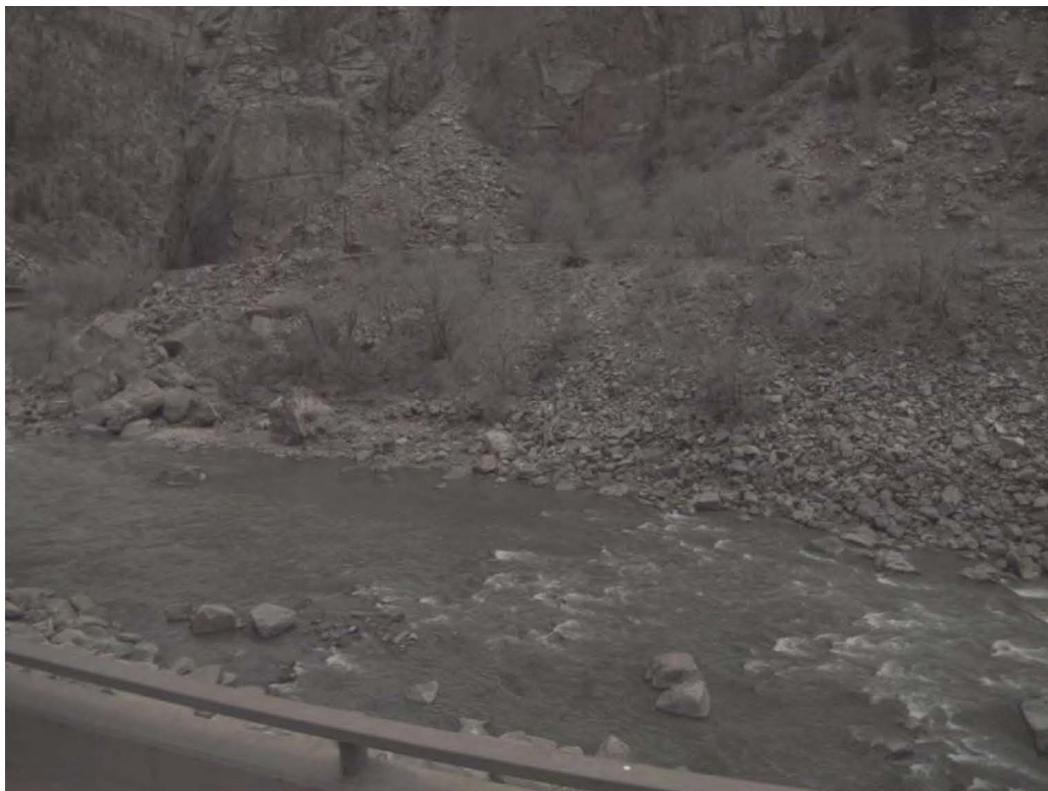
Site 9 - 123.20 EB

View of the approximate location where the VSL sign would be placed along the guardrail. The trail is located directly below the guardrail.

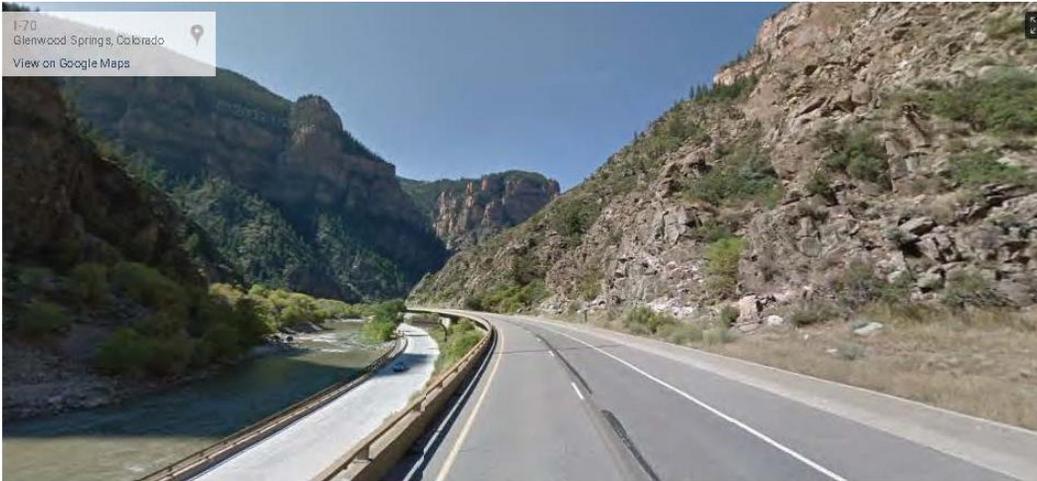
Site 10 - 124.50 WB

View looking west at the Colorado River on the left and scenic vistas including large cliffs and vegetated slopes of Glenwood Canyon in the distance.

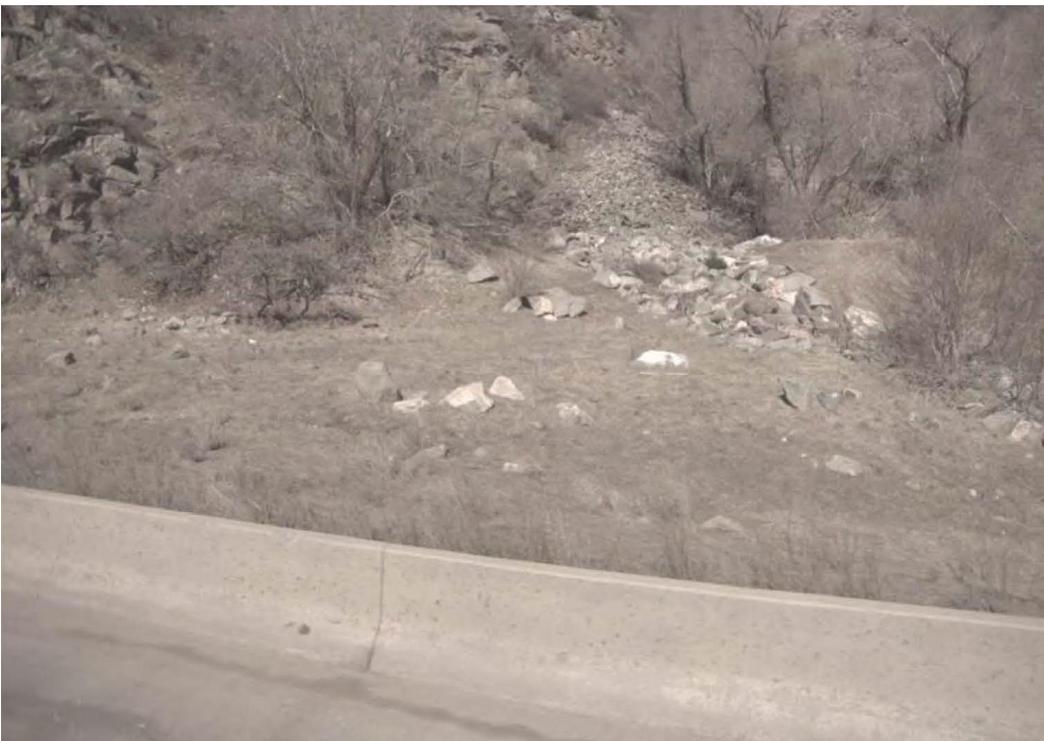
Site 10 - 124.50 WB

View of the approximate location where the VSL sign would be placed along the shoulder.

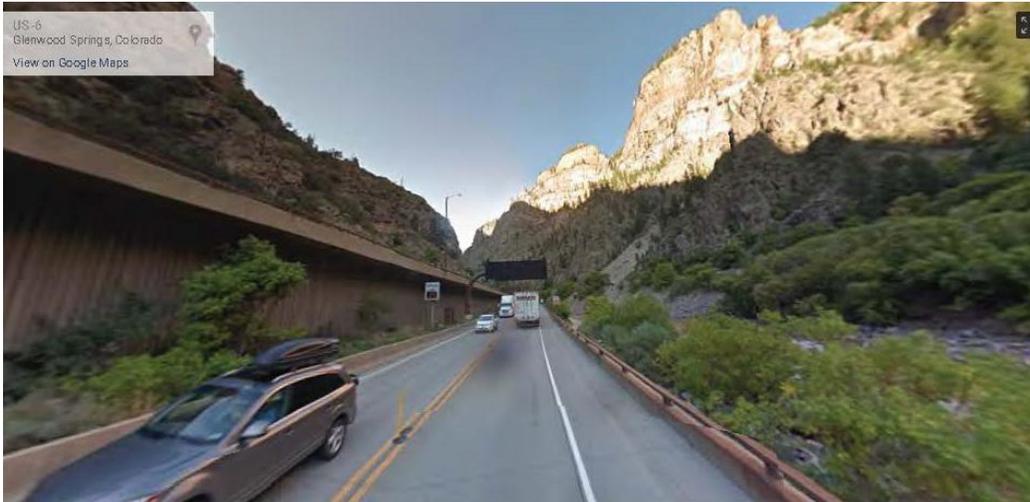
Site 11 and 12 - 124.64 EB

View looking east at exemplary I-70 construction design elements on the left, the Colorado River corridor on the right, and canyon cliffs in the distance. An existing VSL sign and overhead gantry sign are visible in the center of this image.

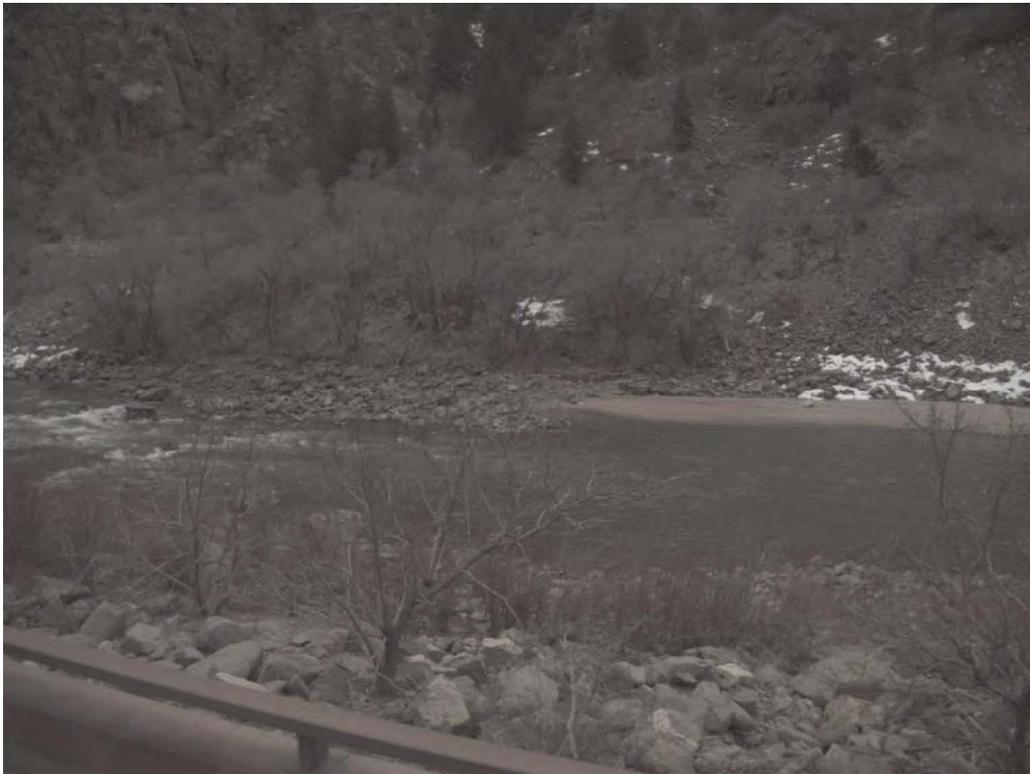
Site 11 and 12 - 124.64 EB

View of the approximate location where the VSL sign would be placed along the shoulder. The trail is located below the guardrail.

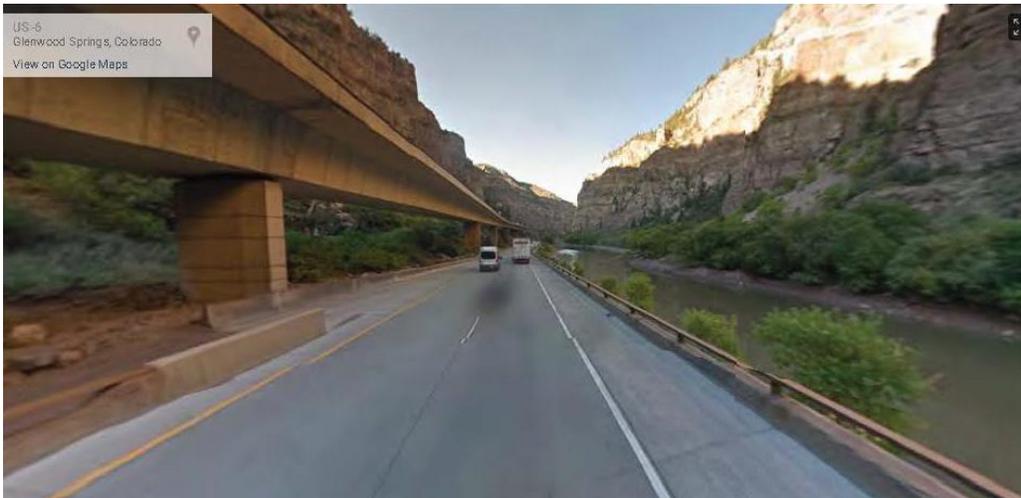
Site 13 - 126.07 EB

View looking east at classic I-70 construction design elements on the left, the Colorado River corridor on the right, and canyon walls framing the scene.

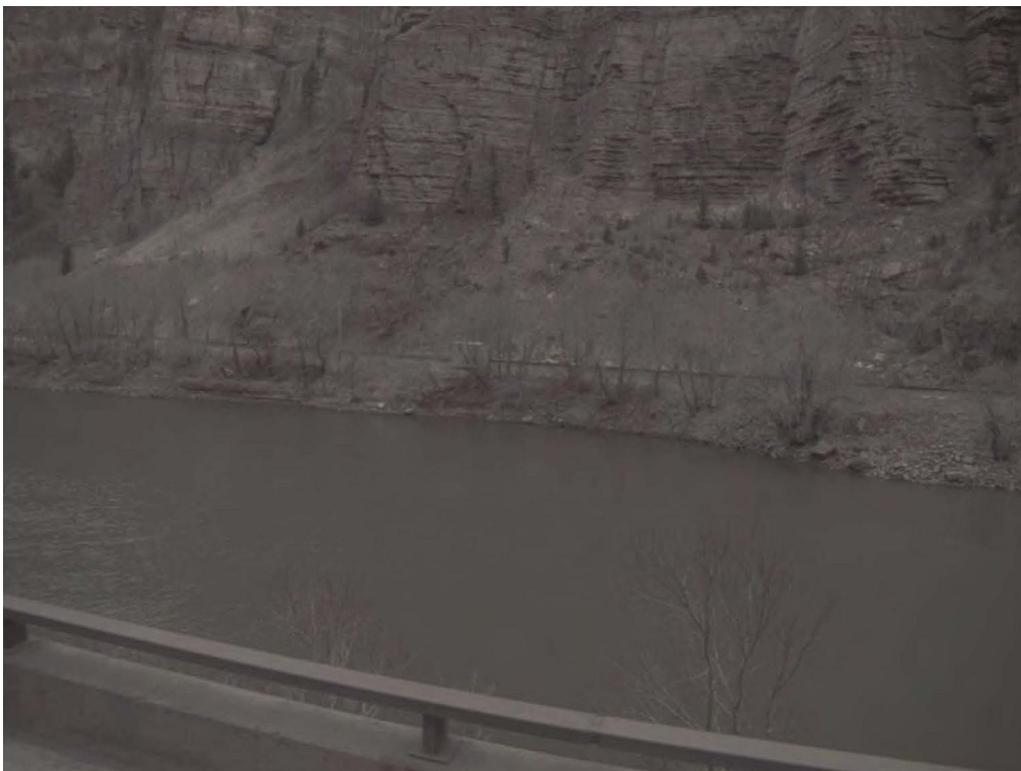
Site 13 - 126.07 EB

View of the approximate location where the VSL sign would be placed along the shoulder. The trail is located below the guardrail. The railroad tracks located along the other side of the Colorado River are visible through the center of this image.

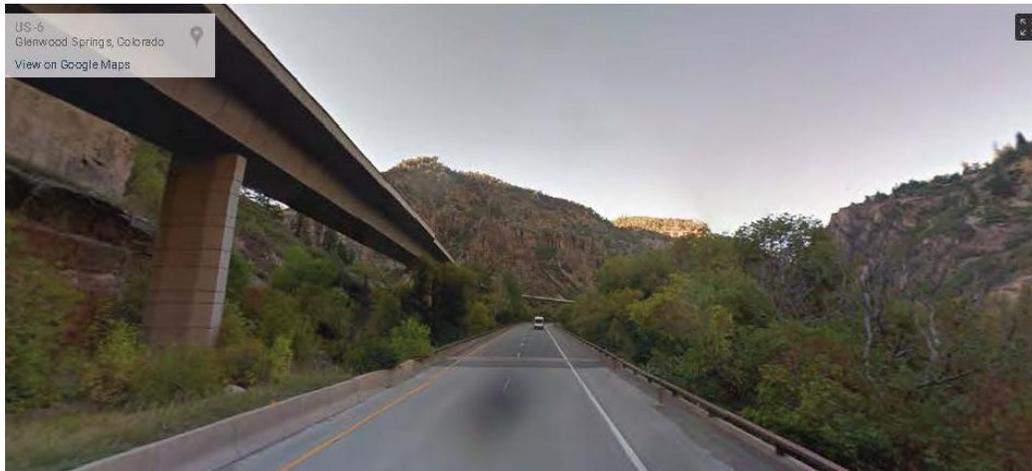
Site 14 - 127.56 EB

View looking east at iconic I-70 construction design elements on the left and the vegetated Glenwood Canyon corridor below and to the right.

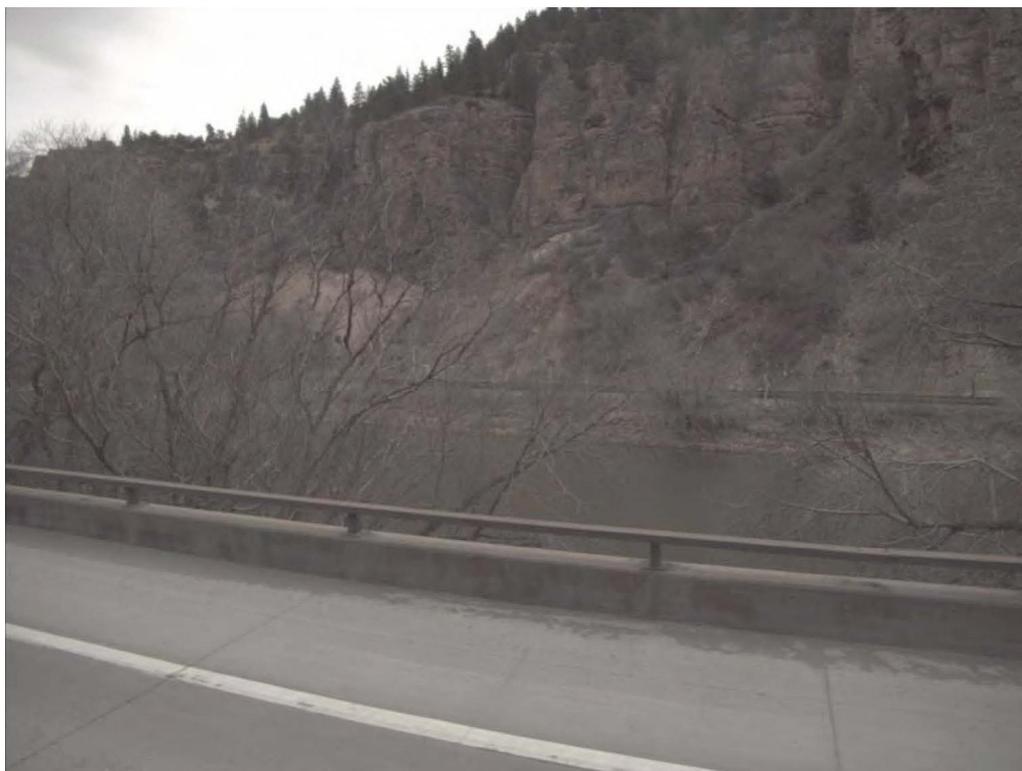
Site 14 - 127.56 EB

View toward the guardrail from a vantage point near Site 14. The trail is located below the guardrail. The railroad tracks located along the other side of the Colorado River are visible through the center of this image when no leaves are present.

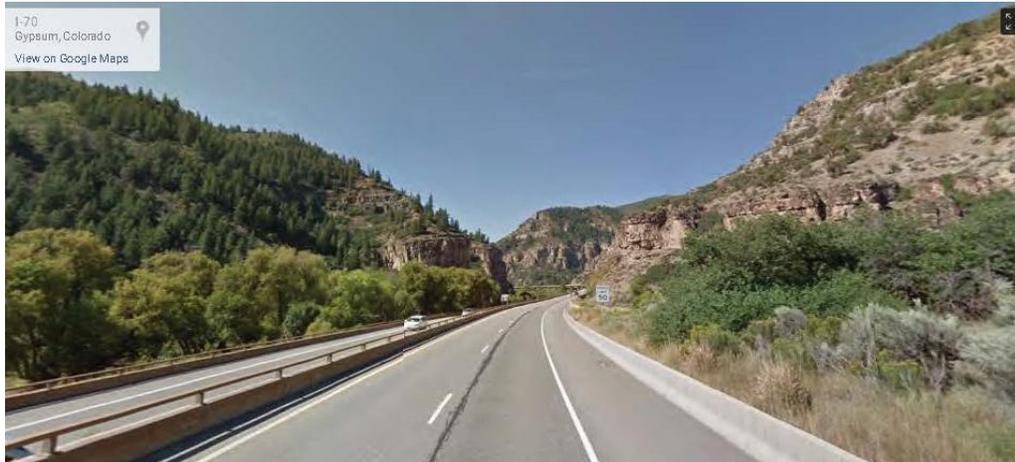
Site 15 - 128.13 WB

View looking east at I-70 construction design elements on the left and the vegetated Glenwood Canyon corridor. An existing speed limit sign is visible on the right side of the road near the center of this image.

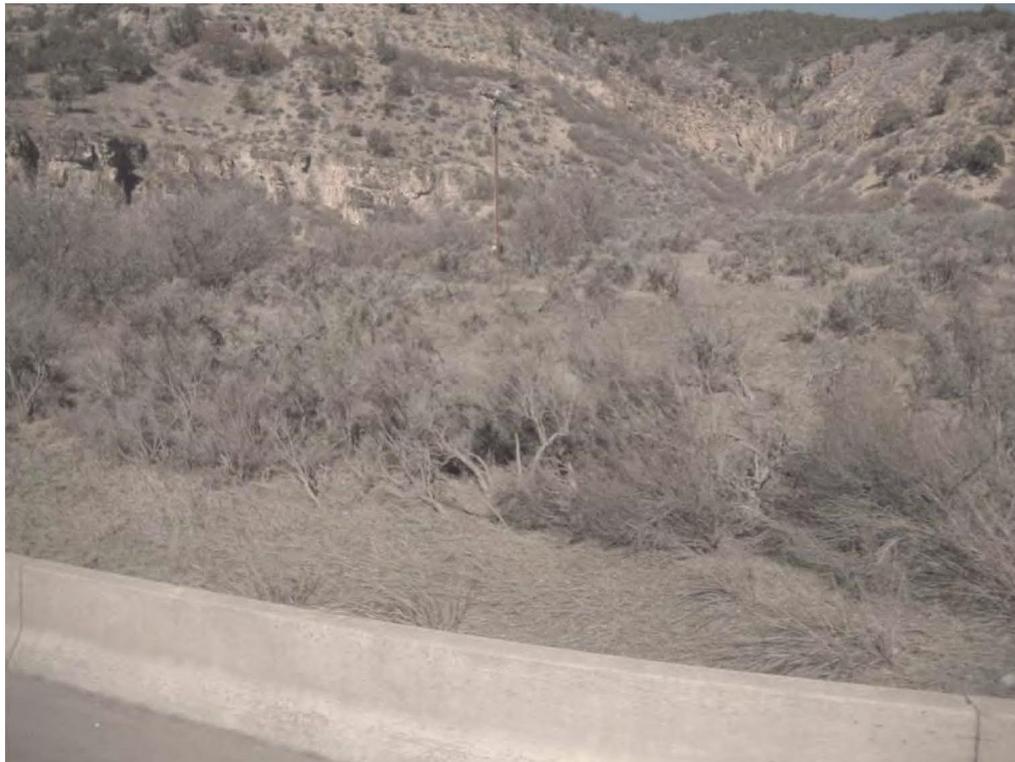
Site 15 - 128.13 WB

View of the approximate location where the VSL sign would be placed along the shoulder.

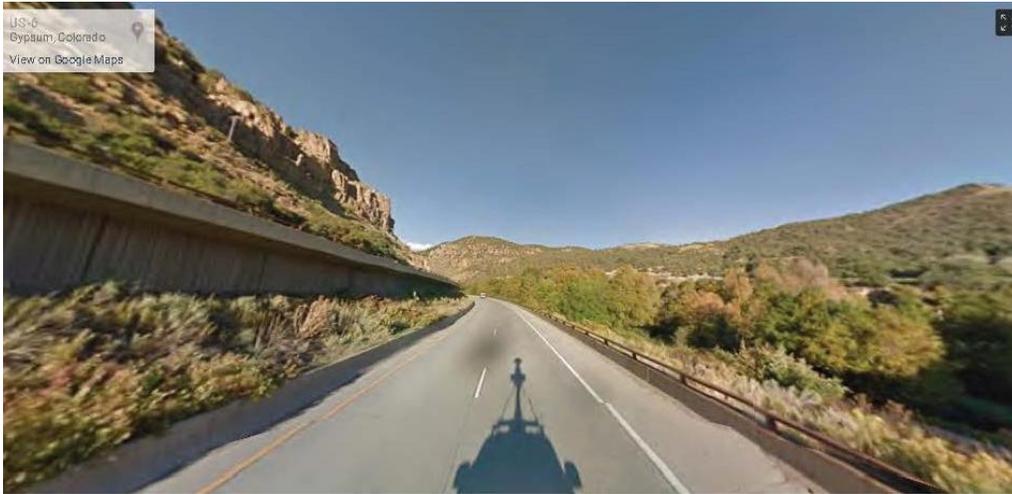
Site 16 - 128.13 EB

View looking east at I-70 design elements on the left and the vegetated Glenwood Canyon corridor.

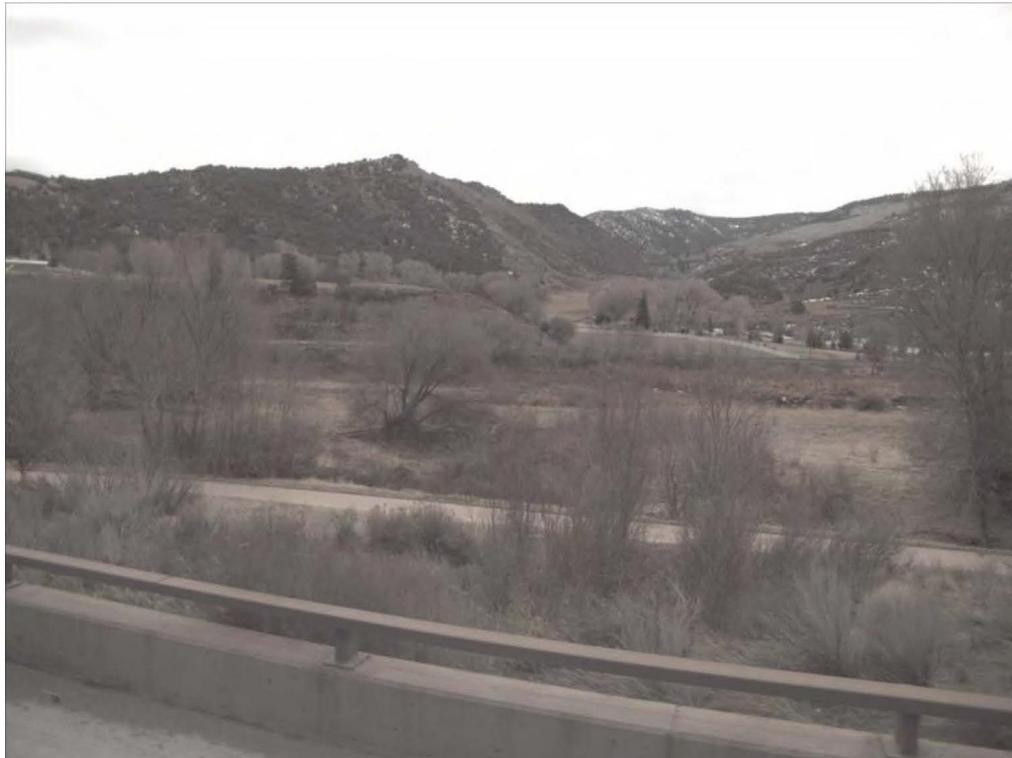
Site 16 - 128.13 EB

View of the approximate location where the VSL sign would be placed along the guardrail. The trail is visible across the middle of this image.

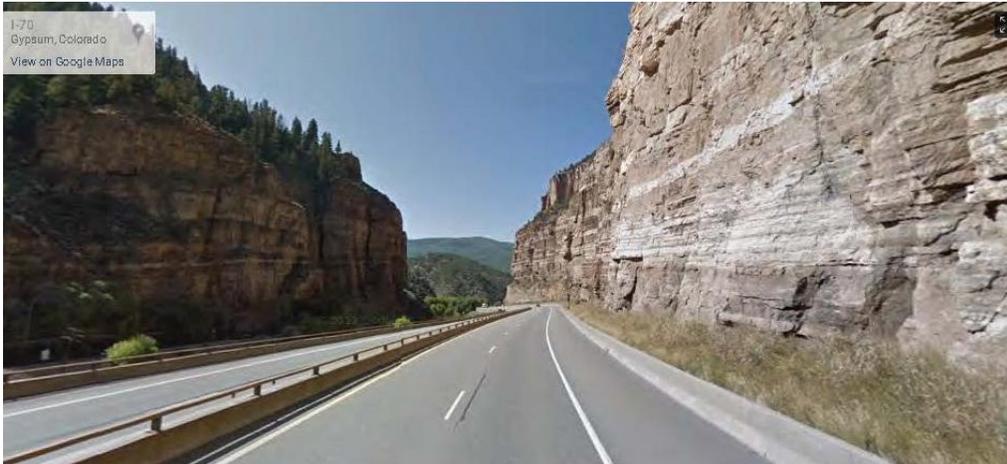
Site 17 - 129.66 WB

View looking west at the visually dominant steep cliff walls of Glenwood Canyon.

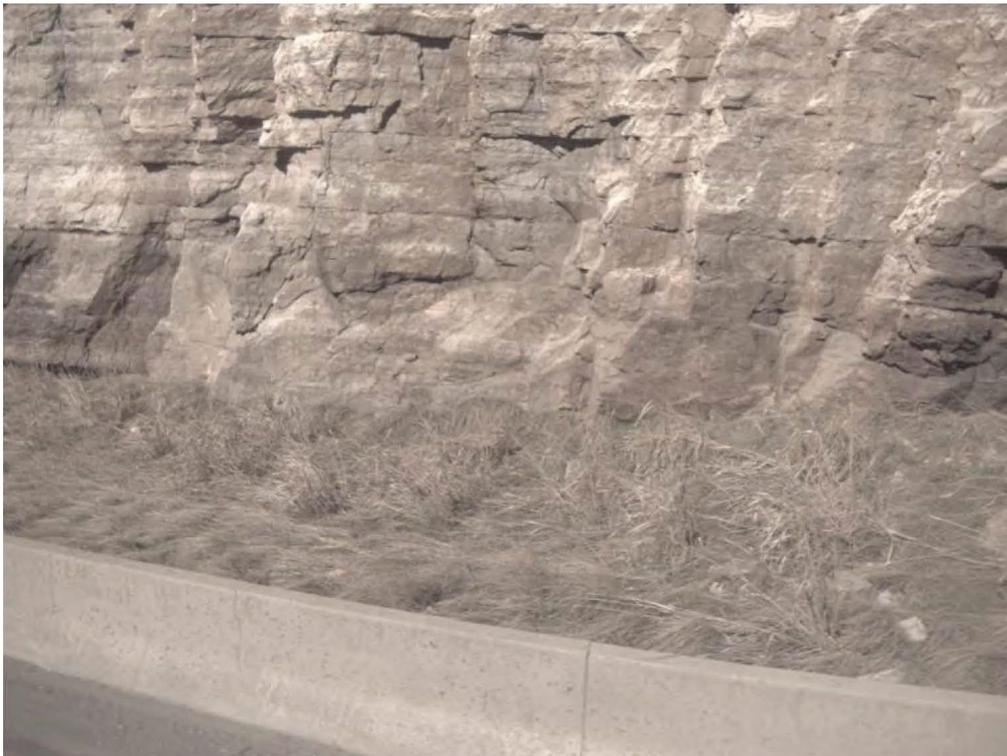
Site 17 - 129.66 WB

View of the approximate location where the VSL sign would be placed along the shoulder below the cliffs.

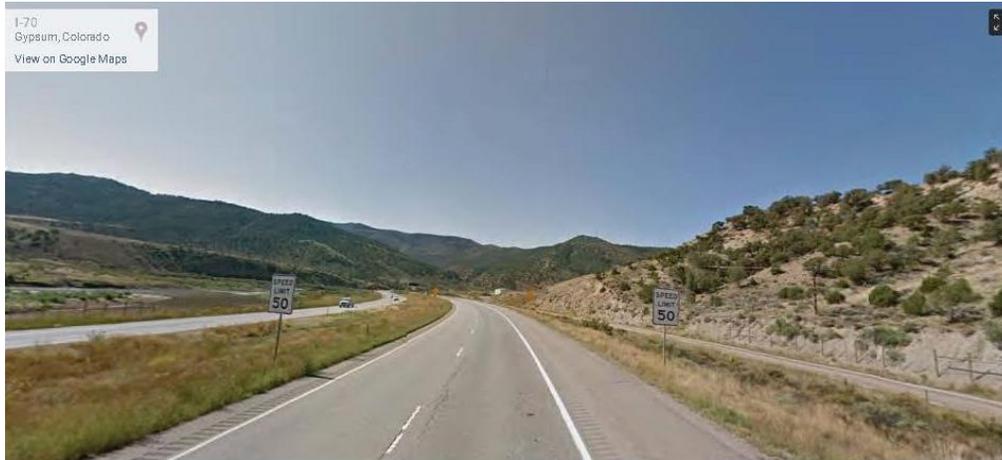
## Site 18 and 19 - 131.05 WB

View looking west at the broad, vegetated Colorado River valley and slopes located east of Glenwood Canyon. Two existing speed limit signs are visible in this location. Both signs would be replaced with VSL signs.
