I-70 GLENWOOD CANYON  
VARIABLE SPEED LIMITS

ABBREVIATED VISUAL IMPACT ASSESSMENT

FINAL

June 27, 2017

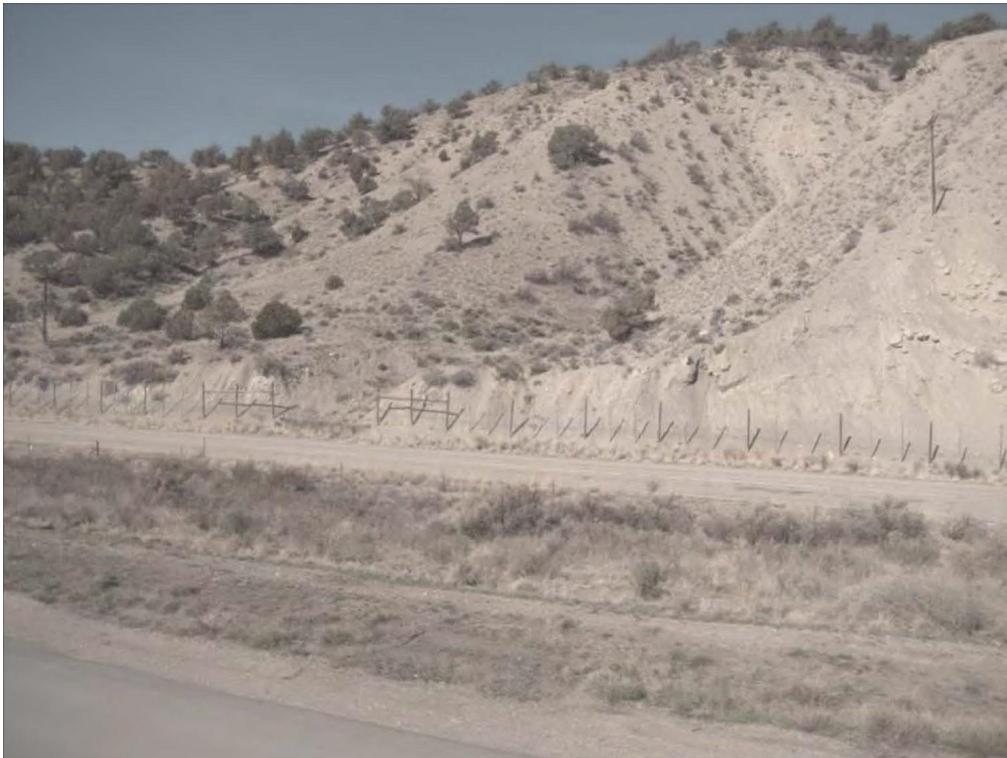
## Site 18 and 19 - 131.05 WB

View of the approximate location where one of the VSL signs would be placed. The trail is visible across the middle of this image. A frontage road along I-70 is visible across the middle of this image and the image above. A Glenwood Canyon Trailhead with a parking lot and restroom is located approximately 0.4 miles further west. This trailhead provides a starting point or a turnaround point for some Glenwood Canyon trail users.

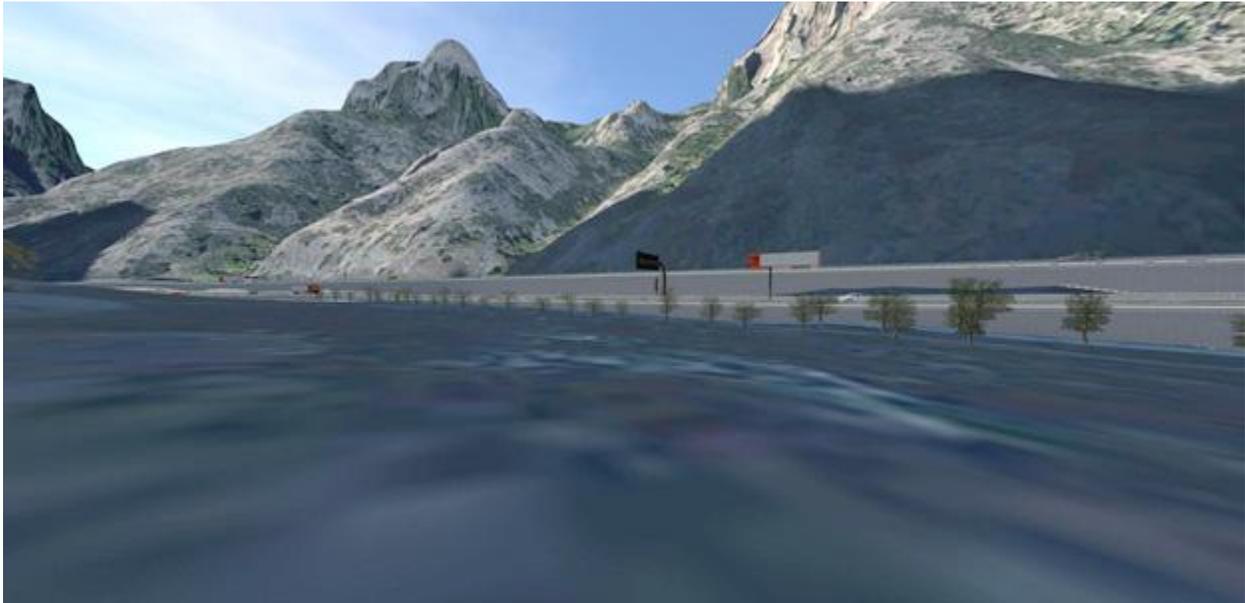
View from the river looking northwest (downstream) toward milepost 124.66 with vegetation screening. One of the signs is located in front of the truck on I-70 with the red cab. The other sign is located just behind the truck cab. The existing overhead gantry sign in this location is visible above the sign on the left. The signs look like vertical lines from this vantage point.

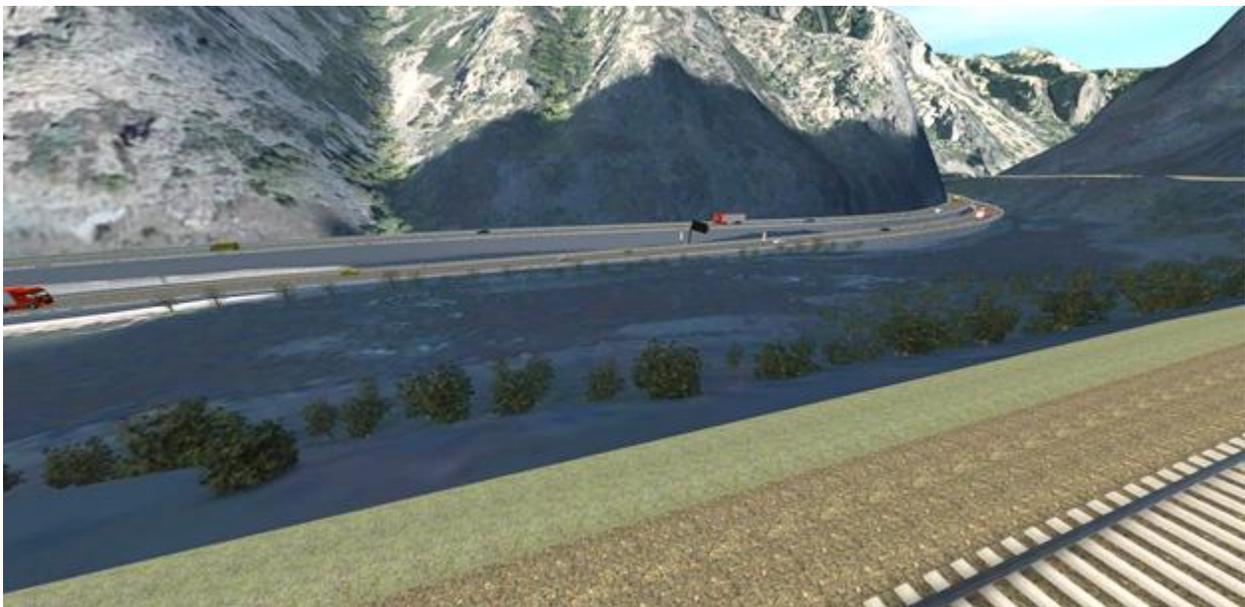
View from the railroad looking northeast (upstream) toward milepost 124.66 with vegetation screening at a distance of approximately 370 feet. This vantage point represents a railroad site that is one of the closest locations to I-70. Two white VSL sign fronts are visible near the existing overhead gantry sign adjacent to the truck on I-70 with the red cab.

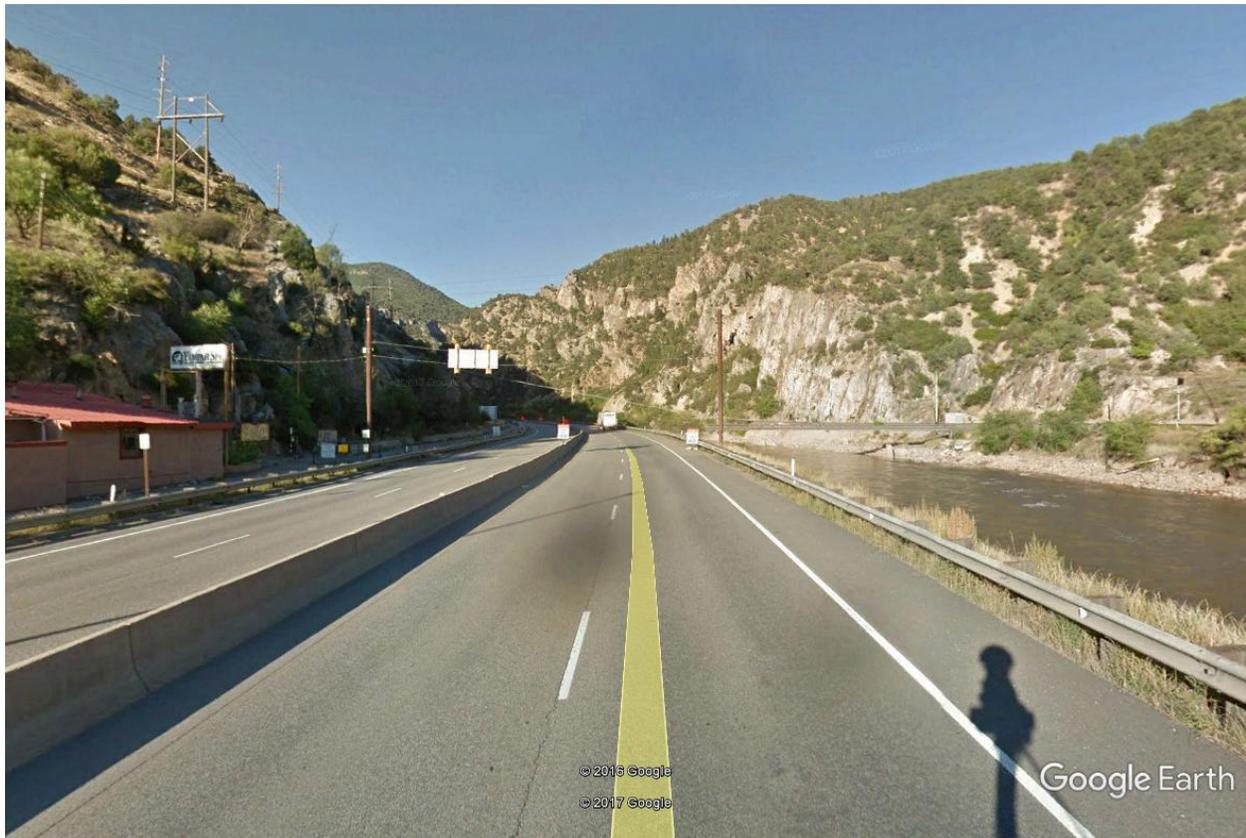
Site 1 – 116.89 EB (Pre-VIA/Post VIA)

Relocation of this EB sign to be located on the right shoulder to the east or west along the guardrail would not modify visibility for motorists who need to see the sign or reduce visual impacts from the trail, river or railroad because of high exposure and a lack of vegetation in this corridor location. Relocation of the sign to the median is not possible due to a lack of median width and a lack of access to fiber in the median.

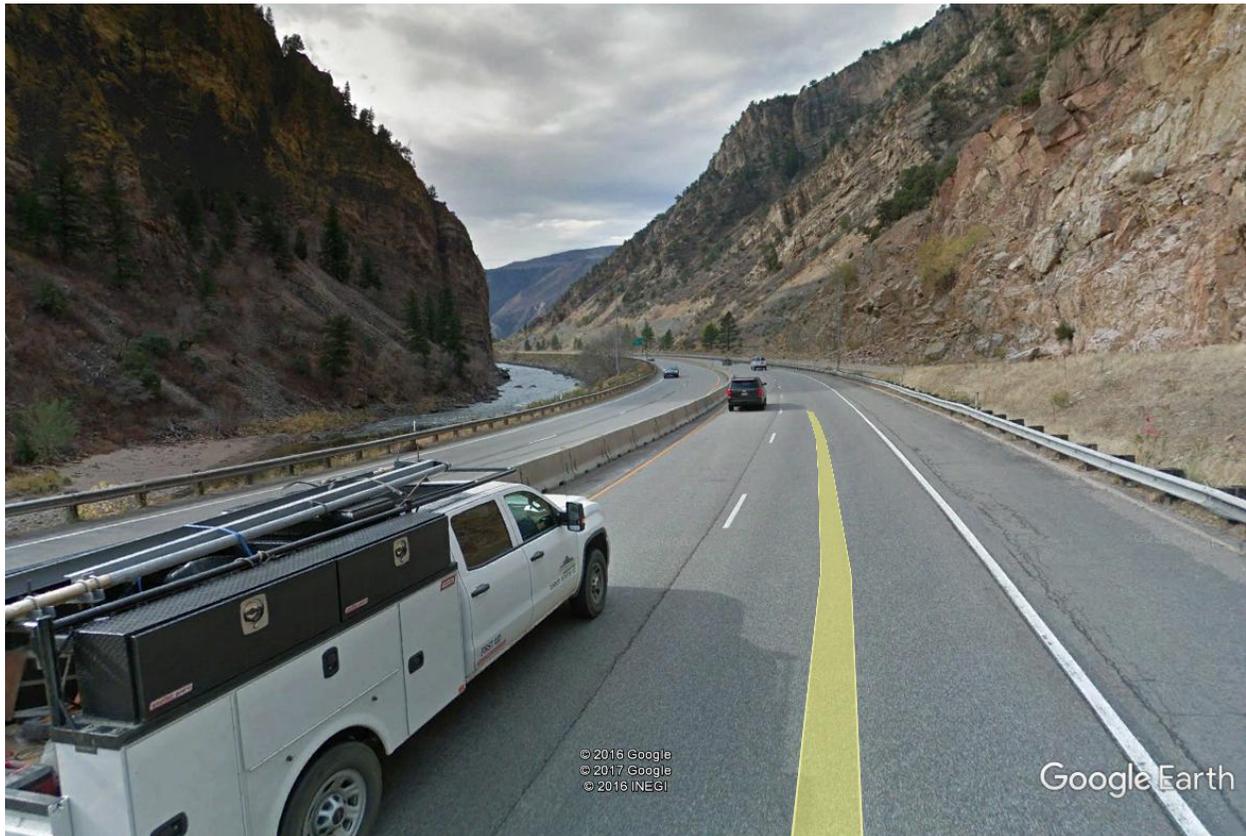
Site 2 – 117.68 WB (Pre-VIA/Post VIA)

Relocation of this WB sign on the right shoulder to the east or west would not modify visibility or visual impacts from any vantage point because of high exposure and a lack of vegetation. Relocation to the median increases visual impacts and is not possible due to a lack of median width and a lack of access to fiber in the median.

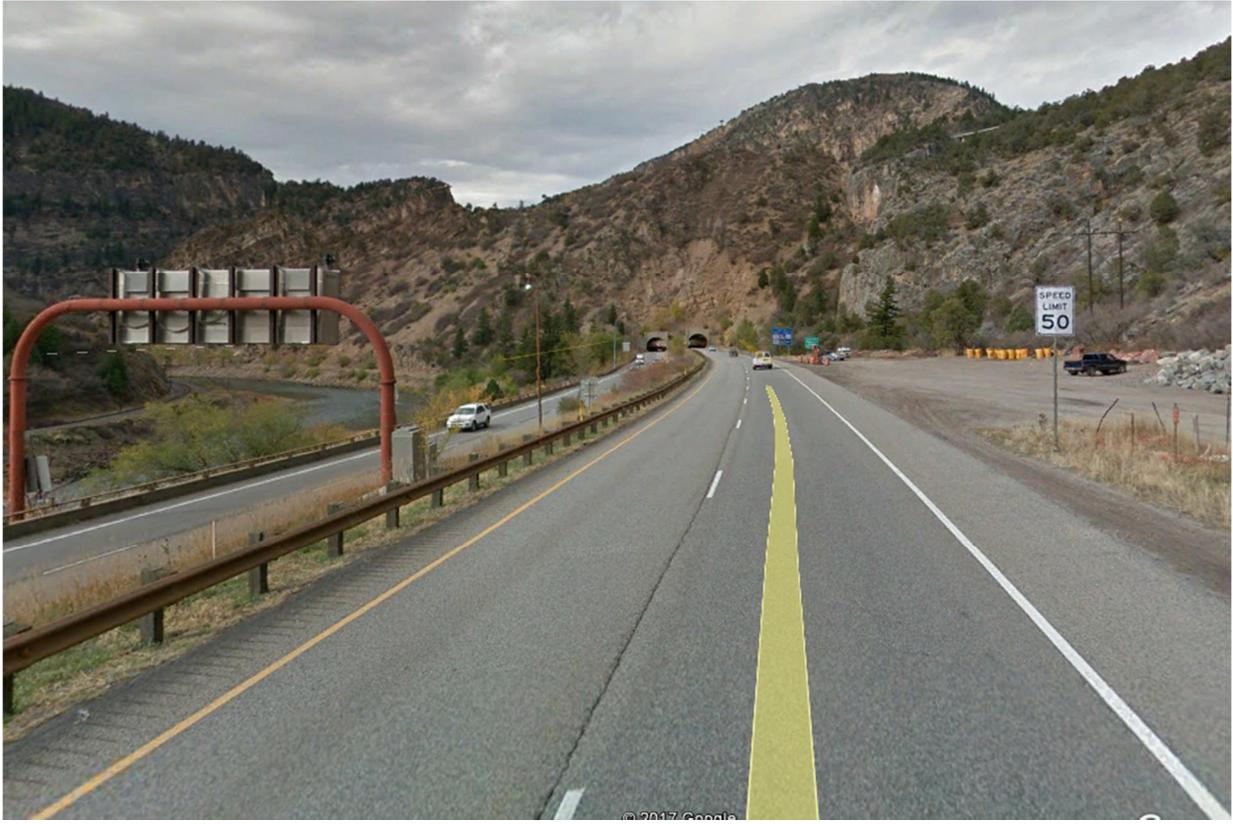
Relocation of this median sign to a location further east (in front of the existing overhead gantry sign post) from this vantage point was selected to reduce visual impacts for motorists viewing the sign from either side. Relocation of this sign to the right shoulder could reduce visual impacts from all vantage points, but would require introduction of guardrail and other visually intrusive elements due to the high exposure and a lack of safe places to move the sign in the vicinity of the pull-off area. A location closer to the tunnel does not provide sufficient distance between the sign and the tunnel portal.

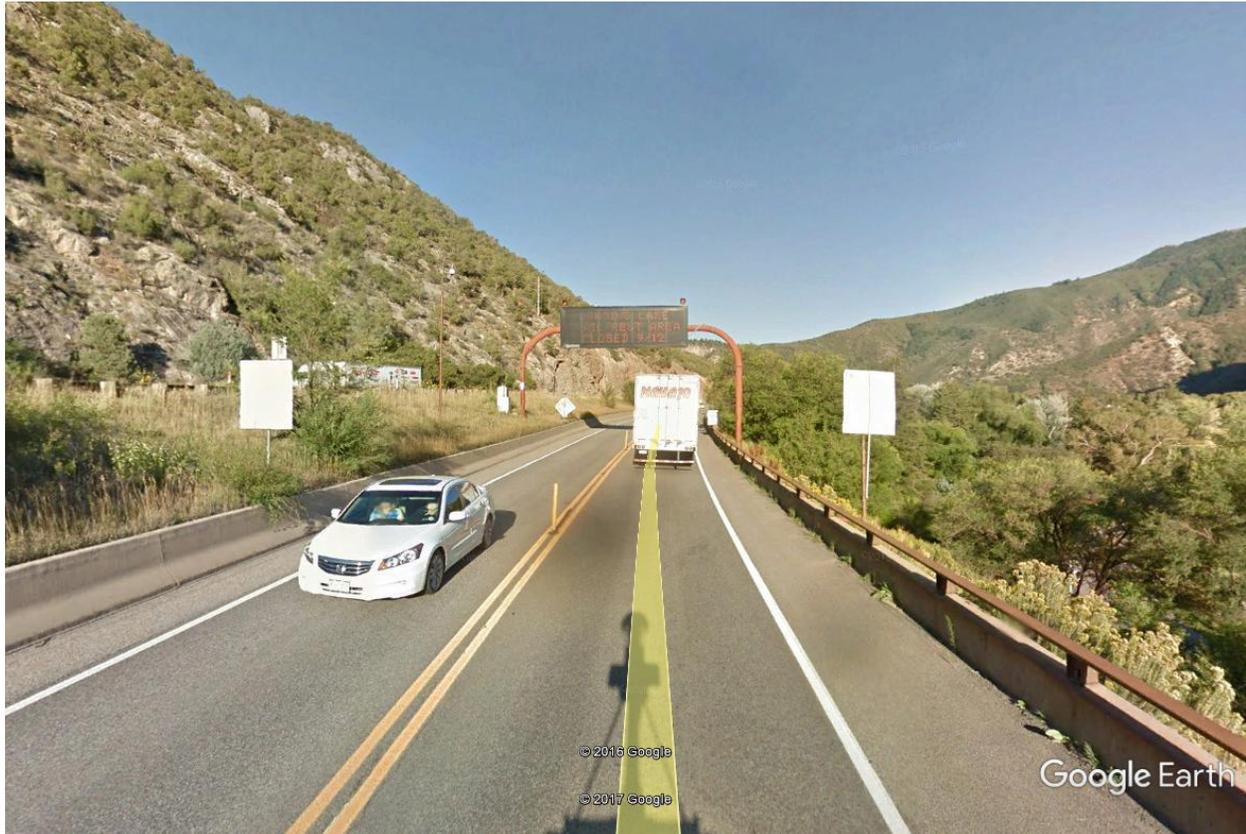
Relocation of this sign from the right side to the median and to a location in front of the existing overhead gantry sign post would reduce visual impacts from all vantage points.

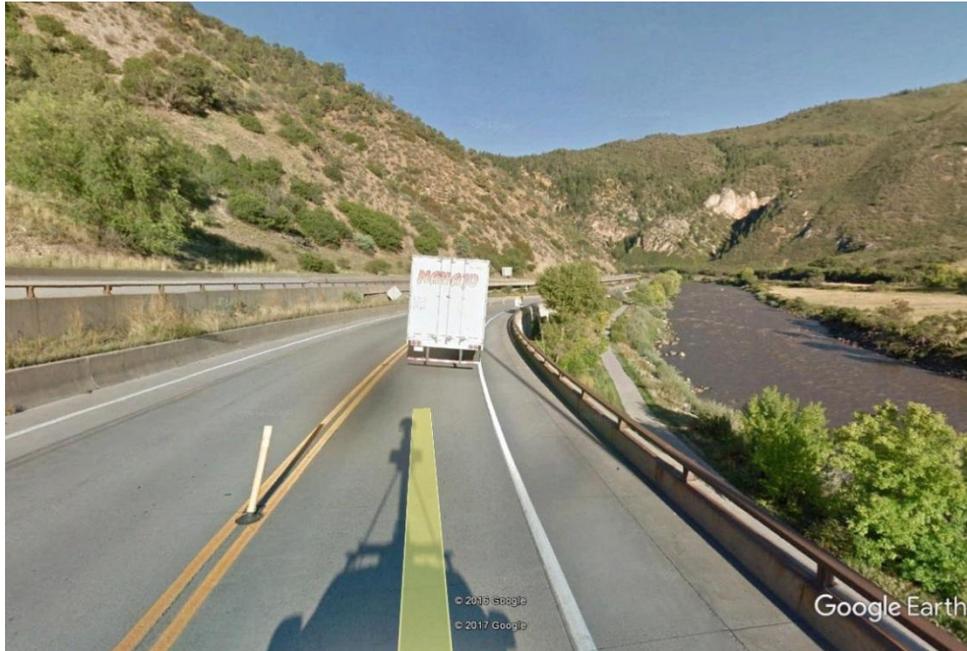
Relocation of this EB sign on the right shoulder to a location near the tree on the right beyond the truck in this image can reduce visual impacts from the trail, by WB motorists (opposite) direction and from the railroad and river. The tree will not impact visibility of the sign by motorists traveling in this direction (EB).

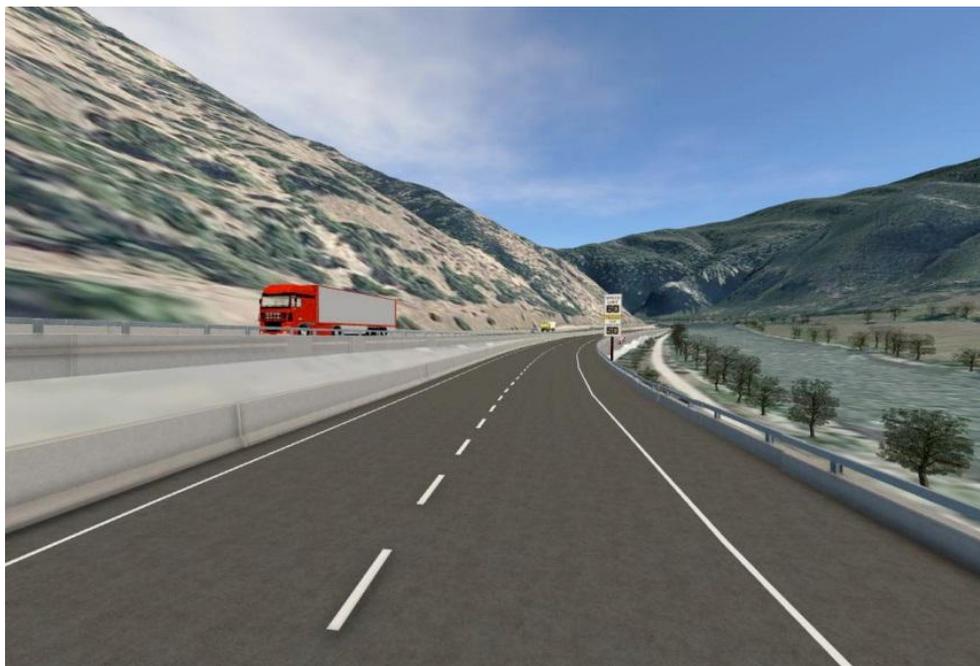
This 3d model image was used to evaluate the sign location from multiple vantage points and shows the approximate location of the relocated sign.

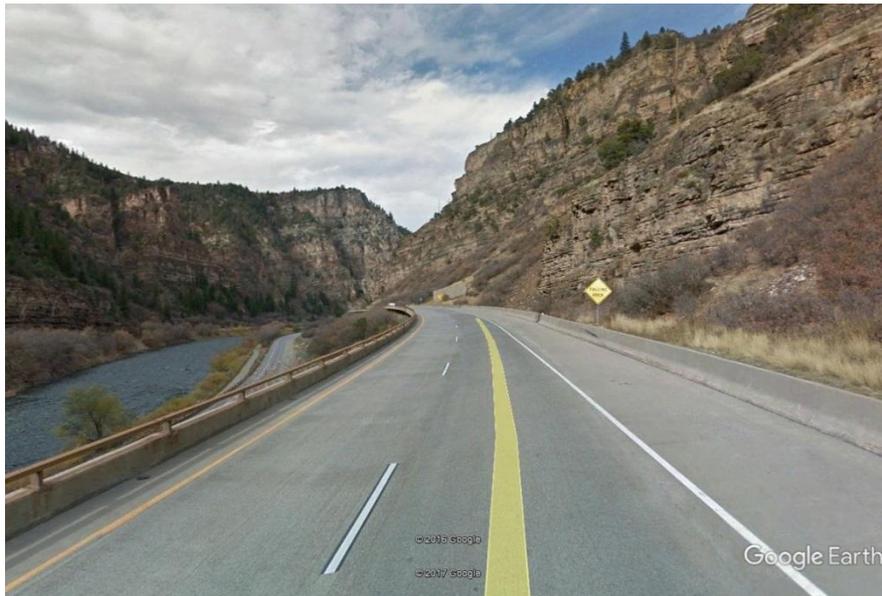
Relocation of this WB sign on the right to a point further west where the vegetation along the road ends and the retaining wall begins would reduce visual impacts for WB motorists and would not increase visual impacts from other vantage points. The second yellow sign (deer crossing) would be relocated to make room for the relocate VSL sign.

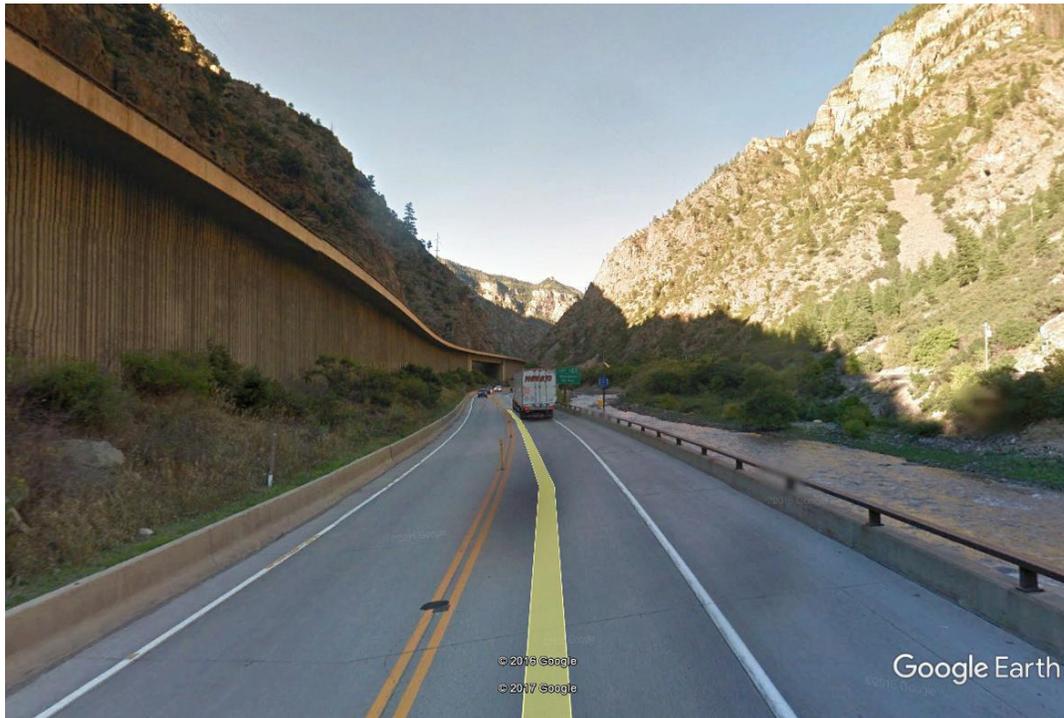
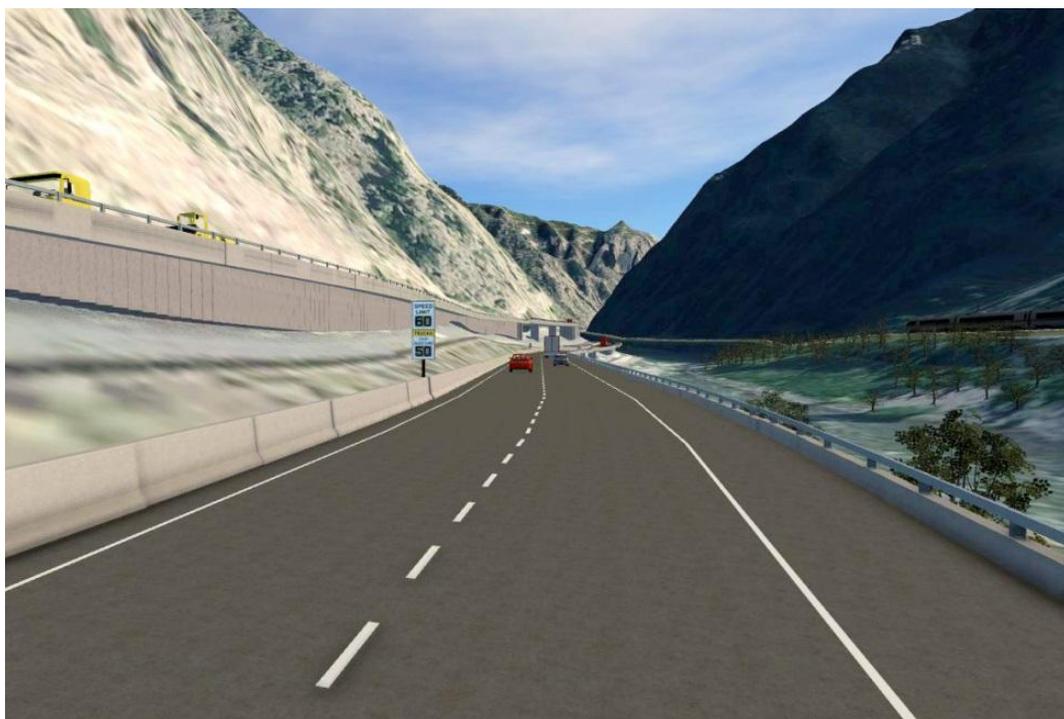
Site 7 – 121.73 EB (Pre-VIA/Post VIA)

Relocation of this EB sign in the median would not reduce visual impacts from roadway, trail, river or rail vantage points, but keeping the sign low to the ground in the median with a low mount would help reduce visual effects, including views by WB motorists of the back of the sign.

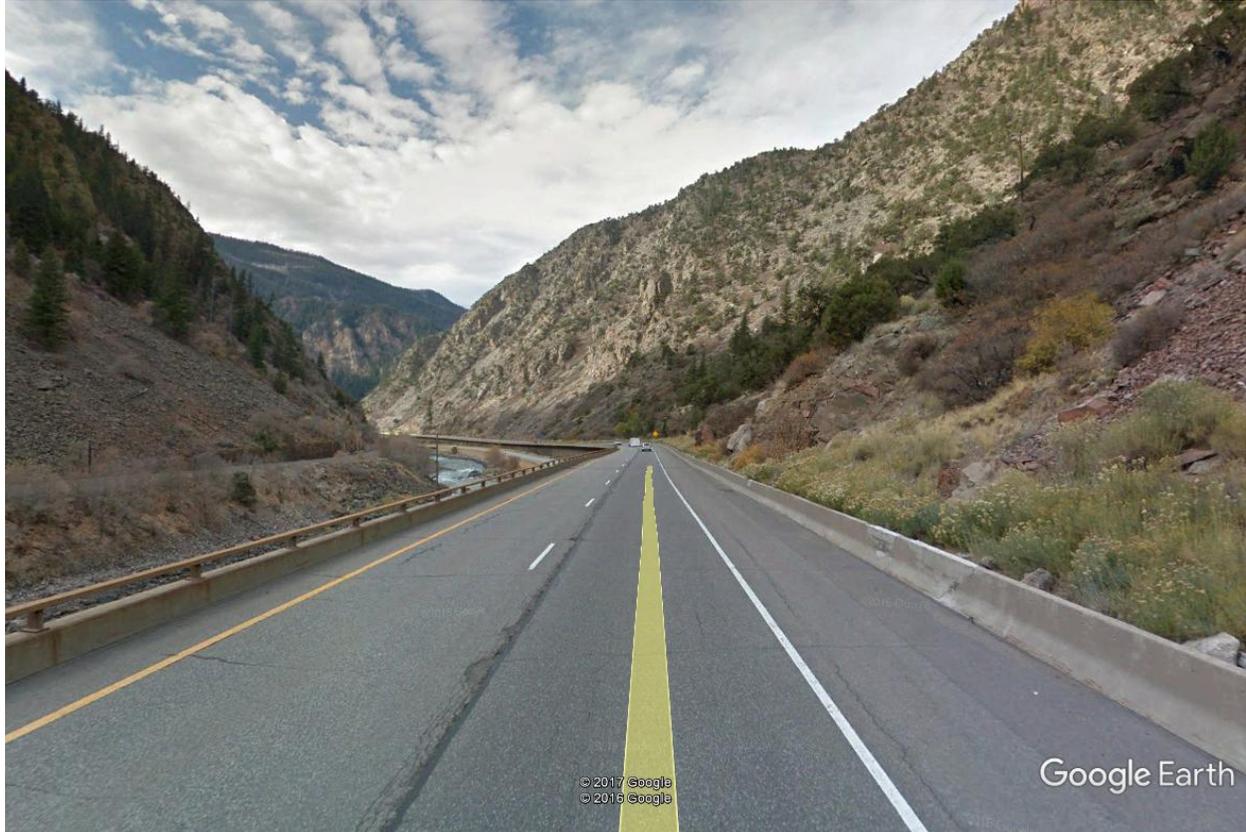
Site 8 – 122.45 WB (Pre-VIA/Post VIA)

Relocation of this WB sign on the right shoulder cannot be minimized by moving the sign east or west due to the relatively uniform conditions on the right side of the road. Placing the sign anywhere in the median would be highly visible from all other vantage points.

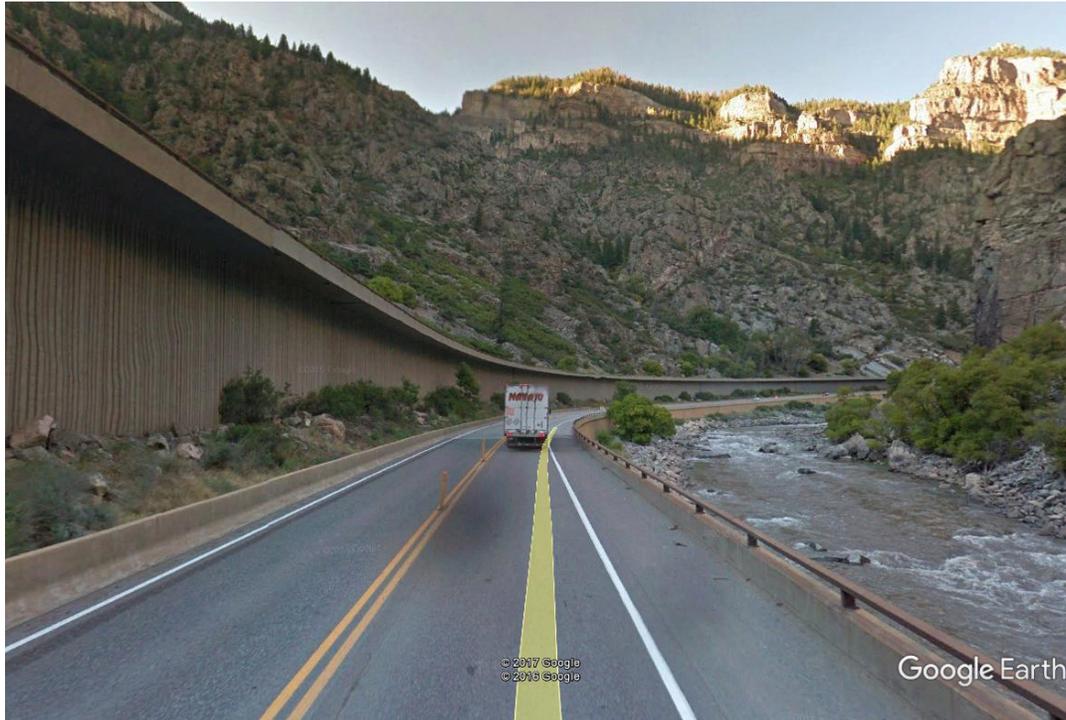
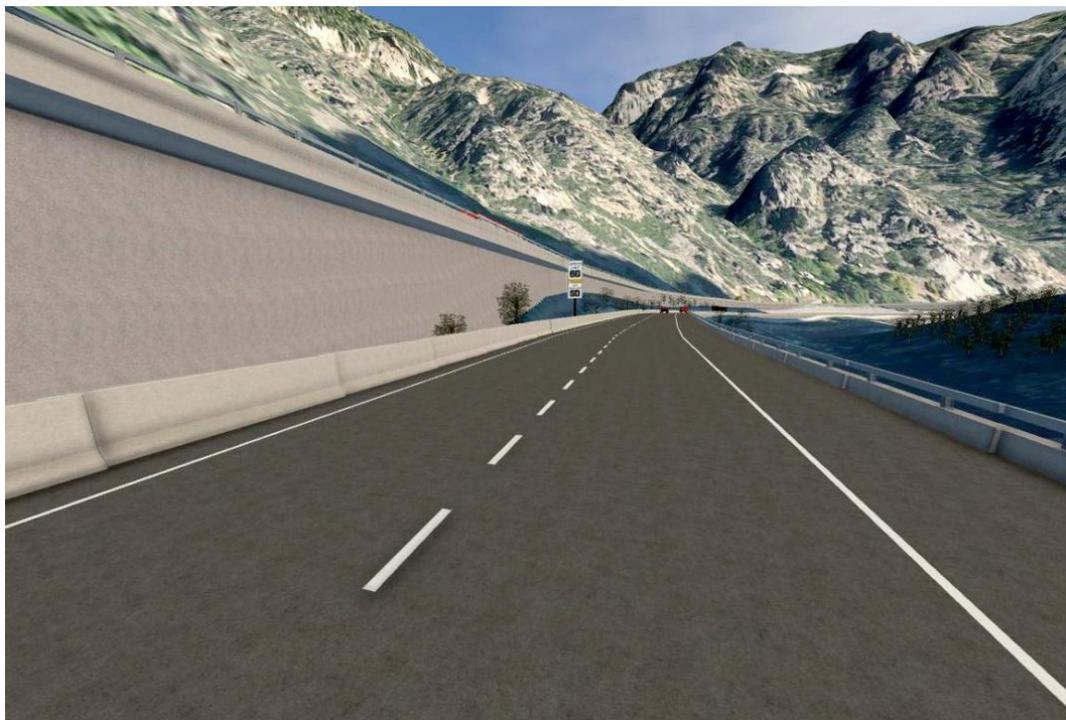
Relocation of this EB sign in the median would not reduce visual impacts, but keeping the sign low to the ground with a low mount would help address visual effects from all vantage points. The placement of the sign is shown in the 3d image.

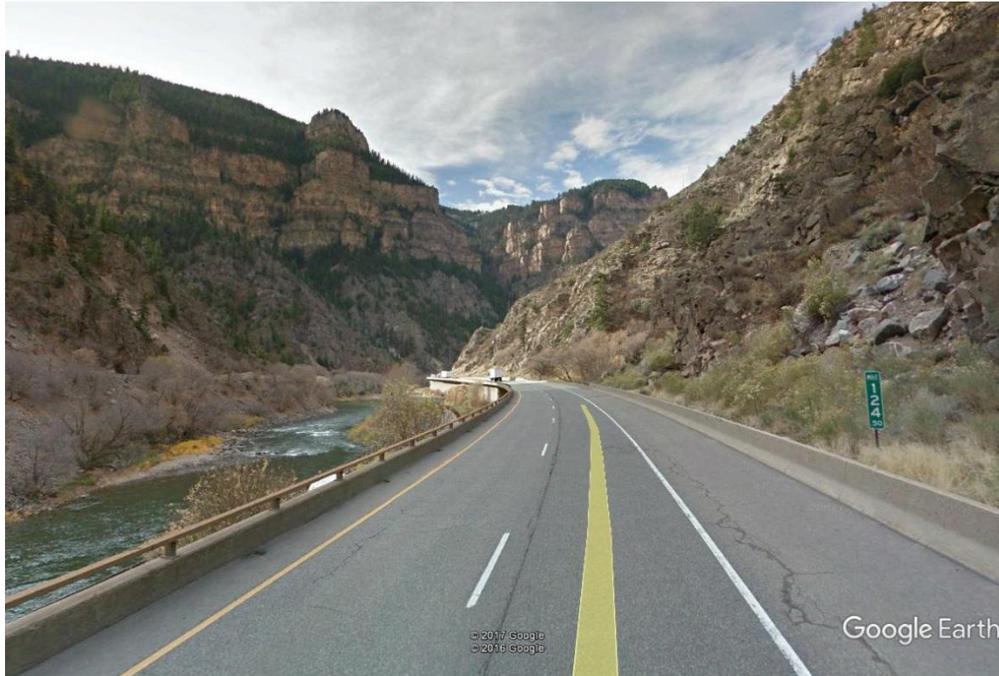
Site 10 – 124.50 WB (Pre-VIA/Post VIA)

Relocation of this WB sign on the right shoulder cannot be minimized by moving the sign east or west due to the relatively uniform conditions on the right side of the road. Placing the sign anywhere in the median would be highly visible from all other vantage points.

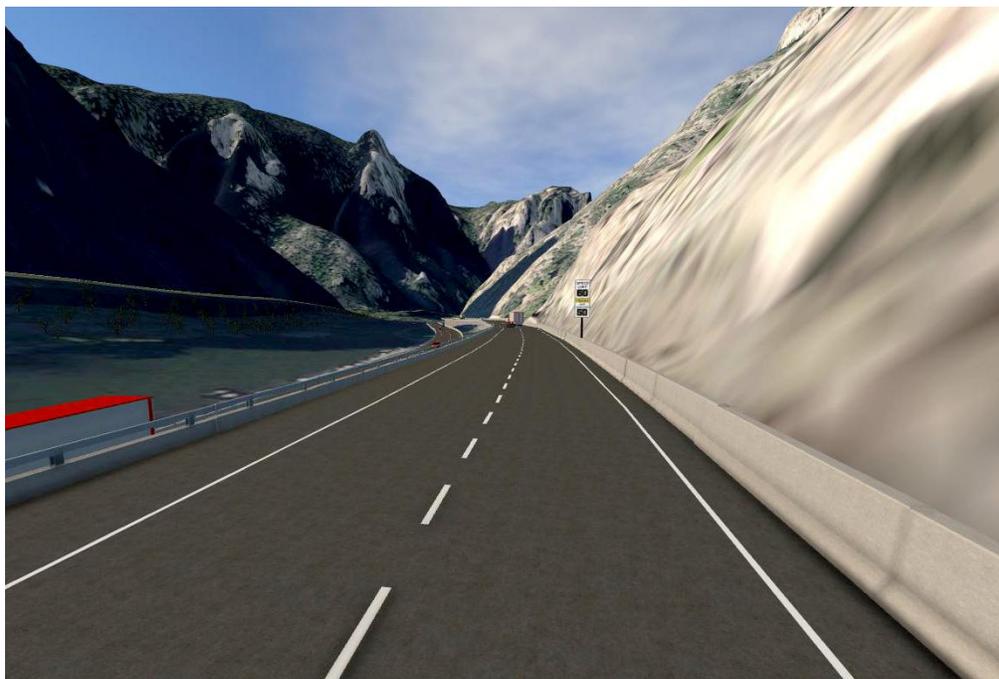
This 3d image shows the approximately location of Site #10.

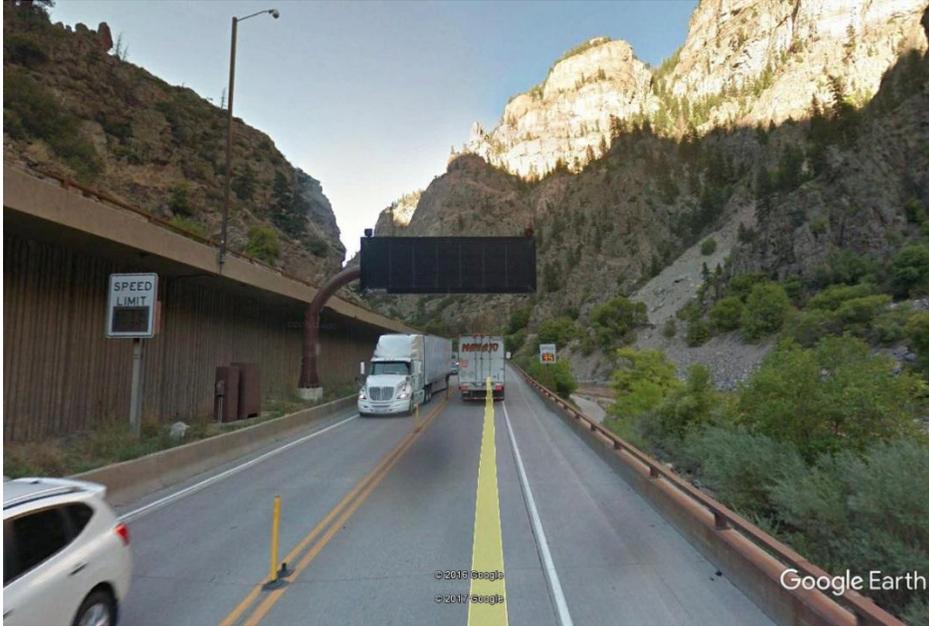
Site 11 – 124.64 EB, Left (Pre-VIA/Post-VIA)  
Site 12 – 124.64 EB, Right (Pre-VIA)

Existing VSL signs and an existing overhead gantry sign are shown in this image. The nearby trail is visible on the right.

Relocation of the sign in the right shoulder was recommended to minimize the visual impacts to the trail where the trail is next to and slightly under the roadway deck. The new location, further to the east of the original site, is screened from view from the trail by existing vegetation and bridge deck.

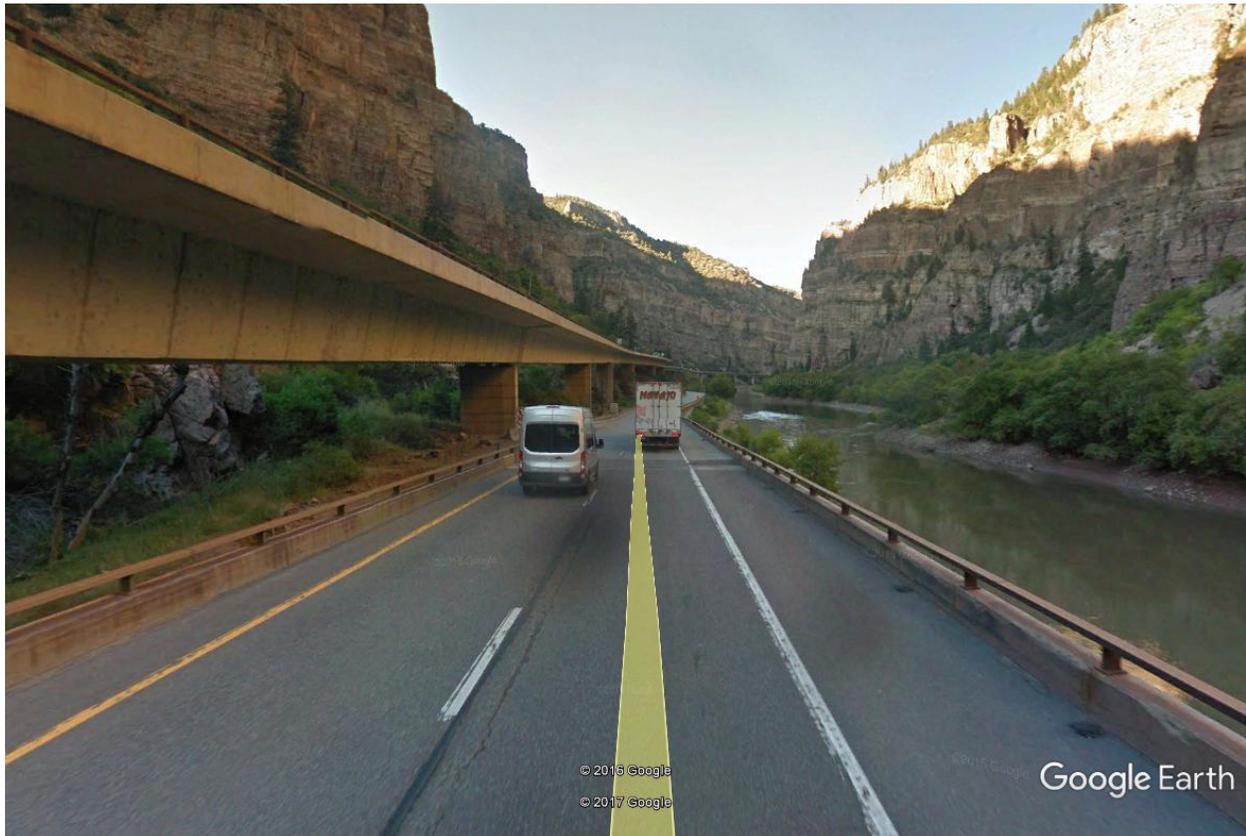
Relocation of the sign in the right shoulder to the median was feasible here given the location of required fiber connections in the median. This placement would reduce visual effects from all vantage points.

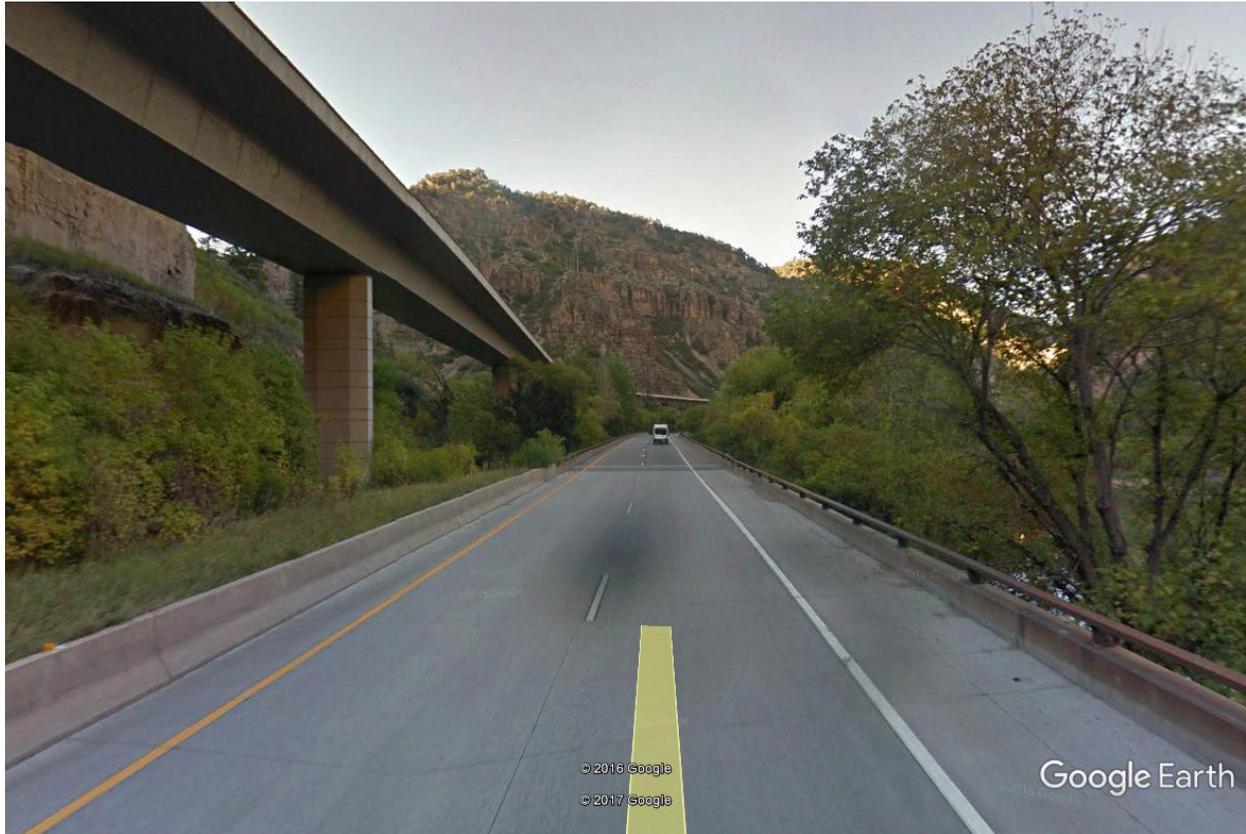
Site 14 – 127.56 EB (Pre-VIA/Post-VIA)

Relocation of the sign on the left to the east or west would not reduce visual impacts. Relocation of the sign to the guardrail would increase visual impacts.

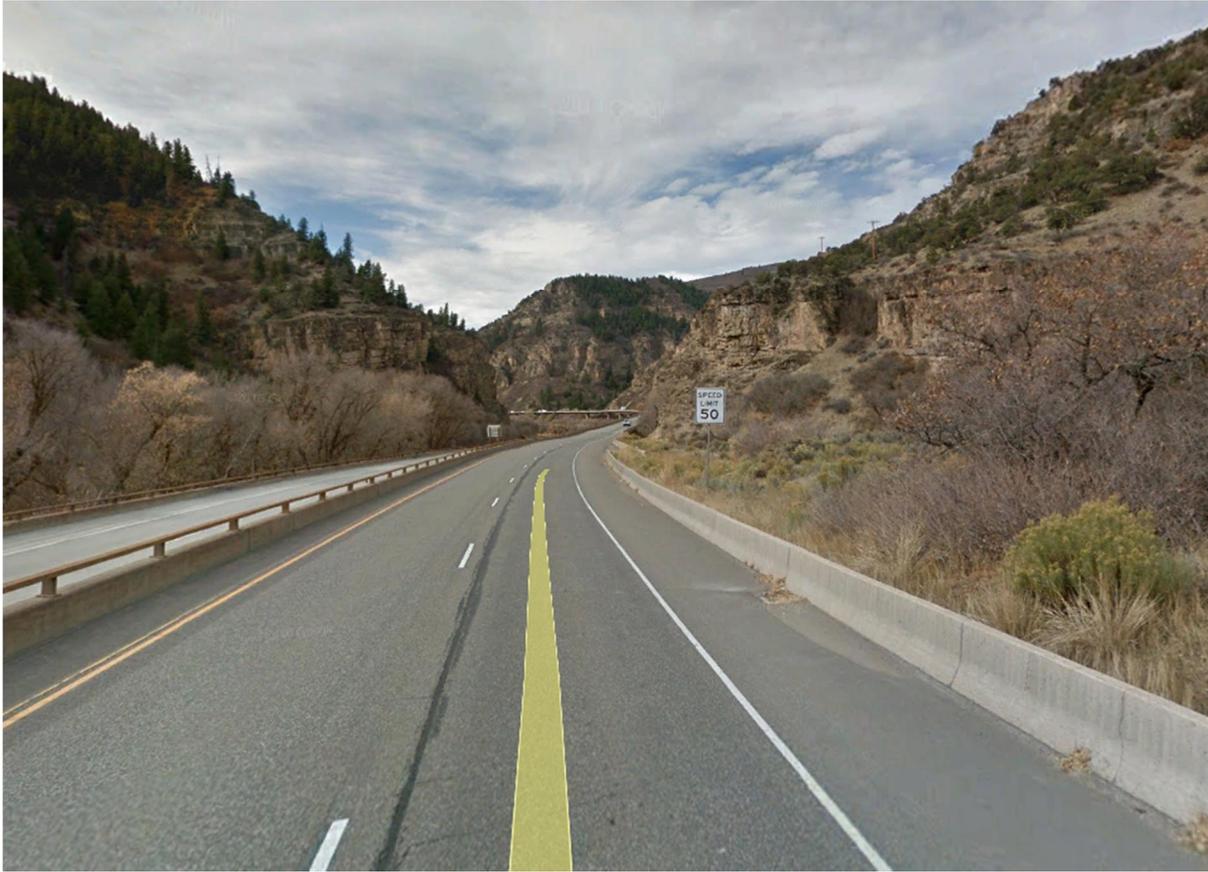
Site 15 – 128.13 WB (Pre-VIA/Post-VIA)

Relocation of this WB sign on the right shoulder cannot be minimized given site conditions to the east and west. No fiber is located within the median in this location. Relocation to the median would increase visual impacts.

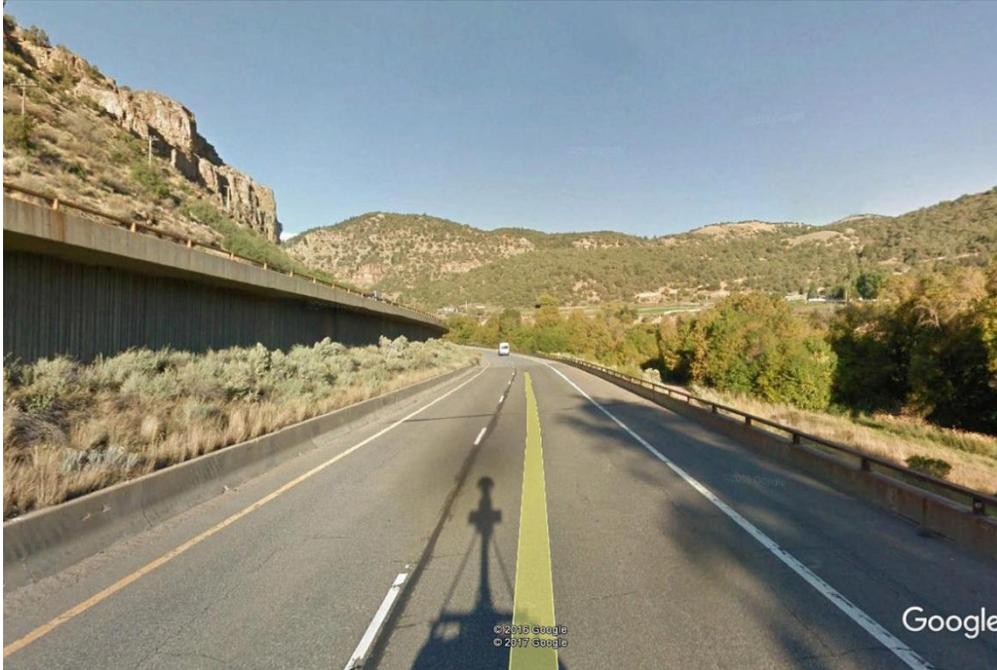
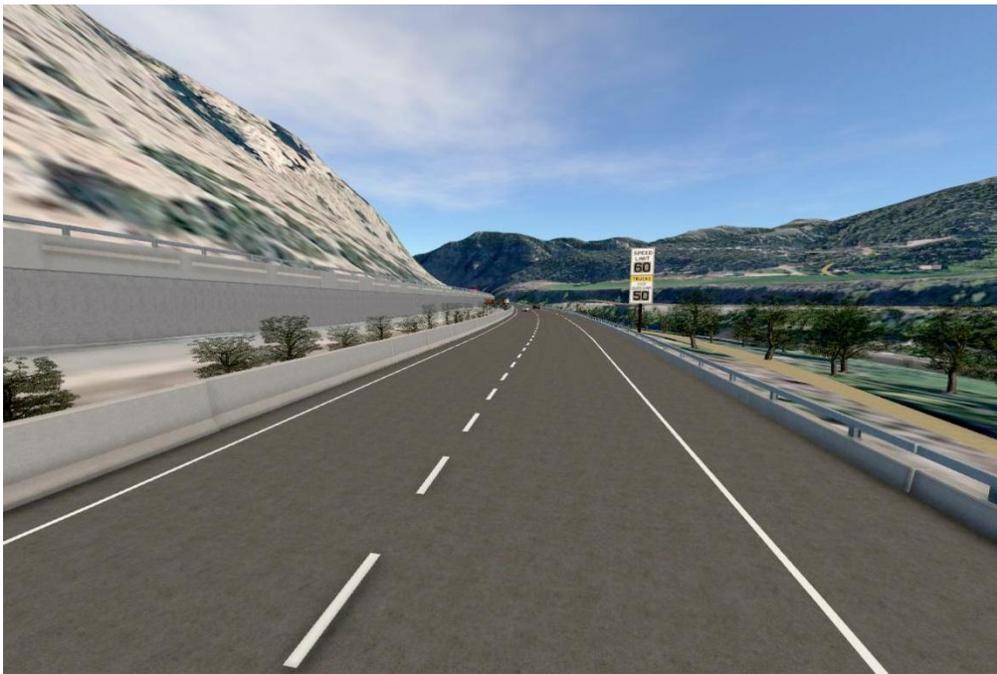
Site 16 – 128.87 EB (Pre-VIA)

Relocation of this EB sign on the right shoulder cannot be minimized given site conditions to the east and west. No fiber is located within the median in this location. The 3d image shows the sign on the shoulder. Existing trees would screen the back of this sign from vantage points located to the south.

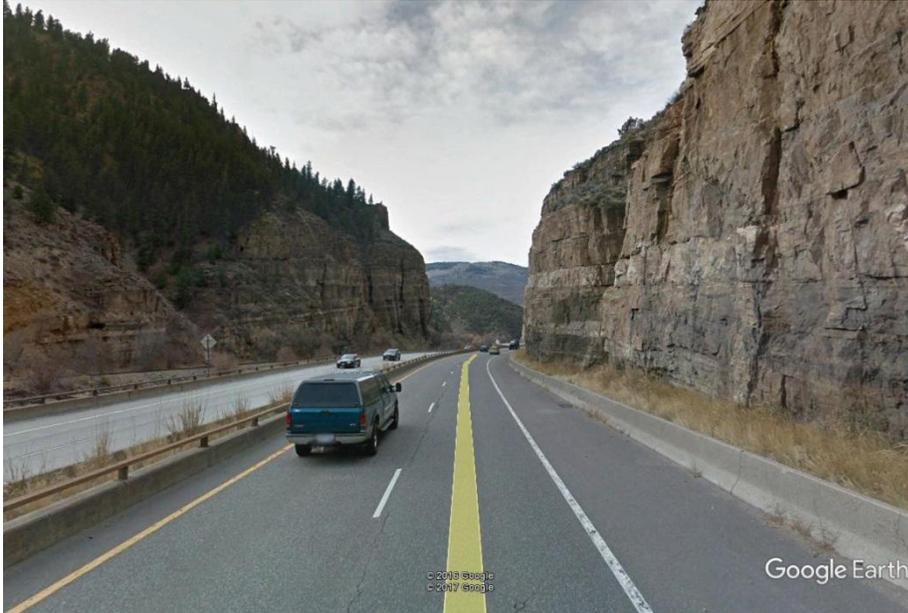
Relocation of this sign on the right shoulder to a location west of the bicycle tunnel would reduce visual effects. The selected site is just east of the point where the vegetated hillside transitions into cliff. This location would create the lowest level of visual effects. The location of the bicycle tunnel is identified by the yellow left turn sign visible in the image below. The new sign location would be just beyond the yellow turn sign.

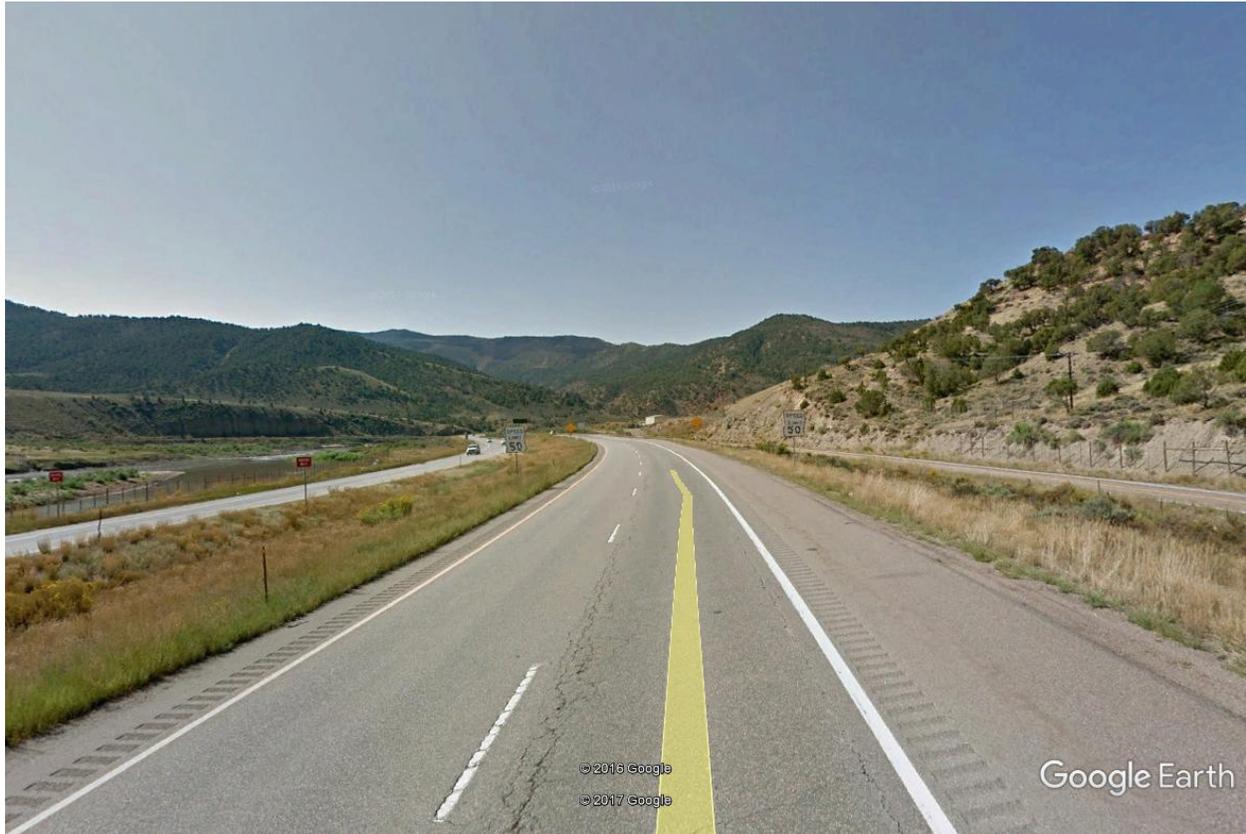
Sites 18 and 19 – 131.05 WB (Pre-VIA/Post-VIA)

Two WB signs (median and right shoulder) are visible in this image. These sites cannot be relocated to reduce visual impacts because both signs are needed to alert driver prior to their entry into Glenwood Canyon.
