The Colorado Department of
Transportation (CDOT) **Region 4**

BICYCLE & PEDESTRIAN SAFETY STUDY

Final Report

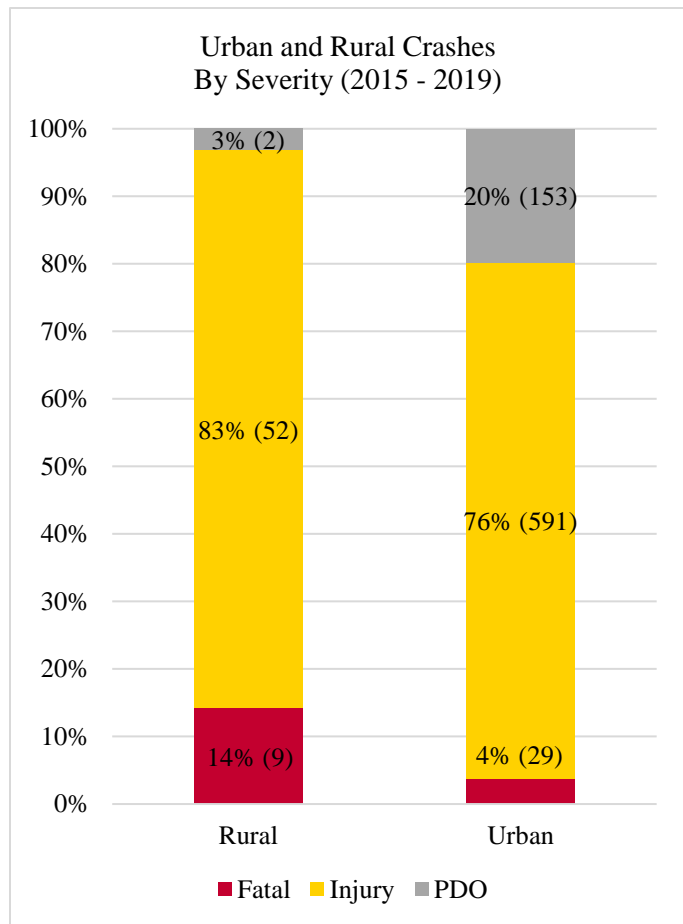
Figure 13: Urban and Rural Crashes by Severity

Despite the smaller proportion of total bicycle and pedestrian crashes on rural roads, these rural crashes have a higher probability of resulting in injury or fatality (97%), as compared to urban areas (80%), as shown in Figure 13. Even though rural crashes only make up 8% of the total crashes, they accounted for 24% of the total fatalities. This is slightly higher than national statistics of pedestrian fatalities in urban and rural areas. According to a May 2021 report³, the National Highway Traffic Safety Administration (NHTSA) stated that in 2019, more pedestrian fatalities occurred in urban areas (82%) than rural areas (18%). This indicates that rural roads in Region 4 represent a higher risk for fatalities than rural roads nationally. One observation that could explain the higher risk for fatalities in rural areas is shown in Figure 14. Figure 14 shows the correlation between fatal crashes, speed limits and urban versus rural classified roadways. All of the fatalities on rural roads, and 30 of the 38 total fatalities occurred on roadways where posted speed limits were greater than or equal to 45MPH.

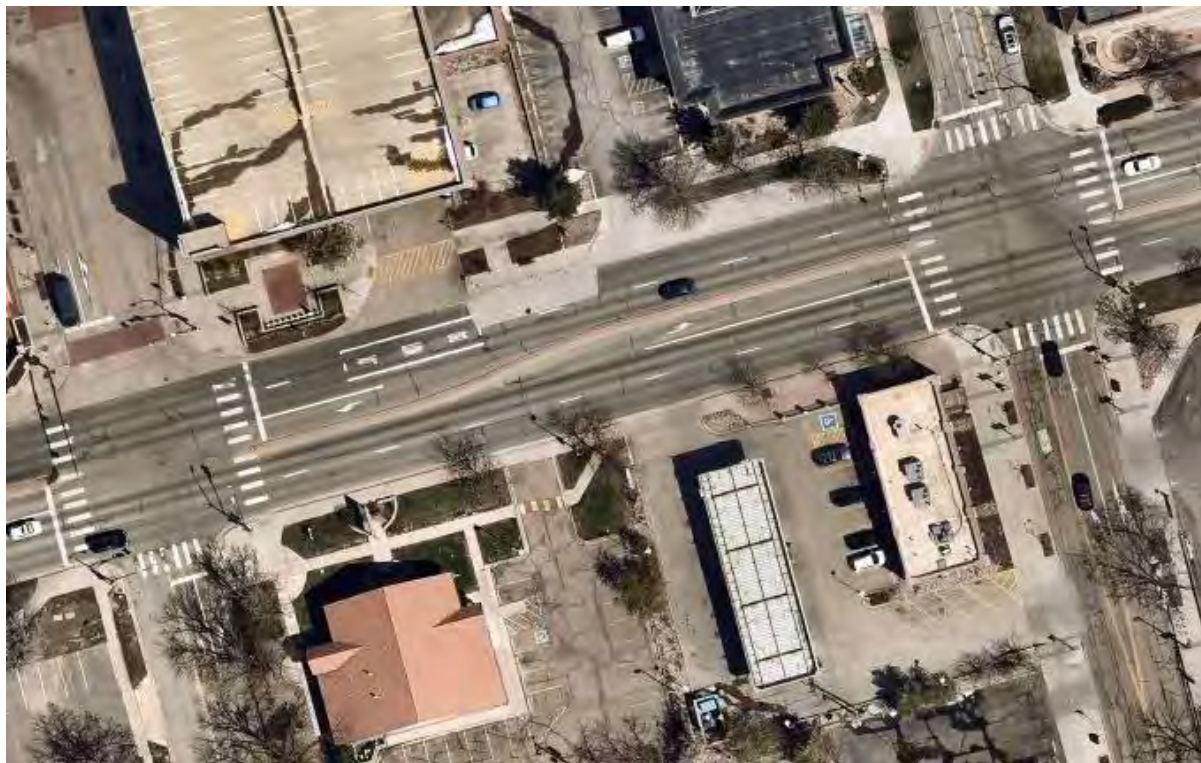
Figure 34: Example of Channelized – Raised Curb

As shown on Figure 33, the crash analysis shows that the majority of bicycle and pedestrian crashes occurred on either roads with a Channelized - Raised Curb (31%), or no median (27%). Channelized – Raised Curbs (Figure 34) are typically found in areas where high concentrations of access to adjacent properties are provided. They designate where left turn access can be provided or where access will be restricted to only right-in and right-out movements. While these types of medians are helpful for restricting some conflicting turning movements, the left turn restrictions typically result in additional U-turn movements and weaving maneuvers as motorists cut across traffic to get into the turn lane so they can make a U-turn and head in the opposite direction. The shorter the distance between allowable left turn movements, the less time a motor vehicle has to get across the road, but the more distributed the U-turn movements. Roadways with Channelized – Raised Curbs should be evaluated to identify whether providing additional distance between median openings and allowable left turn movements would improve safety. Some considerations that should be evaluated include, proximity of access points to the median opening (this will influence the danger of weaving movements), volume of traffic at the intersection (U-turn maneuvers take longer to make than left turn movements), and space to comfortably make a U-turn maneuver.

Since *Channelized - Raised Medians* typically occur in areas with a high density of driveways and intersections, this indicates that driveway density could be a high, risk factor. During the functional classification discussion, it was also noted that the introduction of access points on higher speed roads results in more bicycle and pedestrian crashes, so managing access may be a solution to improve safety on these types of roads. One of FHWA’s proven safety countermeasures is “Corridor Access Management”¹⁶, which is proven to reduce fatal and injury crashes on urban/suburban arterials by 25-31%. FHWA states that every intersection, from a signalized intersection to an unpaved driveway, has the potential for conflicts between motor vehicles, pedestrians, and bicycles. Additionally, they state that the

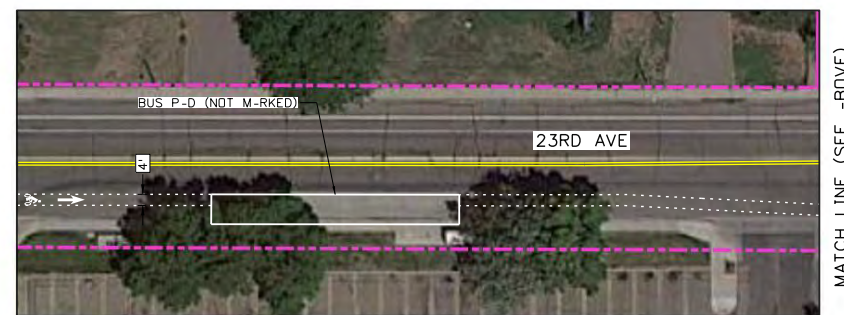
Figure 54: US 287 & 23rd Ave Concept Design & Cost Estimate

Concept Design

As previously indicated, the project team identified 10 specific locations throughout the region. For each location, a set of countermeasures was identified to address specific crash patterns, risk factors, or field observations. Users of this report should review the 10 locations and their identified crash patterns and field observations to determine if they are dealing with comparable facilities or intersections. Figures 43 through 53 provide detail on the crash data, field observations and potential countermeasures for each of the top locations. As users of this report identify comparable facilities, the countermeasures, concept designs and cost estimates on Figures 54 through 66 may prove valuable for future planning / design work and budgeting purposes.

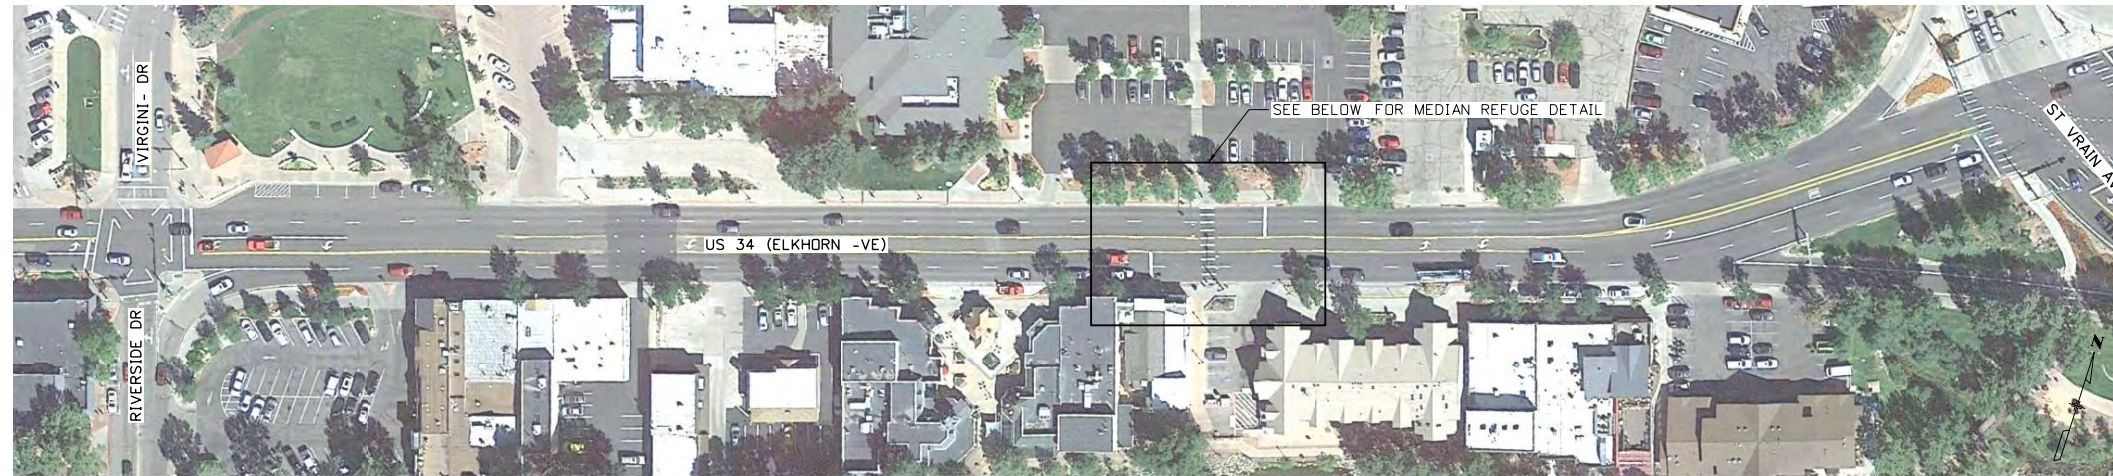
Figure 61: US 34 from Riverside Dr to St Vrain Ave Concept Design & Cost Estimate

Concept Design

Draft Report:	April 2022
Crash Data:	1/2015 - 12/2019
CMF:	0.697 (Continuous Raised Median), 0.685 (Pedestrian Refuge)
Cost Estimate:	\$50,000 (Pedestrian Refuge)
B/C Ratio:	2.63 (Pedestrian Refuge)

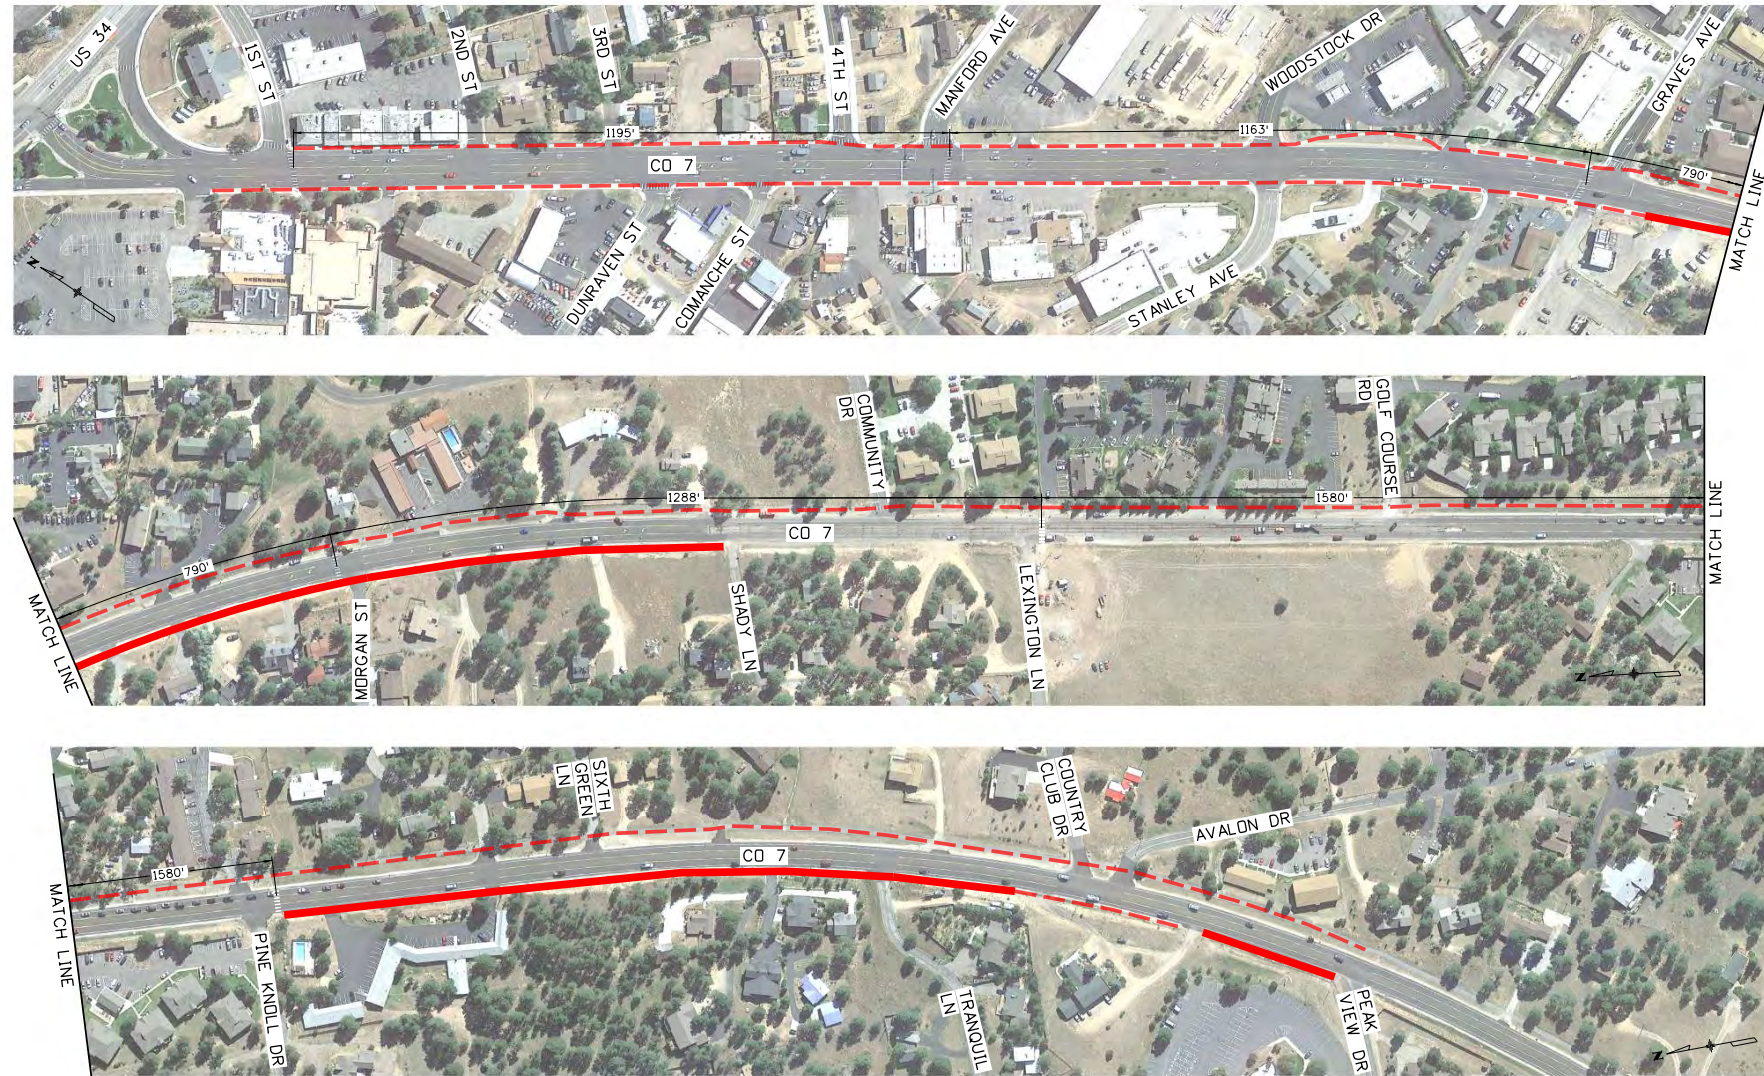
Figure 63: CO 7 from US 36 to Peak View Dr Concept Design & Cost Estimate

Concept Design

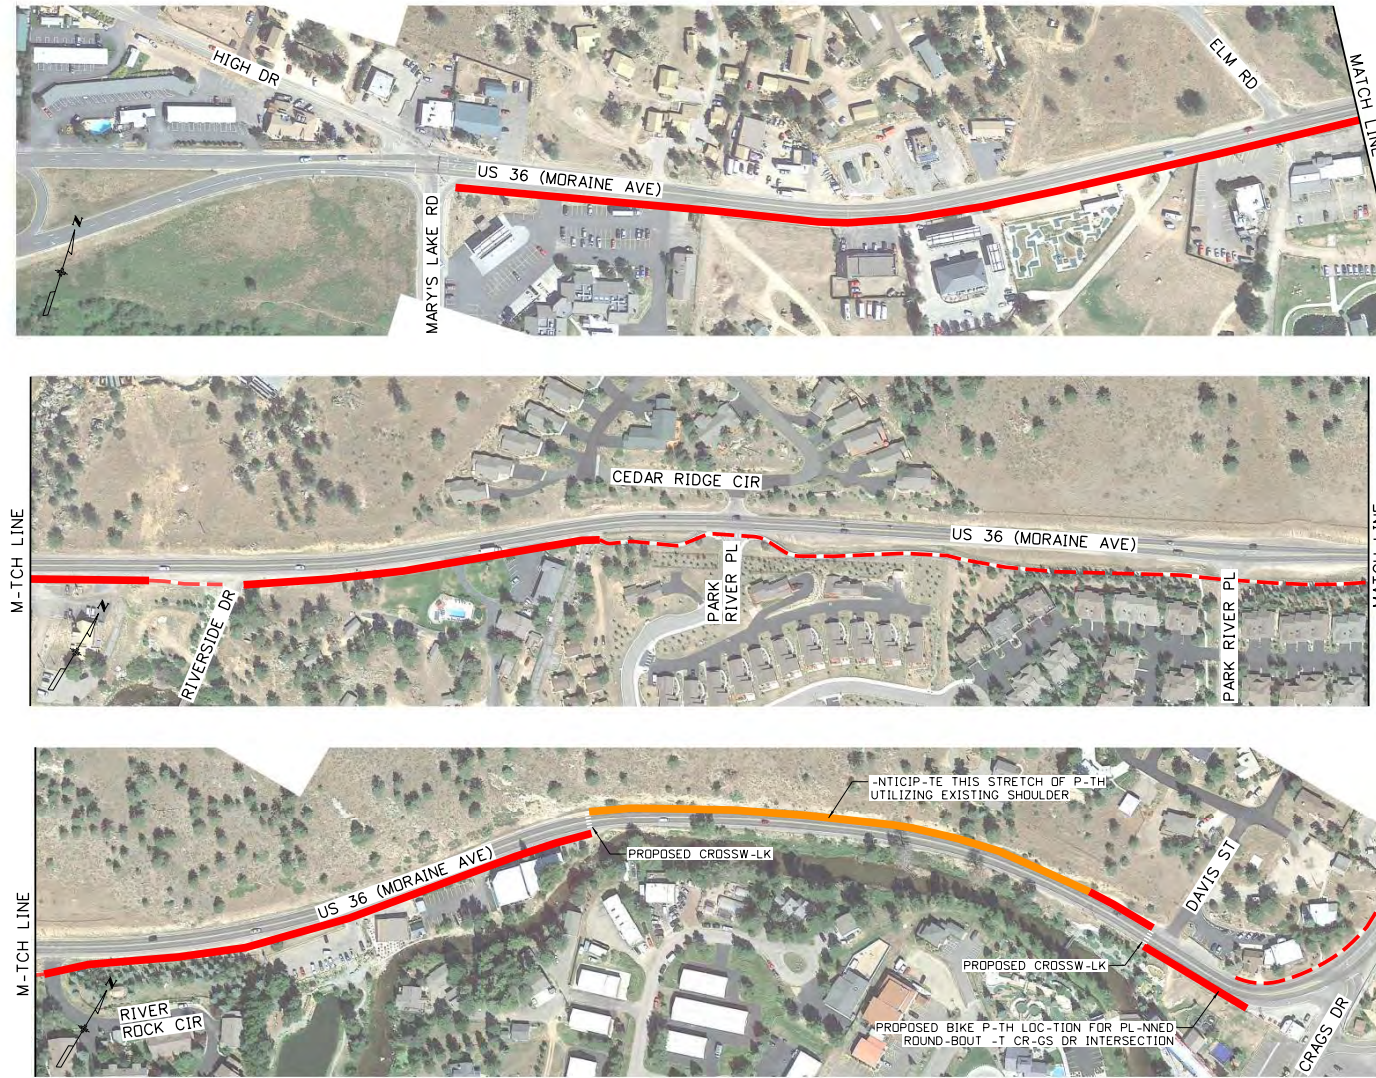
Figure 66: US 36 from Crags Dr to RMNP Entrance Alternative #3 Concept Design & Cost Estimate

Concept Design - Alternative #3

PROPOSED ALTERNATIVES
US 36 (MORAINA AVE)
FROM RMNP ENTRANCE TO CRAGS DR
US 36 CONTINUOUS MULTIMODEL PATH
OPTION #3
