# SH82 GRAND AVENUE BRIDGE

## Modified Phase I Environmental Site Assessment Technical Report

for the  
**SH 82 Grand Avenue Bridge Environmental Assessment**

**October 2014**

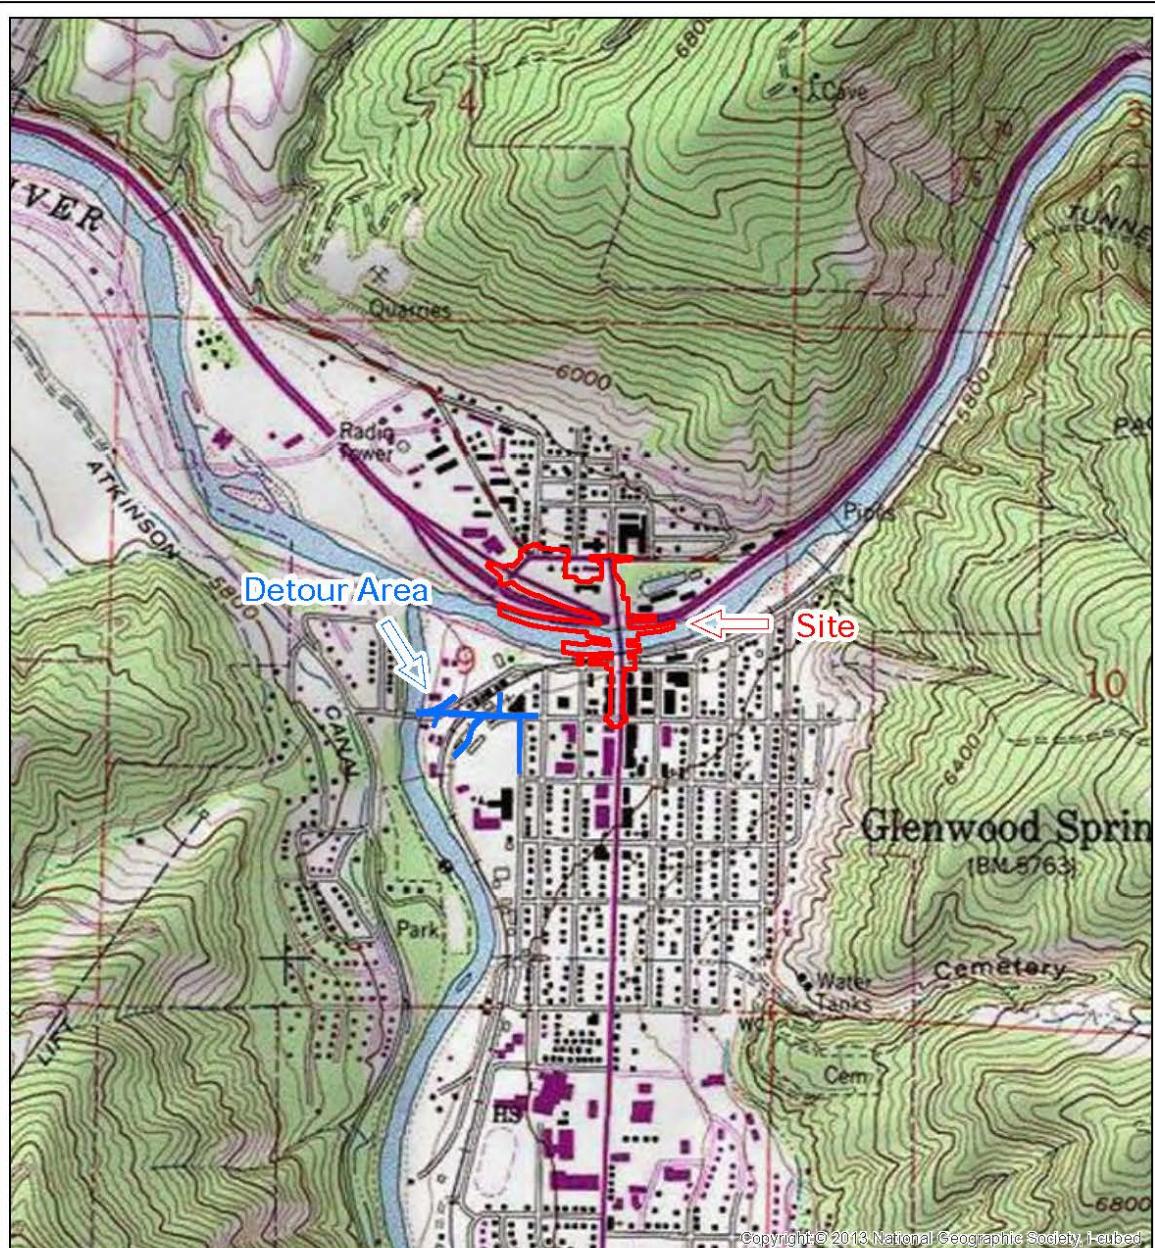
**Figure 1 – Site Location**

| <b>Legend</b><br><br>USGS 7.5' Topographic Map<br>Glenwood Springs, CO 1961 (revised 1987)<br> ← <b>Site</b> | <br><b>SITE LOCATION</b><br>SH82 Grand Avenue<br>Bridge Project<br>Glenwood Springs, Colorado |

Typically, groundwater flow direction mimics topography. Based on the topographic conditions of the Site (Figure 1), the groundwater flow direction is likely towards the west-northwest at the southern portion of the Site. Based on previous reports (Section 3.2.6), the depth to groundwater at the northern portion of the Site is expected to be approximately 20 feet below ground surface with the groundwater flow direction to the southwest (DEC, 1995).

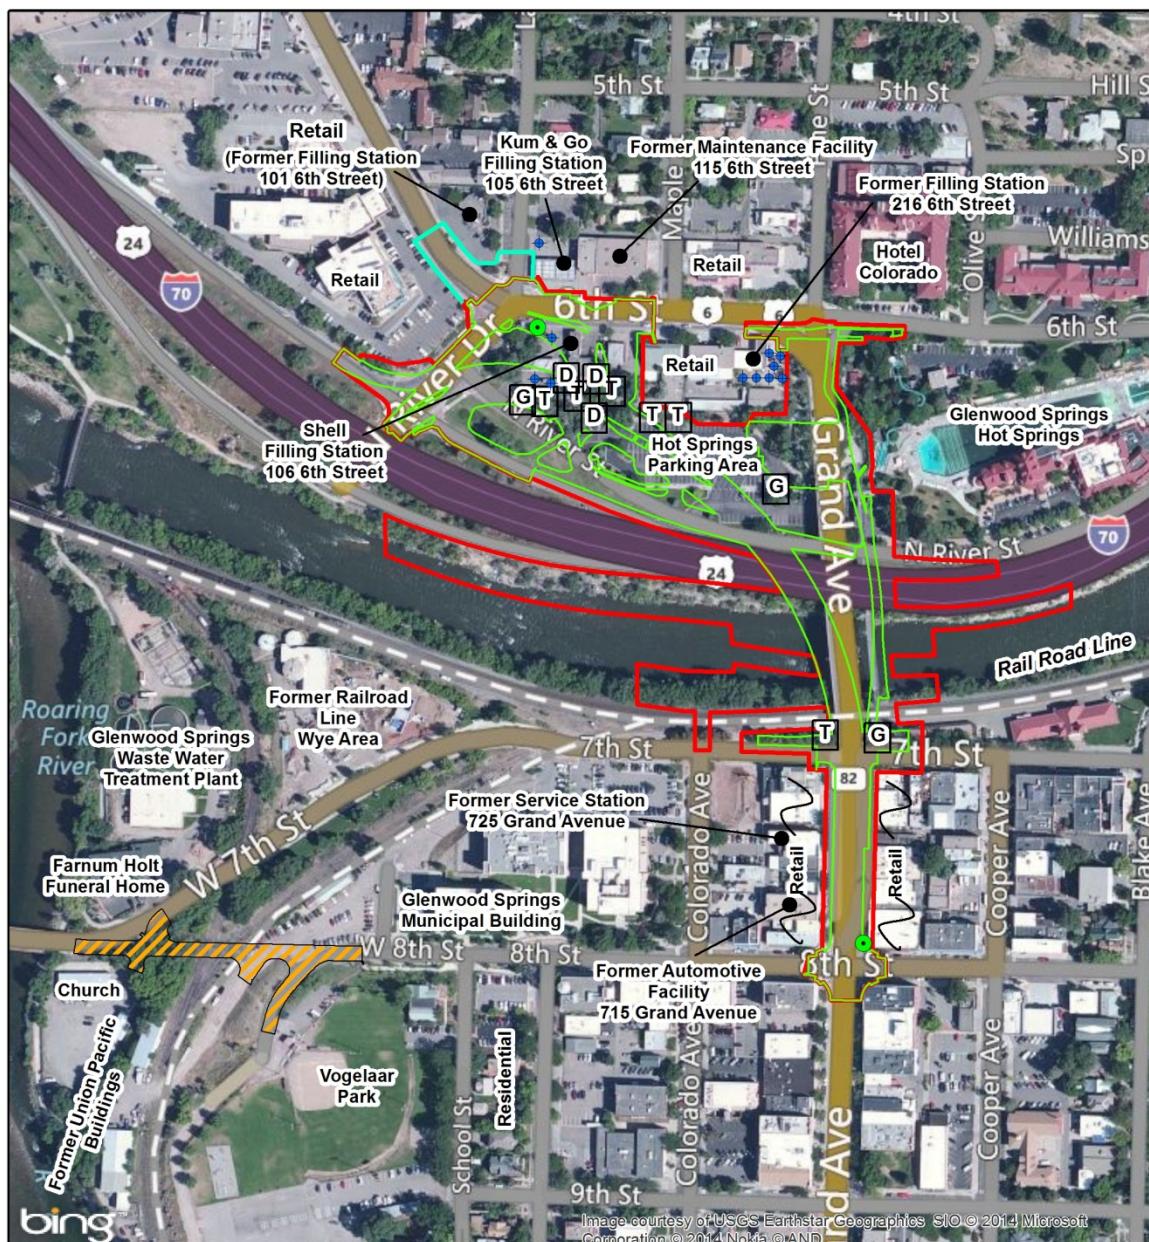
Figure 2 – Current Site Use and Conditions

#### ***Current Site Use and Conditions (Figure 2):***

Approximately six pad-mounted electric transformers were identified on or in the immediate vicinity of the Site (Figure 2). All appeared to be in good condition, and are apparently owned by Glenwood Light and Power Company. Five of the six transformers were labeled as containing no polychlorinated biphenyls (PCB). No visible evidence of a release was noted near the transformers.

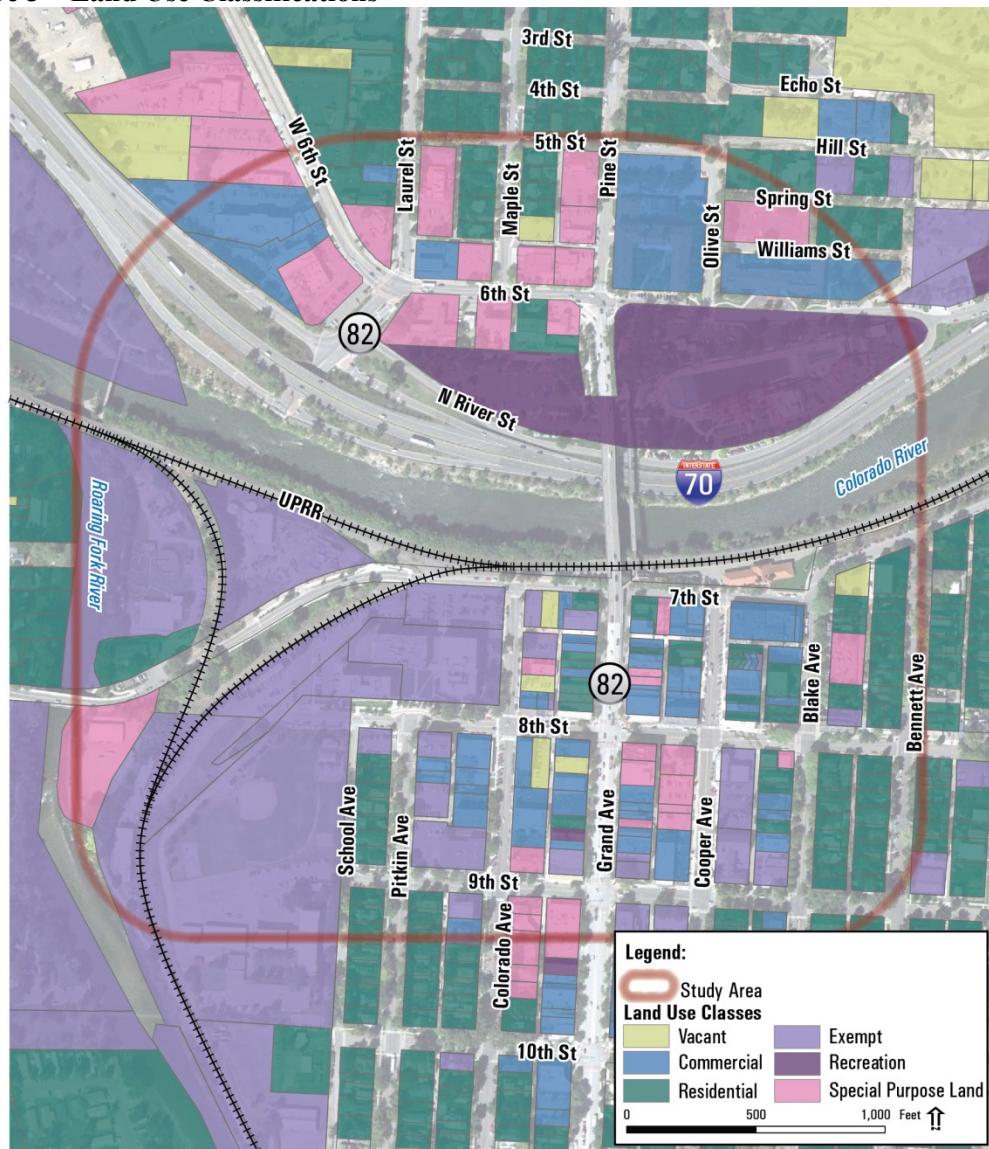
**Figure 3 – Land Use Classifications**

Existing land uses in the study area are mostly commercial, mixed with some residential and public (Figure 3). In the north part of the study area, 6th Street is mostly commercial, with some light residential use; 5th Street is a residential area. Also to the north, the Glenwood Springs Hot Springs and the Hotel Colorado are popular commercial tourist destinations. South of the Colorado River is a mix of commercial, residential, and special purpose properties (e.g., parking lots) that have gone through the City's special review process. The area that will be temporarily impacted during construction is considered to be exempt property.
