U.S. 287 at Lamar: Wetlands and Waters of the U.S., and CDOT Wetland Finding

PREPARED FOR: CDOT Region 2
PREPARED BY: Jessie Gourlie/CH2M HILL
COPIES: Tim Eversol/Kirkham Michael
DATE: July 7, 2003

1.0 Introduction and Project Description

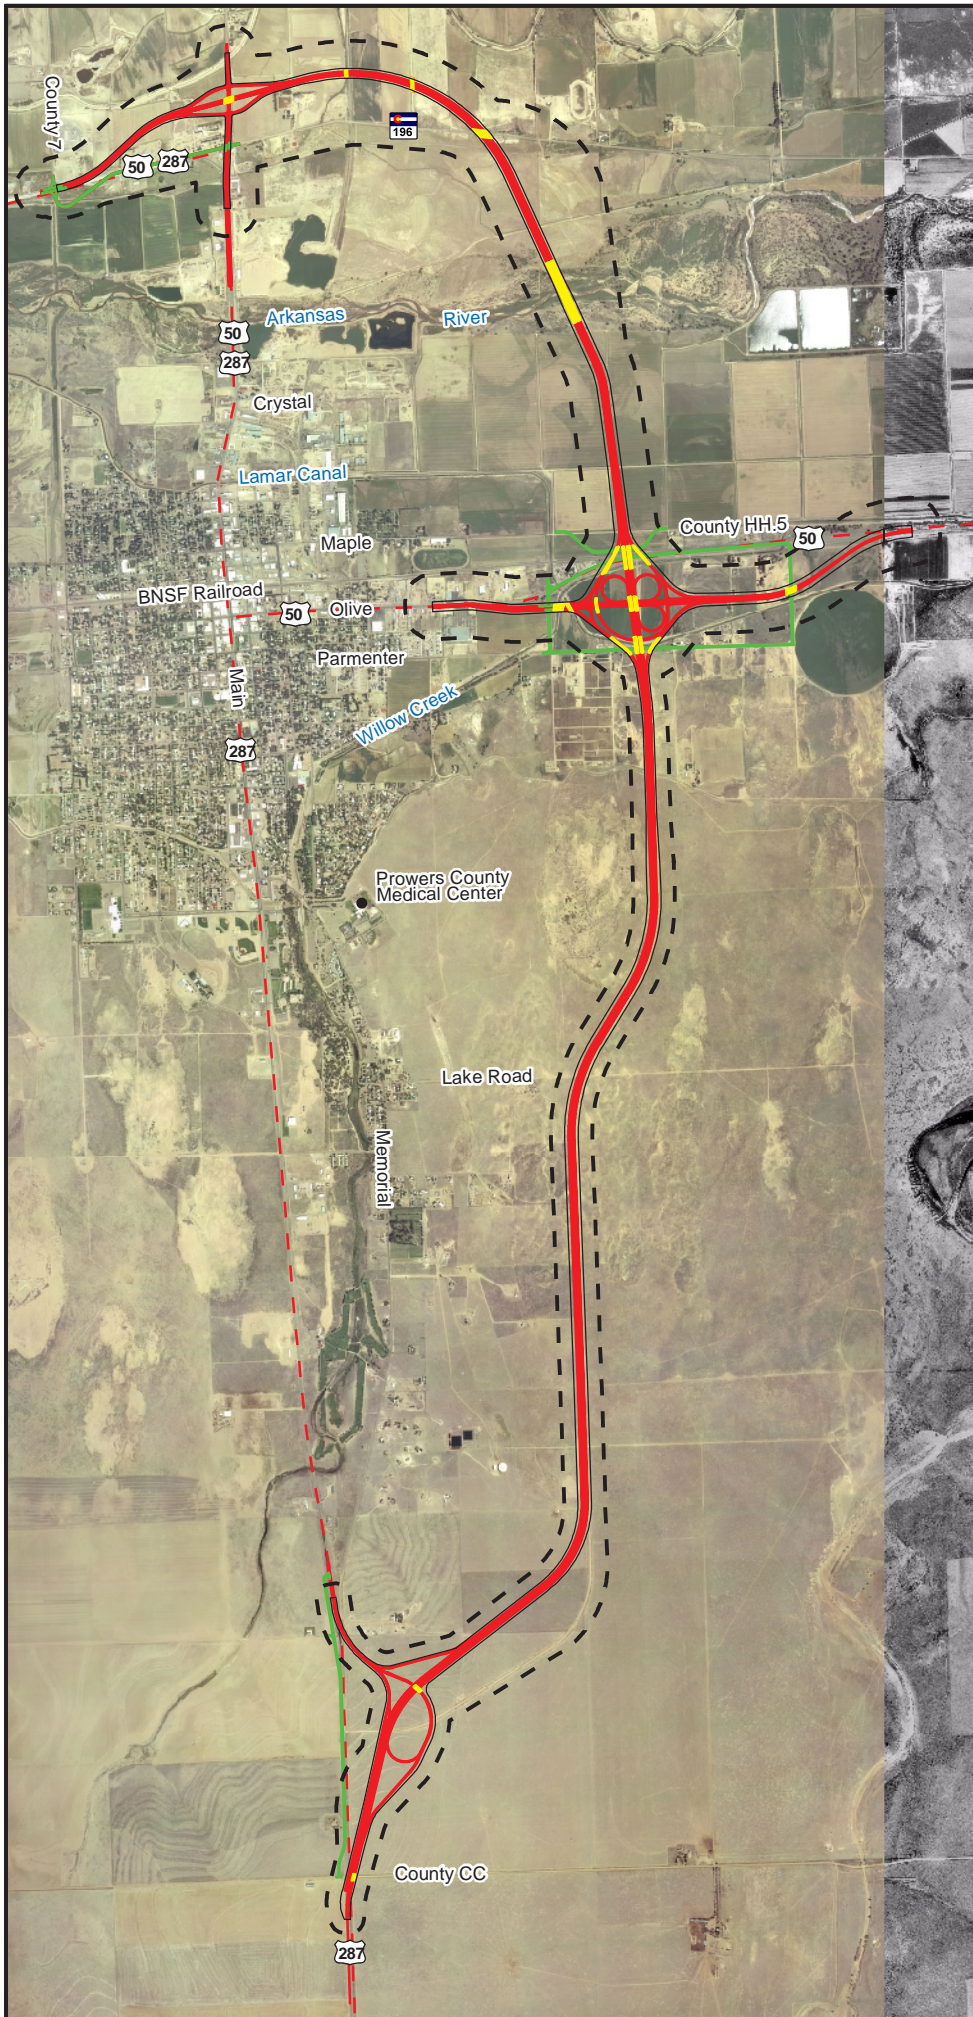
Figure 1
Proposed Action

The “study area” in which environmental resources were evaluated is 600 feet wide south of U.S. 50 and 1,200 feet wide north of U.S. 50. The “project footprint” or “preferred alignment” comprises a 300-foot-wide right-of-way, including the features described above, and is illustrated in Figure 1.

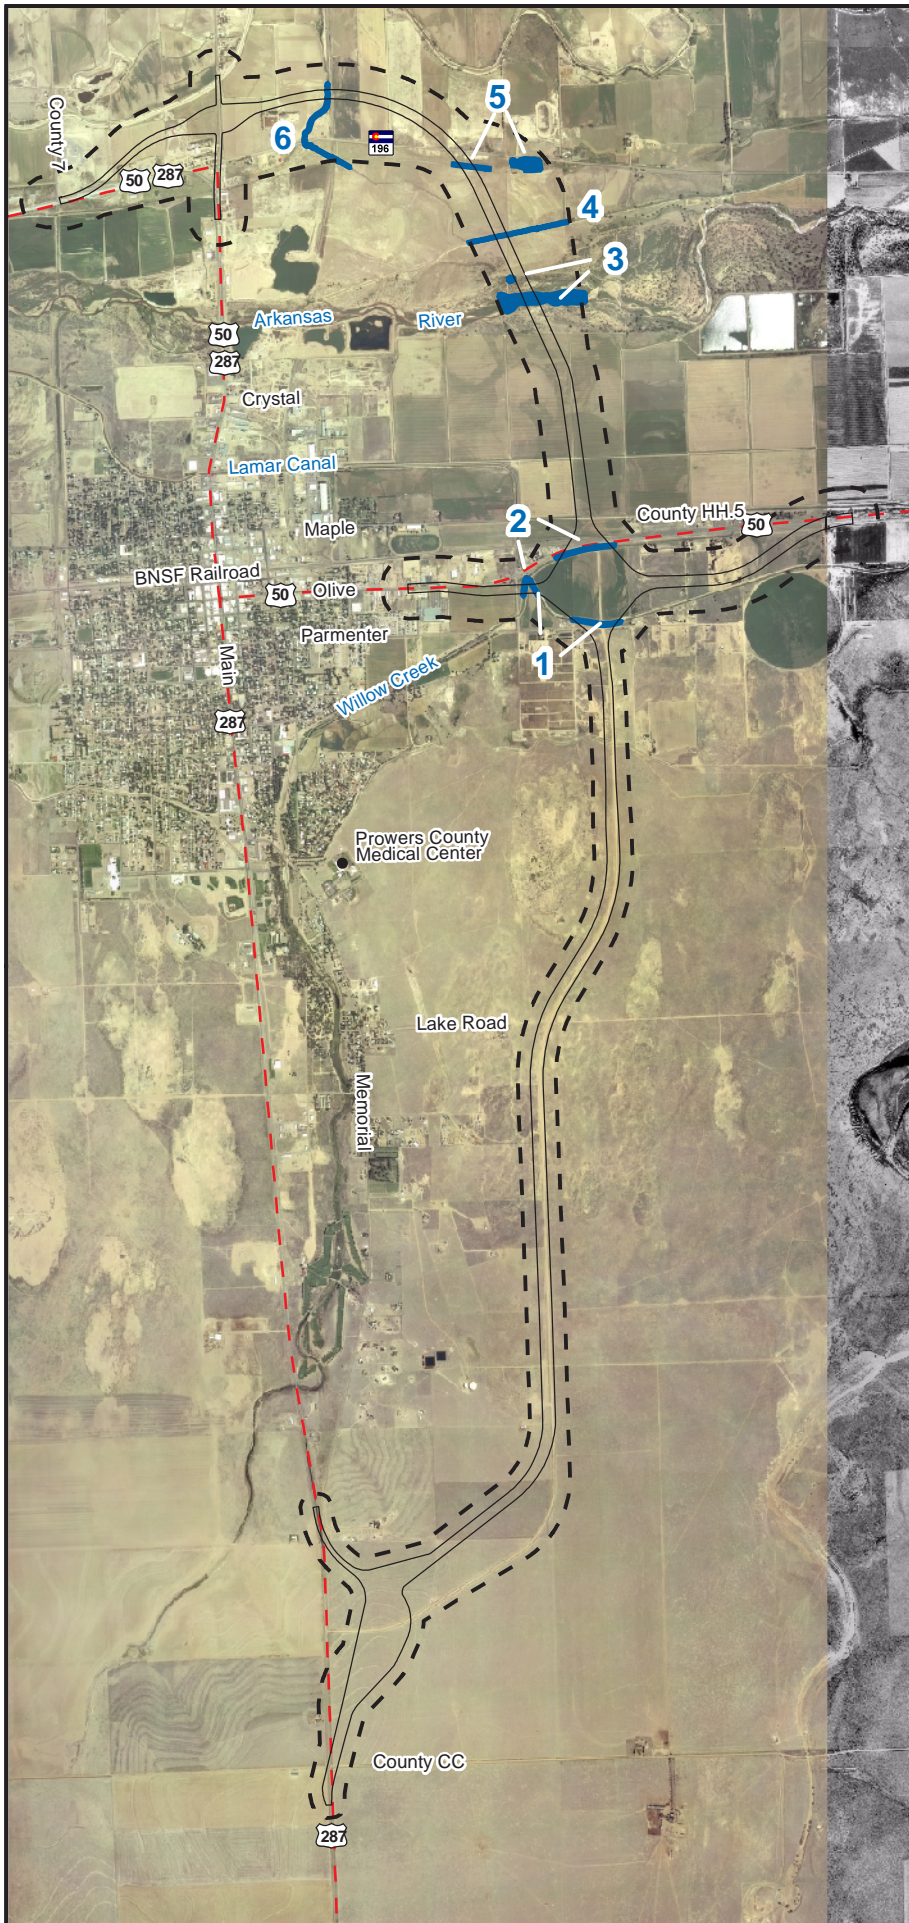
Figure 2
Identified Wetlands

Six surface waters including wetlands were identified in the study area as shown in Figures 2 and 3. Summary wetland descriptions including jurisdictional status and NWI classification are provided in Table 1. Based on review of existing data and field conditions, and in consultation with USACE and CDOT during an onsite meeting in September 2002, three waters – Willow Creek (WL-2), Arkansas River (WL-3), and Markham Arroyo (WL-6) – are jurisdictional under Section 404 CWA and CDOT requirements. Project activities conducted in these jurisdictional areas are subject to Section 404 CWA regulations and permitting requirements as administered by the USACE.

No.	Name	Acres*
1	Lamar Canal	0.79
2	Willow Creek	0.96
3	Arkansas River	1.46
4	Hyde Canal	0.08
5	Vista del Rio Ditch	0.15
6	Markham Arroyo	0.10

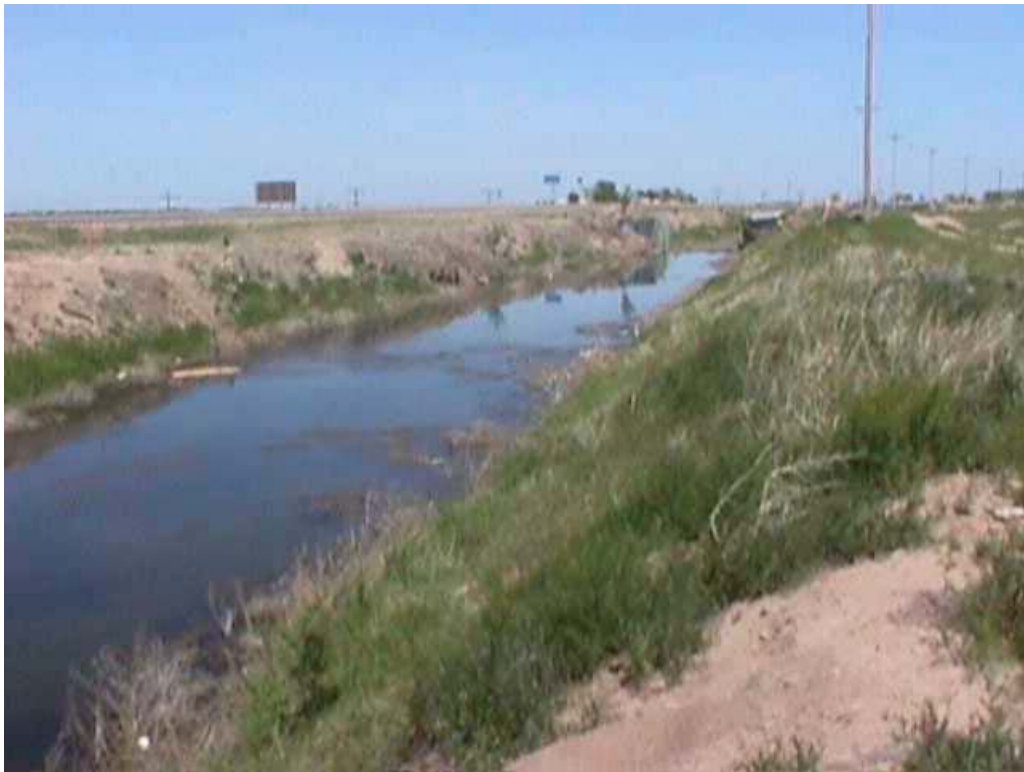
Willow Creek (WL-2) is characterized by narrow fringe wetlands adjacent to the perennial creek. Willow Creek in the study area is highly disturbed, with a channelized streambed and steep, high banks adjacent to U.S. 50. Streambanks are lined with concrete riprap in some areas. Water quality is poor, likely due to upstream urban and agricultural discharges. Wetland vegetation is varied, but dominated by spikerush (*Eleocharis macrostachya*) and reed canarygrass (*Phalaris arundinacea*). Invasive, weedy vegetation dominated by kochia (*Kochia scoparia*) and Russian thistle (*Salsola collina*) exists in the upland transitional area. Adjacent land uses to Willow Creek in the study area are urban and agricultural, including roads and cropland.

Channelized creek; narrow fringe wetland; steep banks, riprap, poor water quality

WILLOW CREEK, VIEWED TOWARD EAST FROM SOUTH BANK

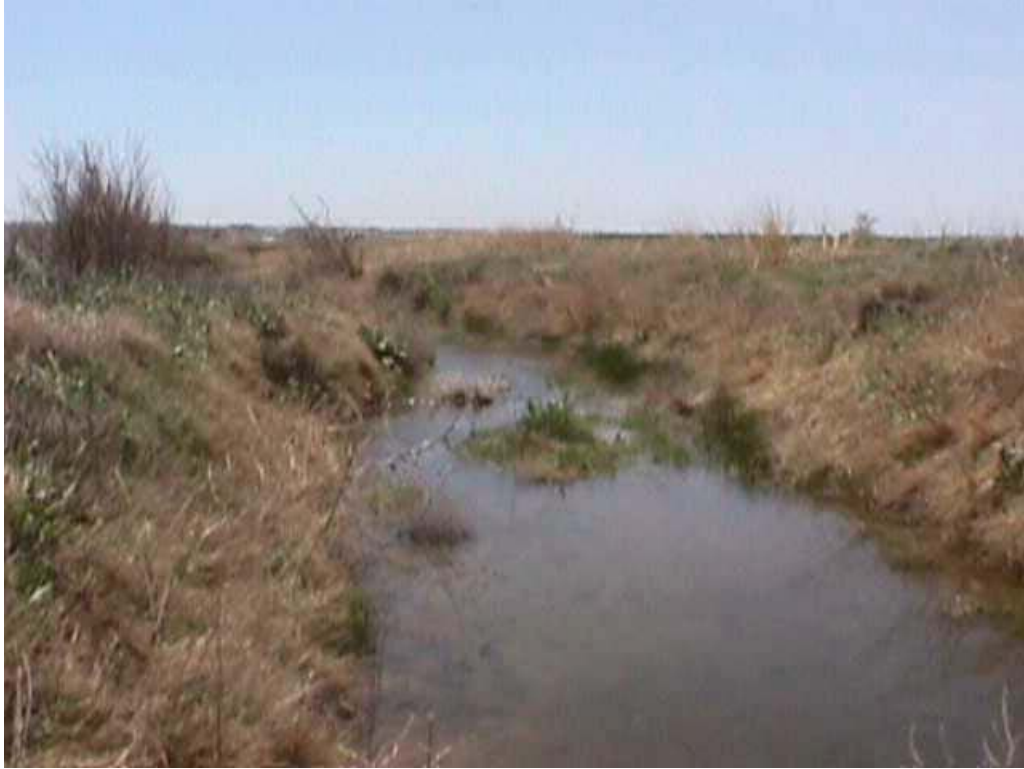
The Markham Arroyo (WL-6) in the study area is characterized by narrow fringe wetlands adjacent to a winding channel. Wetland vegetation is dominated by watercress (*Nasturium officinale*) and rushes (*Juncus balticus*). Observed water appears relatively clear, and the ditch supports minnow populations, submerged aquatic plants, and waterfowl. Adjacent land uses in the study area are irrigated cropland on the north side and a dirt road/former railroad right-of-way on the south side.

Remarks Relatively natural creek channel with clear water, minnows and waterfowl

MARKHAM ARROYO, VIEWED FROM BANK

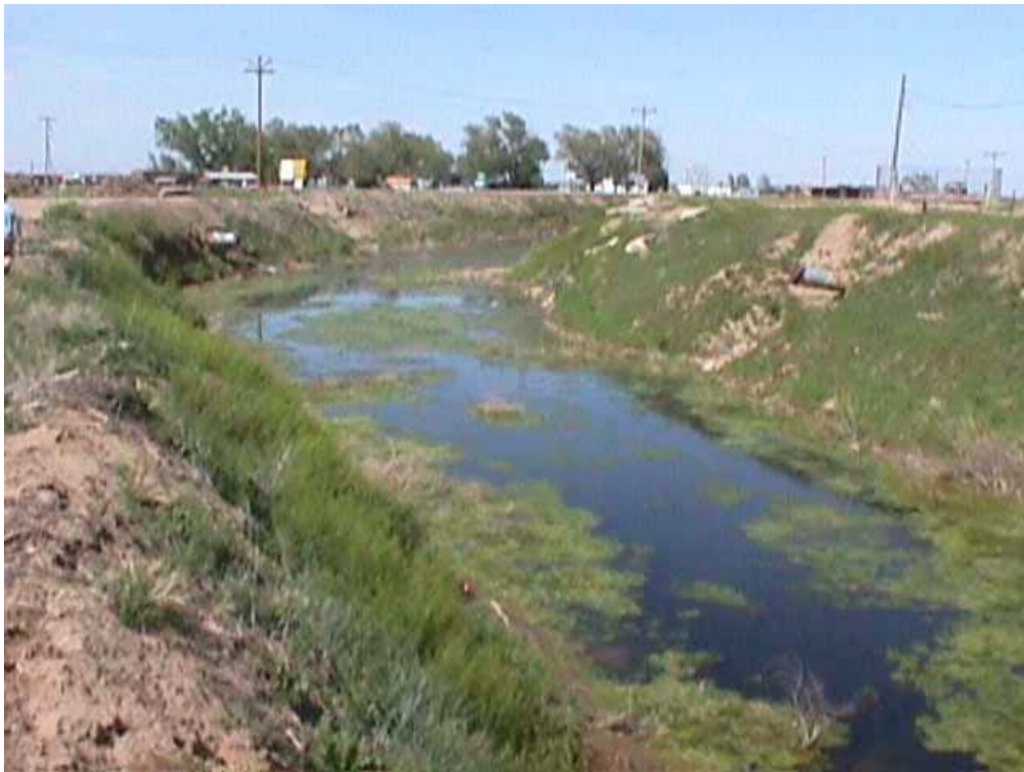
Nonjurisdictional wetlands to be evaluated for CDOT regulatory compliance consist of three agricultural irrigation ditches (Lamar Canal, Hyde Canal, and Vista del Rio Ditch). Representatives of the USACE confirmed lack of jurisdictional status during the field meeting. The Lamar Canal (WL-1) is characterized as highly disturbed, with a channelized

streambed, steep, high banks covered with concrete rip-rap, a narrow-fringe wetland, and invasive weedy vegetation in the upland transitional area. The Hyde Canal (WL-4) is a channelized streambed with heavily eroded banks from intense cattle use. Water quality in both these canals appeared to be poor. The Vista del Rio Ditch (WL-5) is an intermittent shallow ditch that did not have surface flow during the site reconnaissance, though wetland vegetation and soils were observed in portions of the intermittent channel in the study area.

Channelized canal; narrow fringe wetland; steep banks, riprap, poor water quality

LAMAR CANAL, VIEWED FROM NORTH BANK TOWARD EAST

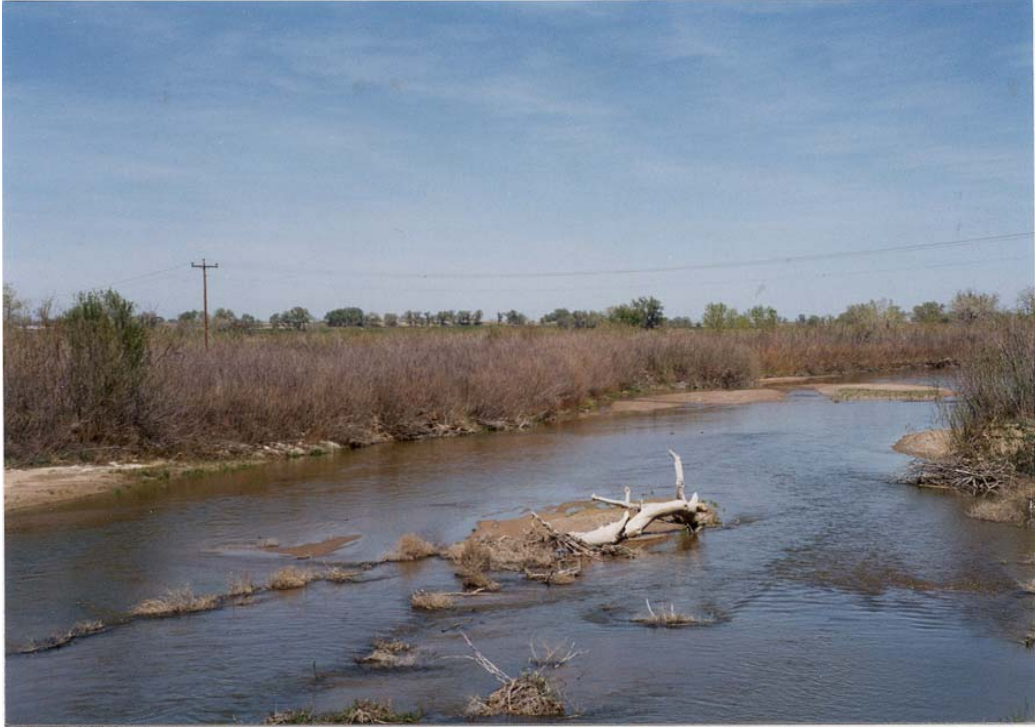
The most important jurisdictional wetlands in the study area are the riparian wetlands adjacent to the north and south banks of the Arkansas River (WL-3). Located on high banks in the floodplain above a winding, wide riverbed, these wetlands are characterized by dense stands of willow (*Salix exigua*) and tamarisk (*Tamarisk ramosissima*). The NWI classifies the river and adjacent wetlands as riverine, lower perennial, open water, intermittently exposed permanents. Additionally, some wetland areas adjacent to the river are classified by NWI as palustrine, scrub-shrub or forested, intermittently flooded temporary.

At the time of the survey, which was conducted during a significant drought, the tops of the riverbanks were 10 to 15 feet above the river bottom. Portions of the jurisdictional line were identified based on vegetation as the ordinary high-water mark on the riverbank. Soils were characterized as loamy sand, with soils in the wetland areas being characterized as having higher organic content. Hydrology varies seasonally based on river flood stages. Drought conditions appeared to have affected water-table levels and growth of herbaceous vegetation species. River flows were low, and large sandbars were exposed in the riverbed.

The riparian wetlands adjacent to the Arkansas River in the study area were generally undisturbed, with the exception of cattle grazing in a small area of the northeast portion of wetlands. Tamarisk, a phreatophyte and an invasive noxious weed species, is intermixed with the willows adjacent to the river. Tamarisk becomes the dominant species upland of the wetland transitional line. Several large cottonwoods (*Populus deltoides*) were also observed upland of the wetland transitional line. Land use adjacent to the river in the study area is characterized as rangeland and pasture north of the river, and irrigated agriculture south of the river.

Dense stands of willow and tamarix; tamarix becoming more dominant on wetland transitional edge; minimal herbaceous cover due to drought conditions

ARKANSAS RIVER IN STUDY AREA

- Minimize riprap placed in the Arkansas River and irrigation canals to reduce bank disturbance and preserve natural conditions.
- Enhance **acres of riparian habitat near the Arkansas River crossing by permanently removing tamarisk. Controlling tamarisk will improve wetland conditions and reduce water use.

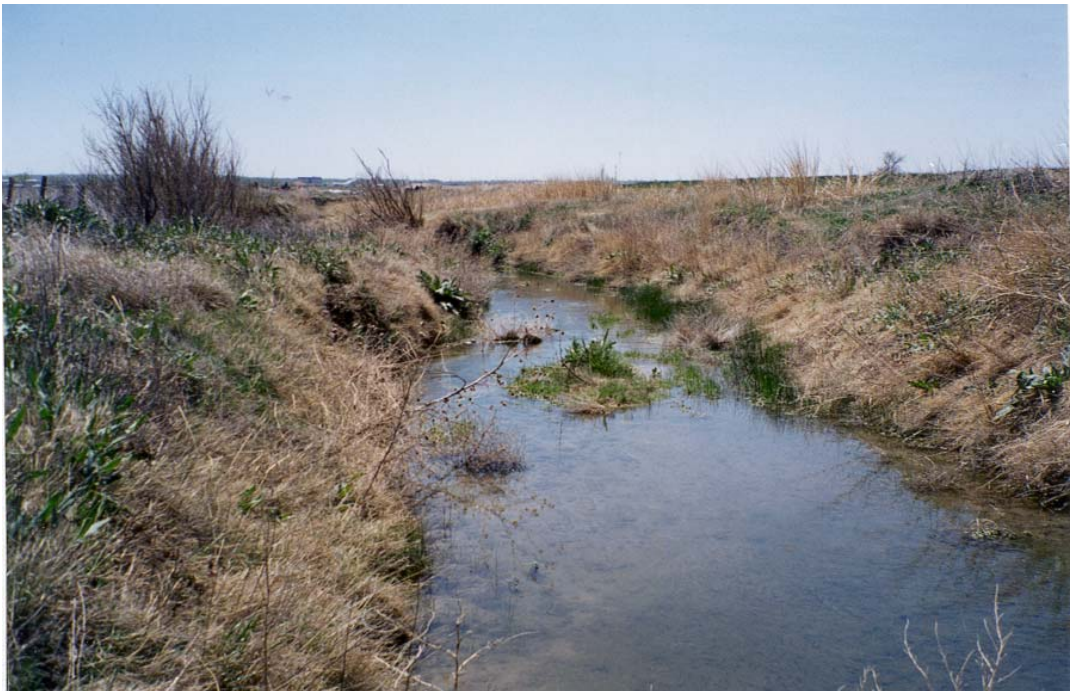
MARKHAM ARROYO IN STUDY AREA
