**AN HISTORICAL INVENTORY  
OF THE PROPOSED U. S. 287 LAMAR BYPASS IN  
PROWERS COUNTY, COLORADO**

**CH2M HILL**  
19 South Tejon Street, Suite 100  
Colorado Springs, CO 80903

February, 2010

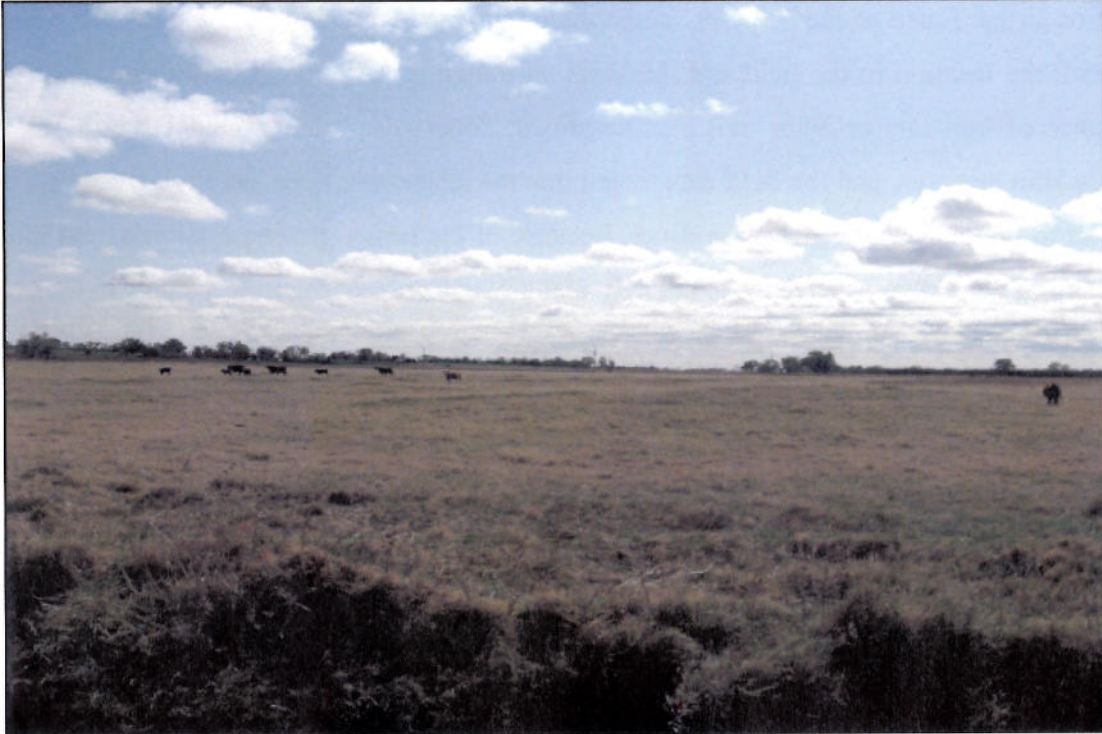
**Figure 1. View of the USGS mapped location of the Santa Fe Trail in the Proposed US 287 Bypass Route.** Looking east across the proposed route and the lower view looks west across the route. No clear ruts or other evidences of a trail were observed. Rather, the undulating nature of the floodplain is seen in the photos.

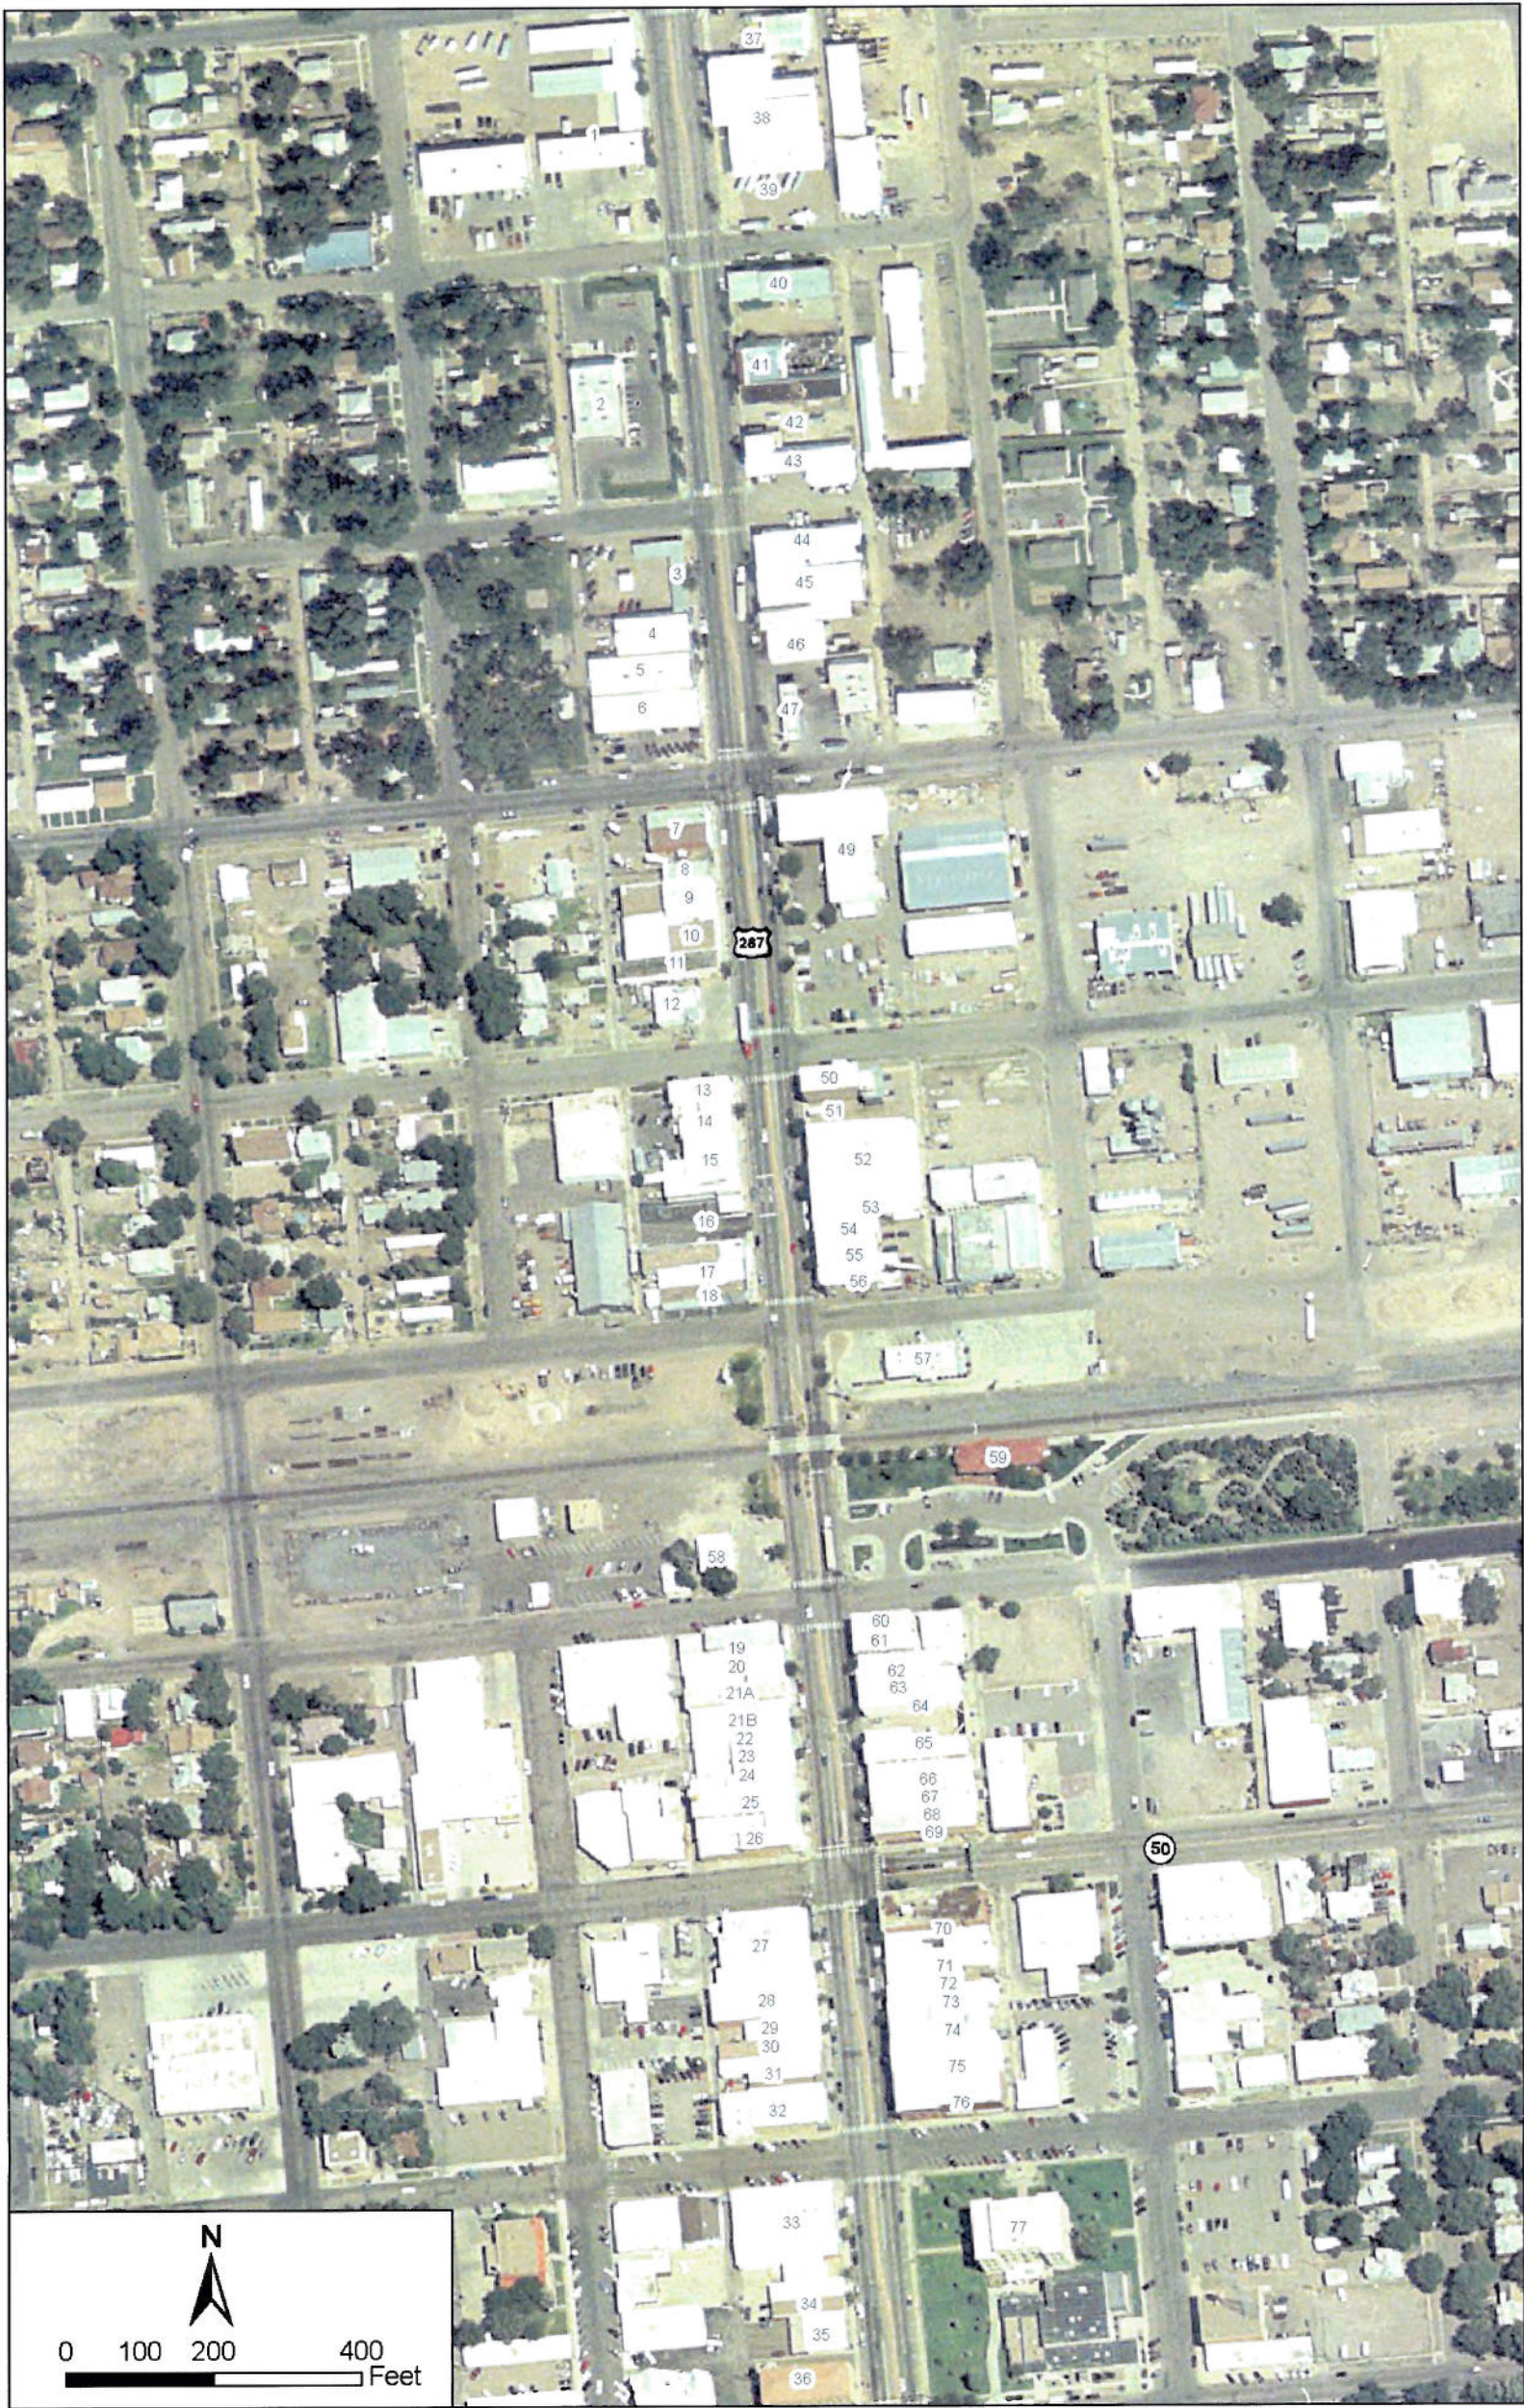
Figure 4. Lamar Reconnaissance Survey Parcel Map

The reconnaissance level survey resulted in the identification of 77 properties (one a vacant lot) along Main Street within the boundaries of Washington Street and Oak Street. Research at the assessor's office provided information on the year built for each property and on a few occasions, the year when alterations were made. The assessor's information helped with the field analysis, at which point photographs of each property were taken and notes regarding building style and modifications were observed. Please see the Lamar Commercial Reconnaissance table in Appendix B and the Lamar Commercial Reconnaissance Images in Appendix C for details of the findings. Overall, buildings appeared to have very little historic integrity and it was often

nearly impossible to tell that an historic structure was located beneath years of unsympathetic modifications and alterations. Because of the extent of modifications completed at different times, the structures lacked continuity.

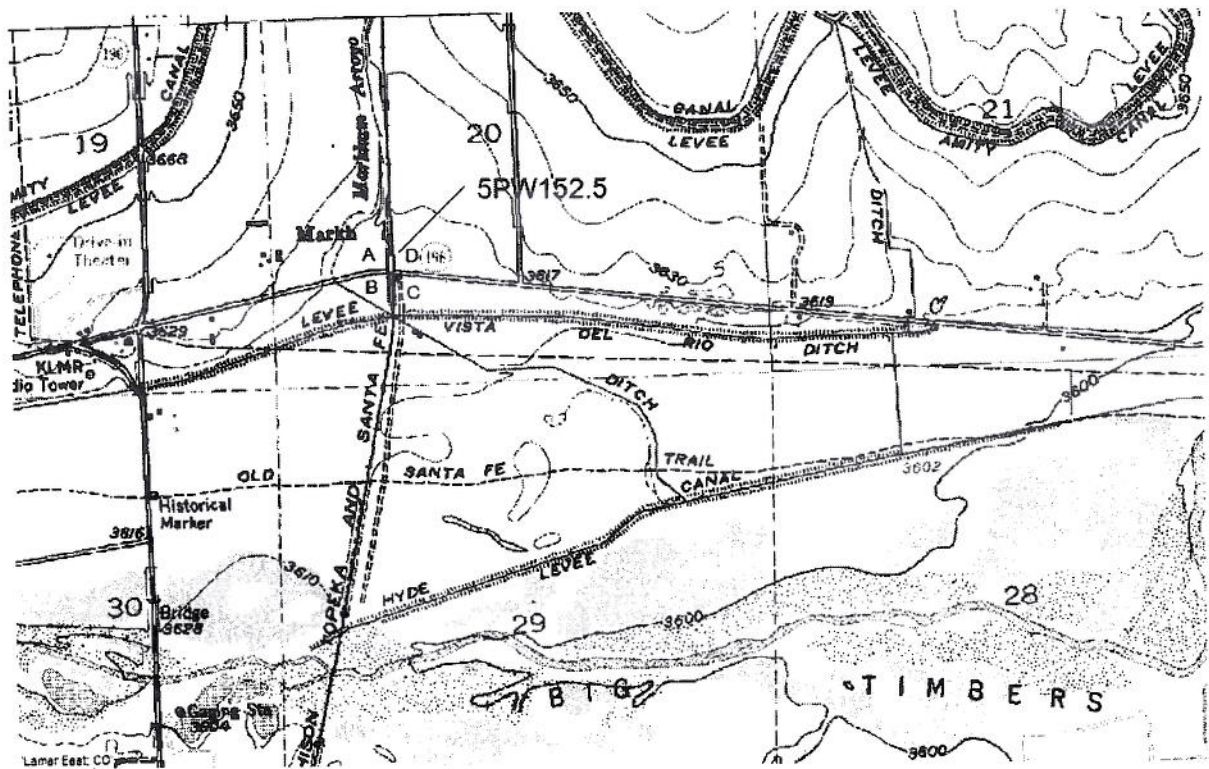
# 5PW152.5 Santa Fe Railroad

34. Describe condition: Tracks and ties have been removed, rail line abandoned and currently used as two-track for farming agricultural fields to the east.

39. Threats to Resource: Water erosion  Wind erosion  Grazing  Neglect   
Vandalism  Recreation  Construction  Other (specify): \_\_\_\_\_  
comments: Site located within the proposed U.S. 287 Bypass.
40. Existing Protection: None  Marked  Fenced  Patrolled  Access controlled   
other (specify): \_\_\_\_\_
41. Local landmark designation: N/A 42. Easement: N/A
43. Management Recommendations: No further work is recommended for this site.

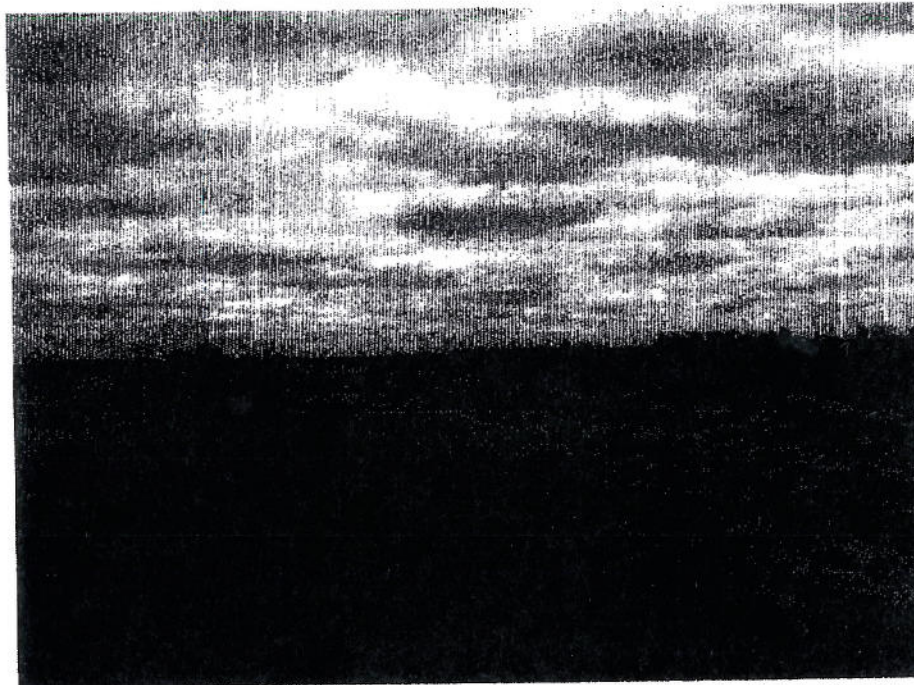
5PW152.5 Santa Fe Railbed, overview in the project area.  
View looks north

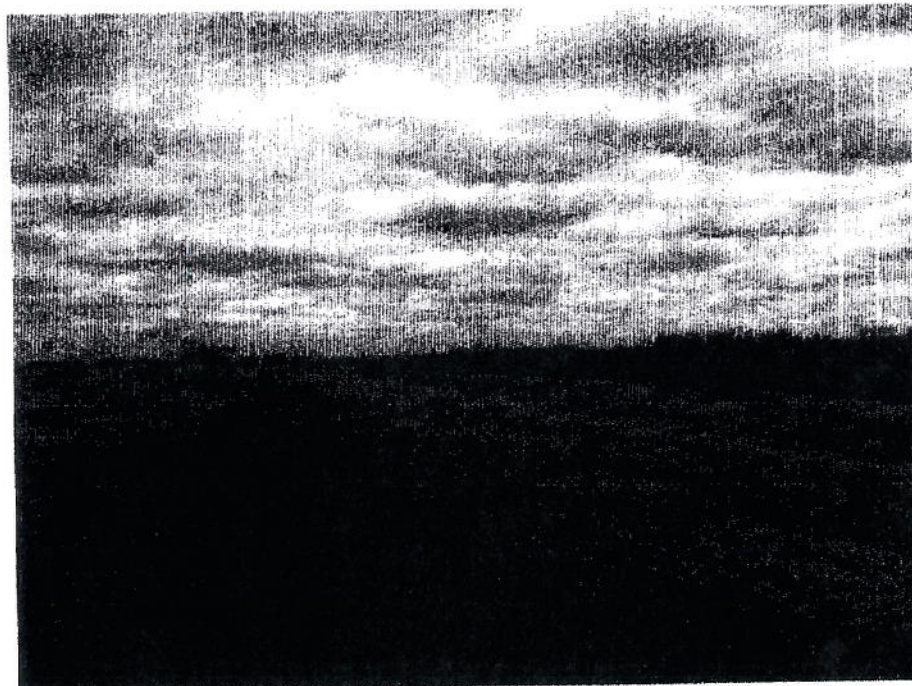
5PW152.5 Santa Fe Railbed, overview including setting of agricultural fields in  
the project area. View looks northeast.

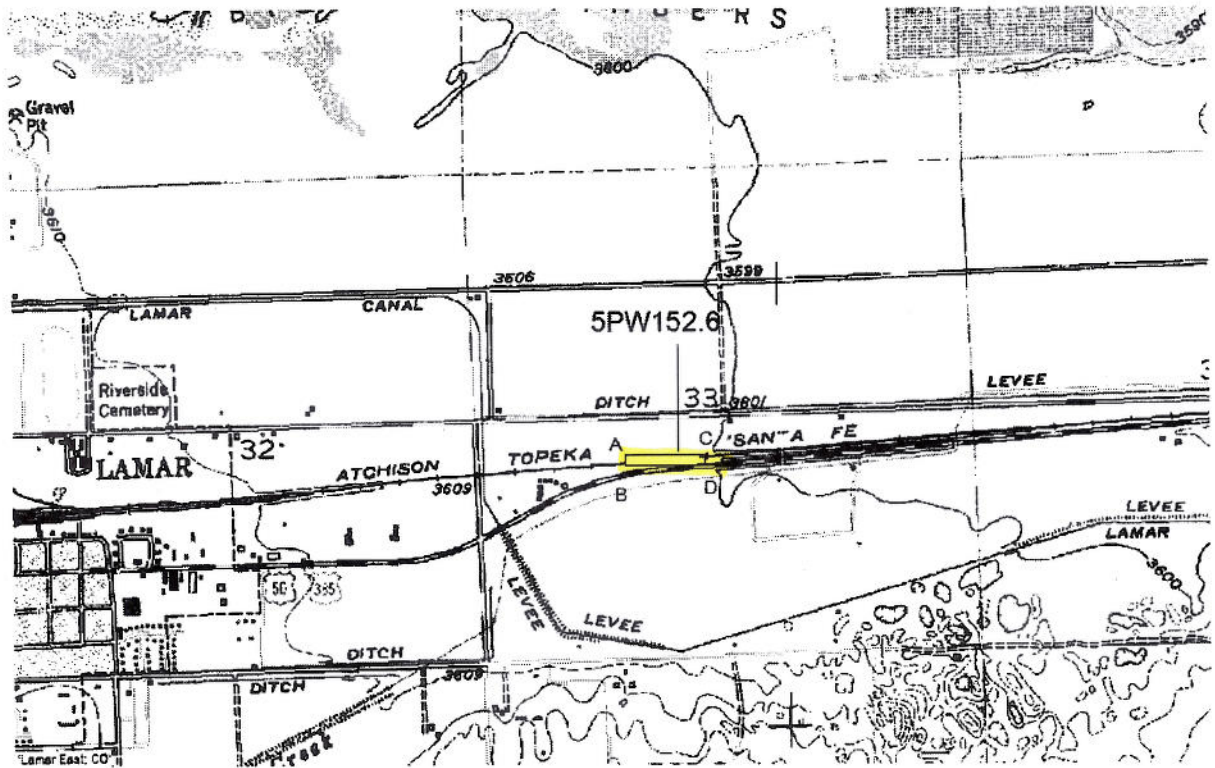
# 5PW152.6 Santa Fe Railroad

34. Describe condition: The line is the active mainline of the BNSF railroad (formerly Santa Fe Railway)

39. Threats to Resource: Water erosion\_\_\_ Wind erosion\_\_\_ Grazing\_\_\_ Neglect\_\_\_  
Vandalism\_\_\_ Recreation\_\_\_ Construction x Other (specify): \_\_\_\_\_  
comments: Site located within the proposed U.S. 287 Bypass
40. Existing Protection: None x Marked\_\_\_ Fenced\_\_\_ Patrolled\_\_\_ Access controlled X  
other (specify): \_\_\_\_\_
41. Local landmark designation: N/A 42. Easement: N/A
43. Management Recommendations: This segment should be archivally photographed and mapped prior to the construction of the proposed highway project.

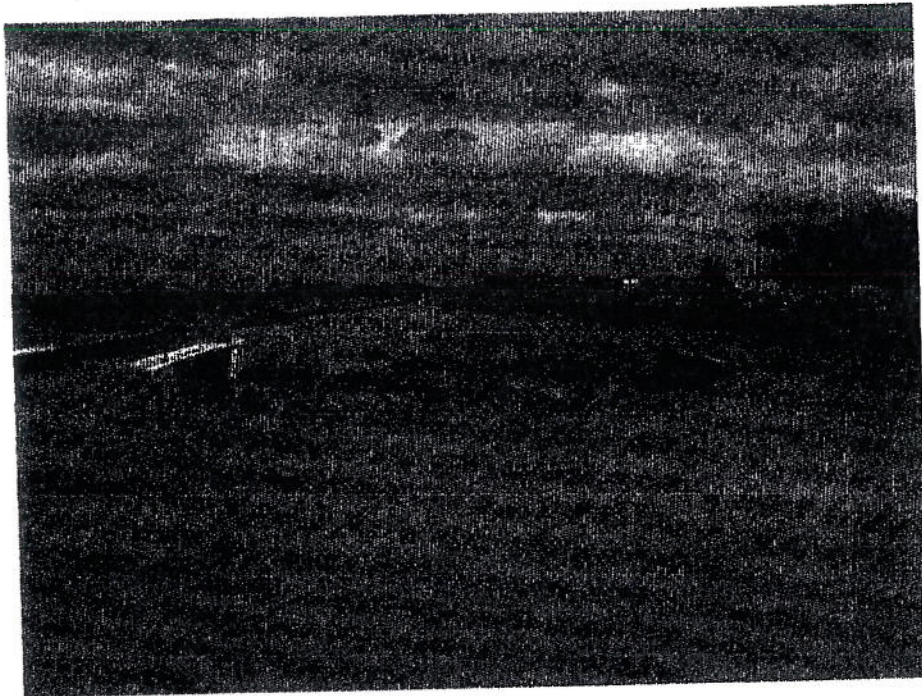
5PW152.6 Santa Fe Railroad, overview of the project area.  
View looks east

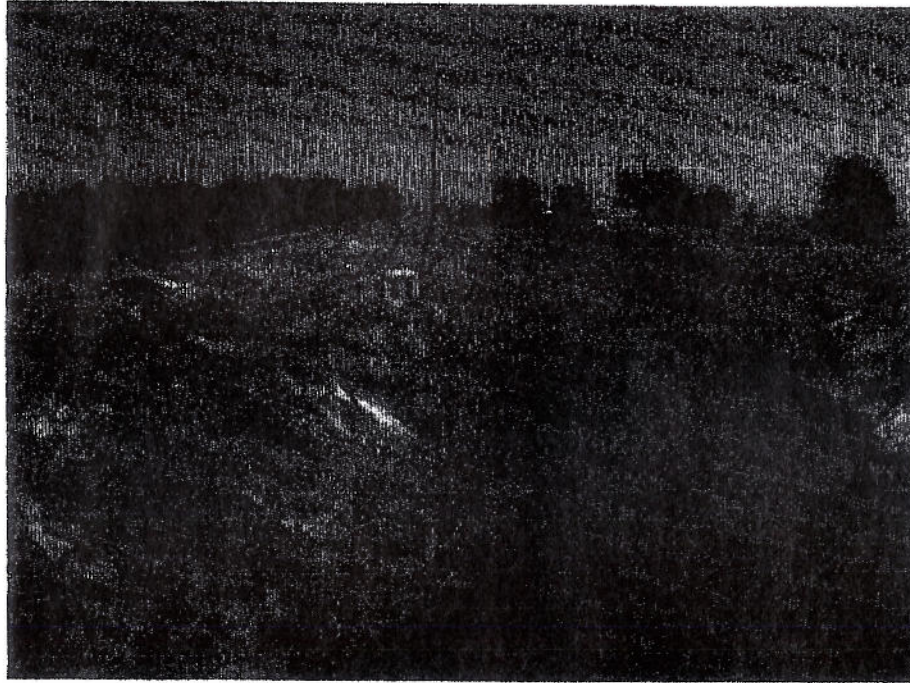
34. Describe condition: Canal condition is good, although recent stabilization efforts are apparent. Chunks of concrete have been laid along the banks for stabilization and recent work has impacted the canal - in April 1993 the current bridge was built at this location (see site map), probably as a final step in the county road construction project

Statement of Significance/N.R.H.P. Justification: Site 5PW191.1 does not retain the integrity necessary for eligibility to support the assumed eligibility to the NRHP of the Lamar Canal. Modern improvements have compromised the site's integrity, as have efforts to stabilize the canal banks. This site does not retain the feel of an historic canal at this location. It does have significance under Criterion a, but its lack of integrity precludes consideration as a segment of the entire linear resource that would support its eligibility. No other evidence was found to support significance under the other National Register criteria.

5PW191.1 Lamar Canal, view of the eastern portion of the recorded segment in the project area. View looks east.

39. Threats to Resource: Water erosion  Wind erosion  Grazing  Neglect   
Vandalism  Recreation  Construction  Other (specify): \_\_\_\_\_  
comments: Site located within the proposed U.S. 287 Bypass
40. Existing Protection: None  Marked  Fenced  Patrolled  Access controlled   
other (specify): \_\_\_\_\_
41. Local landmark designation: N/A 42. Easement: N/A
43. Management Recommendations: No further work is recommended for this project.

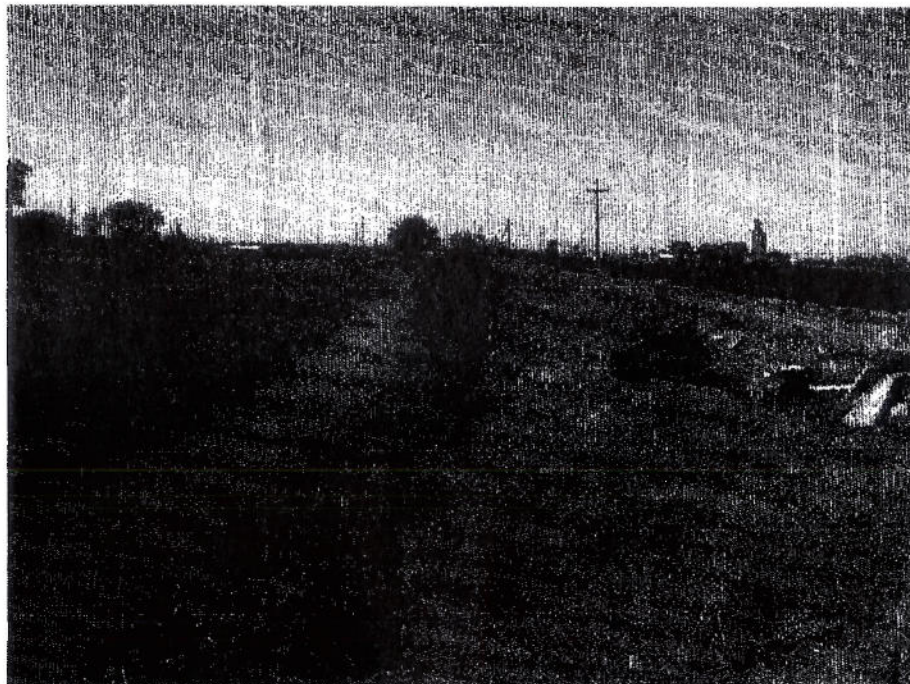
5PW191.1 Lamar Canal, view of the western portion of the recorded segment in the project area. View looks west.

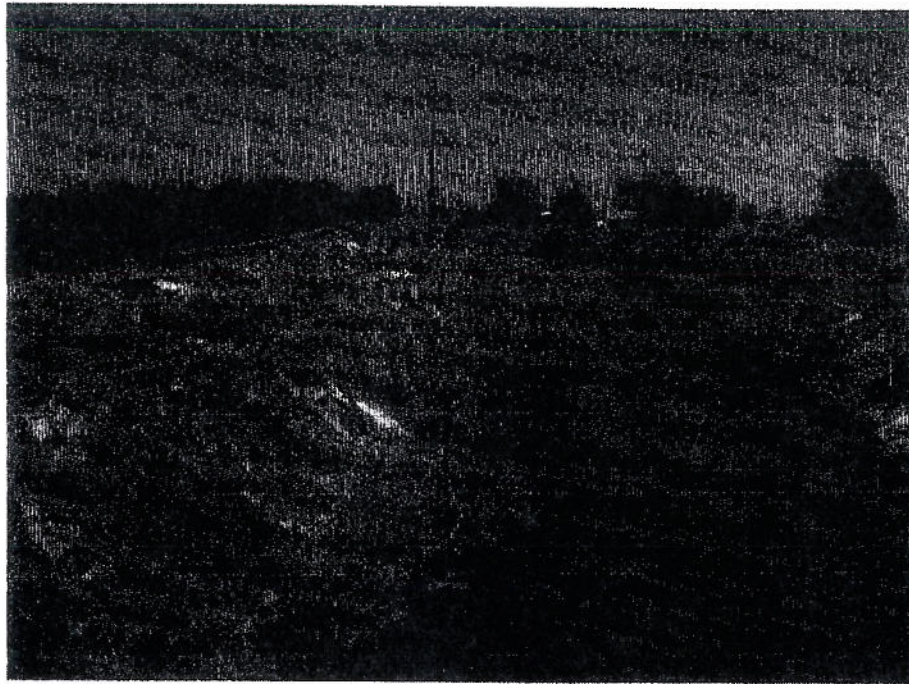
5PW191.1 Lamar Canal, view of the eastern portion of the recorded segment in the project area. View looks east.

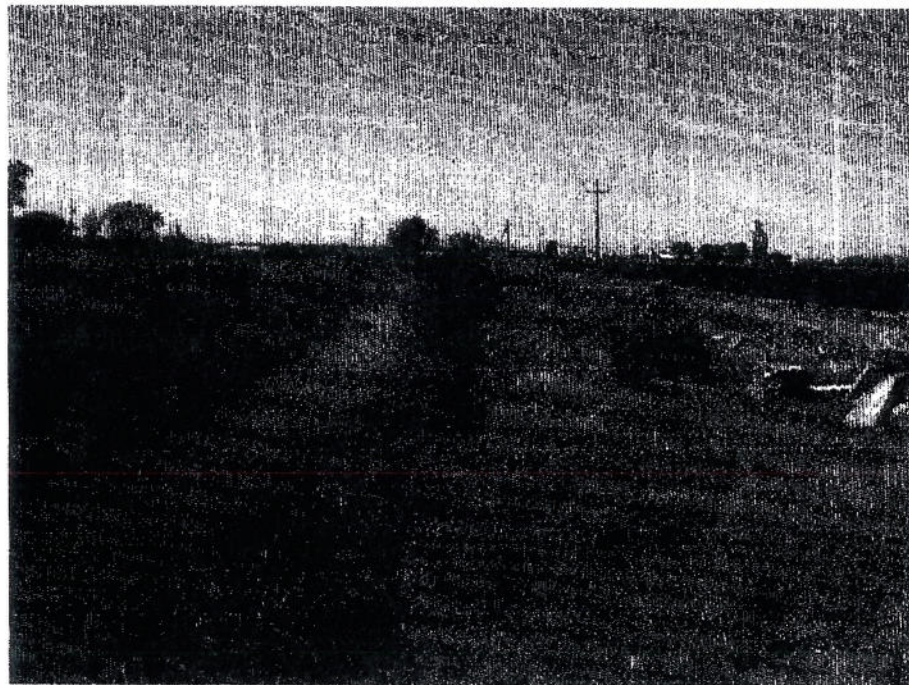
5PW191.1 Lamar Canal, view of the western portion of the recorded segment in the project area. View looks west.

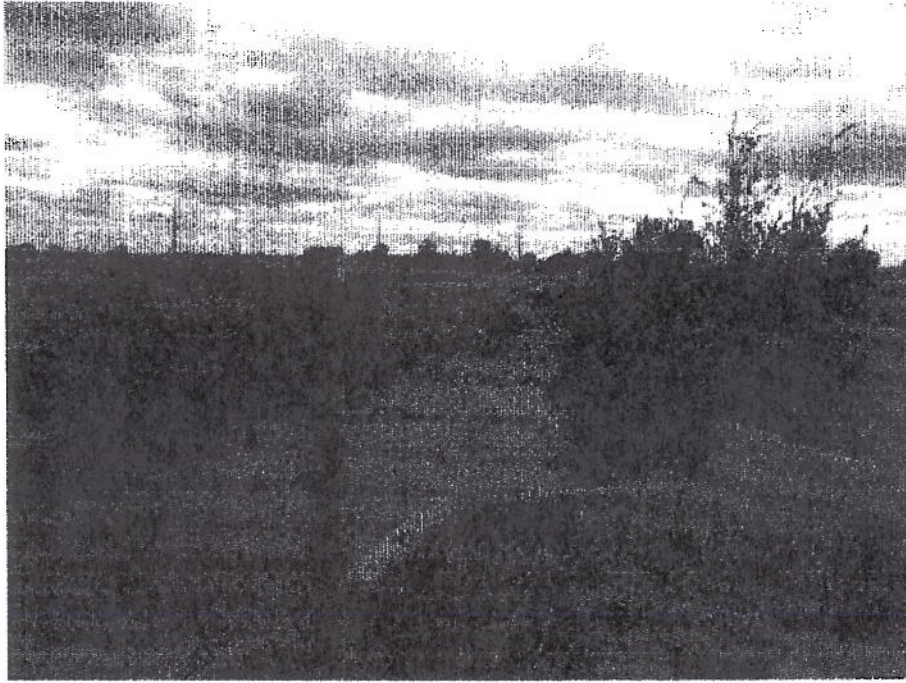
34. Describe condition: Canal condition is good, although recent stabilization efforts are apparent. Chunks of concrete have been laid along the banks for stabilization and recent work has impacted the canal. Portions of the canal gates were rebuilt or improved in 1995 ("3-10-1995, Herb Morlan" scratched in concrete before it dried).

Statement of Significance/N.R.H.P. Justification: Site 5PW191.2 does not retain the integrity necessary for eligibility to support the assumed eligibility to the NRHP of the Lamar Canal. Modern improvements have compromised the site's integrity including new concrete retaining walls and headgates. This site does not retain the feel of an historic canal at this location. It does have significance under Criterion a, but its lack of integrity precludes consideration as a segment of the entire linear resource that would support its eligibility. No other evidence was found to support significance under the other National Register criteria.

5PW191.2 Lamar Canal, view of the eastern portion of the recorded segment in the project area. View looks southeast with gate in foreground.

39. Threats to Resource: Water erosion  Wind erosion  Grazing  Neglect   
Vandalism  Recreation  Construction  Other (specify): \_\_\_\_\_  
comments: Site located within the proposed U.S. 287 Bypass
40. Existing Protection: None  Marked  Fenced  Patrolled  Access controlled   
other (specify): \_\_\_\_\_
41. Local landmark designation: N/A 42. Easement: N/A
43. Management Recommendations: No further work is recommended for this project.

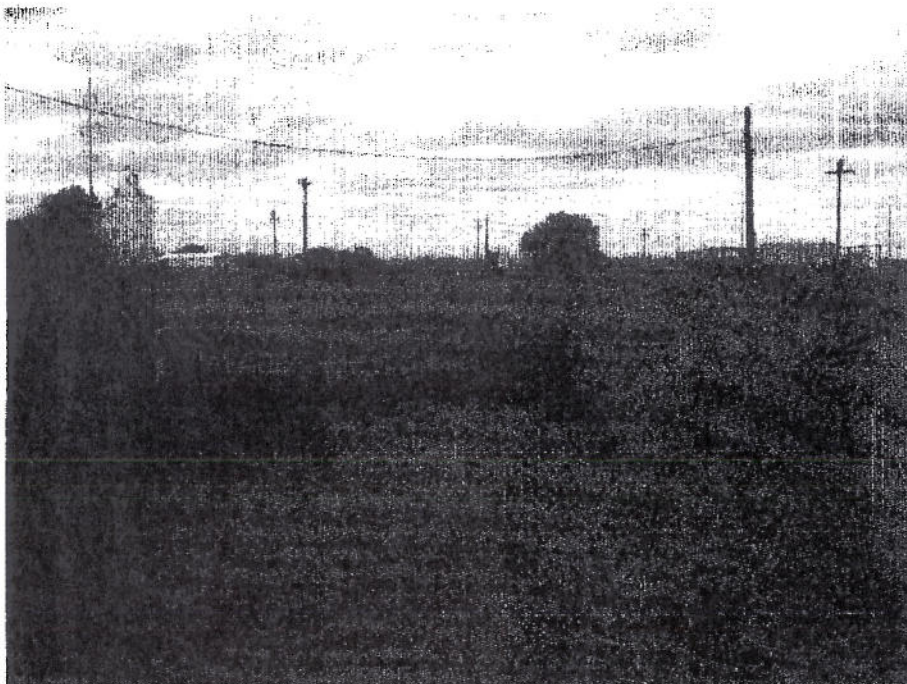
5PW191.2 Lamar Canal, view of the western portion of the recorded segment in the project area. View looks north-northwest with gate in background.

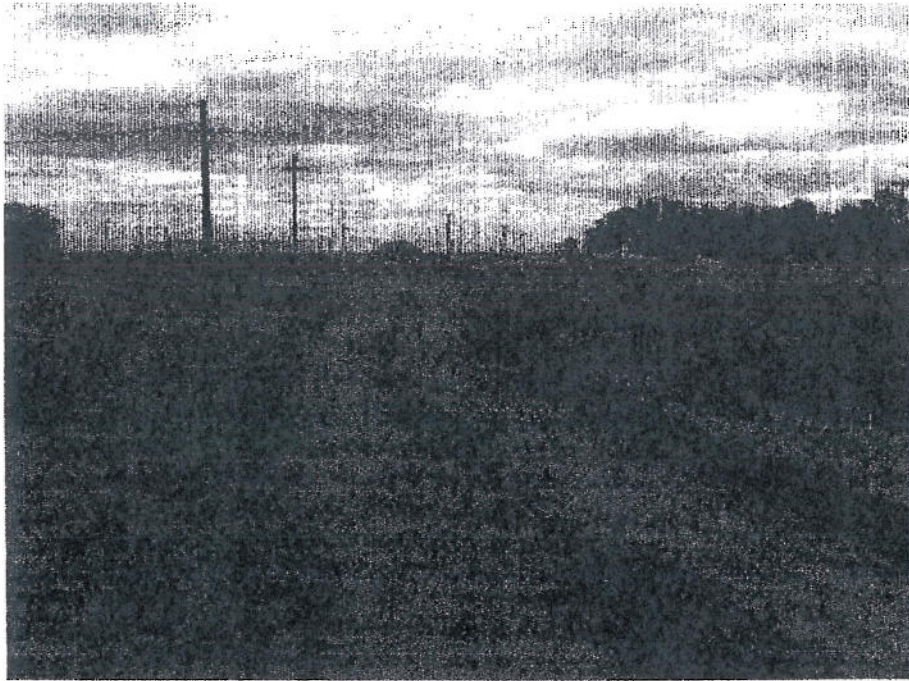
5PW191.2 Lamar Canal, view of the western portion of the ditch riders path in the project area. View looks north-northwest.

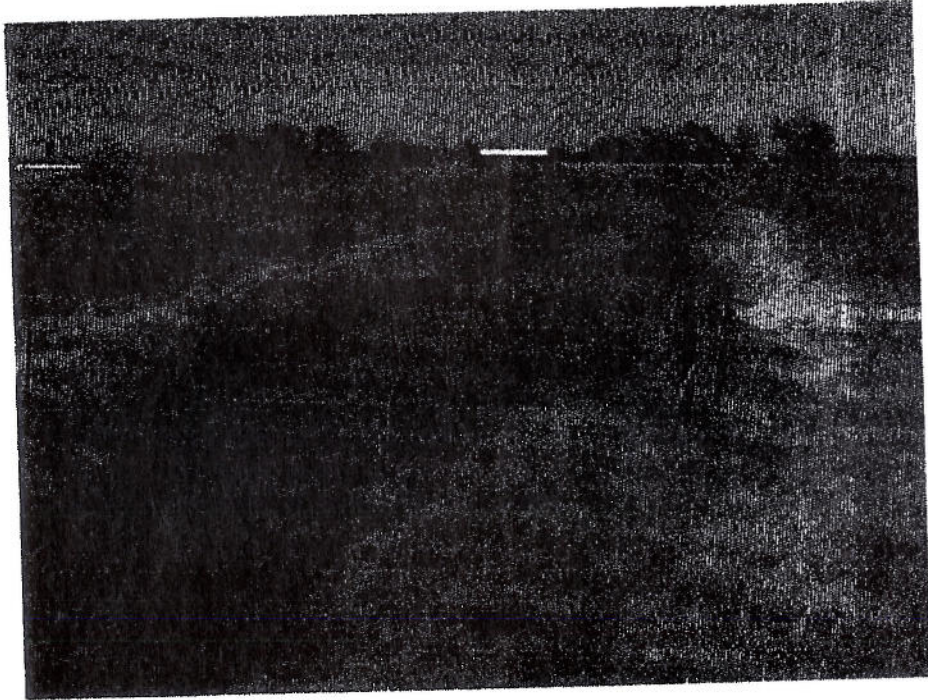
34. Describe condition: Canal condition at 5PW192.1 is good and banks appear stable. There was no water in the canal at time of recording. 1989-90 construction of county road has impacted the site.

Statement of Significance/N.R.H.P. Justification: The Fort Bent Canal has significant associations with the early agricultural development and water resource utilization in the Lamar area and thus is considered eligible under Criterion a. The canal may also have significance under Criterion c in other areas, but there is nothing of engineering significance in the current project area because it has no engineering features such as weirs or gates. No information was found to support eligibility under Criteria b or d.

5PW192.1 Fort Bent Canal, view of the eastern portion of the recorded segment in the project area. View looks east.

39. Threats to Resource: Water erosion  Wind erosion  Grazing  Neglect   
Vandalism  Recreation  Construction  Other (specify): \_\_\_\_\_  
comments: Site located within the proposed U.S. 287 Bypass
40. Existing Protection: None  Marked  Fenced  Patrolled  Access controlled   
other (specify): \_\_\_\_\_
41. Local landmark designation: N/A 42. Easement: N/A
43. Management Recommendations: If the resource is to be impacted by this project it is suggested that it be photo-documented prior to disturbance if it cannot be avoided

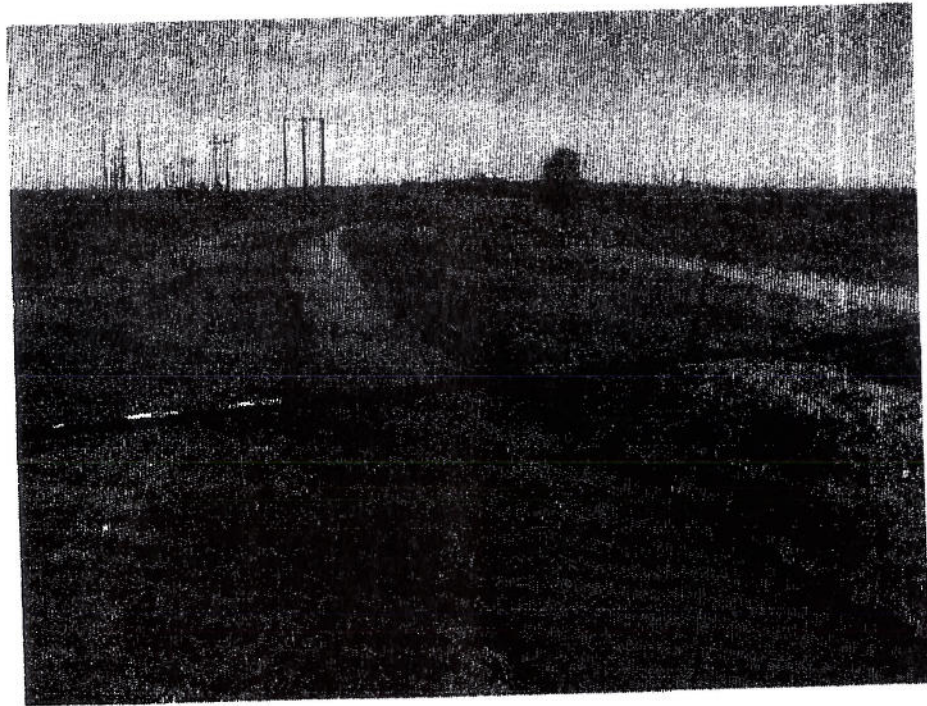
5PW192.1 Fort Bent Canal, view of the western portion of the recorded segment in the project area. View looks west.

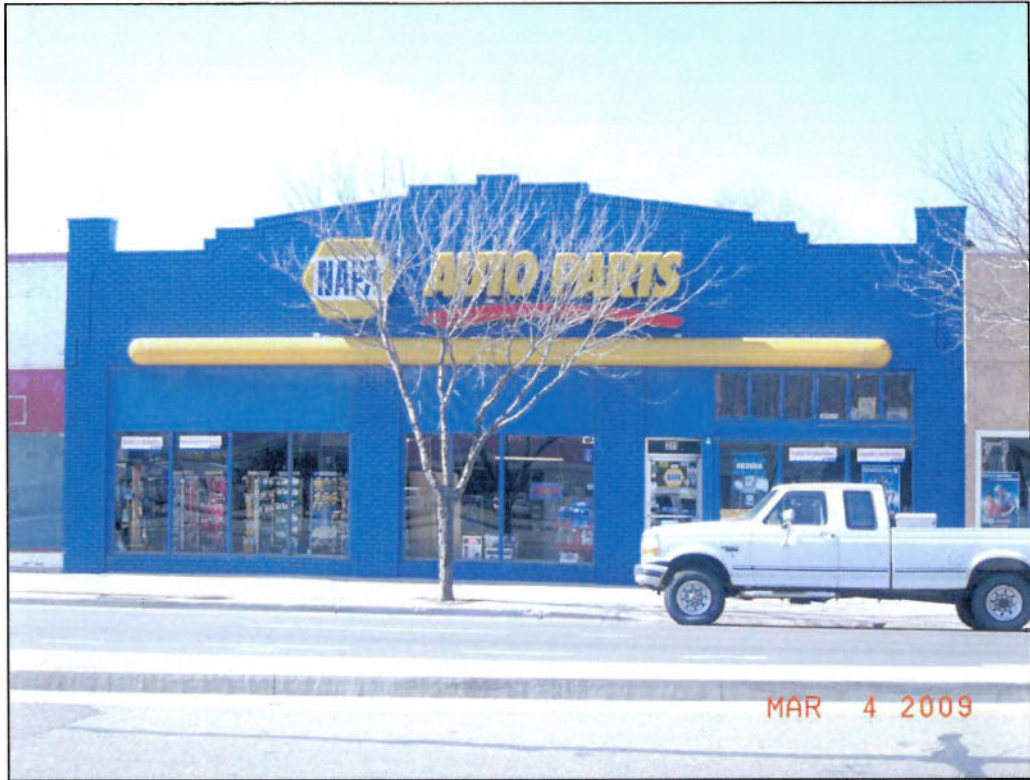
5	311 N. Main Street	Napa Auto Parts	2009-3, 102	1915
---	--------------------	-----------------	-------------	------

5	311 N. Main Street	Napa Auto Parts	200049650	2009-3, 102	W	1915	Early 20 <sup>th</sup> Century Commercial		Structure appears to match 307 N. Main. Storefront transoms covered. Windows replaced. Transom above entry appears original.	1990
6	307 N. Main Street	Sunshine	200028390	2009-3, 98	NW	1915	Early 20 <sup>th</sup> Century Commercial		Structure appears to match 311 N. Main. Storefront transoms covered with plywood. Windows and doors replaced. The two left bays may have been garage doors?	1980
7	223 N. Main Street		200019161	2009-3, 96, 97, 99	W, SW, SW	1922	Early 20 <sup>th</sup> Century Commercial		Storefront altered. Appears to have been former garage. New door on south end. Building was originally brick, now covered in stucco.	1986**- Garage part remodeled for show and sales
8	217 N. Main Street	Lamar Auto Trim & Glass	200007220	2009-3, 95, 97	W, SW	1916	Early 20 <sup>th</sup> Century Commercial		Storefront transom replaced with vertical boards.

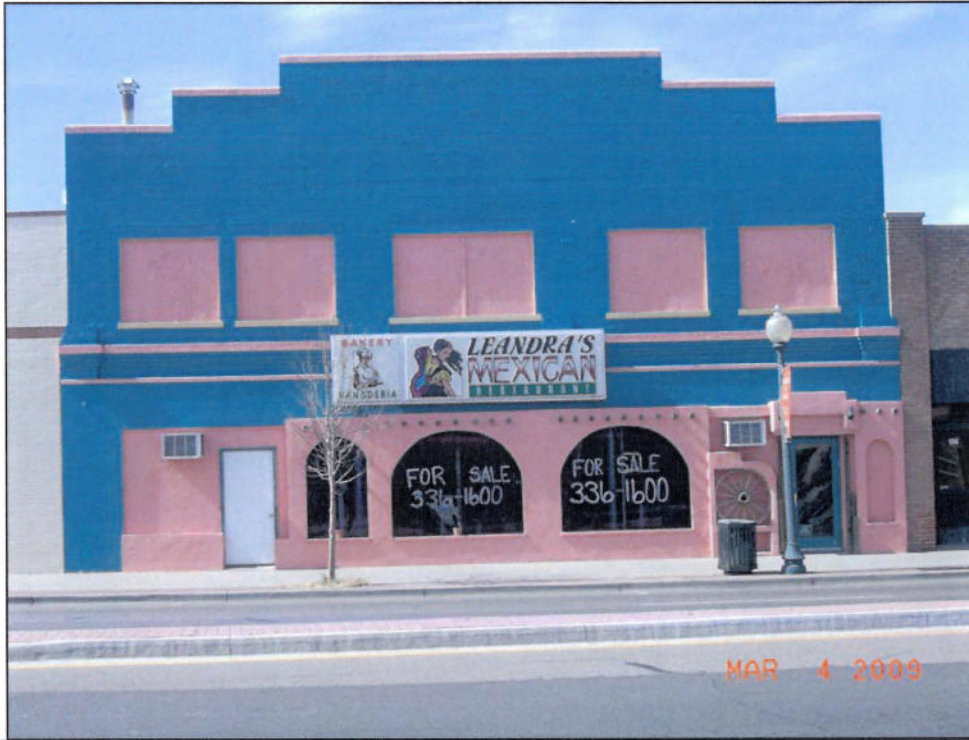
9	211 N. Main Street	Leandra's Bakery/ Panaderia	2009-3, 94, 97	1922
---	--------------------	-----------------------------	----------------	------

9	211 N. Main Street	Leandra's Bakery/Panaderia	200053011	2009-3, 94, 97	W, SW	1922	Early 20 <sup>th</sup> Century Commercial	Second story window boarded. Made to look like an adobe/Pueblo Revival structure. Replaced windows. Incompatible door on south end of façade.	1999**- Renovated to accommodate restaurant.
10	215 N. Main Street	Fastenal	200053012	2009-3, 93	W	1922	Early 20 <sup>th</sup> Century Commercial	Aluminum windows and doors. Ghost bricking of door on north end of façade that was closed in.	1970/1980
11	205 N. Main Street	Kirby	200062630	2009-3, 93	W	1907	Early 20 <sup>th</sup> Century Commercial	Storefront transom covered with plywood.	1970
12	201 N. Main Street	Gas station	200047240	2009-3, 76	NW	1928	Cottage Style Gas Station	Former gas station.. Replaced garage door. 1 garage bay filled in. Some windows replaced. Metal roof. Door replaced. Rear shed additions. According to assessor, used as storage since at least 1977	2003**- New metal roof installed. 1979**- Addition of 1350 sf on rear

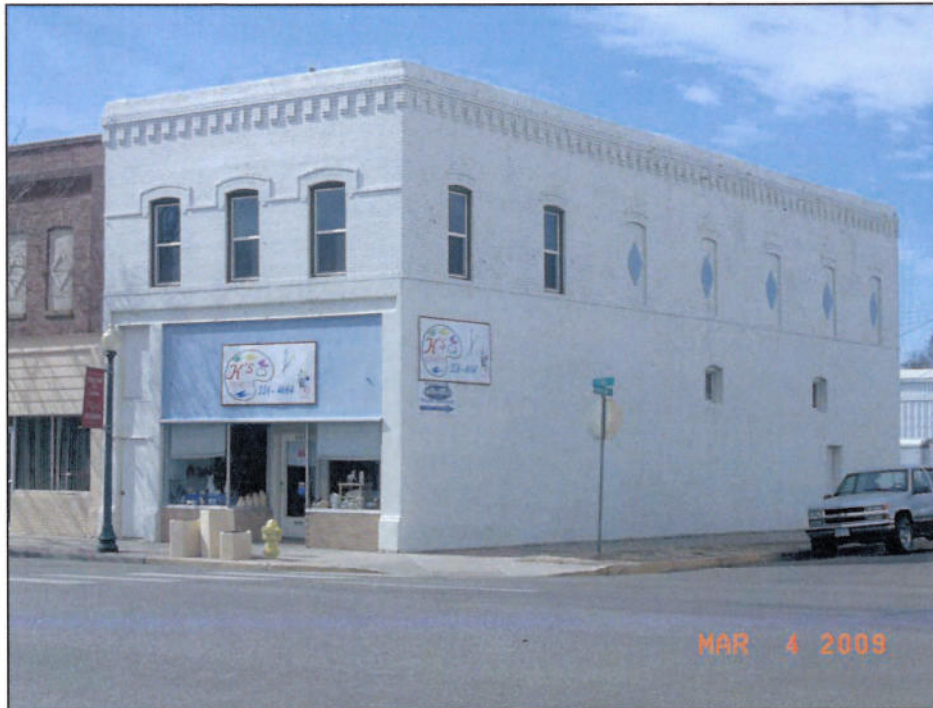
13	123 N. Main Street	K's Ceramics	2009-3, 74, 75	1900
----	--------------------	--------------	----------------	------

13	123 N. Main Street	K's Ceramics	200022531	2009-3, 74, 75	SW, W	1900	Early 20 <sup>th</sup> Century Commercial	First story stuccoed. Storefront transom covered in stucco. New storefront windows. Replacement brick below storefront windows. South stairway entry has replacement door and window covered in plywood. Vinyl second story windows.	1970, 2 <sup>nd</sup> story windows unboarded post 1983 (see before and after photos)
14	119-121 N. Main Street	Ye Olde Rummage Shoppe	20180	2009-3, 77	W	1913	Early 20 <sup>th</sup> Century Commercial	Storefront transoms covered with vertical vinyl siding. Staircase central entryway altered with new door and covered transom. Replacement windows on first floor. North section of	1985

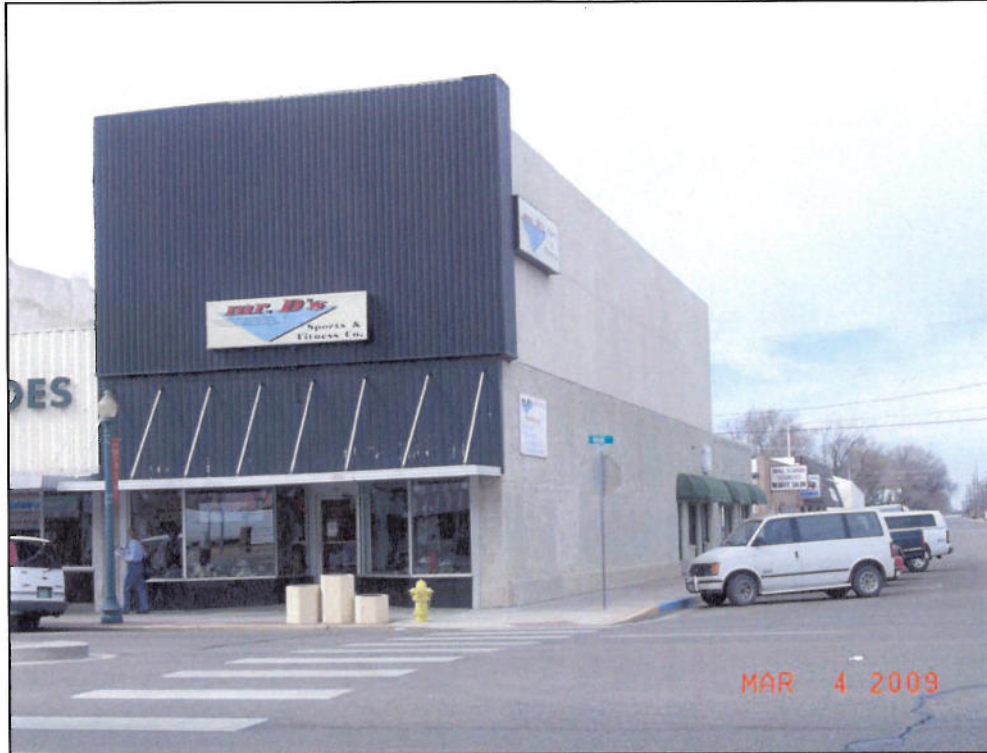
19	100 S. Main Street	Mr. D's Sports and Fitness Co.	2009-3, 52, 53	1895
----	--------------------	--------------------------------	----------------	------

19	100 S. Main Street	Mr. D's Sports and Fitness Co.	200008980	2009-3, 52, 53	W, SW	1895	No Style	Second story covered in vertical metal siding. Aluminum replacement windows on first floor. Metal awning. North elevation stuccoed.	Altered before 1986***
20	102 S. Main Street	J&N Shoes	200023060	2009-3, 51	W	1900	No Style	Vertical vinyl or metal siding on upper portion of façade. Aluminum awning. Replacement aluminum	1974**

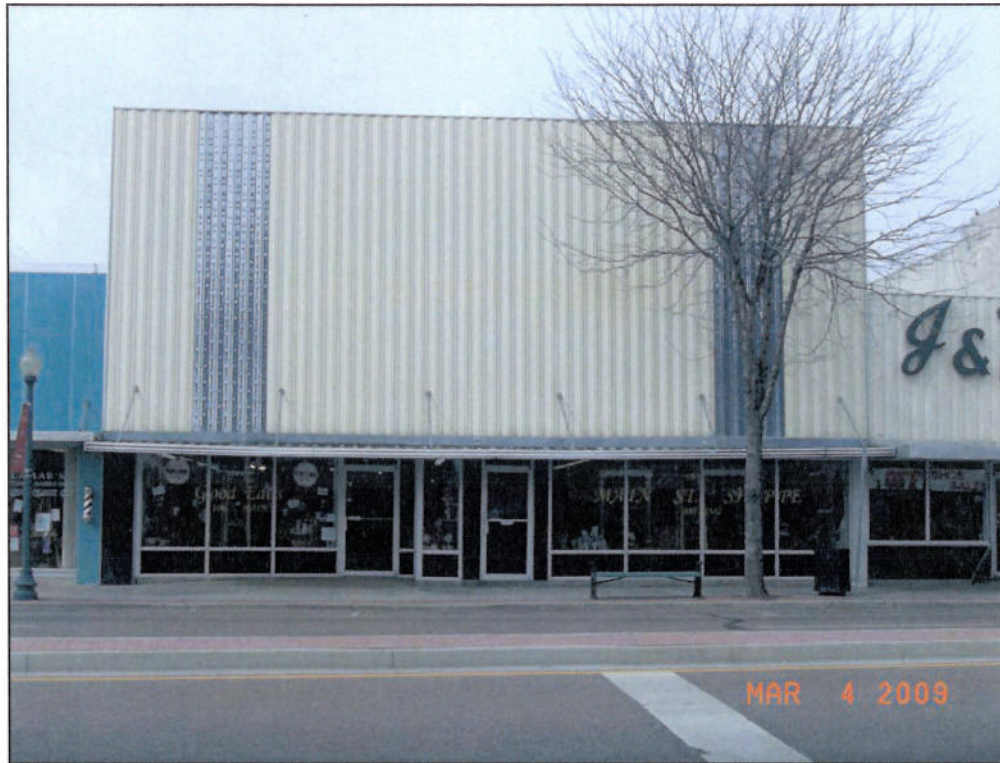
21A	106 S. Main Street	Good Eats & main Street Shoppe	2009-3, 50	1887
-----	--------------------	--------------------------------	------------	------

21A	106 S. Main Street	Good Eats & main Street Shoppe	200019470	2009-3, 50	W	1887	No Style	storefront windows, angled panels below storefront windows. Vertical vinyl or metal siding covering second story façade. Aluminum awning. Replacement aluminum storefront windows.	Between 1970-1986 ***
21B	108 S. Main Street	Citi Financial/ Barber Shop	200049600	2009-3, 49	W	1910	No Style	Façade completely covered in metal panels with blue enamel. Aluminum awning. Replacement storefront windows. Northern bays of one story green façade.	Before 1986 ***
22	110 S. Main Street	Bettiann's Travel	200049570	2009-3, 49	W	1910	No Style	Southern bay of one story façade covered in blue. Façade covered in metal panels with blue enamel. Aluminum awning. Replacement storefront windows.	Before 1986
23	112 S. Main	Bettiann's Gifts & Interiors	200049580	2009-3, 48	W	1910	No Style	One and a half stories of façade covered in metal panels with blue enamel. Upper portion of façade stuccoed. Modified wood windows in second story. Storefront windows and door replaced with aluminum. Metal cornice.	Before 1986

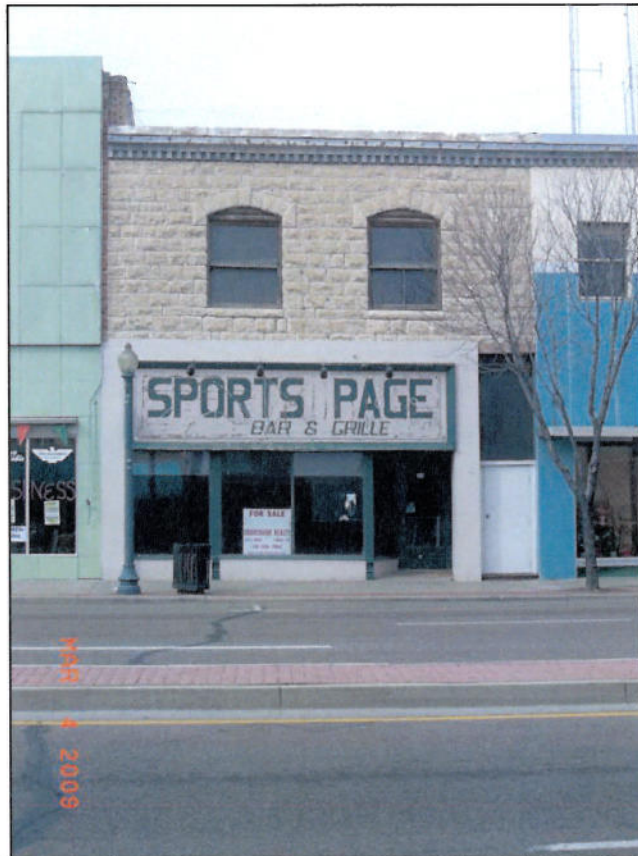
24	114 S. Main Street	Sports Page Bar & Grill	2009-3, 47	1895
----	--------------------	-------------------------	------------	------

24	114 S. Main Street	Sports Page Bar and Grill	200030440	2009-3, 47	W	1895	Early 20 <sup>th</sup> Century Commercial	Retrofitted wood windows on second floor. Metal cornice. Right stairway door replaced and opening filled with plywood. Cast iron columns. Storefront transom covered with incompatible sign.	1980

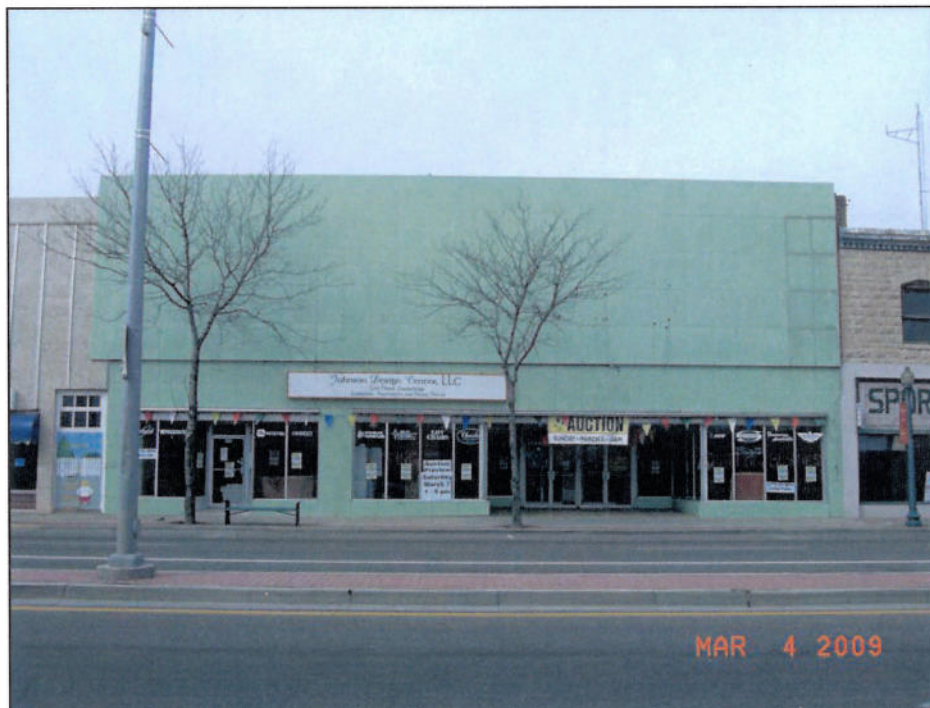
25	116 S. Main Street	Johnson Design Center	2009-3, 46	1895
----	--------------------	-----------------------	------------	------

25	116 S. Main Street	Johnson Design Center	200049510	2009-3, 46	W	1895	No Style	Storefront surround covered in stucco. Large green metal tiles covering entire façade. Replaced and remodeled storefront with aluminum window frames and doors.	1950
26	122 S. Main Street	The Berry Patch	200049520	2009-3, 43, 45	NW, W	1900	No Style	Sprayed concrete or rough stucco on second story with vertical metal separators. Tile below storefront windows. North stairway entry painted, but transom is original. Main storefront entry replaced and angled.	1971**
27	200 S. Main Street	First National Bank	200021011	2009-3, 42, 44	NW, SW	1965	Neo-Mansard	Property consists of three storefronts covered entirely in stone with recessed entries. Large green metal awning wraps around east and north facades- 1965 construction date. Third bay to the left (south), covered entirely in stone- built in 1980.	1980
28	208-210 S. Main Street	Robinson Printing for SE Colorado	200005600	2009-3, 41	W	1950	No Style	Vertical boards cover storefront transom. Granite base of storefront windows. Replacement aluminum storefront windows.	1975
