**AN HISTORICAL INVENTORY  
OF THE PROPOSED U. S. 287 LAMAR BYPASS IN  
PROWERS COUNTY, COLORADO**

**CH2M HILL**  
19 South Tejon Street, Suite 100  
Colorado Springs, CO 80903

February, 2010

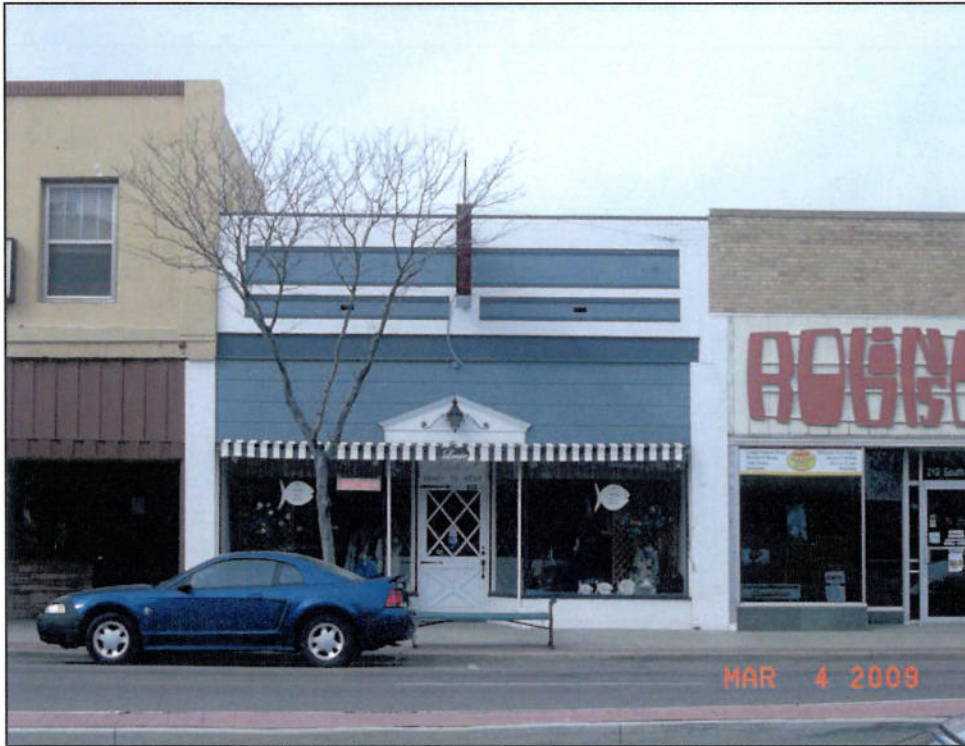
29	212 S. Main Street	The Lassie	2009-3, 40	1914
----	--------------------	------------	------------	------

29	212 S. Main Street	The Lassie	200002420	2009-3, 40	W	1914	No Style	Incompatible triangular pediment over entry. Storeform transom covered with horizontal wood planks. Replacement diamond pane door.	1980
30	214 S. Main		200042030	2009-3, 39	W	1912	Early 20 <sup>th</sup> Century	Stuccoed second story. Vertical wood board transom.	1975

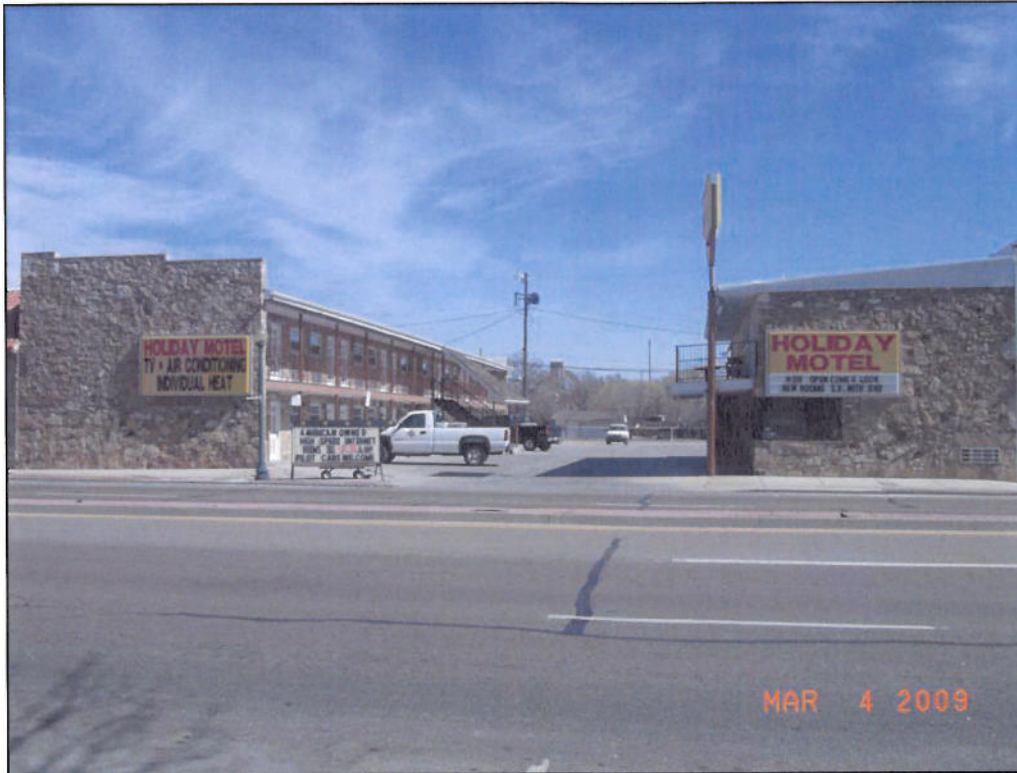
41	414 N. Main Street	"Holiday Paul's Parking"	2009-3, 113	1957
----	--------------------	--------------------------	-------------	------

41	414 N. Main Street	"Holiday Paul's Parking"	200012450	2009-3, 113	E	1957	No Style		Uncut, non-coursed stone veneer. Replacement windows in three bay which appear to have been garage bays. Door retrofitted into central bay. Right (south) bay boarded with plywood and painted. Structure resembles 308 N. Main Street	2000
42	404 N. Main Street	Holiday Motel	20005370	2009-3, 114	E	1927	No Style		Uncut, non-coursed stone veneer.	1970**, 2004**
43	402 N. Main Street	Ron Austen Repair	200002630	2009-3, 115, 116	E, NE	1930	Early 20 <sup>th</sup> Century Commercial		Assessor's address is 402 N. Main, Building reads 400 N. Main. Garage building with boarded storefront transom. Replacement storefront windows. Possible garage addition to rear	
44	318 N. Main Street	Lamar Starter	200043480	2009-3, 117	SE	1923	No Style		Brick veneer on surrounding storefront. Vertical metal siding covering upper half of façade. Aluminum storefront windows and door.	1980

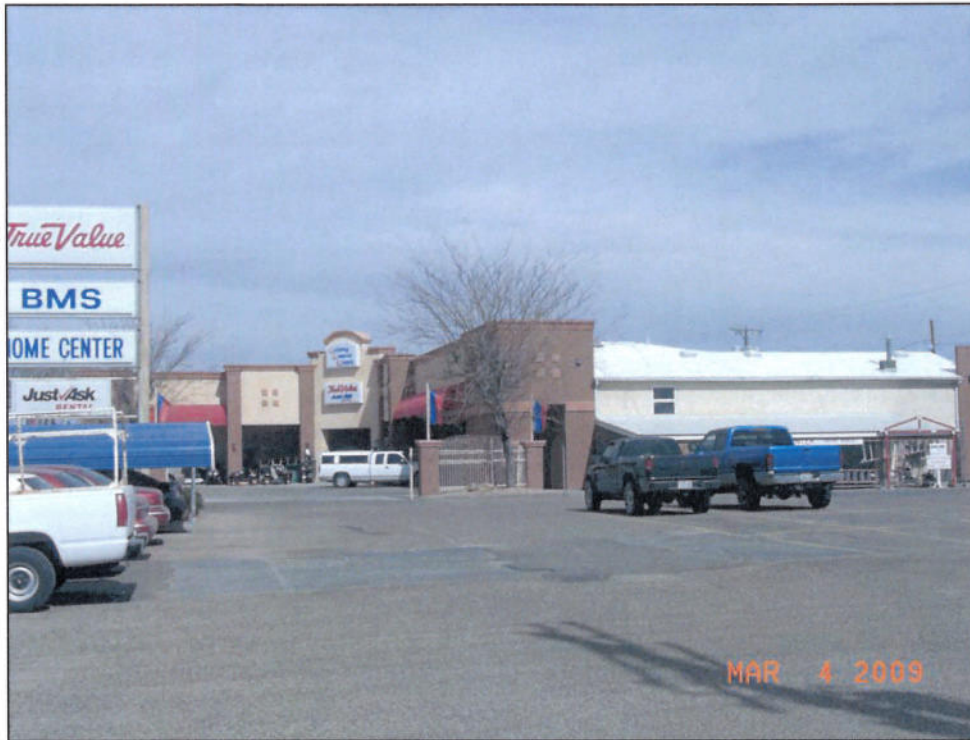
47	300 N. Main Street	Loaf N' Jug	2008-15, 5027	1987
----	--------------------	-------------	---------------	------

47	300 N. Main Street	Loaf N' Jug	200048640	2008-15, 5027	NE	1987	Oblong Box		Main Street	Modern gas station	
48	224 N. Main Street	True Value Hardware	200014771	2009-3, 73	N	1961	No Style			Stuccoed and remodeled hardware store. 1997, constructed additional building to replace one that collapsed in snow. 2001, added new covered storage	2005**- Remodeled whole store
49	200 N. Main Street	VACANT LOT	200036511							Demolished 1990.	
50	122 N. Main Street	Davies Hotel	200022873	2008-15, 5016, 2009-3, 90, 91	NE, SE	1902	Early 20 <sup>th</sup> Century Commercial	5PW.25-National Register Listed		Windows boarded and replaced.	2000
51	124 N. Main Street	VACANT LOT	20002874							Demolished sometime after 1977 according to assessors files	
52	110-114 N. Main Street	Wild West Athletics	200064211	2009-3, 89	E	1920	Neo-Mansard			All of second story features covered with stucco. Historically was three storefronts that have been combined. All storefronts replaced. Shingled awning spanning all three bays. Some ancillary buildings were demolished in 1977.	2008**- remodeled, 1996** received bathroom and interior remodeled.

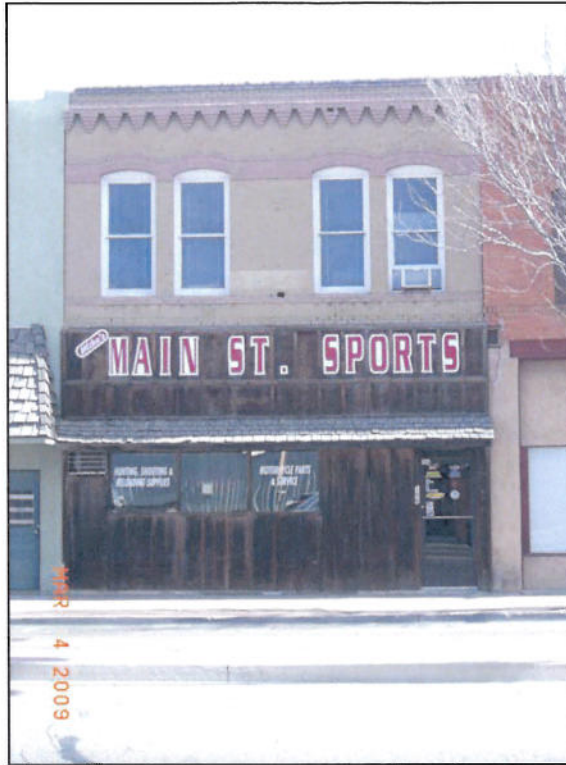
53	108 N. Main Street	Rug Rat flooring	2009-3, 88	1920
----	--------------------	------------------	------------	------

53	108 N. Main Street	Rug Rat flooring	200064212	2009-3, 88	E	1920	Neo-Mansard			Green stucco, shingled awning. Board and batten entry. Replaced storefront windows. Staircase entry door possibly original. Storefront door replaced. Second story	Upstairs-1998**

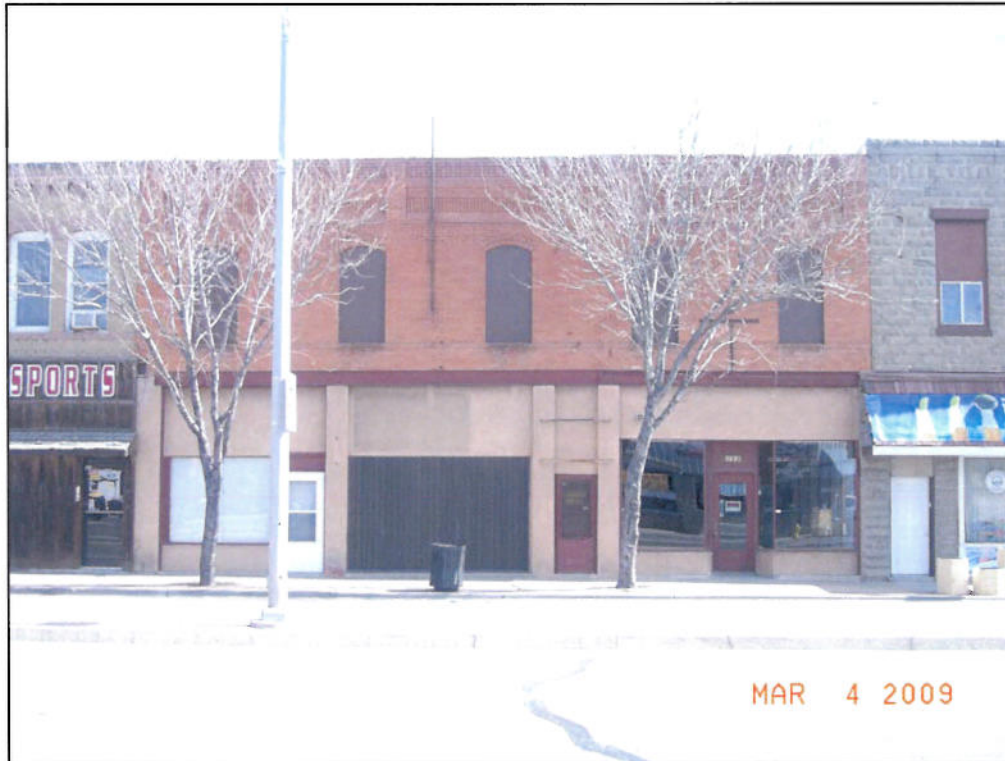
54	106 N. Main Street	Mike's Main Street Sports	2009-3, 87	1910
----	--------------------	---------------------------	------------	------

54	106 N. Main Street	Mike's Main Street Sports	200061650	2009-3, 87	E	1910	Early 20 <sup>th</sup> Century Commercial	Board and batten storefront alteration. Shingled awning. Original second story windows. First story windows and doors replaced.	1999**- Remodel. 1996**, office added
55	102-104 N. Main Street		200064200	2009-3, 86	E	1908	Early 20 <sup>th</sup> Century Commercial	First floor storefronts stuccoed. Central storefront bay enclosed with accordion metal wall. Replacement door on left storefront bay. Central door and right storefront appear original. Second story windows boarded with plywood. Brick work on 2 <sup>nd</sup> story appears to be original.	First floor storefront altered before 1976***
56	100 N. Main Street	Five-E Liquor Store	200021230	2009-3, 84, 85	E, NE	1910	Early 20 <sup>th</sup> Century Commercial	New doors, shingled awning. Metal frame (?) replacement windows retrofitted and infilled with stucco.	1985

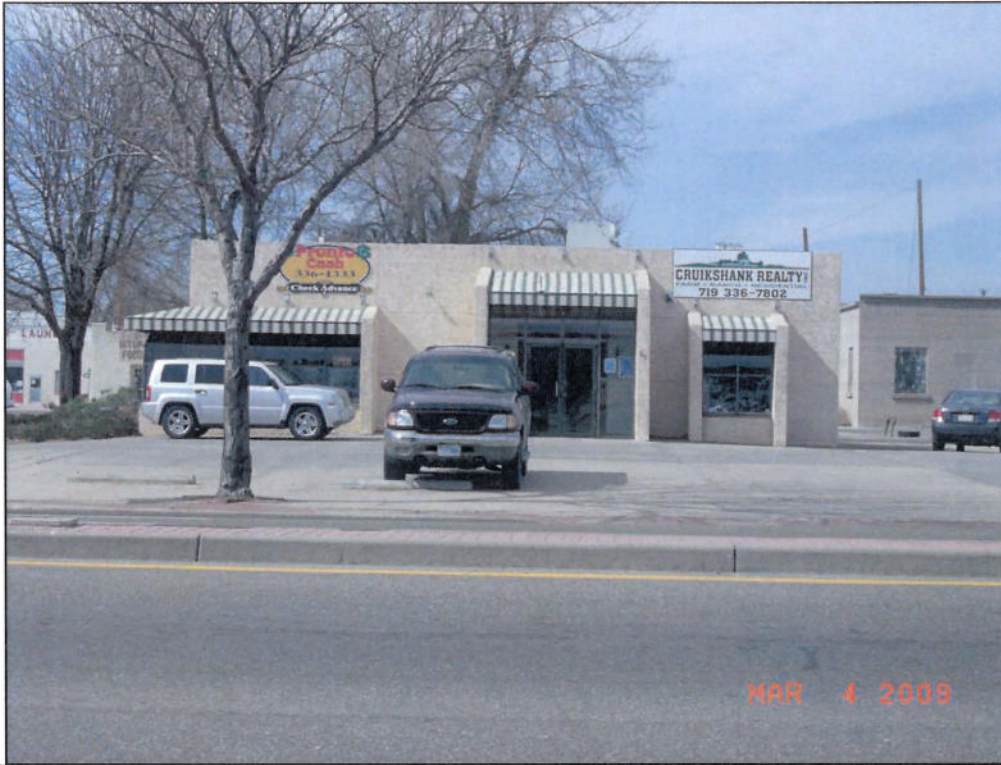
57	10 N. Main Street	Thai Spicy Basil	2009-3, 83	1990
----	-------------------	------------------	------------	------

57	10 N. Main Street	Thai Spicy Basil	200017101	2009-3, 83	SE	1990	No Style	Fast food building fairly intact.	
58	20 S. Main Street	Pronto Cash/ Cruikshank Realty	200015090	2009-3, 72	NW	1956	No Style	Appears to be modified for use as a fast food/ restaurant construction.	1985**
59	109 E. Beech Street	Lamar Depot	21351	2008-15, 5009	NE	1920	Late 19 <sup>th</sup> and early 20 <sup>th</sup> Century Revival	Depot in good condition. Very few alterations	
60	101 S. Main Street	Western Store	200015570	2008-15, 5007, 2009-3, 54-57	E, SE, SE, SE	1912	Novelty	Sculpted concrete façade (1965) placed over original storefront door and stairway entry door). Replacement storefront windows. North	1965 (per previous owner)

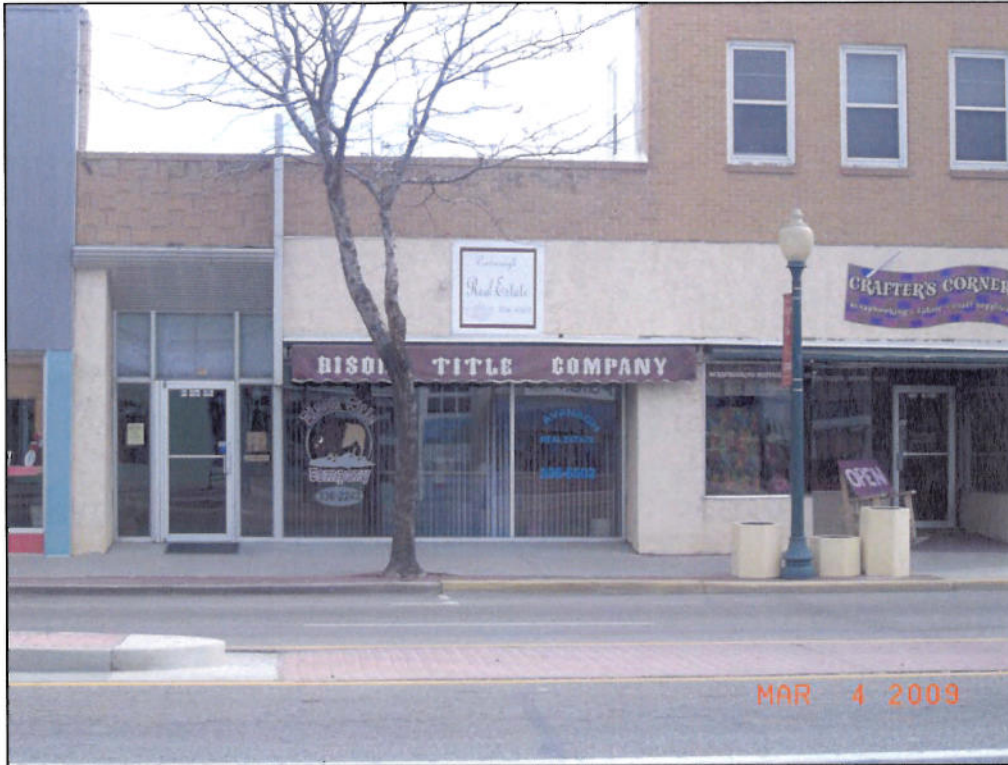
67	121 S. Main Street	Sweethearts	2009-3, 64	1918
----	--------------------	-------------	------------	------

Main Street			63					Style		Green Awning. Original brickwork.	1993**
67	121 S. Main Street	Sweethearts	200030080	2009-3, 64	E	1918	No Style		No Style		Vertical metal on upper portion of façade. Enamel coated metal panels on either side of replaced storefront and below.	Remodeled 1999**
68	123 S. Main Street	Bison Title Co./Cavanaugh Real Estate	200035131	2009-3, 65, 66	E, E	1897	No Style		No Style		Stuccoed storefront, new windows. Retractable awning. Metal divider between door and window section. Brick laid in decorative pattern to left of metal divider. Storefront door with angled metal above. Interior wall built in 1997.	1975
69	125 S. Main Street	Crafters Corner (Wilson Building)	200035132	2009-3, 66, 67	E, NE	1897	No Style		No Style		Replaced vinyl windows. First floor stuccoed. Replaced aluminum windows and door. Retractable awning.	1999** Remodeled
70	201-205 S. Main	Prowers County Development	200061710	2009-3, 1, 2	E, SE	1937	Art Deco		Art Deco		Replacement storefront windows. First floor stuccoed. Second story windows are original. Art deco cornice detailing. Vertical siding in storefront window retrofitting. "The Perk" one story section-replacement door. Incompatible vertical siding in lower half of storefront.	1990

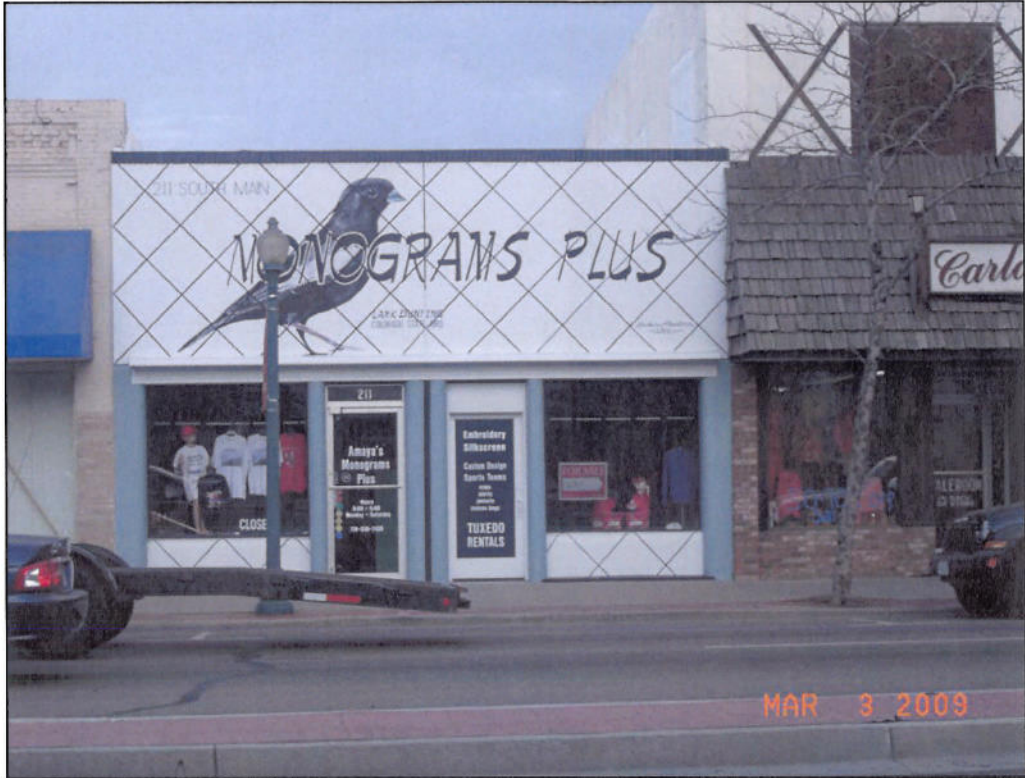
71	207 S. Main	Vacant	2009-3, 3	1908
----	-------------	--------	-----------	------

71	207 S. Main	Vacant	200028340	2009-3, 3	E	1908	Early 20 <sup>th</sup> Century Commercial		Early 20 <sup>th</sup> Century Commercial		Incompatible blue awning. Original brickwork. Replacement windows. Boarded transom above door.	1970
72	209 S. Main	Monograms	200054460	2009-3, 4	E	1897	No Style		No Style		Replacement windows. Upper part of façade completely covered with signage.	1980
