Site Habitat Assessments
for
Preble's Meadow Jumping Mouse

US 36 Corridor Environmental Impact Statement

October 2004

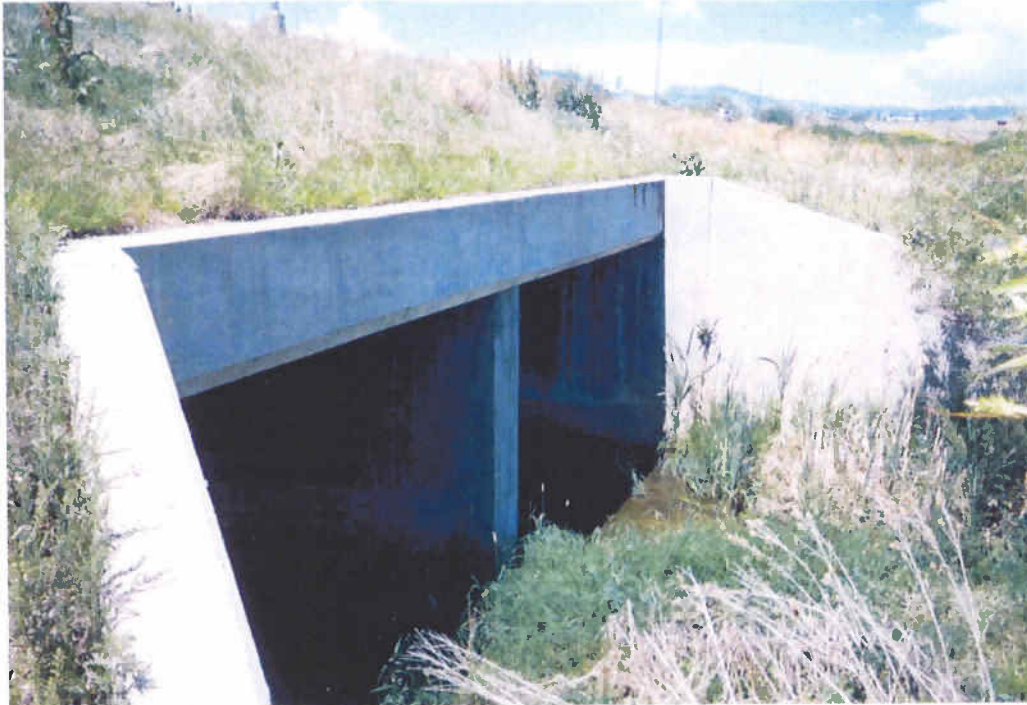
View of Rock Creek Culvert under North Side of US 36.

The crossing under US 36 is a two-span concrete box culvert, approximately 8 feet high by 20 feet wide by 360 feet long. This culvert would be extended to approximately 400 feet to 630 feet in length. The west side of the culvert carried flowing water and the east culvert was muddy at the time of site visit. Trapping is not recommended north of the US 36 crossing at Rock Creek due to heavy disturbance in the area in recent years as well as previous negative trapping surveys (USFWS 2004b).

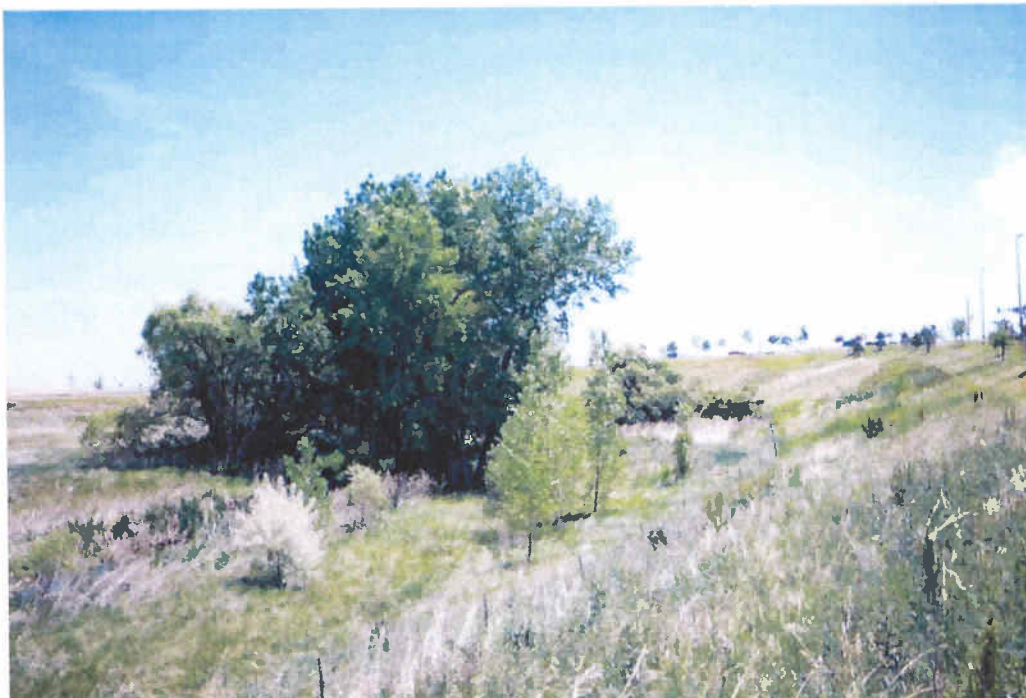
Rock Creek on the North Side of US 36 (Facing north).

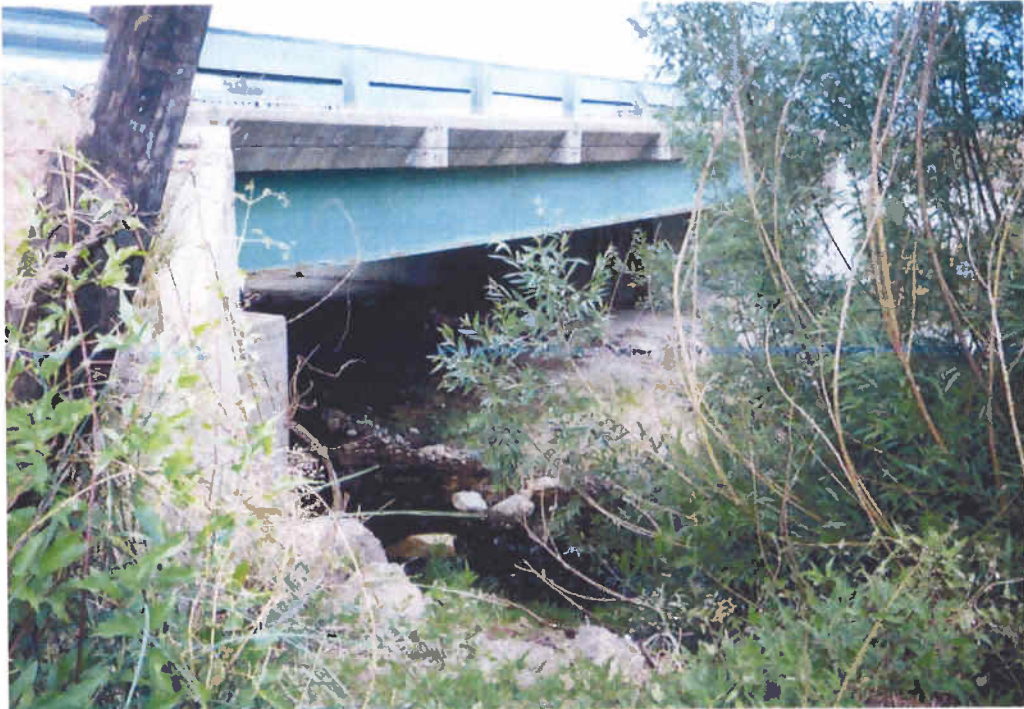
Culvert under US 36 at Coal Creek.

The immediate banks of Coal Creek are protected, though the areas surrounding Coal Creek are developed. On the north side of US 36, Coal Creek is bounded on the west by buildings and a golf course, and on the east side by a residential development. The existing bridge would be replaced with a three span bridge 260 feet long by 175 feet to 225 feet wide. The dense riparian woodland on the north side of US 36 at Coal Creek consists of crack willow (*Salix fragilis*), plains cottonwood, Russian olive (*Elaeagnus angustifolia*), green ash (*Fraxinus pennsylvanica*), Siberian elm (*Ulmus pumila*), American elm (*Ulmus americana*), hawthorn (*Crataegus* sp.), American plum (*Prunus americana*), chokecherry (*Prunus virginiana*). Understory vegetation includes sandbar willow, snowberry (*Symphoricarpus occidentalis*), bluestem willow (*Salix irrorata*), leadplant, wild grape (*Vitis* sp.), western virgin's bower (*Clematis occidentalis*), meadow fescue (*Festuca pratensis*), horsetail (*Equisetum* sp.), Canada thistle, bulrush (*Scirpus* sp.), teasel, orchardgrass (*Dactylis glomerata*), creeping spikerush (*Eleocharis palustris*), false tarragon (*Artemisia dracunculus*), and goldenrod (*Solidago* sp.).

The portion of Coal Creek on the south side of US 36 is within the Denver Metropolitan Preble's Block Clearance Zone. Areas of Coal Creek upstream and downstream of US 36 have been previously trapped (USFWS 2004b) and the site is disturbed and developed in areas adjacent to the creek. Based on this, Coal Creek at US 36 is not recommended for trapping or further evaluation.

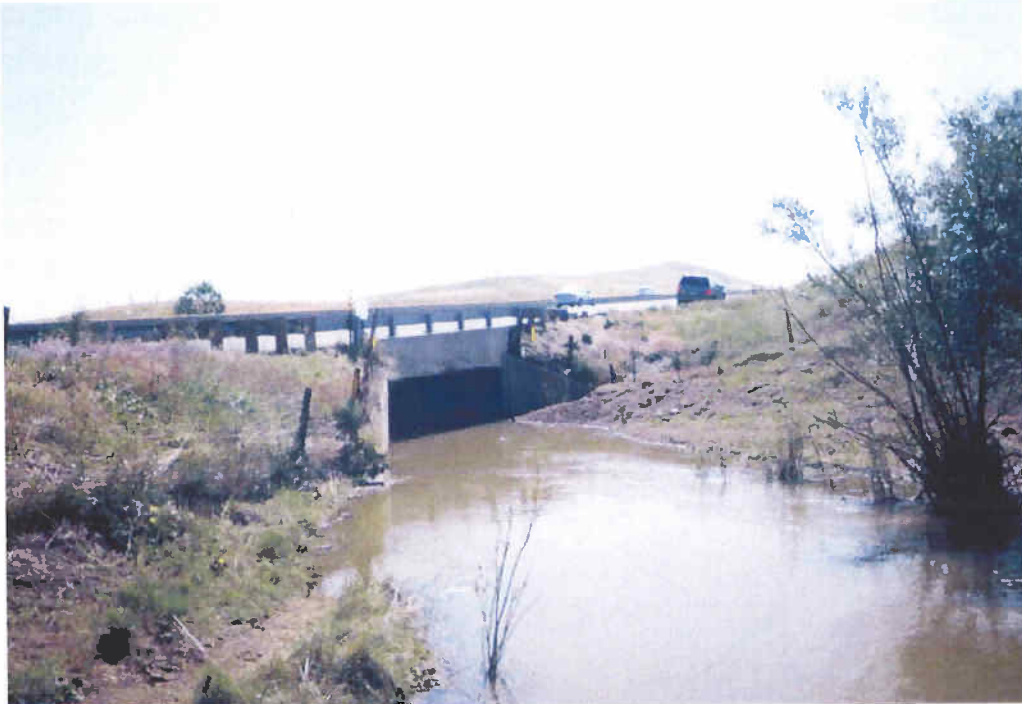
Davidson Ditch crossing on south side of US 36.

Understory species include smooth brome, cheatgrass (*Agropyron cristatum*), and Canada thistle. The vegetation was heavily grazed on the south side of US 36 where the ditch crosses under the highway. Recent trapping conducted by Anne Ruggles confirmed presence of Preble's at this ditch crossing (USFWS 2004c), therefore no further trapping is recommended at this location.

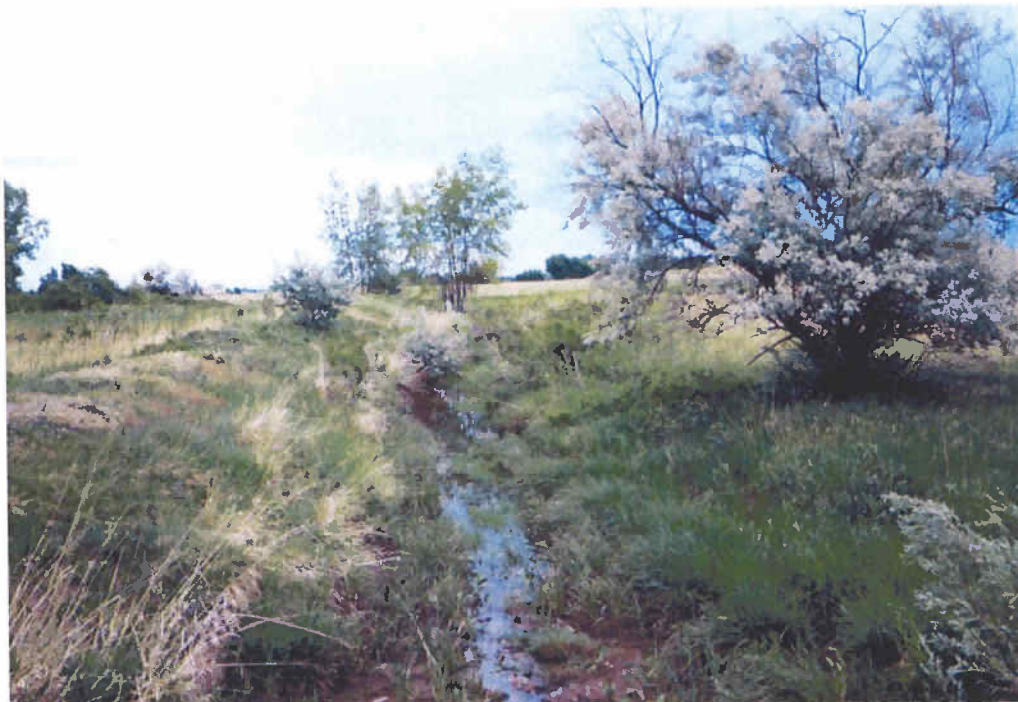
Goodhue Ditch on north side of US 36.

This ditch is located on Boulder County OSMP land. The current structure is a 12 feet wide box culvert; no change in structure width or length is proposed. Riparian shrub consists mostly of sandbar willow and leadplant, with some crack willow, box elder, American plum, Russian olive, and plains cottonwood. Additionally, wild rose (*Rosa* sp.) grows in the adjacent grasslands north of US 36. Water does not flow continuously in this ditch and stagnant water was observed during one site visit. However, recent trapping conducted by Anne Ruggles confirmed presence of Preble's at this ditch crossing (USFWS 2004c), therefore no further trapping is required at this time.

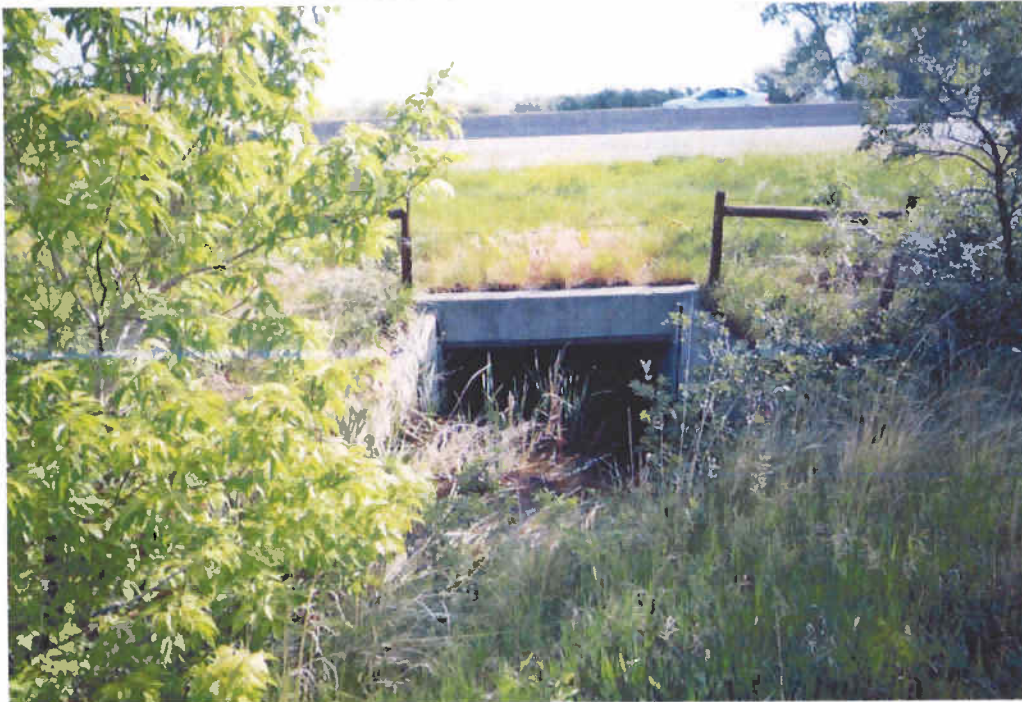
Culvert under Marshallville Ditch on southwest side of US 36.

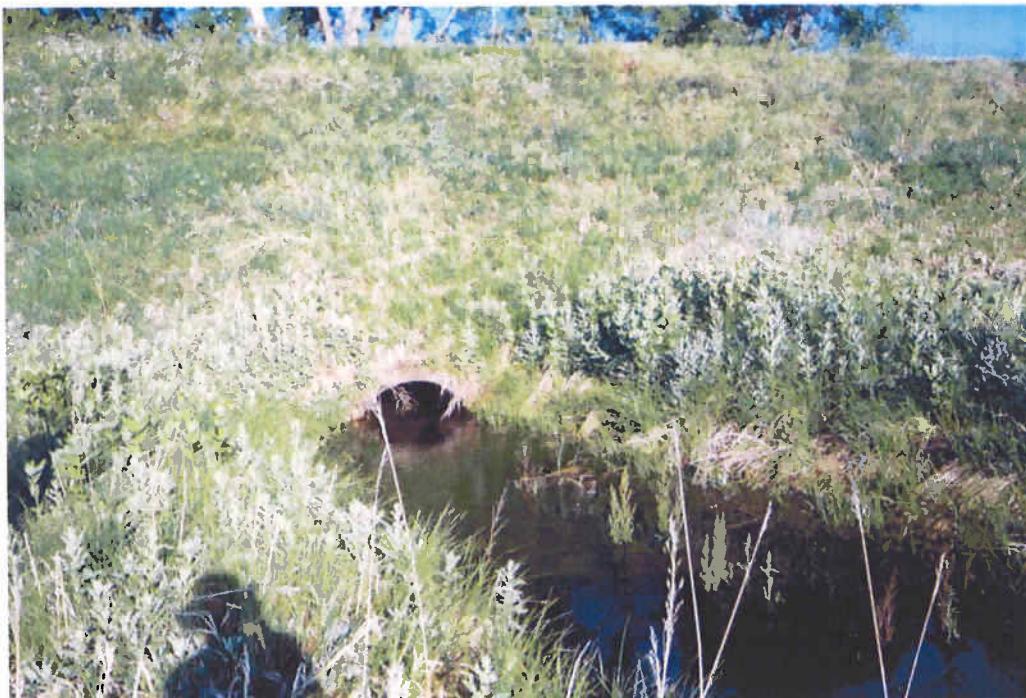
Pipe Culvert under Cherryvale Road on the North Side of US 36.

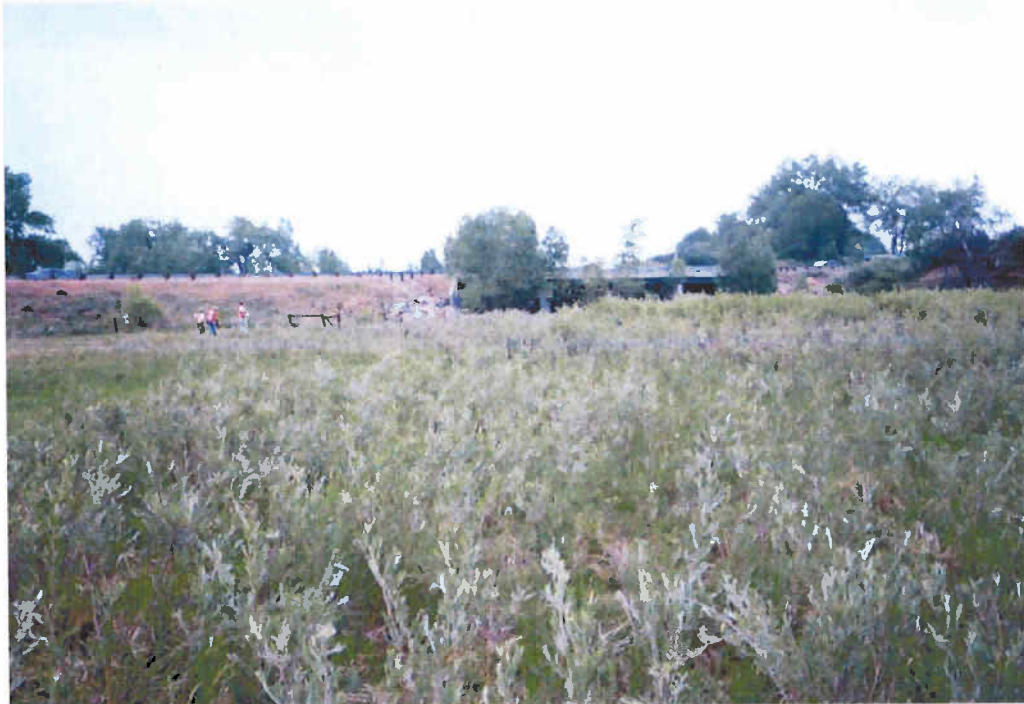
Bridge over South Boulder Creek (facing east)

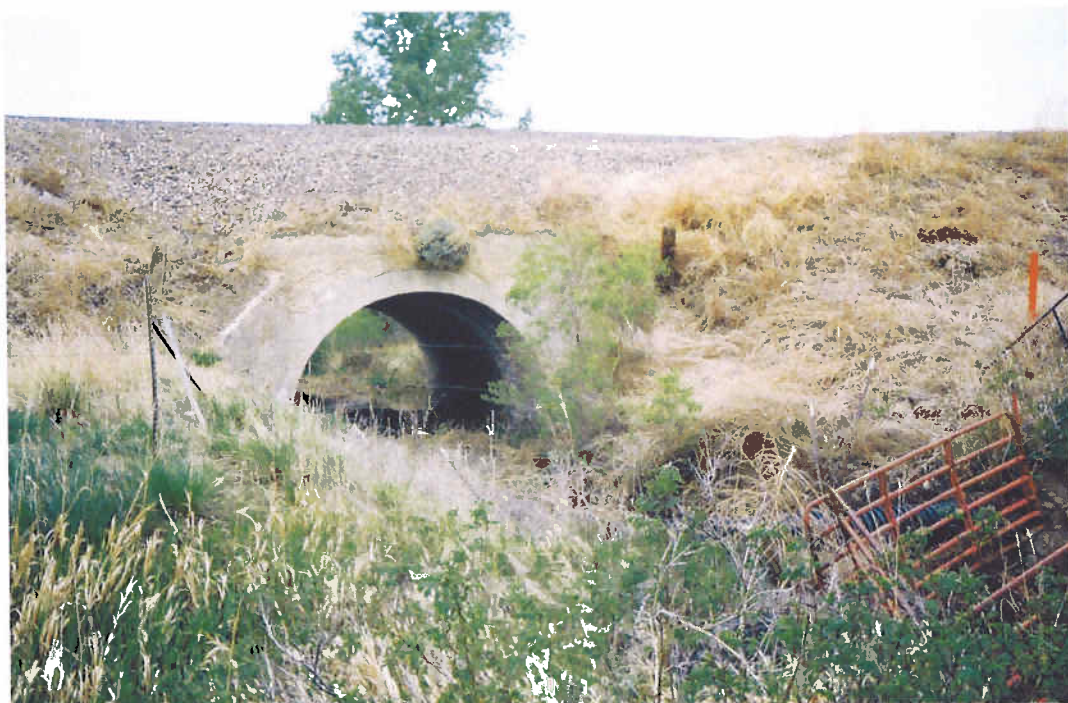
Rock Creek Culvert under BNSF tracks (facing west).

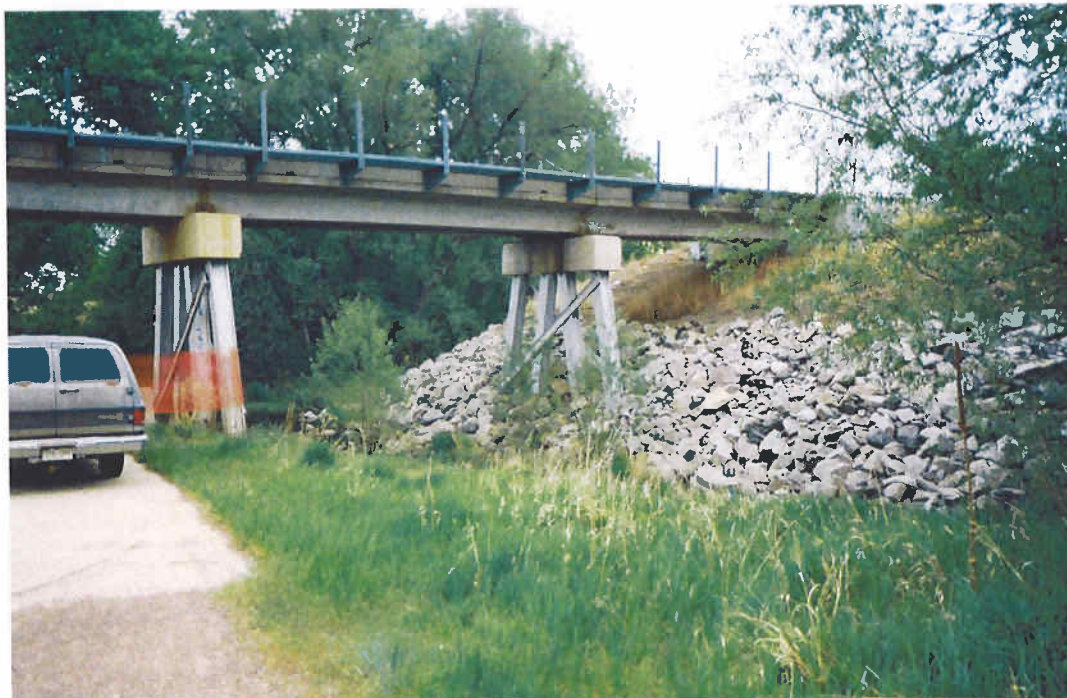
BNSF railroad bridge over Coal Creek (facing west northwest).

The south bank of Coal Creek is rip rapped under the bridge; a pedestrian path and grass occurs on the north bank. Both sides of Coal Creek support riparian woodland with crack willow, cottonwood, chokecherry, golden current, some snowberry, smooth brome, yarrow (*Achillea* sp.), flaxweed (*Descurainia sophin*), alfalfa (*Medicago* sp.), ragweed (*Ambrosia artemisiifolia*), meadow fescue, and diffuse knapweed (*Centaurea diffusa*). A large area on the southeast side of Coal Creek (east side of BNSF track) is immature green ash, snowberry, Canada thistle, smooth brome, Tartarian honeysuckle (*Lonicera tatarica*), and chokecherry. A thicket on the south side is hawthorn, chokecherry, American plum, golden current, false Solomon's seal (*Smilacina racimosa*), Canada thistle, meadow rue (*Thalictrum* sp.), cow parsnip (*Heracleum maximum*). A road is being constructed on the south side of Coal Creek. An abandoned ditch on the south side of Coal Creek is impacted by this road construction. This old ditch supports snowberry, chokecherry, skunkbush sumac, poison ivy, and Siberian elm.

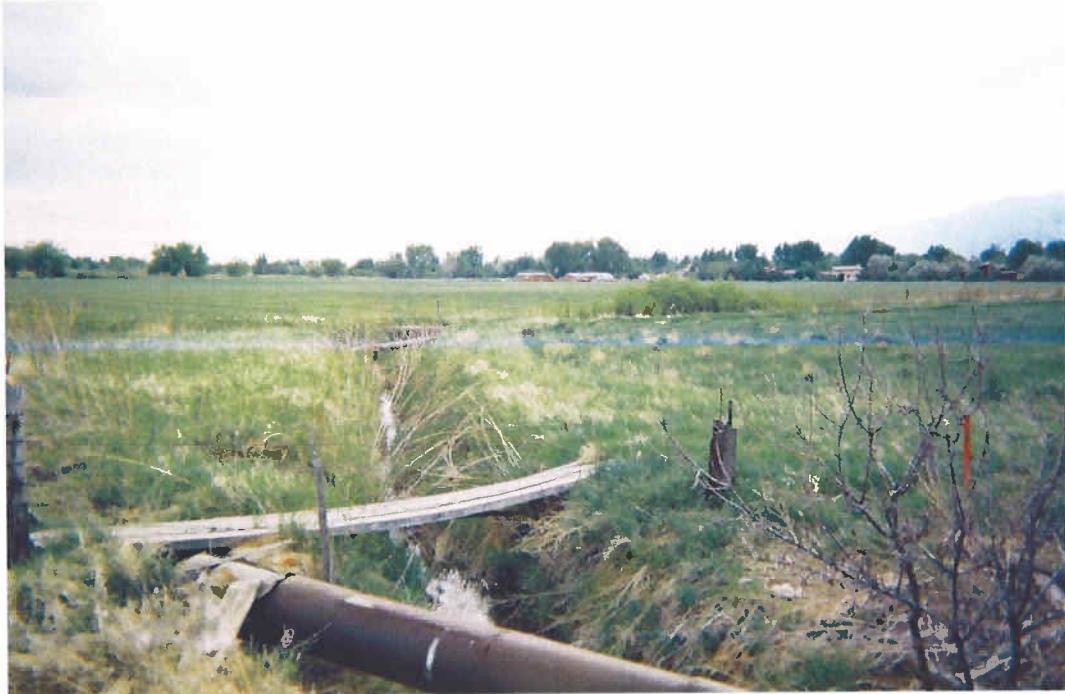
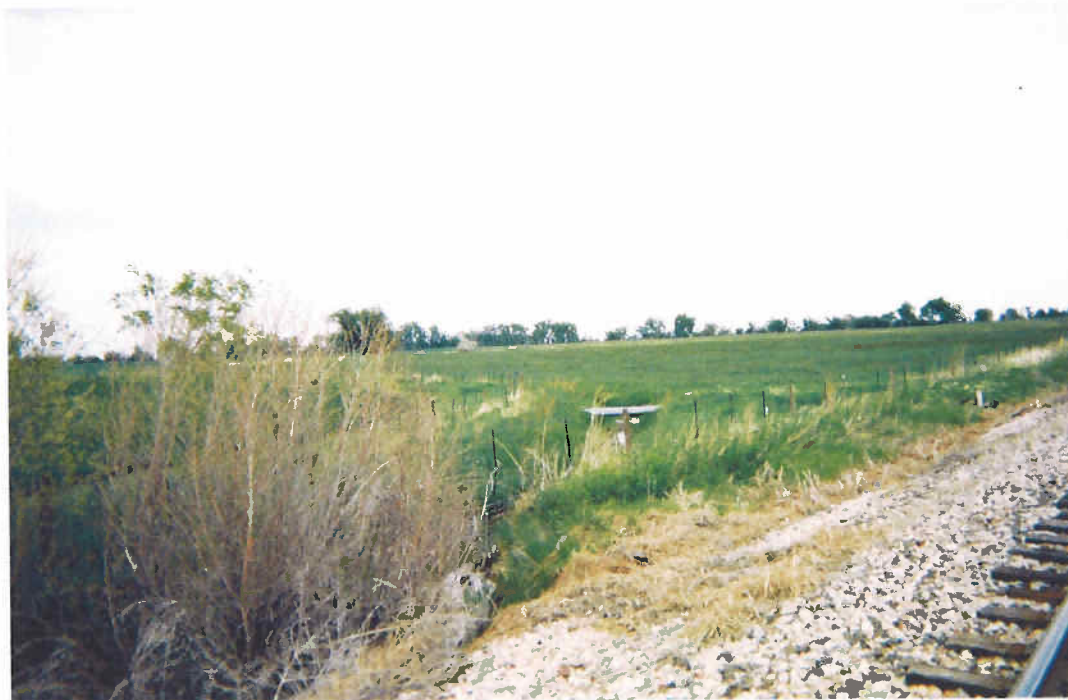
City of Boulder Burke-Hodgson Lateral at BNSF crossing (facing west-southwest).

City of Boulder Burke-Hodgson Lateral at BNSF crossing (facing northwest).

This ditch is located within agricultural hay meadows. The vegetation at the BNSF crossing over City of Boulder Burke-Hodgson Lateral is grassland/agricultural with only one large cottonwood at the culvert. The habitat is not suitable for Preble's and no trapping is recommended.

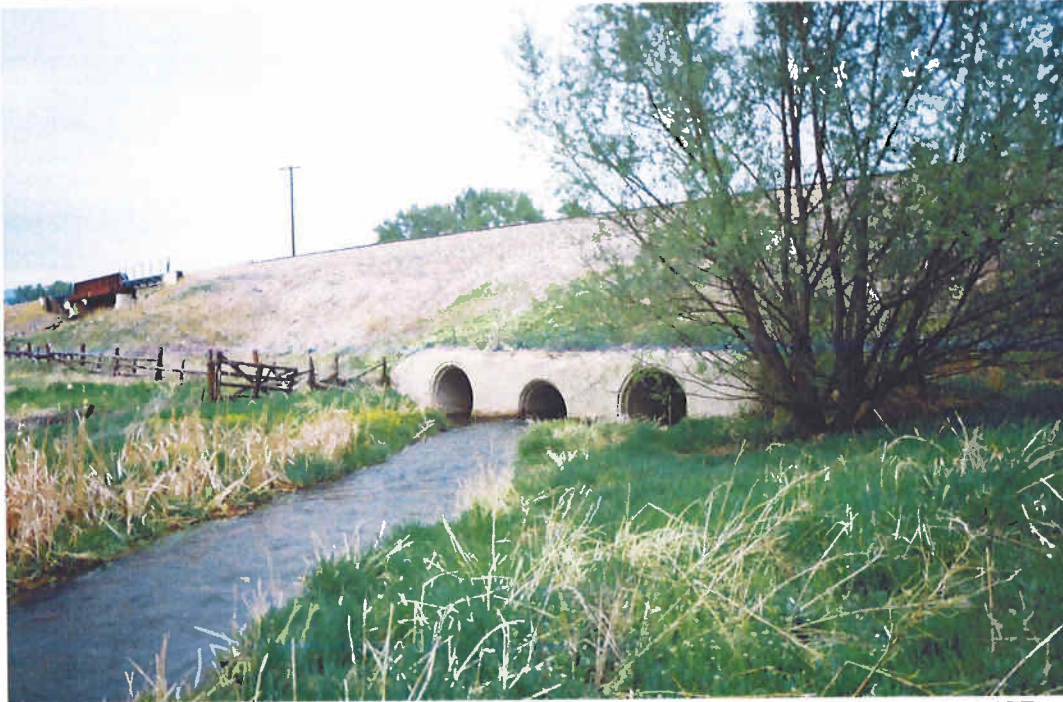
Culvert at Cottonwood No. 2 Ditch and Dry Creek Davidson Ditch crossing under BNSF tracks on south side (facing northwest).

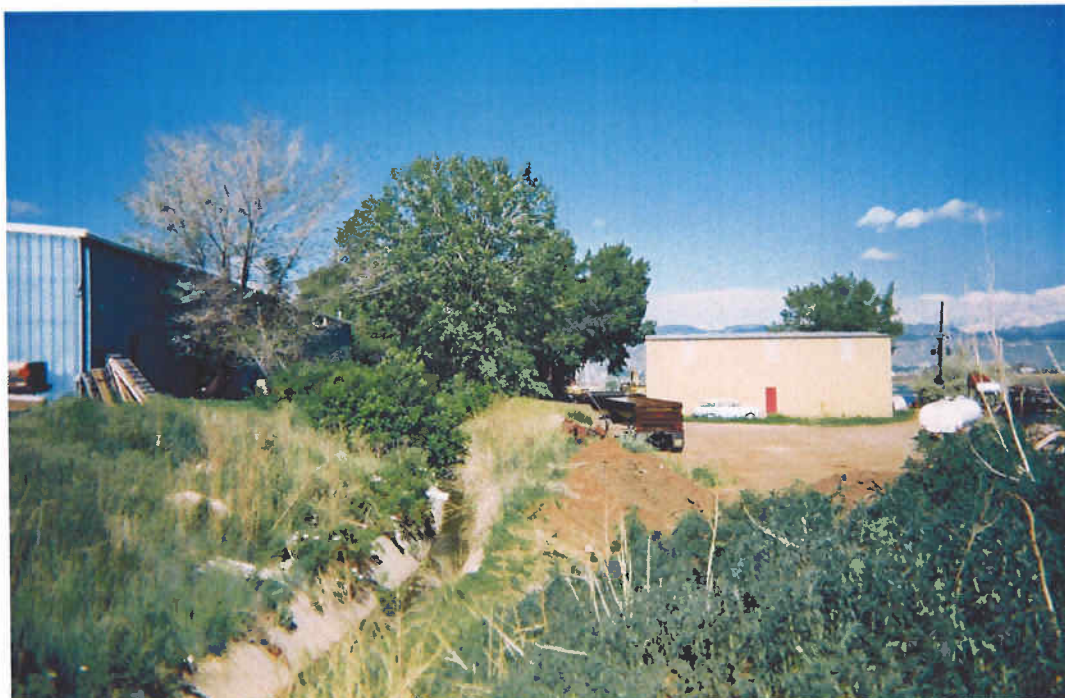
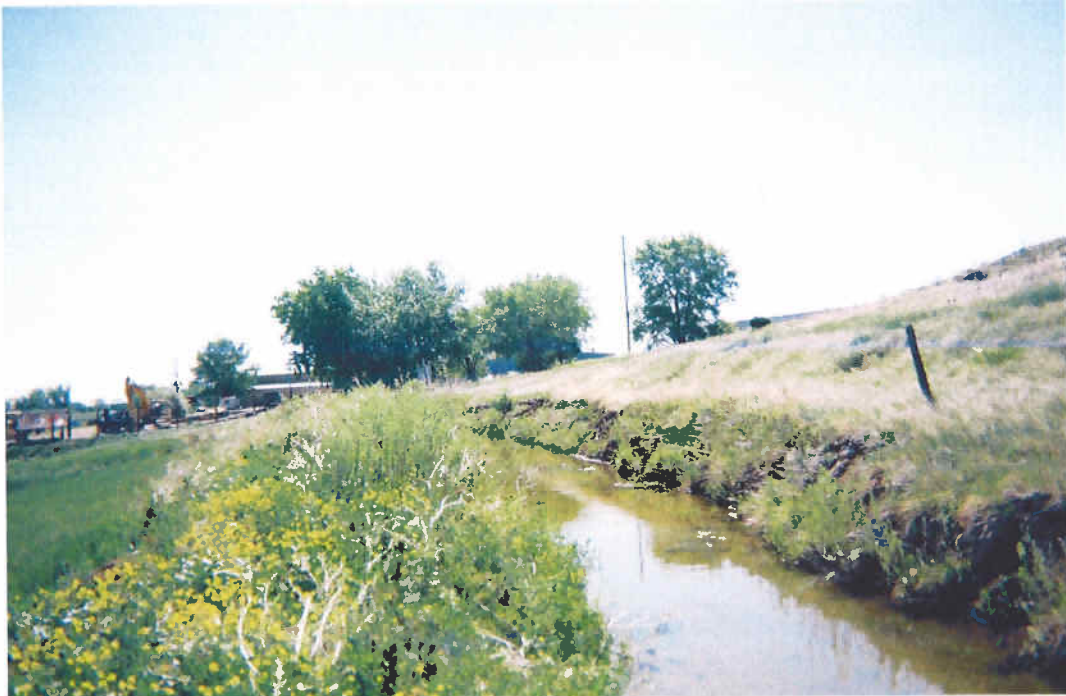
Enterprise Ditch, south of BNSF tracks (facing west)

Enterprise Ditch where ditch parallels BNSF tracks (facing east).

The Enterprise Lateral is located just south of Arapahoe Road. The drainage is lined with riparian woodland, which is localized at the crossing. Species include cottonwood, crack willow, chokecherry, boxelder, and American plum. The woodlands are associated with both the ditch and the old

farmsteads in the vicinity. The surrounding land use is agricultural. The habitat at this location is not considered suitable to support Preble's; no trapping is recommended at this site.

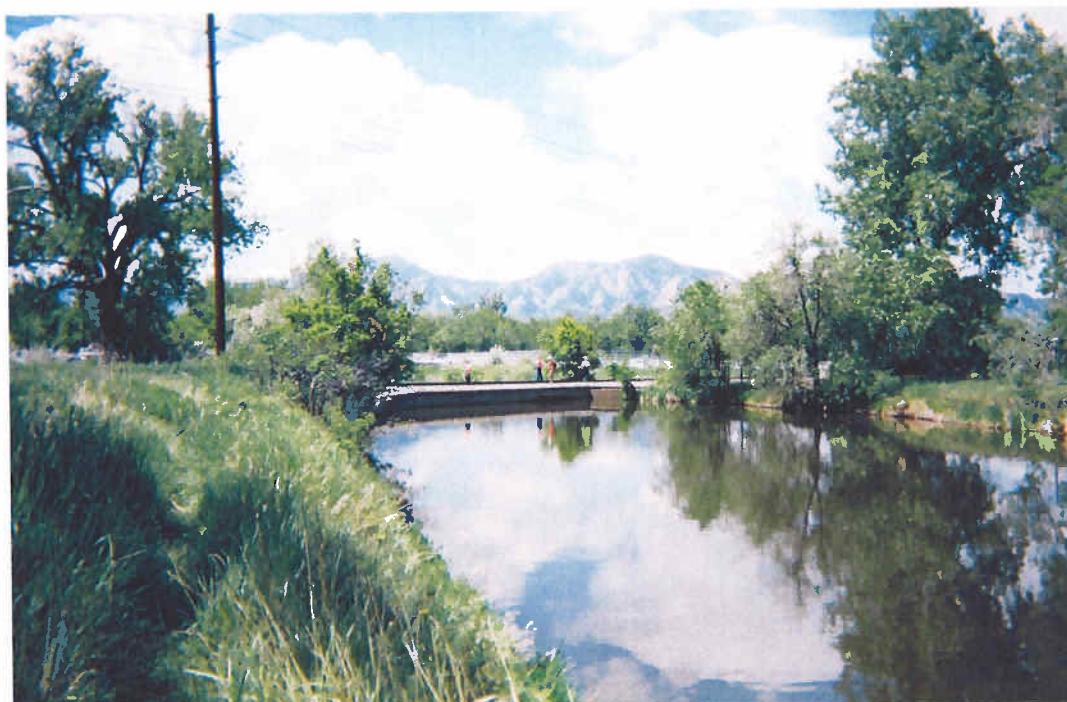
South Boulder Creek Inlet Canal to Leggett Reservoir (facing north from bridge)

The BNSF tracks cross over South Boulder Creek Inlet Canal by a low 80-foot long bridge; this would be replaced with an 82-foot long by 42-foot wide concrete culvert with five chambers. A new bridge structure is proposed to be constructed north of and parallel to the existing bridge over South Boulder Creek. The vegetation at these crossings is a mix of riparian woodland, riparian shrub, wetlands, and grassland. Woodland species consist of crack willow, cottonwood, sandbar willow, boxelder, Russian olive, and Siberian elm. Grasses are smooth brome, crested wheatgrass, Kentucky bluegrass, and western wheatgrass. Surrounding land uses are open space, industrial, and undeveloped private land. Based on conversations with Alison Dean-Michael (USFWS), no trapping is necessary at these crossings as recent trapping in the vicinity indicates that Preble's are not present.

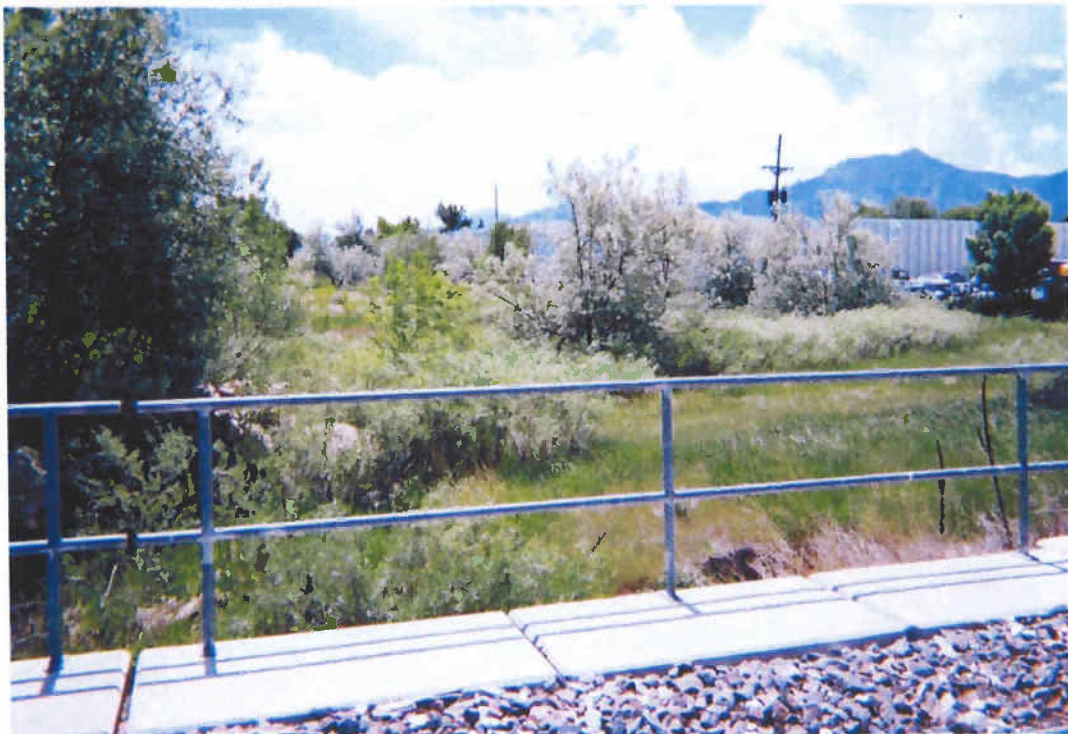
BNSF Bridge Crossing over Dry Creek No. 2 Ditch (facing north).

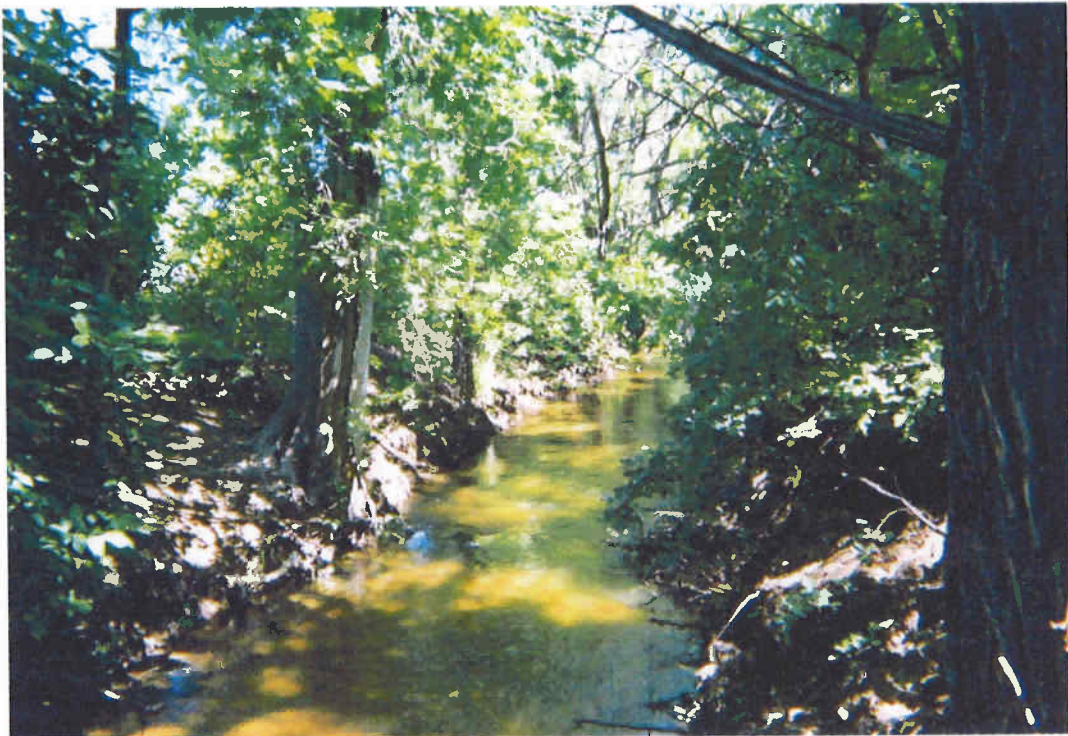
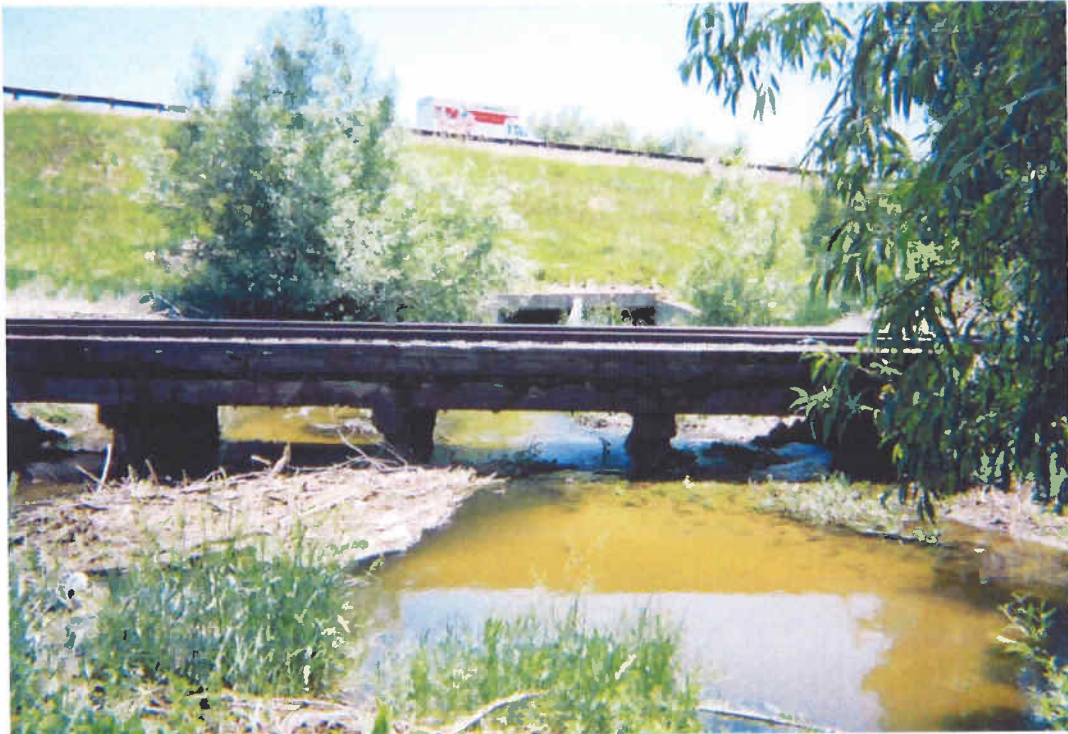
South crossing of Wonderland Creek from BNSF tracks (facing southwest).

South Crossing of BNSF Railroad Tracks over Wonderland Creek (facing east).

The Wonderland Creek drainage crosses the BNSF tracks just west of 47th Street. The creek parallels the railroad for 1000' on the west side of the tracks. On the east side of the tracks the ditch crosses 47th Street, medians, and berms. Riparian woodland along Wonderland Creek on the west side of BNSF tracks consists of crack willow, boxelder, cottonwood, chokecherry, American plum, and green ash. Due to surrounding and upstream developments, Wonderland Creek is unlikely to support Preble's, therefore, no trapping is recommended.

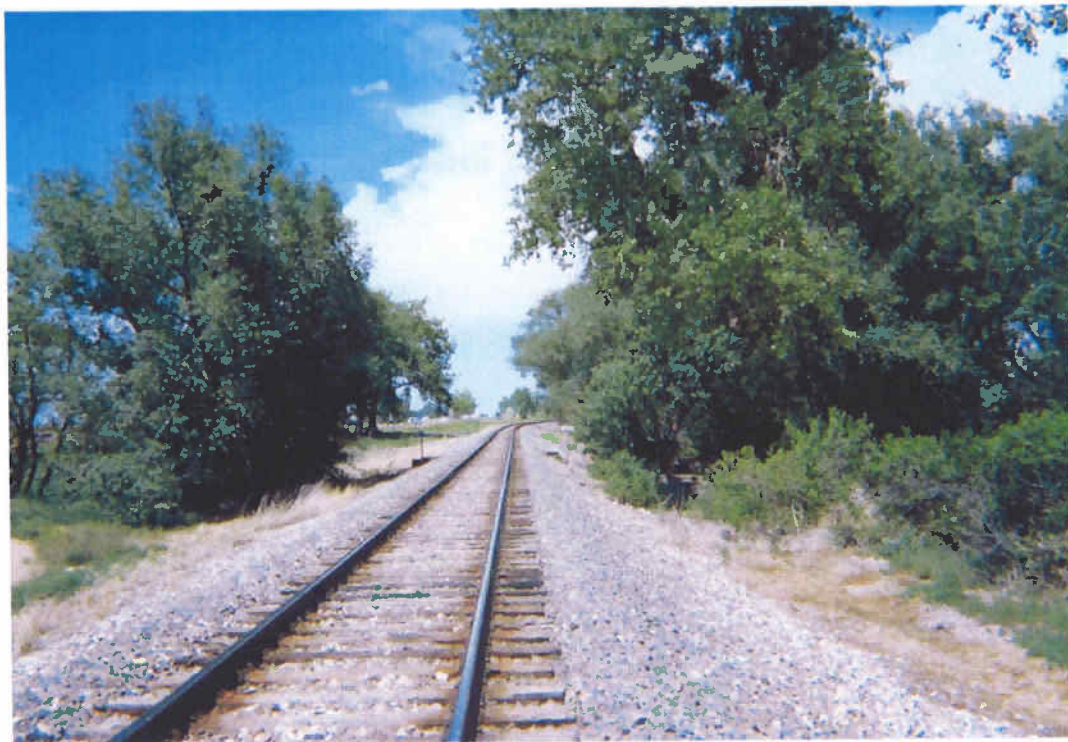
Fourmile Canyon Creek at BNSF Railroad Tracks (facing northeast).

Fourmile Canyon Creek crosses the BNSF track just east of Highway 119. The riparian woodland at this crossing consists primarily of cottonwood, American plum, chokecherry, crack willow, golden current, and peachleaf willow. The understory vegetation includes smooth brome, perennial pepperweed, and Canada thistle. This site has been previously trapped with no Preble's captured, therefore, no trapping is necessary.

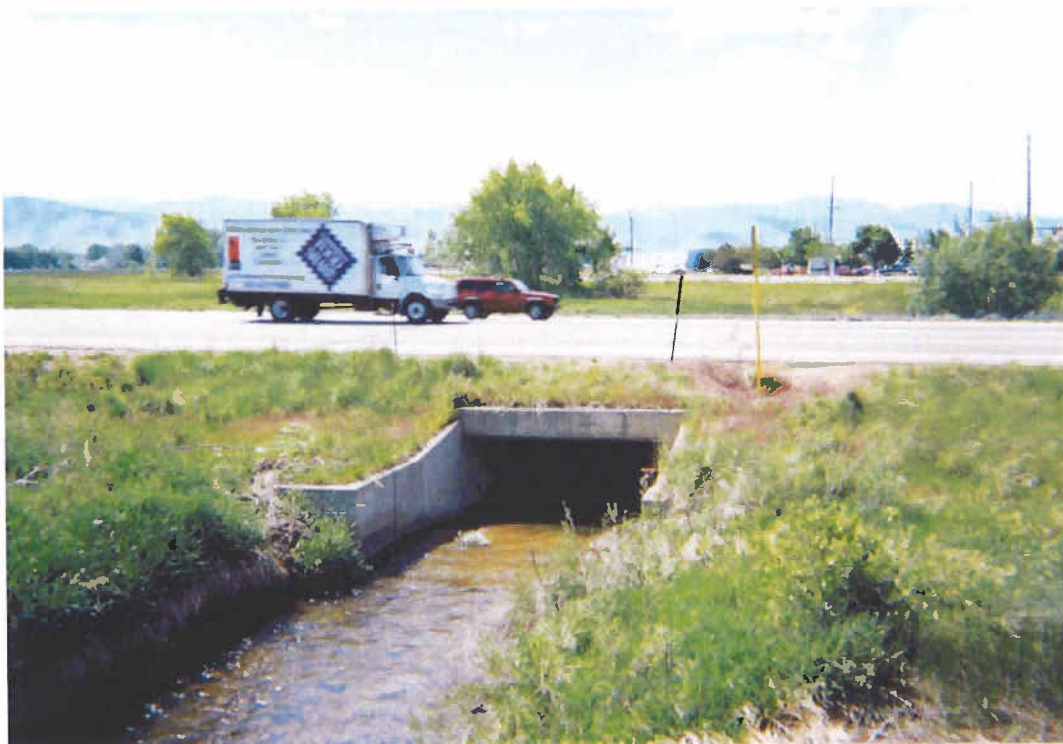
Boulder and Whiterock Ditch Culvert at BNSF Railroad Tracks (facing north, just south of Jay Road).
