# I-70 ECO-LOGICAL MONITORING and I-70 WILDLIFE WATCH REPORT

September 2011

## PART I: I-70 ECO-LOGICAL MONITORING REPORT 2009 – 2010

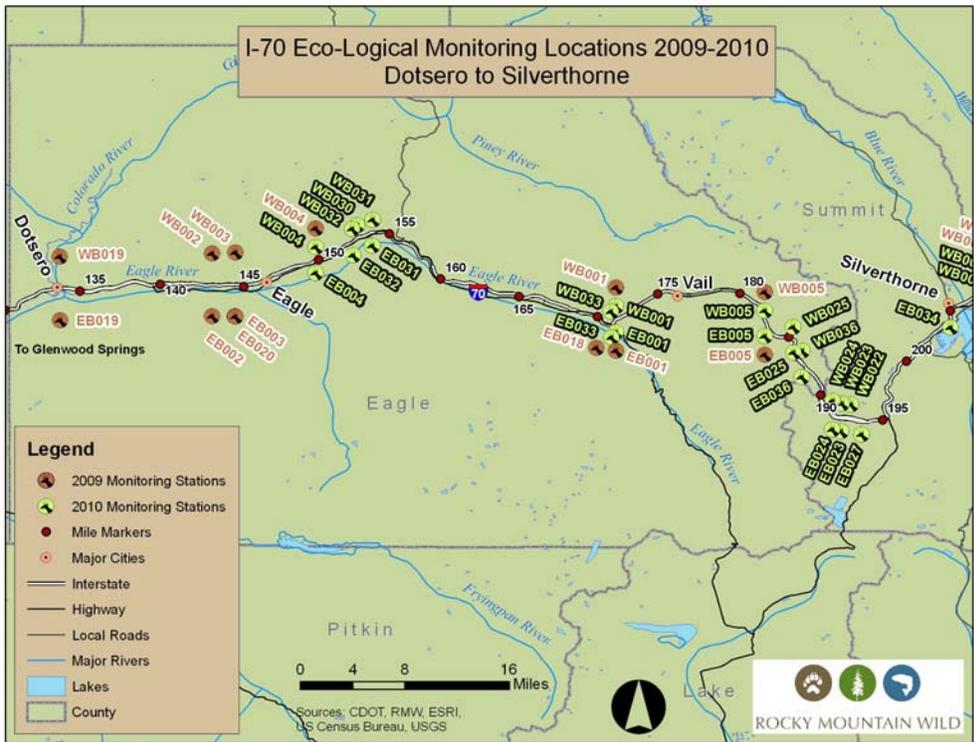
Map 1 – I-70 Ecological 2009 and 2010 Monitoring Locations – Dotsero to Silverthorne

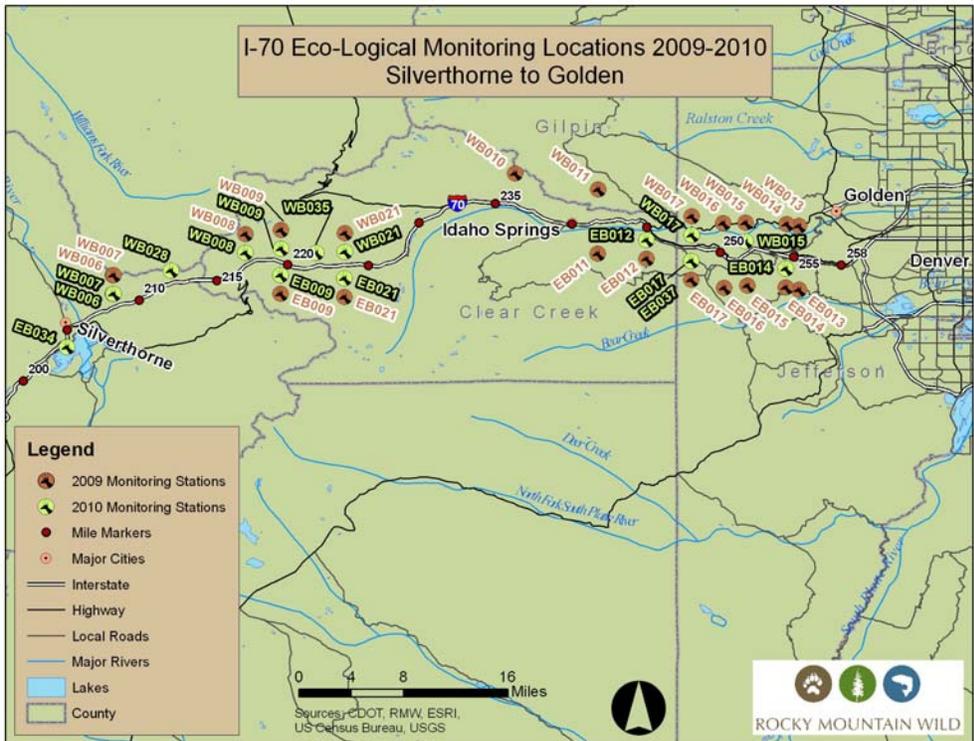
Map 2 – I-70 Ecological 2009 and 2010 Monitoring Locations – Silverthorne to Golden

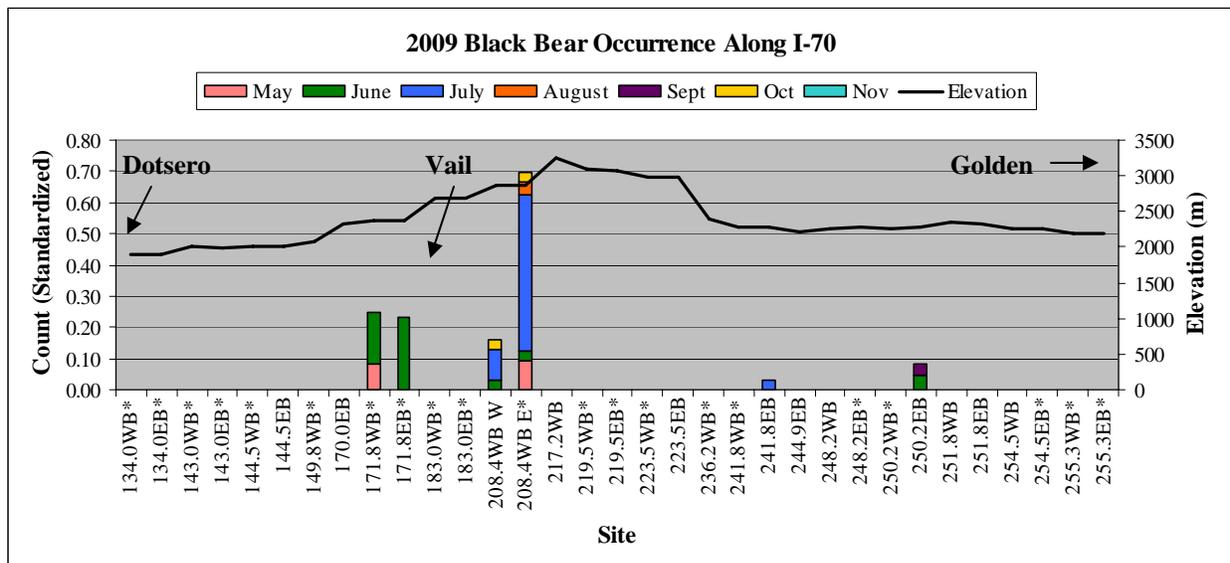
Figure 1 – Number of black bears detected in 2009

\* The camera at this site was functioning for less than 50% of the time for 1 or more months in the study period.

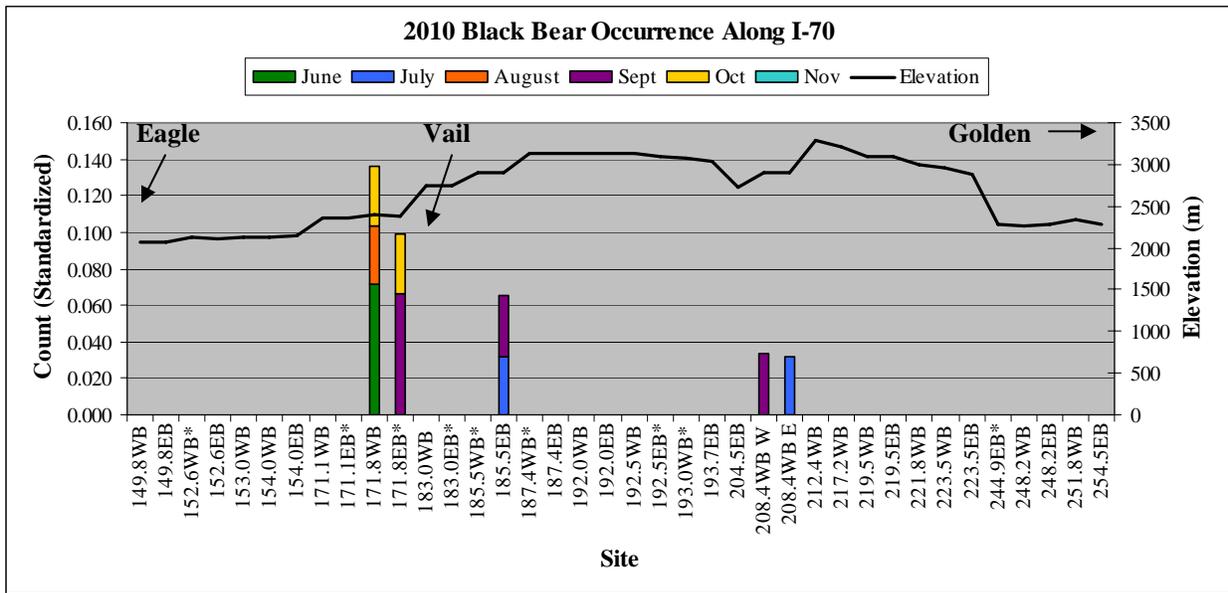
Figure 2 – Number of black bears detected in 2010

\* The camera at this site was functioning for less than 50% of the time for 1 or more months in the study period.

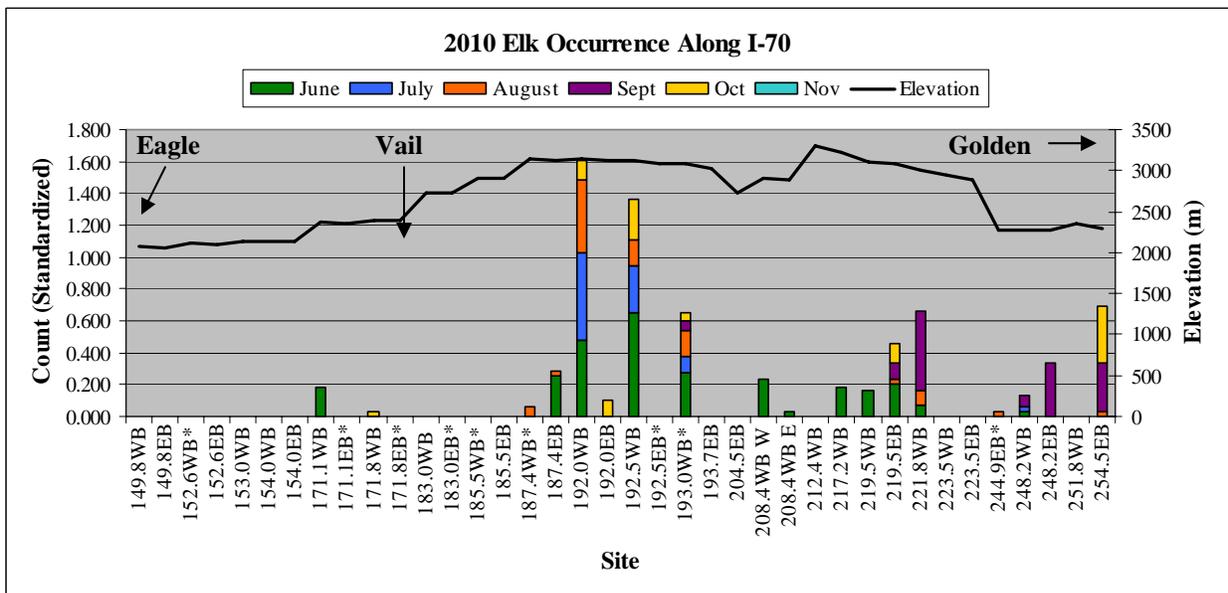
Figure 7 – Number of elk detected in 2010

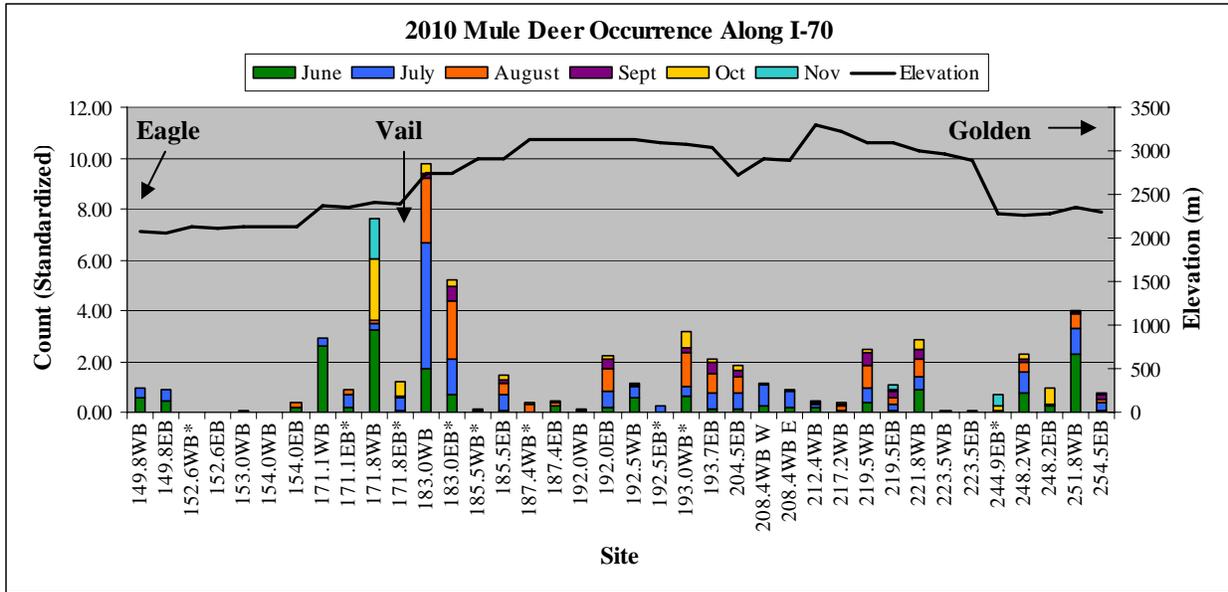
Figure 12 – Number of mule deer detected in 2010

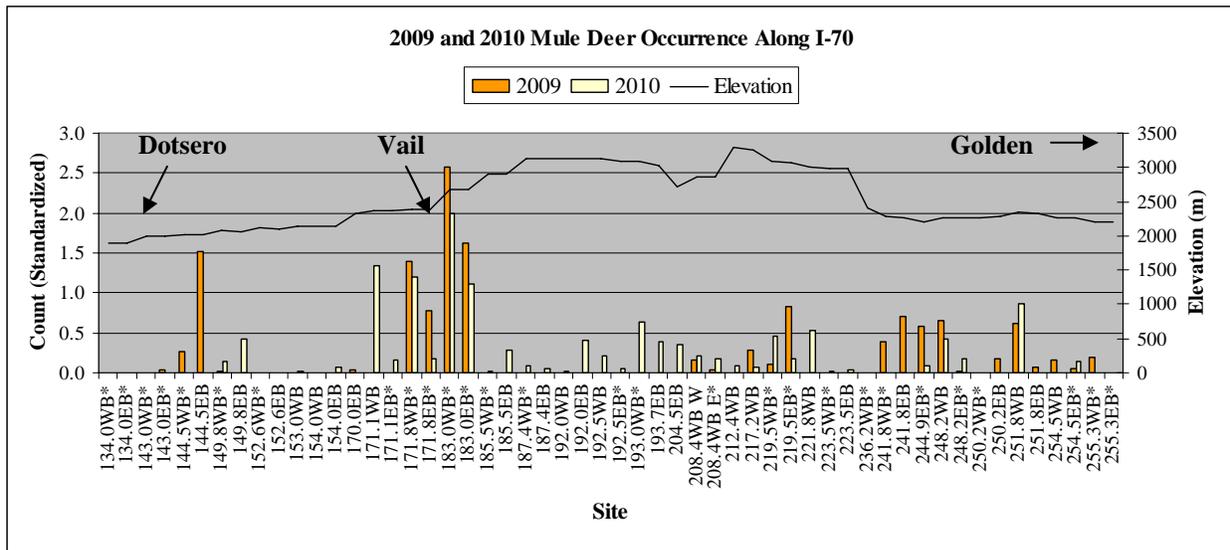
Figure 24 – Number of mule deer detected in 2009 and 2010  
 \* The camera at this site was functioning for less than 50% of the time for 1 or more months in the study period.

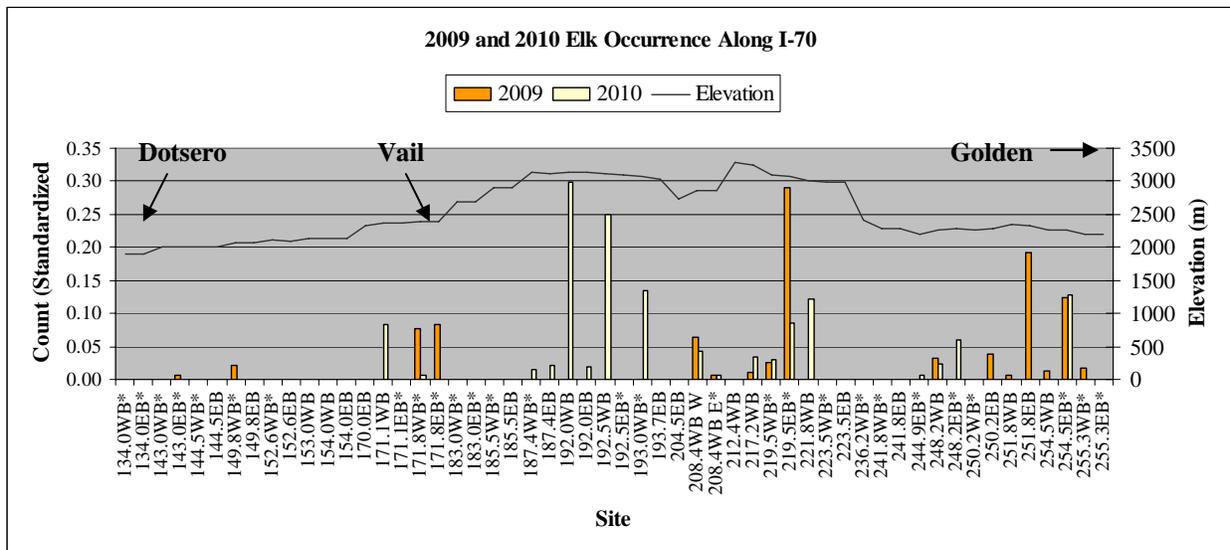
Figure 25 – Number of elk detected in 2009 and 2010  
 \* The camera at this site was functioning for less than 50% of the time for 1 or more months in the study period.

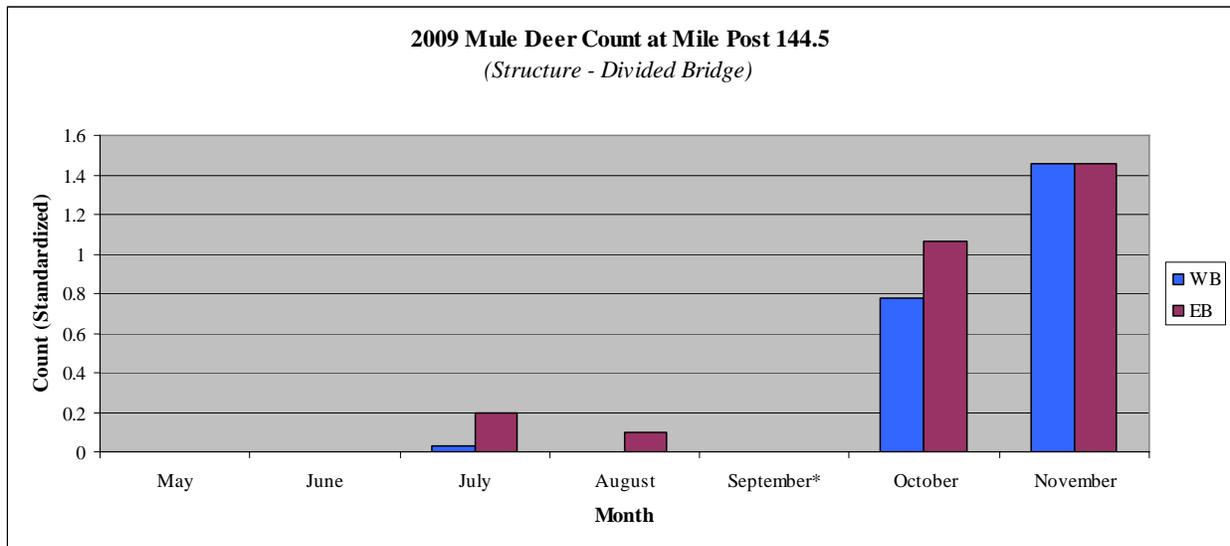
Figure 26 – Number of mule deer detected by month at the eastbound and westbound monitoring sites at mile post 144.5 west of Eagle. Elevation – EB and WB approx. 2000m

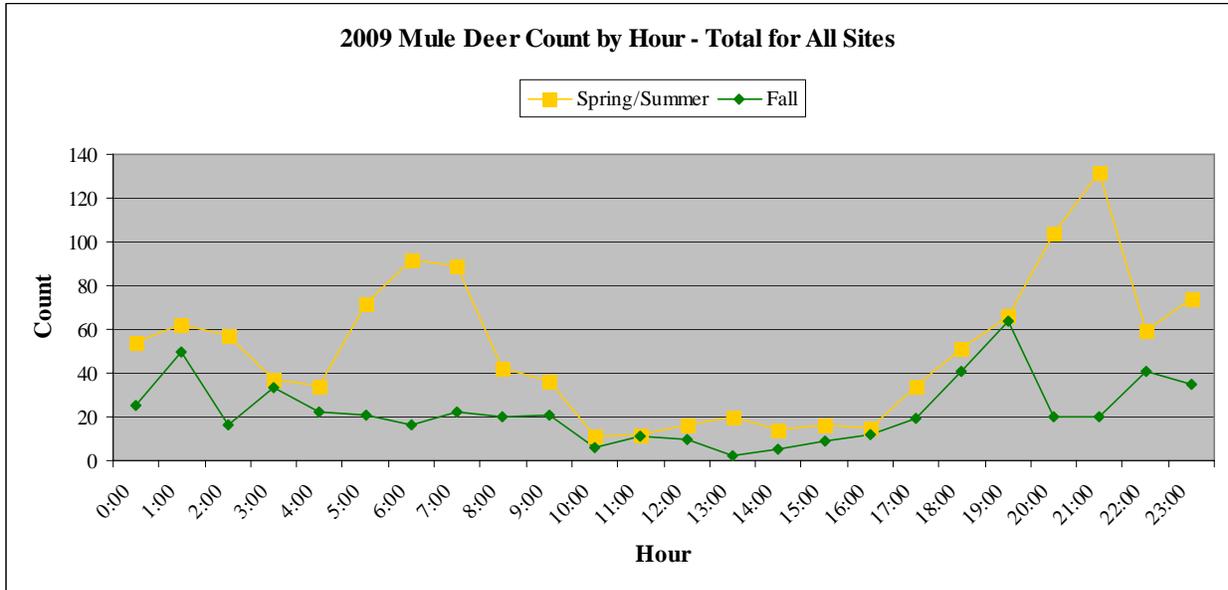
Figure 50 – Number of mule deer detected by hour across all sites in 2009

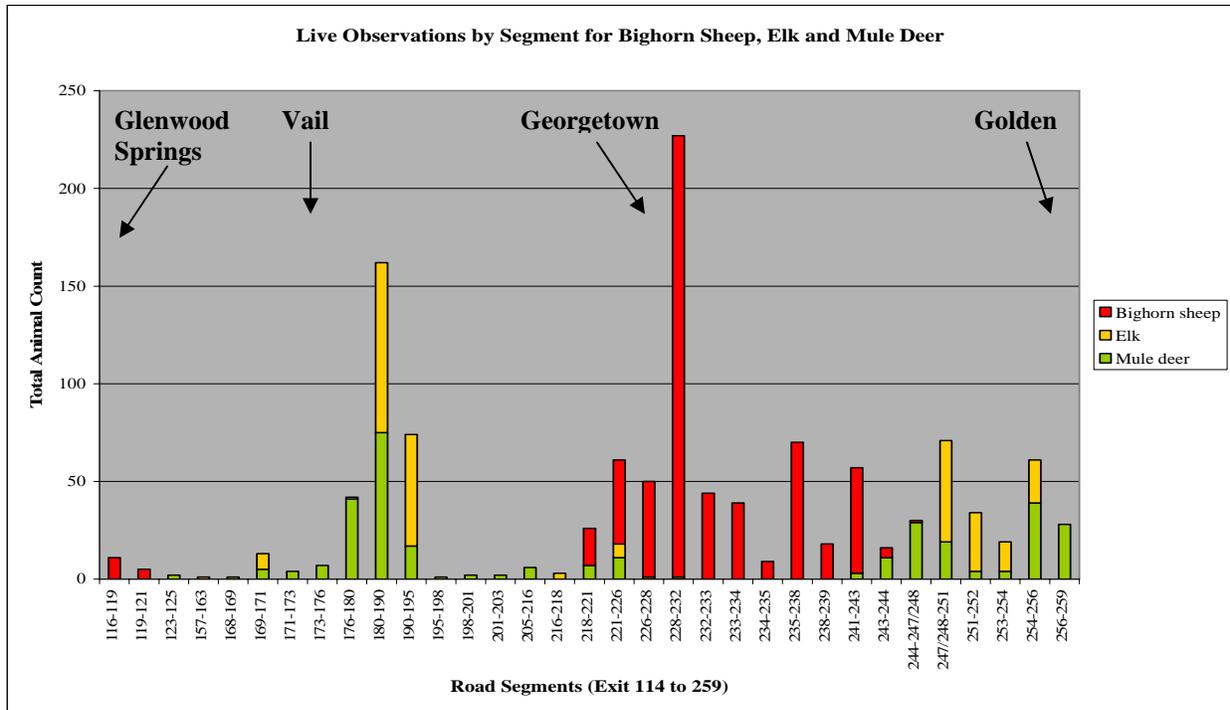
Figure 13: Total animal count by road segment for live observations of bighorn sheep, elk and mule deer. (Total n = 1196).

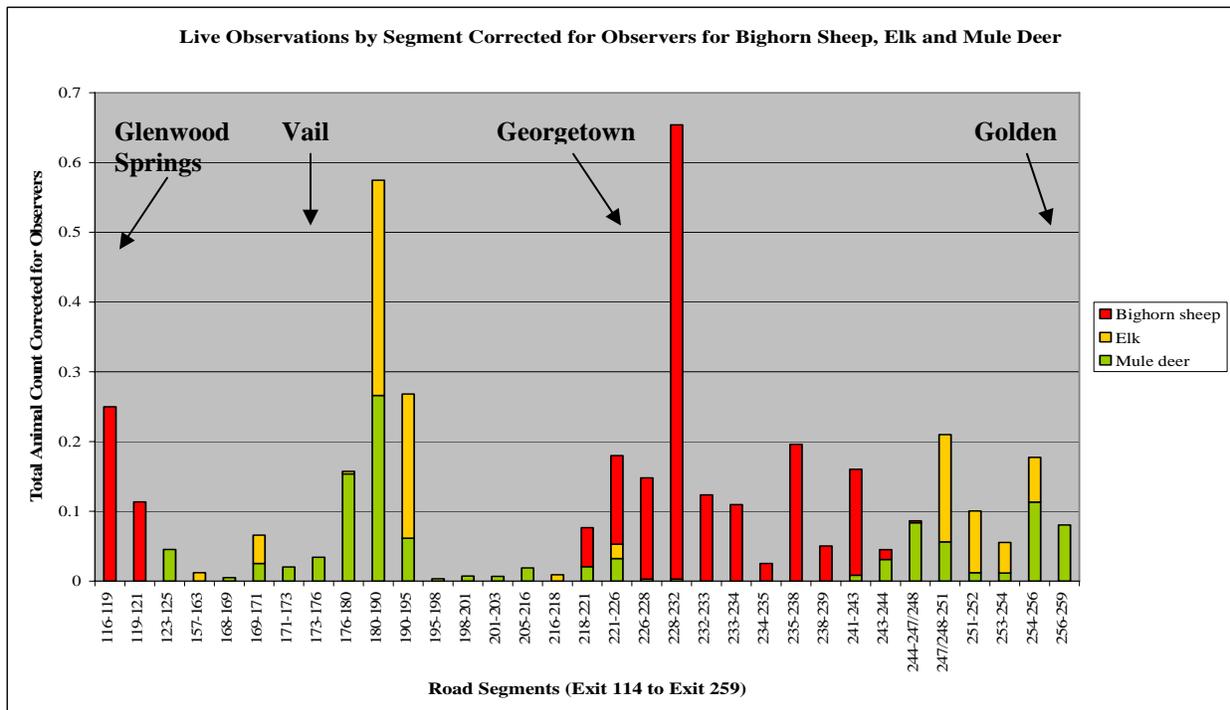
Figure 14: Total animal count by road segment corrected for observers for live observations of bighorn sheep, elk and mule deer
