Close Out Documents

AP-28 – 4646 Vine St.

Structural Demolition

3a. SSAR

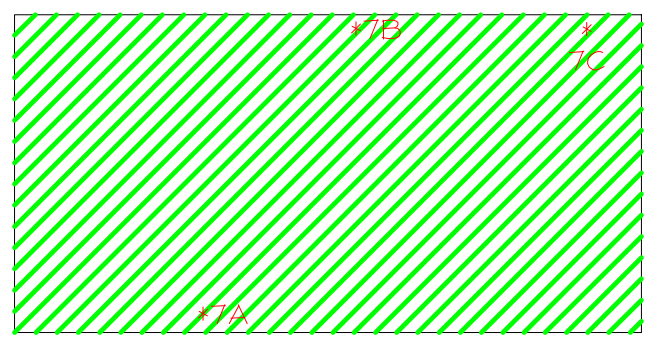
FIGURE 2 - Asbestos Bulk Sample Locations
CENTRAL 70 - Structure Survey Assessment Map
AP-28
 4646 Vine Street, Denver, CO
 June 7, 2018
 APEC #: 18-3066

- R1 = Room Numbers
- 4B = Asbestos Samples (Detect)
- 4B = Asbestos Samples (Non-Detect)
- = Positive Asbestos at Roofing

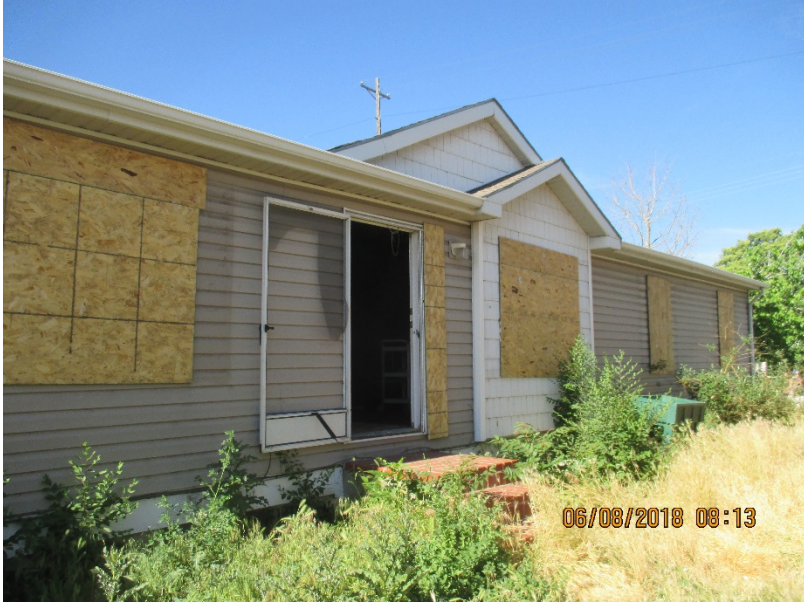
Approximately 1,300 square feet of roofing mastic, observed as the bottom layer on the roof of the house, was confirmed to be an ACM. This material is a Category II Non-friable ACM and exempt, per NESHAP and Regulation 8. The structure can be demolished without abatement of this material.

Roofing Mastic

Samples Represented –
4646V-EX-R7A
4646V-EX-R7B
4646V-EX-R7C
