Close Out Documents

AP-34 – 4639 Claude Ct.

Asbestos Abatement and Structural Demolition

Re: SSCR AP-34 – 4639 Claude Ct. Denver, CO 80216

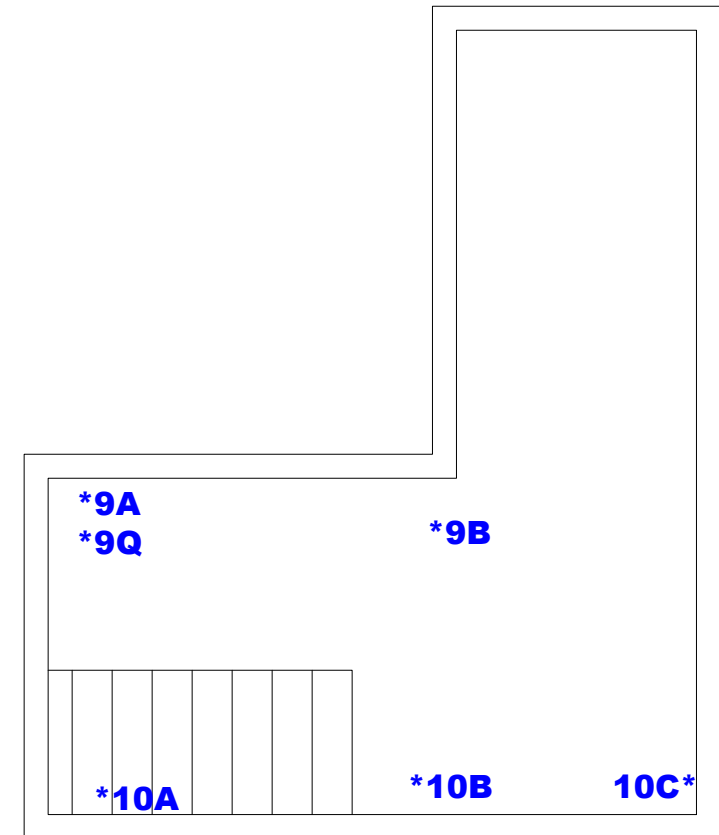
FIGURE 2 - Asbestos Bulk Sample Locations
 CENTRAL 70 - Structure Survey Assessment Map
 AP-34
 4639 Claude Ct., Denver, CO
 April 26, 2018
 APEC NUMBER: 18-3066

12A & 12B - Positive Transite siding-entire exterior (ACM)
 14A & 14B - Insulation taken in Attic

/// = Walls and Ceilings - Positive Surfacing Material (ACM)

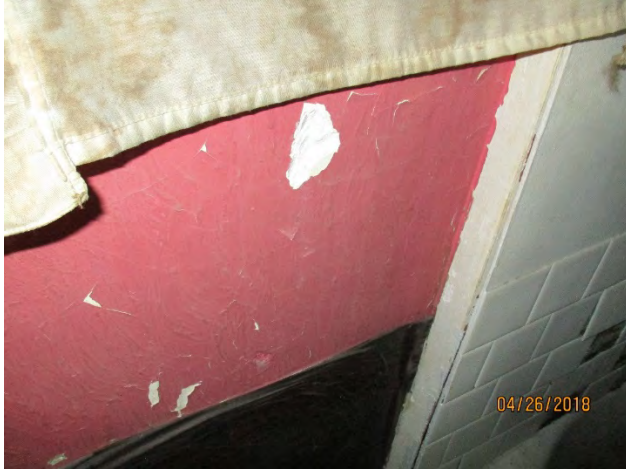
Rough Textured Plaster

Samples Represented –
4639CLD-R9-1A
4639CLD-R7-1B
4639CLD-R6-1C

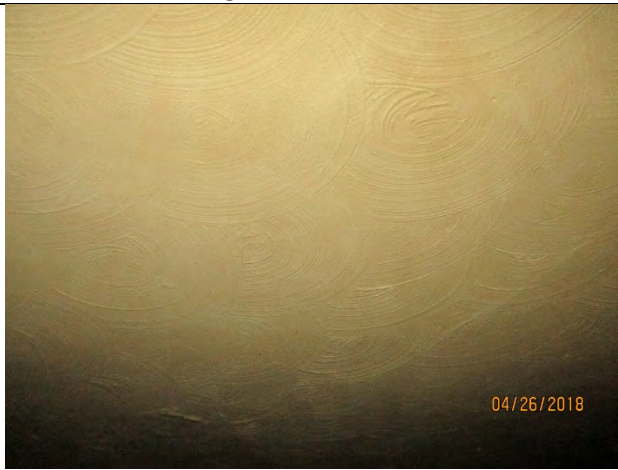
Swirl Textured Plaster

Samples Represented –
4639CLD-R9-2A
4639CLD-R5-2B
4639CLD-R4-2C

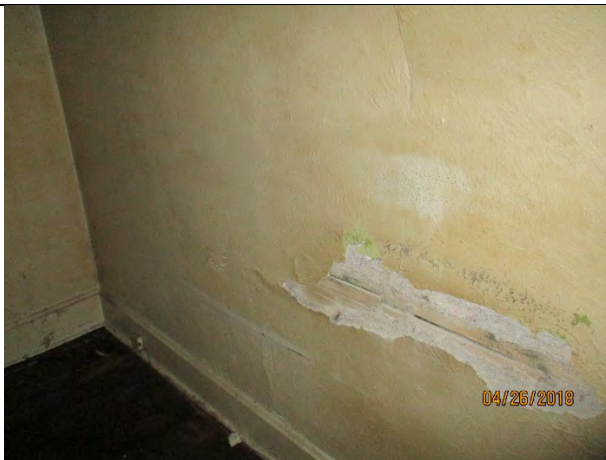
Textured Plaster

Samples Represented –
4639CLD-R5-3A
4639CLD-R4-3B
4639CLD-R4-3C

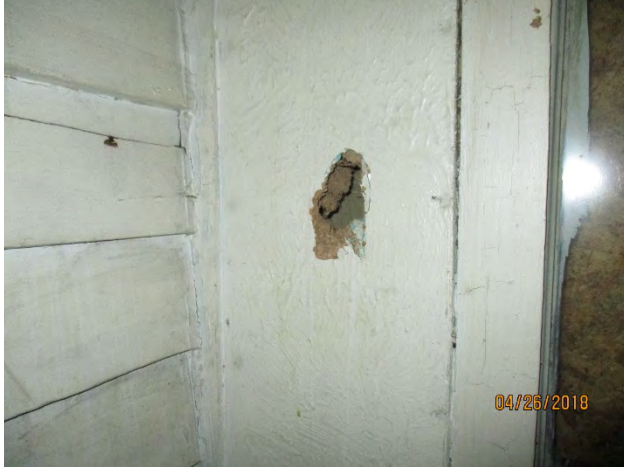
Textured Composite Board

Samples Represented –
4639CLD-R11-4A
4639CLD-R11-4B
4639CLD-R10-4C

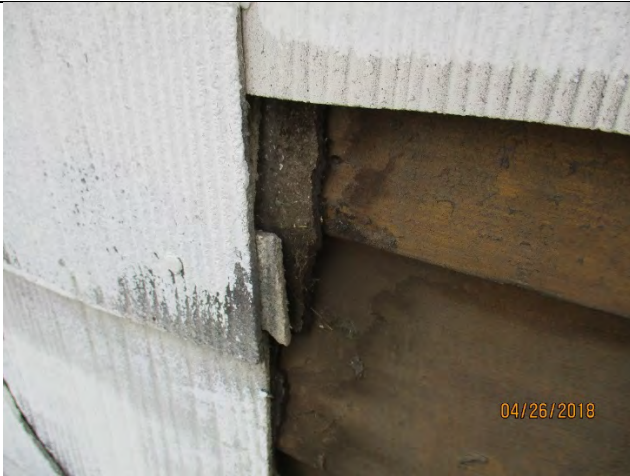
Transite Siding

Samples Represented –
4639CLD-EX-12A
4639CLD-EX-12B

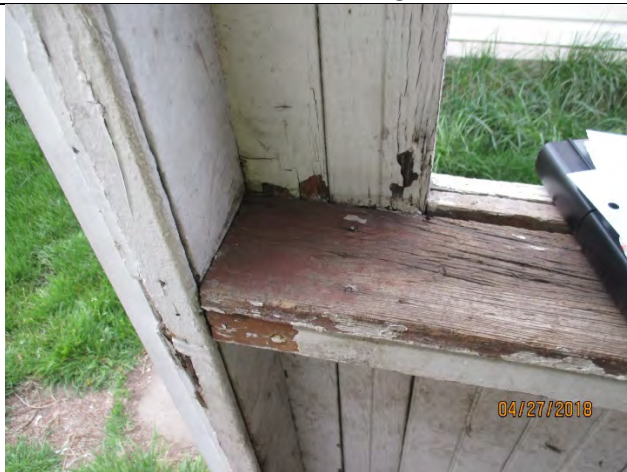
White Paint – LBP

Sample Represented –
4639-CLD-2L

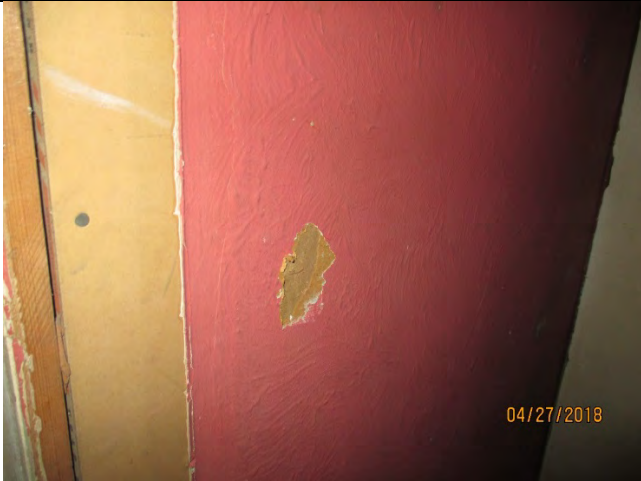
Pink/Orange – LCP

Sample Represented –
4639-CLD-3L

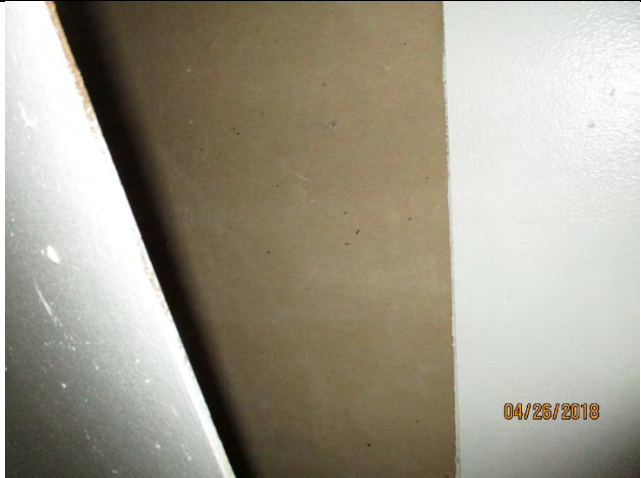
Brown – LCP

Samples Represented –
4639-CLD-4L
4639-CLD-5LQ

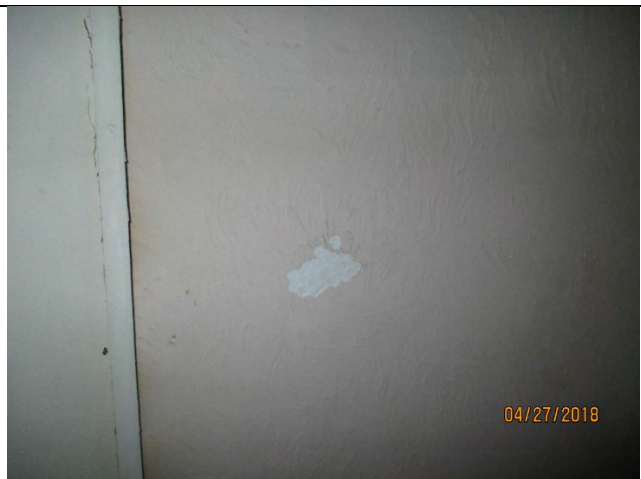
Tan - LCP

Sample Represented –
4639-CLD-6L

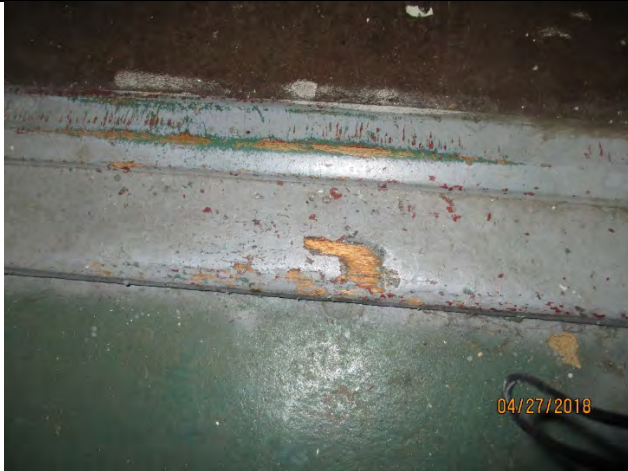
Green (bottom) – LCP

Sample Represented –
4639-CLD-8L

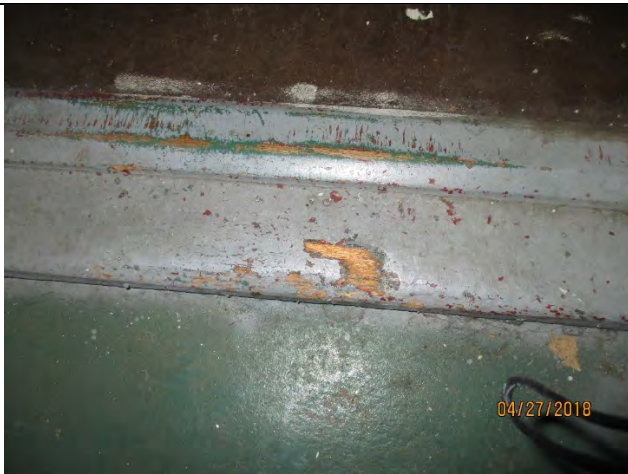
Gray (trim) - LBP

Sample Represented –
4639-CLD-9L

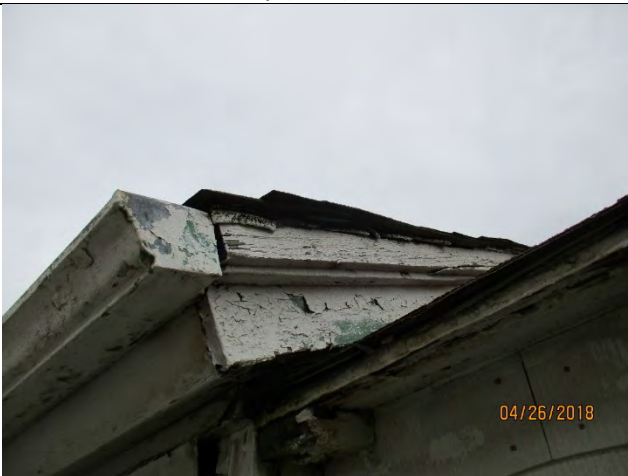
White – LCP

Sample Represented –
4639-CLD-10L

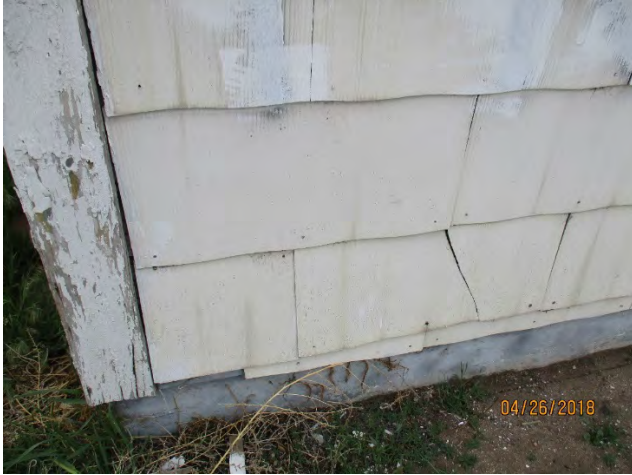
White – LBP

Sample Represented –
4639-CLD-11L
