Close Out Documents

AP-86B Blue Beacon Truck Wash

Structural Demolition

Structural Survey Assessment Report AP-86B

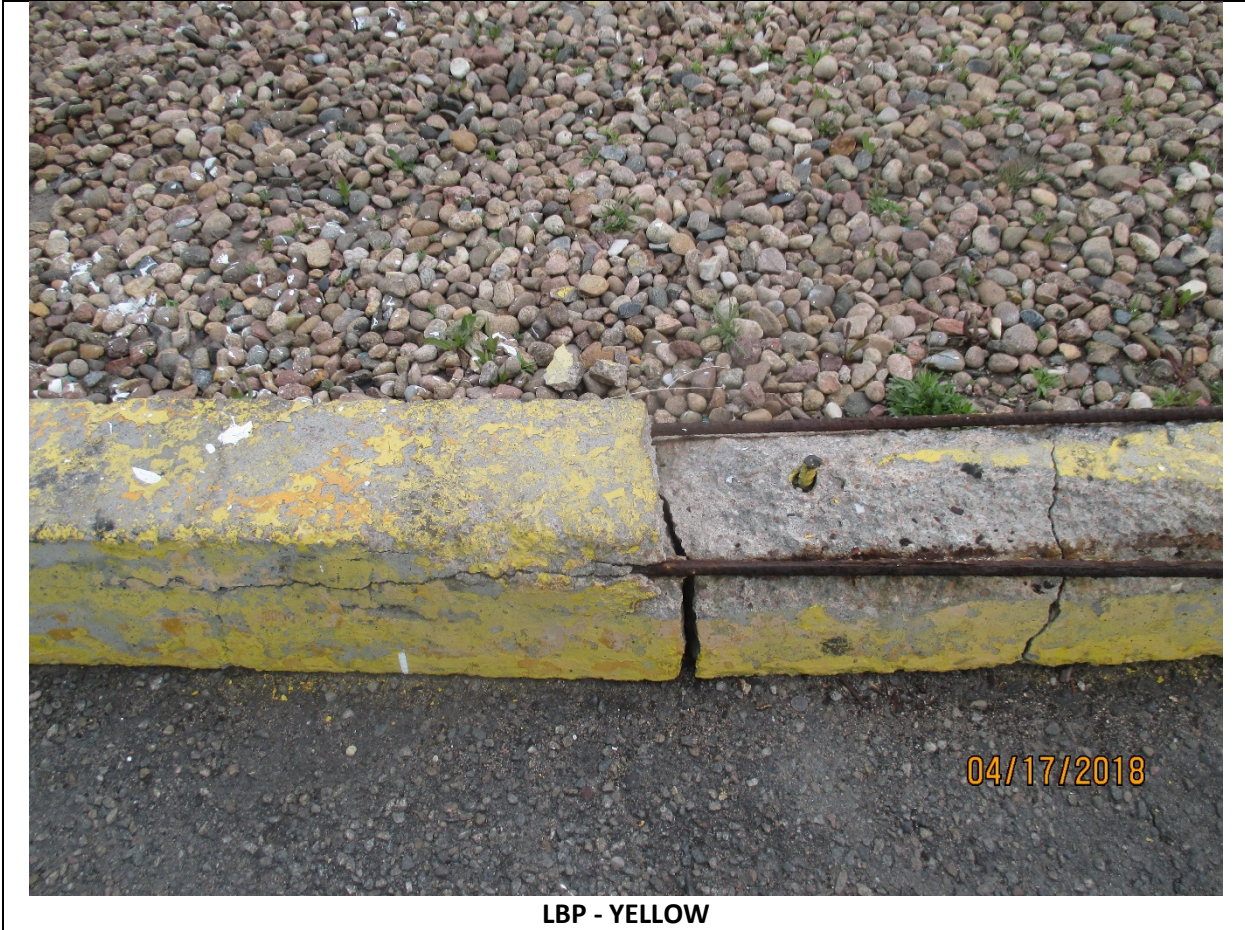
POSITIVE LEAD SAMPLE
MATERIAL PHOTOGRAPHS

LBP - YELLOW
