Close Out Documents

AP-93 3538 E 46th Ave

Structural Demolition

Structure Survey Assessment Report AP-93

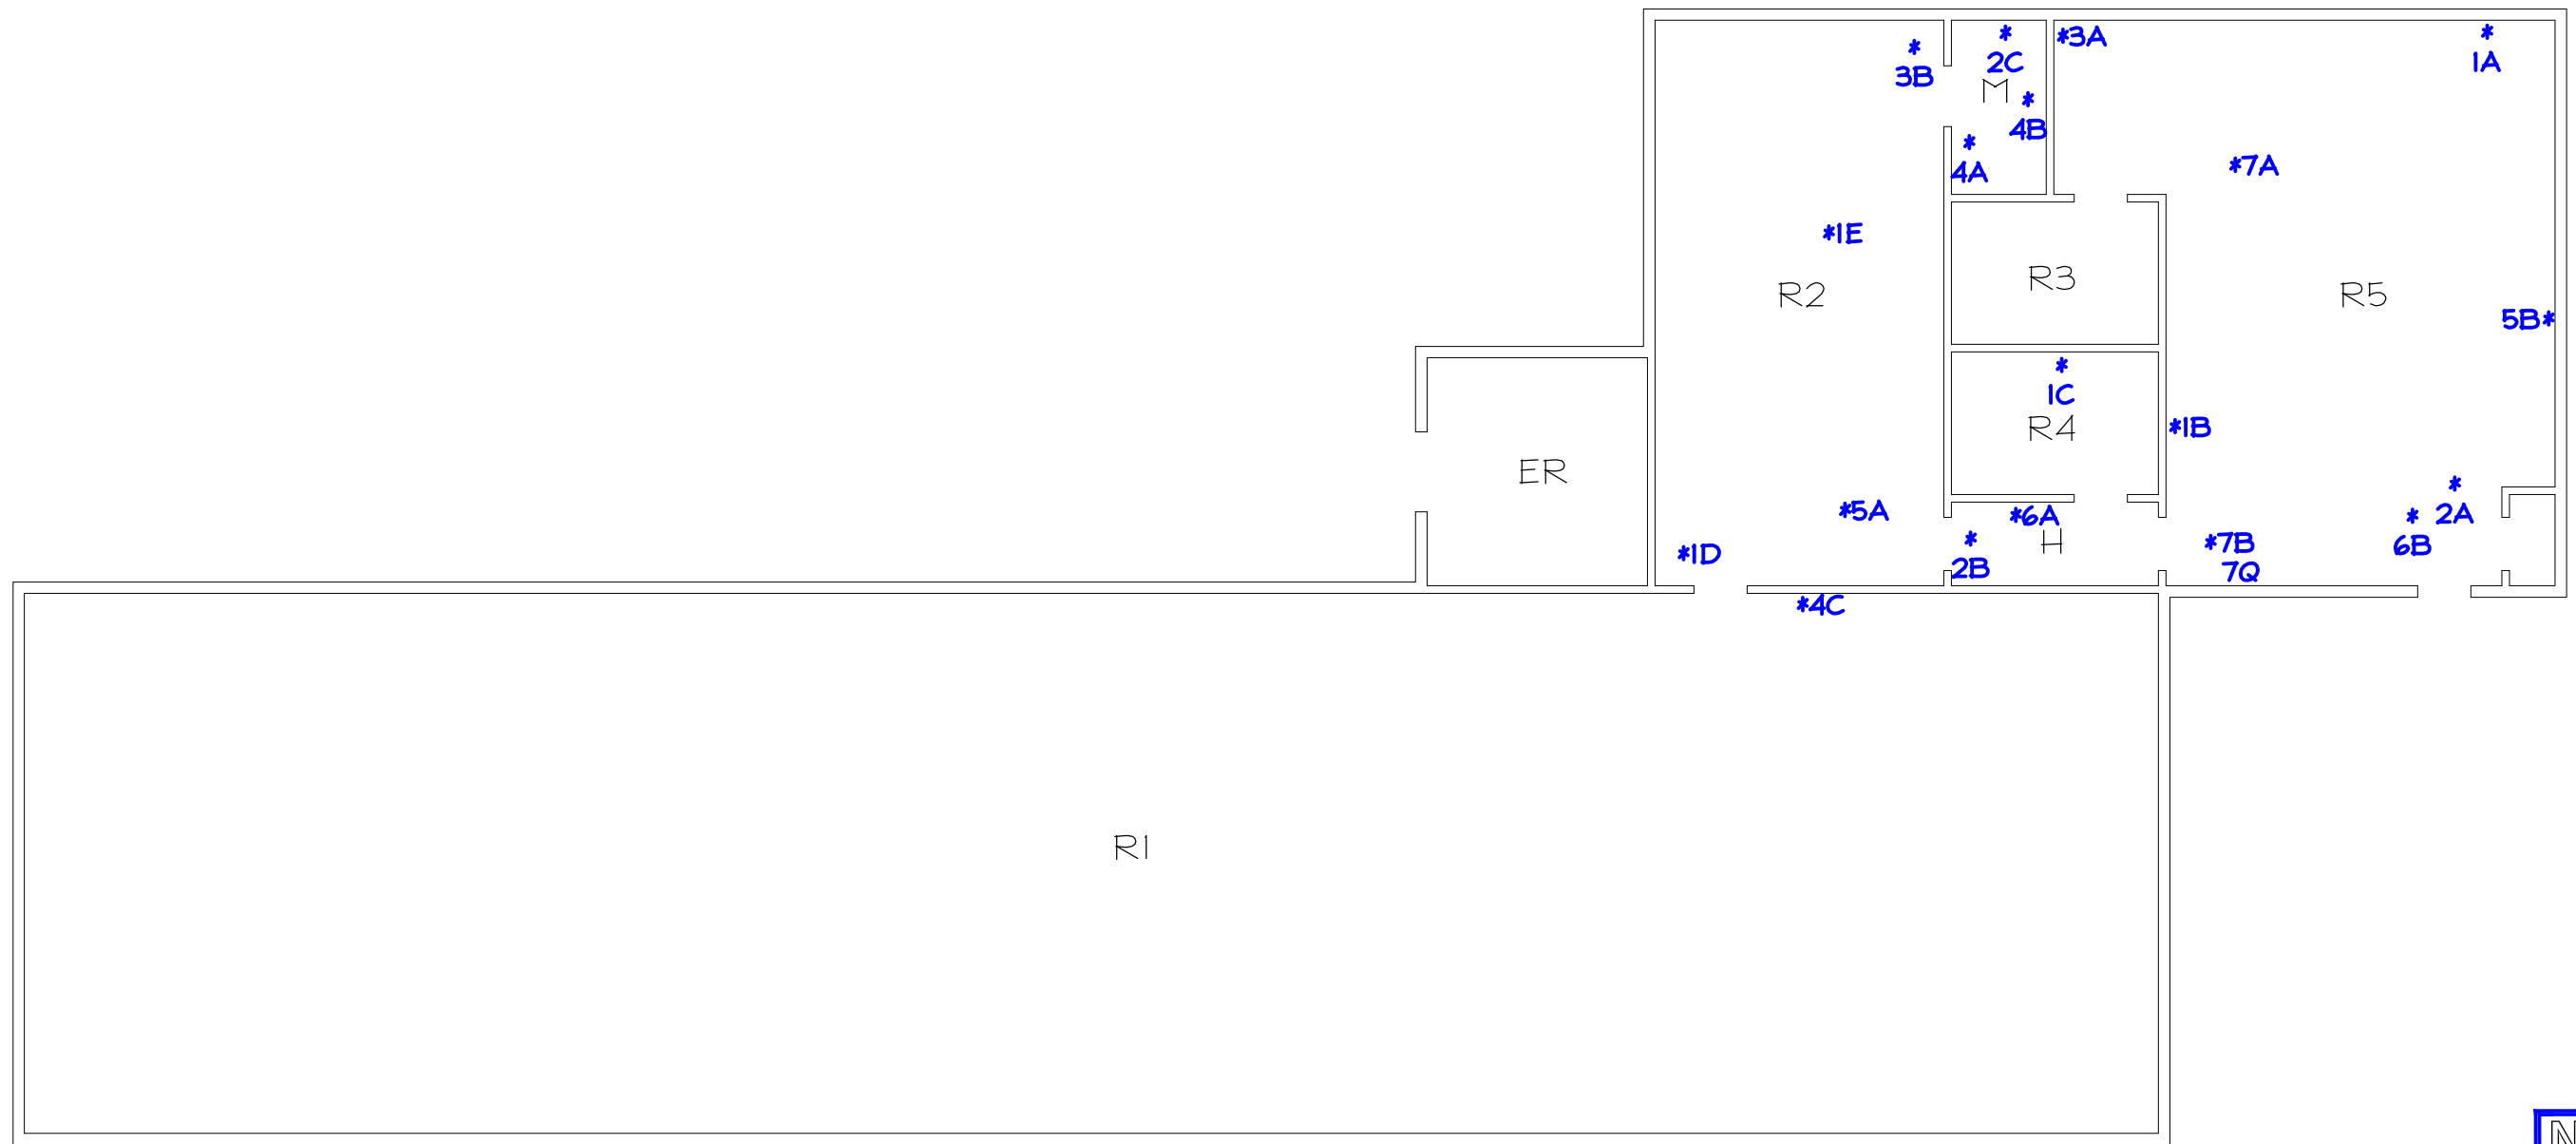
FIGURE 2 - Asbestos Bulk Sample Locations
CENTRAL 70 - Structure Survey Assessment Map
AP-93
 3538 E. 46th Ave., Denver, CO
 March 20, 2019
 APEC #: 19-3447

A total of 20 bulk samples including 1 duplicate sample, were collected on March 20, 2019 during the initial inspection throughout the structure. The results of the PLM analysis for the inspection is presented in Table 2 and the sample locations are located on Figure 2. No samples analyzed were positive ACMs (i.e. present greater than 1%):

Point count analysis occurs for samples with <1% of asbestos by PLM analysis. Point count results were not needed because the initial results all analyzing at nondetect.

No ACMs were identified during the initial limited sampling event. However, an additional sampling event is required, or suspect materials not sampled during the initial should either be assumed to be ACM or should be sampled prior to disturbance.

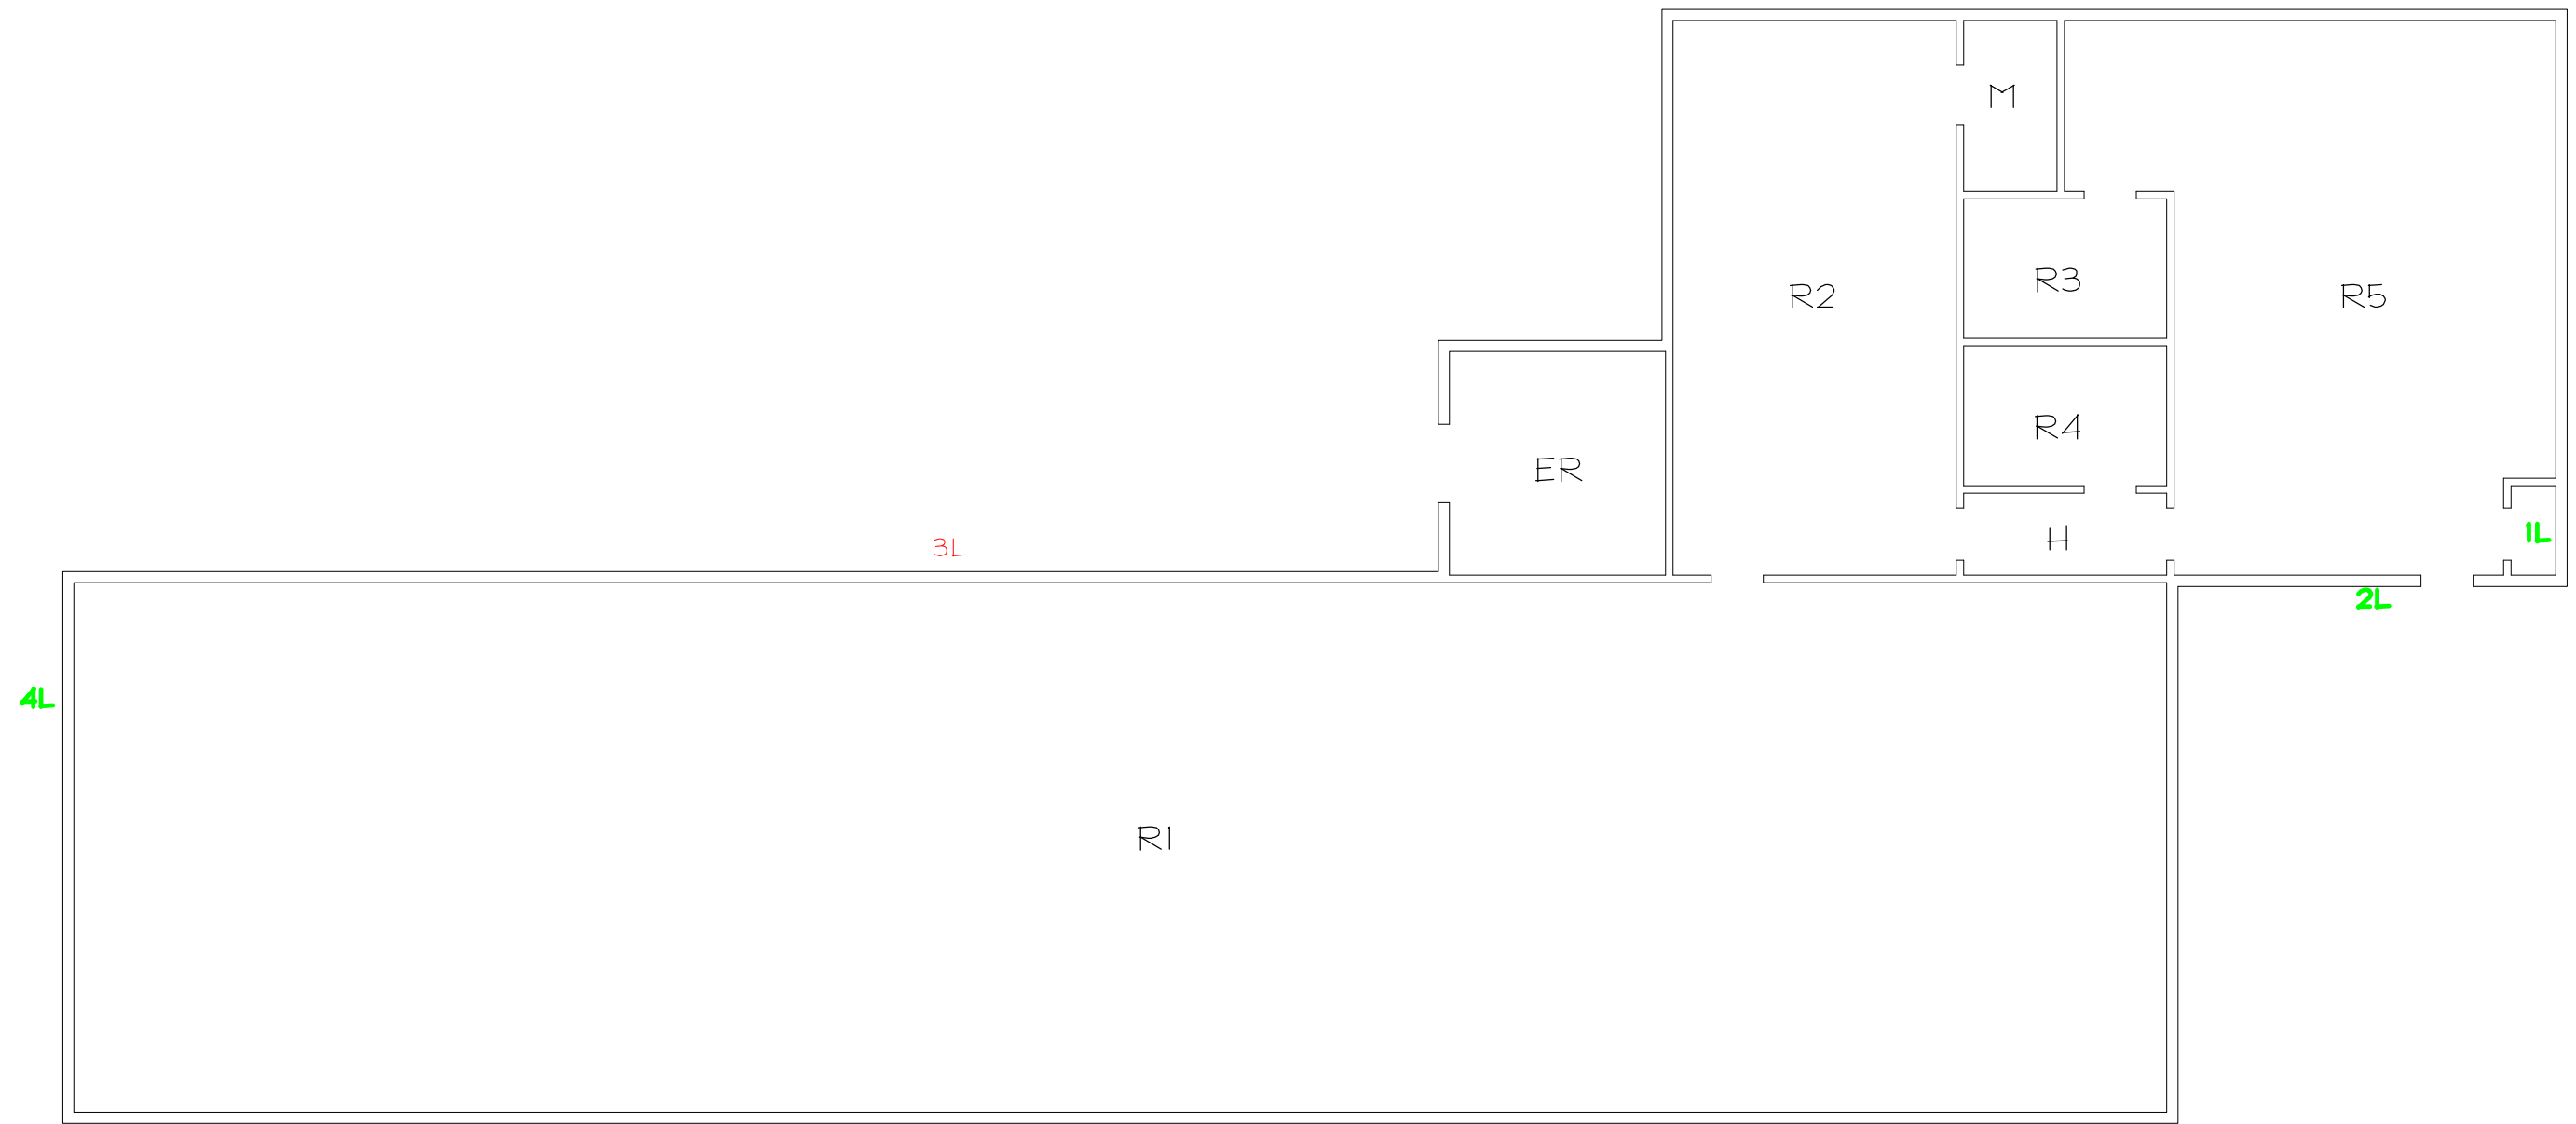
FIGURE 3 - Lead Based Paint Sample Location
CENTRAL 70 - Structure Survey Assessment Map
AP-93
 3538 E. 46th Ave., Denver, CO
 March 20, 2019
 APEC #: 18-3066

A total of 4 homogeneous paint color variations were analyzed for the presence of LBPs and LCPs (Table 3; Figure 3). Under EPA 40 CFR Part 745, LBP is defined as any paint or surface coating that contains lead equal to or exceeding 0.5% (by weight), while LCP is defined as any paint or surface coating containing lead greater than or equal to 0.06% up to 0.5% (by weight). Caution should be taken during demolition to minimize cutting, abrading, or otherwise causing an air disturbance to this material and work must be completed in accordance with the OSHA Lead in Construction Standard (29 CFR 1926.62).

One lead sample (AP93-3L) was found to be greater than 0.5% by weight and is considered LBP (Table 3). The remaining 3 samples were less than the LCP and LBP thresholds, and are considered non-lead containing paint (NLC). The laboratory analytical report is included in Appendix D.

Lead was detected at concentrations above the LBP threshold in 1 of the 4 samples. The remaining 3 samples are considered NLC.

TCLP results will confirm if the waste stream is hazardous with respect to lead content.

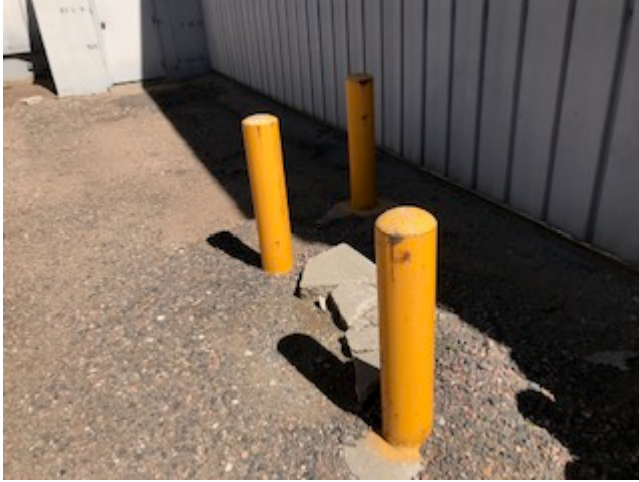
Sample Represented –
AP93-3L

LBP – Yellow
