Interstate 70 (I-70) Wildlife Overpass Screening Documentation CDOT Region 1

Prepared by:
Felsburg Holt & Ullevig
6300 South Syracuse Way, Suite 600
Centennial, CO 80111

Prepared for:
Colorado Department of Transportation
Region 1
18500 E. Colfax Ave
Aurora, CO 80011

April 2013

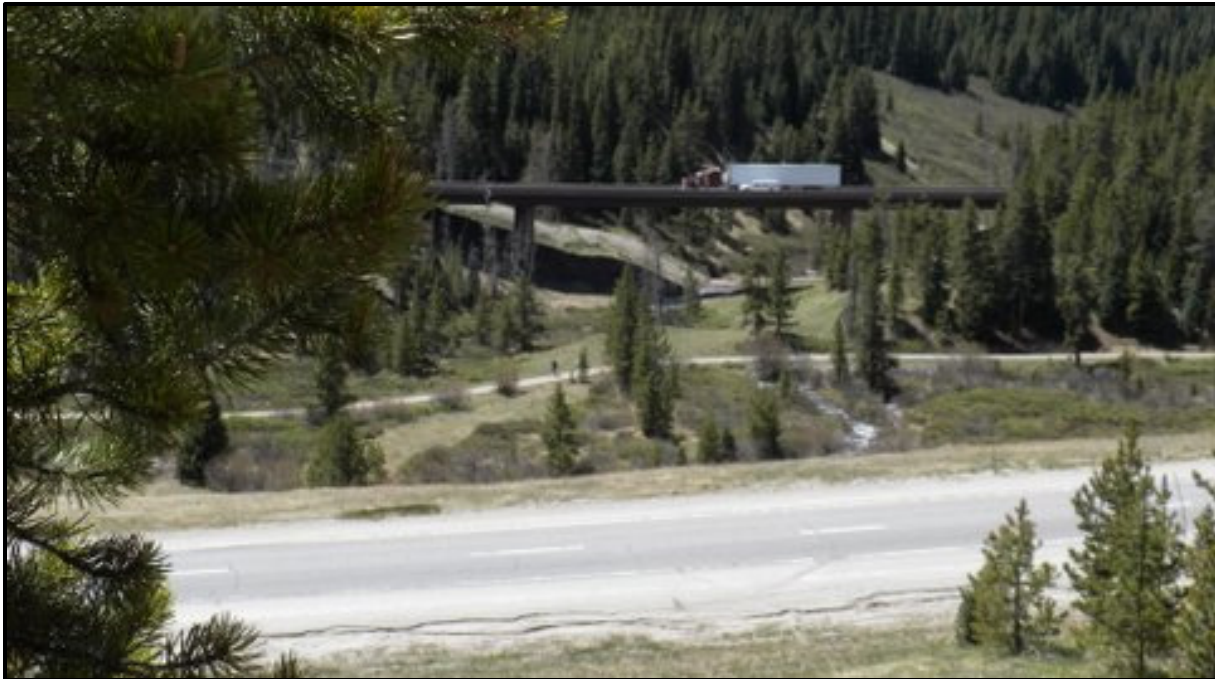
Figure 6-1 Recommended Wildlife Overpass Site on East Vail Pass (Mile Post 192.3)

Figure 6-1 provides perspective of the location of the proposed vegetated wildlife overpass. The expansive median, wetlands, and span bridge on the eastbound lanes are visible. The photo, taken from the north side of I-70, looks south.

Within Site 5, the one-tenth-mile segment between mileposts 192.3 and 192.4 serves as a prime location to construct a vegetated wildlife overpass because it will have to cross only the westbound lanes of I-70, is in alignment with a large span bridge over eastbound I-70, and has an expansive median with high-quality wetlands that serves as a habitat draw. Additionally, the current plans for the expansion of I-70 lanes do not include this area and the Advanced Guideway System does not appear to be a hindrance, at this point.

By spanning just the westbound lanes, the overall cost associated with the structure is reduced dramatically when compared to the Wolcott and Bakerville LIZs.

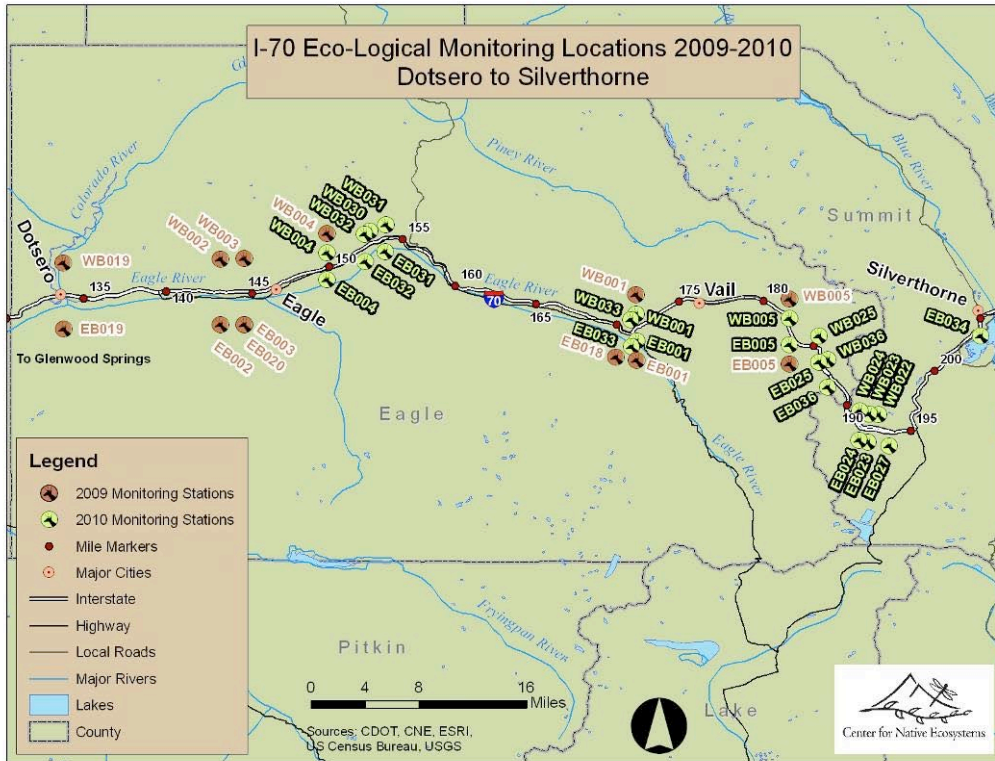
Map 2. Camera monitoring locations in 2009 and 2010 in the western portion of the study area, from Dotsero to Silverthorne.
