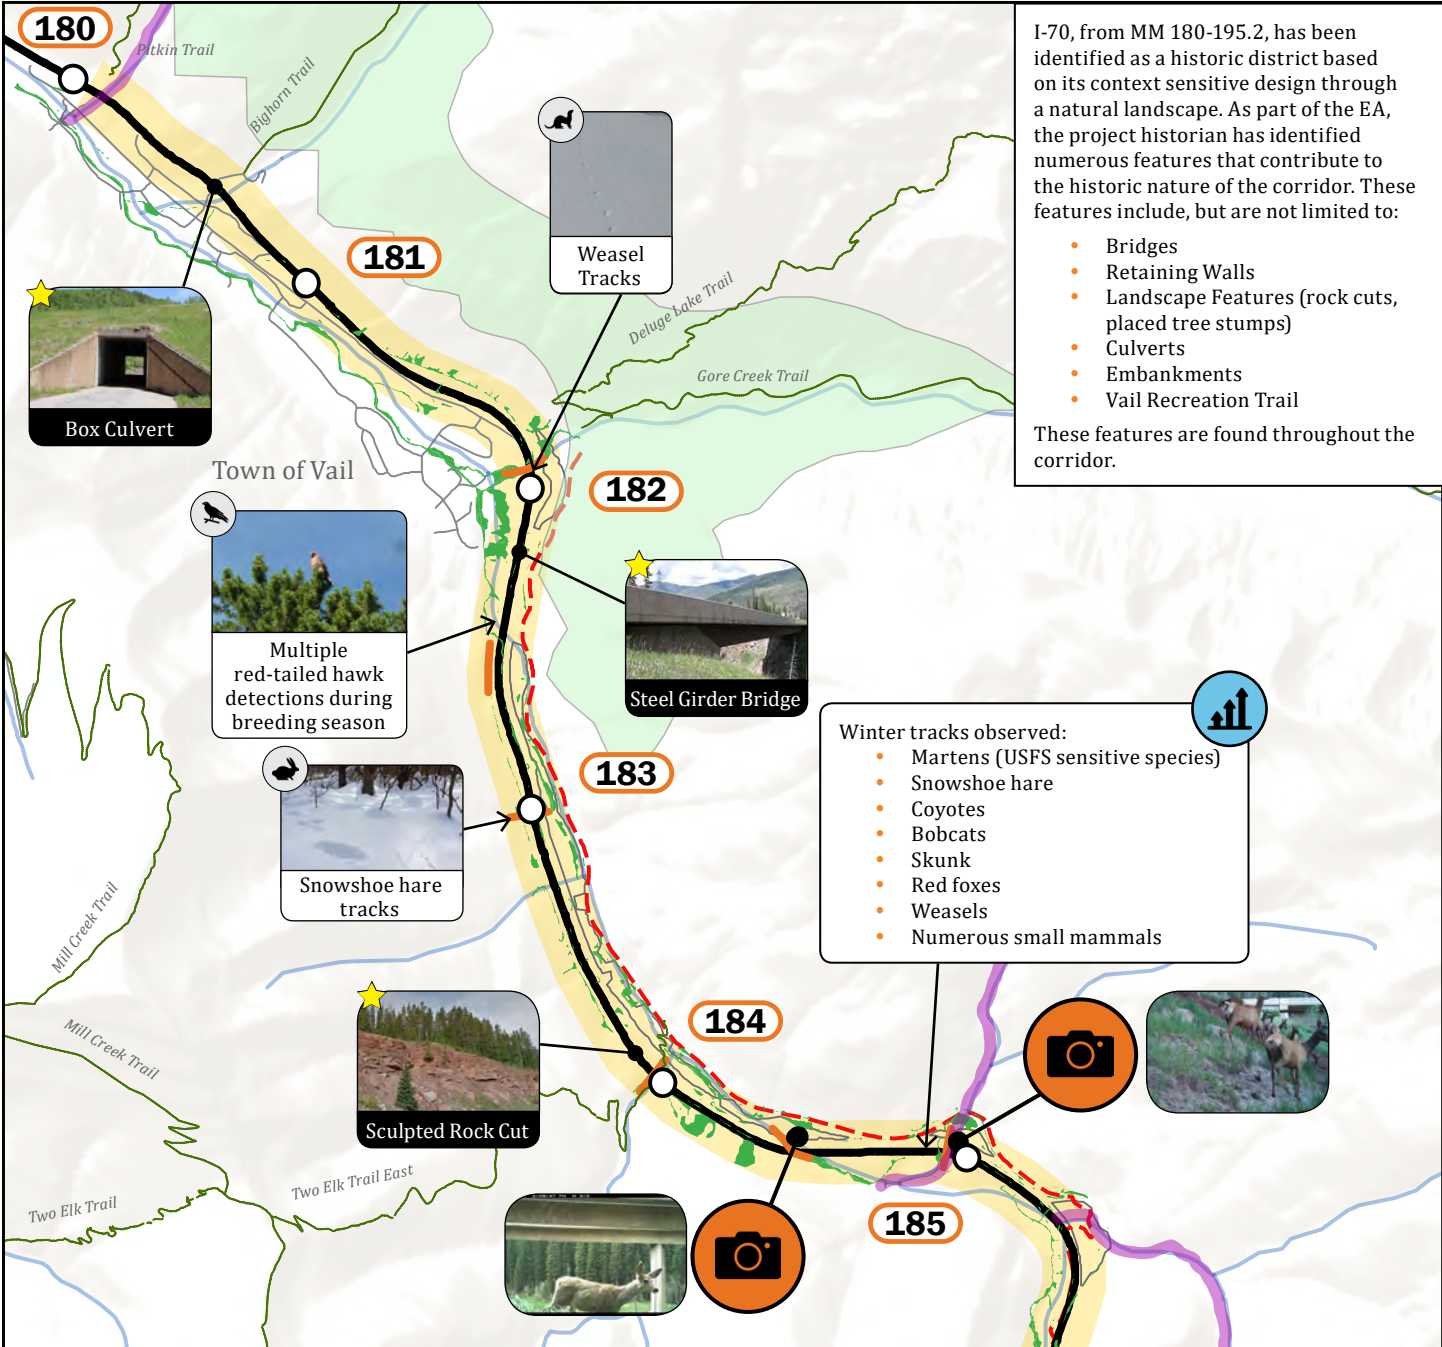
Field surveys for wildlife, wetlands, and historic resources were conducted during the summer and fall of 2018. The map below depicts the results of this field work. Wetland boundaries were surveyed based on vegetation and hydrology; soils were not analyzed but will be confirmed prior to permitting and construction.

Selected wildlife information regarding camera locations/observations, lynx prey (snowshoe hare, squirrel) and other animal tracks, and other wildlife sightings are indicated on the map. Lynx are a threatened species in Colorado and the study area is within the Vail Pass Lynx Linkage Area, as identified by the US Forest Service. Surveying their primary prey in the corridor helps the wildlife experts determine/confirm the presence of suitable lynx habitat.

Historic resources, including the I-70 Vail Pass Historic District, have been surveyed and will be analyzed for impacts once all design options and the final alignment have been determined.

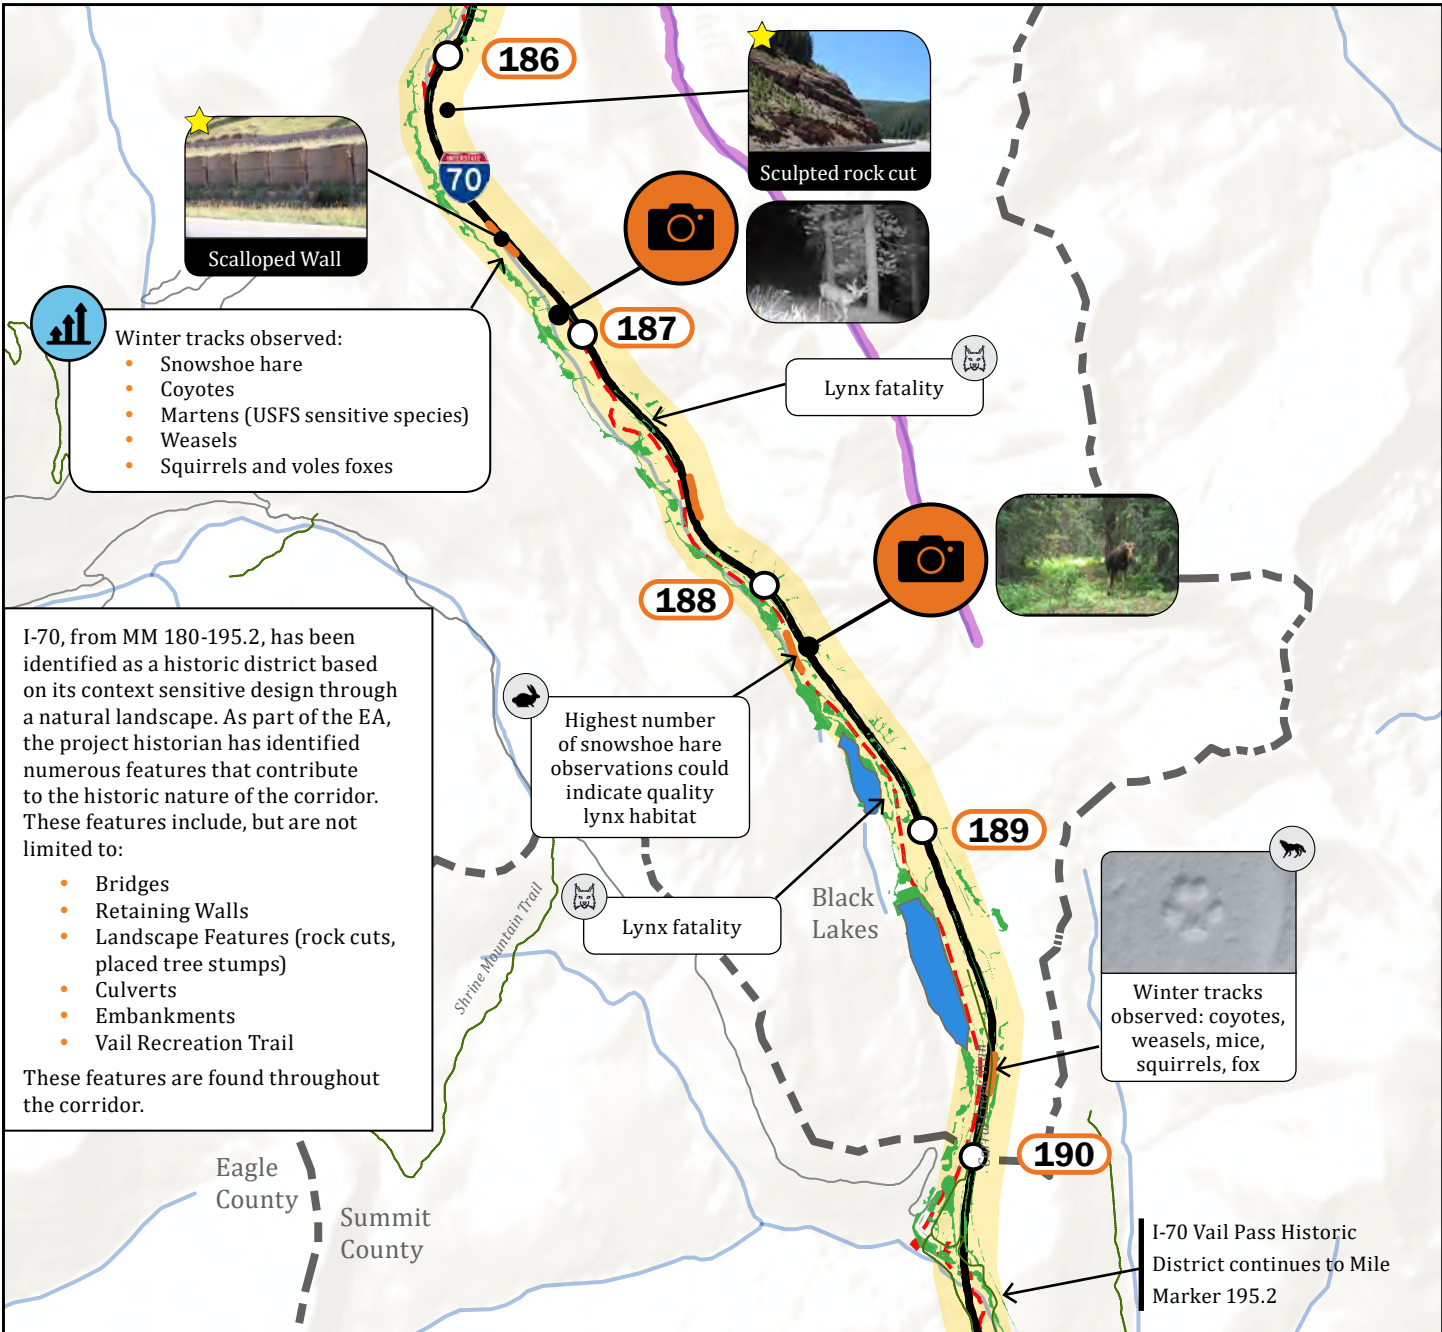
Field surveys for wildlife, wetlands, and historic resources were conducted during the summer and fall of 2018. The map below depicts the results of this field work. Wetland boundaries were surveyed based on vegetation and hydrology; soils were not analyzed but will be confirmed prior to permitting and construction.

Selected wildlife information regarding camera locations/observations, lynx prey (snowshoe hare, squirrel) and other animal tracks, and other wildlife sightings are indicated on the map. Lynx are a threatened species in Colorado and the study area is within the Vail Pass Lynx Linkage Area, as identified by the US Forest Service. Surveying their primary prey in the corridor helps the wildlife experts determine/confirm the presence of suitable lynx habitat.

Historic resources, including the I-70 Vail Pass Historic District, have been surveyed and will be analyzed for impacts once all design options and the final alignment have been determined.
