APPENDIX A16
WETLAND TECHNICAL MEMORANDUM

WETLAND TECHNICAL MEMORANDUM

April 2020
By AlpineEco

The I-70 West Vail Pass Auxiliary Lanes project is located in Eagle and Summit Counties, with the eastern terminus just east of the Vail Pass Rest Area and the western terminus in the Town of Vail. The project study limits include eastbound (EB) and westbound (WB) I-70 from mile post (MP) 179.5 to MP 191.5. The project location and approximate study area are shown in **Figure 1**.

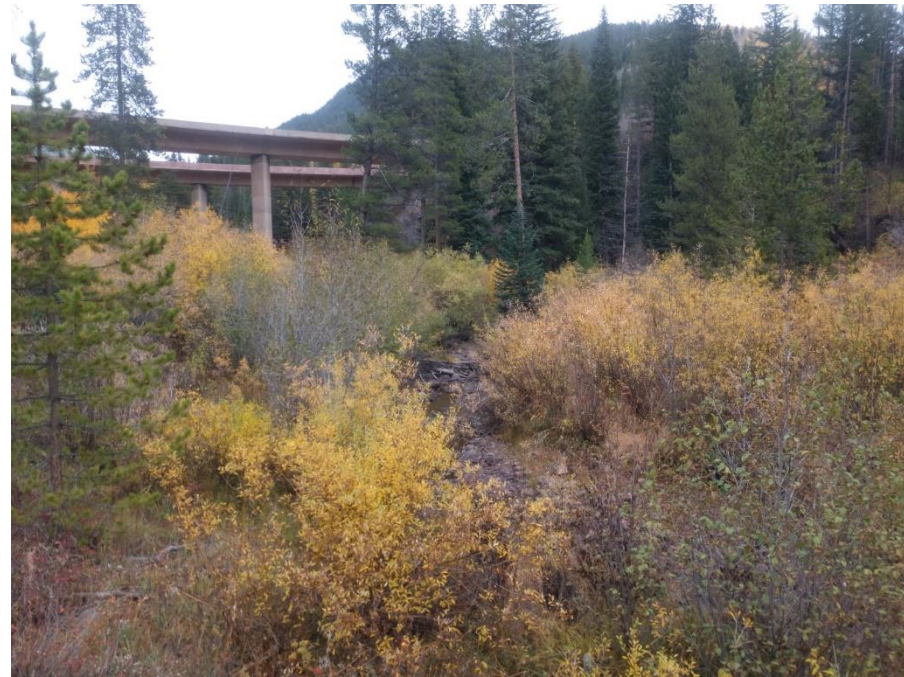
Wetland 5-1 (Gore Creek)

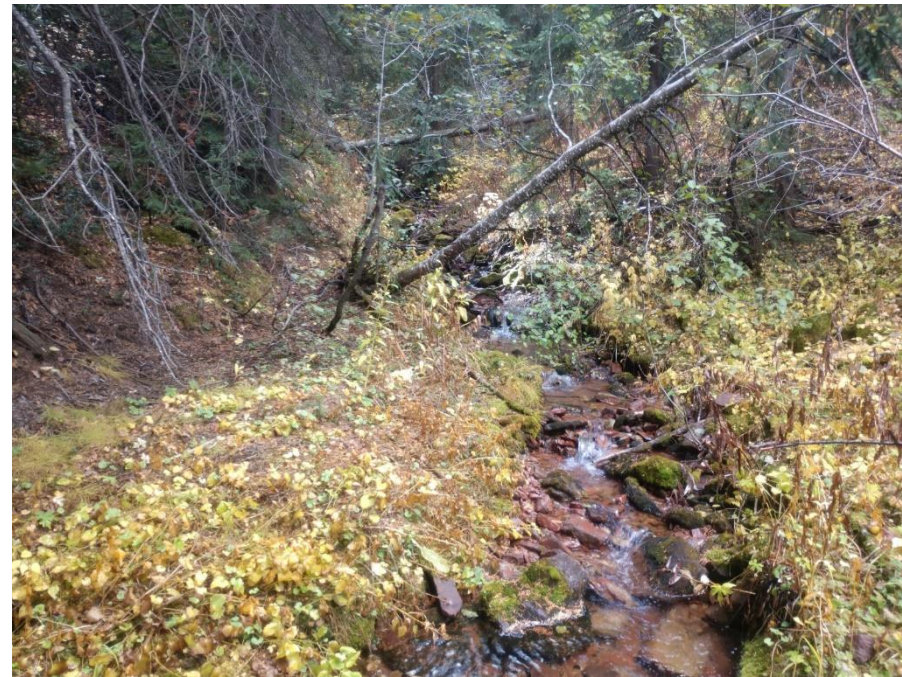
Wetland 8-5 (unnamed tributary to Black Gore Creek)

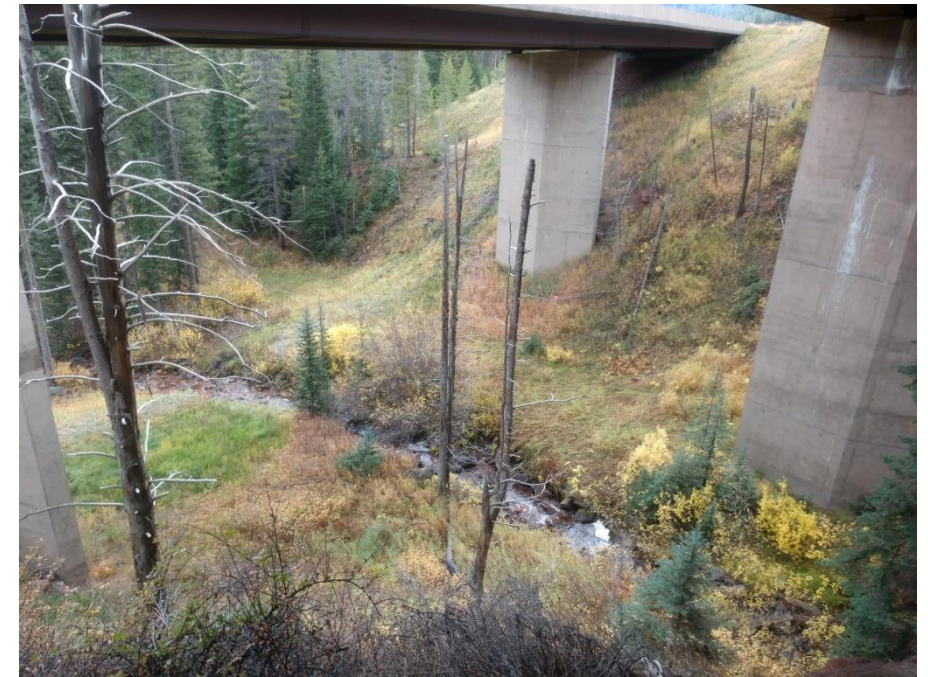
Wetland 10-1 (Timber Creek)

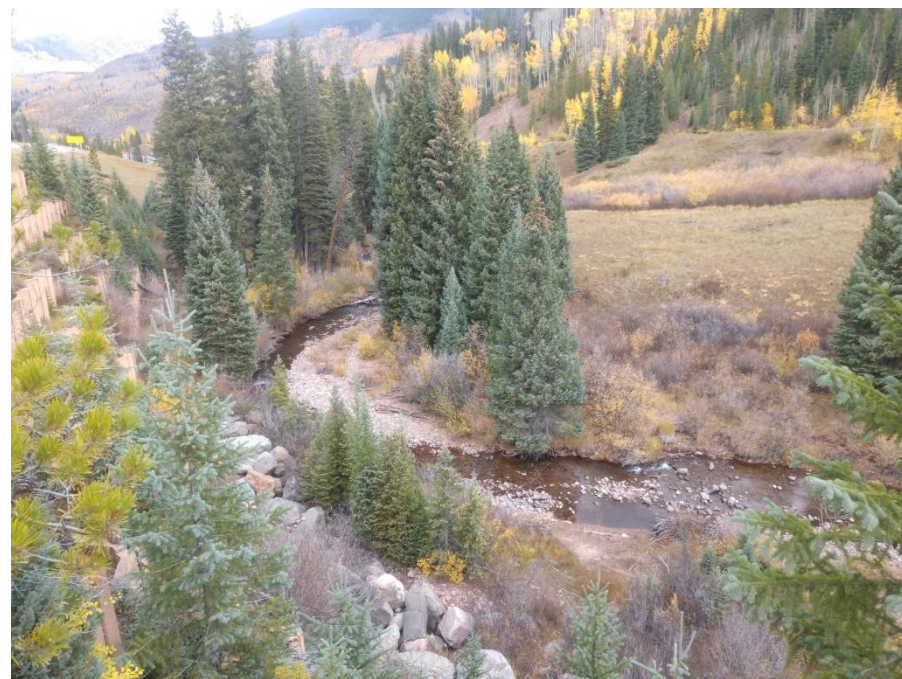
Wetland 10-4 (Black Gore Creek)

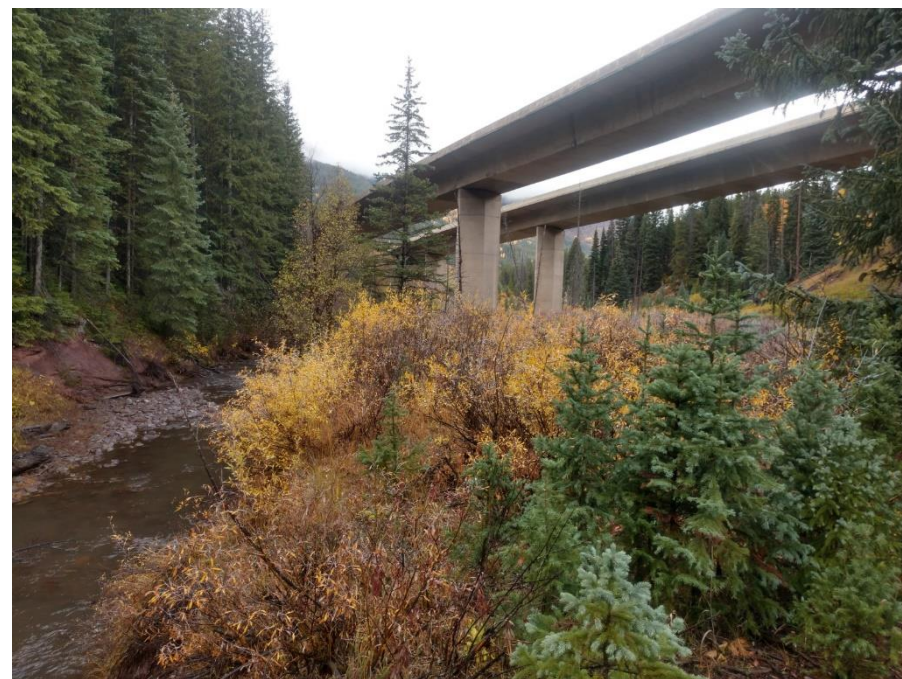
Wetland 11-10 (Black Gore Creek)

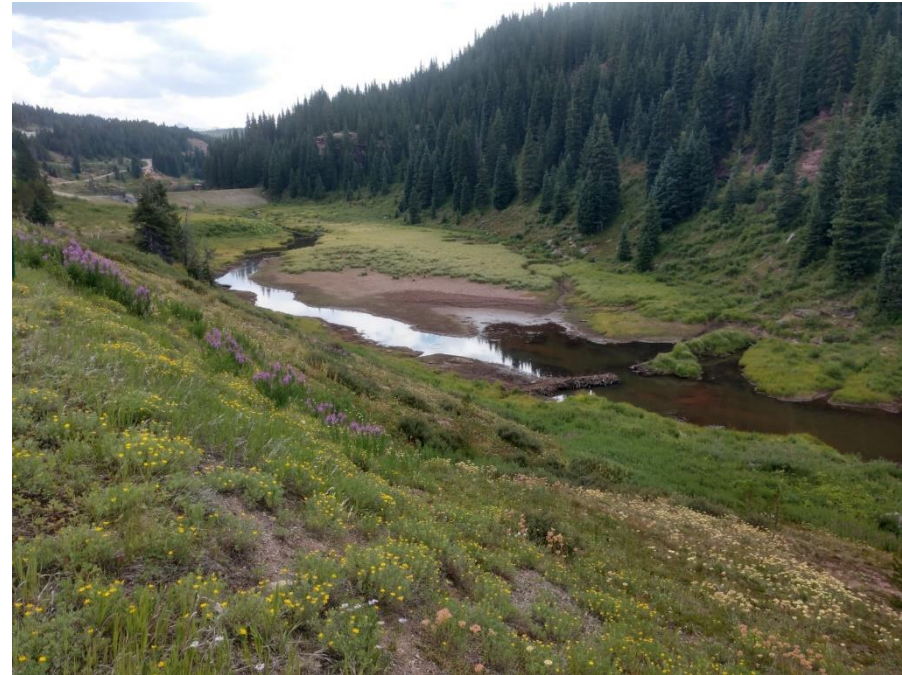
Wetland 18-1 (Black Gore Creek – fen)

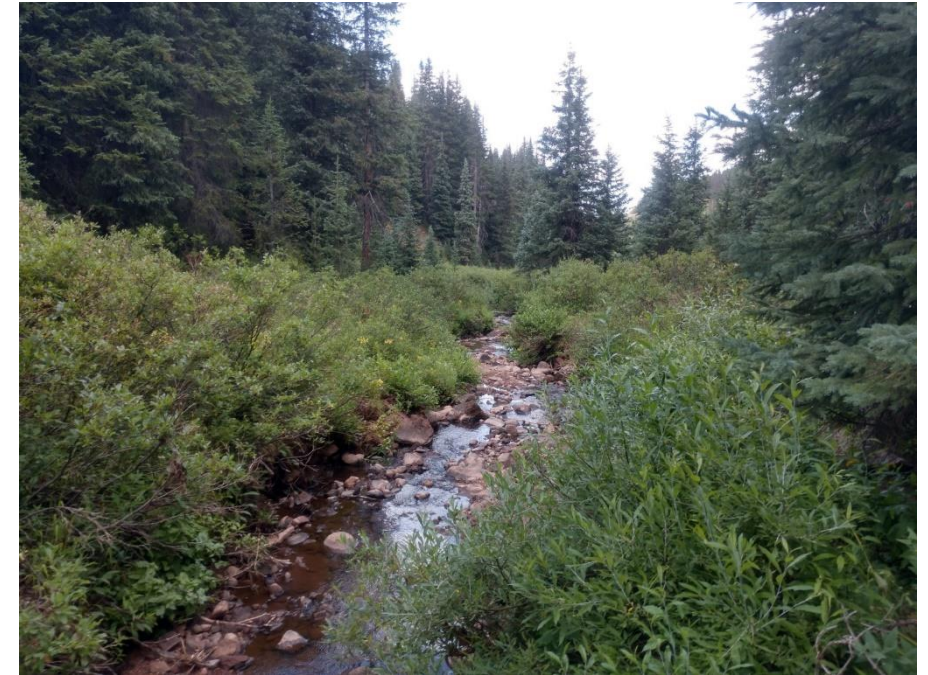
Wetland 18-2 (Black Gore Creek)

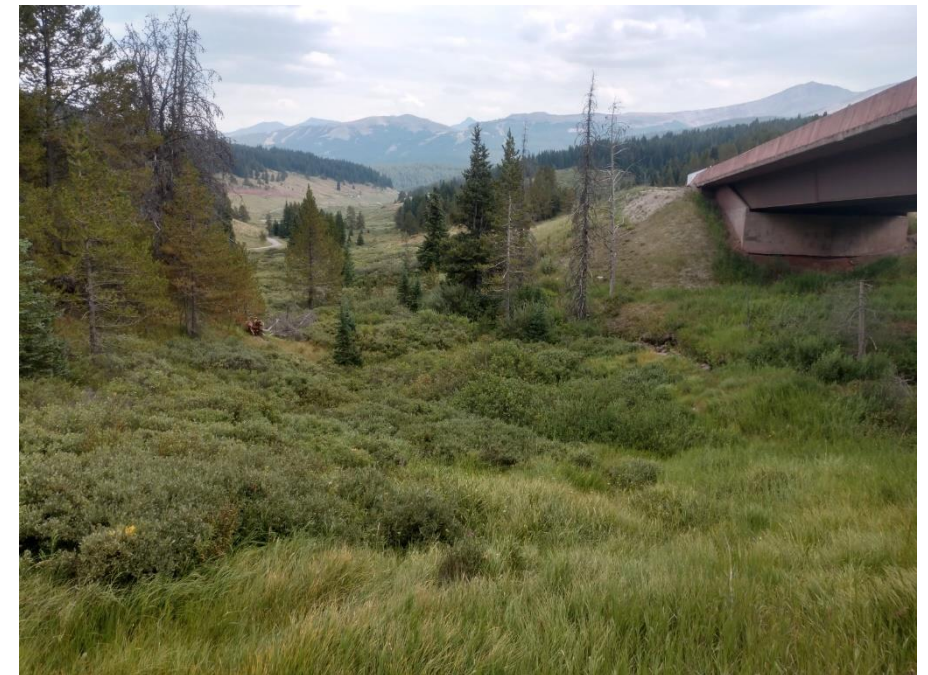
Wetland 23-3 (Wilder Gulch – fen)

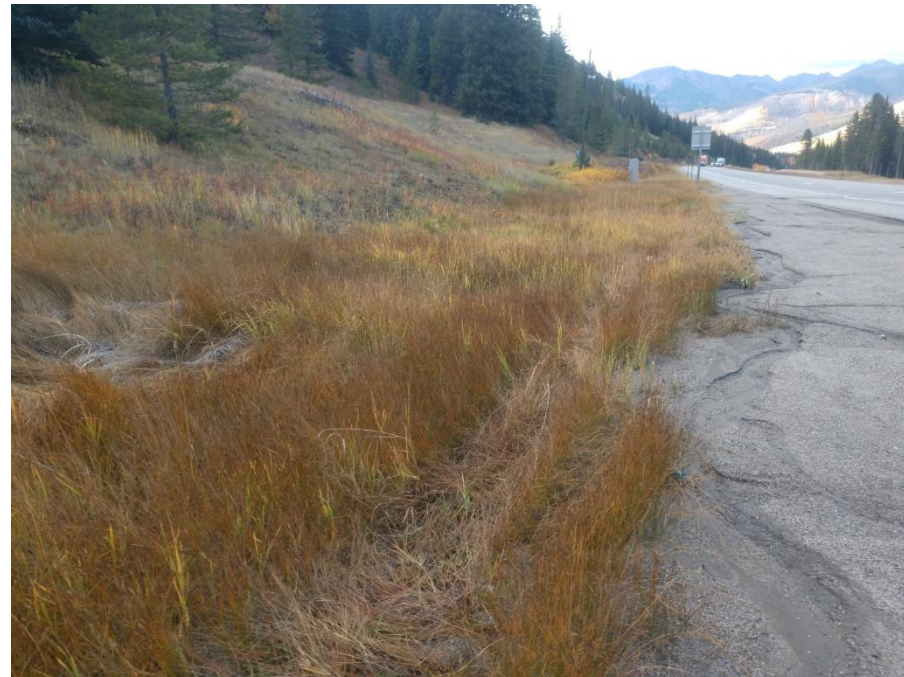
Wetland 9-3

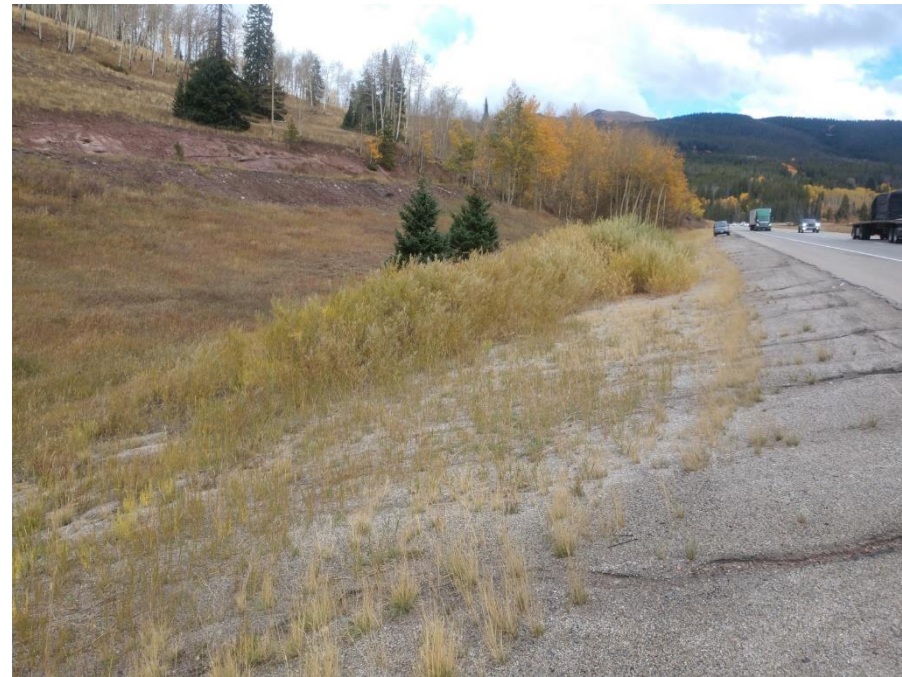
Wetland 11-7

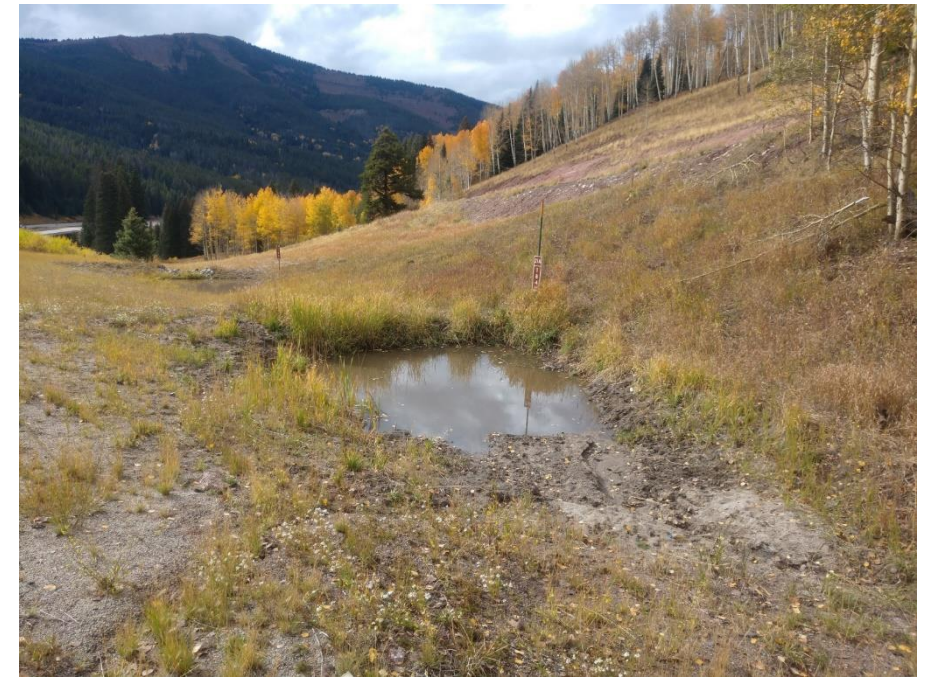
Wetland 12-11 (pond)

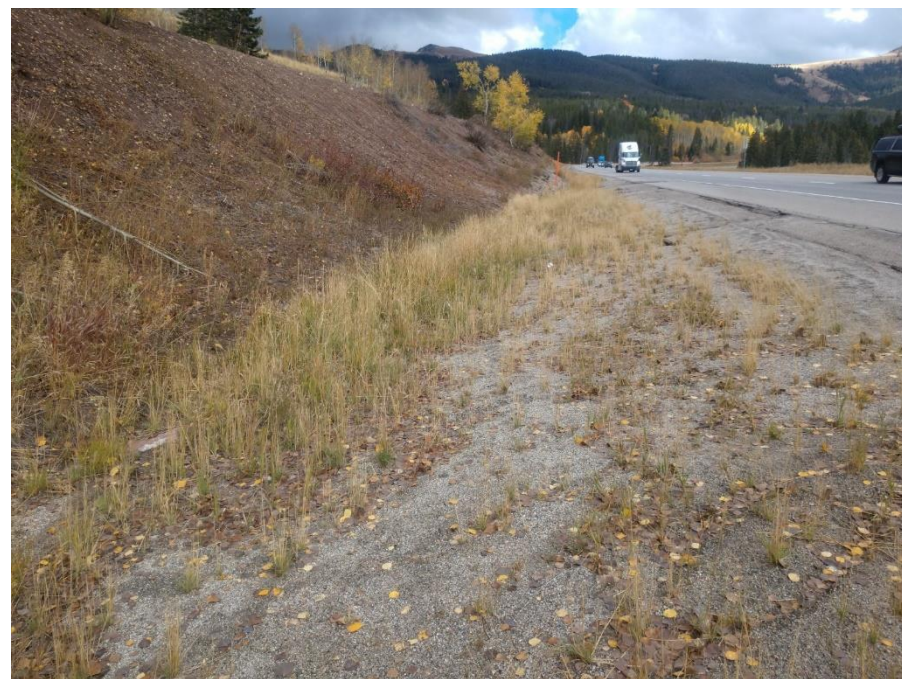
Wetland 12-11 (ditch)

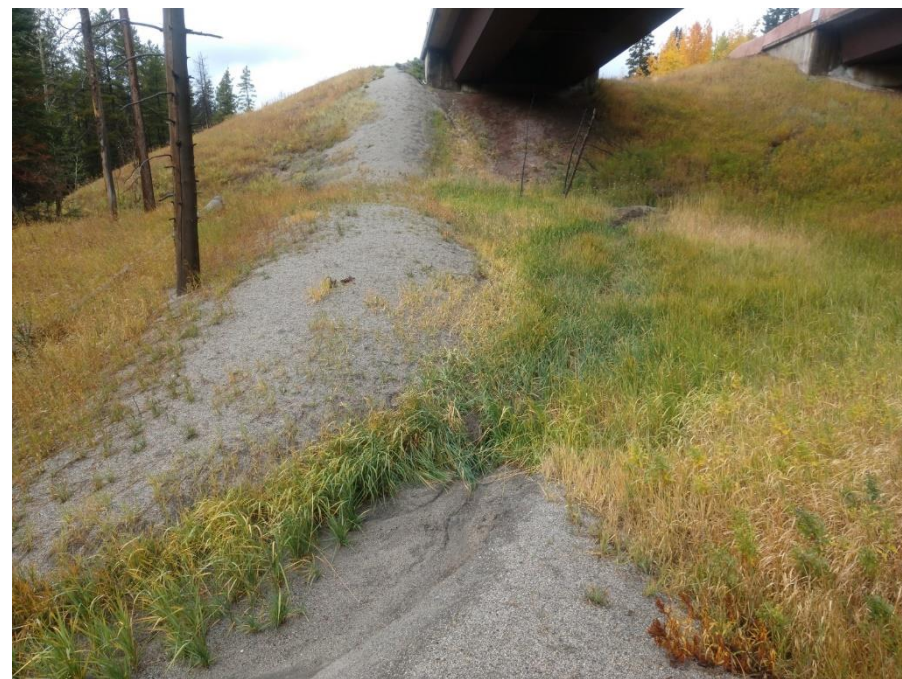
Wetland 13-10

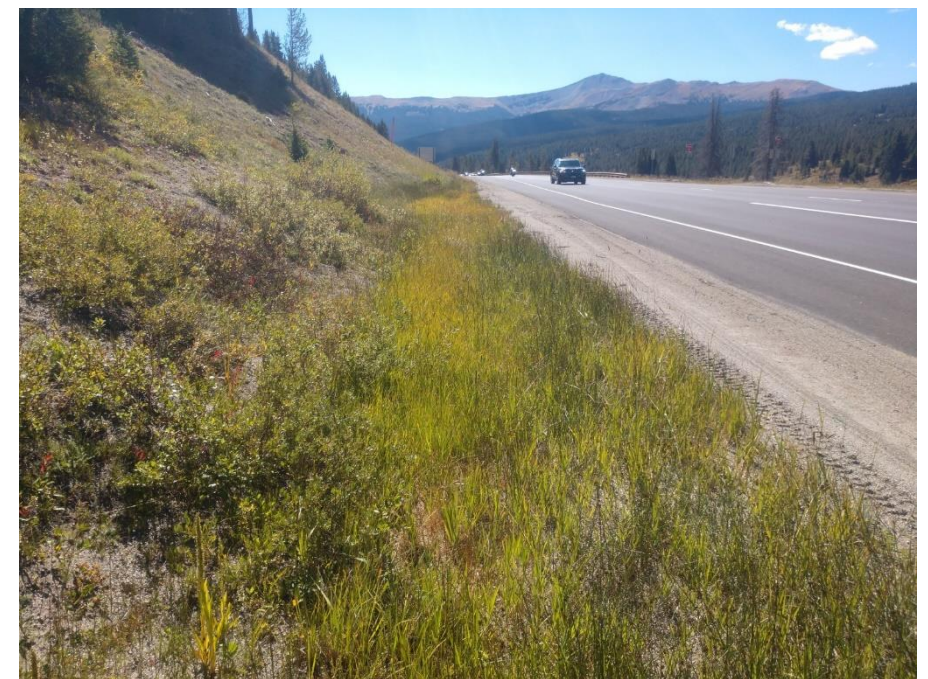
Wetland 23-9

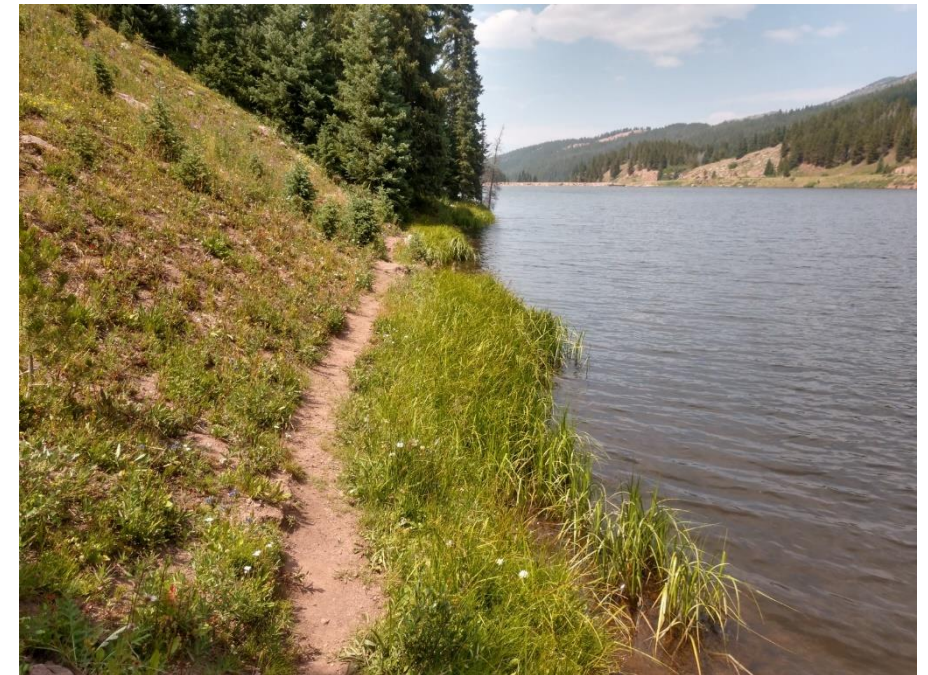
Wetland 21-2 (Black Lake)

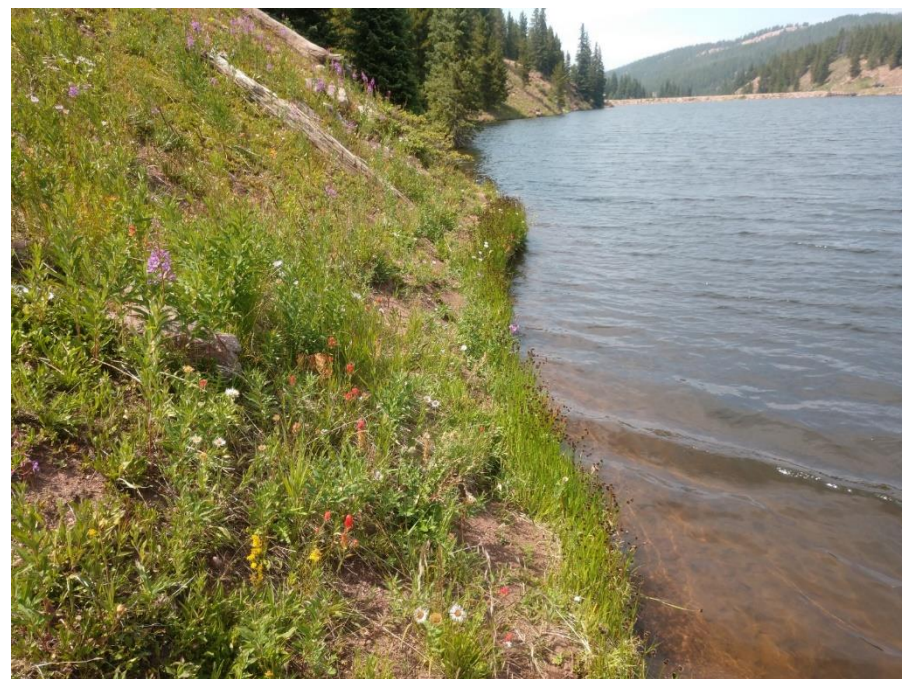
Wetland 21-2 (Black Lake)

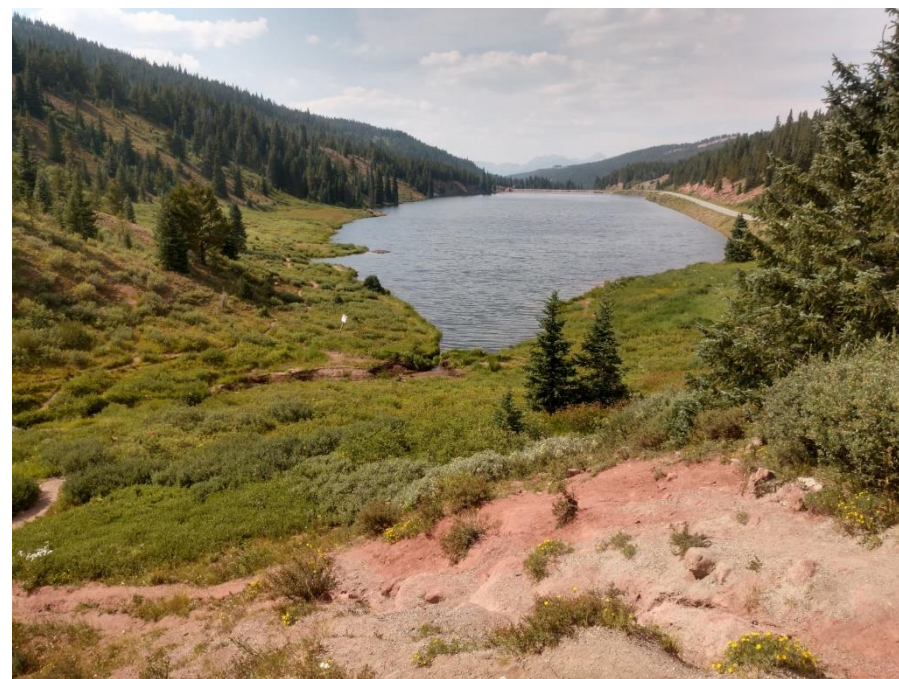
Wetland 21-2 (Black Lake – fringe only)

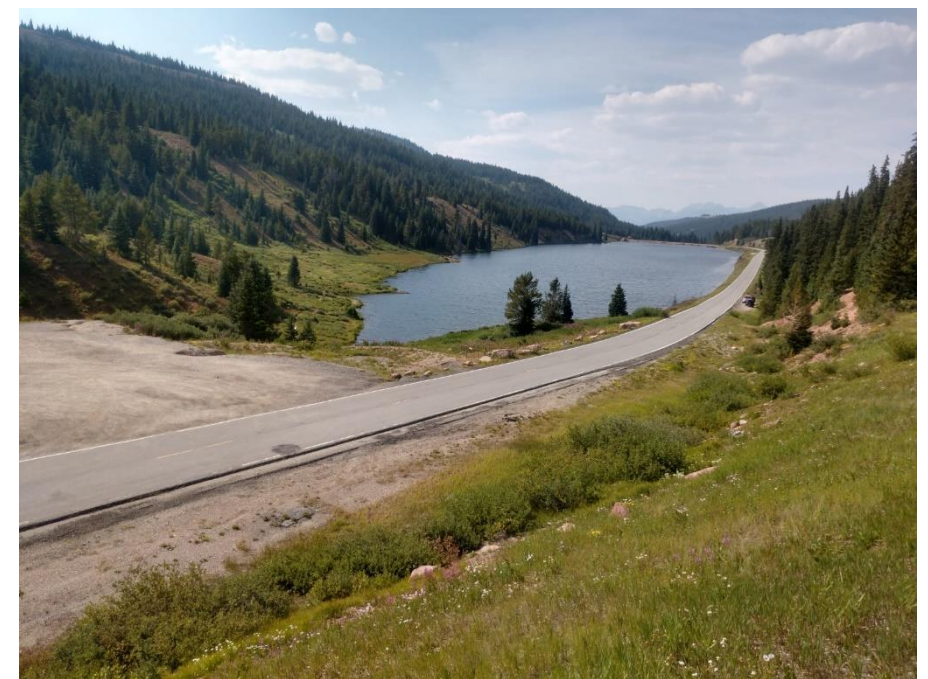
Wetland 21-2 (Black Lake – fringe only)
