APPENDIX A7
HISTORIC RESOURCES DOCUMENTATION

SUBJECT: Determinations of Eligibility and Effects (Historic Resources,) Project NHPP
0701-240, I-70 West Vail Pass Auxiliary Lanes Environmental Assessment,
Eagle and Summit Counties

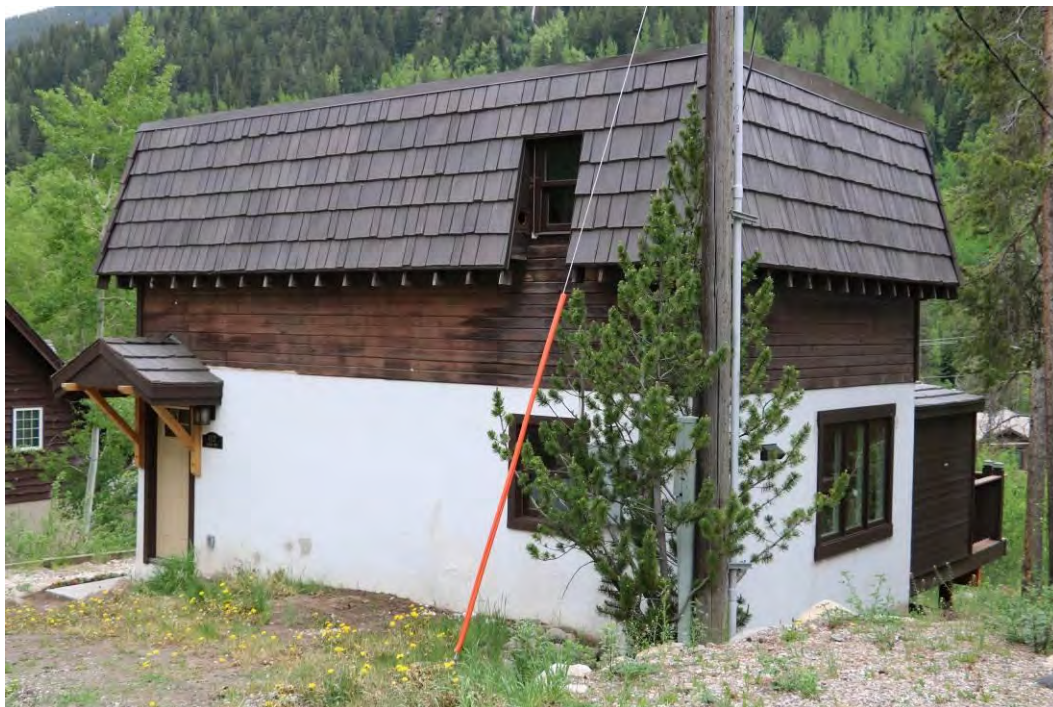
Overview of northeast (front) elevation and side (northwest) elevation with replacement wood deck and storage building visible at right, view facing south.

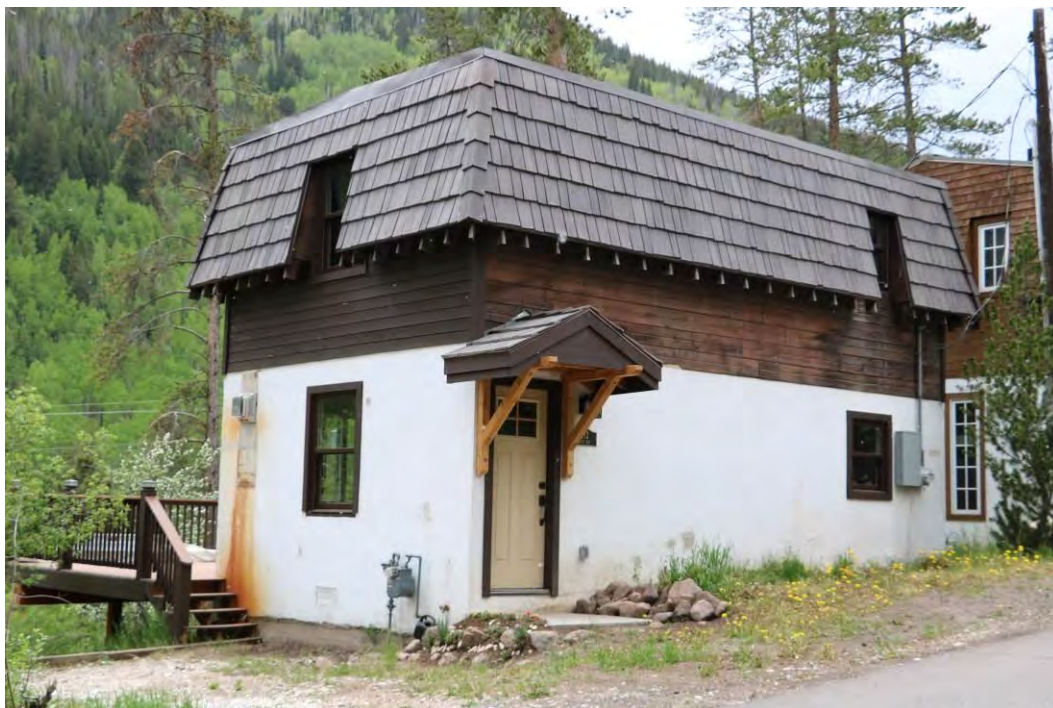
The front (northeast) and side (southeast) elevations. The deck on the rear (southwest) elevation is visible at left, view facing southwest.

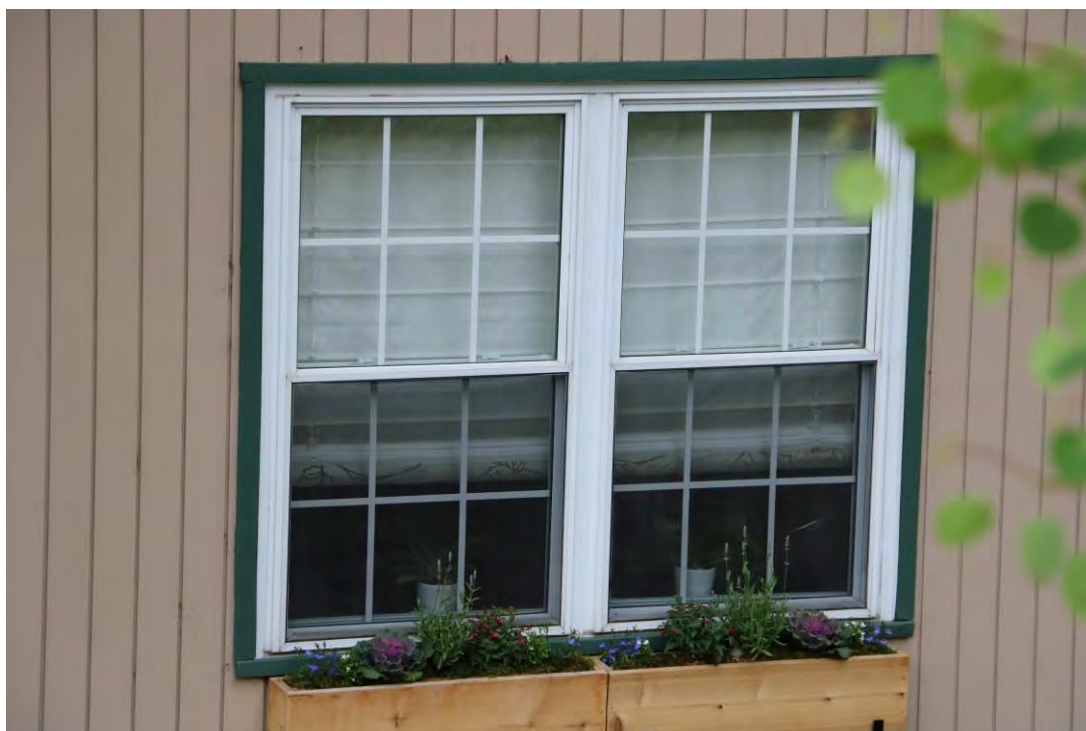
Detail of replacement, multi-light, vinyl windows, view facing south.

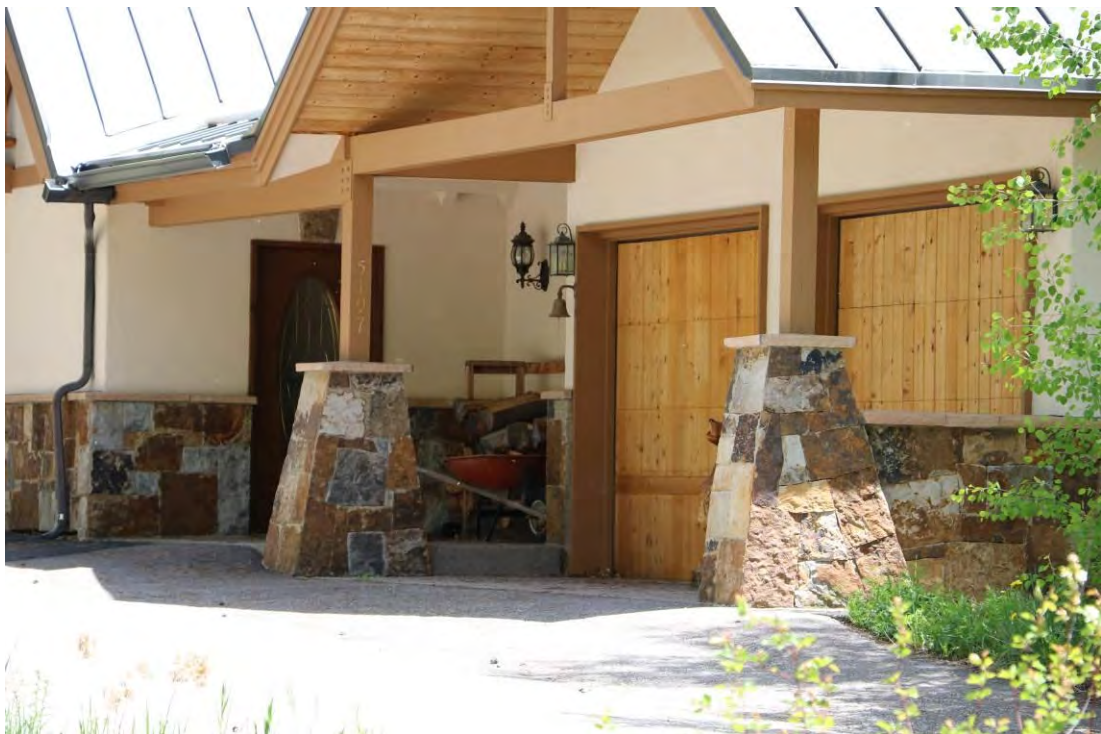
Detail of the front (north) elevation illustrating the range of replacement materials on the house, view facing southeast.

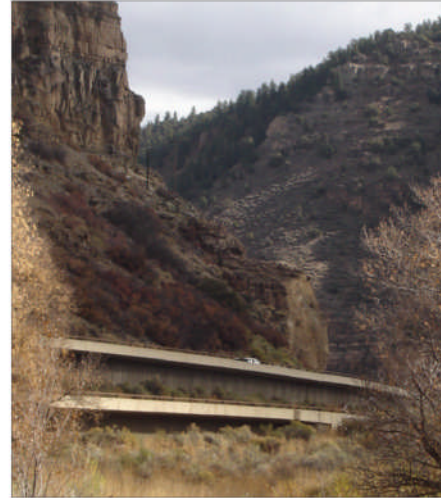
A | Using a split elevation for the travel lanes will adapt the corridor to the steep slopes found in this segment.

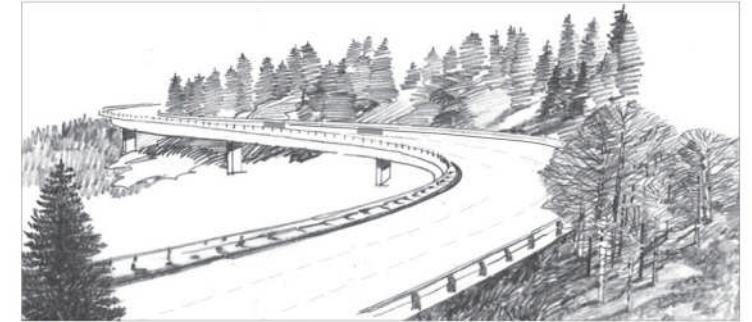
B | Elevated solutions can fit into the landscape and respond to sudden changes in topographic, hydrologic, or environmental conditions.

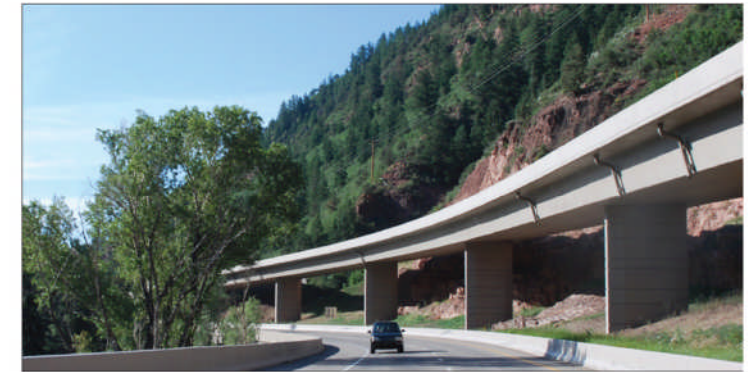
C | Elevated roadways will minimize disturbance on steep slopes.

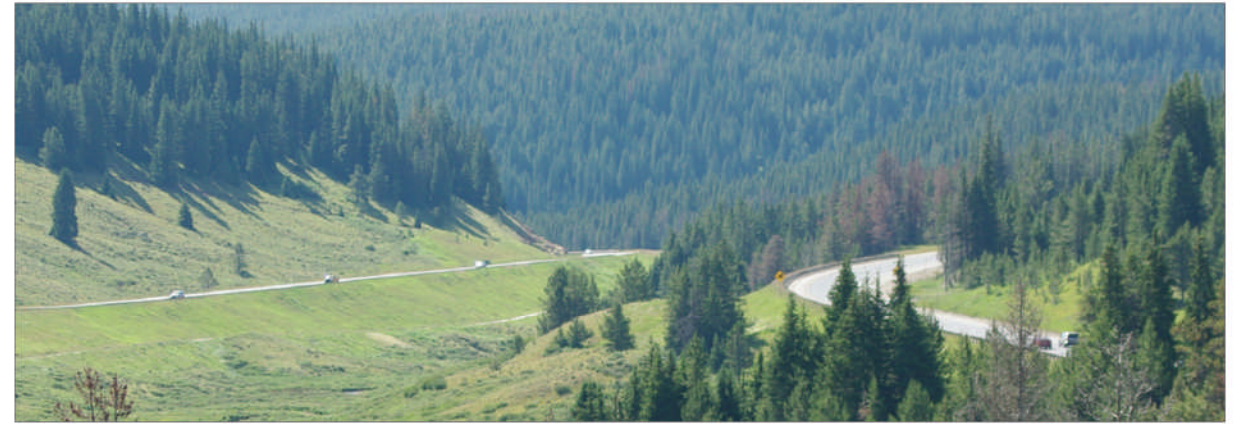
A | Medians of variable width blend the transportation corridor with natural landscape and drainage patterns.

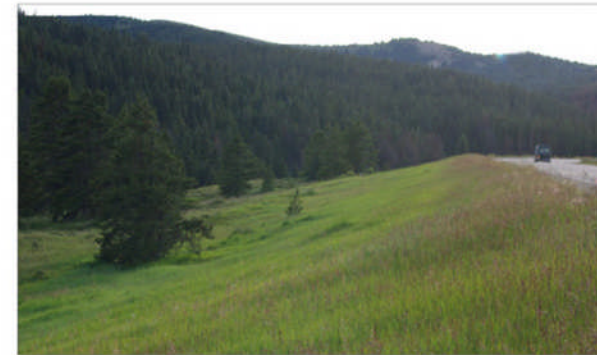
A | Rounding the top and toe of the slope blends embankments into the existing landscape and facilitates

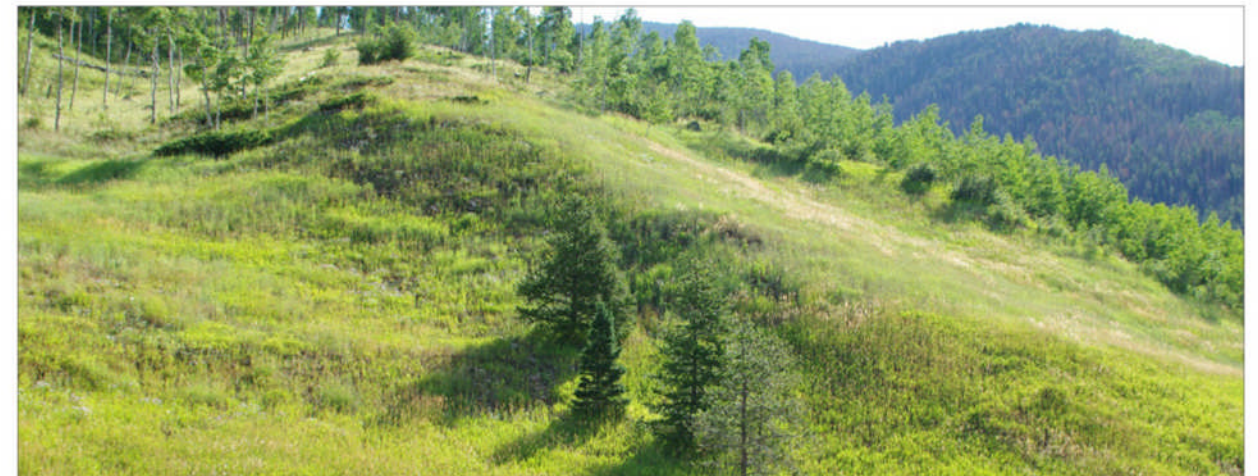
D | Utilizing variable slopes through the length of an embankment mimics the natural patterns found in the

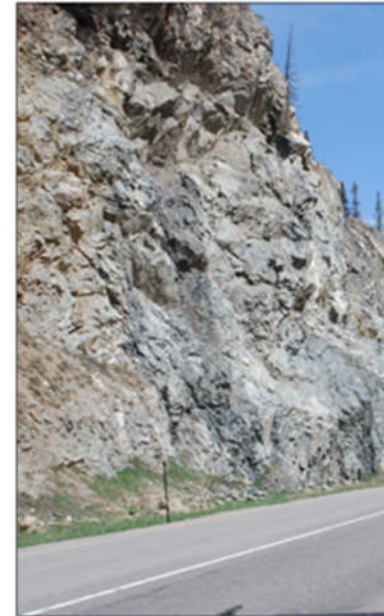
A | Color staining techniques may be used to blend new rock cuts with existing rock features.

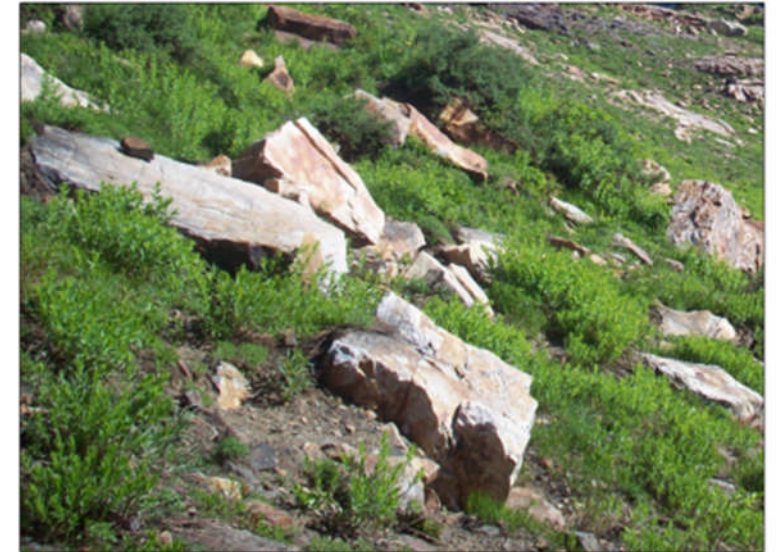
B | Allow rock outcrops and boulders to be left in earthwork to create a more natural appearance.

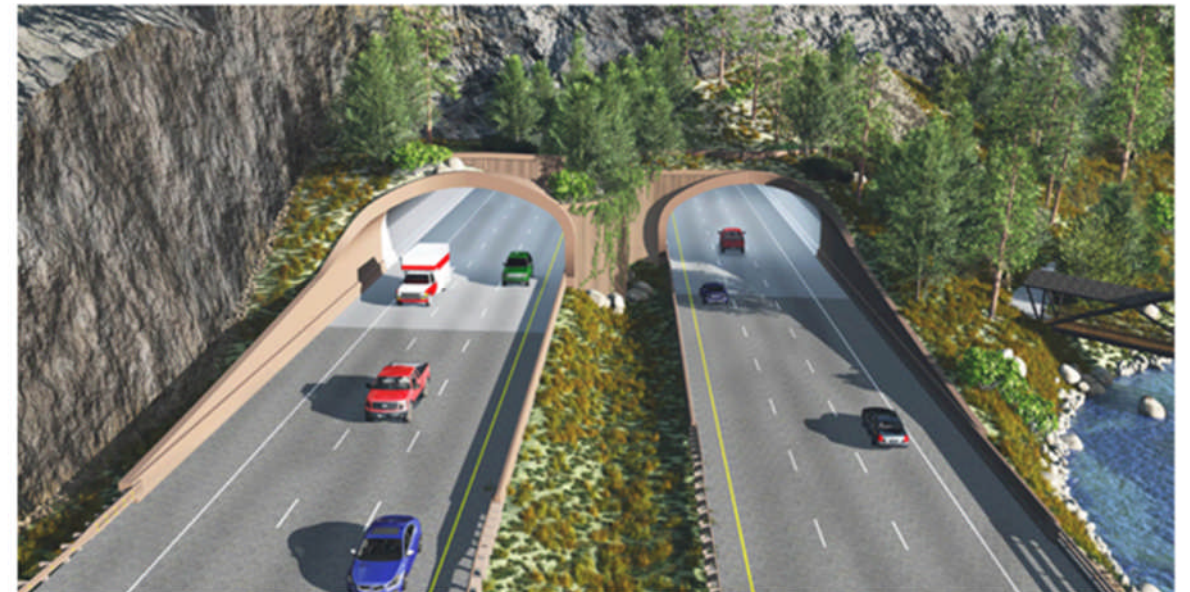
C | The transportation facility at the Twin Tunnels aids in rock fall protection by incorporating rock fall protection into design of retaining walls, noise wall, grading and landscaping.

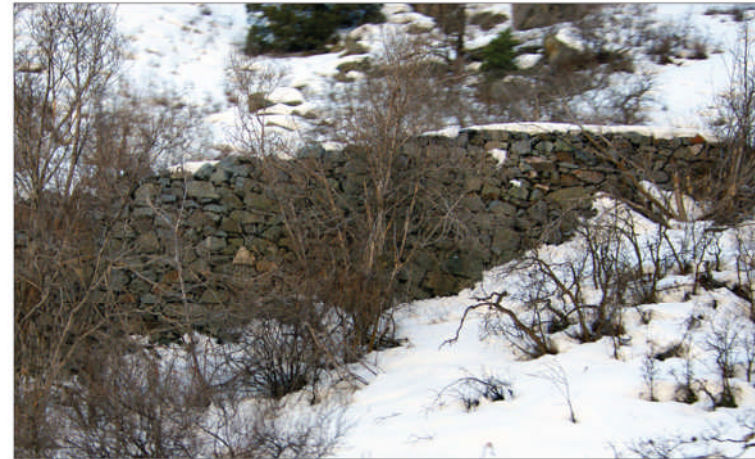
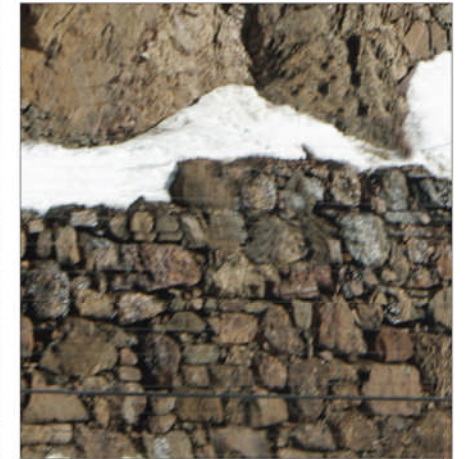
A | Landscape retaining walls are completely set within the existing landscape and should complement the surrounding natural materials, textures, and colors.

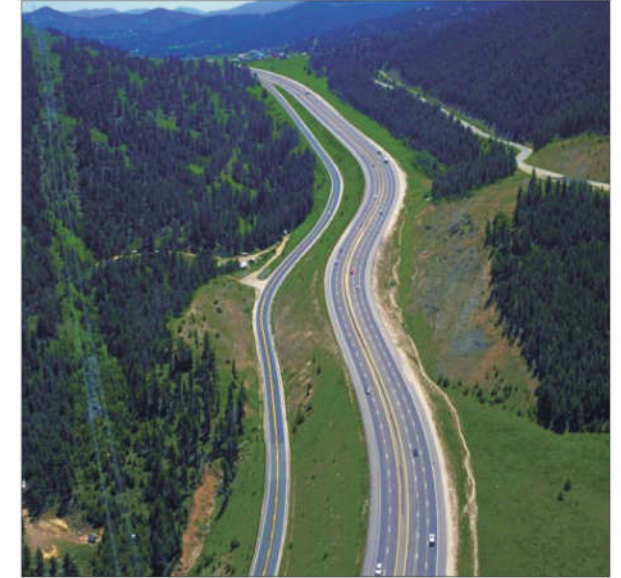
A / Straight, linear utility cuts appear highly unnatural and impact the scenic quality of the high alpine environment found in this segment.
