## 4 | Wildlife Crossing Screening Methodology and Results

### TYPES OF WILDLIFE CROSSING MITIGATION STRATEGIES AND THEIR EFFECTIVENESS

## SCREENING METHODOLOGY

## **SCREENING RESULTS**

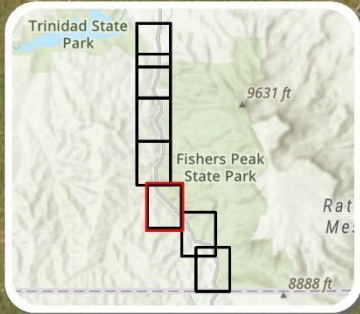
**Group 4 to address hotspots at MPs 4.5 and 4.7**

**Hotspot #11 at MP 4.7.**  
An over and underpass were considered. The cut slope to the east makes an underpass unfavorable. The fill slope, railroad, and river to the west would make it infeasible to build a landing for an overpass.

**ADVANCE. Underpass at MP 4.5 (Hotspot #4)** to address the hotspots at MPs 4.5 and 4.7.

**MP 4.1.** An underpass was considered. The area to the east is fairly level, so an underpass would require a significant amount of excavation.

**MP 4.0.** An overpass was considered spanning I-25, Raton Creek, and the railroad, but due to the high cost and difficulty coordinating with the railroad, this idea was screened out.

**Advance:** The underpass at MP 4.5 was ranked as the best crossing location within group 4 based on the matrix evaluation.

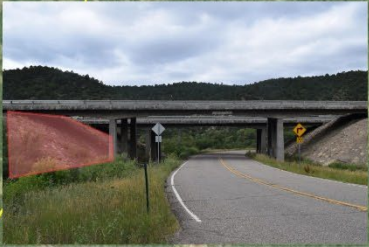
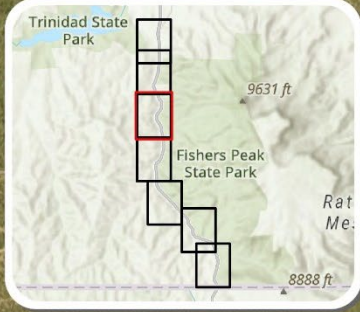
Group 6 to address hotspot at MP 8.0

**ADVANCE.** Underpass at either MP 8.0 (Hotspot #3) or 8.2 to address the hotspot at MP 8.0.

**Hotspot #3 at MP 8.0.** An overpass was also considered, but was not advanced because the topography is better suited for an underpass.

Removing the slope under the bridge and adding a wall were considered, but because of the high cost of construction and unlikelihood of animal use, this idea was not advanced.

**ADVANCE.** Add fence and deer guards to allow wildlife to cross at interchange to address hotspot at MP 8.0.

**MP 6.9.** Topographically, this is an excellent location for an underpass. It is in a drainageway and lines up with the railroad bridge to the west. However, it is over a half mile from any hotspot.

The topography at MP 6.9 is well-suited for a potential underpass, as it is a drainageway and lines up with a railroad bridge to the west. However, it is over a half mile from any WVC hotspot.

**Advance:** Add fencing and deer guards at the Exit 8 interchange, arranging them to allow wildlife to cross under I-25 at the interchange.

**Advance:** Underpass at either MP 8.0 or 8.2. While the crossing at MP 8.2 is scored better in the matrix evaluation than the crossing at MP 8.2, it is further from the hotspot.

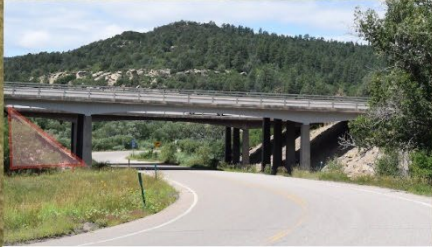
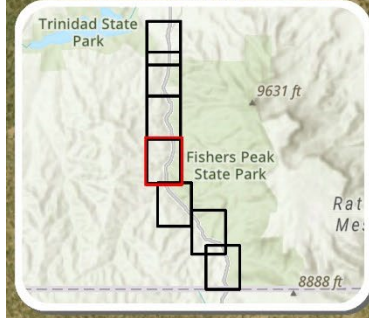
**Group 5 to address hotspots at MPs 5.6 and 6.0**

Removing the slope under the bridge and adding a wall were considered, but because of the high cost of construction, and unlikelihood of animal use, this idea was not advanced.

**MP 6.6.** An underpass was considered at this location. It is feasible, but MP 6.9 is a better location. Both locations are over a half mile from any hotspot.

**ADVANCE.** Underpass at MP 6.1 to address hotspots at MPs 5.6 and 6.0.

**Hotspot #9 at MP 6.0.** An under and overpass were considered. The cut slope to the east makes an underpass unfavorable. The fill slope and river to the west would make it infeasible to build a landing for an overpass.

**MP 5.6.** This cut section just north of the bridges could be a good location for an overpass. However, arranging the deer guards to allow wildlife to use the interchange bridges is a much lower-cost solution.

**ADVANCE.** Add fence and deer guards to allow wildlife to cross at interchange to address hotspots at MPs 5.6 and 6.0.

**Advance:** Underpass at MP 6.1

**Advance:** Addition of fencing and deer guards at the interchange at MP 5.6 to guide wildlife to cross at the interchange.

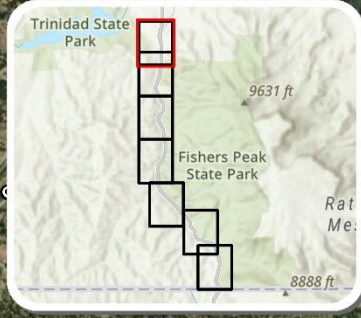
**Group 7 to address hotspots at MPs 10.5, 10.6, and 11.0**

**ADVANCE.** Add fencing and deer guards to keep wildlife out of the interchange.

**MP 10.8.** An underpass was considered, but a significant cut would be required on the east which would likely disturb the existing driveway.

**Hotspot #2 at MP 10.6.** I-25 is in a cut here, so an underpass is infeasible. An overpass could work, but would be very costly as it would have to span the frontage road and I-25.

**Hotspot #5 at MP 10.5.** This area has level terrain and there is a frontage road to the east, making it unfavorable for either an under or overpass.

**ADVANCE.** Underpass at MP 10.4 to address the hotspots at MPs 10.5, 10.6, and 11.0. Topography with stream under I-25 provides a favorable location for an underpass.

**MP 10.0.** An underpass was considered. Topographically, this is a good location for an underpass, but the crossing at MP 10.4 is closer to the hotspots.

The potential underpasses at MP 10.0 and 10.4 scored comparably in the screening. However, the underpass at 10.4 is preferable because it has a frontage road on only one side, which would allow for a smaller structure, and it is closer to the WVC hotspots.

**Advance:** Underpass at MP 10.4.

**Advance:** Add fencing and deer guards through the interchange to keep wildlife out of the interchange area. This is recommended due to the high traffic volumes at the interchange.
