**SUBJECT:** Current Conditions Analysis for Parks and Recreation Resources  
for the I-225 PEL Study  
FHU Reference No: 112200-01

**Subject:** Current Conditions Analysis for Traffic Noise for the I-225 PEL Study  
FHU Reference No: 112200-01

**SUBJECT:** Current Conditions Analysis for Floodplains and Water Quality for the I-225 PEL Study  
FHU Reference No: 112200-01

**SUBJECT:** Hazardous Materials Assessment Analysis for the I-225 PEL Study  
FHU Reference No:112200-01

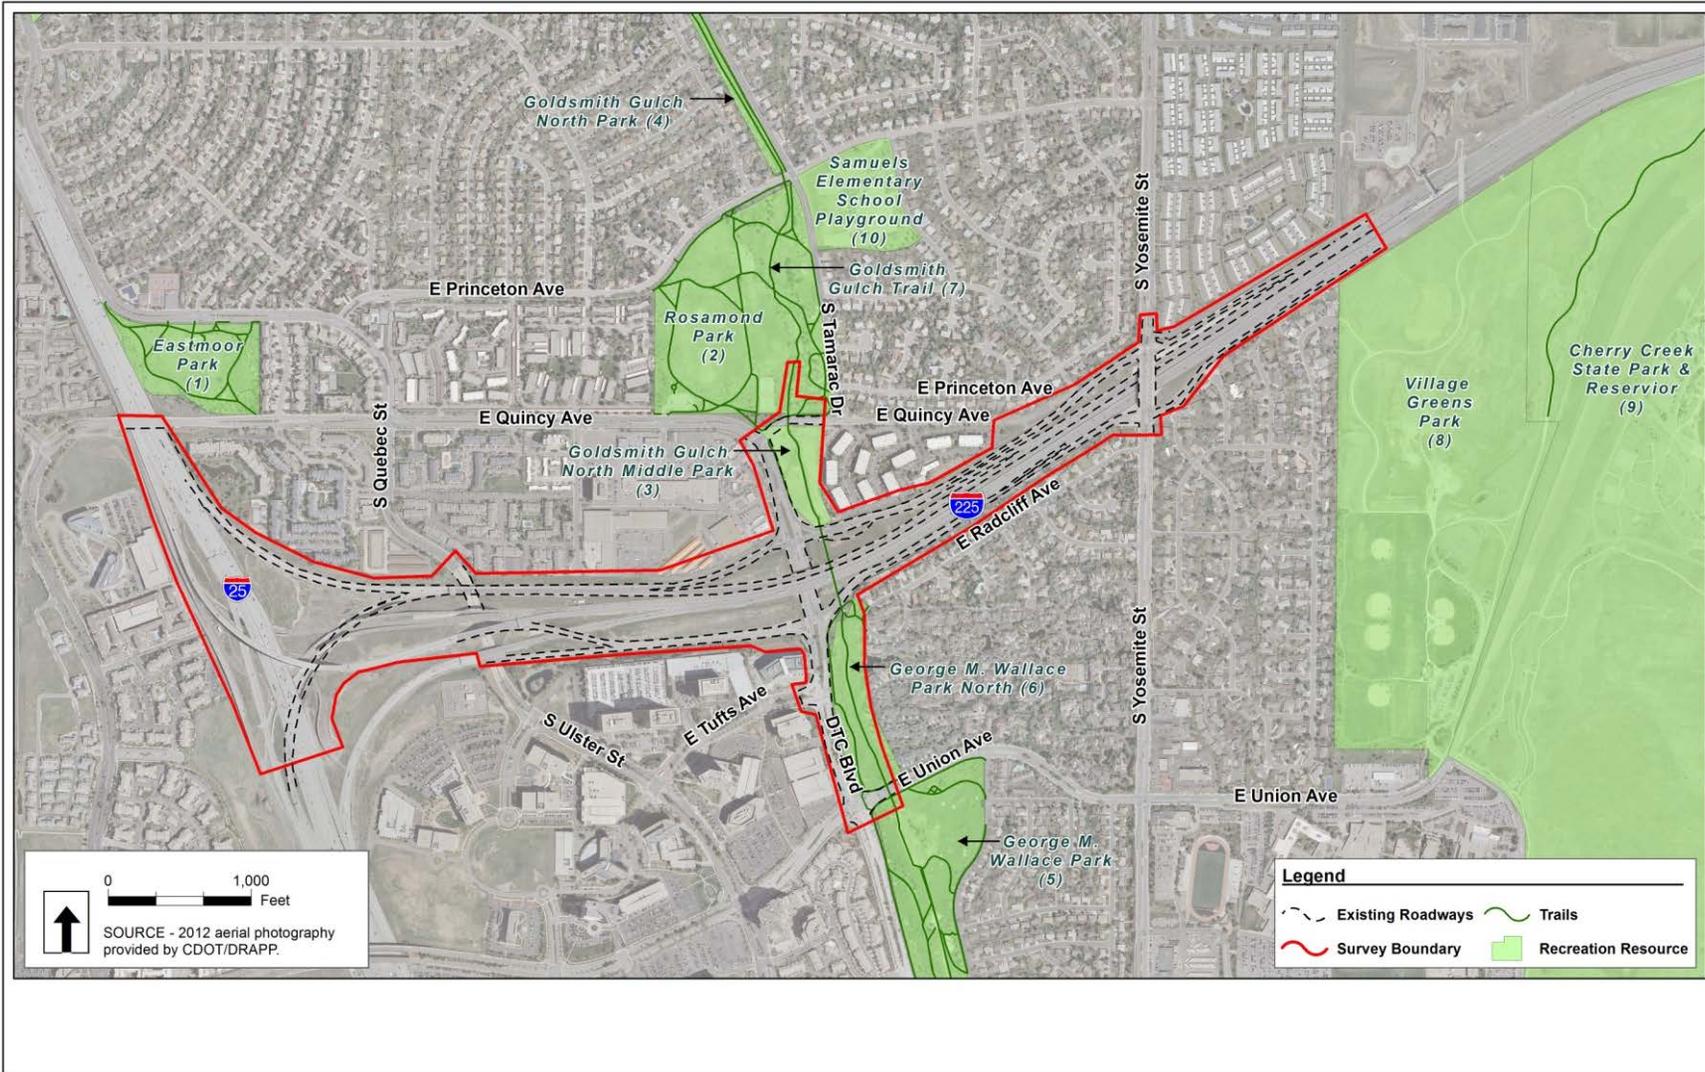
Figure 1 Existing Parks and Open Spaces

- ▶ The study area in which parks, trails and open space resources were evaluated is shown in **Figure 1**. Properties were identified that were within the close proximity or adjacent to the study area. Details and characteristics of existing parks and recreational resources in the study area were identified through GIS and then field verified in May 2013. Additional inventory details about the resources, such as ownership, size and amenities were obtained from accessing individual municipalities' websites in May 2013. Research was centered on utilizing the most current version of information available online. The information has not been confirmed with the jurisdictions and may change as the project progresses through the planning phases.

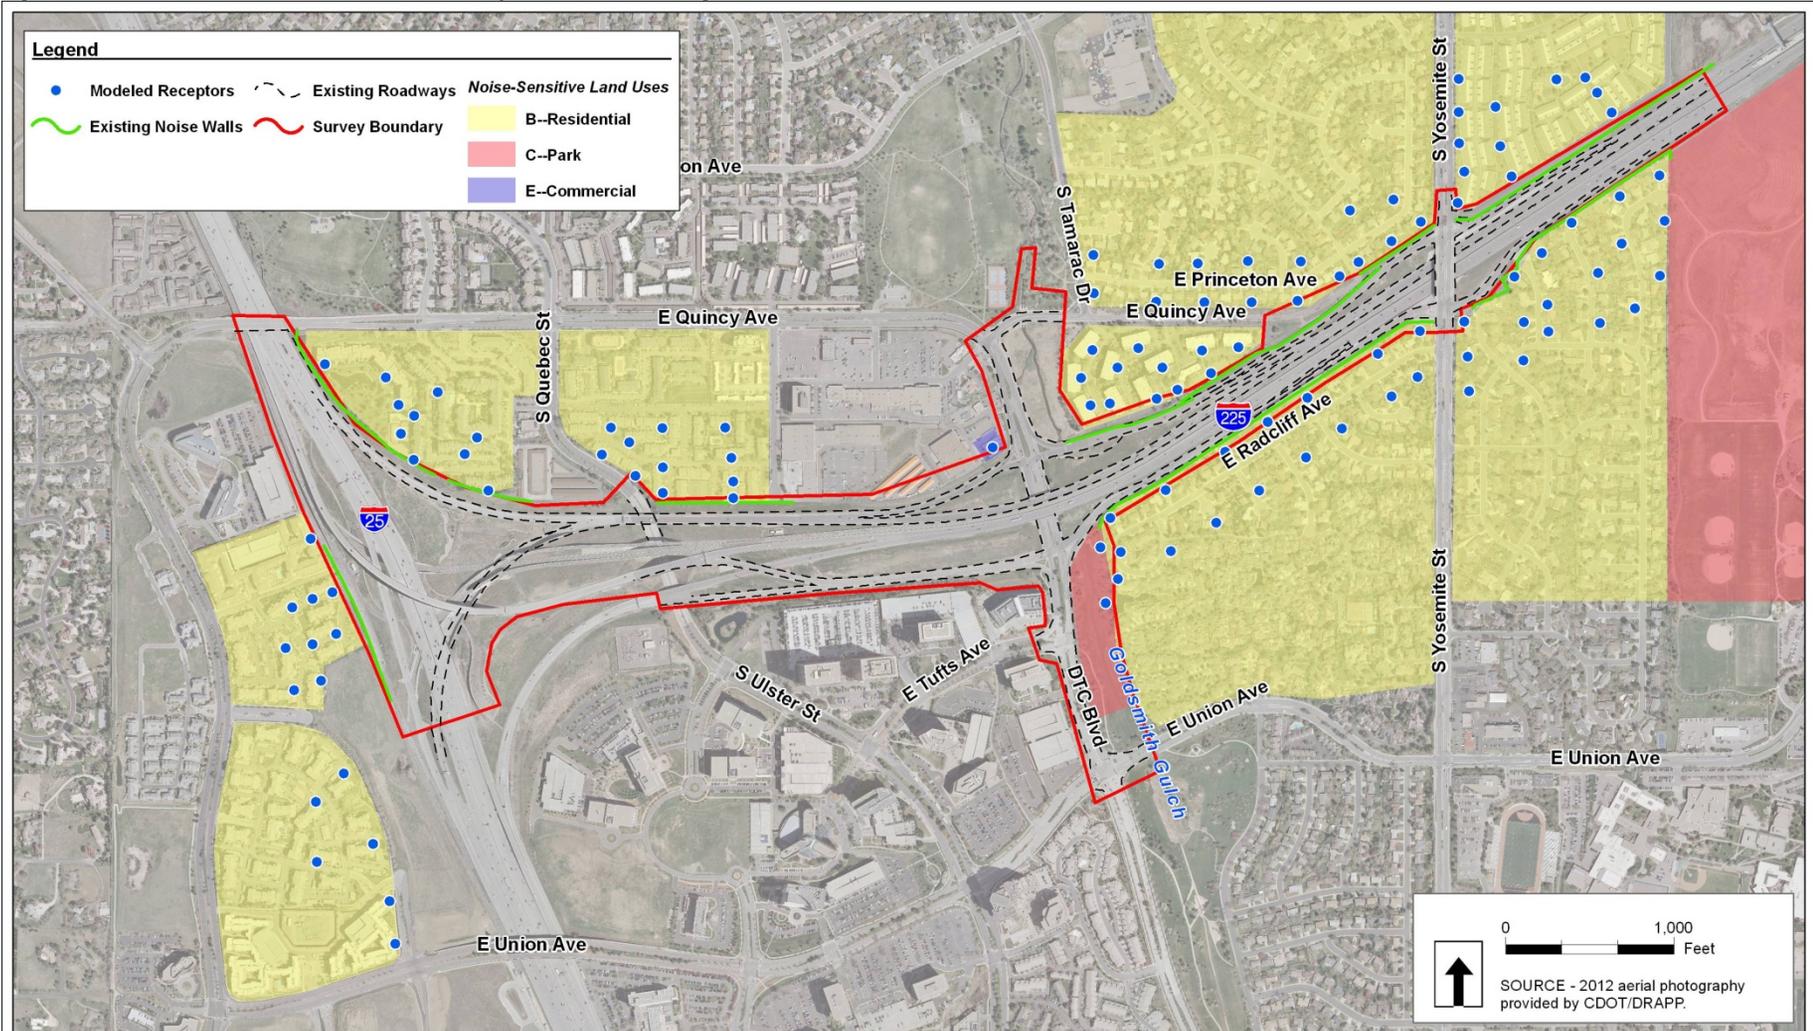
Figure 2. Land Uses, Modeled Receptors and Existing Noise Walls

The modeling was used to calculate traffic noise levels at numerous representative locations throughout the PEL study area (**Figure 2**, located at the end of this technical memorandum). The modeling results represent predicted typical average traffic conditions during peak traffic noise periods for 2012.

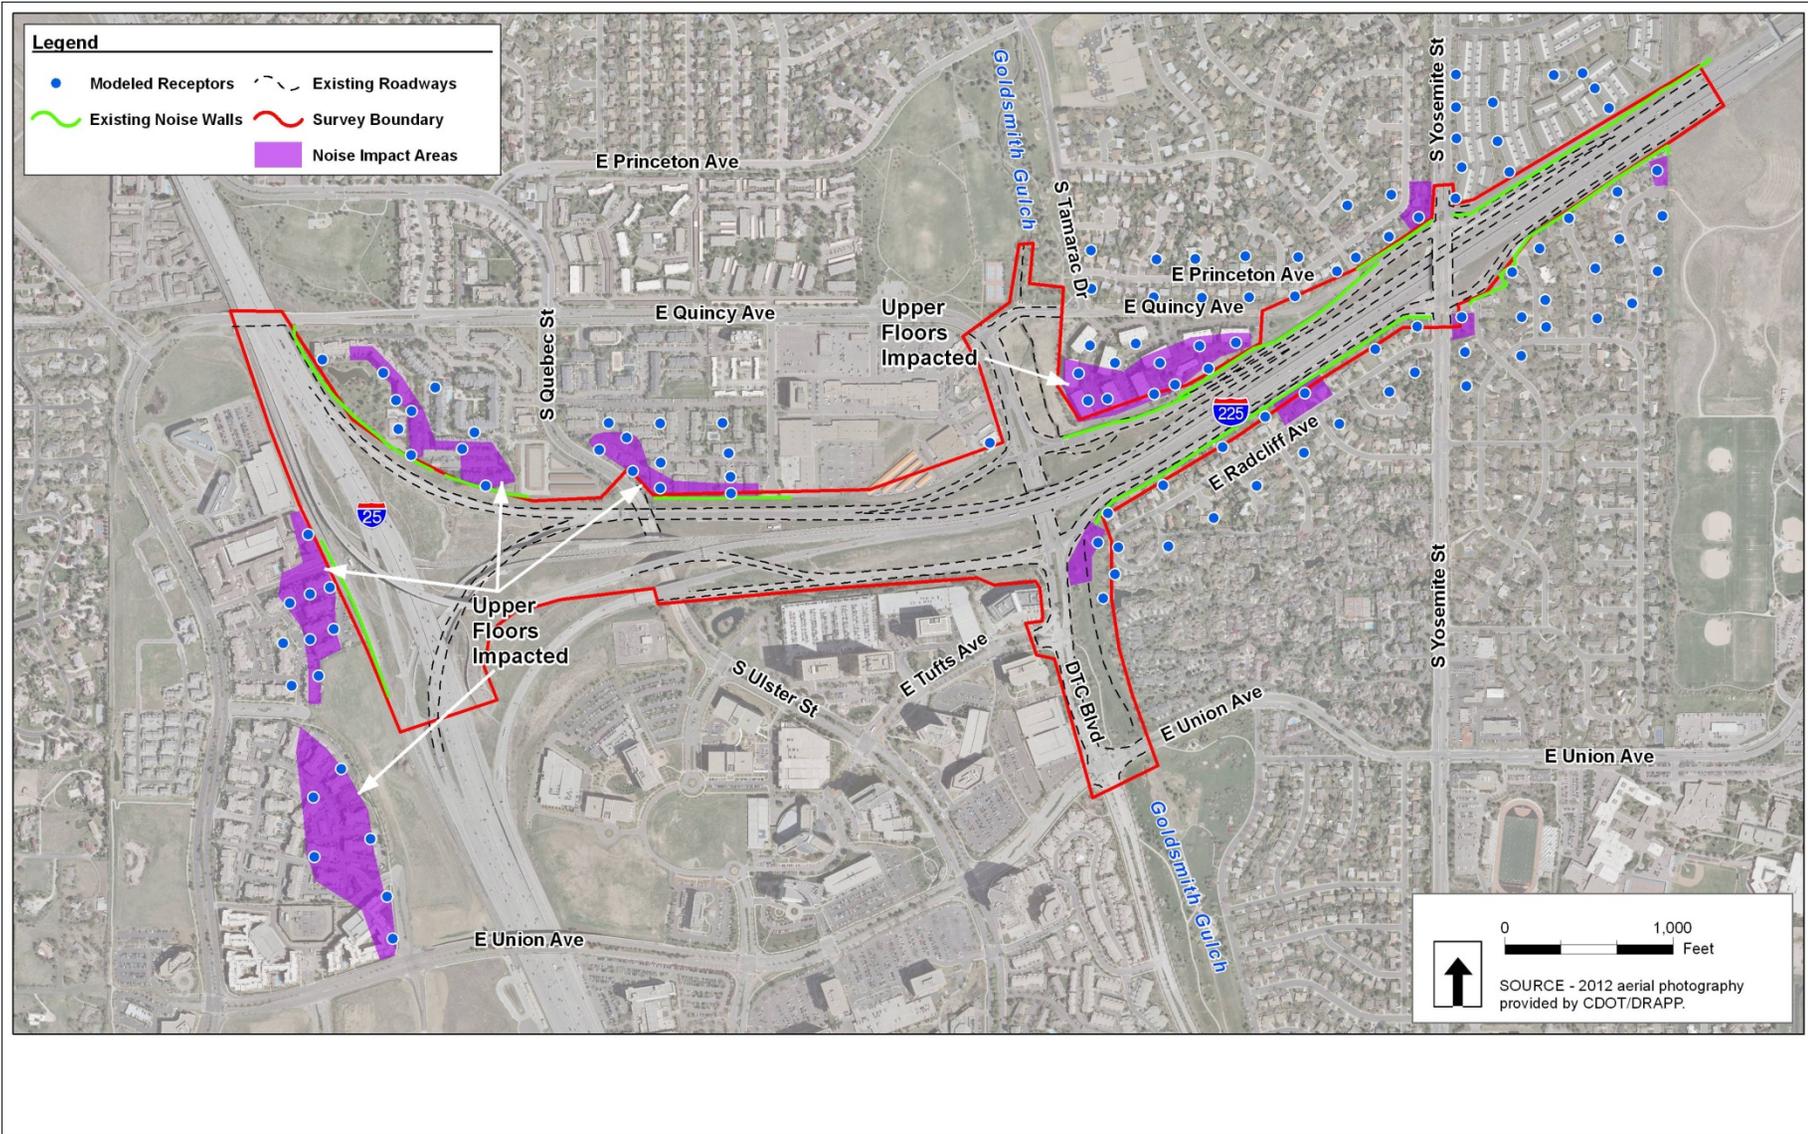
**Figure 3** Noise-Impacted Areas from Noise Model Results

The noise model for current conditions was used to evaluate traffic noise levels within the I-225 PEL study area. The noise-impacted areas are illustrated in **Figure 3**, located at the end of this technical memorandum. Overall, the calculated noise level range at the model points was 52-76 dBA.

Current (2012) traffic noise conditions in the I-225 PEL study area were evaluated through noise modeling. Approximately 475 residential units (**Table 1**) were calculated to have traffic noise levels at or above the Category B NAC (**Figure 3**, located at the end of this technical memorandum), although most of these were on upper floors.

The existing noise walls were installed as mitigation actions by previous projects. The alternatives and improvements examined through the I-225 PEL should seek to avoid these walls. An alternative or improvement that requires the removal of any of these walls will result in the I-225 project needing to replace the affected walls to maintain the mitigation actions of the earlier projects.

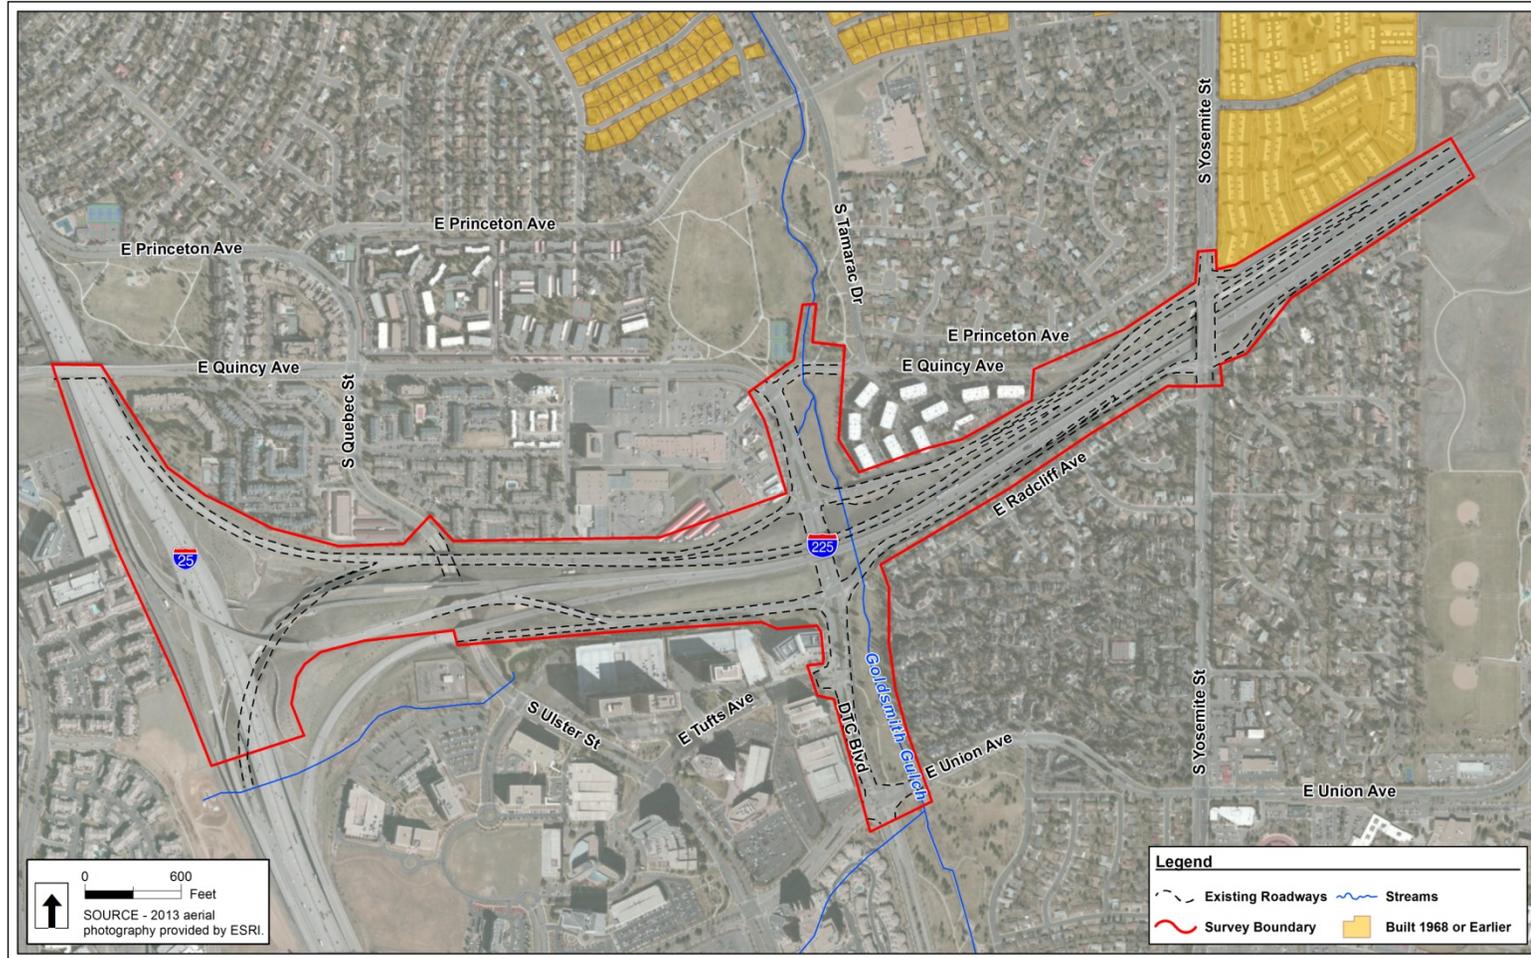
**Figure 2**      **Previously Recorded and Potentially Historic Sites**

Only one site within the APE was found to be at least 45 years old which satisfies the age-eligibility requirement for historic cultural resources. This site is known as the Cherry Creek Townhouses, a residential condominium development, and is located at the northeast corner of Yosemite Street and Oxford Drive at the east end of the study area (**Figure 2**).

The City and County of Denver Assessor's Office showed that the property was developed in 1966, though a field visit revealed that the condominium development does not have the potential for being a historic cultural resource. An initial review of this site suggests that the buildings associated with the Cherry Creek Townhouse development would not be classified as eligible for the NRHP under any of the four eligibility criterion outlined above. These simple residential buildings do not represent any distinctive architectural characteristics, nor do they appear to be associated with events or people of significance in the history of the area or development of the Denver Tech Center.

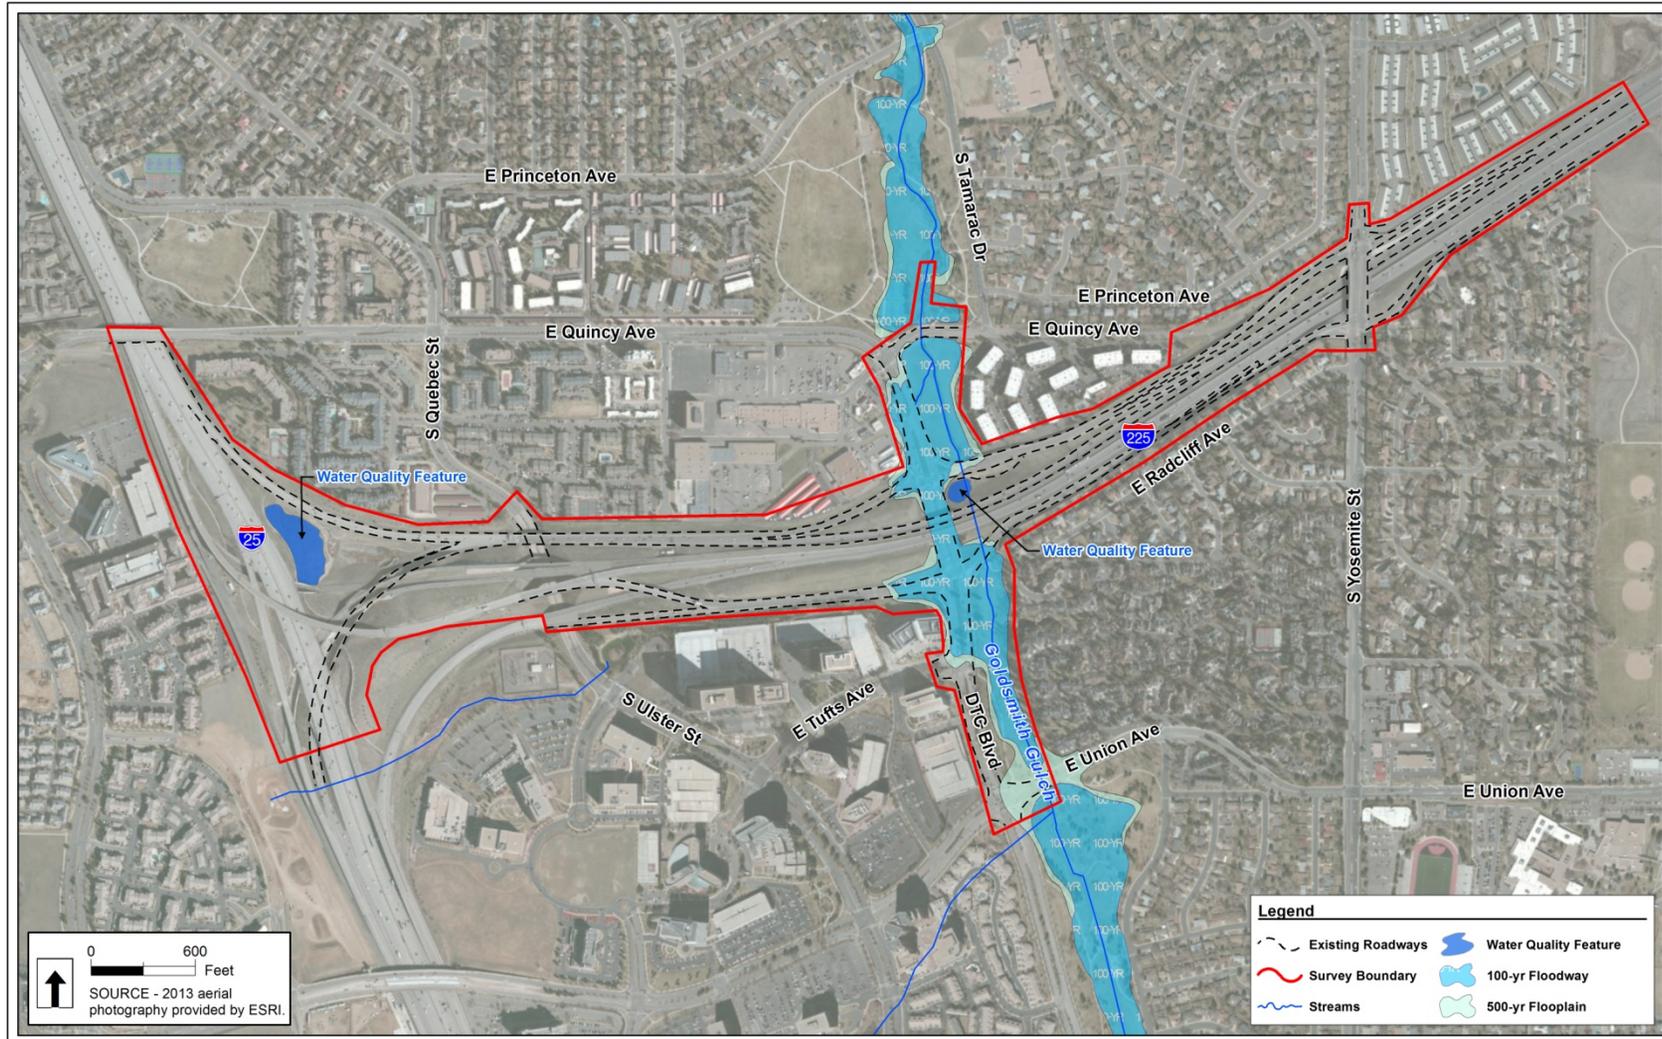
Figure 1. Floodplains and Water Quality Features

Goldsmith Gulch is the only drainageway that has a FEMA designated floodplain in the study area (see **Figure 1**, located at the end of this memorandum). Portions of Goldsmith Gulch flow through open channels while other portions are piped underground, such as under I-225. The gulch is a tributary of Cherry Creek and is mainly used for natural moderation of floods and has limited wildlife usage. FEMA has designated Zones AE and Zone X in the Goldsmith Gulch Floodplain.

Drainageways that have a Zone AE designation, such as Goldsmith Gulch, are sensitive to changes. Relatively small changes that do not result in a net increase of fill may be incorporated in the floodplain without triggering the Conditional Letters of Map Revision (CLOMR)/Letters of Map Revision (LOMR) process; however, floodplain modeling may be required to assess the extent of the impact. If the impacts cause greater than 0.5 foot of rise in the flood elevation, the CLOMR/LOMR process could be required.

If any proposed work is to be done in a water quality feature in the study area, such as Goldsmith Gulch, coordination with the Colorado Water Quality Control Division will be necessary.

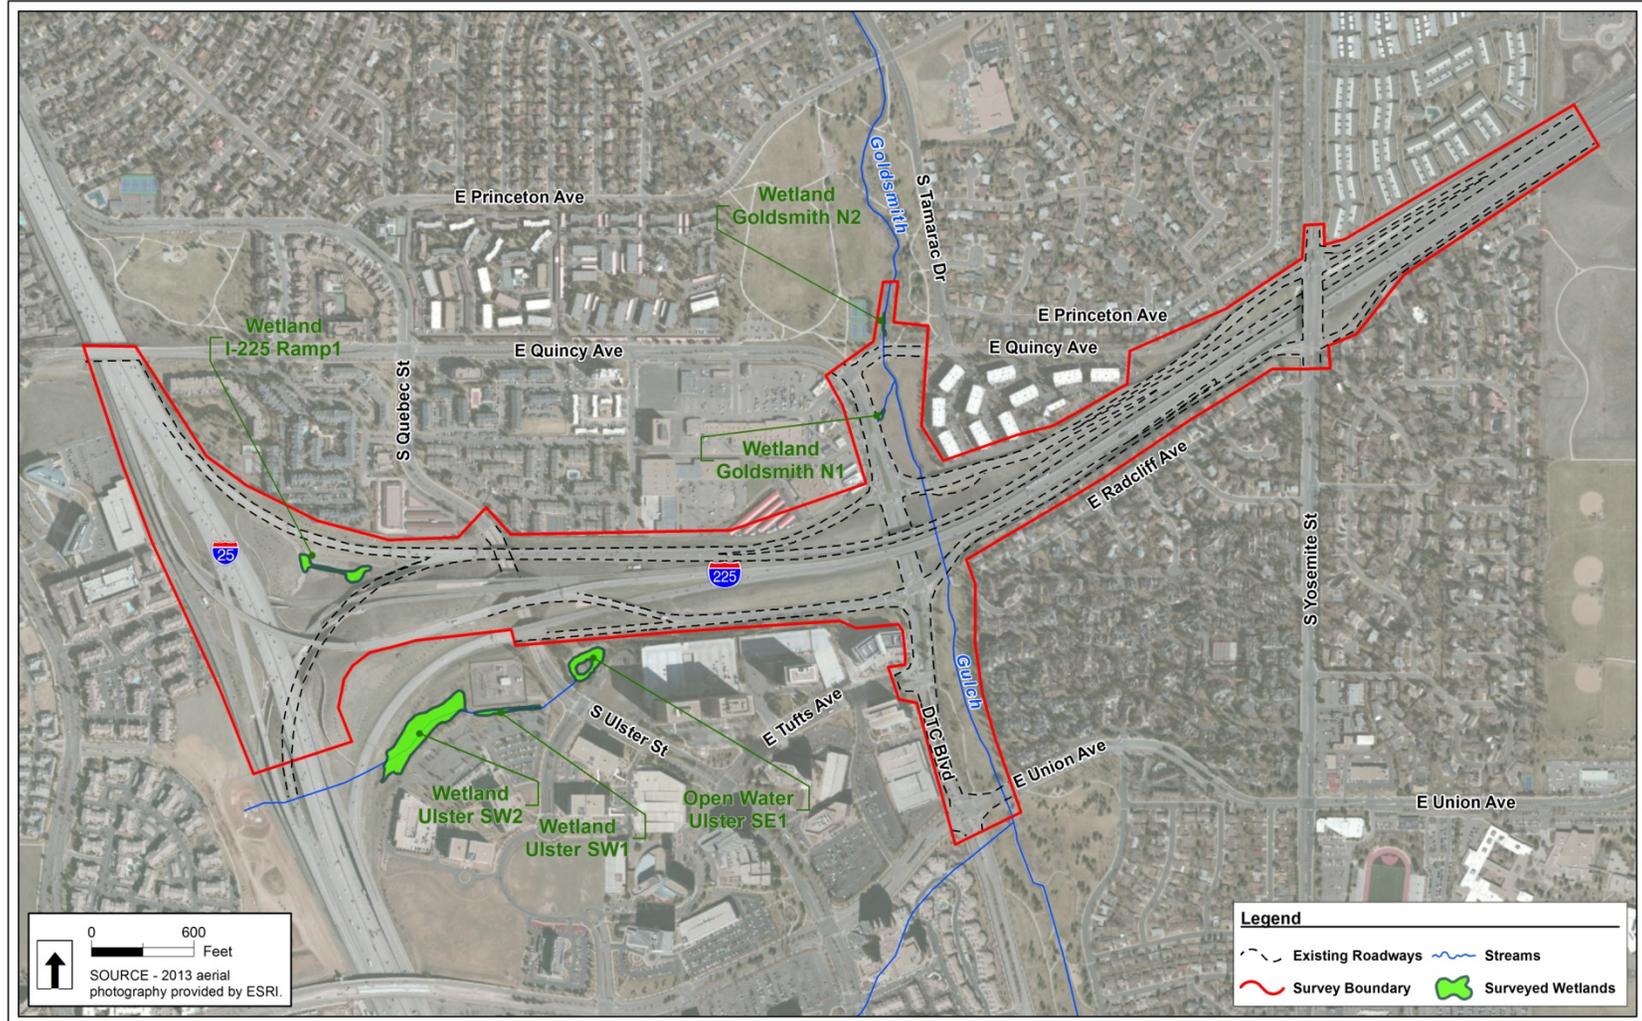
Figure 2. Surveyed Wetlands and Other Waters

All wetlands identified in this field review are shown on **Figure 2** in relation to the study area.

One Black-tailed Prairie Dog (*Cynomys ludovicianus*) colony is located at Goldsmith Gulch North Middle Park, north of I-225 along DTC Boulevard (found on **Figure 2**, around Wetland N1). Black-tailed Prairie Dogs inhabit short and mid-grass prairie and semi-desert shrublands. The extents of the Black-tailed

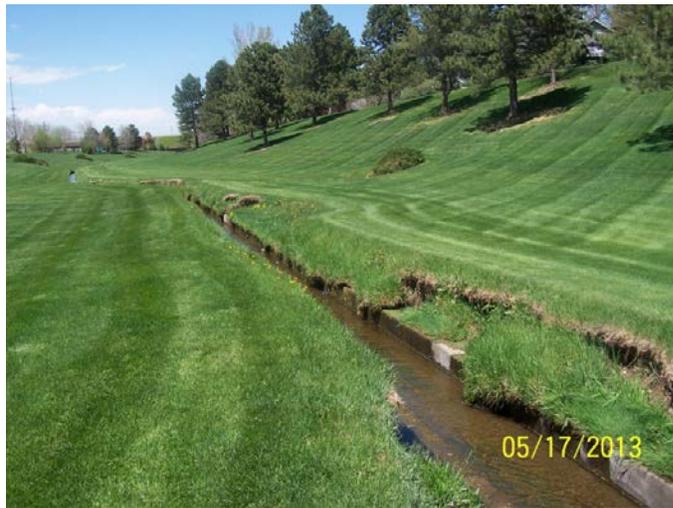
Photograph looking north towards the I-225/DTC Boulevard Interchange. This is a picture of the highly channelized Goldsmith Gulch showing the concrete bottom and banks. No wetlands were found in this area and this is a highly managed park with no wildlife habitat.

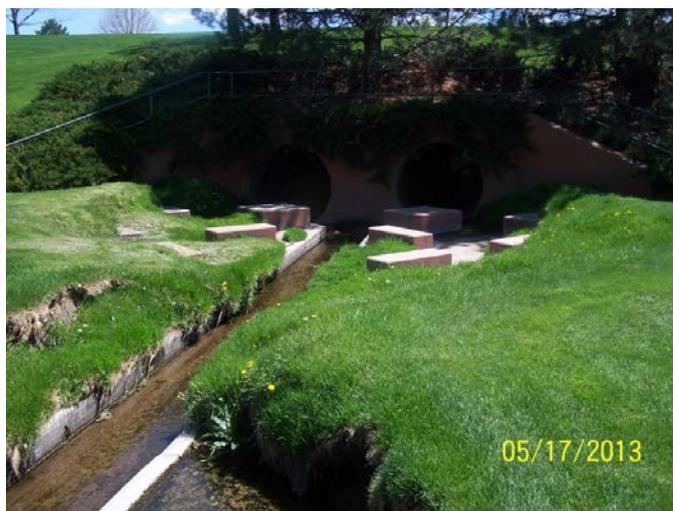
Photograph looking south at the culverts under Ulster Street for Goldsmith Gulch. This entire area is managed as a park and the channel and banks are concrete, no wetlands present.

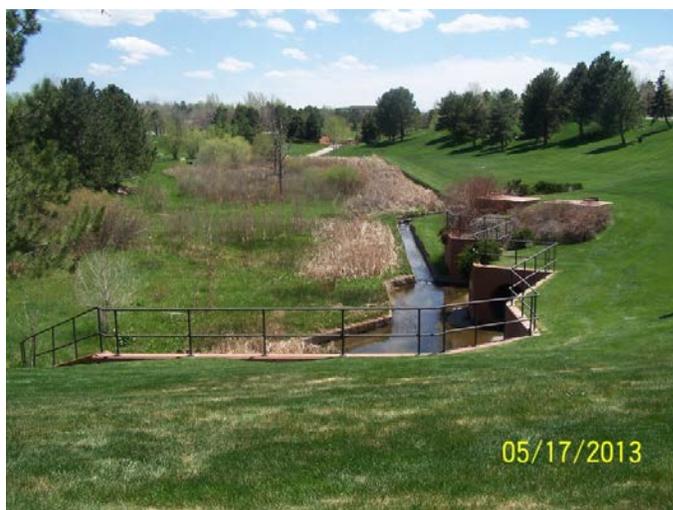
Photograph taken south of Ulster Street of the only natural area with wetlands on Goldsmith Gulch. However, this area is south of the study area.

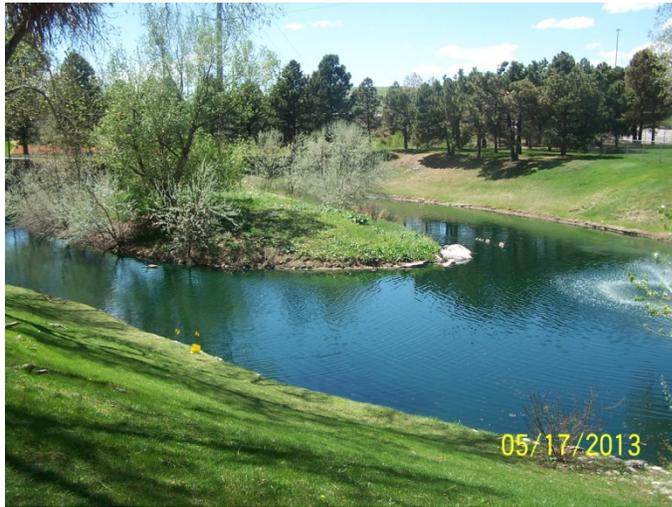
Photograph of the stormwater pond east of Ulster Street and south of I-225. Very little to no wetland vegetation surrounds this pond, possibly due to management or wildlife removing it.

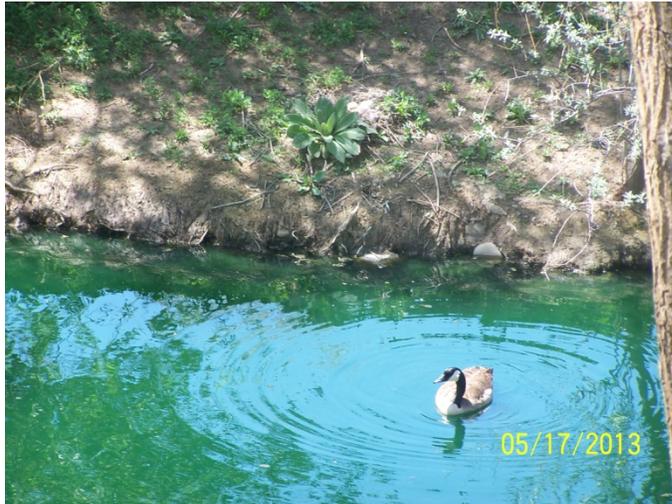
Photograph of Canada Goose nest on the island in the middle of the stormwater pond.

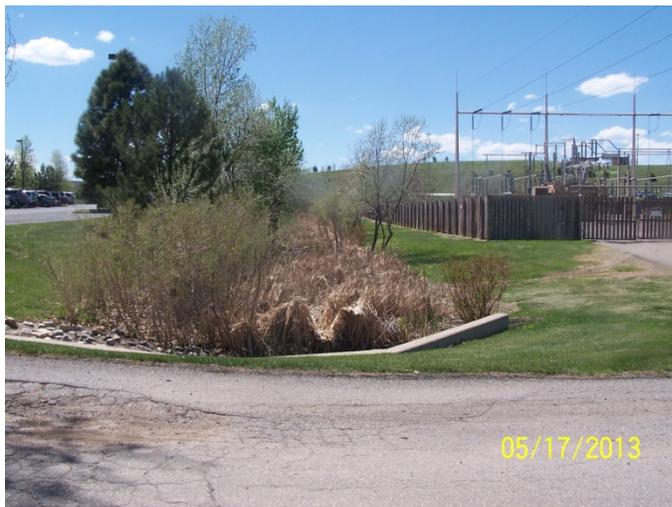
Photograph west of Ulster Street and south of I-225 where there is an electrical substation and a cattail wetland. However, this is south of the study area.

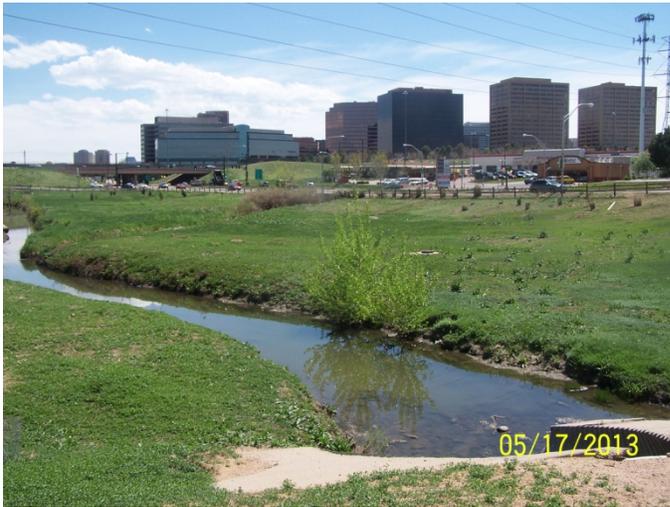
Photograph looking south from E. Quincy Avenue towards I-225 and the DTC Boulevard interchange. The only area with prairie dogs, east of DTC Boulevard and a narrow storm drain channel in the background with sandbar willows. No wetlands were present on either side of the main Goldsmith Gulch channel here.

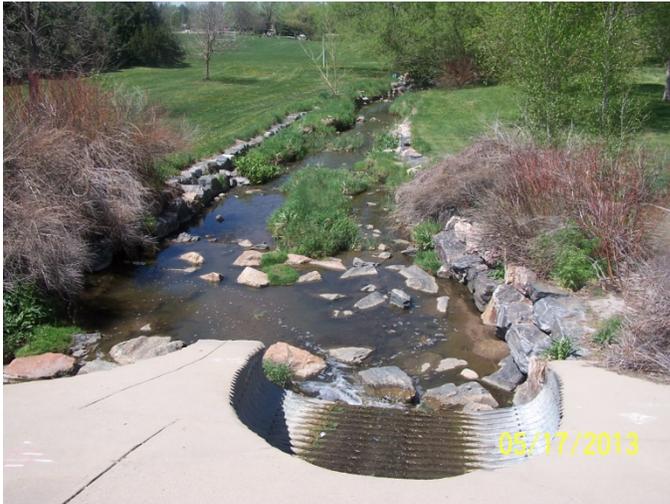
Photograph looking north from E. Quincy Avenue into the nearby park where Goldsmith Gulch crosses E. Quincy Avenue. Fringe wetlands are present in the channel and along the west bank. However, most of the channel is lined with riprap and devoid of wetland vegetation due to park management activities.

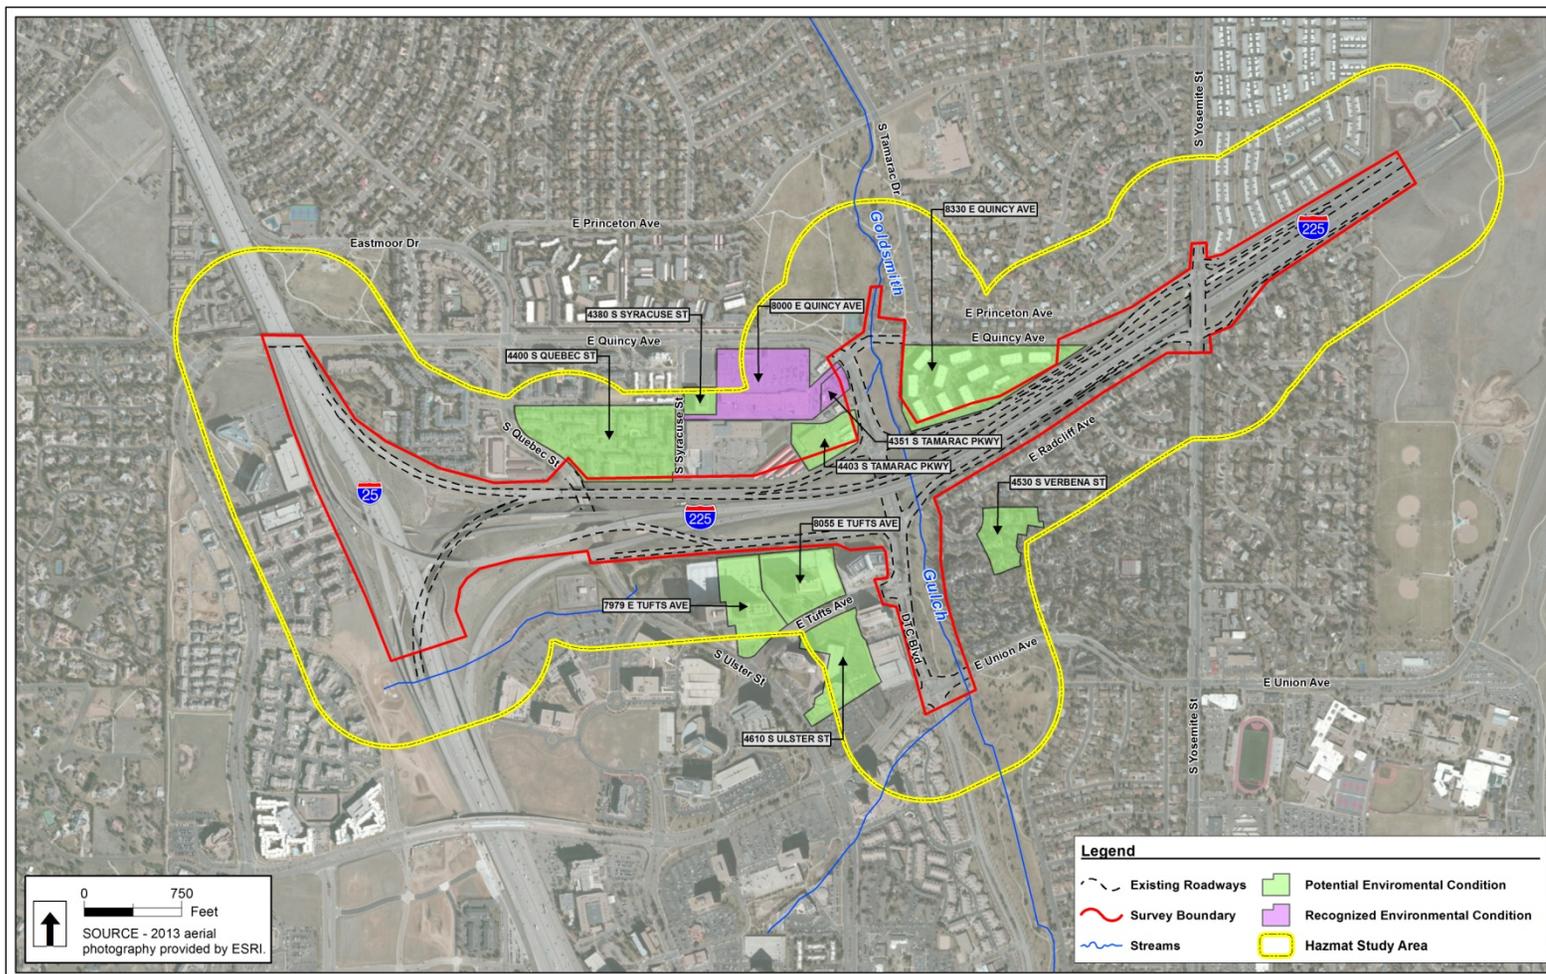
Figure 2. Sites Adjacent to and/or within 1/8 mile of the Project Footprint

An environmental database search was conducted for sites extending up to one mile from the study area with potential hazardous materials concerns. **Table 2 and Figure 2** include sites adjacent to and/or within 1/8 mile (660 feet) of the study area.

Site Address	Location/Gradient	Site Description
4351 S. Tamarac Pkwy.	Adjacent/Down-gradient	Closed LUST (Closed); Open 7-11 Gasoline Station with operating USTs. Site identified as a recognized environmental condition due to closed LUST. If ground-disturbing activities are expected to occur in the vicinity of this site, residual soil and/or groundwater contamination could be present.
8000 E. Quincy Ave.	Adjacent/Down-gradient	Closed LUST; Dry Cleaners/Historical Dry Cleaners; Open Coloradoland Tire & Service Auto Repair Shop; Monitoring well located on the south side of building. Site with recognized environmental conditions due to closed LUST and historical dry cleaning operations.
4403 S. Tamarac Pkwy	Adjacent/Down-gradient	Dry Cleaners/Historical Dry Cleaners; Open dry cleaning business - DTC Cleaners. Site identified as a potential environmental condition due to historic dry cleaning operations. It is unknown if any spills/releases have occurred at this site in the past. Based on the history of this site as a historical dry cleaner facility, any work within the vicinity of the site should be closely monitored for signs of soil and/or groundwater contamination during construction activities.

4400 S. Quebec St.	Adjacent/Up-gradient	Historical Auto; Currently the Brandy Chase Apartment Home Complex. Site identified as a potential environmental condition due to historic auto operations. It is unknown if any spills/releases have occurred at this site in the past. Based on the history of this site as a historical auto facility, any work within the vicinity of the site should be closely monitored for signs of soil and/or groundwater contamination during construction activities.
8330 E. Quincy St.	Adjacent/Up-gradient	Historical Auto; Currently a public storage unit complex. Site identified as a potential environmental condition due to historic auto operations. It is unknown if any spills/releases have occurred at this site in the past. Based on the history of this site as a historical auto facility, any work within the vicinity of the site should be closely monitored for signs of soil and/or groundwater contamination during construction activities. Also, as a storage unit, the potential exists for methamphetamine lab activity.

4380 S. Syracuse St.	Approximately 500 feet from project footprint/Up-gradient	Historical Auto; Currently the Westgold Centre Office Building (brick, multi-story). Site identified as a potential environmental condition due to historic auto operations. It is unknown if any spills/releases have occurred at this site in the past. Based on the history of this site as a historical auto

8055 E. Tufts Ave.	Adjacent/Up-gradient	Historical Auto; Currently the Stanford Place Office Building (glass, multi-story). Site identified as a potential environmental condition due to historic auto operations. It is unknown if any spills/releases have occurred at this site in the past. Based on the history of this site as a historical auto facility, any work within the vicinity of the site should be closely monitored for signs of soil and/or groundwater contamination during construction activities.
4610 S. Ulster St.	Approximately 325 feet from project footprint/Up-gradient	Historical Auto; Currently an office Building (multi-story) Site identified as a potential environmental condition due to historic auto operations. It is unknown if any spills/releases have occurred at this site in the past. Based on the history of this site as a historical auto facility, any work within the vicinity of the site should be closely monitored for signs of soil and/or groundwater contamination during construction activities.

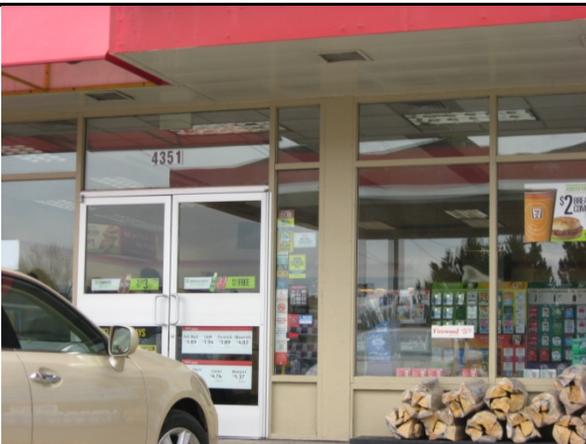
<p>4351 S. Tamarac Pkwy. Closed LUST (Closed); Open 7-11</p>

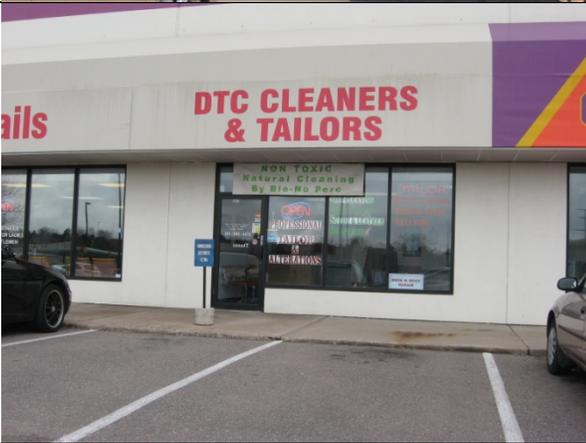
<p>4403 S. Tamarac Pkwy Dry Cleaners/Historical Dry Cleaners; Open dry cleaning business - DTC Cleaners.</p>

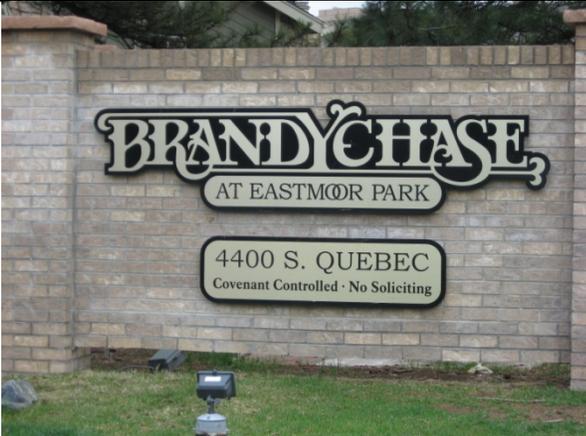
<p>4400 S. Quebec St. Historical Auto; Currently the Brandy Chase Apartment Home Complex.</p>

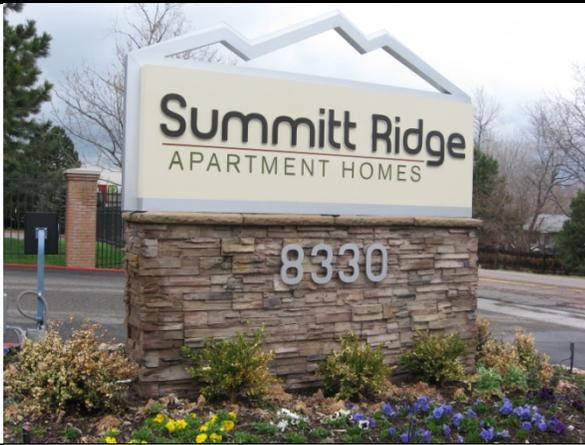
8330 E. Quincy St.  
Historical Auto; Currently  
the Summit Ridge  
Apartment Home Complex.

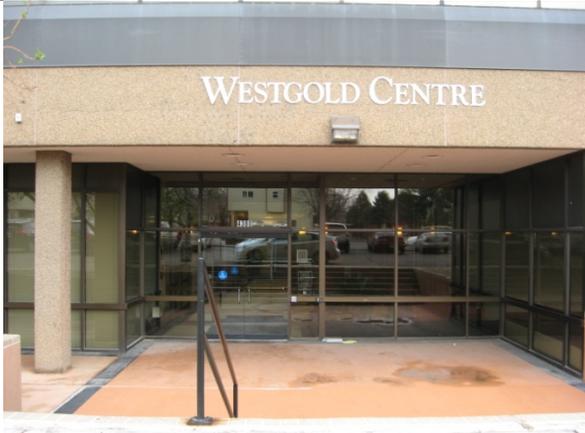
4380 S. Syracuse St.  
Historical Auto; Currently  
the Westgold Centre Office  
Building (brick, multi-story).

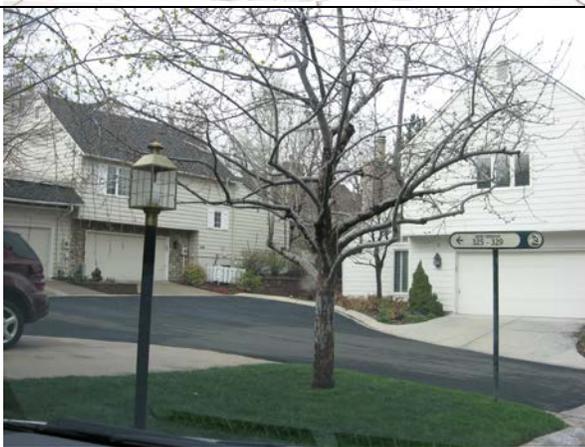
4530 S. Verbena St.  
Historical Cleaners;  
Currently multi-unit  
residences/Large parcel w/  
multiple patio homes.

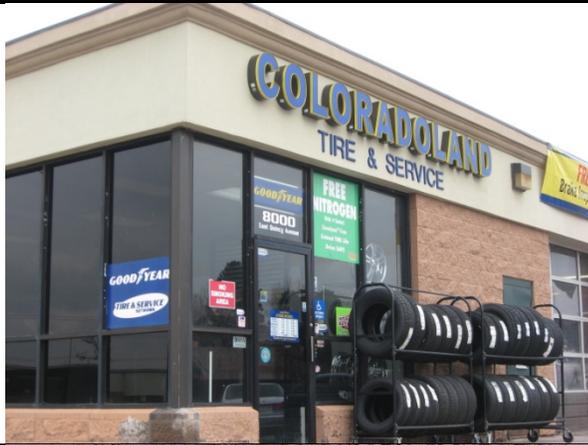
<p><b>Chemical Handling/Storage</b></p>	<p>Automotive service station (Coloradoland Tire &amp; Service at 8000 E. Quincy Ave.) with vehicle maintenance bays. Unknown material handling and disposal practices. Potential materials include: fuel, motor oils, hydraulic fluids, degreasers, paints, and solvents. Former leaking underground storage tank (LUST) site. A 55-gallon drum was observed at the restaurant adjacent to 8000 E. Quincy Ave. The contents are unknown.</p> <p>Two open dry cleaning operations (4403 S. Tamarac Pkwy and 4680 S. Yosemite St.) with unknown cleaner and solvent handling and disposal practices. No reported contamination of soil and groundwater associated with this site.</p>
<p><b>Potential for Methamphetamine Lab Activity</b></p>	<p>Storage Units. Although not reported, the potential exists for methamphetamine lab activity.</p>

8000 E. Quincy Ave.  
Closed LUST; Dry  
Cleaners/Historical Dry  
Cleaners; Open  
ColoradoLand Tire & Service  
Auto Repair Shop;  
Monitoring well located on  
the south side of building.

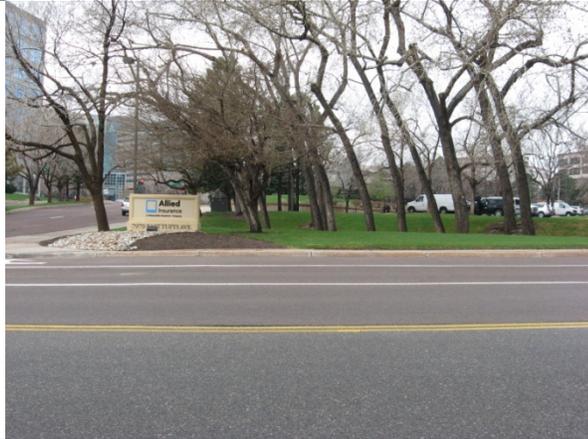
7979 E. Tufts Ave.  
UST, Aboveground storage  
tank (AST); Currently the  
Allied Insurance Office  
Building (brick, multi-story,  
w/fenced in generator)

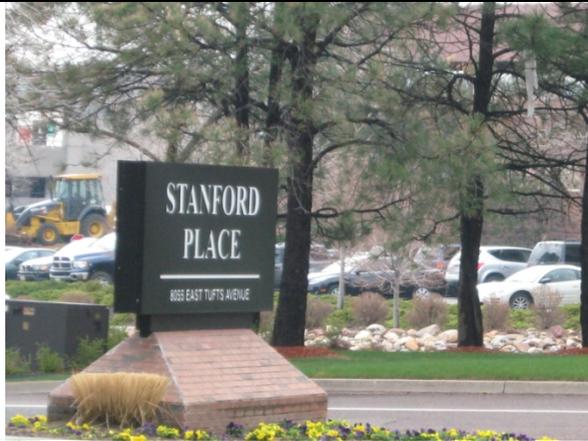
8055 E. Tufts Ave.  
Historical Auto; Currently  
the Stanford Place Office  
Building (glass, multi-story)

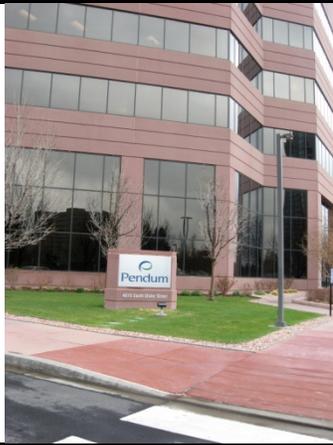
4610 S. Ulster St.  
Historical Auto; Currently  
an office Building (multi-  
story)
