**ENVIRONMENTAL ANALYSIS AND
EXISTING CONDITIONS ASSESSMENT REPORT
FOR
INTERSTATE HIGHWAY 225 (I-225)
PLANNING AND ENVIRONMENTAL LINKAGES (PEL) STUDY**

CDOT Project No. STA 2254-085 (19187)

**Colorado Department of Transportation
Region 1
2000 South Holly Street
Denver, CO 80222**

November 2013

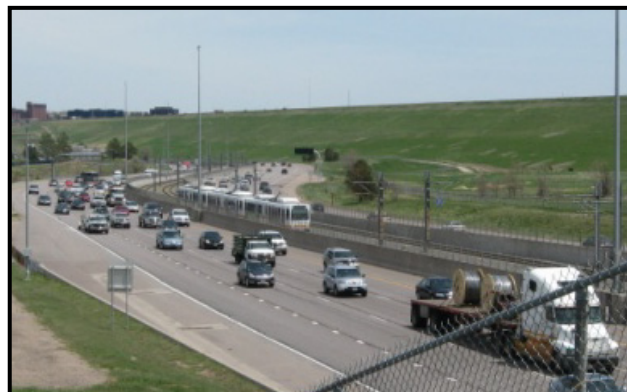
Figure 3.2 Southbound I-225 East of Yosemite

The interstate highway, ramps, and C-D roads are characterized by general purpose and auxiliary lanes and paved shoulders, whereas DTC/Tamarac and Yosemite are delineated by general purpose lanes, turn lanes, vertical curb and gutter inside and outside the roadway, and limited shoulders. **Table 3.1** describes information for I-225, associated ramps, and C-D roads.

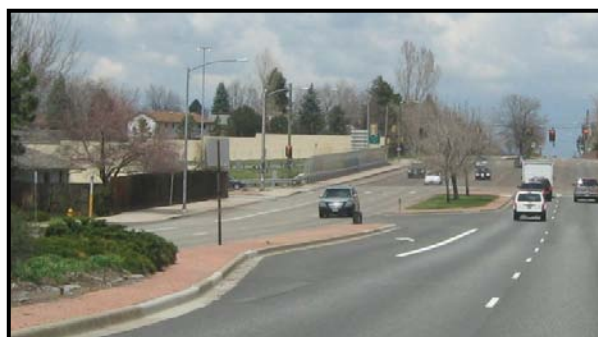
Figure 3.3 Raised Median on Yosemite, South of I-225

There are two general purpose lanes in each direction with right-turn lanes south of the northbound ramp intersection. North of the southbound ramp intersection, there are three general purpose lanes in each direction with the southbound outside lane transitioning to a right-turn lane at the ramp intersection. Across the Yosemite Bridge over I-225, there are two general purpose lanes in each direction and a full length single left-turn lane in each direction. Yosemite has vertical curb and gutter along the inside and outside of the roadway within the project limits. There are wider than 12-foot shoulders on each side of the bridge. Along Yosemite Street, bike lanes are provided. **Section 3.6** describes bicycle facilities in detail.

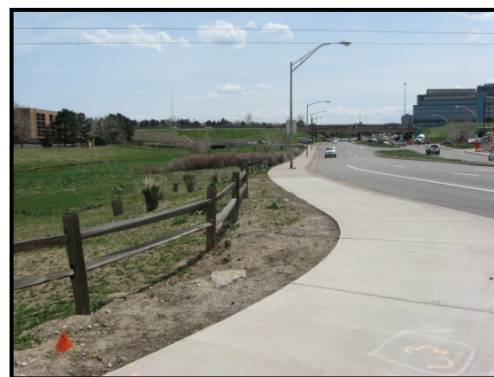
Figure 3.4 8-foot Sidewalks Along Tamarac

Location	Description
DTC/Tamarac	
North Side of I-225	8-foot sidewalks, segment of 5-foot sidewalk on southbound side approaching ramp intersection
Under I-225	8-foot sidewalks under bridge
South Side of I-225	8-foot sidewalks
Yosemite	
North Side of I-225	8-foot sidewalks
Over I-225	8-foot sidewalks
South Side of I-225	8-foot minimum sidewalks

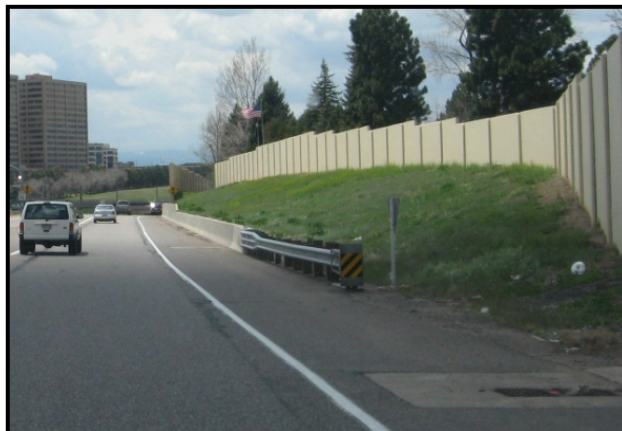
Figure 3.5 Guardrail Along Southbound C-D Road

Both Type 3 and Type 7 guardrails are provided along I-225 to protect obstacles such as signs, bridges, and walls. The Type 3 guardrail is the metal W-beam guardrail set on wood or metal posts whereas the Type 7 guardrail is a concrete barrier, both types are shown in **Figure 3.5**. A barrier within the median of I-225 for the entire stretch from Parker Road to I-25 protects the LRT corridor. Yosemite has a Type 3 guardrail across the I-225 Bridge. DTC/Tamarac does not provide any guardrail. The study area contains many gores that provide a triangular zone of lanes splitting or merging that allow drivers to match the speed of through traffic. **Table 3.4** identifies the segments of guardrail that have been located and quantified.

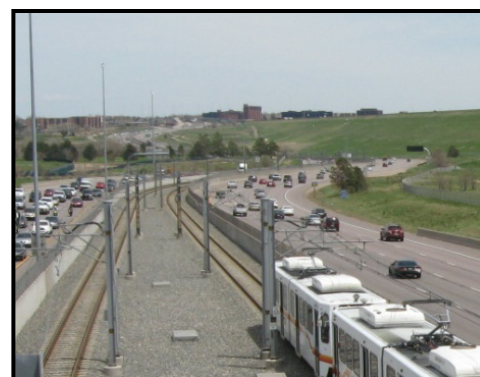
Figure 3.6 Fence Along LRT

Roadway Section	Fence Type
I-225	
Southbound Mainline	RTD fence atop ballast walls, Chain link fence
Southbound I-225 Yosemite Exit Ramp	None
Southbound C-D Road	Chain link fence
Southbound I-225 DTC/Tamarac Entrance Ramp	Chain link fence
Southbound I-225 to Northbound I-25	Chain link fence
Southbound I-225 to Southbound I-25	RTD fence around LRT substation and along LRT, steel fence on top of retaining walls adjacent to roadway and drainage areas
Northbound C-D Road	None

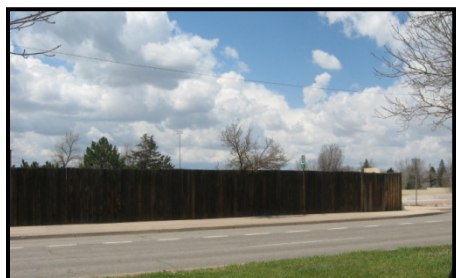
Figure 3.7 Privacy Fence Along Yosemite

Roadway Section	Fence Type
Local Roads	
DTC	None
Tamarac	Chain link fence (portion on east side for drainage), split rail fence
Yosemite	Wood fence on west side

Southbound I-225 contains significant lengths of chain link fence. In addition to the fencing along the highway, several types of fencing are located on private property, adjacent to the project. All fences on the local roads are located behind sidewalk or curb and gutter and offset from the roadway.

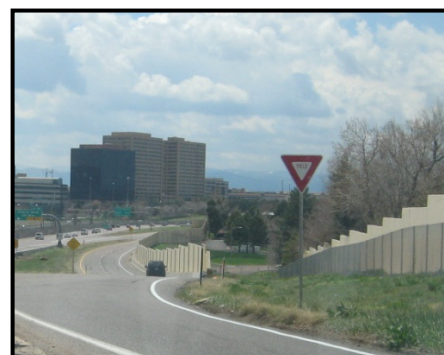
Figure 3.8 Sound Walls Along Southbound C-D Road

There are significant lengths of noise walls along this section of I-225 and adjacent to the local roads such as Yosemite. **Section 5.2** discusses in detail the located noise walls along I-225. Some lengths of retaining wall are a significant height. Some of the walls identified in **Table 3.6** are associated with drainage and landscaping and may not be structural.

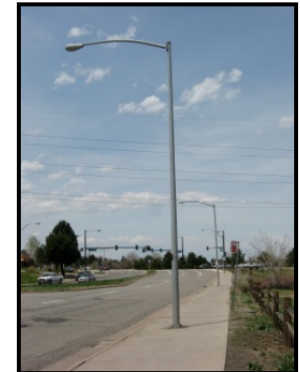
Figure 3.9 Standard Lighting Along Tamarac

I-225 is continuously lit throughout the study area by high mast lighting in the median and at the interchanges. While the Yosemite Interchange does not appear to specifically have high mast interchange lighting, it seems the interchange is lit through the I-225 median lighting and supplemental street lighting.

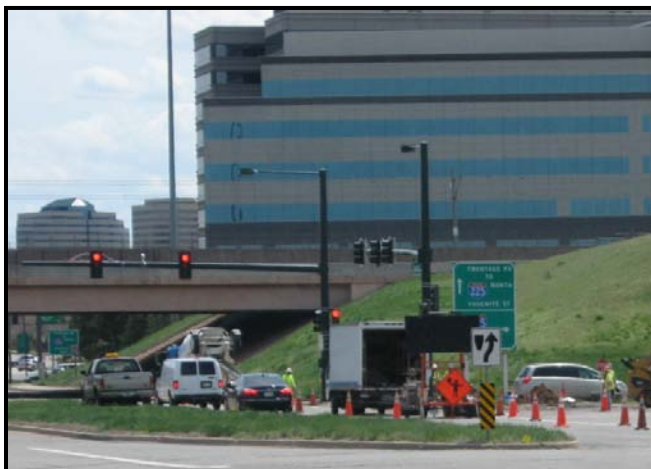
Figure 3.10 New Mast Arm Signals at DTC/Tamarac & I-225

The study area contains traffic signals and ramp meters. **Table 3.8** identifies the location and signal types. The span wire signal poles at DTC/Tamarac and the northbound and southbound ramps had shown signs of rust and corrosion. These were recently replaced with mast arm signals in spring 2013. Lights are located on each signal pole. **Figure 3.10** shows these locations.

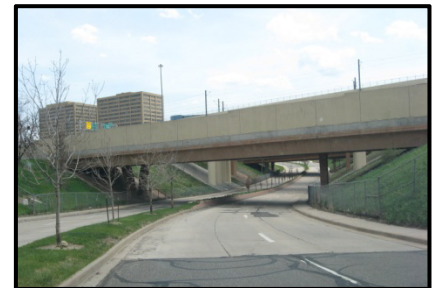
Figure 3.11 Southbound I-225 over Quebec

Structure ID	Milepost	Description
Southbound I-225		
F-17-GM	1.842	Future roadway bridge over I-225 – Used as pedestrian bridge
F-17-OI	1.802	Dayton Station LRT Pedestrian Bridge over I-225
F-17-GL	1.333	Yosemite over I-225
F-17-GQ	0.785	Southbound I-225 over DTC/Tamarac
F-17-ES	0.859	Goldsmith Gulch Culvert under I-225, east of DTC/Tamarac
F-17-OF	0.382	Southbound I-25 ramp tunnel
F-17-FU	0.325	Southbound I-225 over Quebec

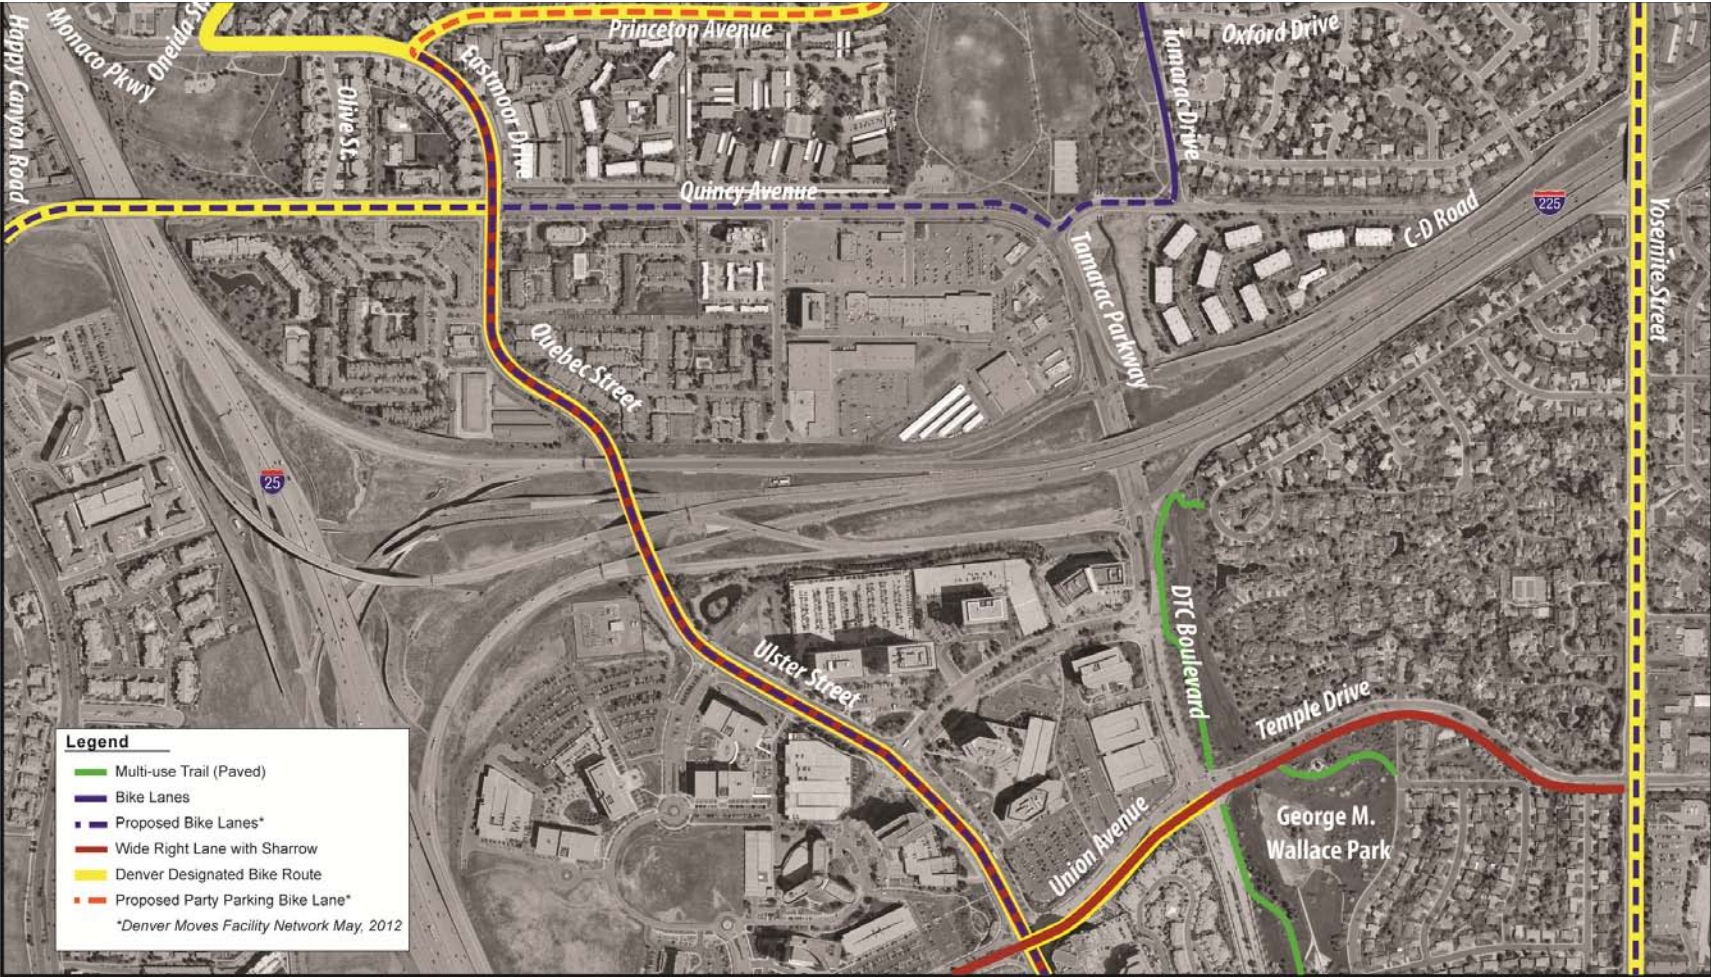
Figure 3.16 Study Area Bicycle Services

The area contains a few designated bike routes. Ulster Street and its name changes (Quebec Street, Eastmoor Drive, Princeton Avenue, and Monaco Parkway) are designated as bike routes, as is Yosemite Street. Other bike routes include Union Avenue, west of DTC Boulevard; Quincy Avenue, west of Eastmoor Drive; Oneida Street, north of Princeton Avenue; and Princeton Avenue, east of Eastmoor Drive. While these streets are designated bike routes, physical bike infrastructure is not present unless otherwise noted. **Figure 3.16** shows existing bicycle facilities in the study area.

The City and County of Denver’s bike plan, *Denver Moves – Making Bicycle and Multi-Use Connections*, identifies a few bicycle improvements for the study area. It lists bike lanes along Ulster Street/Quebec Street/Eastmoor Drive from Princeton Avenue to the south (2011). It also identifies future bike lanes for Quincy Avenue from the western boundary of the study area to the northern segment of Tamarac Drive, and along Yosemite Street for its entirety within the study area. A “party parking bike lane” is listed for Princeton Avenue from Eastmoor Drive to the northern boundary of the study area, which involves on-street parking that is wide enough and often void of parked vehicles so that it typically operates like a de-facto bike lane. **Figure 3.16** also shows planned bicycle facilities in the study area.

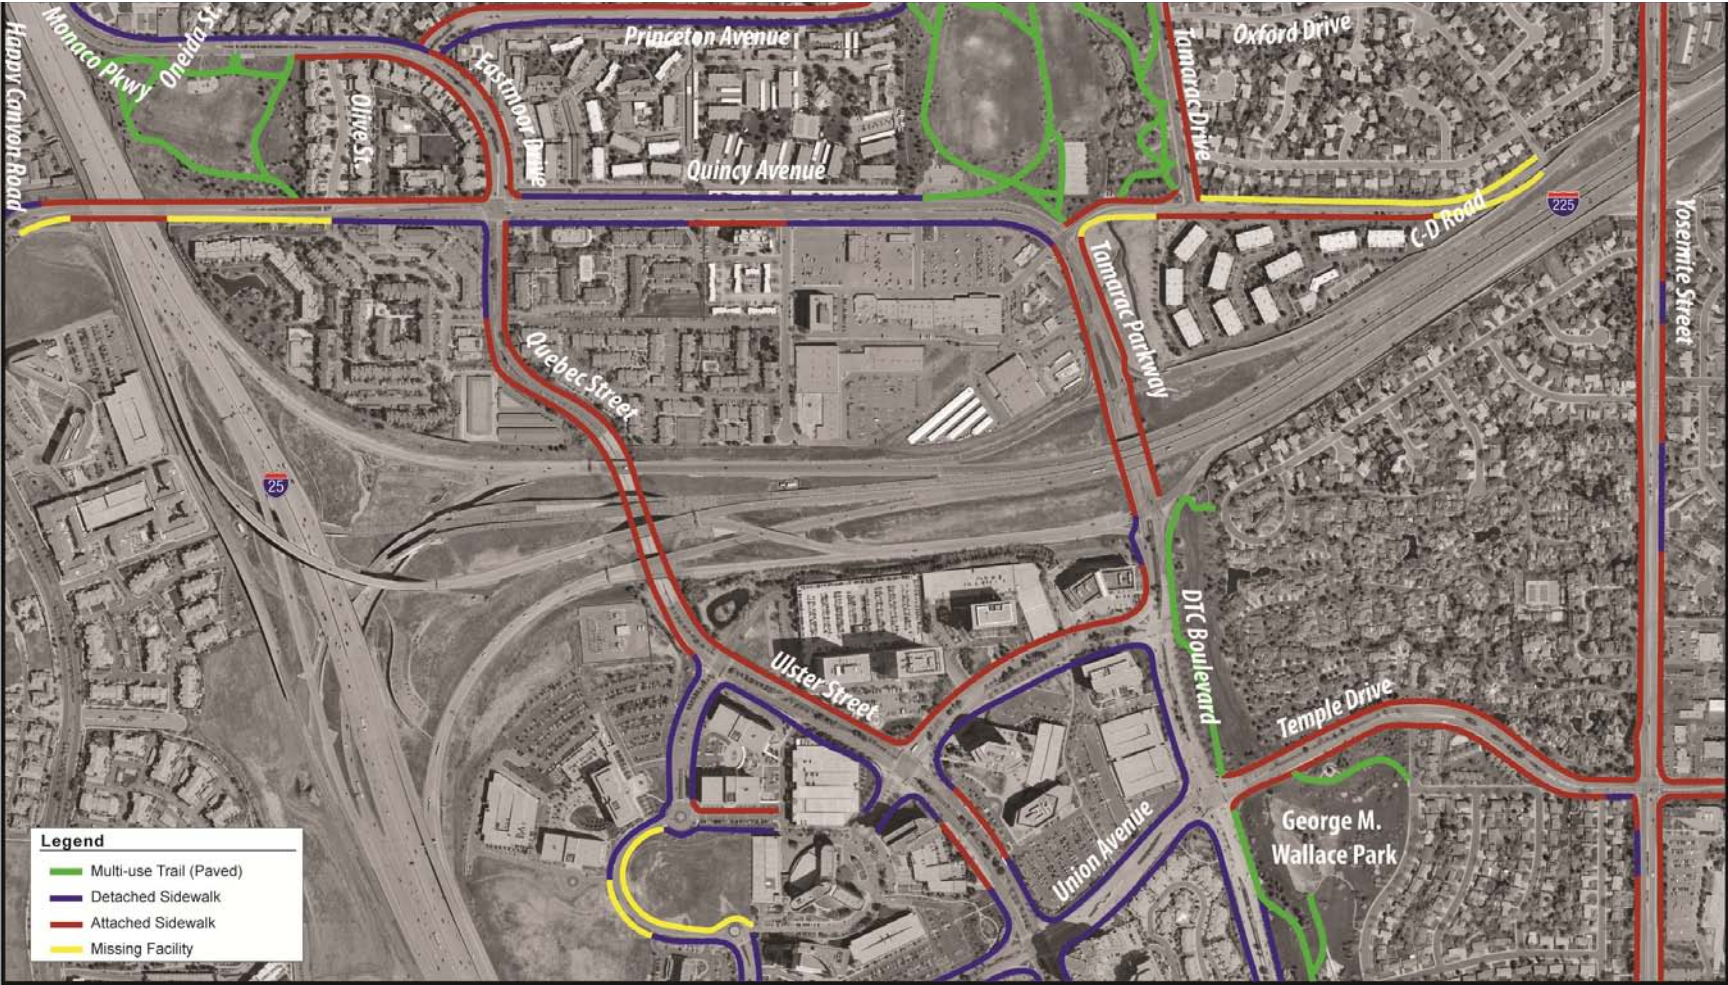
Figure 3.17 Study Area Pedestrian Services

Most roads in the study area have pedestrian facilities on both sides of the road, but a few segments are missing a sidewalk, see **Figure 3.17**. A segment along the south side of Quincy Avenue from Happy Canyon Road to the end of Olive Street is missing a sidewalk, with the exception of the bridge crossing of I-25. Again, Quincy Avenue is missing sidewalks on the south side between the jog of northern Tamarac Drive and southern Tamarac Parkway, along the north side from the northern leg of Tamarac Drive to where Quincy Avenue ends, and along a short section of the I-225 C-D road sound wall.

Existing sidewalks in DTC are frequently detached, as are sidewalks along Quincy Avenue between Eastmoor Drive and Tamarac Parkway. However, most sidewalks in the remainder of the study area are attached. Many paths exist along and within the three parks that fall within this area. Sidewalks south of I-225 are typically newer and wider, while those north of the highway are older and narrower. **Figure 3.17** shows the current conditions at intersections in the study area.

Pedestrian facilities at intersections in the study area vary per intersection. This is primarily to suit the uniqueness of each intersection environment. Most intersections in the study area are well programmed for pedestrians, but some common amenities that improve use for pedestrians (including American with Disabilities Act [ADA] programming) are lacking in some instances. **Table 3.17** lists the current conditions at intersections in the study area, including existing amenities and deficiencies.

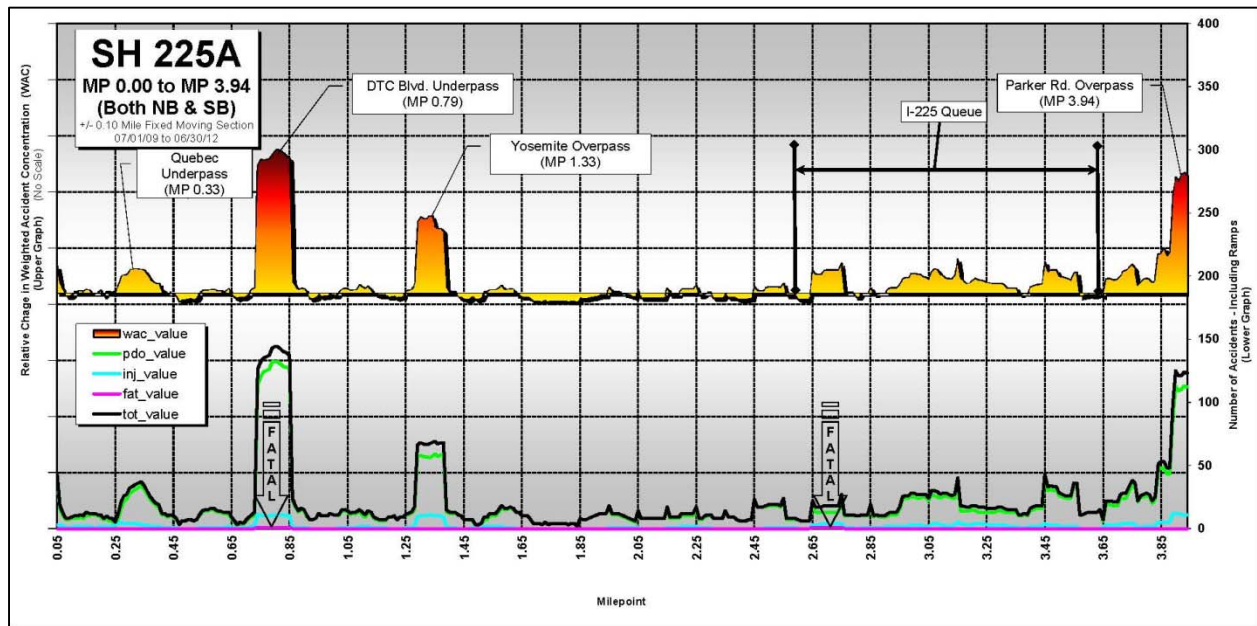
Figure 2. Weighted Accident Concentration

As can be seen on this figure, there are several locations of crash concentrations throughout the I-225 study corridor. In general, the largest concentrations of crashes are related to the interchanges. The largest interchange related peaks on the graph are at DTC Boulevard, Yosemite Street and Parker Road. Of note, this chart includes both southbound and northbound crashes along I-225 as the methodology requires that both directions be included. The two fatal crashes shown on the chart occurred in the northbound direction and as such, have not been reviewed further in this report since the focus is on southbound I-225 only.

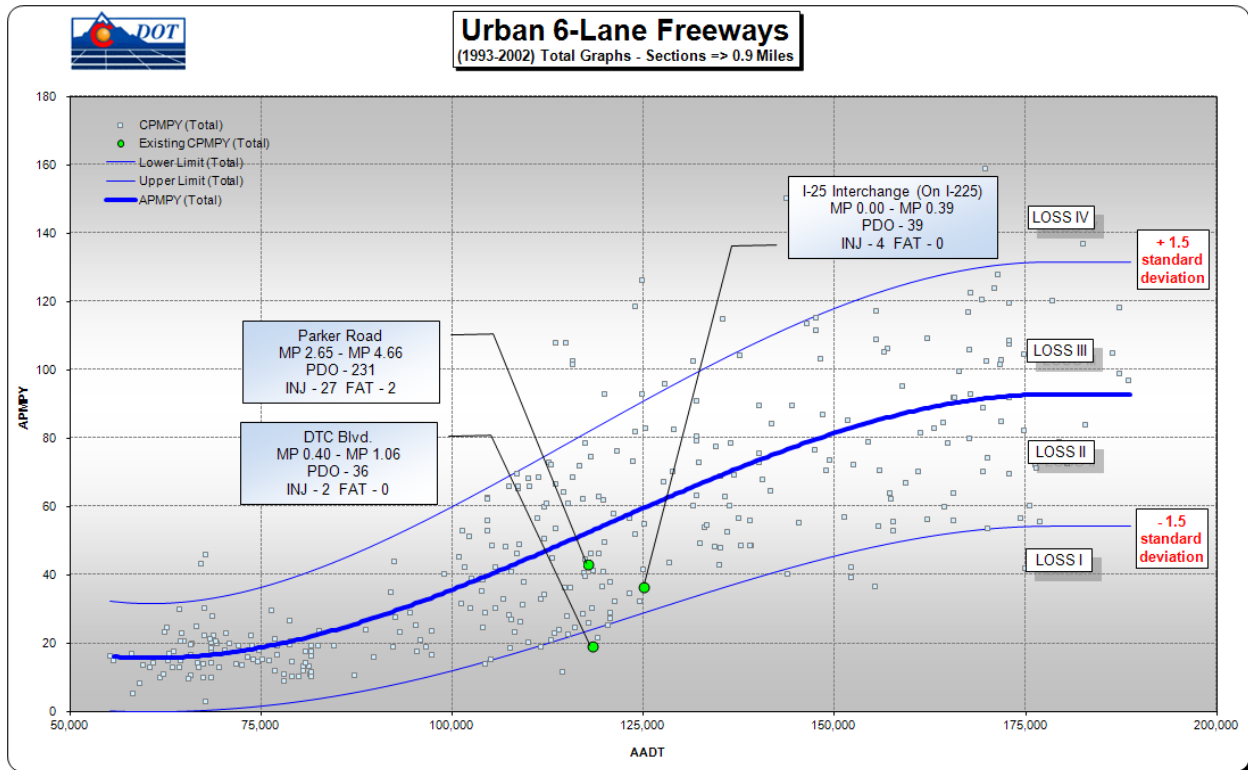
Figure 4. Urban 6-Lane Freeway SPF

Figure 4 depicts the total crash SPF for the 6-Lane Freeway segments based on the given crash data. As can be seen, the SPF segments for the I-25 / I-225 and Parker Road interchanges are below the average expected crash rate for the given AADTs. This places these SPF segments in the LOSS II category, which indicates better than expected safety performance. In addition, the DTC Boulevard interchange SPF segment falls in the LOSS I category which indicates a low potential for crash reduction.

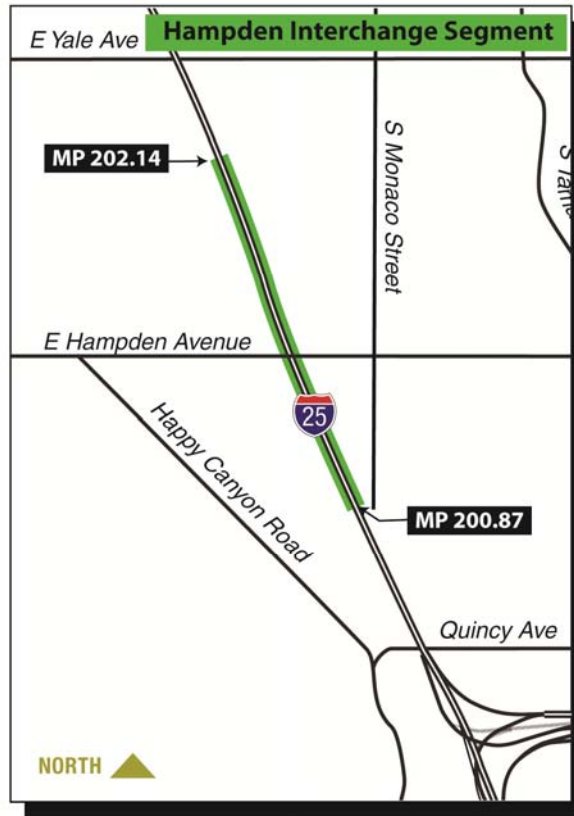
Figure 18. Hampden Avenue Interchange Segment

During the three-year study period there were 171 reported mainline crashes between MP 200.87 and MP 202.14 on I-25. **Figure 18** shows Segment 3 in relation to the other roadways in the vicinity.

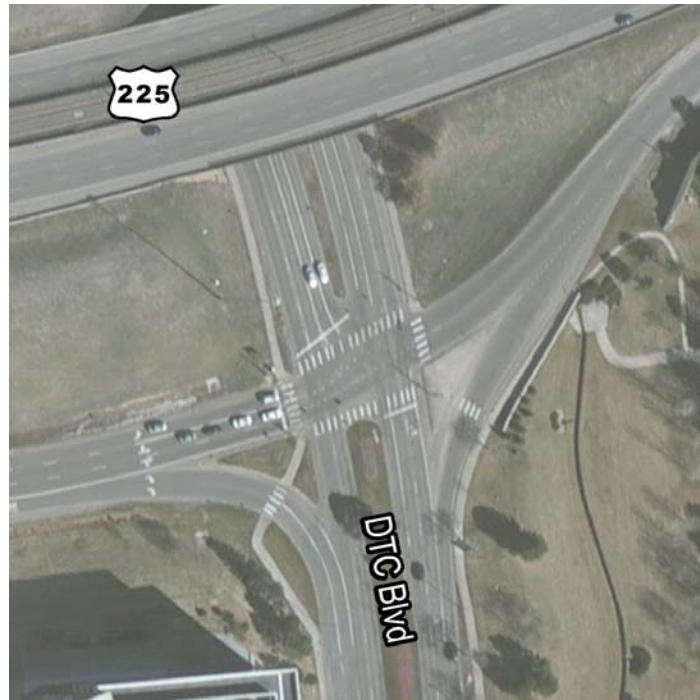
Figure 1. Northbound I-225/DTC Boulevard Ramp Terminal

- Through lanes are approximately 12-feet wide, and the turn lanes are approximately 11-feet wide.
- The mast arm mounted signal heads have 12-inch lenses with backplates.
- The pole mounted signal heads have 12-inch lenses without backplates.
- All signal heads have LED bulbs.
- The southbound left-turns are protected / permissive.
- There is a raised median on DTC Boulevard.
- There are luminaires on all corners at this intersection.
- The street signs are large and easy to read.
- There are painted crosswalks across all legs of the intersection.
- There are pedestrian heads and push-button actuators for all crosswalks at this intersection.
- The lane striping is in fair condition but is worn in spots.

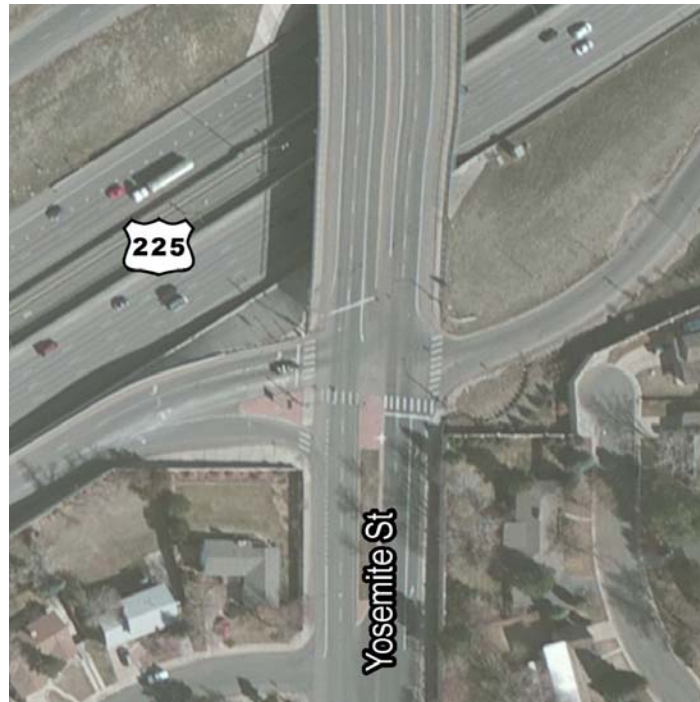
Figure 7. Northbound I-225/Yosemite Street Ramp Terminal

The intersection of the northbound I-225 ramps and Yosemite Street is a four-way, divided, signalized intersection. Currently there are two through lanes and a right-turn lane on the northbound approach. There is a left-turn lane and two through lanes on the southbound approach. There are two left-turn lanes, a through/right lane, and a channelized right-turn lane with acceleration lanes on the eastbound approach. The posted speed limit on Yosemite Street is 35 mph. **Figure 7** shows an aerial of the intersection. The following observations were made in the field:

- Lanes are approximately 12-feet wide.
- The span-wire mounted signal heads have 12-inch red lenses and 8-inch yellow and green lenses. Some of the span-wire mounted signal heads have backplates
- The pole mounted signal heads have 8-inch lenses without backplates.
- All signal heads have LED bulbs.
- The southbound left-turns are protected / permissive.
- There is a raised median on Yosemite Street south of the intersection.
- There are luminaires on all corners at this intersection.
- The street signs are large and easy to read.
- There are painted crosswalks across all legs except the north leg of the intersection.
- There are pedestrian heads and push-button actuators for the south and east leg crosswalks at this intersection. There are no heads or actuators for the west leg of the intersection.
- The lane striping is in fair condition but is worn in spots.

The intersection of the westbound I-225 ramps and Yosemite Street is a four-way, divided, signalized intersection. Currently there is a left-turn lane and two through lanes on the northbound approach. There are two through lanes and a channelized right-turn lane on the southbound approach. There is a left-turn lane, two through lanes, and a channelized right-turn lane on the westbound approach. The posted speed limit on Yosemite Street is 35 mph. **Figure 7** shows an aerial of the intersection. The following observations were made in the field:

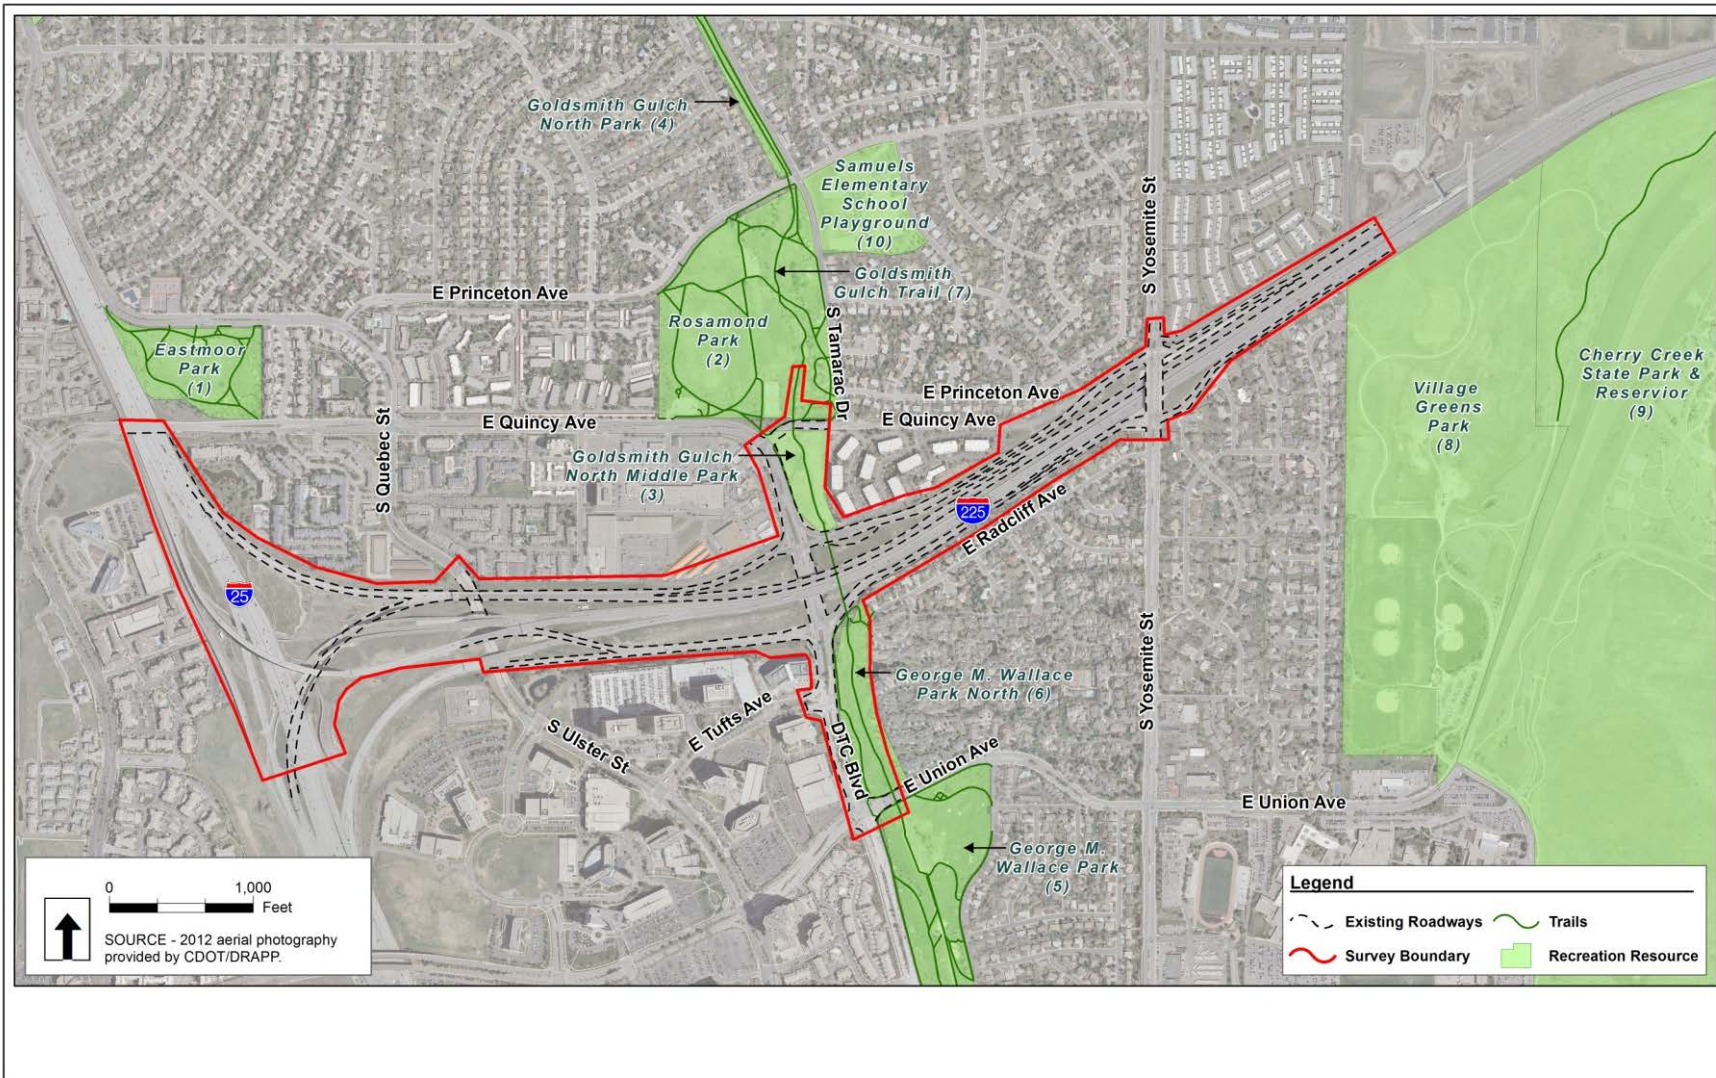
Figure 1 Existing Parks and Open Spaces

- ▶ The study area in which parks, trails and open space resources were evaluated is shown in **Figure 1**. Properties were identified that were within the close proximity or adjacent to the study area. Details and characteristics of existing parks and recreational resources in the study area were identified through GIS and then field verified in May 2013. Additional inventory details about the resources, such as ownership, size and amenities were obtained from accessing individual municipalities' websites in May 2013. Research was centered on utilizing the most current version of information available online. The information has not been confirmed with the jurisdictions and may change as the project progresses through the planning phases.

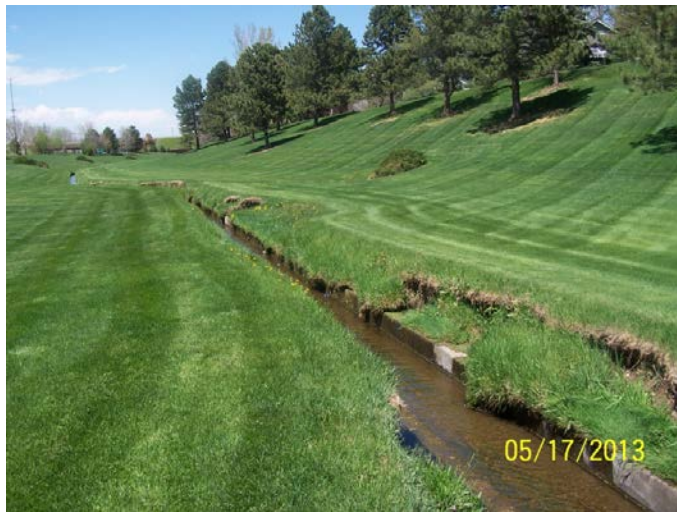
Photograph looking north towards the I-225/DTC Boulevard Interchange. This is a picture of the highly channelized Goldsmith Gulch showing the concrete bottom and banks. No wetlands were found in this area and this is a highly managed park with no wildlife habitat.

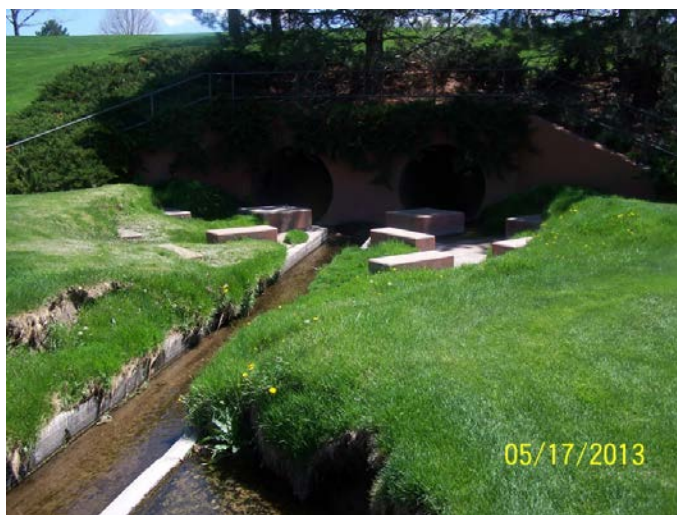
Photograph looking south at the culverts under Ulster Street for Goldsmith Gulch. This entire area is managed as a park and the channel and banks are concrete, no wetlands present.

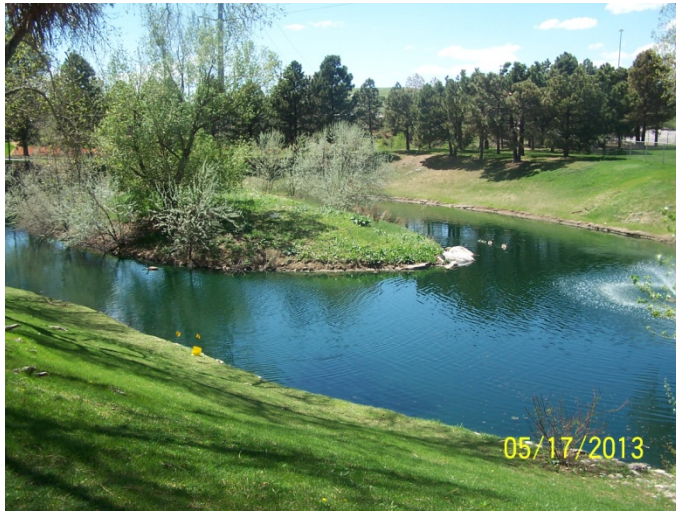
Photograph taken south of Ulster Street of the only natural area with wetlands on Goldsmith Gulch. However, this area is south of the study area.

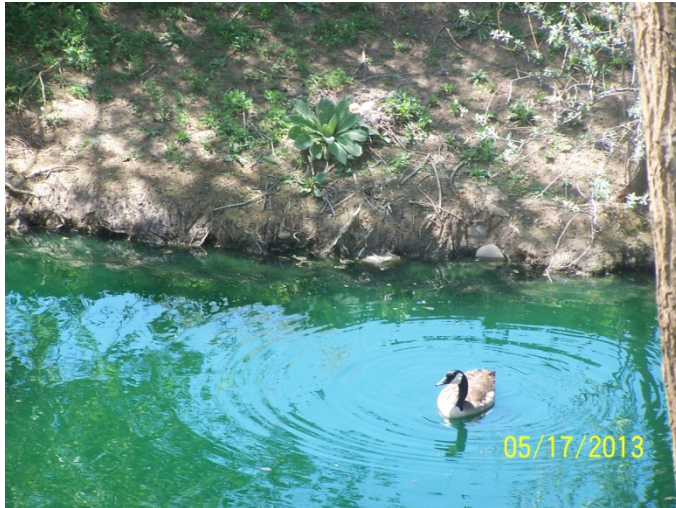
Photograph of the stormwater pond east of Ulster Street and south of I-225. Very little to no wetland vegetation surrounds this pond, possibly due to management or wildlife removing it.

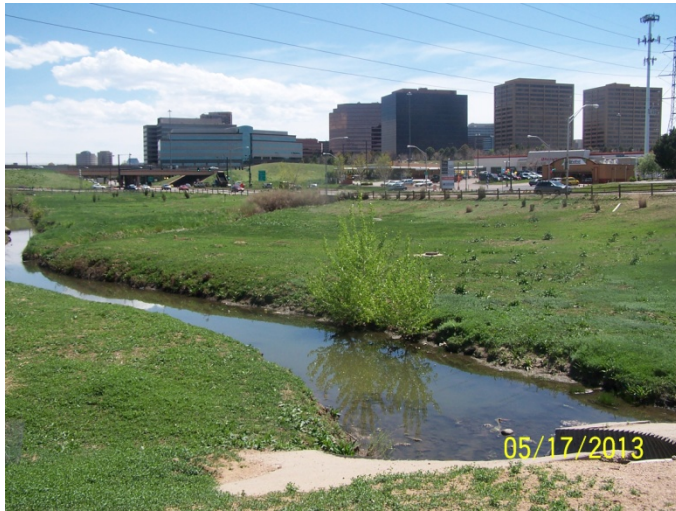
Photograph west of Ulster Street and south of I-225 where there is an electrical substation and a cattail wetland. However, this is south of the study area.

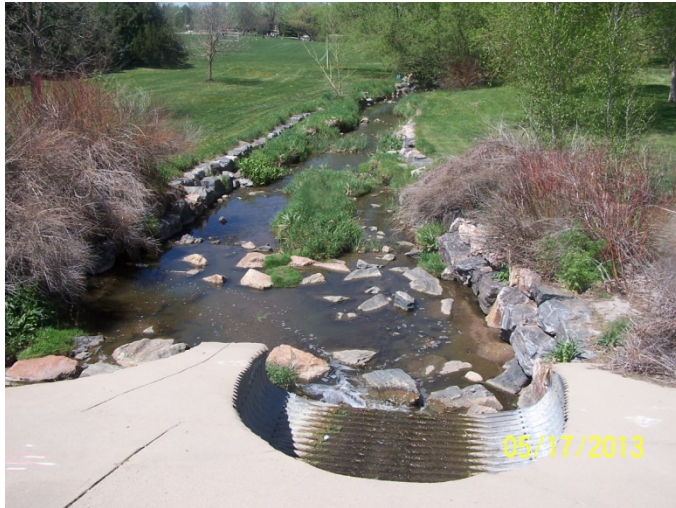
Photograph looking north from E. Quincy Avenue into the nearby park where Goldsmith Gulch crosses E. Quincy Avenue. Fringe wetlands are present in the channel and along the west bank. However, most of the channel is lined with riprap and devoid of wetland vegetation due to park management activities.

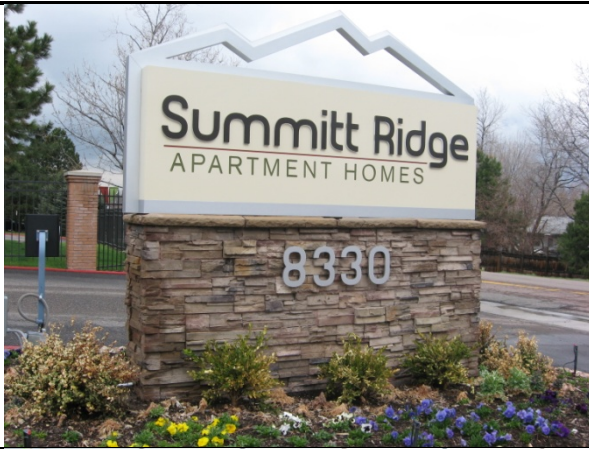
8330 E. Quincy St.
Historical Auto; Currently
the Summit Ridge
Apartment Home Complex.

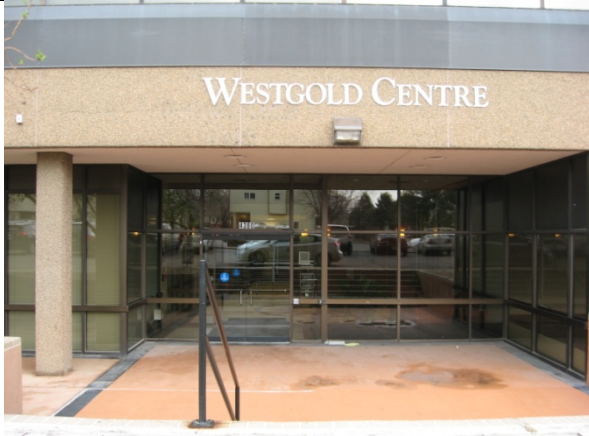
4380 S. Syracuse St.
Historical Auto; Currently
the Westgold Centre Office
Building (brick, multi-story).

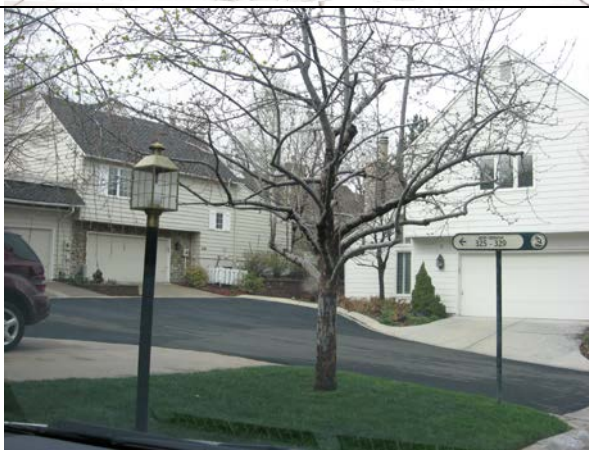
4530 S. Verbena St.
Historical Cleaners;
Currently multi-unit
residences/Large parcel w/
multiple patio homes.

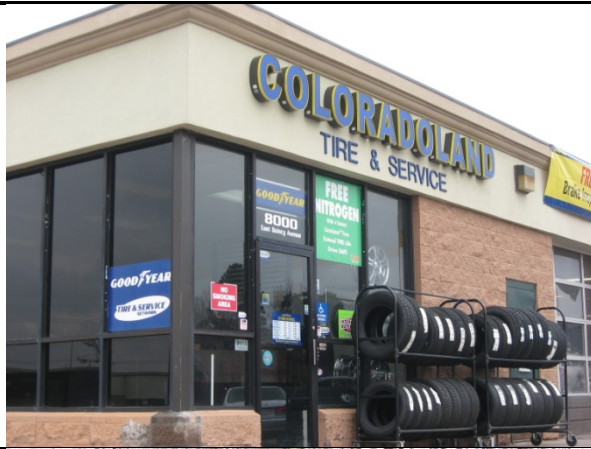
8000 E. Quincy Ave.
Closed LUST; Dry Cleaners/Historical Dry Cleaners; Open ColoradoLand Tire & Service Auto Repair Shop; Monitoring well located on the south side of building.

<p>Chemical Handling/Storage</p>	<p>Automotive service station (Coloradoland Tire & Service at 8000 E. Quincy Ave.) with vehicle maintenance bays. Unknown material handling and disposal practices. Potential materials include: fuel, motor oils, hydraulic fluids, degreasers, paints, and solvents. Former leaking underground storage tank (LUST) site. A 55-gallon drum was observed at the restaurant adjacent to 8000 E. Quincy Ave. The contents are unknown.</p> <p>Two open dry cleaning operations (4403 S. Tamarac Pkwy and 4680 S. Yosemite St.) with unknown cleaner and solvent handling and disposal practices. No reported contamination of soil and groundwater associated with this site.</p>
<p>Potential for Methamphetamine Lab Activity</p>	<p>Storage Units. Although not reported, the potential exists for methamphetamine lab activity.</p>

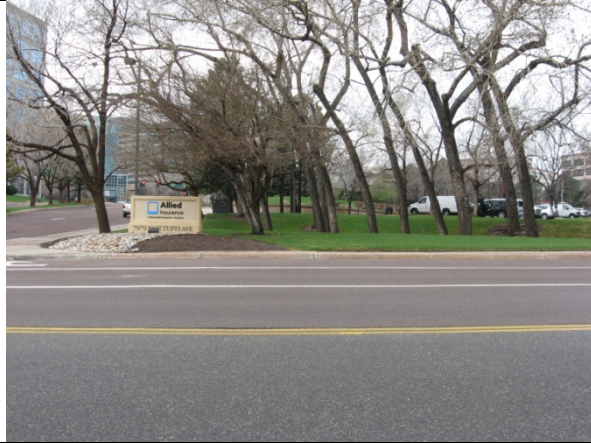
7979 E. Tufts Ave.
UST, Aboveground storage tank (AST); Currently the Allied Insurance Office Building (brick, multi-story, w/fenced in generator)

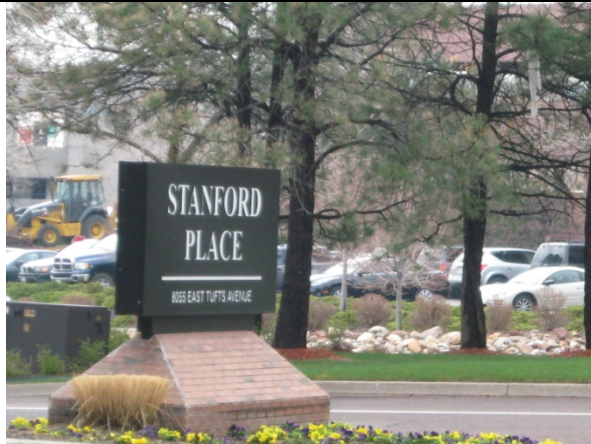
8055 E. Tufts Ave.
Historical Auto; Currently the Stanford Place Office Building (glass, multi-story)

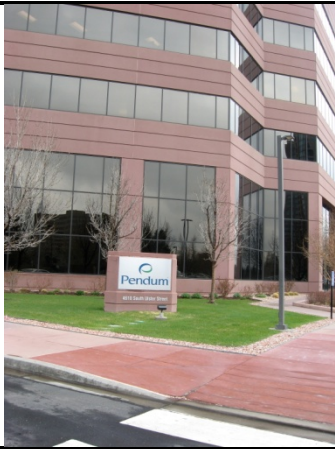
4610 S. Ulster St.
Historical Auto; Currently
an office Building (multi-
story)
