RE: Asbestos and Lead-Based Paint Inspection Report for Bridge M-22-Y located at US Highway 350 over Draw at MM 57.474 Northeast of Timpas, Colorado

Bridge M-22-Y Photographic Log

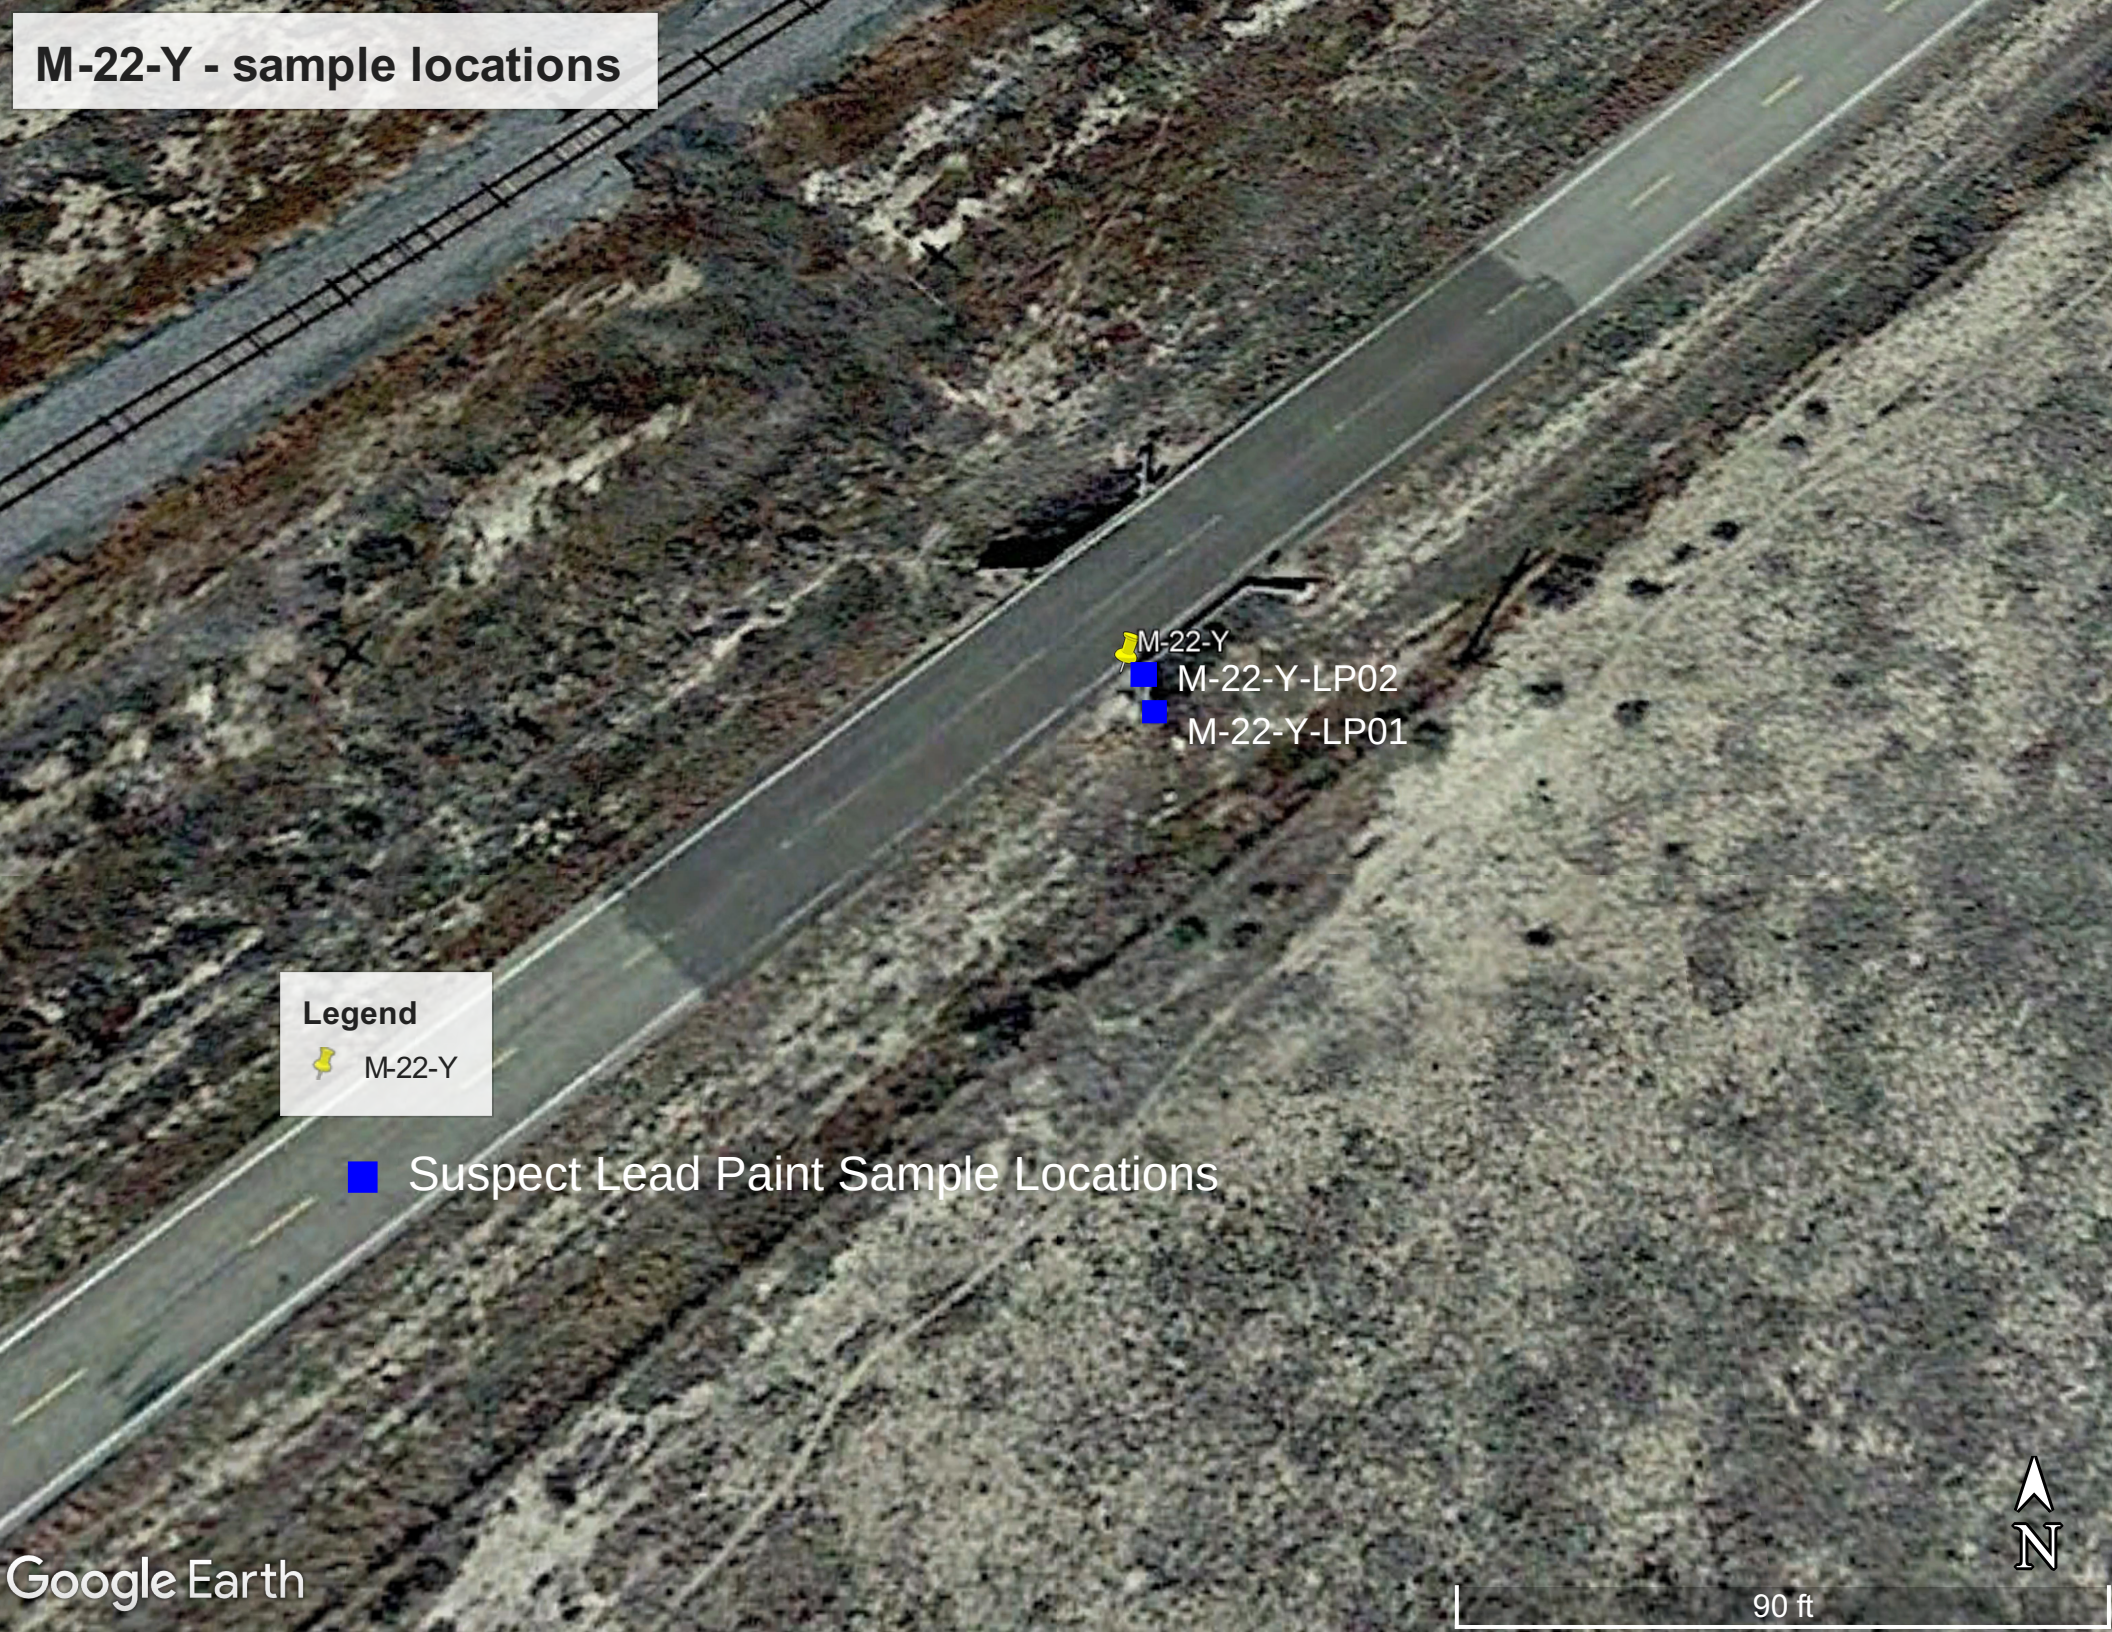
M-22-Y - sample locations
M-22-Y
M-22-Y-LP02
M-22-Y-LP01
Legend
M-22-Y
Suspect Lead Paint Sample Locations
Google Earth
N
90 ft
