STRUCTURE ALTERNATIVES EVALUATION REPORT

Structure N-21-C

(Region 2 – US 350 MP 47.131)

Stanley Consultants Project No. 29715
January 2021

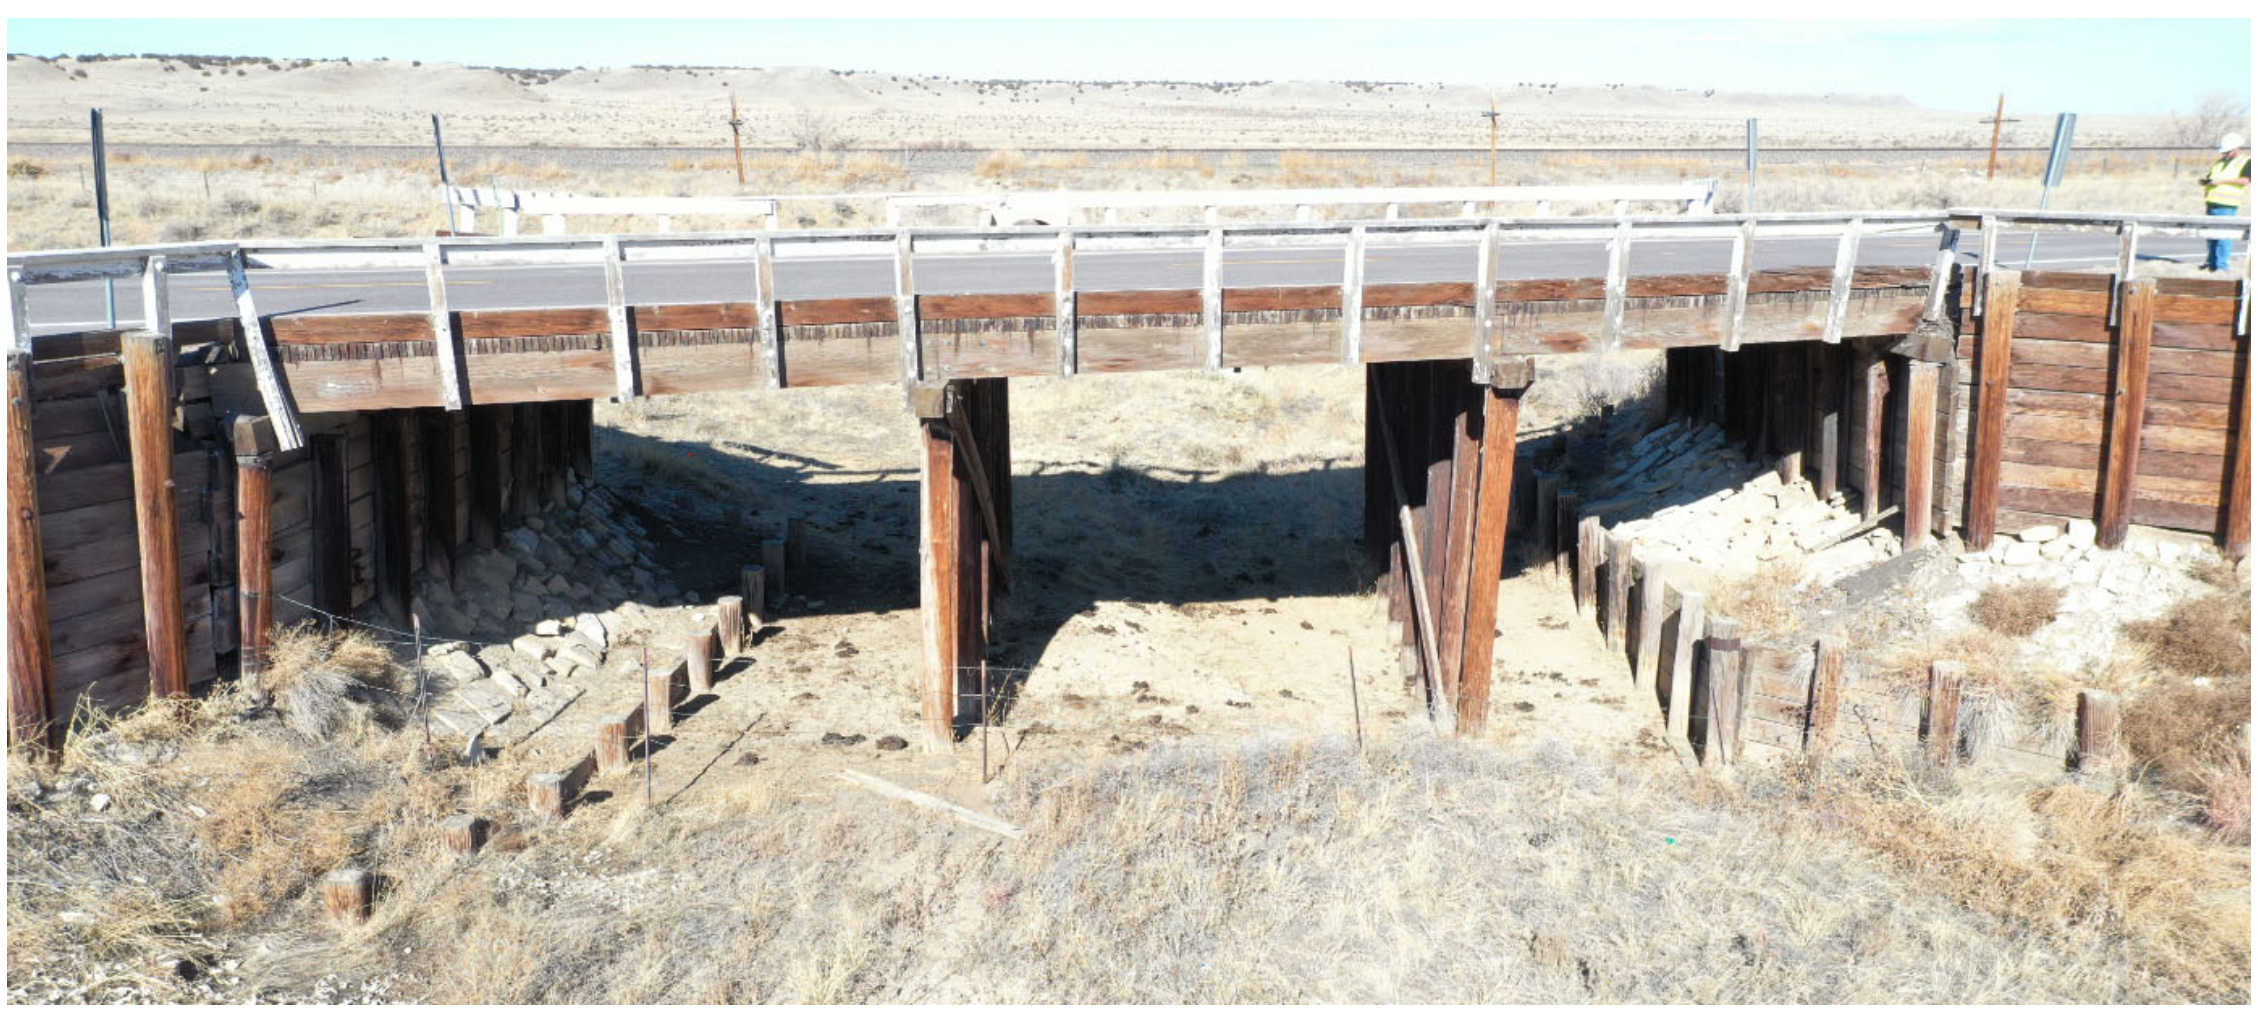
The replacement of Bridge N-21-C is warranted due to the age and deteriorating conditions. Five girders are split or repaired. Five girders have been repaired with lag bolts, additional girders are beginning to split. Other issues include:

- Exterior girders are weathered
- 24 piles have cracks penetrating 5% to 50% of pile thickness

- Rot, mold, water staining, and deterioration are present throughout numerous primary structural components
