COLORADO DEPARTMENT OF TRANSPORTATION
REGION 4
10601 West 10th Street
Greeley, CO 80634

Summary Observations

An on-site ADA survey was conducted November 25, 2016, by Patrick Going, ADA Consultant. All observations are based on the *2010 ADA Standards for Accessible Design*. These Standards may be found at www.access-board.gov.

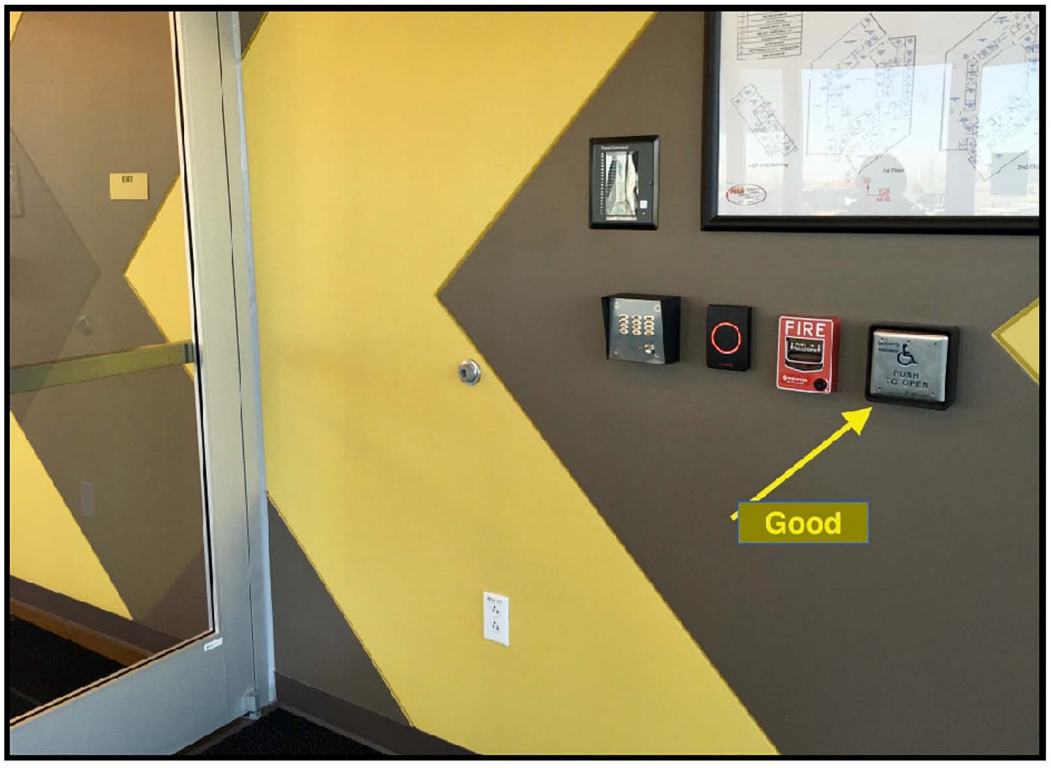
Power assist entrance door
TRASH
MIXED RECYCLABLES
Recommend moving bin 2' left for clear floor space at door activation pad

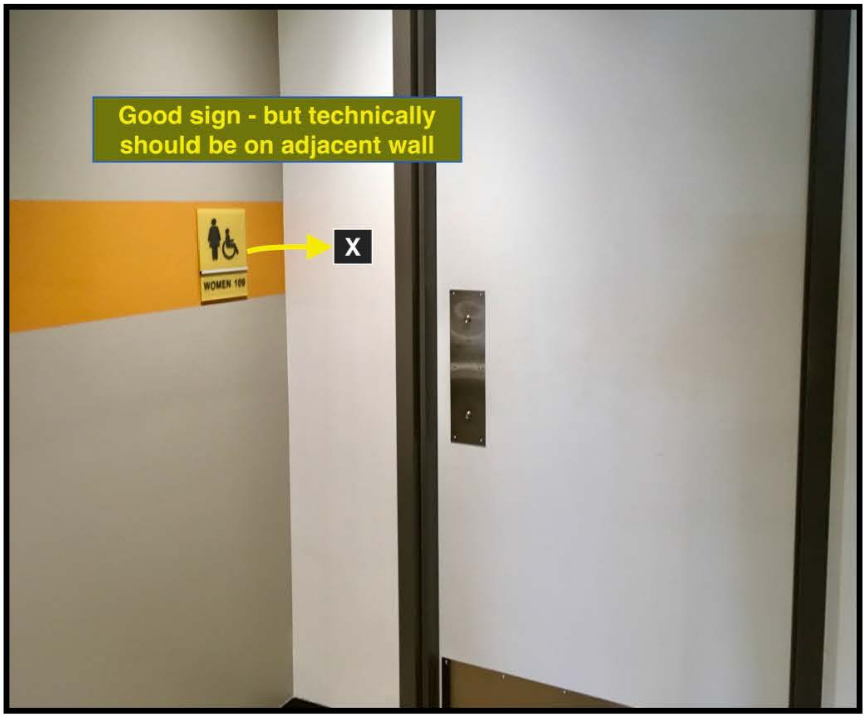
Better to put sign on wall on latch side of door
X
MEN 108

Good sign - but technically should be on adjacent wall
X
WOMEN 109

Recommendations	
Description	**Priority**
Add a'van' sign to two of the vertical posts designating accessible parking spaces.	Immediate
Reduce interior opening door pressure to 5 lbs at the two public restrooms and conference room	Immediate
Relocate or add restroom signs next to door - see picture below	Soon

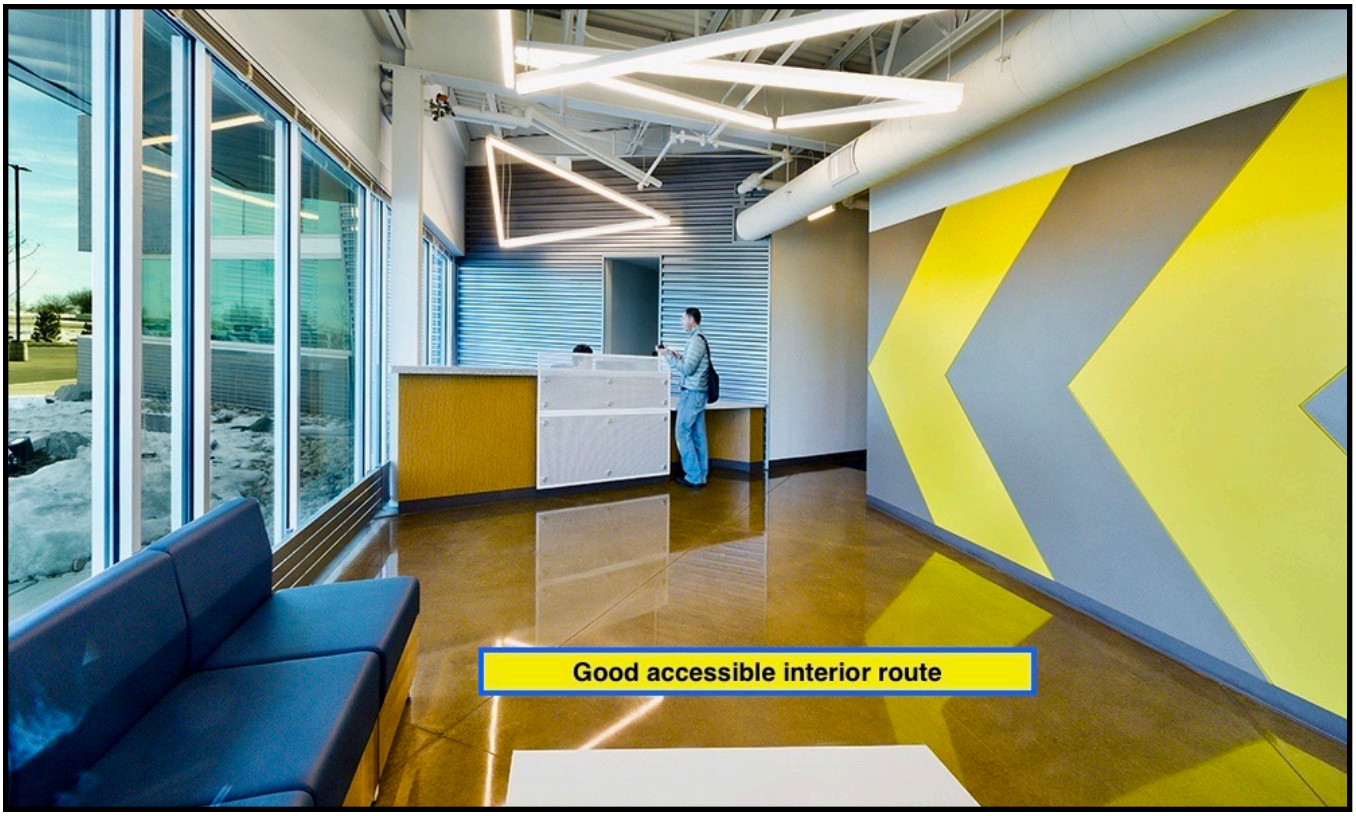
Perfect!
