**I-70 OVER FOREST SERVICE ROAD STRUCTURE  
F-13-S\_MINOR REPLACEMENT FEASIBILITY STUDY  
PROJECT NO: FBR 0702-385 (22712)  
CDOT REGION 3  
SUMMIT COUNTY, CO**

Date: April 11, 2019

REV 1 - Final Report Submittal

# Structure F-13-S\_MINOR Replacement Feasibility Study

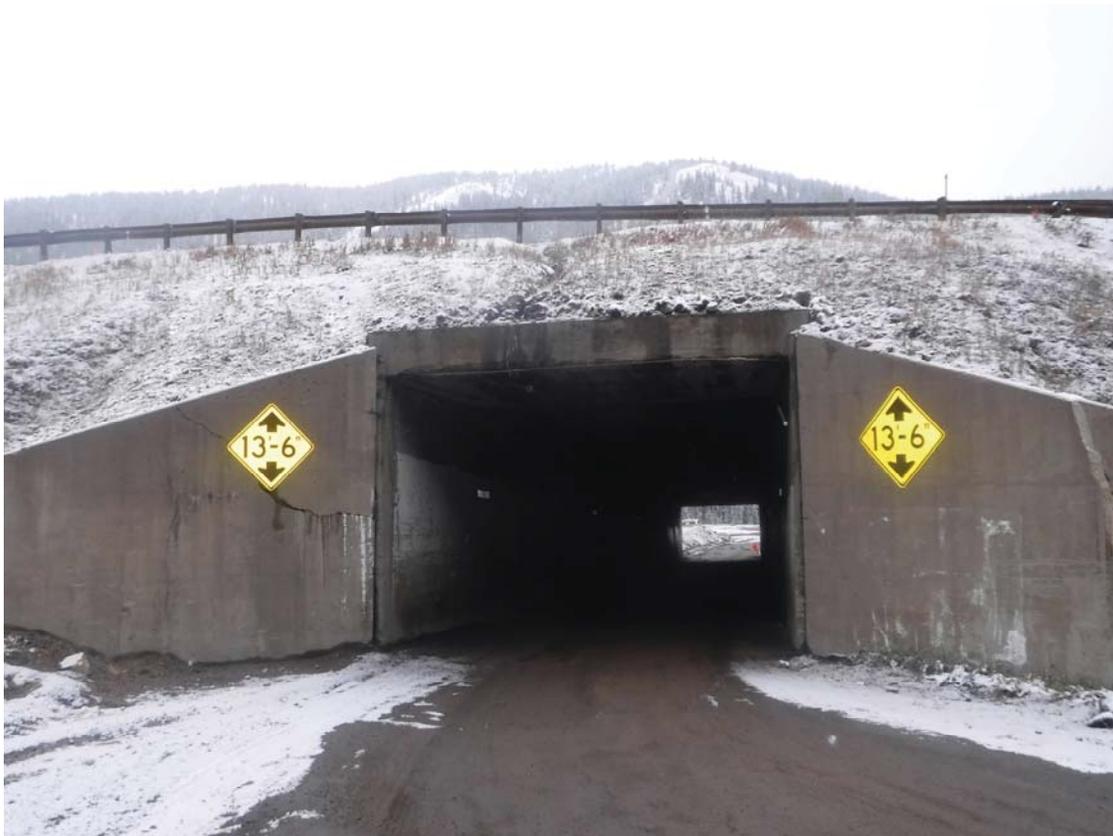
Figure 1 – Structure F-13-S\_MINOR, looking south

The National Bridge Inventory (NBI) Coding Guide was used to evaluate the structural components. Structure F-13-S\_Minor is listed as structurally deficient (SD) due to the condition of the top slab and walls. CDOT Staff Bridge conducted an inspection in April 2017 which was followed by another detailed inspection performed by Region 3 on July 24, 2017. The follow-up inspection and the *Sufficiency Rating Investigation and Inspection* report confirmed this condition. Highlights of these investigative efforts are summarized below:

- Structure Inspection and Inventory Report (SIA) includes a coding of 4 (poor) for Item 62 (Culvert).
- A load rating analysis found that the dead load alone exceeded the capacity of the structure. Failure occurred once fill reached or exceeded approximately 12 feet. The maximum existing fill on the structure is approximately 18 feet. Both headwalls are severely damaged with exposed rebar and several large shear cracks exist on both walls of the CBC.

- The top slab has several large, full-width cracks with large areas of delamination.
- Insufficient vertical clearance of the existing structure is evident by the scrape marks on the roof from apparent vehicular impact. Compounding the issue of vertical clearance, ice builds up in the structure during the winter which further reduces the vertical clearance. The ice also presents a sliding hazard for vehicles approaching the structure from the north.

The project team, with CDOT concurrence, has determined that rehabilitation isn't feasible due to the severity of the structural deficiencies; a post-rehabilitation life expectancy of less than thirty years; and insufficient vertical clearance. Therefore, only structure replacement options are considered and a Life Cycle Cost Analysis (LCCA) considering rehabilitation alternatives is not required. Refer to Appendix C for the as-built plans, structure extension plans, the April 2017 Structure Inspection Report (SIA), and the July 2017 Structure Inspection and Sufficiency Rating Investigation Report.

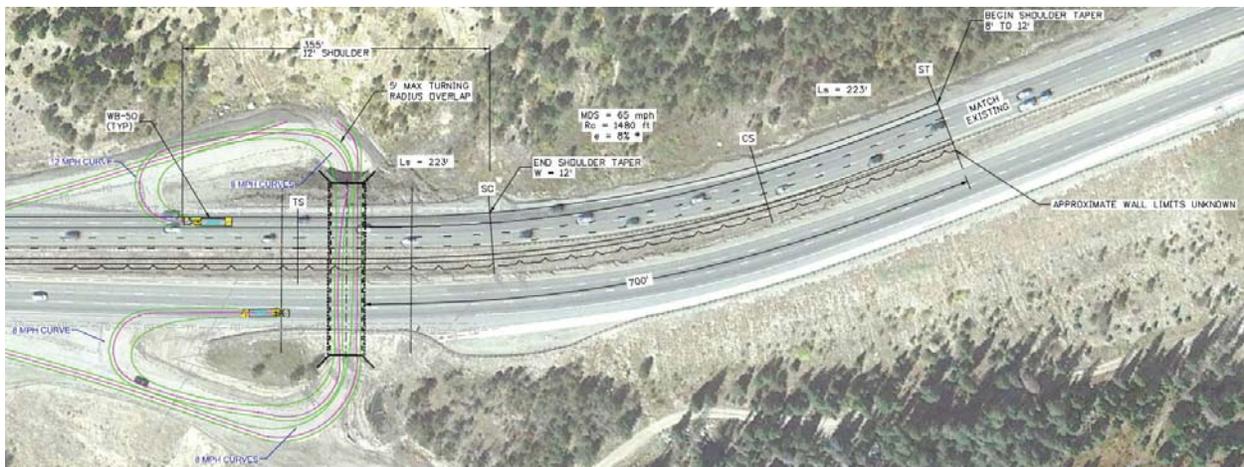
Figure 6 – Westbound I-70 Shoulder Widening Concept

- Ideally, increasing the existing I-70 WB outside shoulder width from 8 feet to 12 feet is desired at the WB exit access to allow the aforementioned turning movements. It is also desired to minimize the length of I-70 that is widened and therefore, as shown in Figure 6, the project team set the length of the widened shoulder to 355 feet. From that point, the proposed shoulder tapers from 12 feet back to 8 feet at the east project tie-in. If required, the alignment can shift further south but would require a moment slab, as previously mentioned.

As previously mentioned the WB I-70 shoulder should be widened to increase sight distance and better accommodate the turning movements for design vehicles entering the proposed structure. After discussions with CDOT and review of I-70 as-built data, the project team developed conceptual I-70 alignment alternatives to determine the feasibility and approximate length of impact along I-70 WB. This design increases the WB shoulder widths allowing design vehicles to use a 12-foot shoulder to turn from I-70 into the proposed structure. A summary of the project team's approach and the initial design results are summarized below and shown in Figure 6.

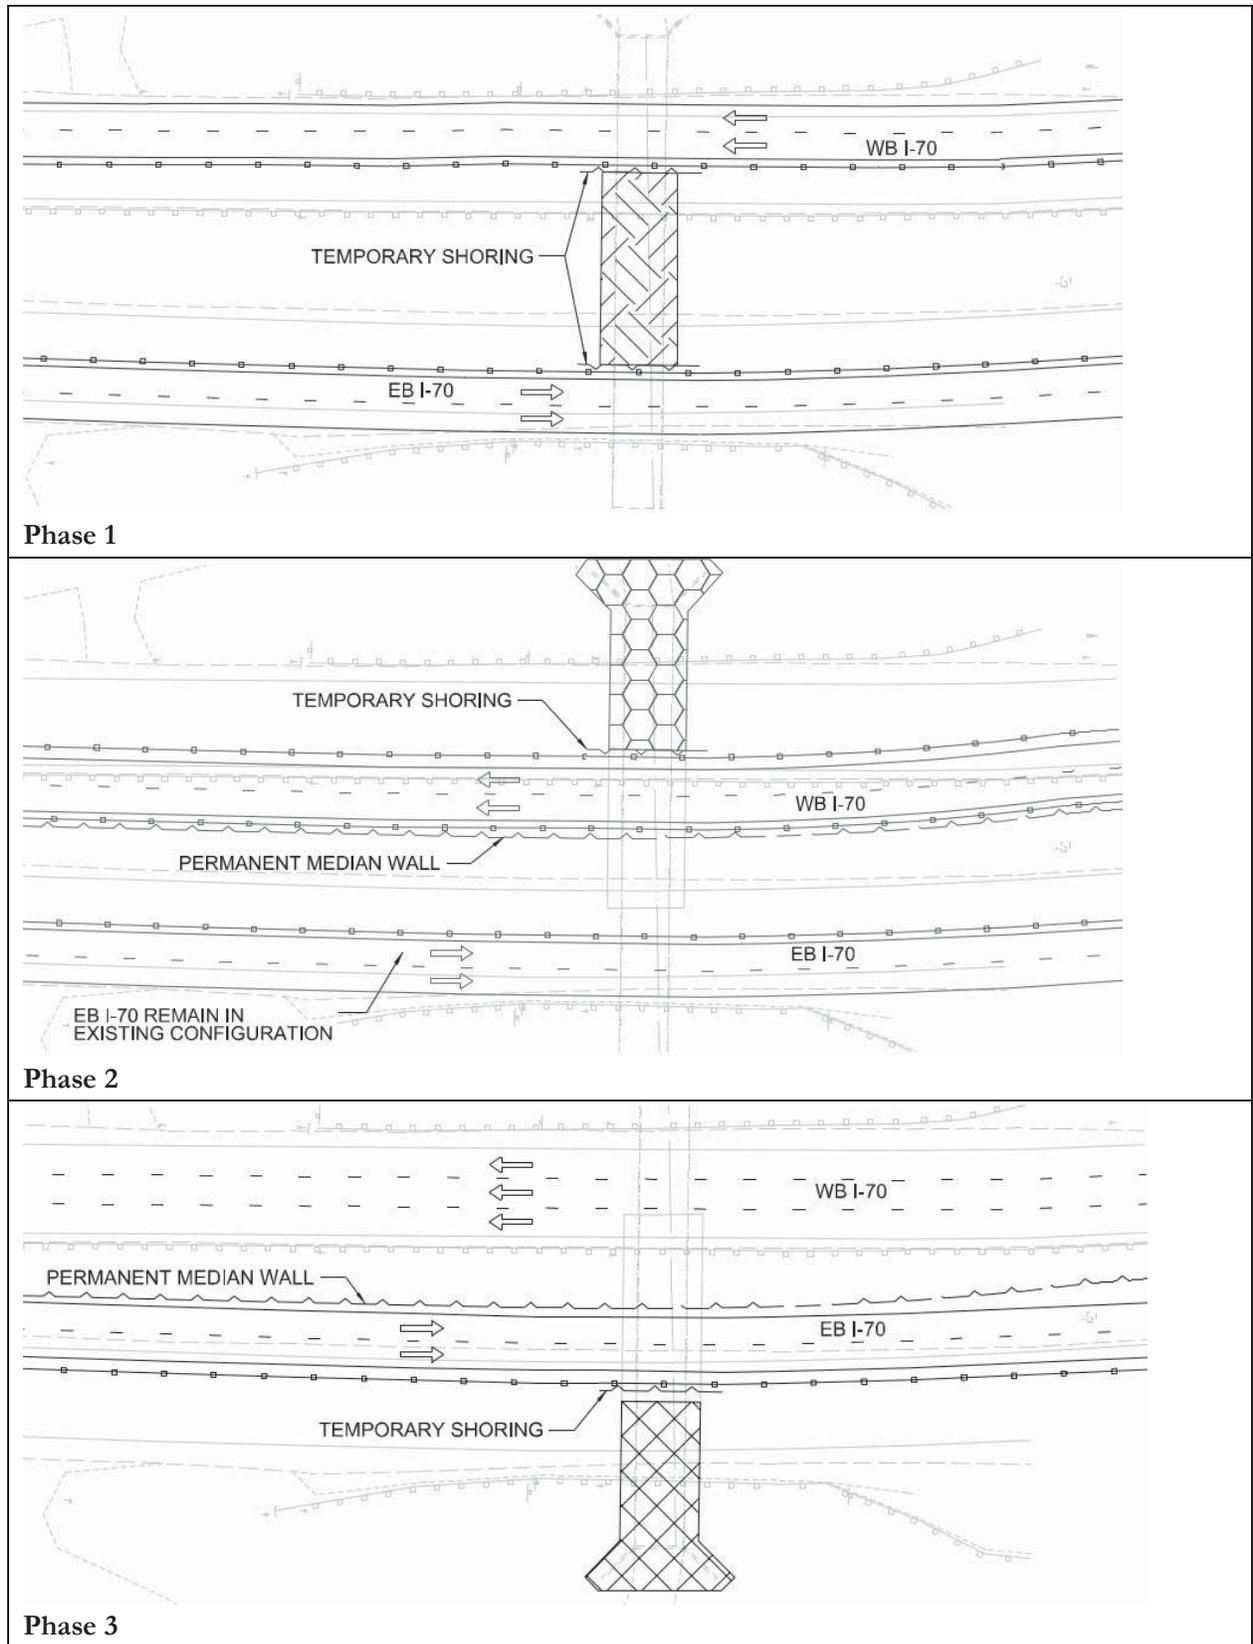
Figure 7 – Construction Phasing Plan

The second phase shifts WB traffic to the inside such that the remaining portion of the structure under the WB lanes can be built. To allow for this construction, the WB lanes need to shift into the existing median. A retaining wall must be constructed in the first phase to allow the shift. An extended single lane closure in accordance with the Region 3 lane closure strategy is required to reduce travel from three lanes to two lanes. Eastbound traffic will remain in the two lane configuration from phase one. Shifting the WB lanes south and constructing the retaining wall affects the existing drainage ditch and inlets located within the I-70 median. These will need to be addressed in the next phase of design. The project team assumed a lump sum drainage cost would be added to the cost estimate to account for all drainage related issues.

The third phase is similar to the second phase but in the EB direction. Eastbound travel lanes shift to the inside such that the remaining portion of the structure under the EB lanes can be built. An extended single lane closure in accordance with the Region 3 lane closure strategy is required to reduce travel from three lanes to two lanes. The median retaining wall from the second phase can be left in place and used for this phase. Westbound traffic will be placed back into the existing three-lane configuration.

Replacing the existing structure in the existing location using cut and cover methods requires a three-phase construction approach given the stipulations provided by CDOT. See Figure 7 - Construction Phasing Plan.
