**SH 7A (Lower)
Raymond to Lyons
Site Repairs between Mileposts 19 and 33**

**Boulder County
COLORADO**

Damage Assessment Report

**100% DRAFT
Revised: July 28, 2014**

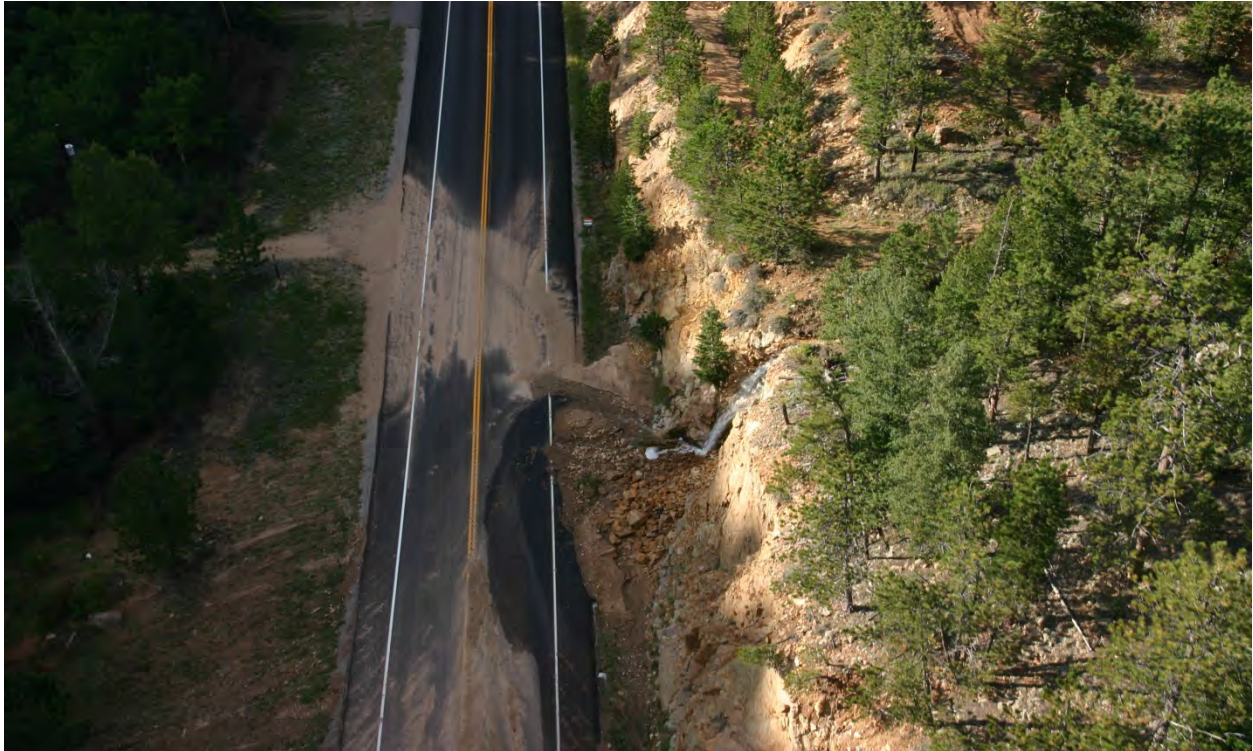
Figure 13 - MP 21.68, Material slide onto road.

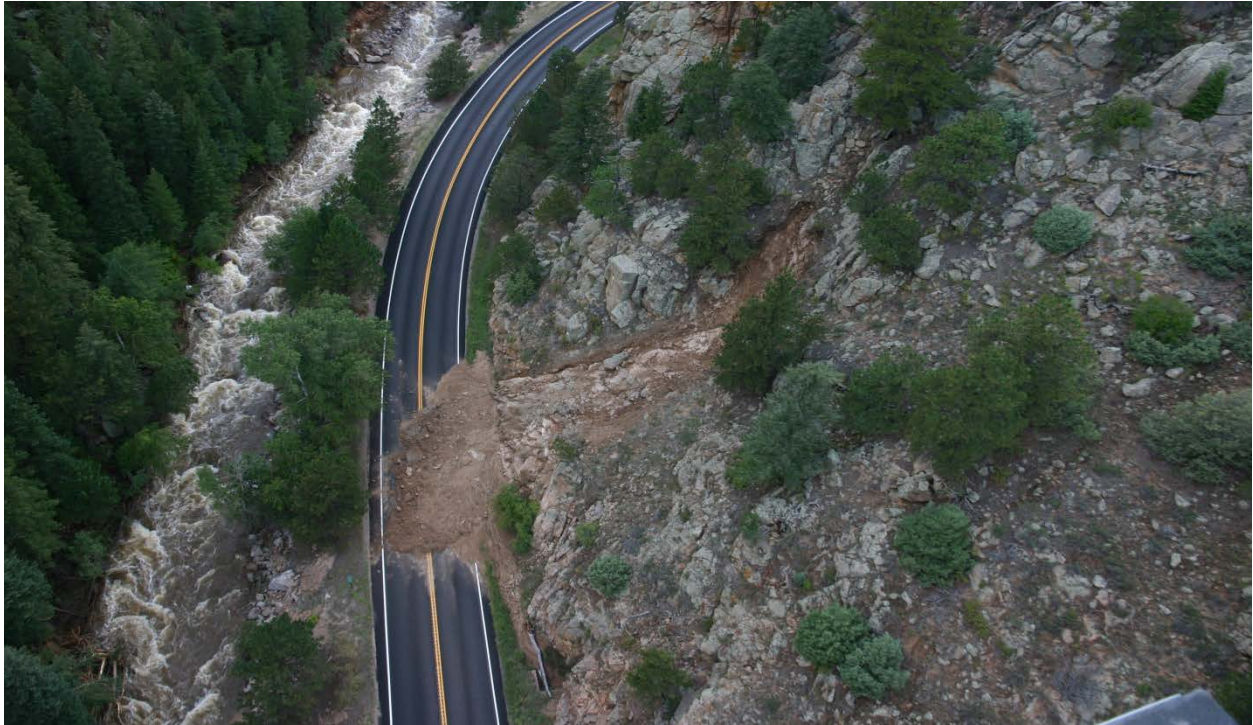
Figure 26 - MP 24.0, Rock slide covering both roadway lanes.

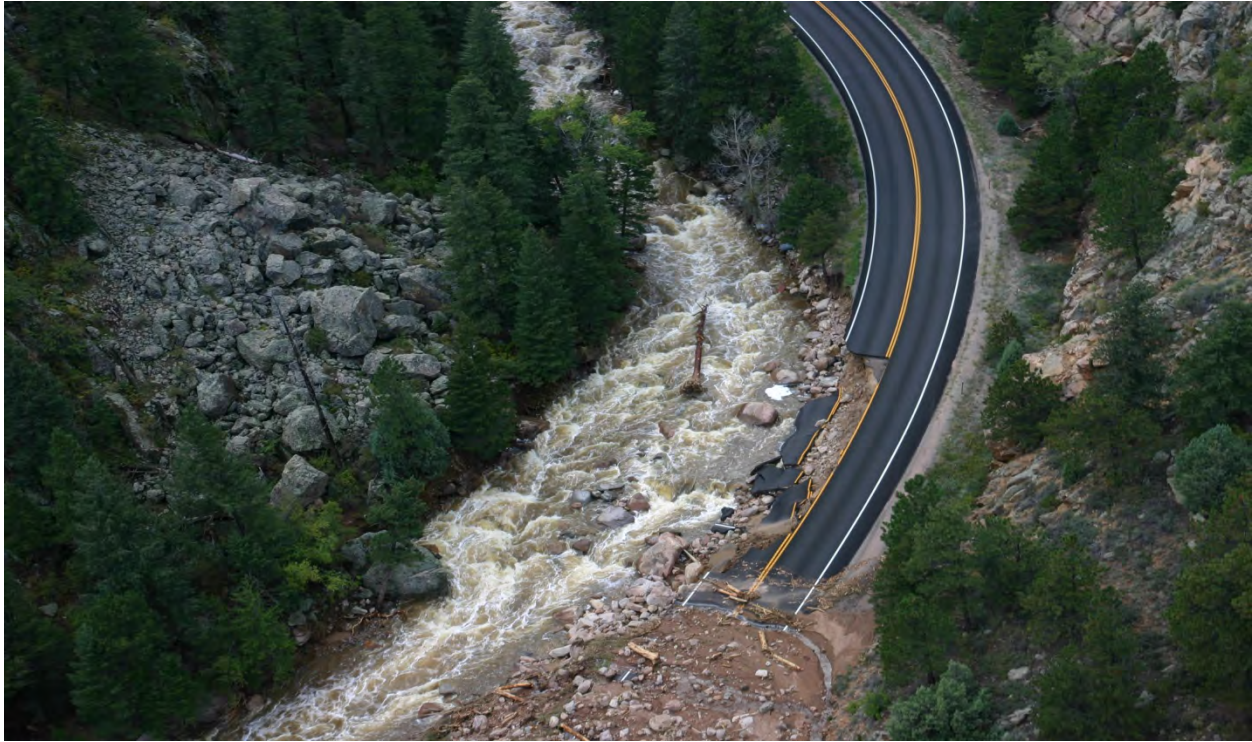
Figure 28 - MP 24.75, Rock slide and debris covering roadway lanes, embankment and roadway washout.

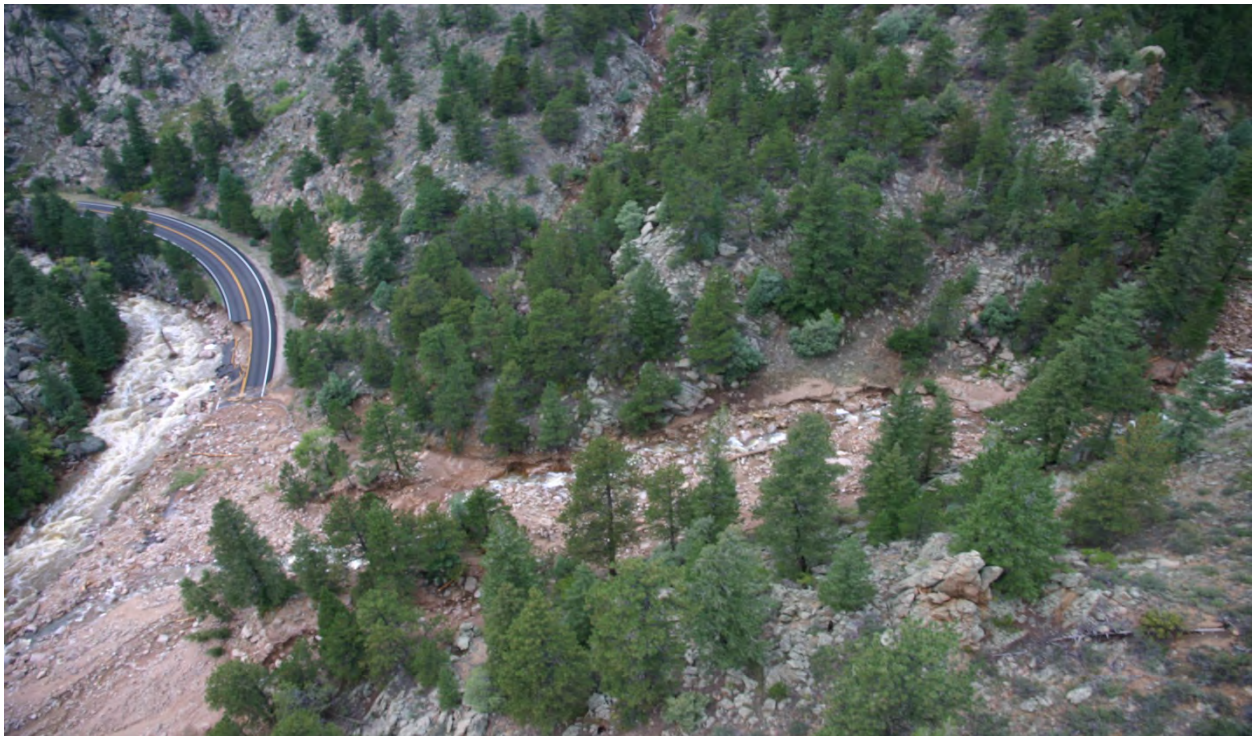
Figure 29 - MP 24.75, Rock slide covering roadway lanes. Embankment and roadway washout.

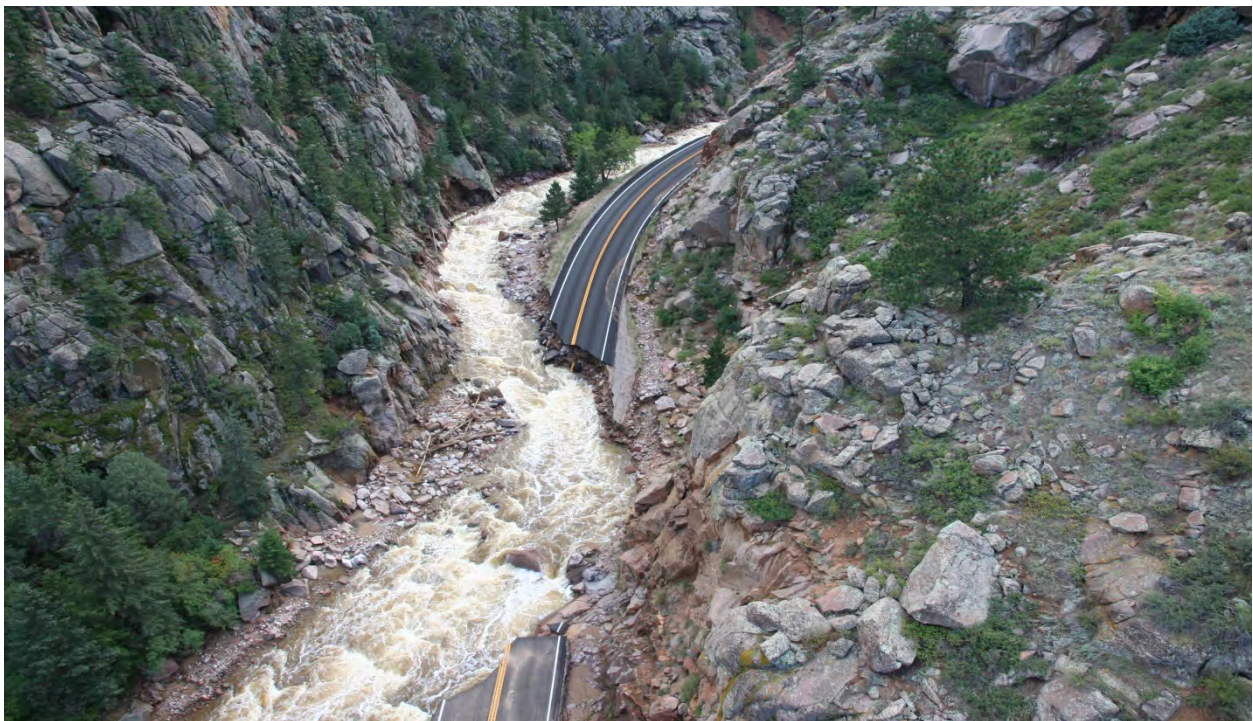
Figure 35 - MP 26.9, Complete roadway loss due to overtopping at the river bend
