Drainage Assessment Report

US 50 Corridor
Pueblo to Kansas

Colorado Department of Transportation

PRELIMINARY DRAINAGE ASSESSMENT REPORT
US Highway 50 Corridor
Pueblo to Kansas Border

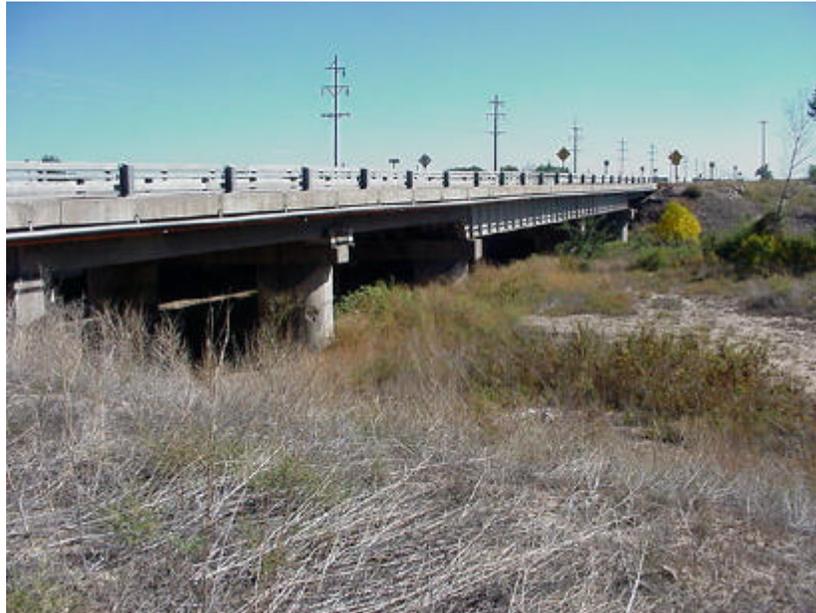
US 50 bridge over Apishapa River, structure L-21-G/DA, mile: 355.1

The confluence of the Apishapa and Arkansas Rivers occurs approximately 2200-ft north of the US 50 bridge(s) over the Apishapa River. The US 50 ROW is within the 100-yr Flood Boundary of the Apishapa River and the flood plain is approximately 1100-ft wide near the existing bridge(s). Any changes in the elevation of the Arkansas River due to aggradation will most likely result in a widening of the Apishapa River Flood Boundary at the US 50 crossing.

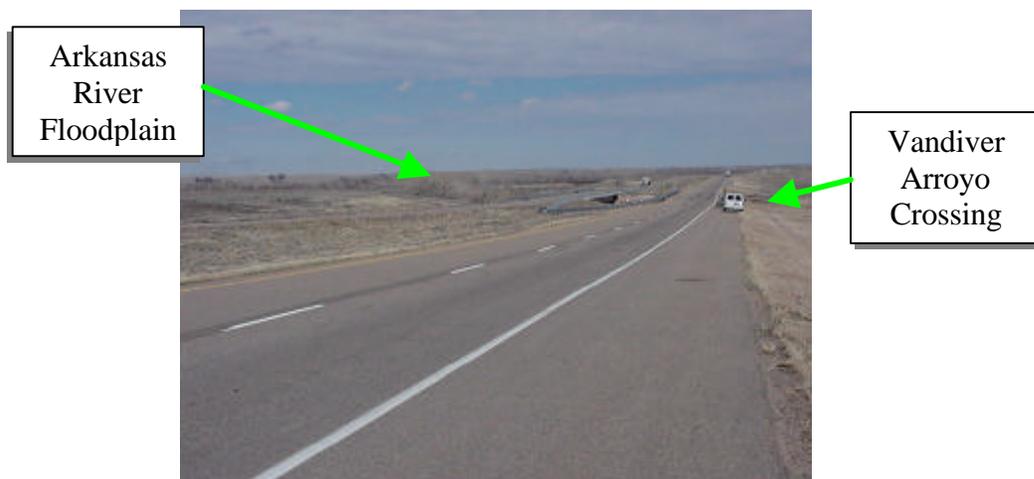
Vandiver
 Arroyo
 Crossing

US 50 crosses Vandiver Arroyo on structures L-23-S & J. US 50 is contained within the approximate 100-year Flood Boundary for Vandiver Arroyo along its length (east to west) for approximately 2000-ft. The confluence of Vandiver Arroyo and the Arkansas River is approximately ½-mile north of the US 50 crossing. Backwater affects from the Arkansas River will most certainly impact this crossing site.

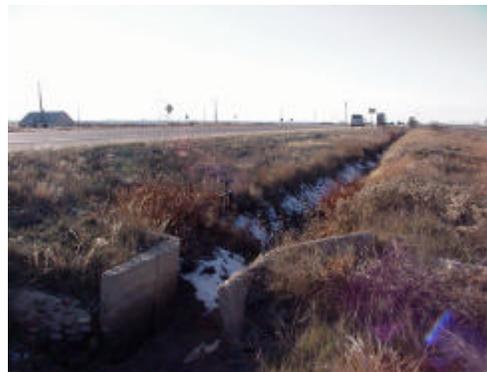
After crossing under US 50, the Excelsior Ditch runs immediately parallel to US 50 for approximately 2000-ft. The close proximity of the ditch to the highway has resulted in vehicle accidents as reported by Mr. Evans. Mr. Evans recommends relocating the ditch further to the north to improve safety and maintainability. Also, as originally constructed, a lateral exists just east of the existing crossing site and crosses back under US 50. Mr. Evans feels re-routing the lateral along the southside of US 50 could eliminate the need for an additional crossing under US 50.

Excelsior Ditch running along northside of US 50

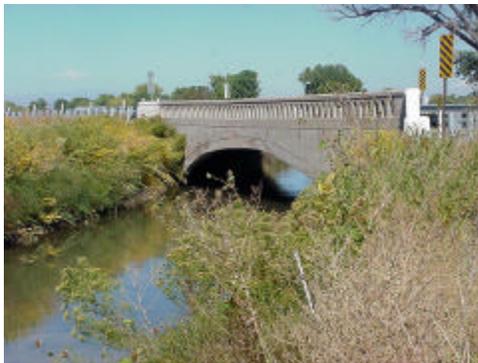
Rocky Ford Highline Canal,
CDOT Structure L-20-B

The existing structure is a 65-ft concrete arch bridge constructed in 1932. The existing structure performs adequately and at present there are no significant issues with this crossing. The Rocky Ford Highline Canal normally conveys 350 to 500-cfs; the Decreed Flow is 505-cfs. Significant amounts of storm runoff can enter the canal raising the flow to near 1000-cfs at the crossing site. Currently there is good access to the Ditch Rider roads off both shoulders of US 50. Any improvements to US 50 at this site would need to consider and include access to the Ditch Rider road in both directions. The existing access for ditch maintenance is adequate and unhampered.

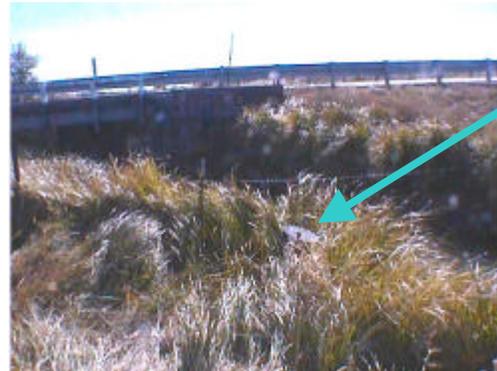
Headgate approx. 50-ft upstream of structure

The existing structure is a 25-ft single span timber bridge constructed in 1938. The ditch has a Decreed Flow of 130 cfs and a normal flow of approximately 130-cfs. Storm water runoff to the canal can be as much as 70 cfs increasing total flow at this site to 200 cfs. There is a head gate located approximately 50-ft just upstream and north of US 50. The existing structure is showing signs of severe deterioration below water level. The timber abutment piles are rotting and have decreased in their overall diameter. The ditch was last overtopped in the Spring of 1999 when an estimated flow of 220 cfs topped the ditch approximately 2 miles upstream of the US 50 crossing. Replacement of this structure will be required in the near future. Capacity of the existing structure is barely adequate for flows approaching 200 cfs. The Ditch Company would prefer a concrete, single span bridge. Access to the Ditch Rider road and structure is adequate but could be improved.

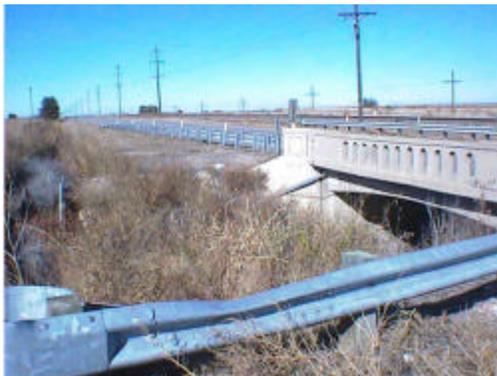
Otero Ditch, CDOT Structure: L-21-A

The existing structure is a 27-ft concrete single span bridge constructed in 1947. The Decreed Flow is 123 cfs however normal flow is only about 25 cfs. The ditch collects some storm water but can collect significant amounts of irrigation runoff/tailwater. Access of maintenance equipment at this site is difficult and in some locations impossible. The existing guardrails prohibit the ditch company's backhoe from reaching portions of the ditch channel. Additionally a combined roadside and irrigation drainage ditch discharges into the canal along the west bank at this crossing site. The outfall of the roadside ditch has experienced substantial erosion in the past (see Maintenance Issues Summary, 11 Oct 00) and currently has timber cribbing to control erosion. Placement of the cribbing limits access for the ditch company on the west side of the ditch.

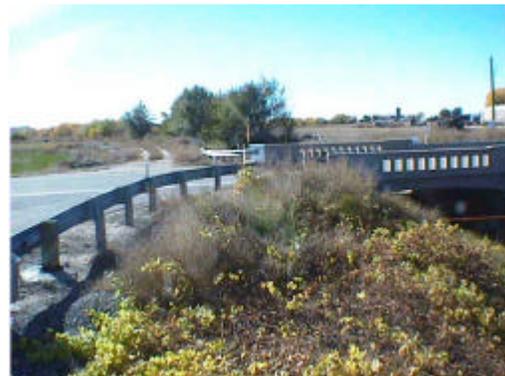
Guardrails limit access for ditch maintenance

Problems with sediment deposits also occur at the confluence of the irrigation and roadside drainage ditches. Improvements at this location should address improving

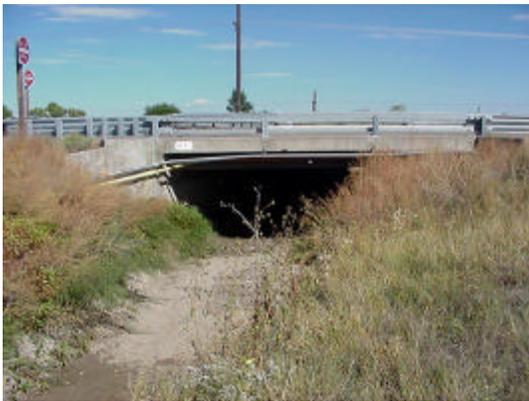
Otero Ditch, CDOT Structure: L-21-I & DC

There are two existing structures at this location. The structures are immediately adjacent to the bridges (structures L-21-G & DA) that span the Apishapa River. The structures over the Otero Ditch are 33 to 34-ft single span concrete bridges. The first was constructed in 1957 and the second in 1998 when improvements were made to the bridges over the Apishapa River. This crossing site is approximately one mile downstream from the previous structure, L-20-C. The existing structures are adequate and perform well. Access for maintenance is good but could be improved. Flows through the structures are excellent with little to no sediment accumulation.

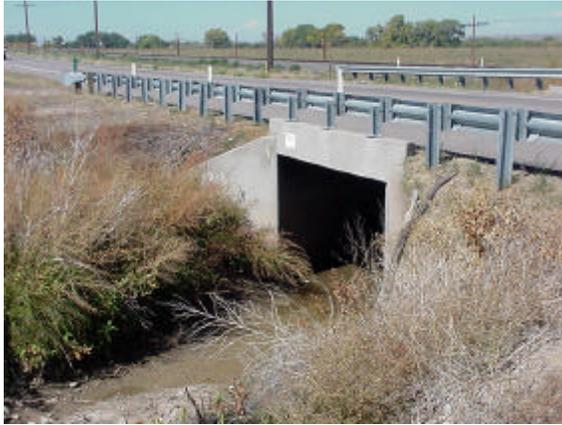
Otero Ditch, CDOT Structure: L-21-b

The existing structure is a 12-ft by 8-ft CBC constructed in 1960. This structure is marginally adequate when storm water combines with the normal irrigation flows (120-125 cfs). A small steel girder bridge belonging to the BNSF Railroad is located approximately 60-ft upstream of the CBC. The location of the roadside ditch on the south and west sides of the structure limit maintenance access to the irrigation ditch. The ditch company representative would like to see this structure increased in capacity by approximately 10% to better convey flows during storms. Any improvements to this location will need to consider impacts and backwater affects to the BNSF railroad bridge upstream.

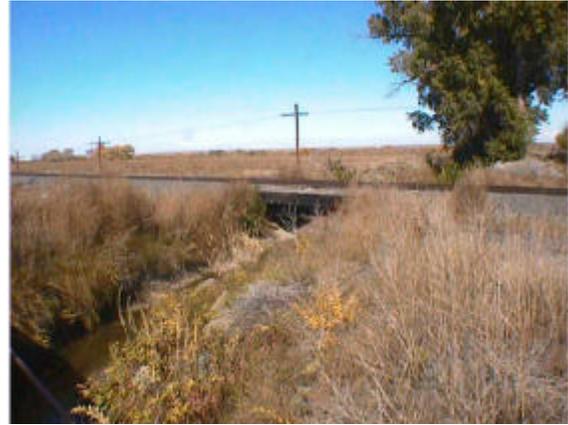
BNSF bridge immediately upstream

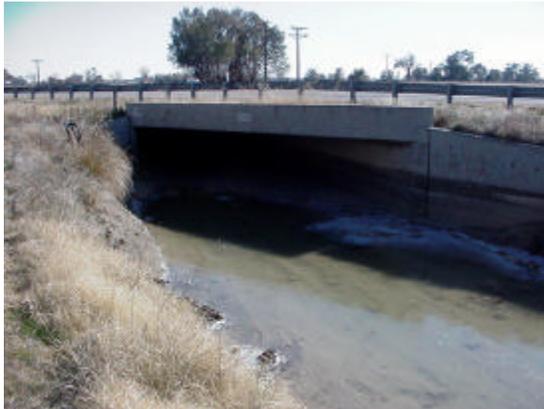
Catlin Canal, CDOT Structure L-21-K/N
upstream entrance

The existing structure is a 20 X 6-ft Concrete Box Culvert constructed in 1968/69. The ditch has a Decreed Flow of 345-cfs and a normal flow of approximately 248-cfs. Stormwater runoff can enter the canal but a waste gate upstream of the structure, near the west end of Manzanola, allows excess runoff to be dumped prior to this structure. There is a head gate located approximately 20-ft just upstream and north of US 50. There are no major issues with this structure. Access to the Ditch Rider road will need to be maintained. The existing channel is riprap lined and usually does not require dredging.

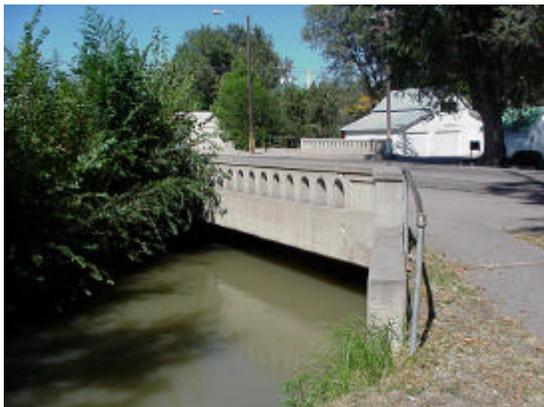
Rocky Ford Ditch, eastbound bridge
CDOT Structure: L-22-I

There are two existing structures in this location, one for the eastbound lanes and one for the westbound lanes. The structure listed on the CDOT Field Log of Structures is a 32-ft concrete single span bridge constructed in 1934. The westbound bridge appears to be a much newer and different type of concrete bridge. The Decreed Flow for the Rocky Ford Ditch is 112-cfs, however the normal flow is only about 52-cfs. It is expected that the Colorado Water Court will reduce the Decreed Flow sometime before 2002. The ditch collects some stormwater runoff but a waste gate approximately ¼ mile upstream of the structure allows excess runoff to be dumped there. The existing structures perform well and there are no special maintenance issues or needs. The existing channel is riprap lined and usually does not require any dredging. There is no requirement for a Ditch Rider road in this location; city streets provide all necessary access.

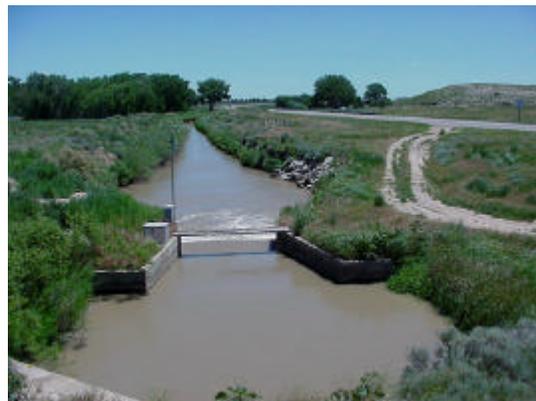
Parshall flume located between levee and US 50 crossing
(photo taken from top of flood control levee)

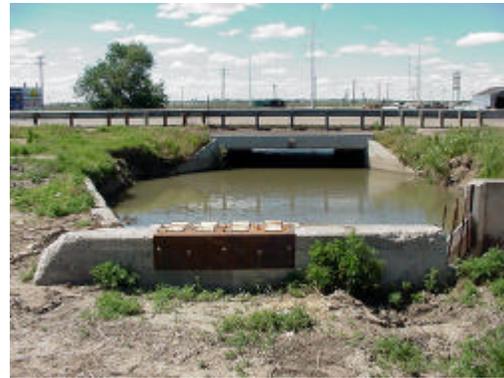
Lamar Canal, CBC Structure L-26-BV
 (photo taken from inverted siphon entrance)

The Lamar Canal crosses US 50 in two locations in or near the city of Lamar, Colorado. The decreed flow for the Lamar canal is 285.7-cfs, the design capacity of the canal at the crossing sites is 285-cfs and the normal flow is approximately 150-cfs. The first crossing is on the north end of town at mile 434.78 utilizing a 25-ft concrete slab bridge. A Parshall flume is located just downstream of this crossing which reduces the flow velocities and causes an accumulation of sediment beneath the US 50 bridge. The second crossing is just east of town through a concrete box culvert at mile 436.76. Immediately downstream of this crossing is an entrance to an inverted siphon where the Lamar Canal passes under the Willow Creek Drainage channel. Sediment routinely collects between the siphon entrance and CBC and within the CBC under US 50.

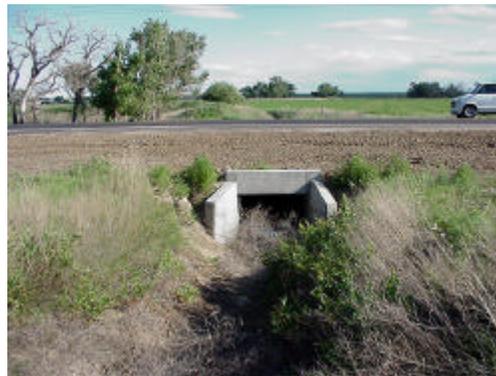
Manvel Canal CBC entrance

The Manvel Canal crosses US 50 through a 60"x60" (estimated) concrete box culvert at approximate mile 444.8 east of the Roosevelt School site. The CBC is not on the CDOT Field Log of Structures. The Manvel Canal was purchased in 1995 by the Lower Arkansas Water Management Association (LAWMA) and is no longer active as an irrigation water supply facility. The decreed flow of 54-cfs is no longer routed through the canal. The canal's primary purpose is to provide drainage for the adjoining agricultural fields. The easements on which the canal lies are being returned to the landowners and regular maintenance of the ditch no longer occurs.

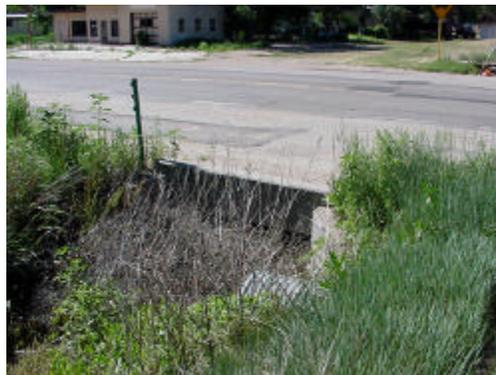
X-Y Canal CBC entrance

The X-Y Canal crosses US 50 through a concrete box culvert at approximate mile 452.2 near the west end of Granada, Colorado. The CBC is not on the CDOT Field Log of Structures. Like the Manvel Canal, the X-Y Canal was purchased in 1996 by the Lower Arkansas Water Management Association and is no longer active as an irrigation water supply facility. The decreed flow of 69-cfs no longer flows through the canal. The canal's primary purpose is to provide drainage for adjoining agricultural fields.

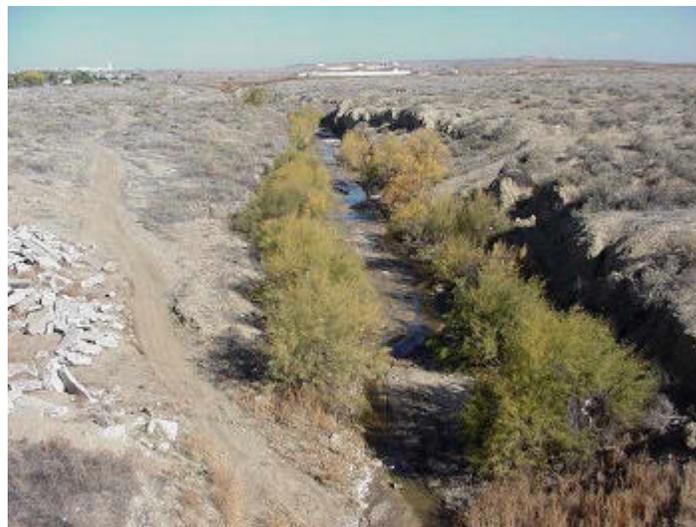
Dry Creek Drainage looking upstream/north

4.3.1.2. Mile 318, Dry Creek Bridge Scour and Erosion. Structures K-18-BZ, BY, and FG all show signs of significant pier and abutment scour. Numerous emergency repairs have been made to curtail erosion of the abutments and piers. The last major event causing damage was in 1999. Support piles beneath the US 50 bridge piers have already been exposed!

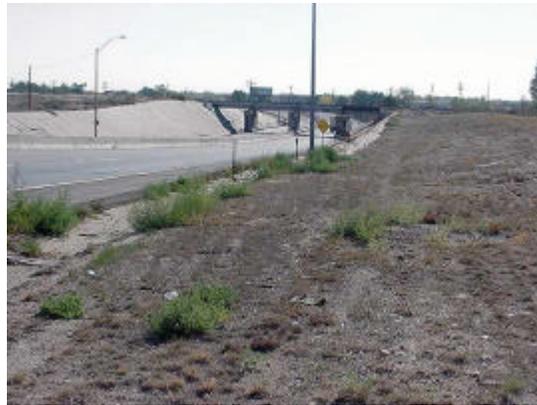
K-18-W looking east

4.3.1.3. Mile 319, Inadequate Underpass Drainage beneath BNSF Railroad Bridge. The US 50 roadway beneath the BNSF railroad tracks (structure K-18-W), east side of Pueblo, is flooded routinely. Two existing sump pumps transfer water from a sump on the south side of the road to a concrete lined ditch that drains generally south and parallel to the railroad ROW toward the Arkansas River. The two pumps were replaced approximately five years ago but are inadequate to handle any but the smallest events. Contributing surface flows converge on the underpass from the east and west along the US 50 roadway and from the northeast along the BNSF roadbed. High ground water can also influence the amount of water entering the pump sump.

Possible corrective action at the BNSF Underpass should include:

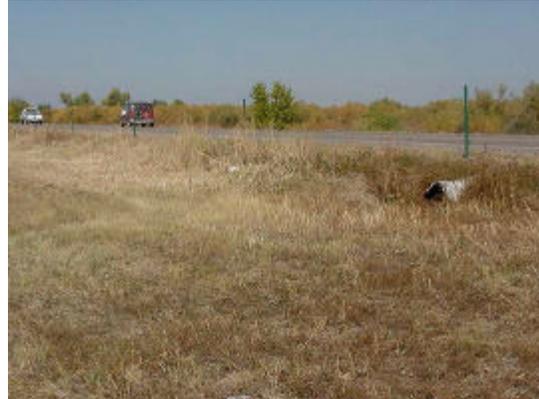
Collection of seven 36-inch Cross Culverts
(three shown)

4.3.1.4. Mile 329 – 330, Inadequate Cross Drainage, vicinity Arkansas River Floodplain. This area begins in the vicinity of the junction of US 50 and CO 96 and extends east approximately two miles along US 50 to the bridge over the Arkansas River (structure L-19-H). There are presently only two locations where cross drainage can occur, a single 72-inch CMP and at a collection of seven 36-inch CMPs located just west of the intersection of US 50 and the roads to Avondale and North Avondale.

The area is located within the floodplain of the Arkansas River; US 50 is often overtopped during flood events. Flood flows originate from the Arkansas River to the south, flow northeast towards US 50 paralleling the Arkansas River, then return to the river just north of the US 50 bridge. The road was last overtopped in 1999 by as much as 1-ft of water and was closed to traffic for over 14 hours. Improvements will likely require raising the US 50 roadway surface and installing additional cross culverts.

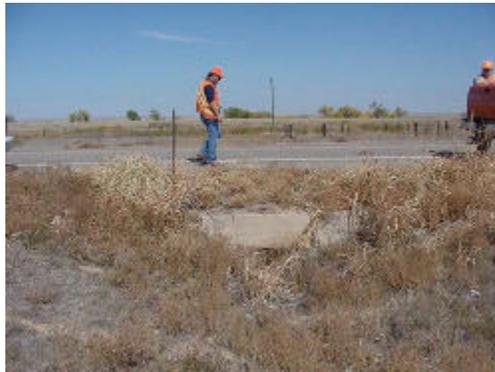
The existing CBC located just west of the Nepesta Road intersection is undersized and overtopped often. Flows to this CBC include roadside drainage and overland runoff for a substantial area to the south and west. The CBC outfall is a ditch that flows approximately 500-ft to and into the Rocky Ford Highline Canal. Upsizing of the CBC and improvements of the outfall ditch will be required.

Undersized CBC near Nepesta Road Intersection

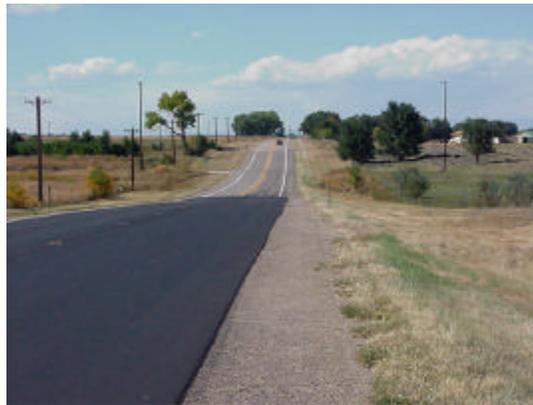
Low area between mileposts 345 and 346

This area is accumulating silt and will be a long-term problem area. The existing small CBC is barely adequate. Will need to raise elevation of US 50 and increase capacity of the drainage structure.

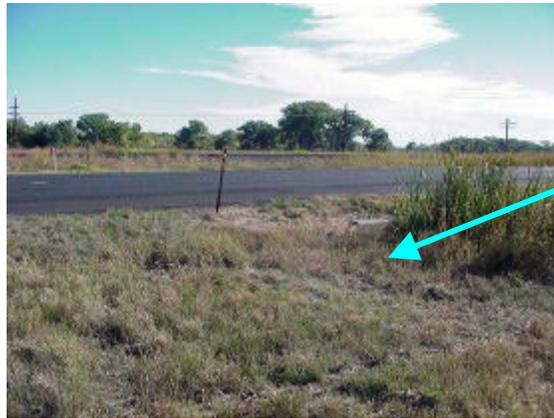
This area is drained with a combination of a small CBC and buried clay tile pipes. Contributing flows are combined stormwater runoff and irrigation drainage. After crossing beneath US 50, there is no established drainage north of the BNSF Railroad embankment to the Arkansas River. Some of the clay tile pipes have probably failed as evident by the need for constant shoulder repairs near the CBC outfall. There is most likely a failed clay tile pipe directly beneath the existing CBC. This area will need a properly sized (increased capacity) structure and drainage established to the Arkansas River. The drainage may be diverted to the west between the BNSF ROW and US 50, and then to the Arkansas River, however an irrigation siphon may be a conflict.

Box culvert
inlet

Undersized Box Culvert, Mile 348.5, looking northeast

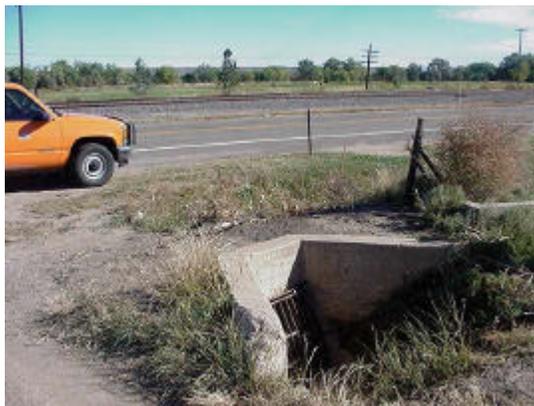
This area is directly across from the Fowler Golf Course on the southside of US 50. There is no cross culvert beneath US 50. Flows appear to be directed entirely to the east along the south side of US 50. However, there is no outfall for the ditch to the east, it just dead ends! Flooding of a private residence and a commercial storage facility occurs routinely. There is an irrigation siphon that crosses beneath the roadside ditch and flows north under US 50. If a cross culvert was installed, there is no established drainage north of the BNSF ROW or through the Golf Course. Walt Pachak, CDOT Pueblo has apparently done some design work to correct this problem; extent of design work is unknown at this time.

Irrigation Siphon under Roadside Ditch

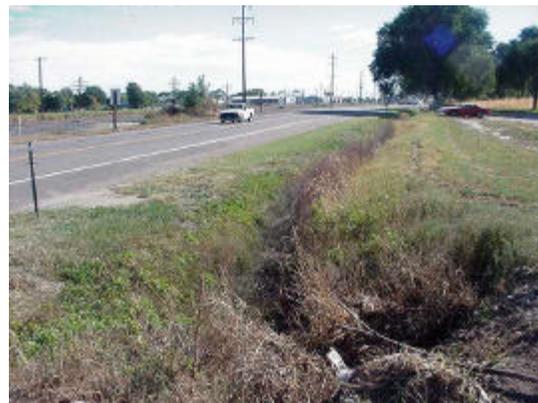
Dead End Roadside Ditch, looking east

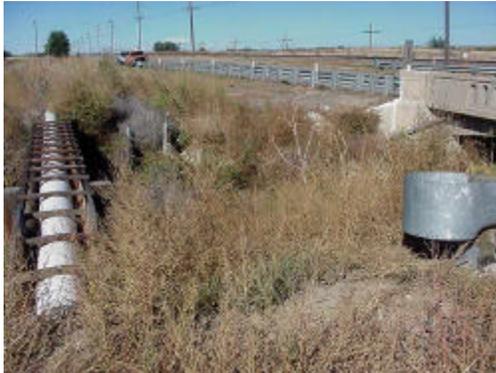
This problem is immediately adjacent to CDOT Structure L-21-A, on the south side of US 50. As the roadside ditch outfalls into the Otero Canal there is significant erosion between the roadside ditch and shoulder of US 50. Timber cribbing placed along both sides of the roadside ditch is currently controlling the erosion.

Roadside Ditch Outfall into Otero Canal

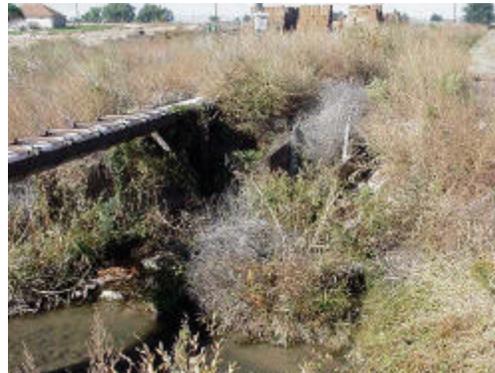
Erosion at Outfall & Temporary Wood Cribbing

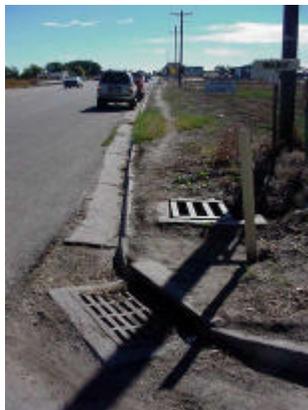
This area has curb and gutter and 4 to 5 storm drain inlets along the southside of US 50. However the pipe connecting the inlets also receives irrigation drainage and silts up quickly. The pipe slope is too shallow causing the storm inlets to back up and water to spread across US 50. The stormdrain pipe crosses beneath the Catlin Canal just east of Manzanola and daylights approximately 500-ft east of the Catlin Canal's crossing under US 50. The stormdrain outfall is heavily silted and must be cleaned at least 3 times per year. A suggested solution is to connect the existing pipe directly to the Catlin Canal on the northside of US 50, where the canal parallels US 50 just east of Manzanola. Any new cross culvert/connections would flow north under US 50 and outfall directly into the Catlin Canal.

Storm Drain Irrigation Drain Inlets

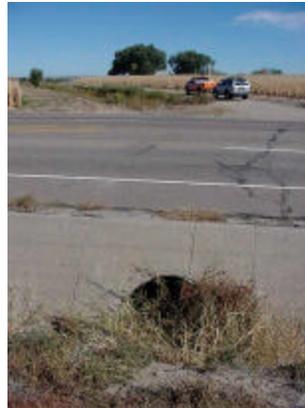
Cross Culvert Looking North Toward
Drainage Ditch and Piggy Back Culvert Outfall

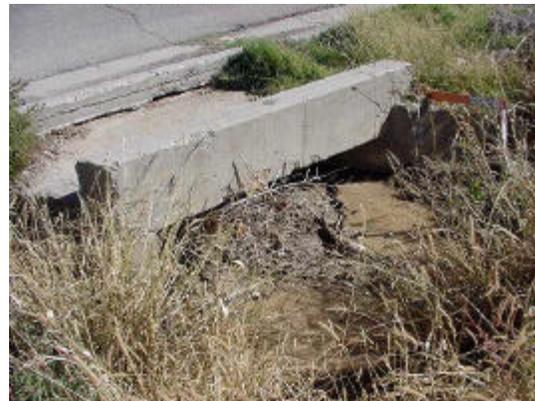
The existing structure beneath US 50 is inadequate, as is the ditch that receives the water and flows north along SH 71 to the Arkansas River. This intersection floods routinely. The existing structure needs to be increased in size and the slopes increased to prevent silt accumulation. Road 18 intersects US 50 from the south and acts as a divide with all flows to the east of the Road 18 intersection flowing east to a different cross culvert. Flows from the west flow to the intersection and underneath US 50 through the existing structure.

Silted Cross Culvert Entrance with Debris

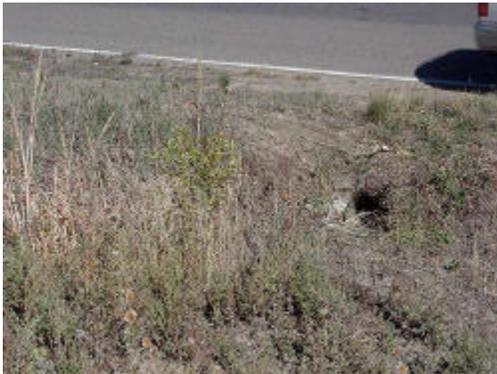
There are two 24-inch cross culverts beneath US 50 at this location, one directly north of the BNSF bridge structure and one approximately 500-ft to the east at the intersection with County Road 22. The BNSF structure has substantially more capacity than the two 24-inch cross culverts. The existing culverts must be upsized to better match the railroad structure. Flooding has occurred at this site with depths in excess of 3-ft in the eastbound lane.

One of two 24-inch Cross Culverts under US 50

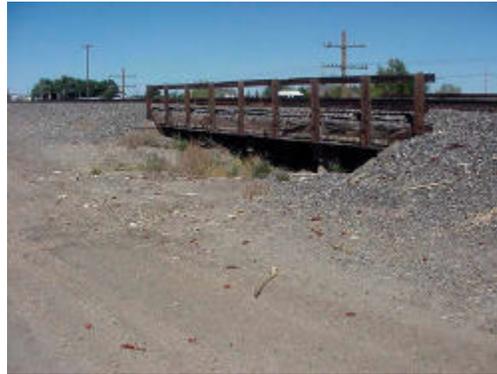
Railroad Structure 50-ft upstream
of 24-inch Cross Culvert

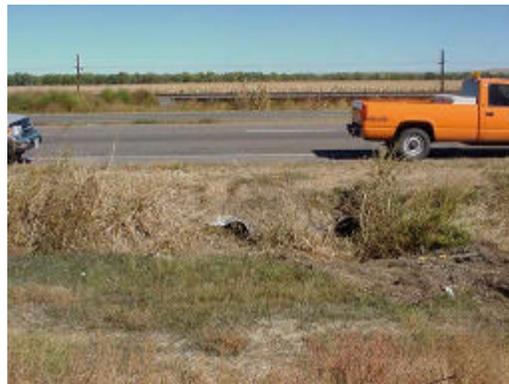
Two 36-inch CMP culverts drain the area in and around the new Wal-Mart store. Culverts are adequately sized but there is no established drainage north of the BNSF Railroad embankment to the Arkansas River. Flows are currently ditched to the west along the northside of the railroad embankment to the King Ditch. Flows to this culvert come along the southside of US 50 from the King Ditch on the west, Wal-Mart store and surrounding area to the south and the KOA campground to the east. This area will require a new established ditch/outfall to the Arkansas River.

Twin 36-inch Cross Culverts with no place to drain

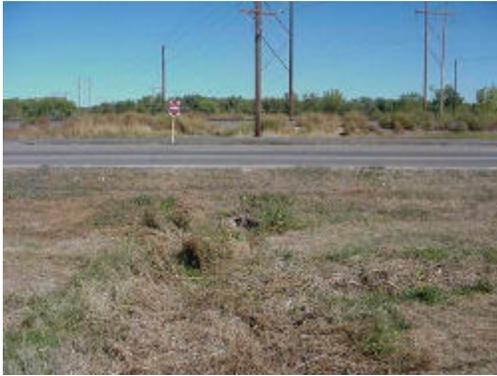
There are two existing 24-inch CMP culverts beneath US 50 which are too small to handle the ditch flows from the south side of US 50 and adjacent stormwater flows. Adjacent to US50 to the north are 6, 48-inch CMP culverts beneath the BNSF Railroad embankment. However, downstream (north) of the railroad grade there is no established drainage ditch to the Arkansas River which is approximately 200-ft to the north. A small ditch with an 18-inch culvert under a gravel access road currently takes the flow toward the Arkansas River but is barely adequate for anything but minor flows. Increased sized culverts beneath US 50, and an established drainage ditch to the Arkansas River, will be required for improvement.

24-inch Cross Culverts under US 50
6, 48-inch culverts under RR grade in the distance

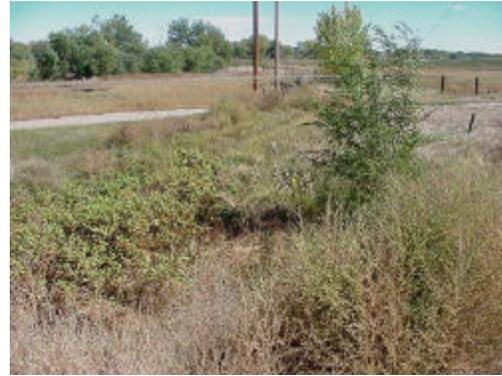
Small Drainage Ditch looking toward the 18-inch
culvert and Arkansas River

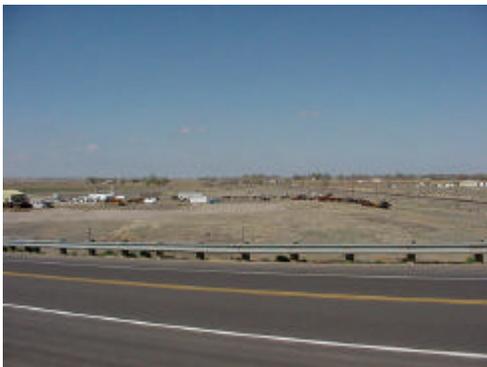
4.3.3.2. Mile 397.7, BNSF RR Overpass. A combination of the elevated BNSF Roadbed and the US 50 bridge approach embankments, on both sides of the bridge over the BNSF railroad tracks, isolates adjacent properties and contributes to reduced drainage. The properties lie between the US 50 ROW and the BNSF railroad tracks (see map). There are no cross culverts or established ditches to provide positive drainage.

Low area that lacks drainage, west of US 50

Corrective action for this area will most likely include improvement of local drainage ditches along the BNSF railroad tracks and possible inclusion of cross culverts beneath the BNSF ROW.

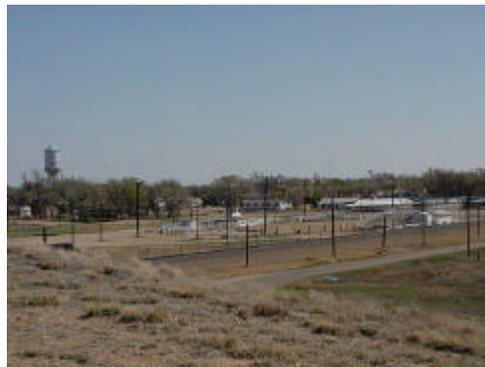
Low area near arena lacks drainage, east of US 50

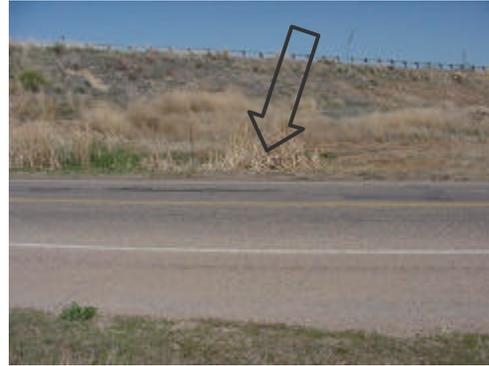
Low/wet area north of SH194 & east of US 50

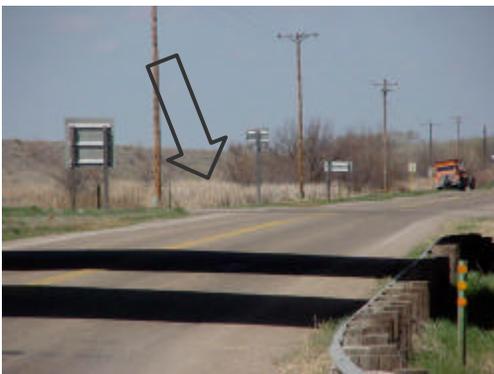
Low/wet area south of SH194 & west of US 50

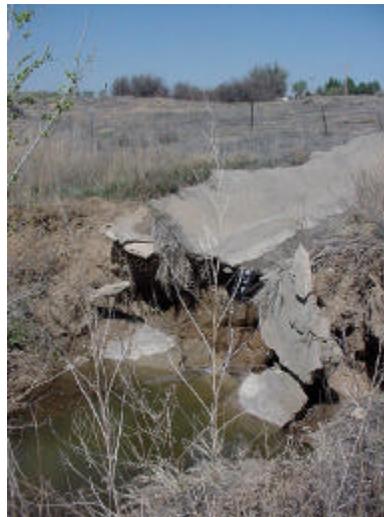
Head cut at downstream end of lined ditch

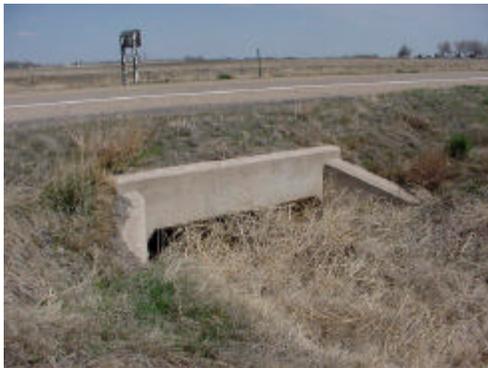
4.3.3.7. Vicinity mile 416 - 417, Hasty, CO. As the US 50 corridor passes through the settlement of Hasty, CO., the highway lays within a large localized depression. During periods of significant precipitation, drainage accumulates along the northside and overtops the US 50 ROW. Two cross culverts, just east and west of Hasty, direct flow beneath US 50 and into ditches that generally drain south and away from US 50. Bent County currently maintains the ditches. Within the settlement of Hasty, two drop inlets, on the northside of US 50, coupled with miscellaneous small berms direct drainage and protect residence and businesses in Hasty.

Cross culvert under US 50, west of Hasty

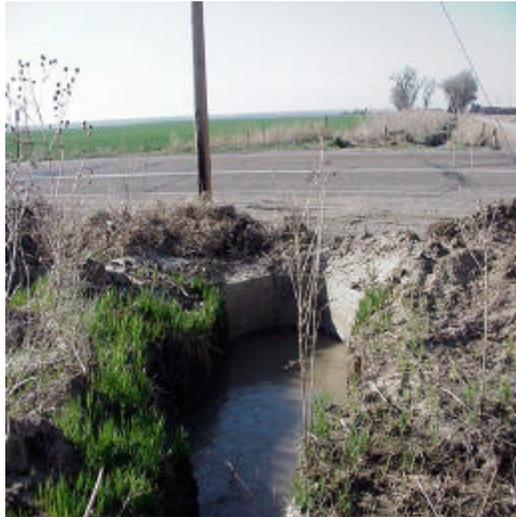
4.3.4.1. Mile 420.8, Intersection of US 50 and SH 196, Undersized and Old Cross Culverts. Three culverts cross US 50 at this location. Two culverts are for irrigation and a third for roadside drainage. Approximately 100-ft north of the intersection, along the east side of SH 196, is an existing division box/structure for the irrigation culverts. Any improvements to this intersection will need to consider the location and hydraulics of the division box. All three culverts are very old (1920 – 30’s). The existing 30-inch (estimated) roadside drainage culvert should be re-evaluated for size using current hydrology and hydraulic design methods.

Irrigation culvert US 50 & SH196 intersection

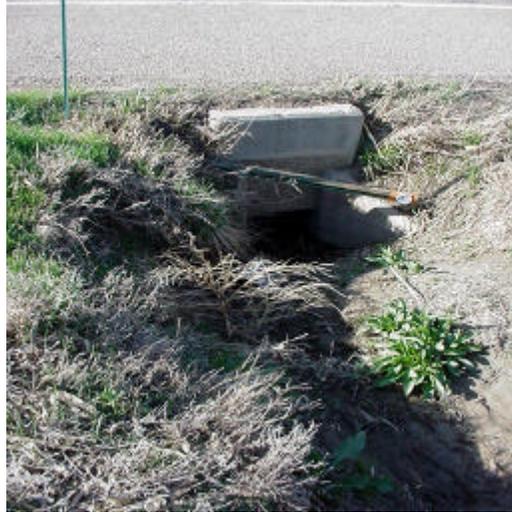
4.3.4.3. Mile 422.1, Undersized Irrigation Cross Culvert. This location typifies the numerous existing small irrigation crossings of US 50 just west of Lamar. Most crossings would benefit from re-evaluation of structure capacity and size.

Typical irrigation ditch cross culvert beneath US 50 west of Lamar, CO

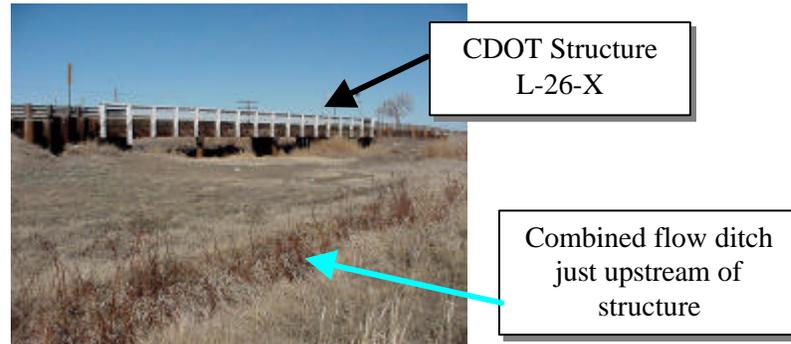
4.3.4.5. Vicinity mile 438 to 439.5, Combined Flows - Drainage and Irrigation tailwater. This southside ditch of US 50 receives combined roadside drainage and irrigation tailwater flows. Flows in this ditch travel east along the US 50 ROW and are discharged into the Willow Creek Overflow channel, immediately upstream of the US 50 structure L-26-X. For most storms the ditch capacity is adequate. However, during larger storms, water accumulates and ponds alongside US 50.

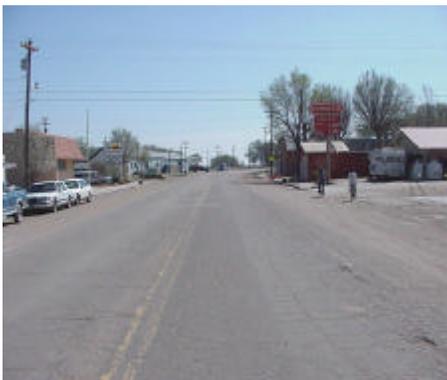
4.3.4.8. Mile 452.5, Granada, CO. There is no established stormwater system within the settlement of Granada other than a very basic system of disjointed curbs and gutters. There are no stormwater inlets or conduits. Existing conditions require stormwater to slowly migrate east through the center of Granada before entering roadside ditches on the eastern end of town. Improvements in this area should consider an underground system of inlets and conduits to remove stormwater runoff from US 50.

Granada, CO, US 50 looking east

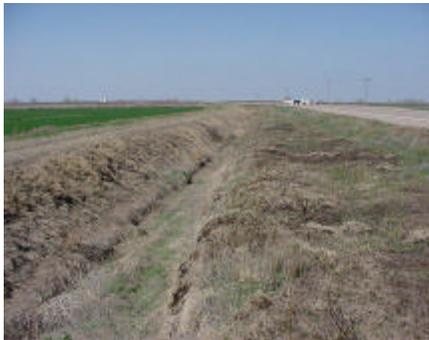
4.3.4.9. Vicinity mile 458 to 460, Aged Seep Ditch and Culvert Crossing. For two miles along the US 50 ROW, this seep ditch parallels the highway along the south shoulder from mile 458 to 459 where it crosses beneath US 50 in a very old CMP. After crossing under US 50 the ditch continues to flow along the north shoulder to mile 460 at which the ditch alignment diverges away from US 50. This ditch was originally constructed to gather seep water from the surrounding agricultural fields. The ditch is relatively deep (8 to 10-ft) making for a hazardous area immediately adjacent to the US 50 ROW. In many locations the agricultural fields are no longer used or irrigated and therefore flows are a fraction of the original ditch design capacity. CDOT does not maintain this ditch since it is outside of the ROW. Improvements to this portion of US 50 will be constrained by the proximity of the ditch to CDOT ROW.

Seep ditch along US 50 ROW

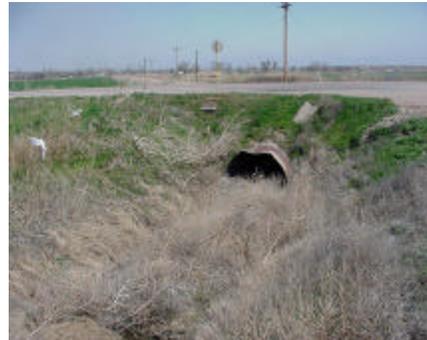
Seep ditch cross culvert under US 50

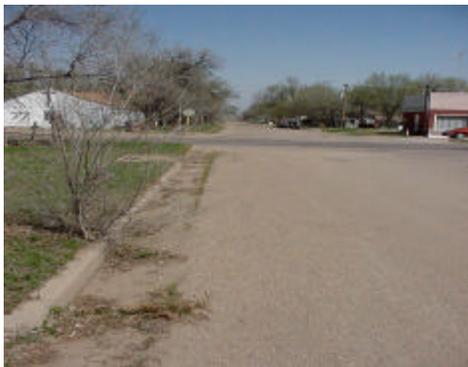
4.3.4.10. Mile 462.5, Holly, CO., Low Intersection. The intersection of US 50 and South 10th Street in the town of Holly accumulates water and does not drain efficiently. The intersection is in a localized low spot and water is forced to pond to a depth of approximately 3-inches before draining south along the west curb line of South 10th Street. There are no existing storm drain inlets or system. Stormwater routinely accumulates in the intersection from the north and is deepest in the westbound travel lane of US 50. Improvements should consider a system of inlets and pipes to properly drain the intersection.

South 10th Street looking north across US 50 intersection
